## **HISTORIC STRUCTURES REPORT**

# **Old Faithful Lodge Yellowstone National Park**

**NOVEMBER 1995**

Prepared By:  
**JAMES R. MCDONALD ARCHITECTS**  
**224 North Higgins Avenue**  
**P.O. Box 8163**  
**Missoula, Montana 59807**

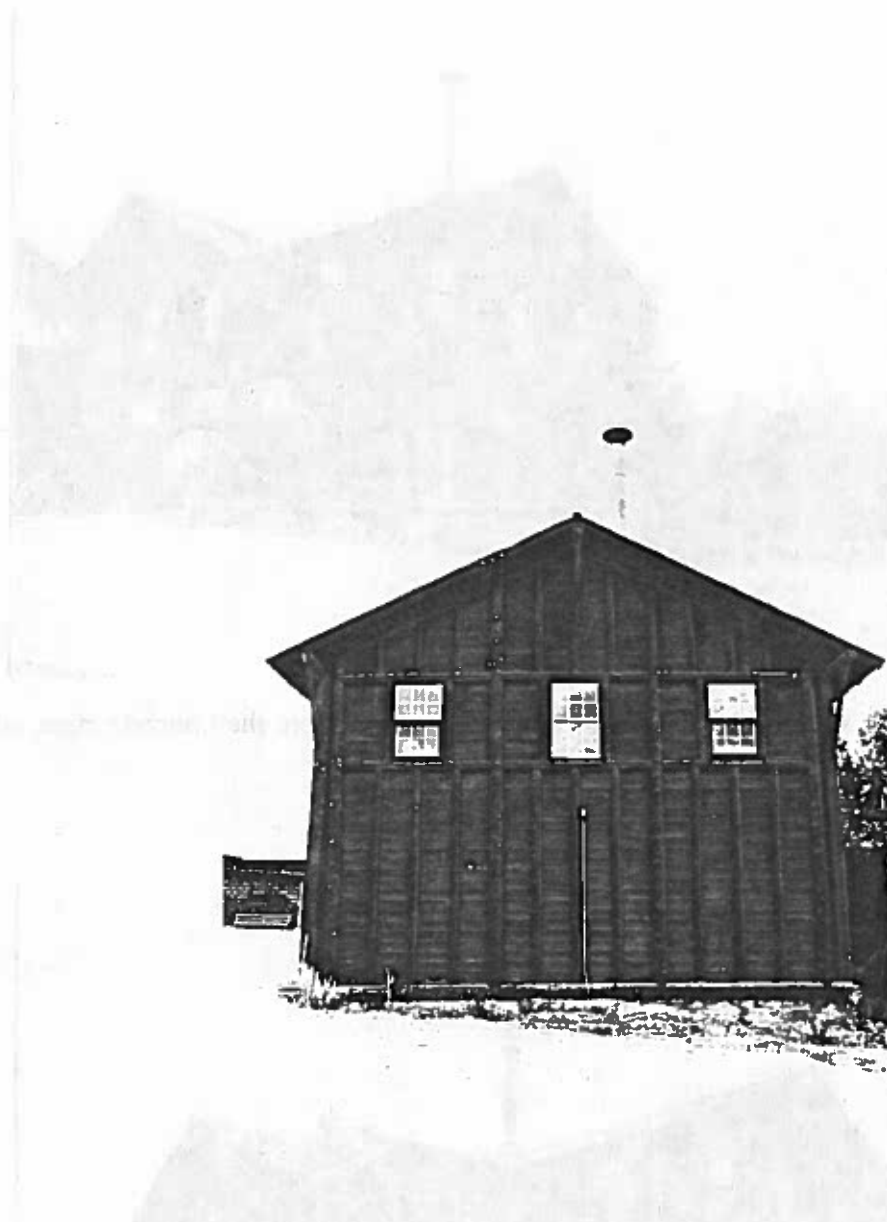
**Figure 211:** Looking west at the Boiler Plant building. Note the weathered sill log and the grade on the south side of the building.

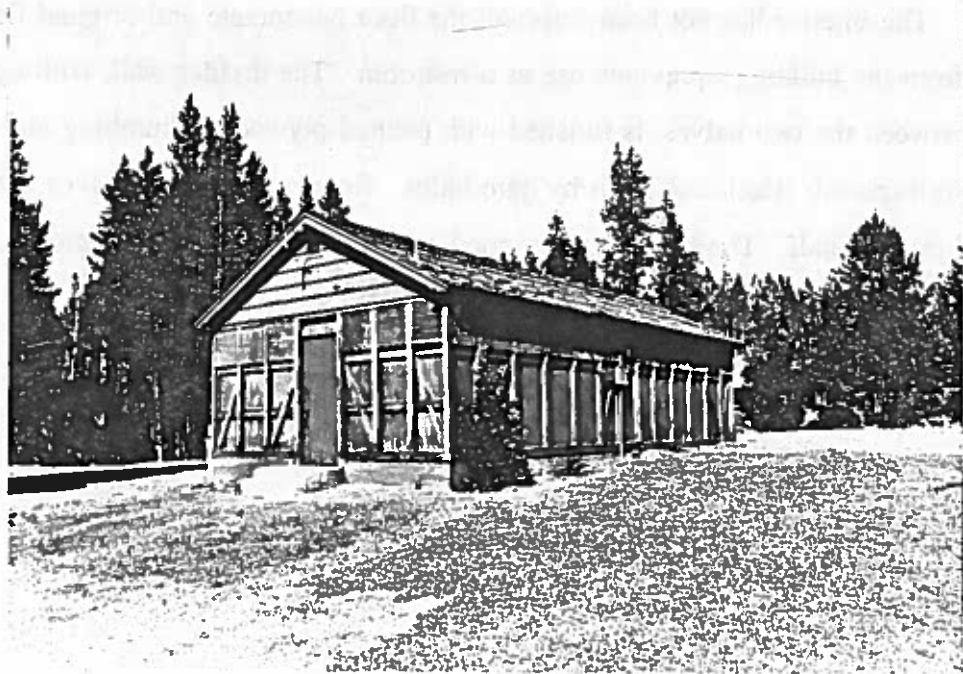
**Figure 212:** Looking northeast at the lower loop linen building. This frame-out building has a poor roof and there is deteriorated wood on the walls and frame. The concrete stoop is also, in poor condition.

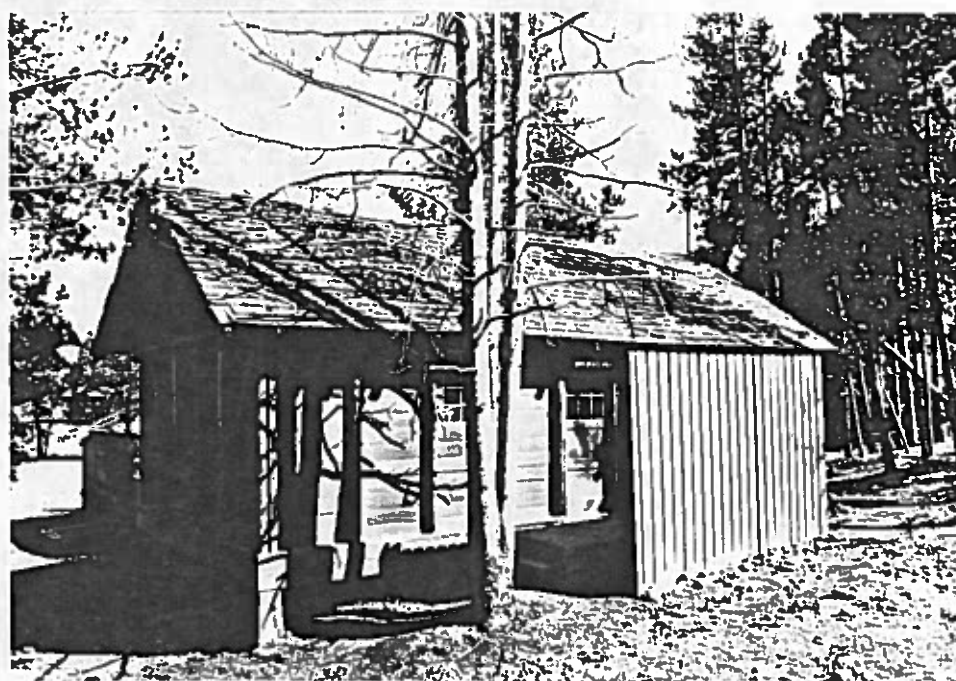
Figure 222: Looking east at the employee laundry building. The roof on this structure in poor condition.

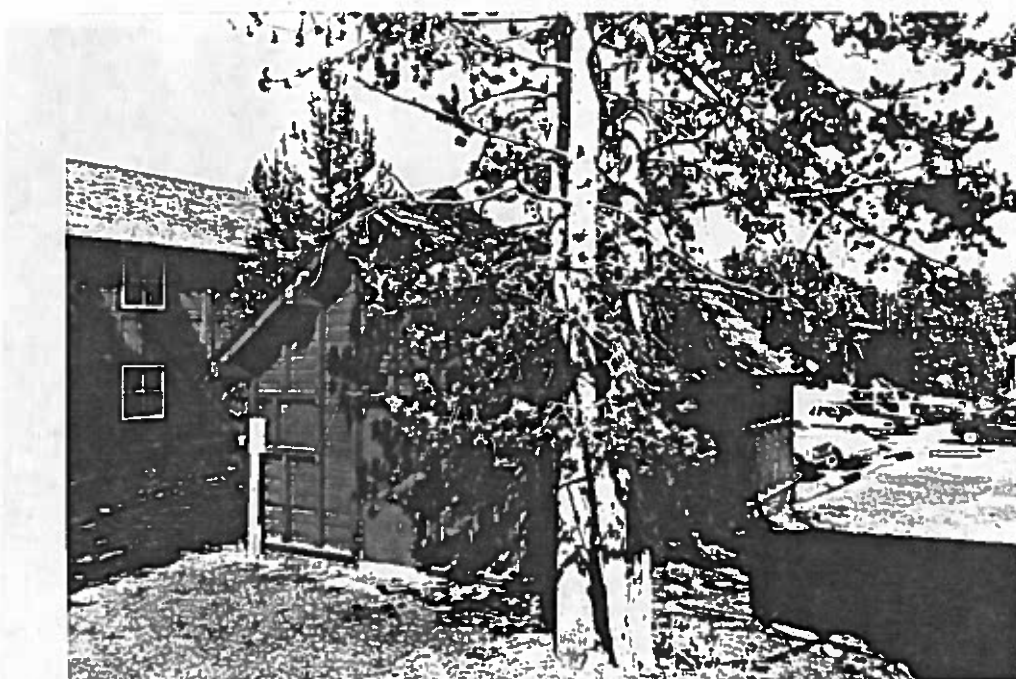
Figure 223: Looking east at the winter storage building. There are some rotted base timbers and the grade around especially the west end is poor.
