# SHAWNEE, OHIO

## Priority Property Asset Report

**Original Town Hall & Garage**  
**Address: 105 West Walnut Street**  
**Owner: Village of Shawnee**

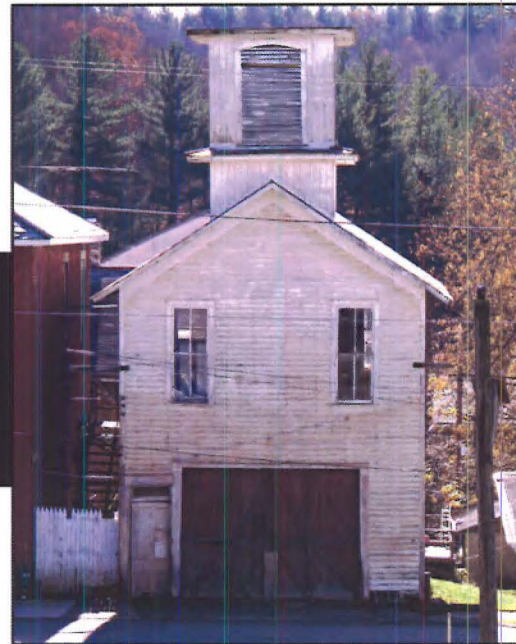
The exterior of the building is covered with a profiled horizontal wood lap siding. The condition of the siding varies from fair (needing cleaning, sanding and new paint) to poor (warped, bent, cracked, due to the settlement of the building). A considerable amount of the siding material is badly damaged or missing, especially in the one-story portion.

Double hung wood windows are similar to the windows in the adjacent Town Hall, but with simple wood trim. Some of the windows are either missing entirely, missing sash, glass or frames. The windows appear to be original and are in poor to fair condition, where present.

The attic/roof space was not accessible but roof framing can be assumed to be wood rafters or trusses spanning east-west (20'). The slate roof shows a lot of staining. There are no gutters remaining on the building so no means of intercepting roof run-off. There are old downspout leader brackets remaining in some places on the building. This has likely contributed to the deterioration of the stone foundation and settling. This is not a good situation especially on this hillside site, as drainage may undermine foundations on this property and other downhill properties.

Overall the building is in poor condition. Floors are not level and walls not plumb. As noted previously there are areas of concern that should be addressed soon to prevent further decay that may make the building more difficult and/or more expensive to repair at a later date.

Demo rear addition. Repair stone foundations. Repair/replace windows. Salvage, clean, paint, re-install lap siding and trim. Provide new roof. Provide new gutters and downspouts and run out to acceptable discharge point. Repair belfry shutters, trim, etc.

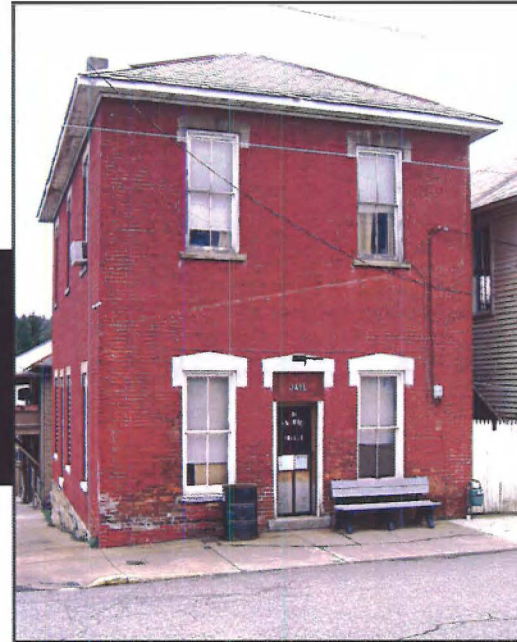
The exterior of the building is brick painted dark red. The brick is generally in good condition with no large areas of missing mortar, etc. The west side of the building was difficult to observe and should be looked at more closely.

Double hung wood windows have sandstone lintels, some peaked, some flat, and jamb drops. Some lintels have been painted white, some are exposed sandstone, similar to the lintels on the K.of P. Hall. The windows in the jail room have closely spaced iron bars over the openings on the outside. Some are painted white. The windows appear to be original and are in fair condition. As to be expected, deteriorated exterior frames (especially the sills) are evident. Each sash is glazed with two panes of glass, side by side. Some glass is broken or missing and has been covered for weather protection.

Overall the building is in fair to good condition. Floors are generally level and walls plumb. As noted previously there are areas of concern that should be addressed soon to prevent further decay that may make the building more difficult and/or more expensive to repair at a later date.

*The intent of this work would be to improve the exterior appearance of the building and to make necessary building envelope and structural repairs (if necessary) to prevent further deterioration of the building.*

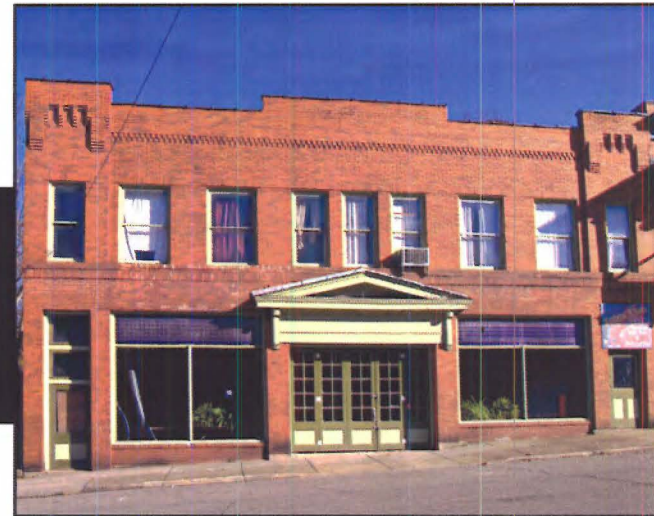
Address: 126 West Main Street

An area of concern is the condition of the back portion of the first floor which extends beyond the back wall of the second floor, thus the ceiling in this area is also a roof. Over time water infiltration and ground moisture has caused the steel beams to rust. A section of steel form decking (installed to allow placement of the concrete roof) is hanging down into the space. Portions of the back wall have been replaced or braced with newer concrete masonry unit construction. There is an area of about one square foot where daylight is visible through the roof/ceiling. A window in the room in the northwest corner of the first floor has earth up against it.

On the front façade there is a noticeable bulge in the brick at the second floor line towards the west end door leading to the stairs up to the apartment. It appears that the brick mortar in this area has been replaced/repared as all joints appear tight. On the inside of the first floor the masonry wall separating the main space from the stair to the apartment has extensive cracks at mortar joints and evidence of some settling or displacement of about 1-1/2". The stairway side of this wall is faced with plaster and has no cracks.

The first floor could continue to serve as garage/storage space "as is". Still the rear area water infiltration and structural concerns should be addressed, possibly by isolating the rear section with a new concrete masonry wall added underneath the east-west beam line. While this would subtract about 600 square feet of area, these back area spaces are not currently used and are significantly deteriorated.
