# **PRESERVATION AND REPAIR OF THE WINDOWS AND DOORS OF THE CURTIS FREEWILL BAPTIST CHURCH**

**HARPERS FERRY NATIONAL HISTORICAL  
PARK**

**HISTORIC STRUCTURES RECORD OF  
TREATMENT**

Harpers Ferry National Historical Park  
FY-2006

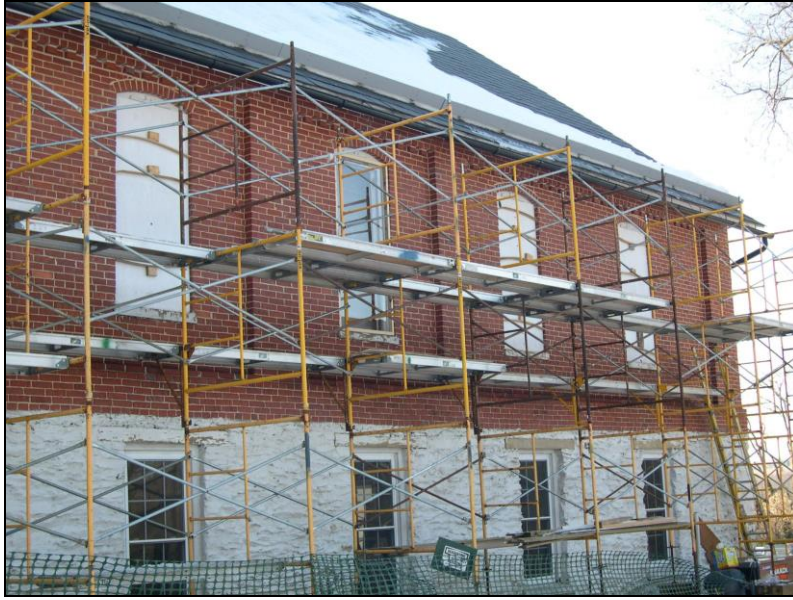
**Photo 1: First floor sash were removed and temporary enclosures were installed**

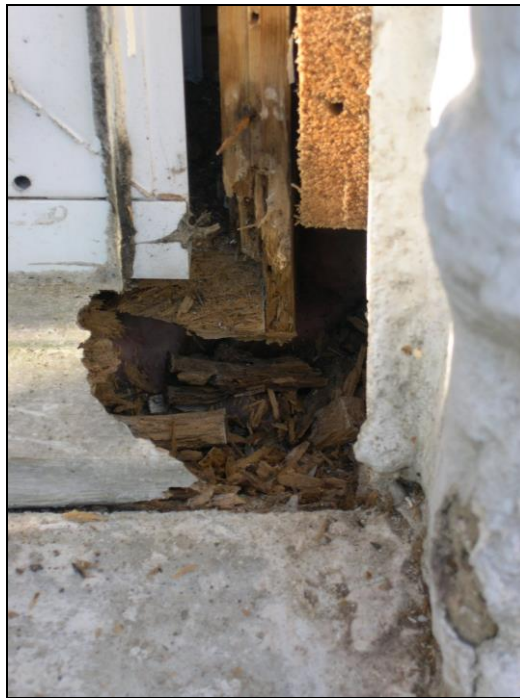
**Photo 2: Deteriorated components were documented**

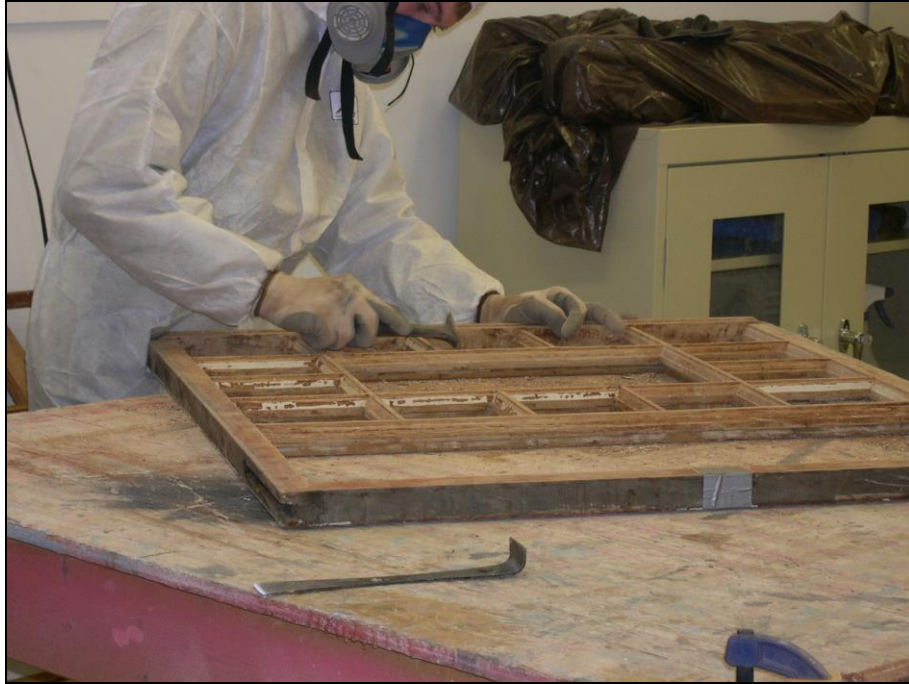
**Photo 3: Lead paint being scraped from the sash at our Jenkins facility**

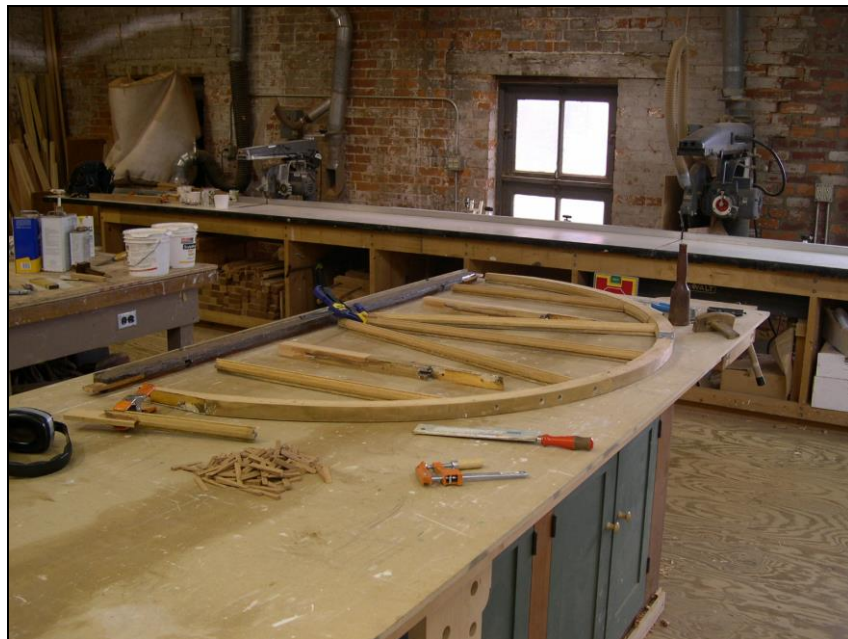
**Photo 4: Carpentry repairs to the west elevation lunette**

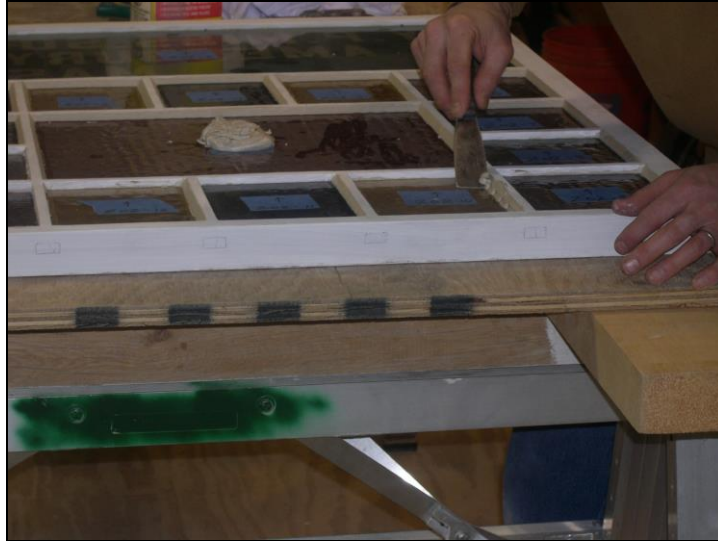
**Photo 5: Glazing the sash**

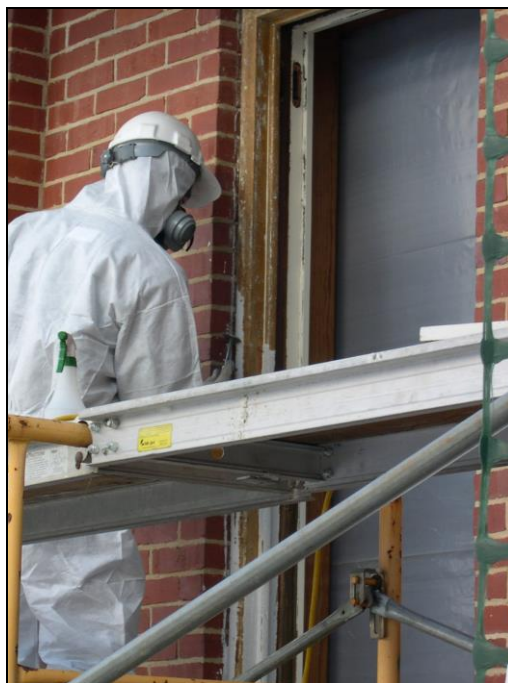
**Photo 6: Scraping paint from the window jambs**

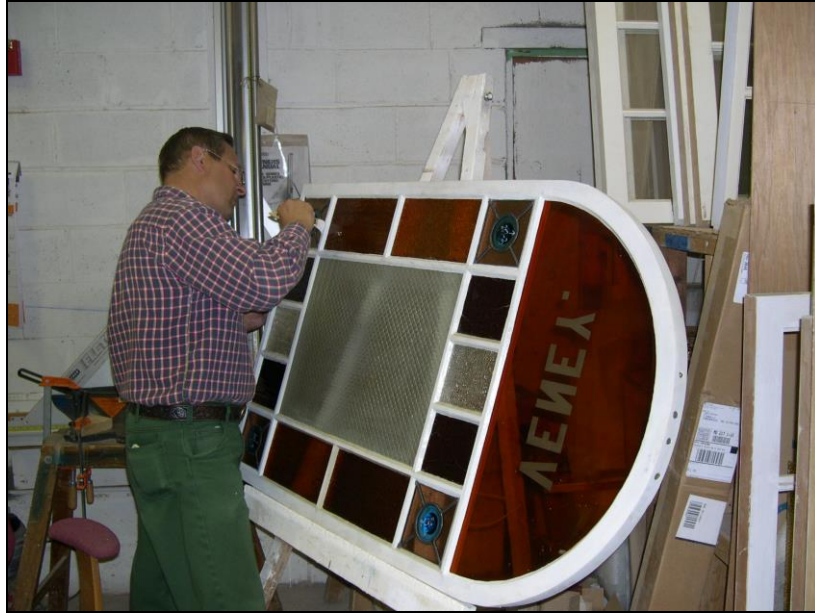
**Photo 7: Painting the sash**

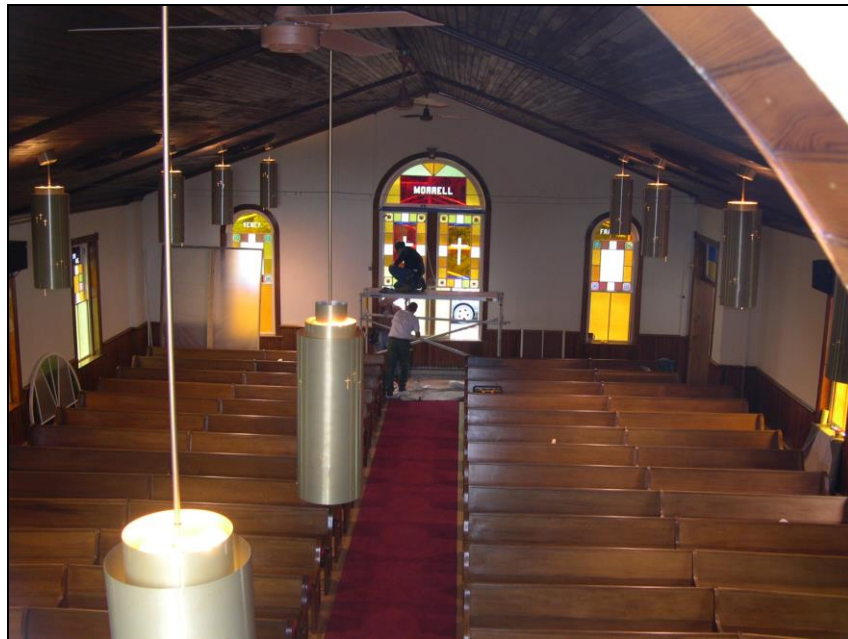
**Photo 8: Installing the east elevation windows**

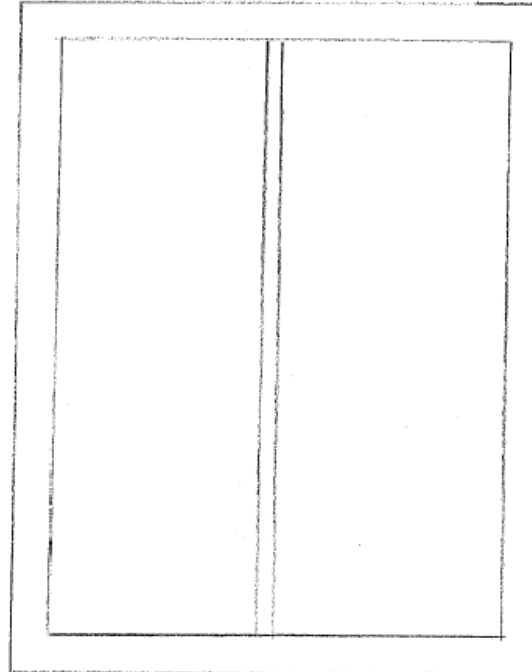
Window #: 201  
 Elevation #: S  
 Location: Lower

leaky original

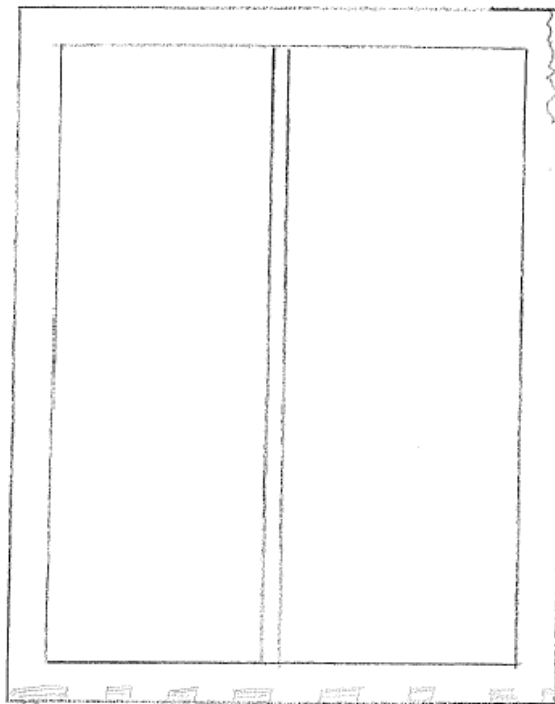
Window #: 202  
 Elevation #: South  
 Location: Lower

① timberflex  
 ② crack glued

Glass OK

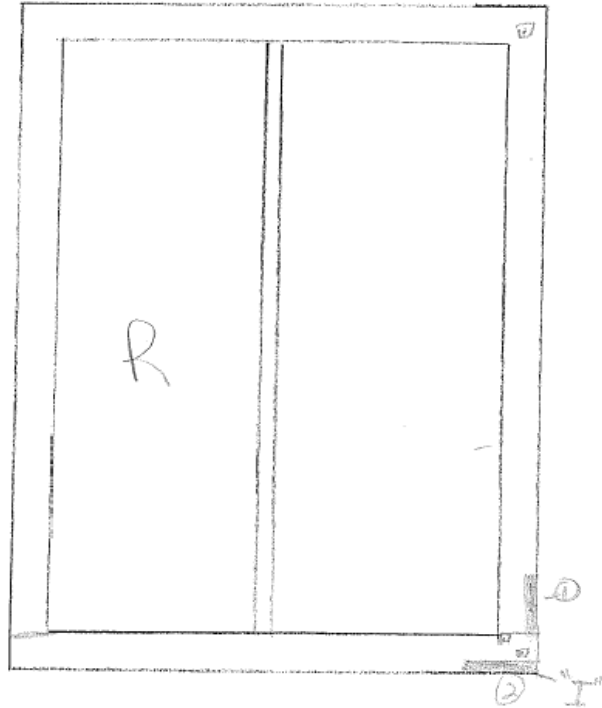
Window #: 203  
Elevation #: South  
Location: Lower

- ① Dutchman - east stile (interior pocket)  
glue to interior stile
- ② Dutchman - bottom rail

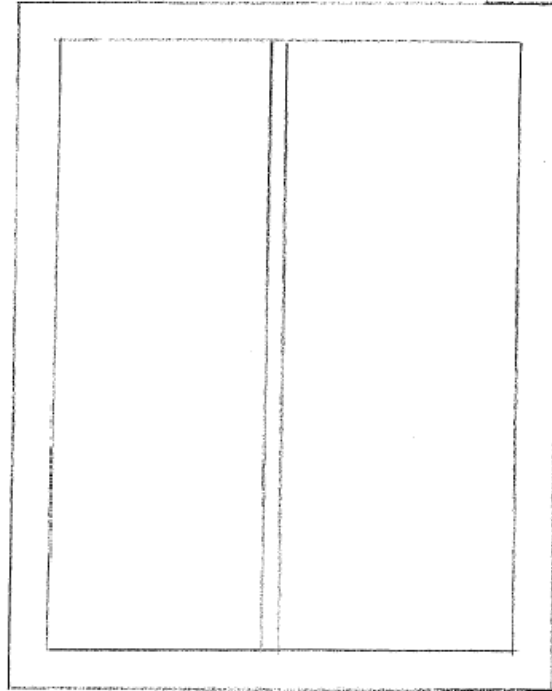
Window #: 205  
 Elevation #: E  
 Location: Lower

end grain repair

Glass OK

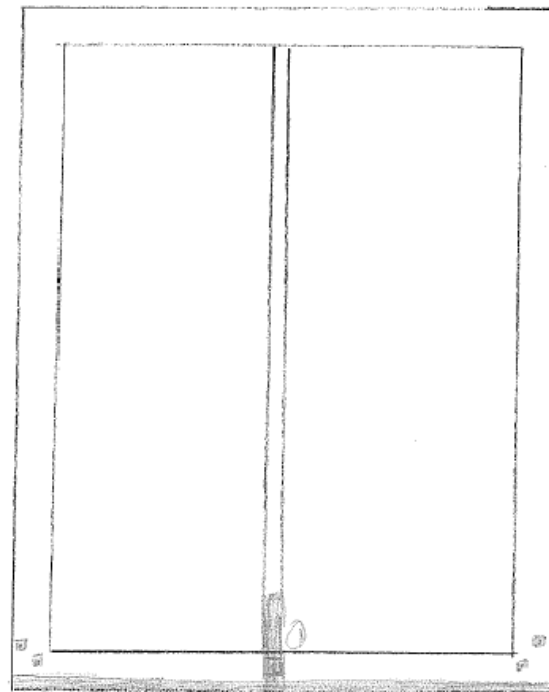
Window #: 206A  
Elevation #: E  
Location: Lower

① - known repair  
② - Dutchman at bottom rail

end grain consolidated

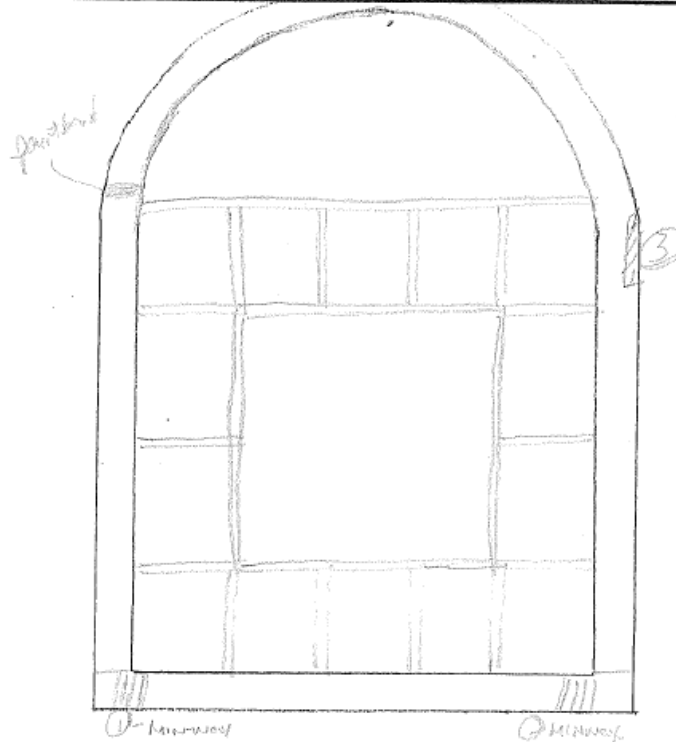
Window #: 207  
Elevation #: East  
Location: Upper

(1) - build-up frame  
mainly just holes filled w/ mixway

(3) - part of sash cord pocket filled w/  
topology

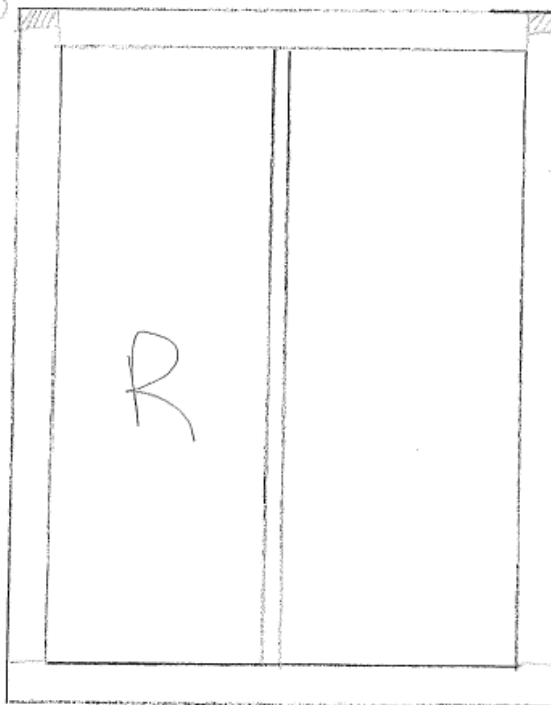
Window #: 209  
 Elevation #: N  
 Location: Lower

1x2" epoxy edge grain

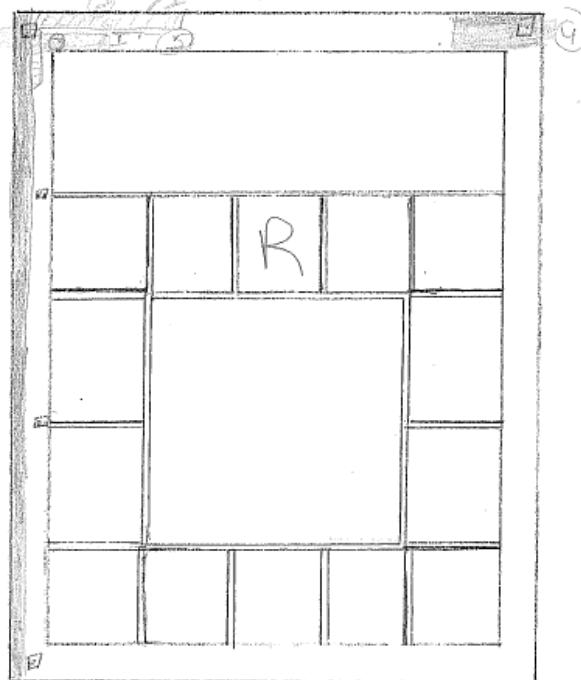
Window #: 210  
 Elevation #: North  
 Location: Upper

- ① Dutchman west side
- ② crack treated wood
- ③ - timberflex system
- ④ Dutchman thru to frame (East side top Rail)
- ⑤ Dutchman thru to frame (West side top rail)

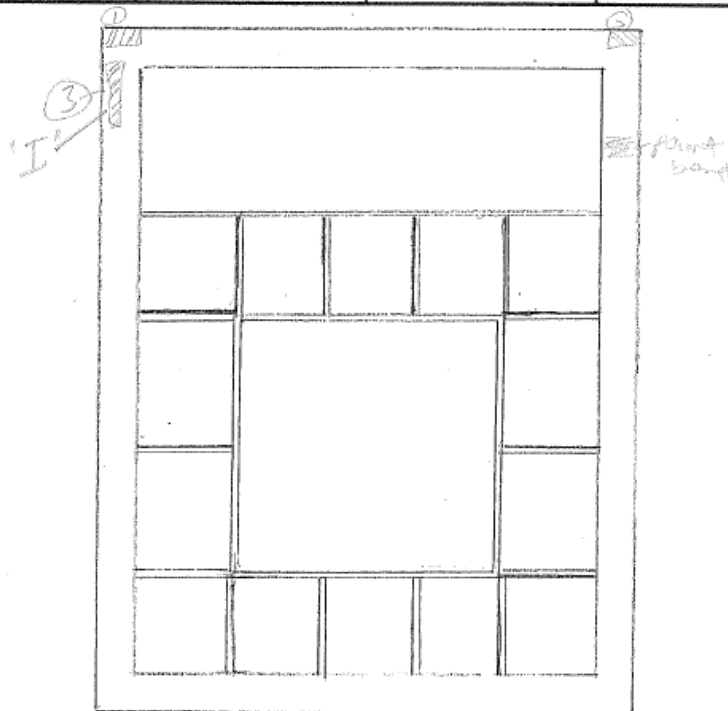
Window #: 211  
Elevation #: North  
Location: Upper

(1+2) end joint treated with epoxy (west)

② = Crack filled with epoxy (west) on WEST side (interior side)

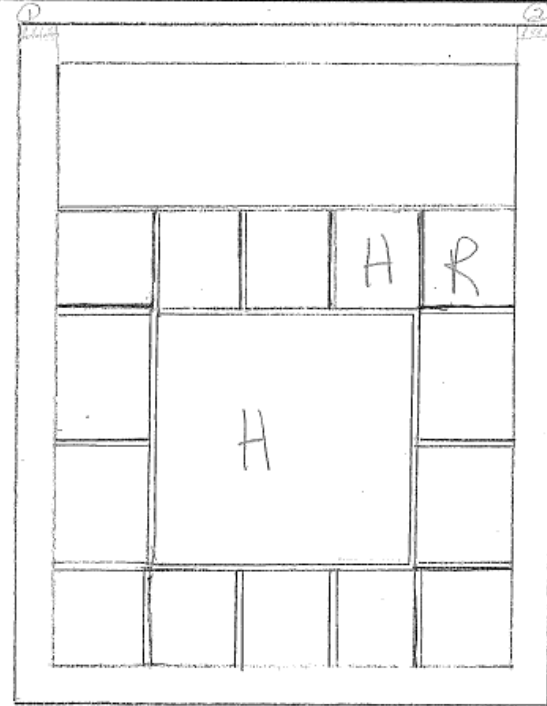
Window #: 212  
Elevation #: Norm  
Location: Upper

H2 epoxy on end grain

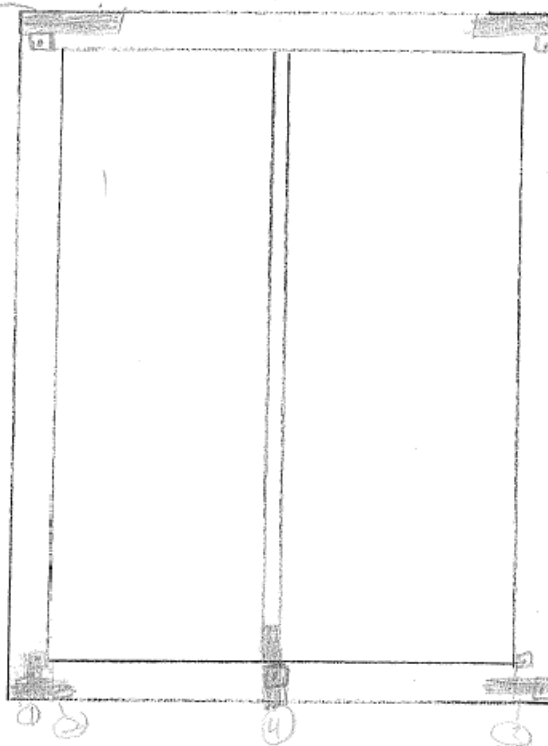
Window #: 212  
 Elevation #: N  
 Location: Lower

- ① dovetail repaired (new)
- ② tenon repaired
- ③ tenon repaired

Glass OK
