# NORTH PACIFIC HALL

## SOUTH FACADE RESTORATION

HISTORIC RESTORATION TEAM | Summer 2015

Sitka Fine Arts Camp | Sheldon Jackson Campus, Sitka, Alaska

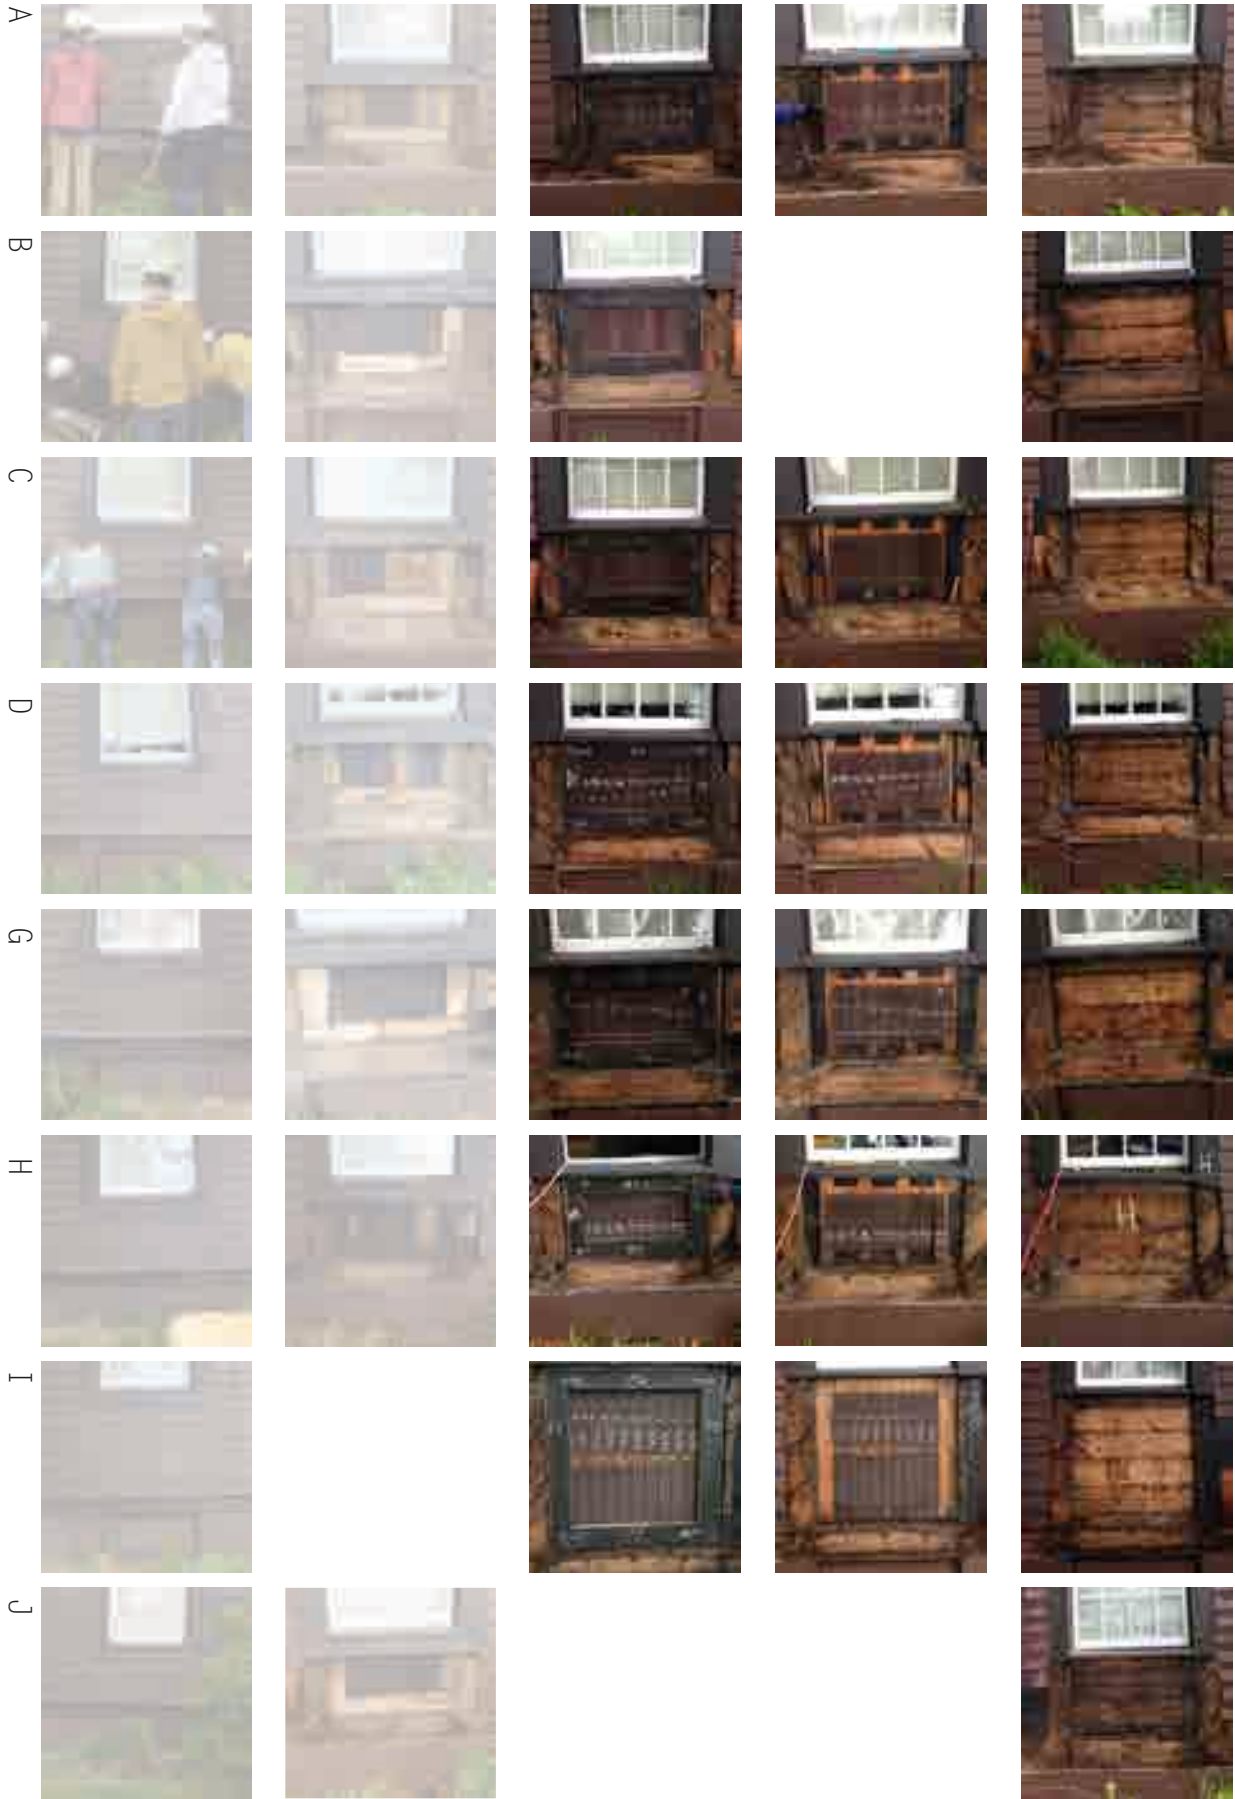
ORIGINAL WOOD PANELS ARE REVEALED AFTER SHINGLE REMOVAL, THEN ARE TAKEN DOWN TO PREPARE FOR WATERPROOFING

Work began on Wednesday with the careful removal of the paneling below each ground level window, with care to protect the tongue-and-groove pattern of the boards' edges for proper fit. Sheldon Jackson College stencils and handwritten equations were discovered on some of this wood. With the paneling removed, sheets of Vycor waterproofing was applied to the wood underneath.

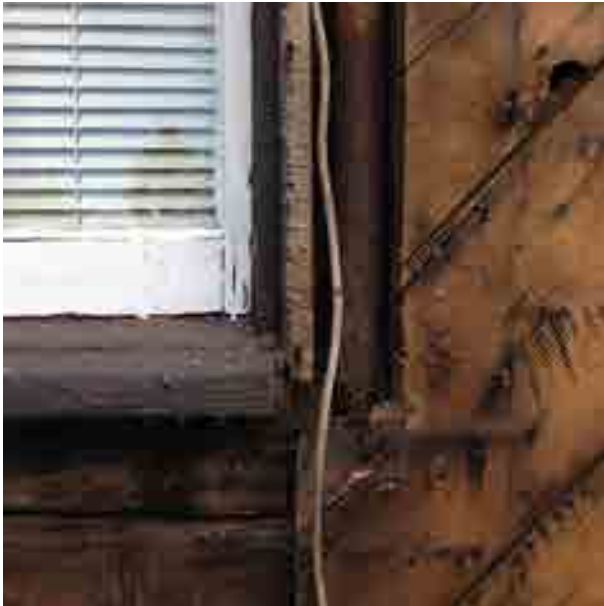
WINDOW SASH WEIGHT REPAIR: SASH WEIGHTS AND CASINGS REMOVED

Work continued on Thursday to repair the window sash weights. The last of the vertical casings were removed, and replacements were fabricated to newly-taken measurements - the lengths are not uniform for each window, or even each side of each window. More shingles were removed from the building - some bore the stencil HAWLEY MILL CO. - PERFECTION - MILLTOWN, WASHINGTON. Cursory internet investigation yields no record of this mill beyond 1921. As interns began to remove shingles beyond ground level, a ladder safety demonstration was given by Larry Jackson.

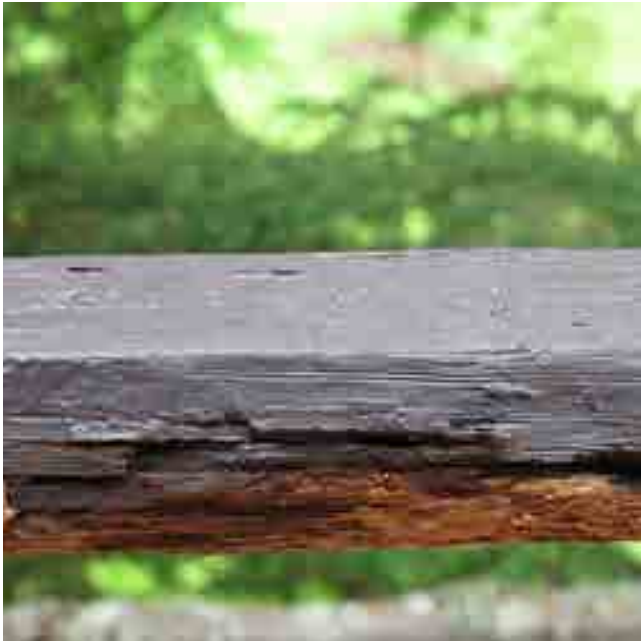
ROT DAMAGE ON WOOD TRIM

REPLACING WOOD TRIM

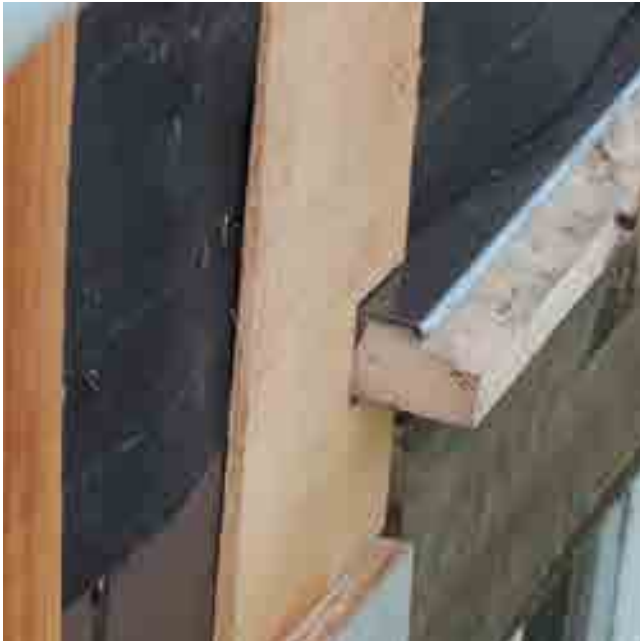
SHINGLES CUT TO FIT AROUND 2ST STORY WINDOW AND DRIP CAP. WATERPROOF TAR PAPER BELOW.

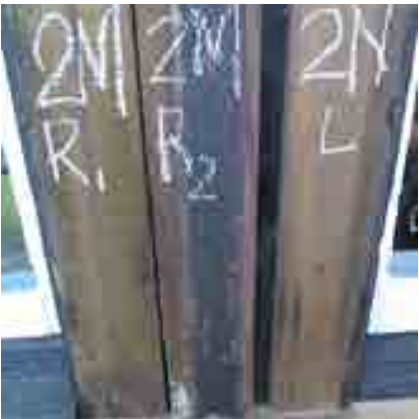
DAMAGED CASINGS  
REMOVED TO REVEAL  
6X1 BOARDS, 61”  
LENGTH, WHICH WERE  
THEN LABELLED

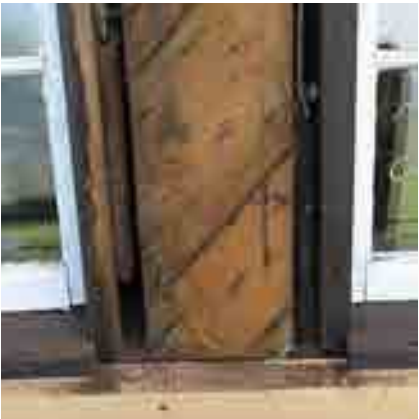
6X1S REMOVED TO  
WATERPROOF AROUND  
WINDOWS

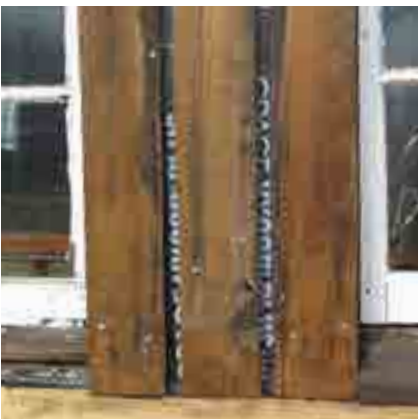
WATERPROOFING  
INSTALLED, 6X1S  
REINSTALLED WITH  
GALVANIZED NAILS,  
TURNED AROUND TO  
MINIMIZE DAMAGE  
EXPOSURE

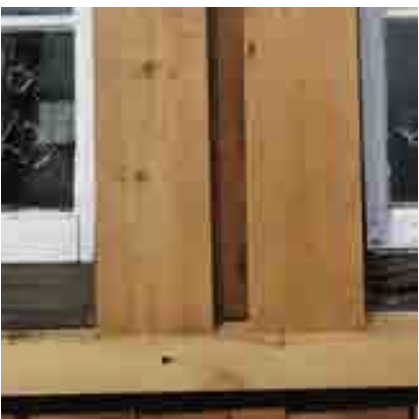
CASINGS FABRICATED  
AND INSTALLED ABOVE  
THE SILL WITH  
GALVANIZED FINISH  
NAILS

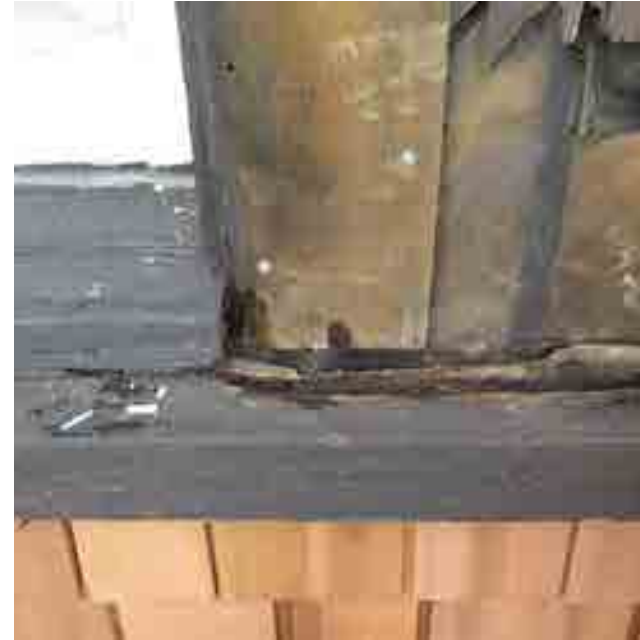
EPOXY IS APPLIED TO ROT-DAMAGED ORIGINAL WOOD PIECES

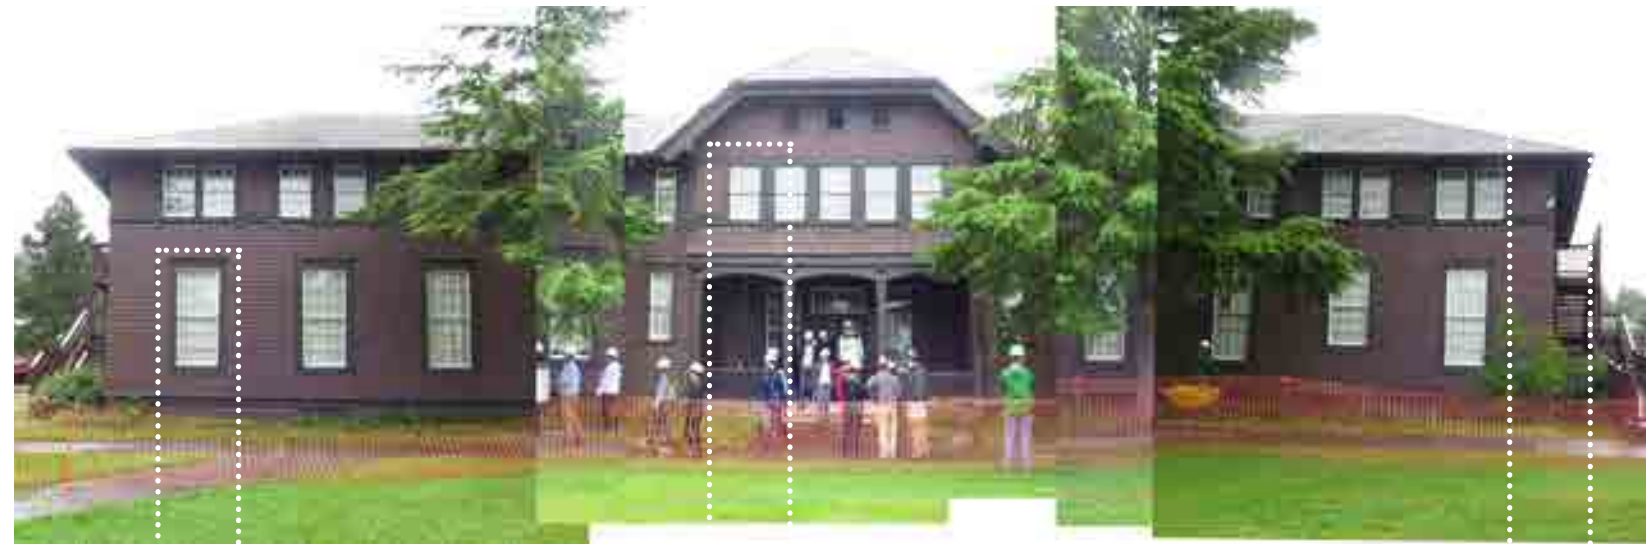
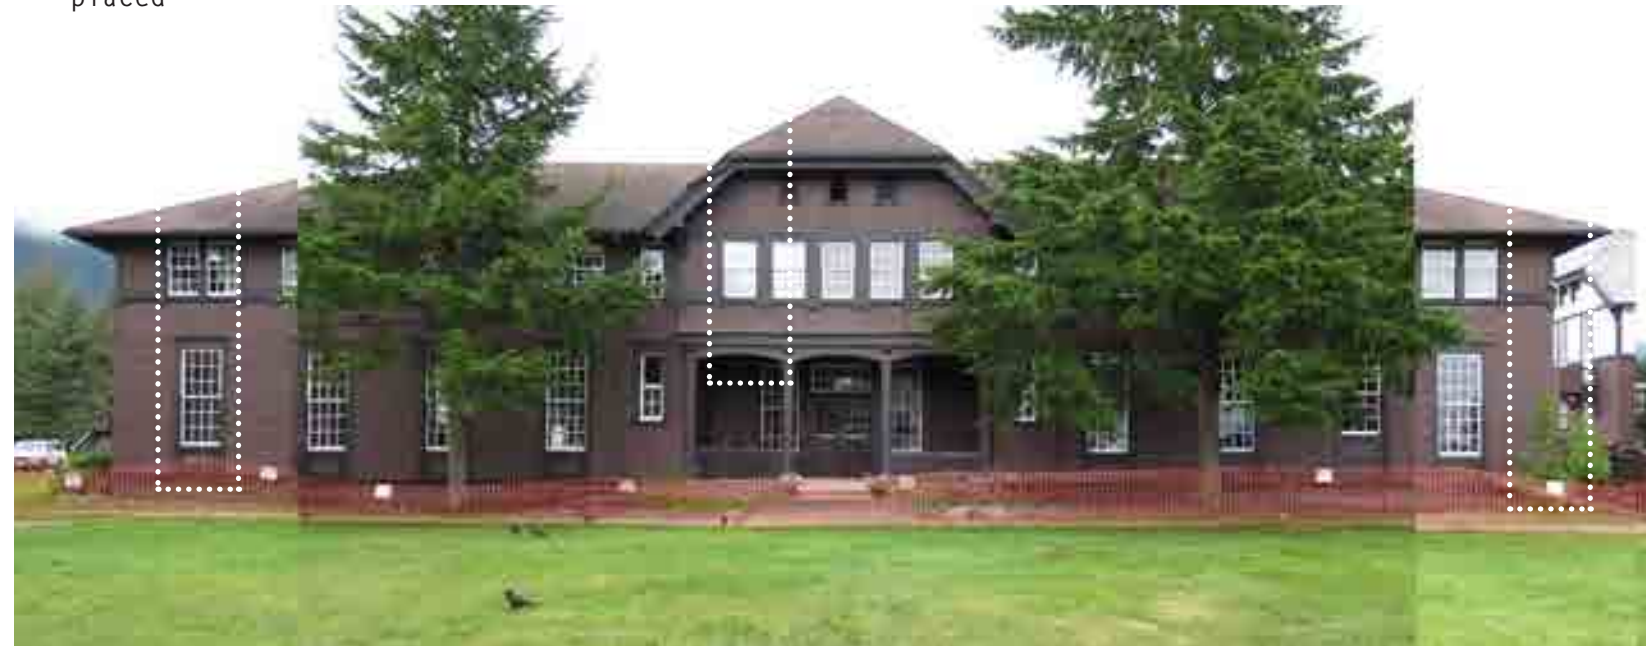
AFTER

Below-window  
panels are un-  
covered by more  
recent shingles  
and restored  
All 1st story  
casings are re-  
placed

Missing blocks  
below 2nd story  
window casings  
are fabricated

New shingles  
on south fa-  
cade are weaved  
with originals  
on east & west  
corners
