**ARCHITECTURAL ASSESSMENT, RECOMMENDATIONS & COSTS  
of  
HISTORIC STRUCTURES**

**MINERAL HILL MINE**

**JARDINE, MONTANA**

**OCTOBER, 2000  
(REVISED JANUARY, 2001)**

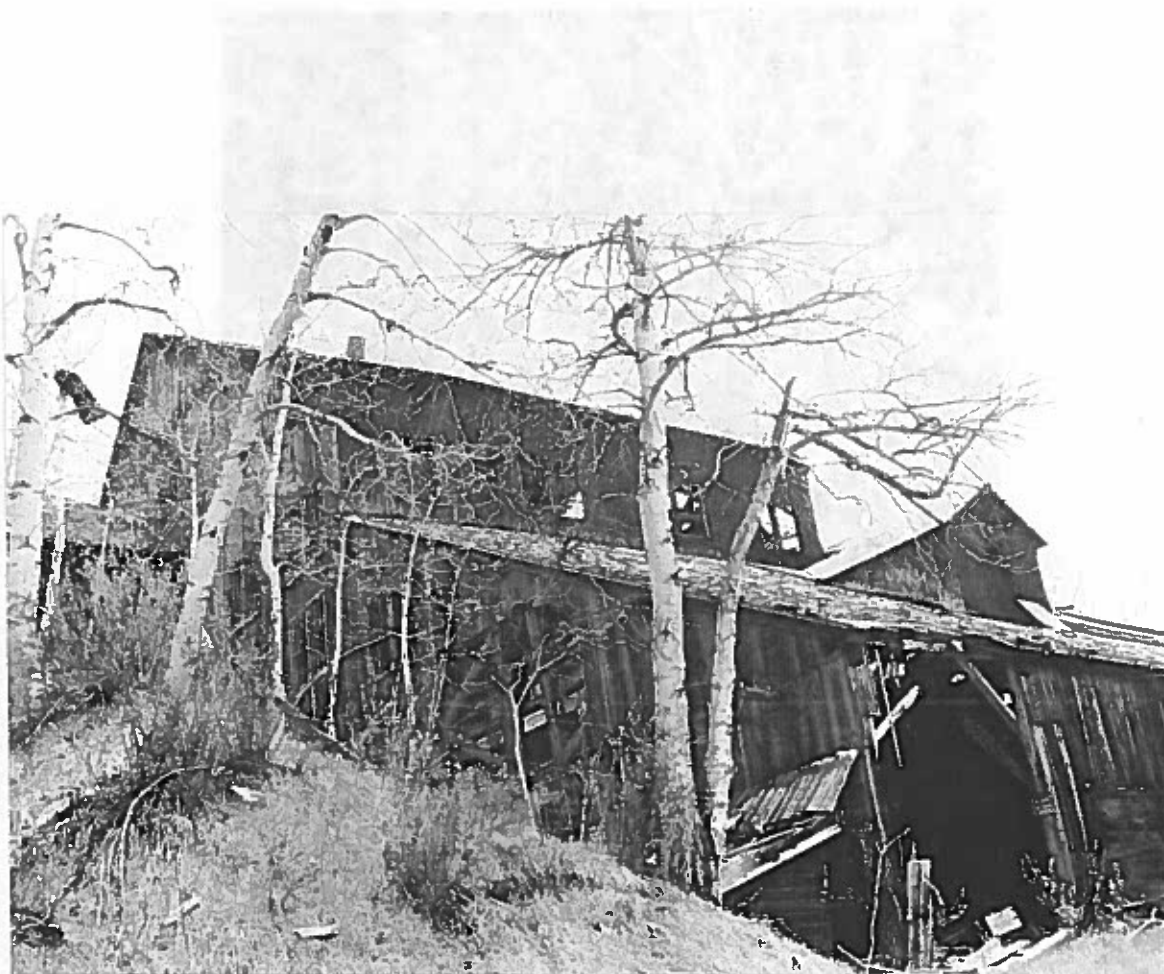
Figure 14: Looking southeast at the lower end of Mill. Note the poor condition of the wood shingle roof. Many of the shingles are loose and deteriorating.

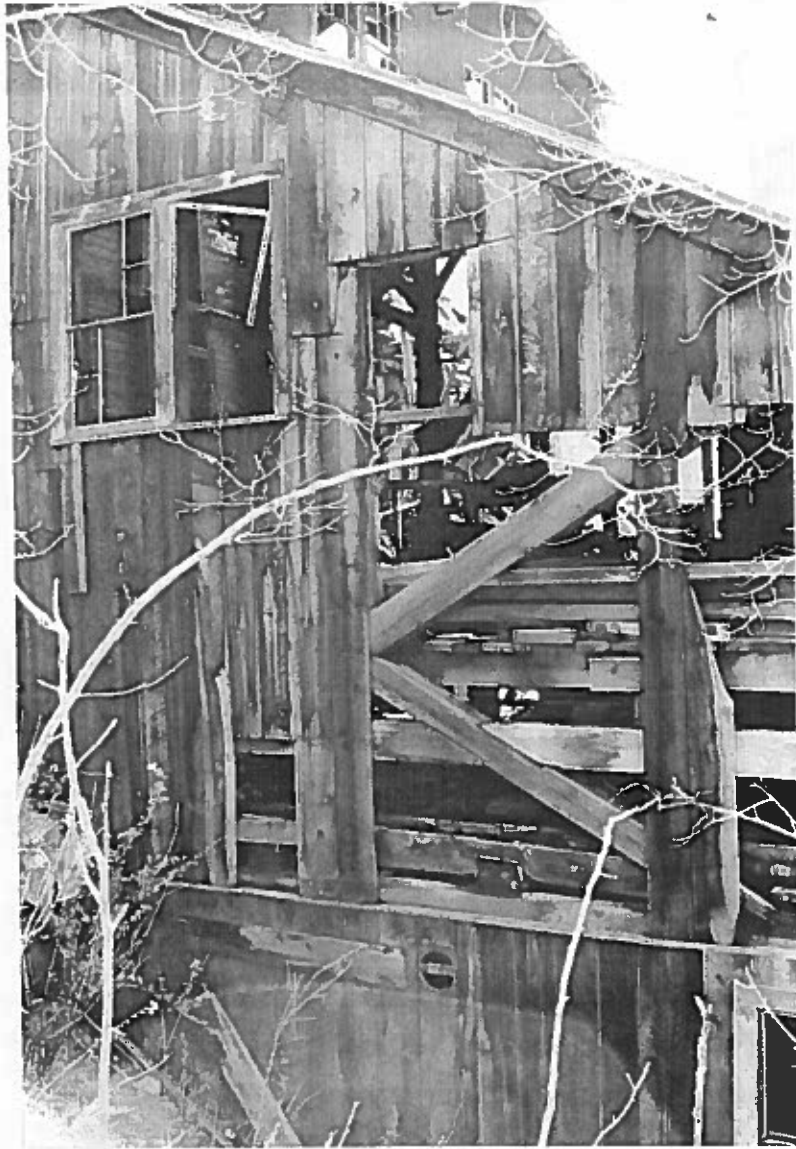
Figure 16: Looking south at the north side of the Mill at the floatation level.. Note the missing siding that was removed from the building. The windows are in poor condition.

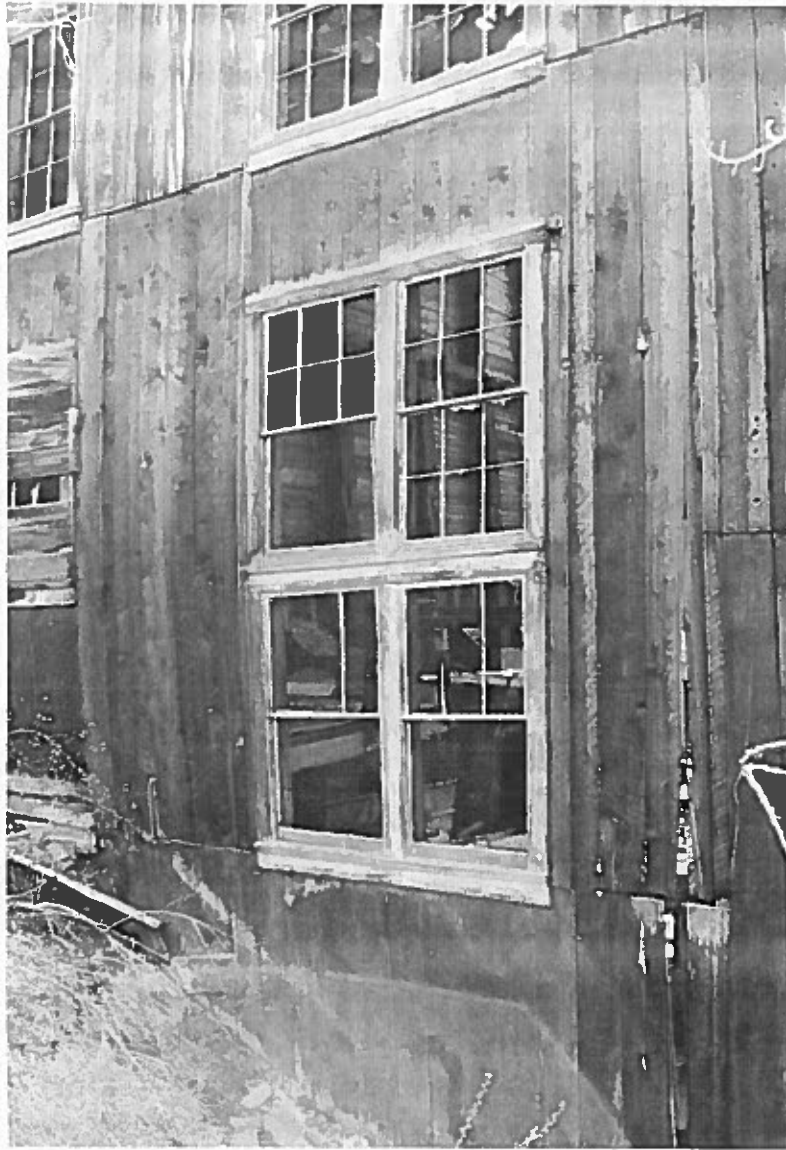
Figure 18: Looking southeast at the details of the windows on the north wall. Note the missing glass and weathered wood.

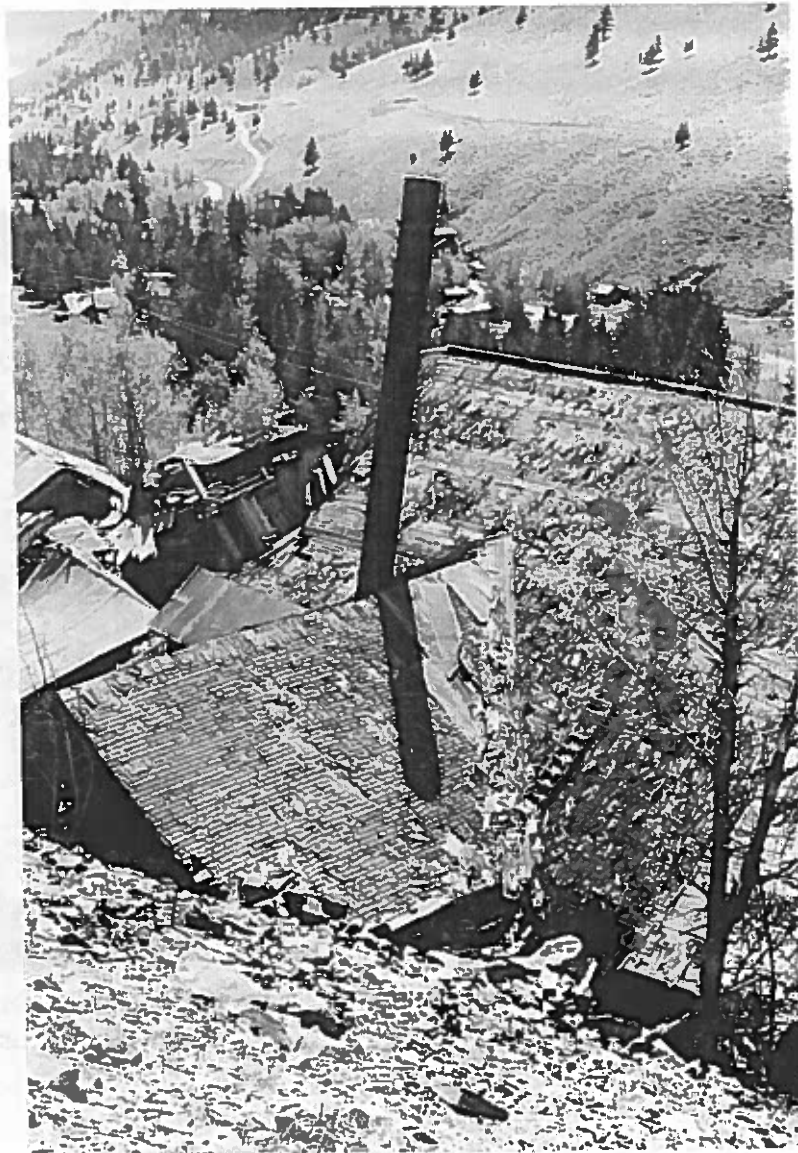
Figure 22: Looking southwest at the roof of the Mill and at the stack of the upper boiler area.

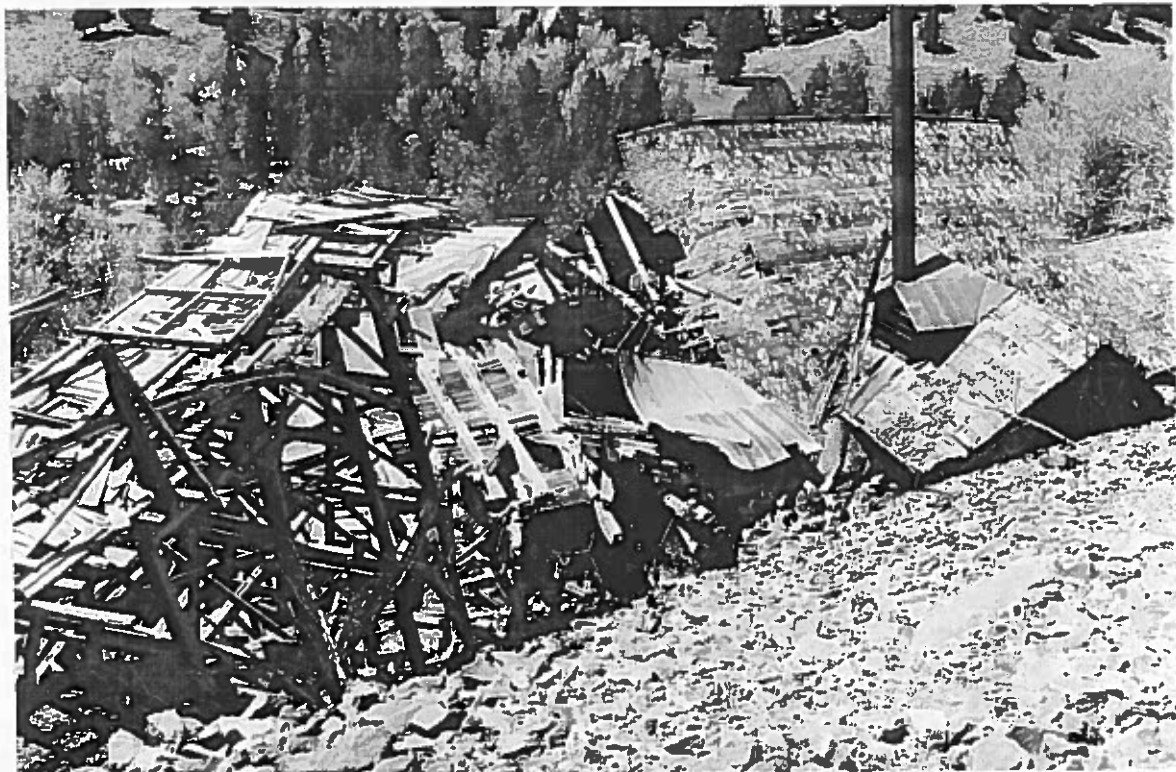
Figure 24: Looking northwest at the tram and the collapsed area of the ore bins. The main structure of the roof appears to be in good condition.

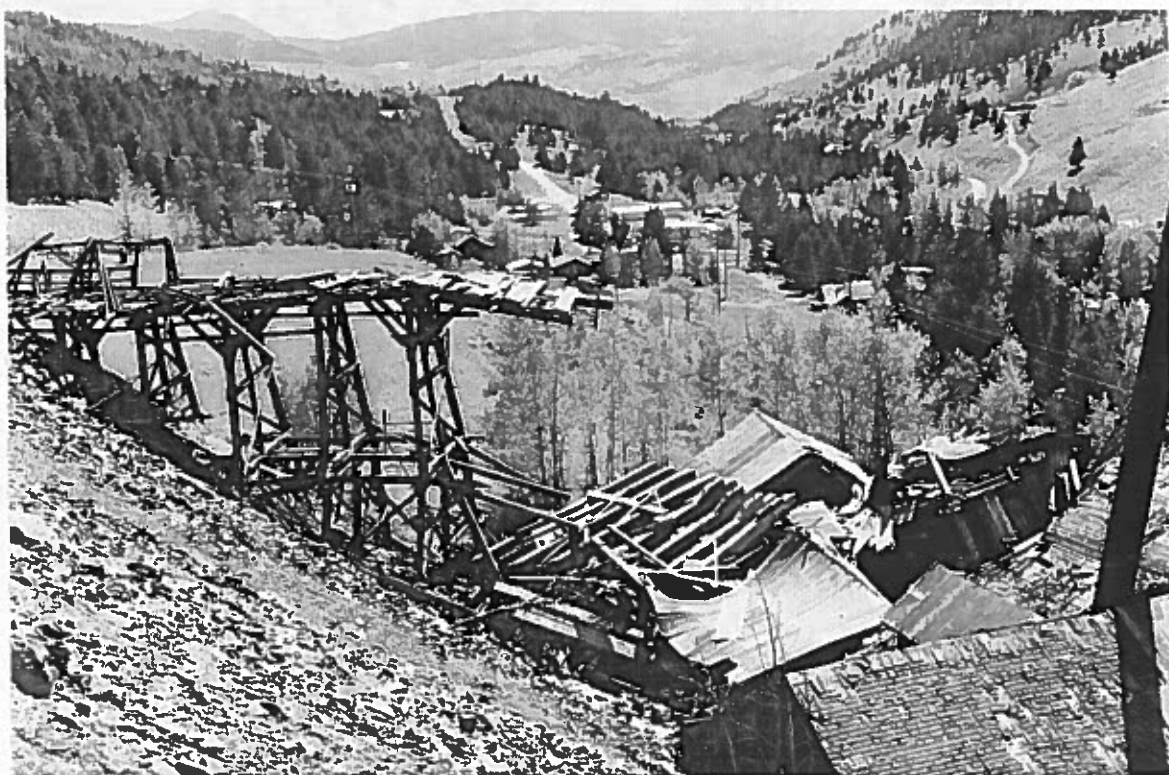
Figure 25: Looking southwest at the tramway and the collapsed ore bin area.

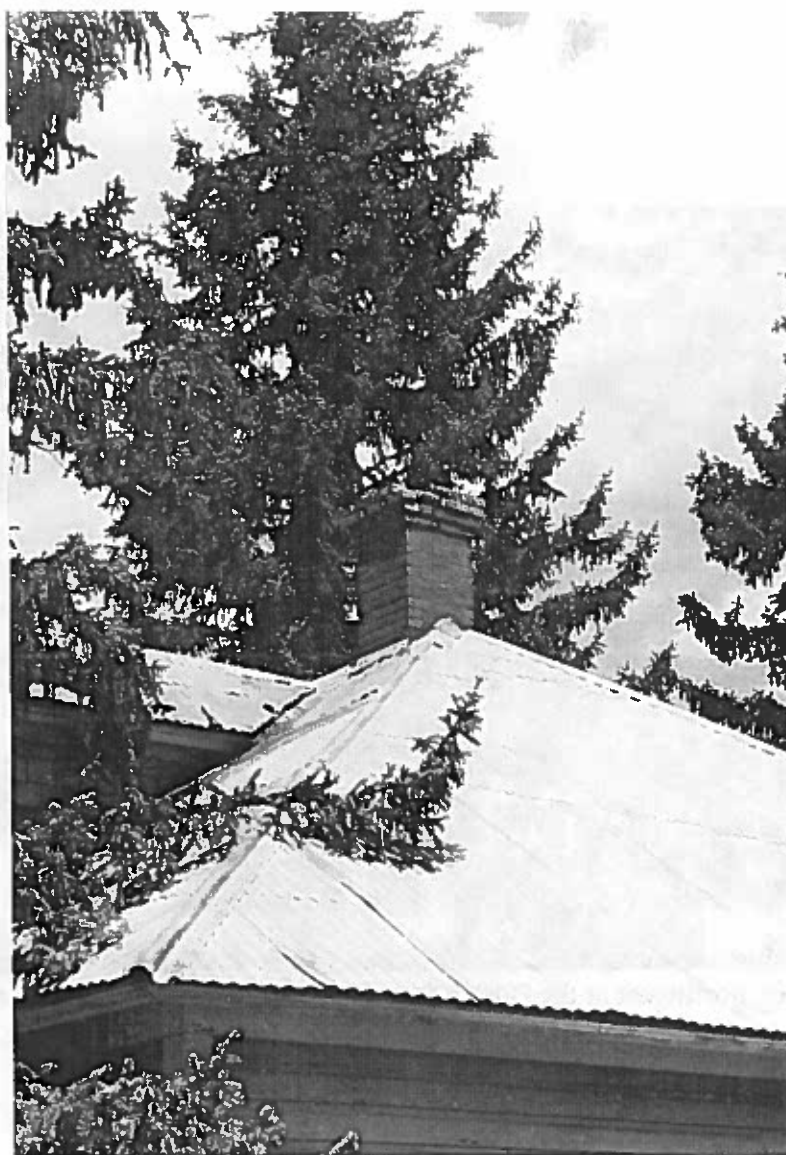
Figure 41: Looking northwest at the roof of the building. Note the galvanized metal roof which was put over the original wood shingle roof for protection. The upper part of the chimney is deteriorating and some of the mortar is missing.

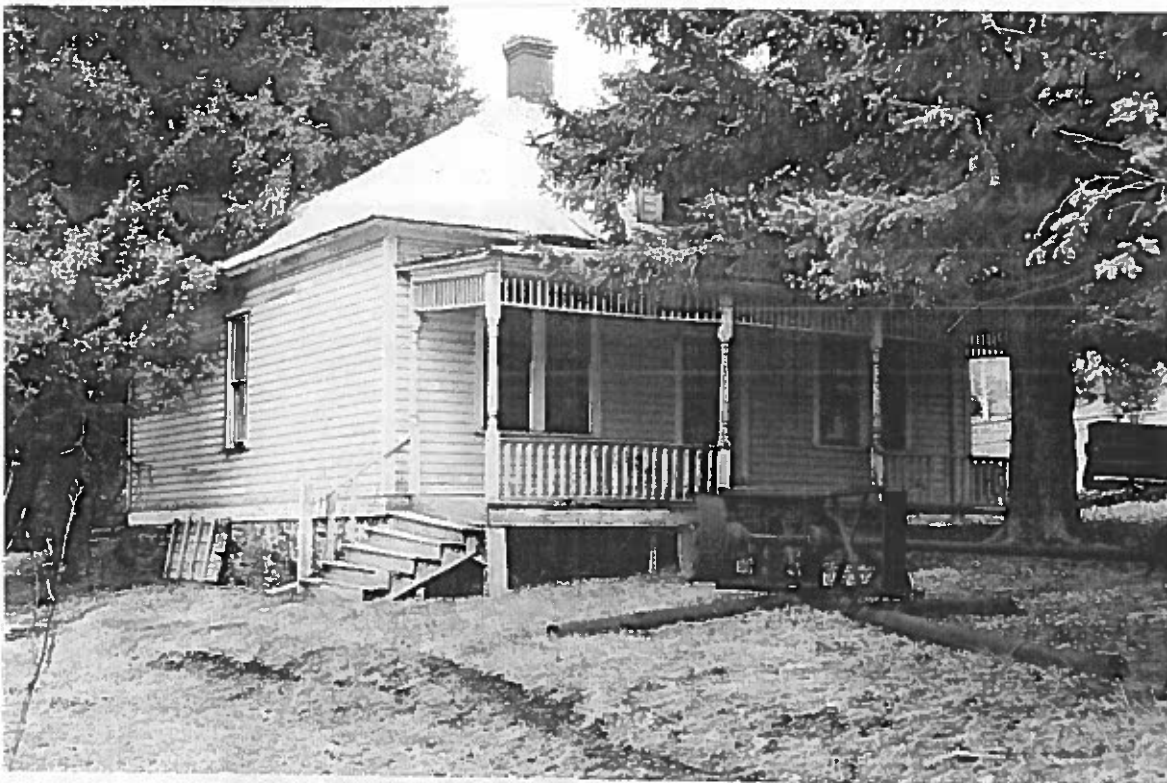
Figure 45: Looking northeast at the Bush Guest House. The materials are generally in good condition.

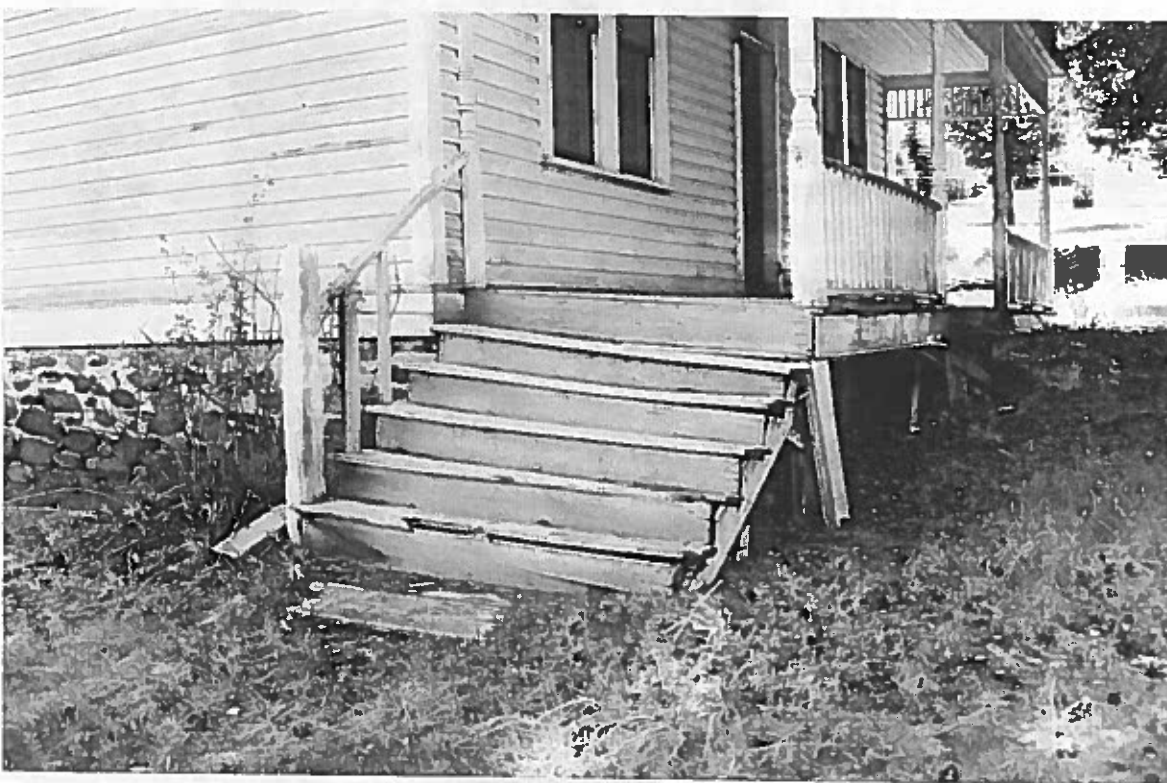
Figure 46: Looking east at the front porch and steps of the building. Note the deteriorating steps on this end of the porch. The support on the corner of the porch is also moving out.

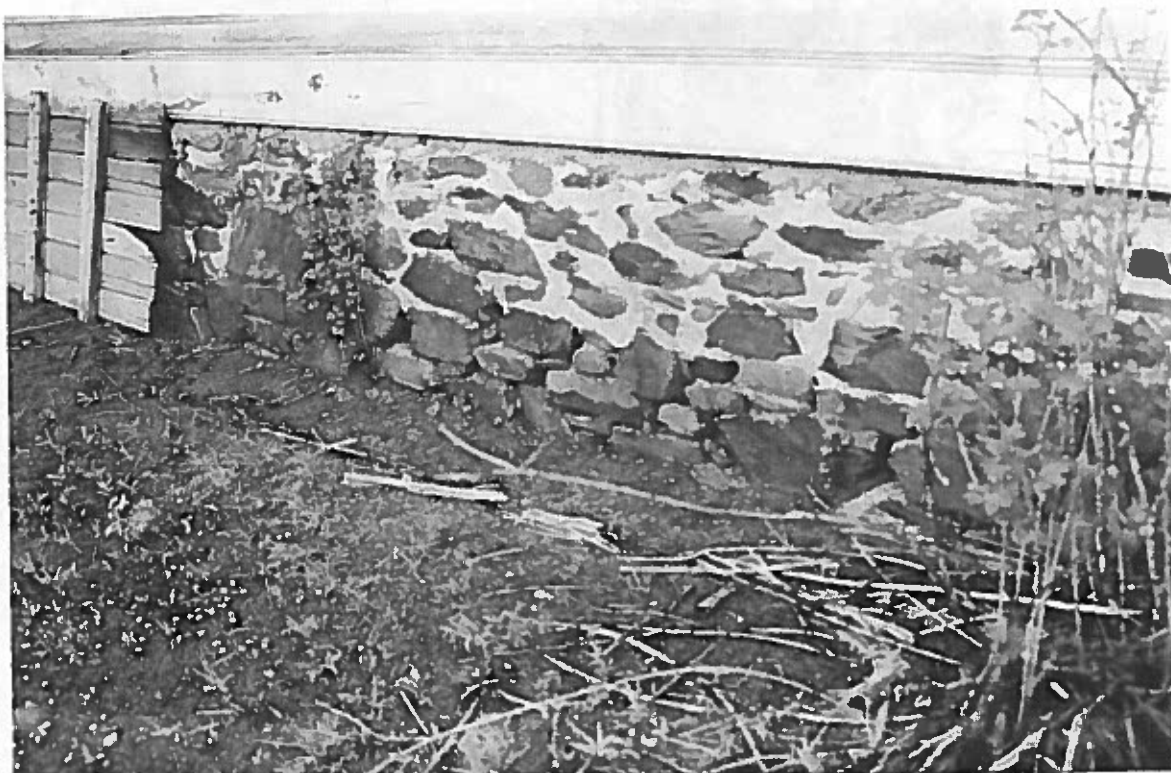
Figure 48: Looking northeast at the stone foundation of the building. Note the missing mortar at the base due to water penetration. Most of the foundation with the exception of the northeast corner is in good condition.

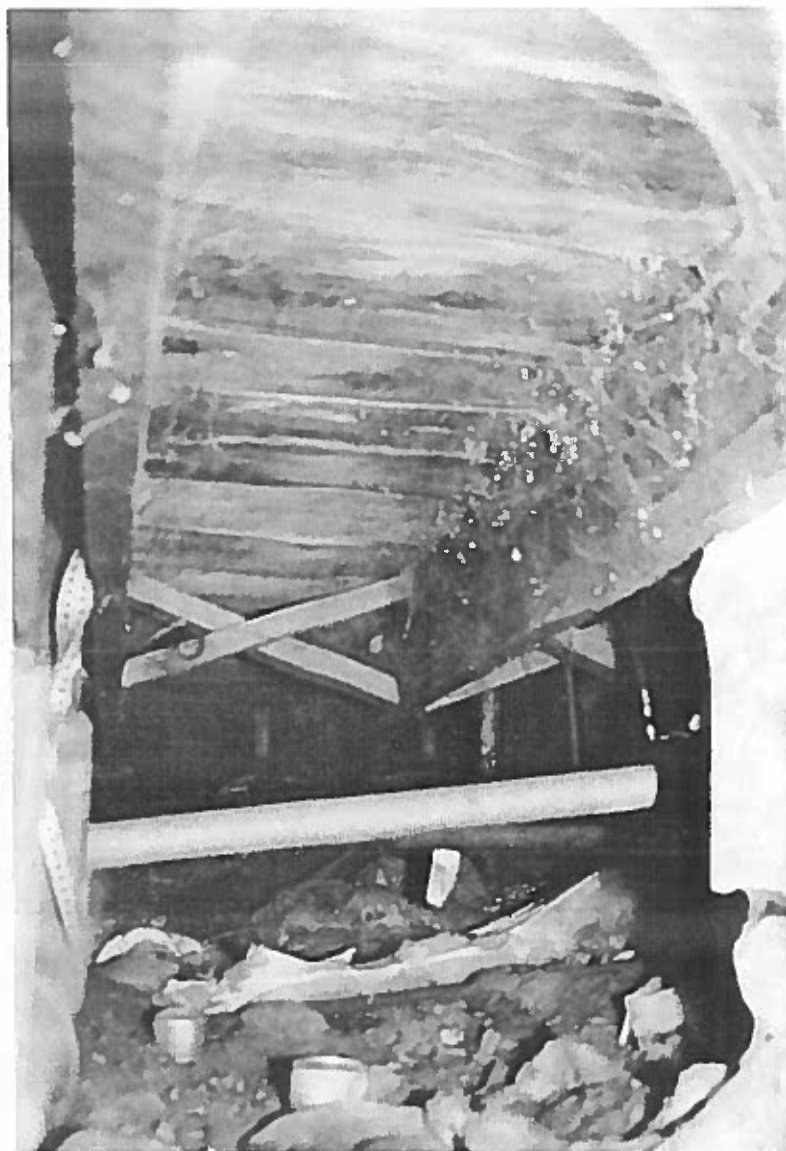
Figure 50: Looking east at the crawl space under the building. The floor joists and floor sheathing are in good condition with some minor dry rot but in most cases the materials are dry.

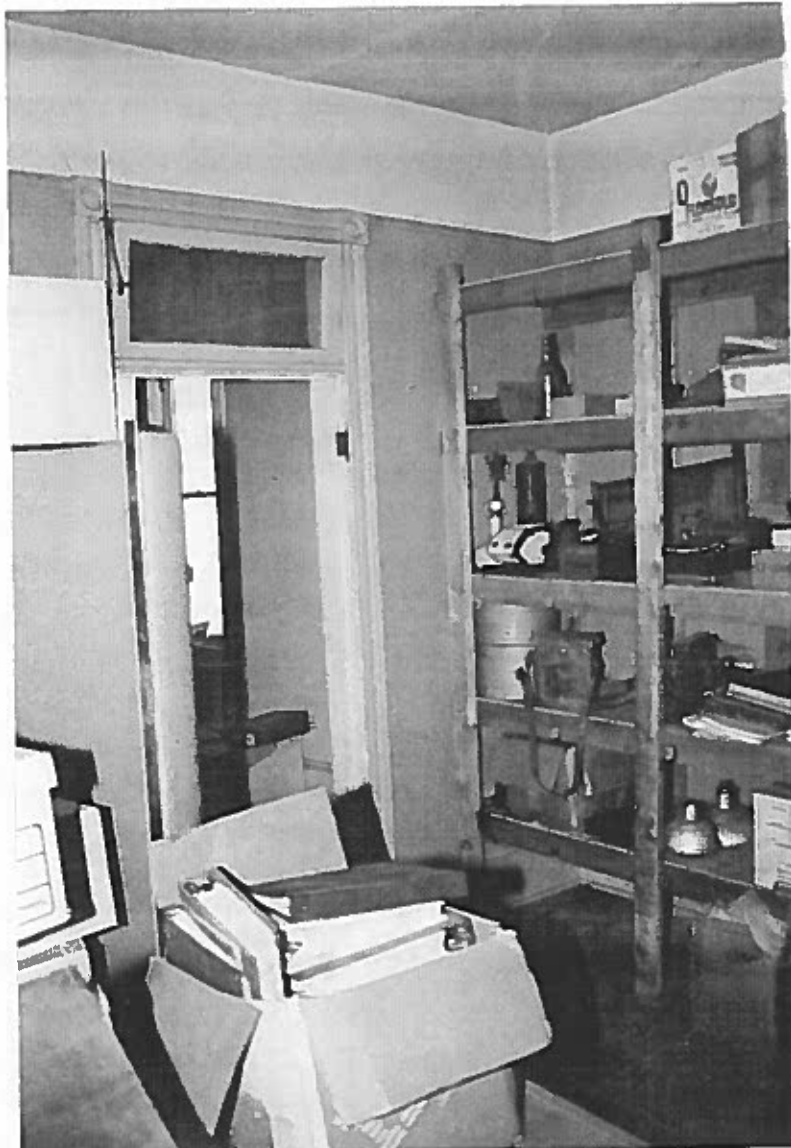
Figure 63: Looking southeast at the doorway to the corridor from the southwest room. This wall appears to be in good condition.

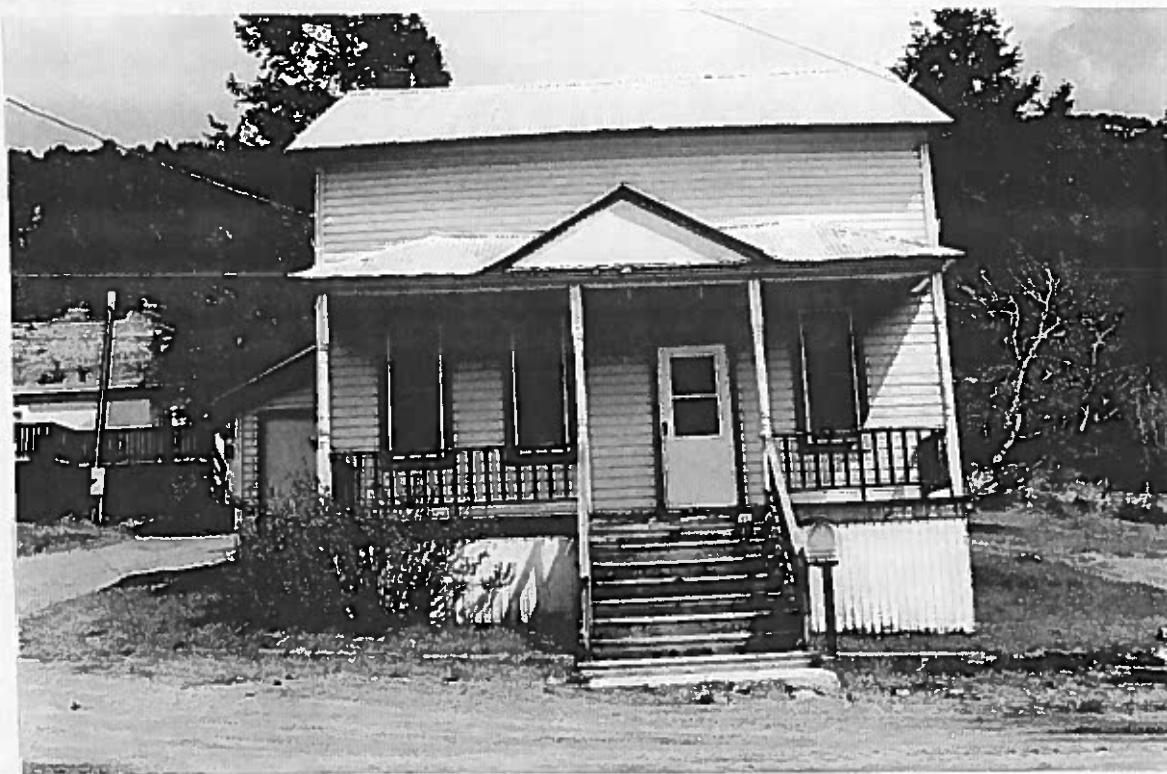
Figure 69: Looking east at the front of the Company Headquarters building. Note that the front porch steps are offset thus the columns are offset. It appears that the porch was rebuilt and the steps moved over.

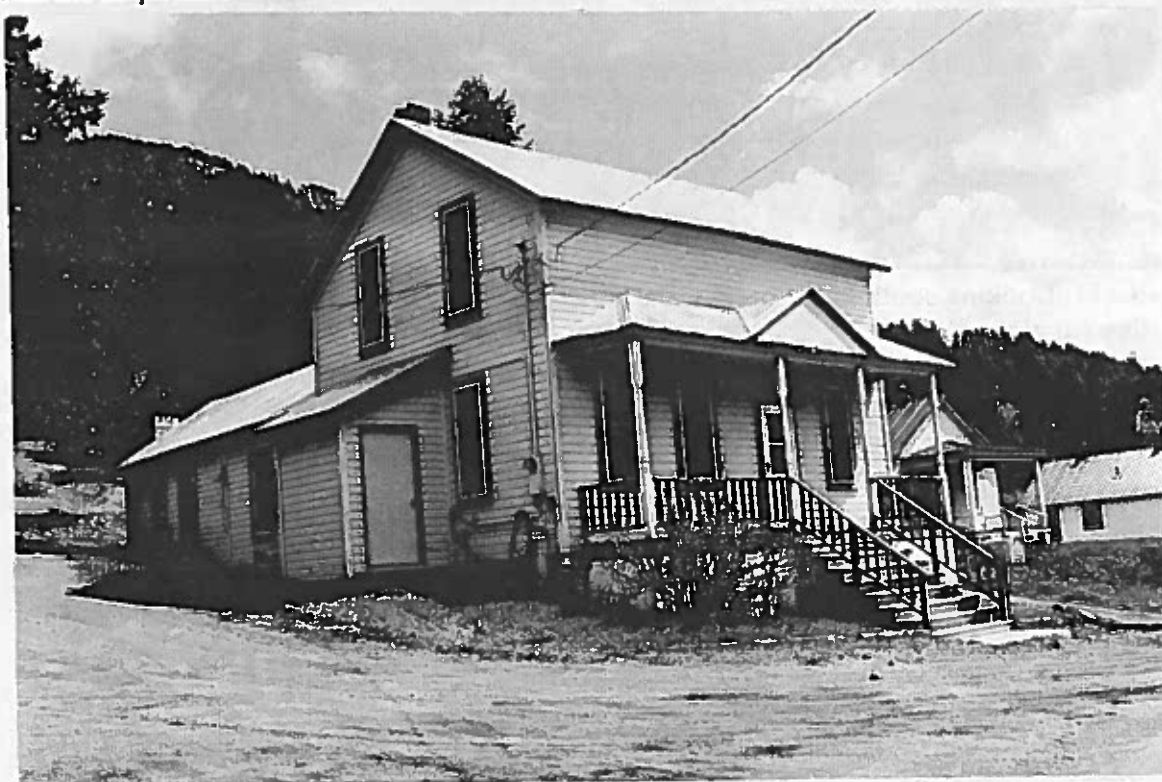
Figure 70: Looking southeast at the building. Note the shed roof addition to the building. The galvanized metal roof on the building covers the original wood shingles. The metal is in good condition.

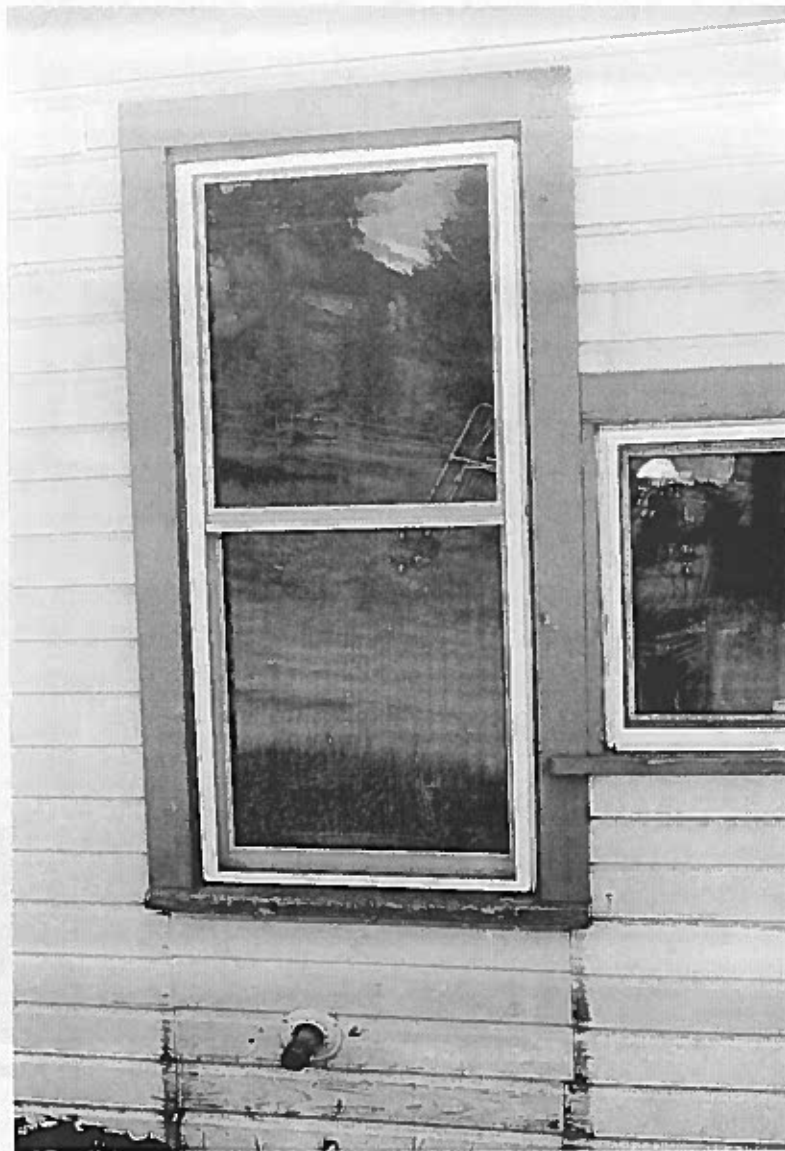
Figure 75: Looking at the vinyl windows covered windows that have replaced the original wood double-hung windows. They are in good condition.

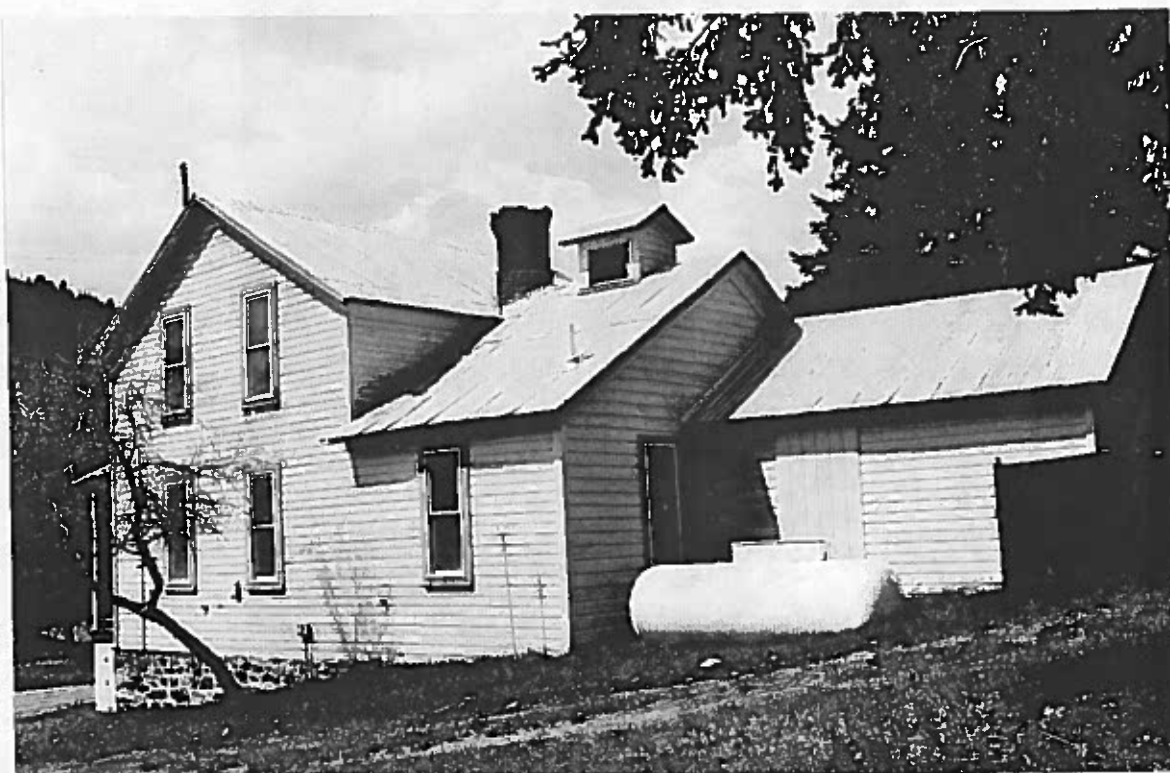
Figure 79: Looking northwest at the building. Note the high grade at the back of the building. Generally with the exception of the base the materials are in good condition.

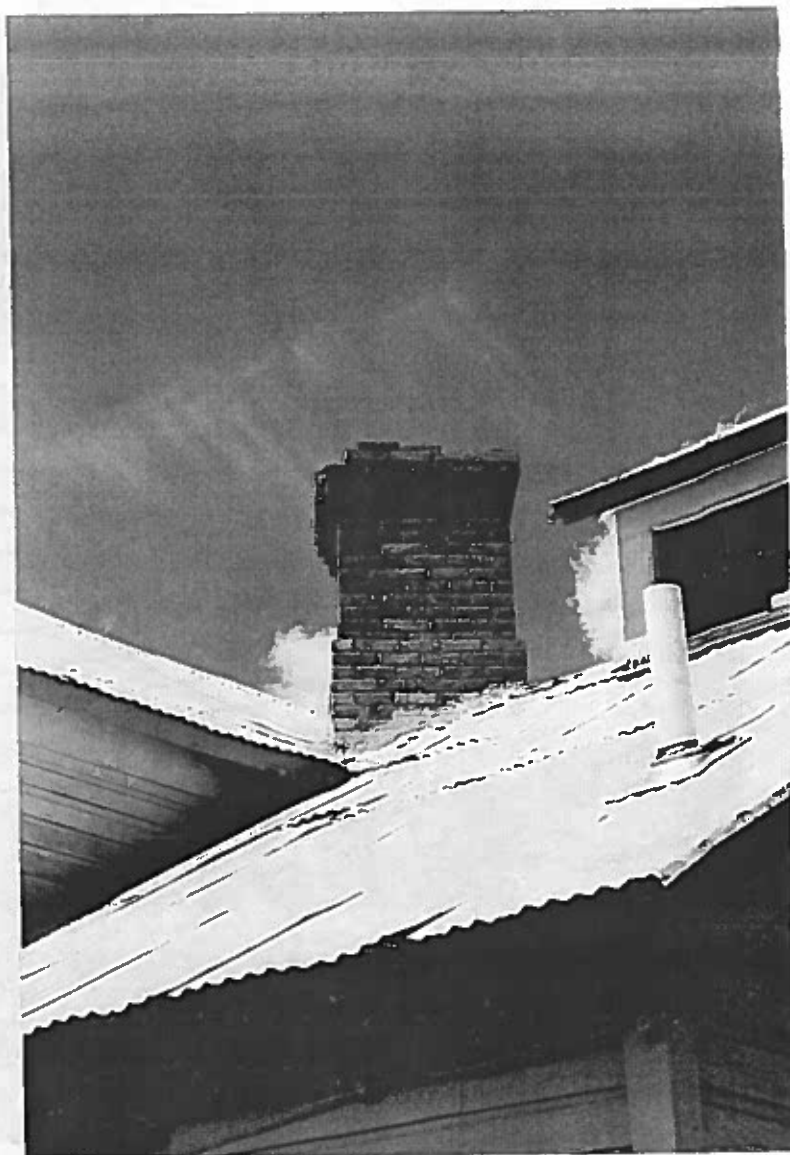
Figure 81: Looking northwest at the roof of the building. There is some brick and mortar deterioration on the top of the chimney. Some of the metal roof panels are loose.

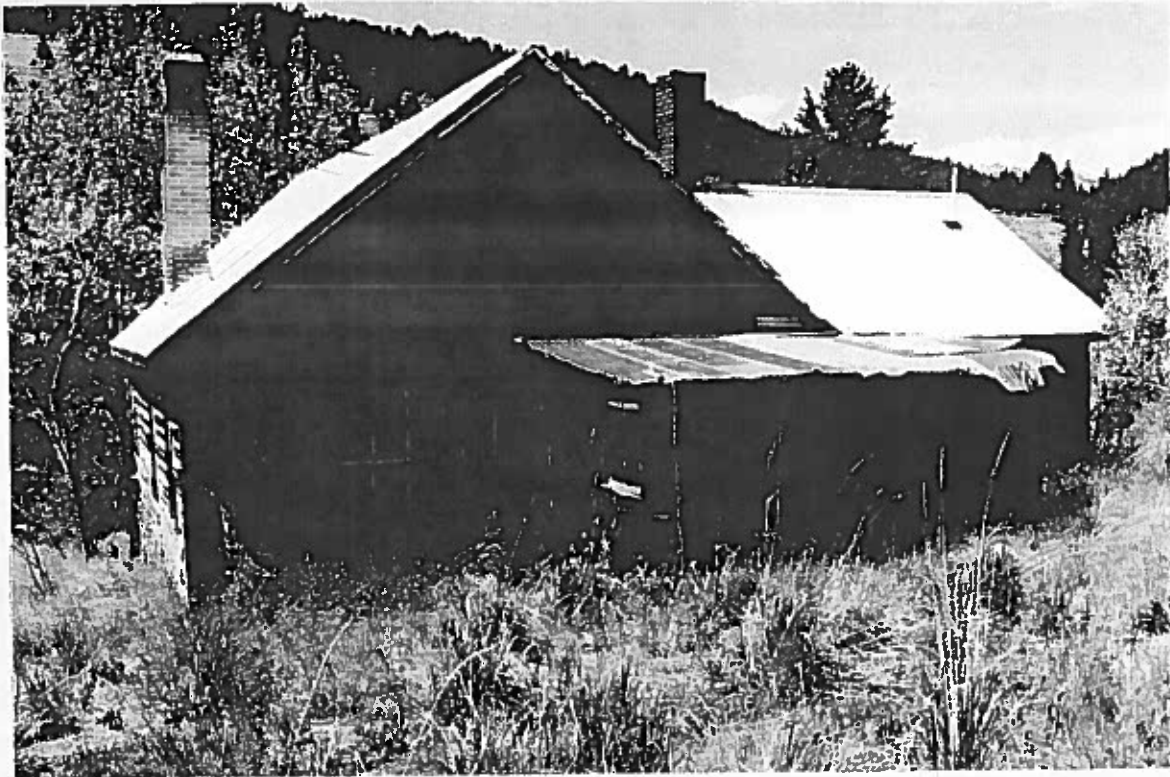
Figure 118: Looking west at the front of the Jardine House. The front shed roof structure was added as a vestibule to the original entrance. It is in poor condition. Note the high grade around this end of the building.

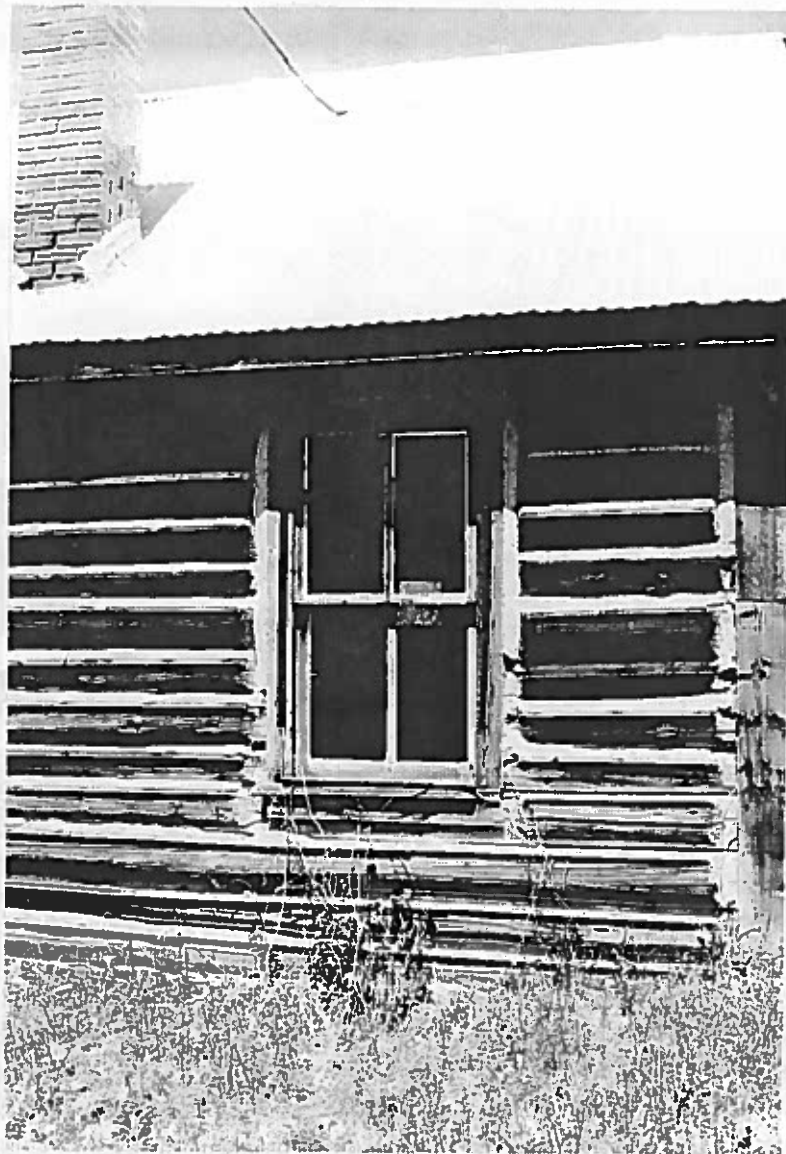
Figure 120: Looking north at the log work and a typical wood double-hung window on the house. The logs and wood windows are weathered but are in good condition. There is some missing putty in the windows and some rot along the base of the logs.

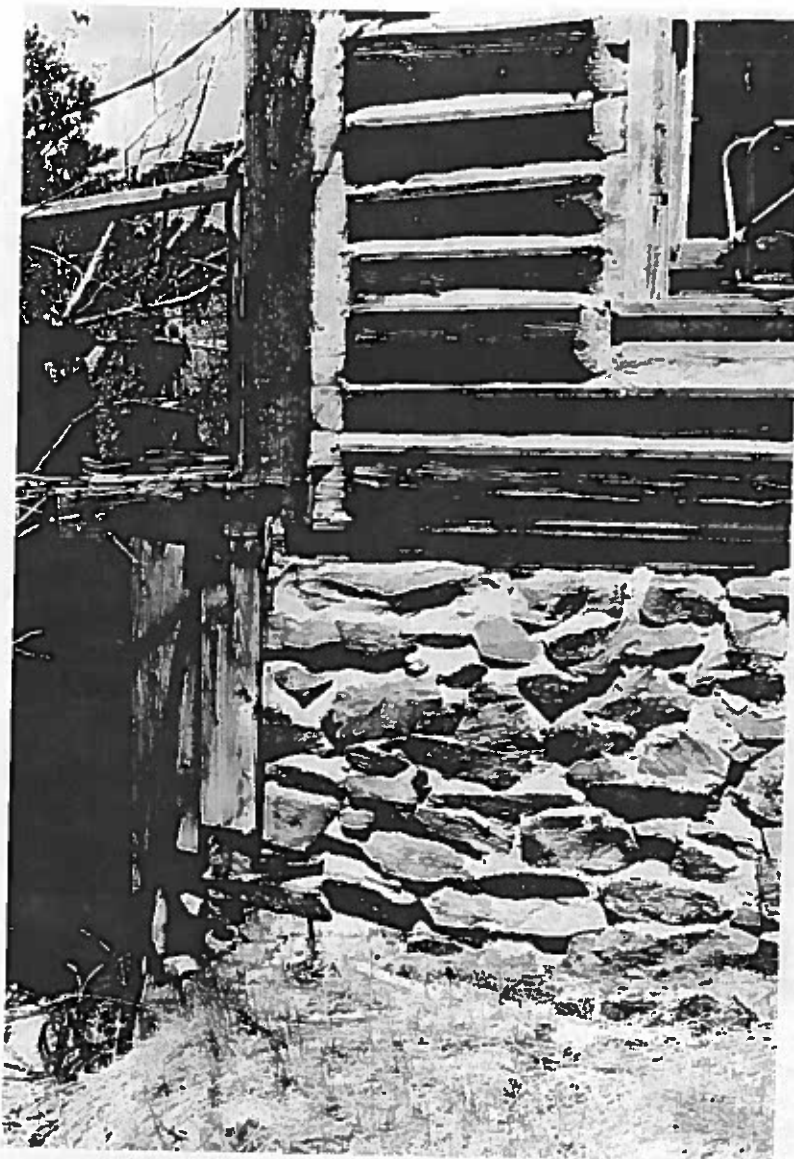
Figure 122: Looking north at a corner of the stone foundation where there is some settlement cracks.

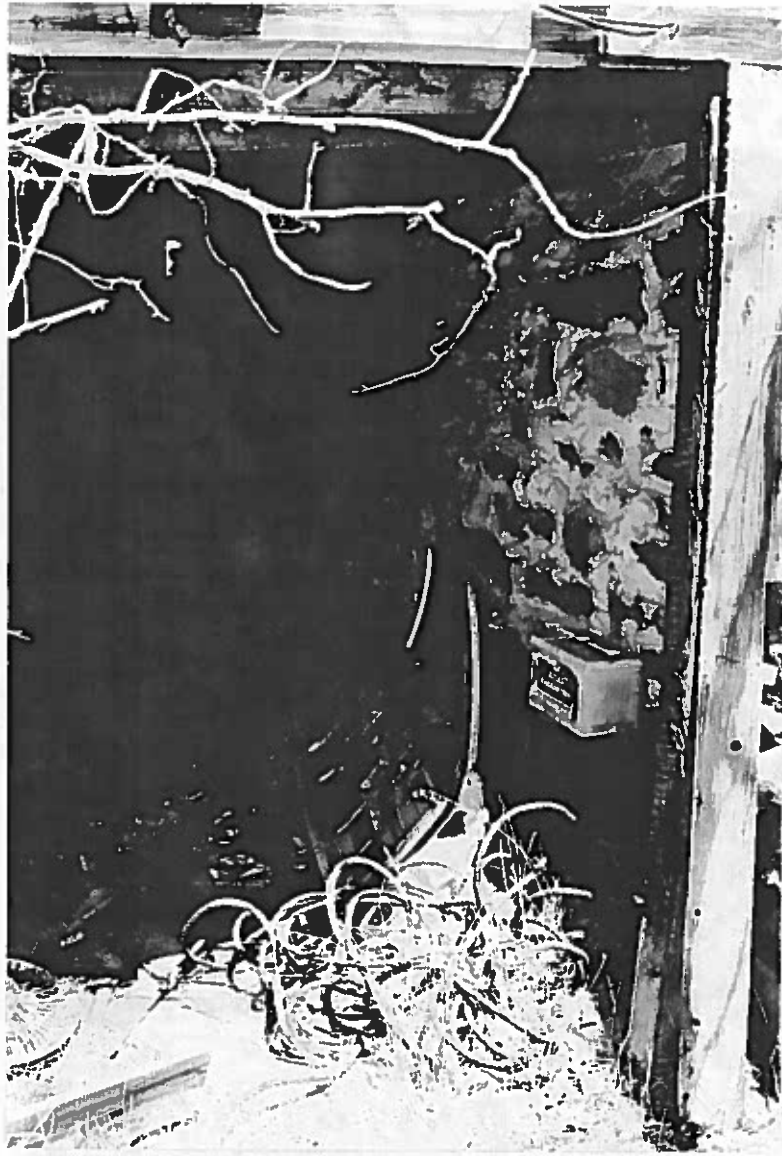
Figure 123: Looking northeast at the base of the foundation under the deck. The foundation is undermined from water coming into the basement on the north side of the building and exiting under the foundation at this point.

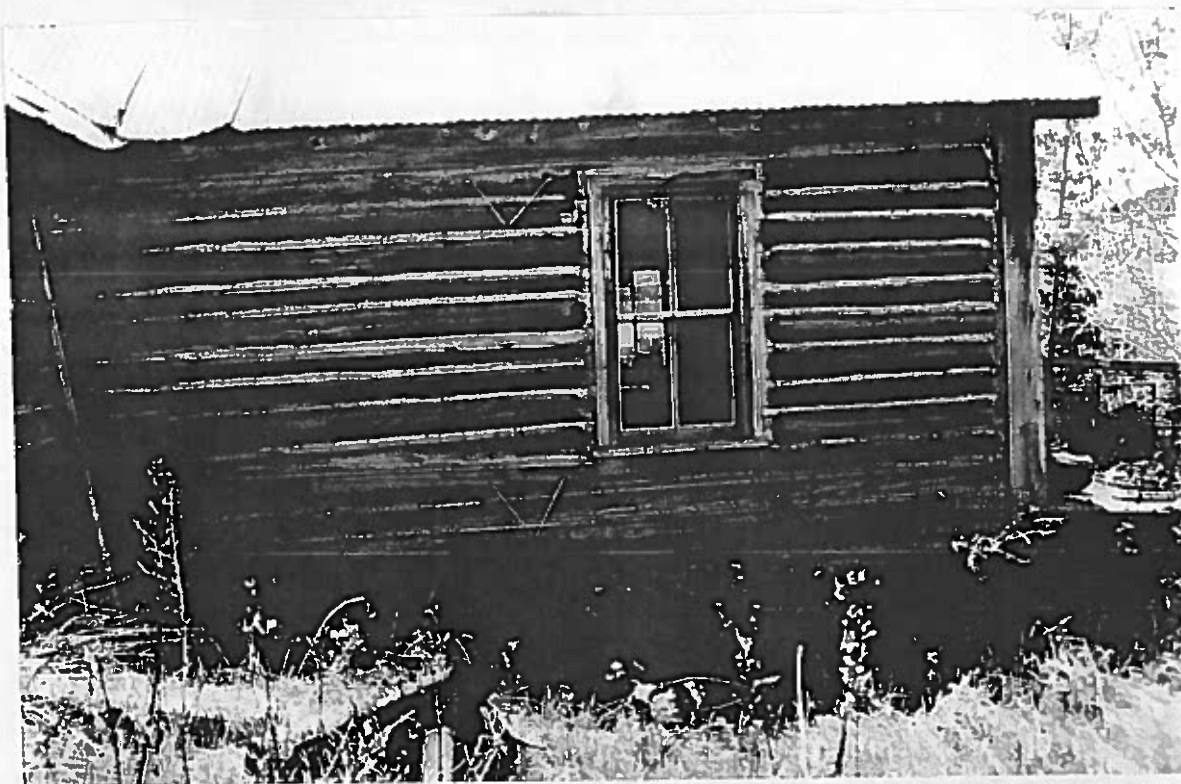
Figure 126: Looking south at the north wall of the house. The log walls and wood in the windows are weathered but in good condition. The daubing has hair line cracks but in most cases is still intact.

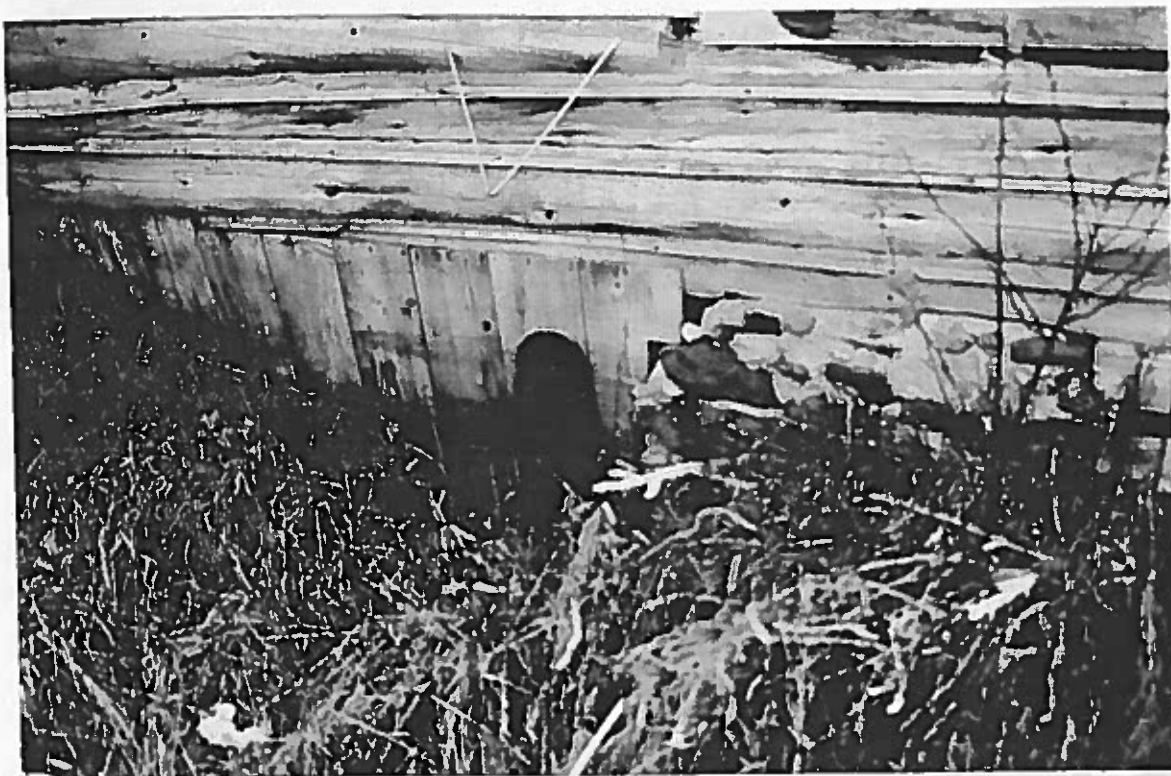
Figure 127: Looking south at the base of the north wall. The stone foundation has been removed partially for the plumbing. Because of the grade water from the roof and slope flows into the basement in this area.

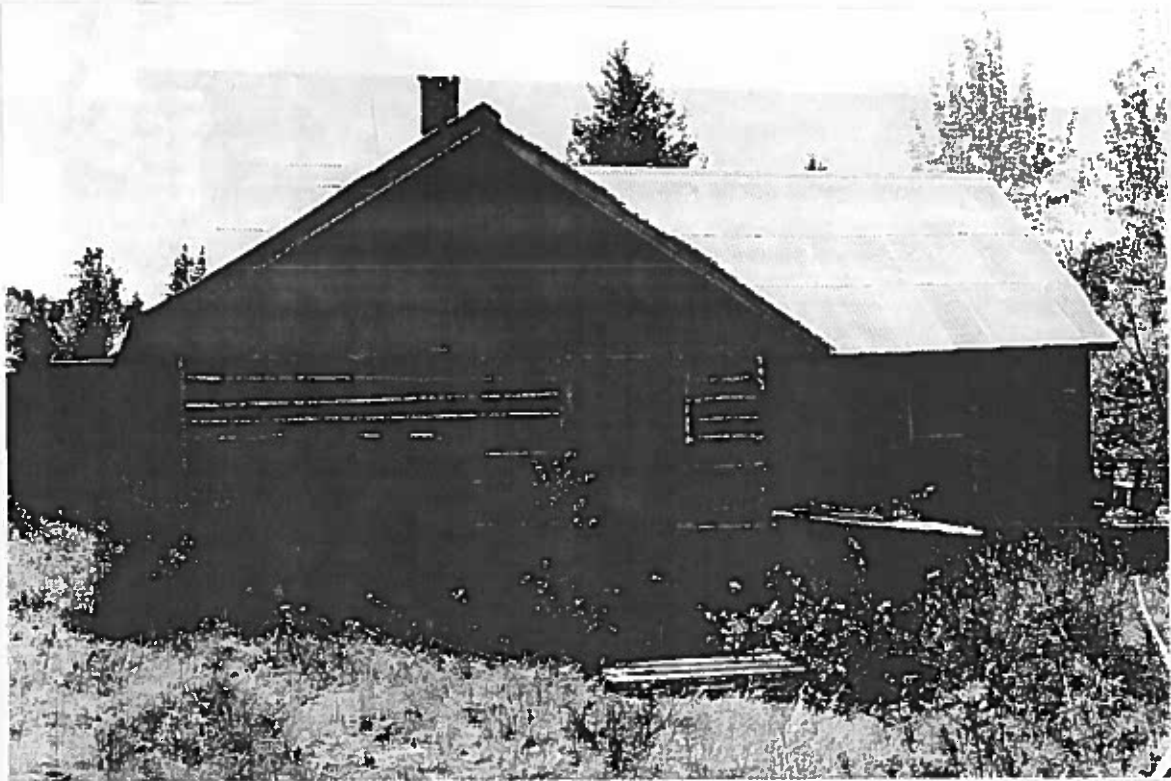
Figure 128: Looking south at the house. The main problem on this side of the building is the built-up grade which is causing rot in the sill logs and into the next one or two logs.
