**ARCHITECTURAL ASSESSMENT, RECOMMENDATIONS & COSTS  
of  
HISTORIC STRUCTURES**

**MINERAL HILL MINE**

**JARDINE, MONTANA**

**OCTOBER, 2000  
(REVISED JANUARY, 2001)**

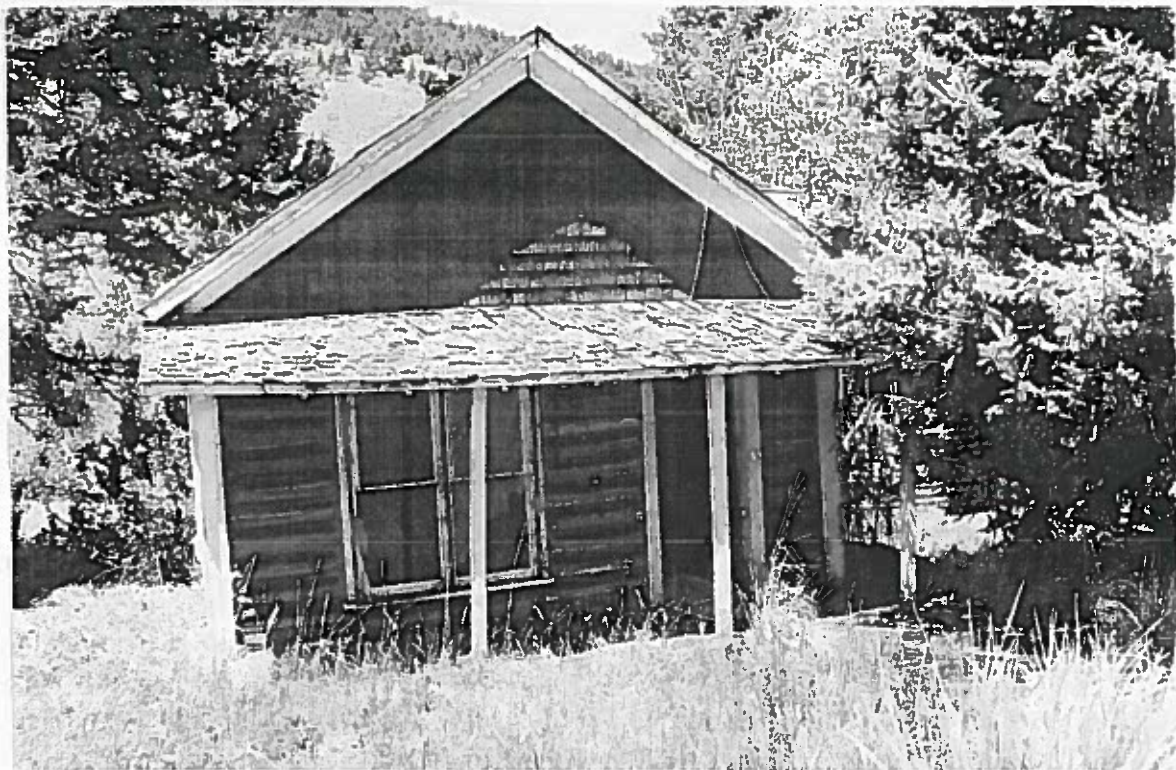
Figure 152: Looking west at the Cabin. Note the high grade at this end of the building causing water to flow onto the porch area from the adjacent road.

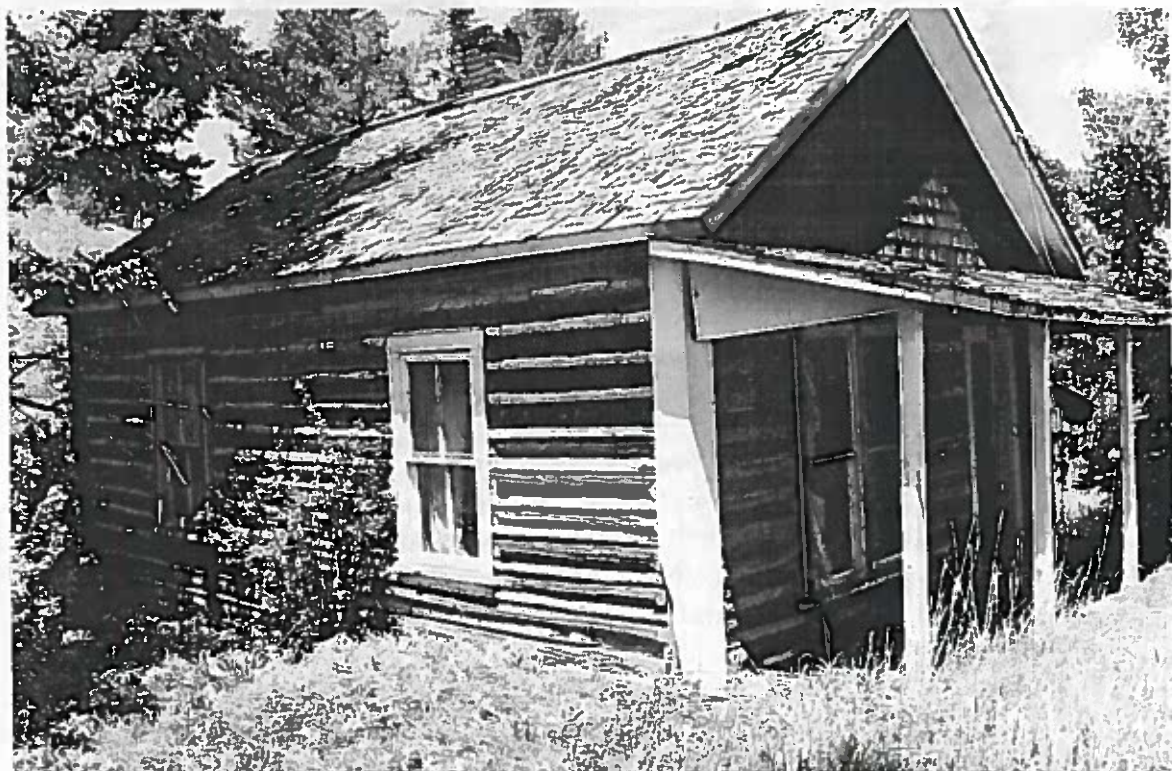
Figure 153: Looking northwest at the Cabin. Note the high grade extending around the corner of the building. Approximately two logs are under the grade and show rot from water penetration. The wood shingle roof is in poor condition.

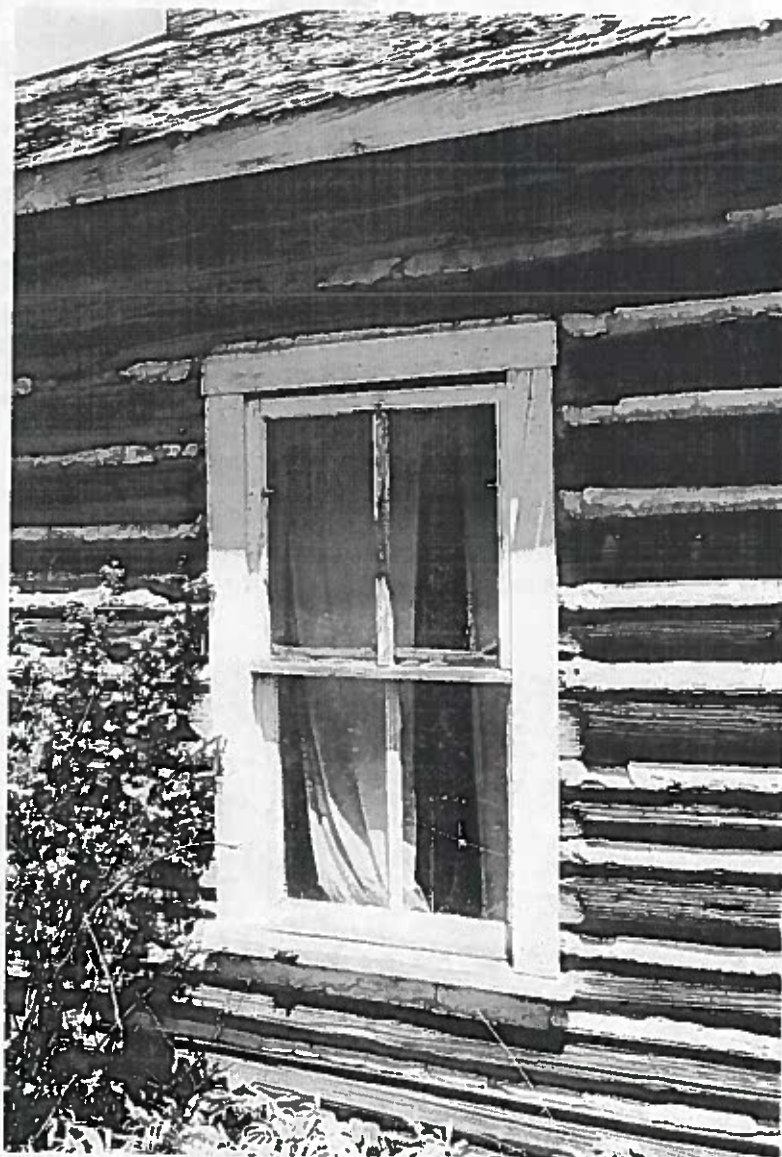
Figure 154: Looking north at a typical wood double-hung window on the building. Note the weathered wood and crack in the trim surround.

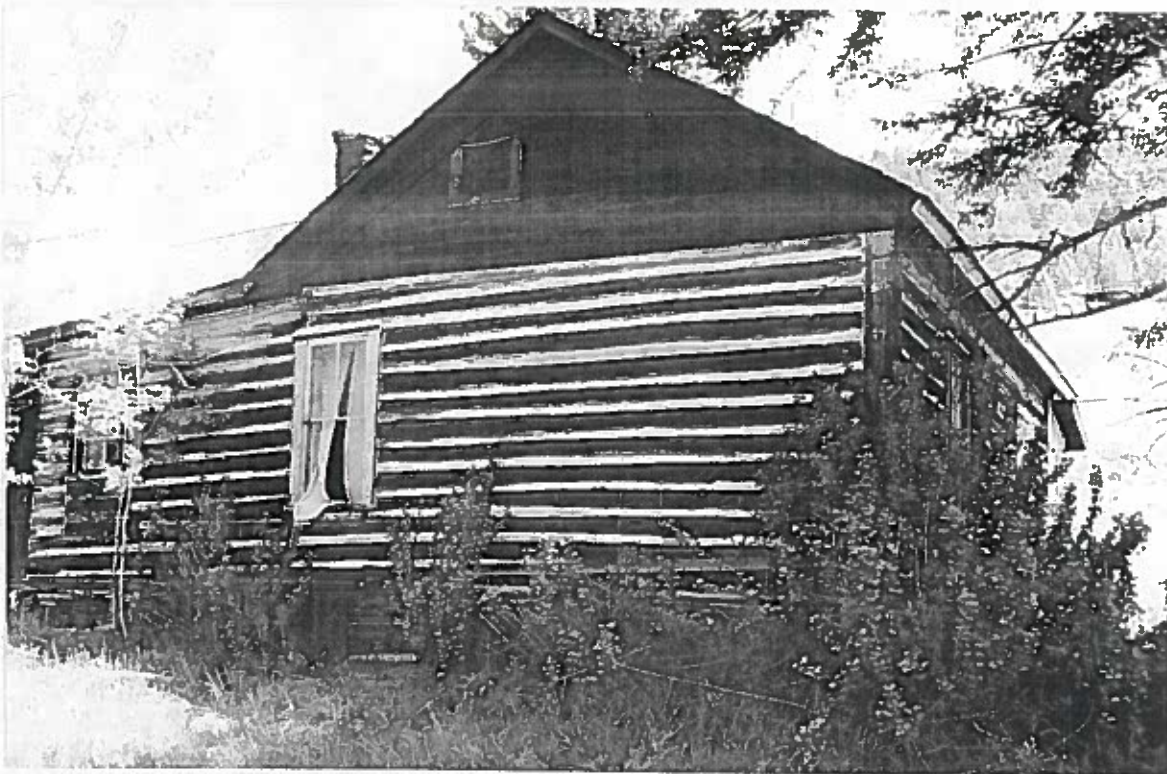
Figure 156: Looking northeast at the back of the building. The log work and gable end shingles are in good condition. The brick chimney has loose bricks and missing mortar.

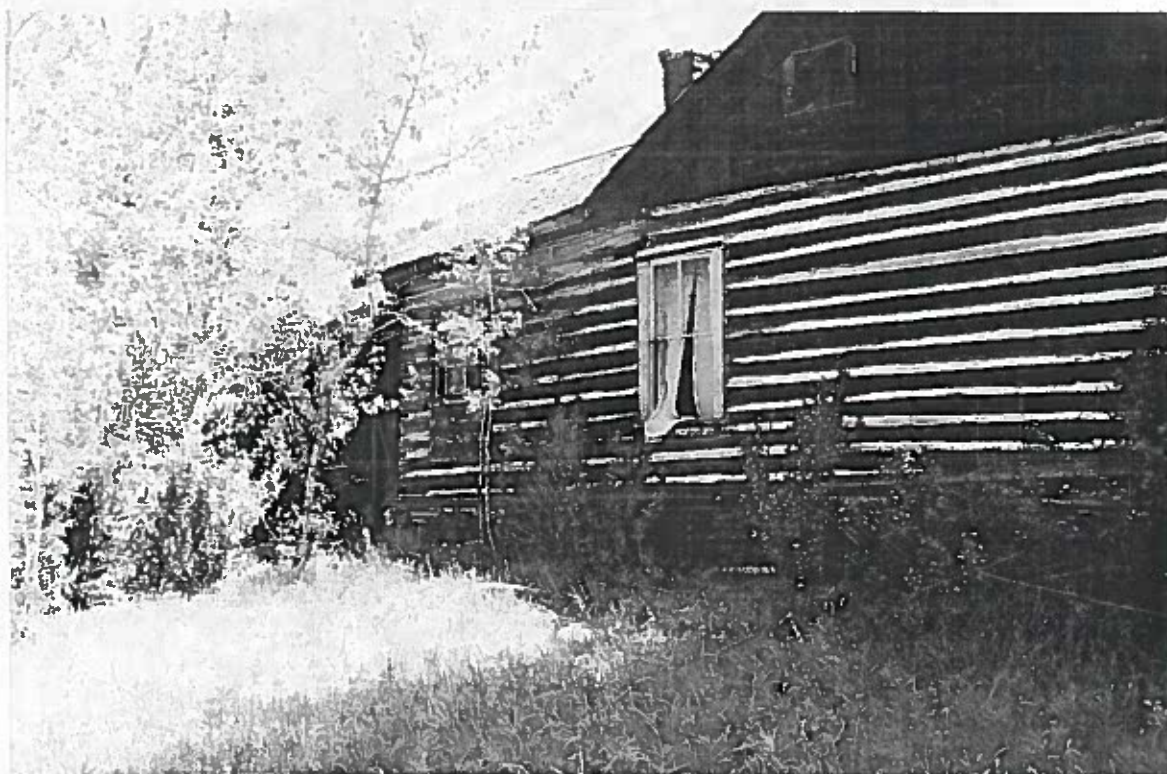
Figure 157: Looking northeast at the back of the building. The trees and shrubbery are too close to the building causing moisture buildup along the base.

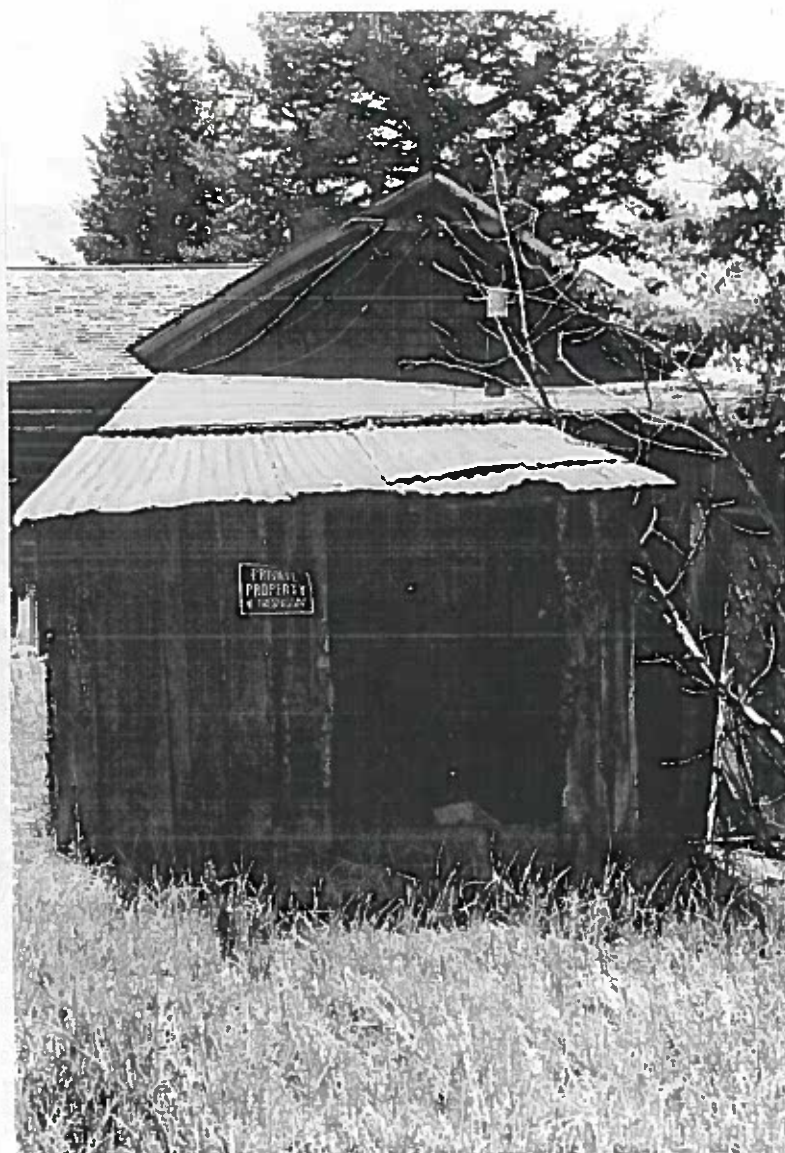
Figure 160: Looking south at the frame addition to the building. Note the wall missing and high grade around the structure.

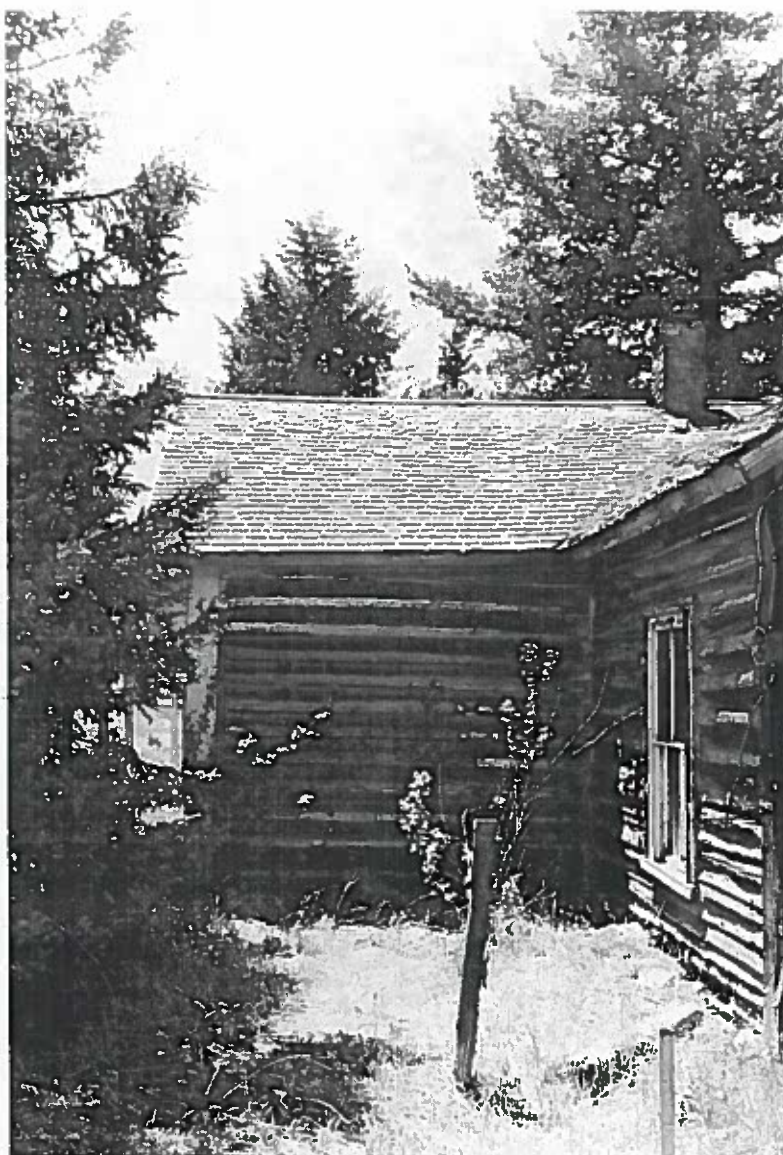
Figure 163: Looking south at the log structure. With the exception of the sill log and part of the second log on the left wing the logs are in good condition. The wood shingle roof on this section is in good condition with some minor shingle problems.

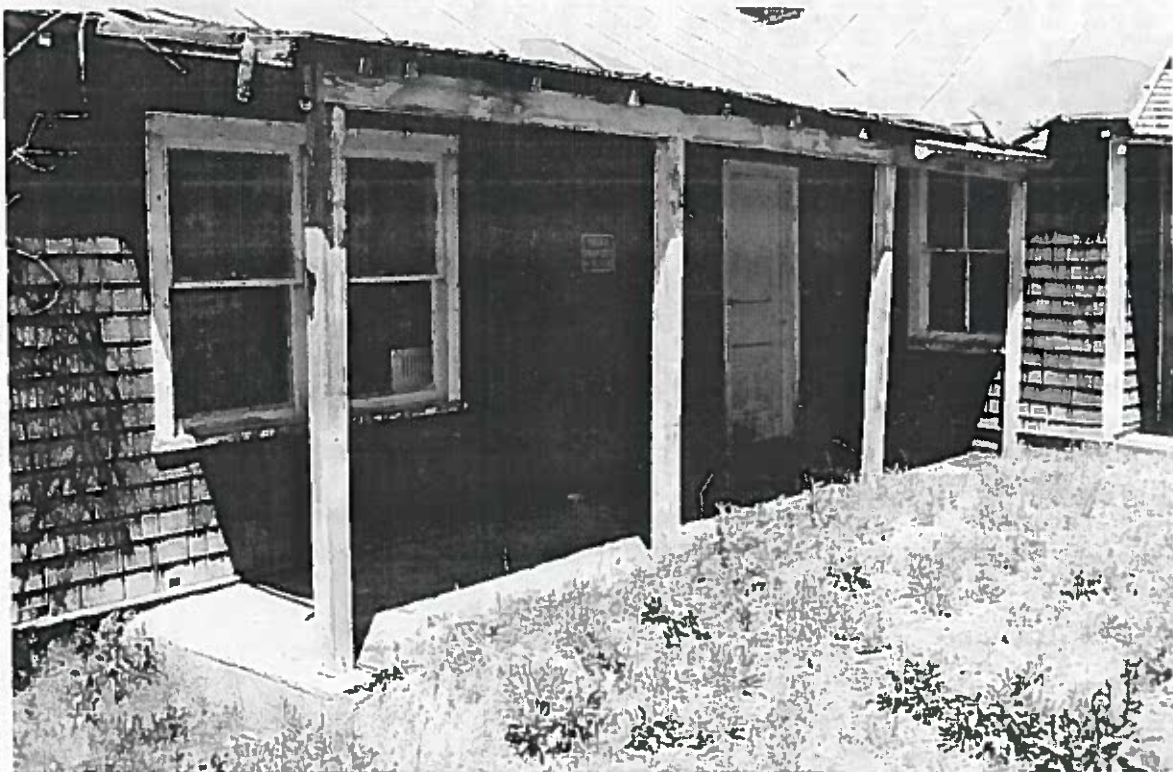
Figure 181: Looking northwest at the porch area. Note the high grade around this end of the building due to the buildup of the road over the years. There is some rot along the base of the wall shingles and the structure base.

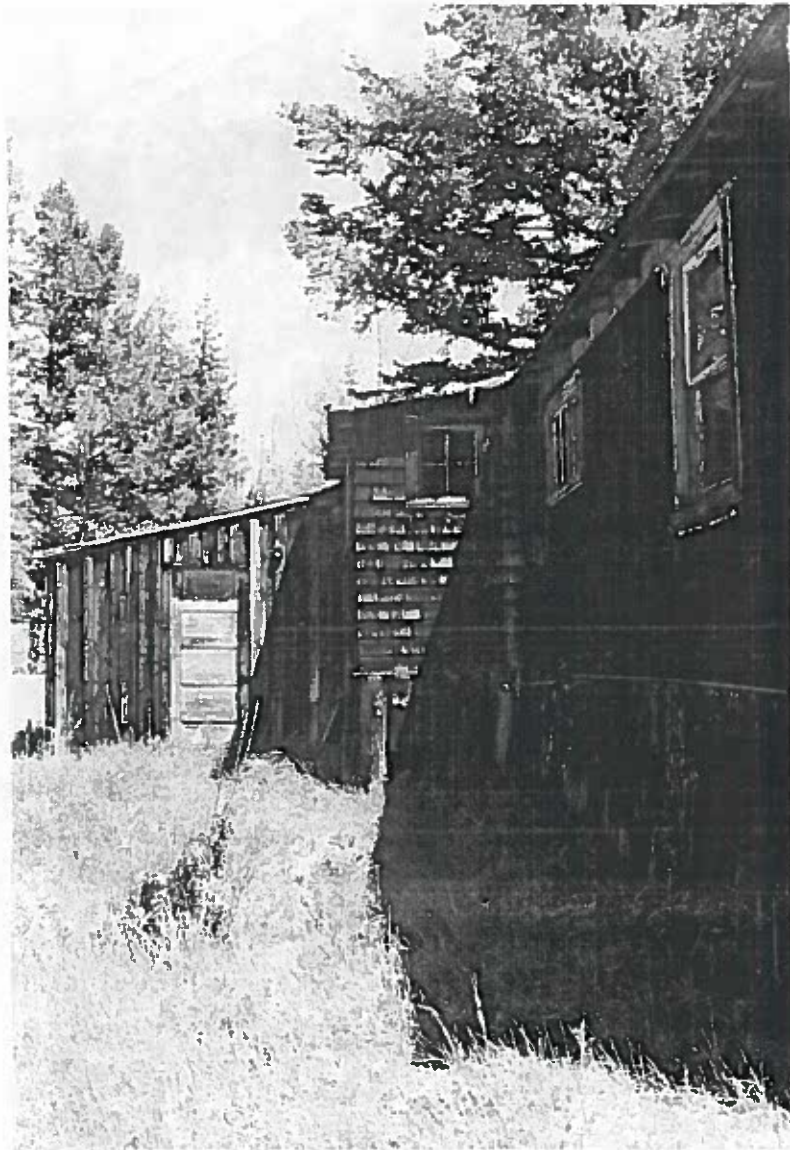
Figure 184: Looking north at the additions on the back of the building. The frame structures are deteriorating badly.

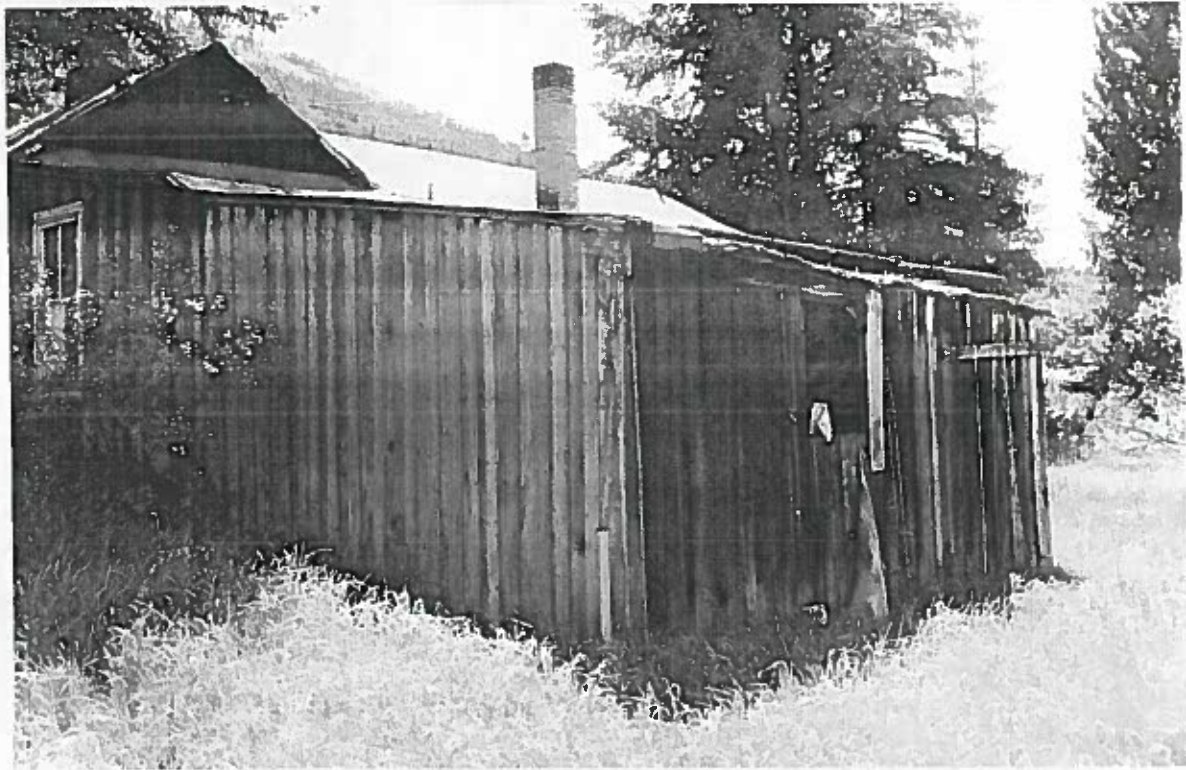
Figure 186: Looking southeast at the frame addition on the back of the building. The base is rotted as well as the roof and wall on the end.

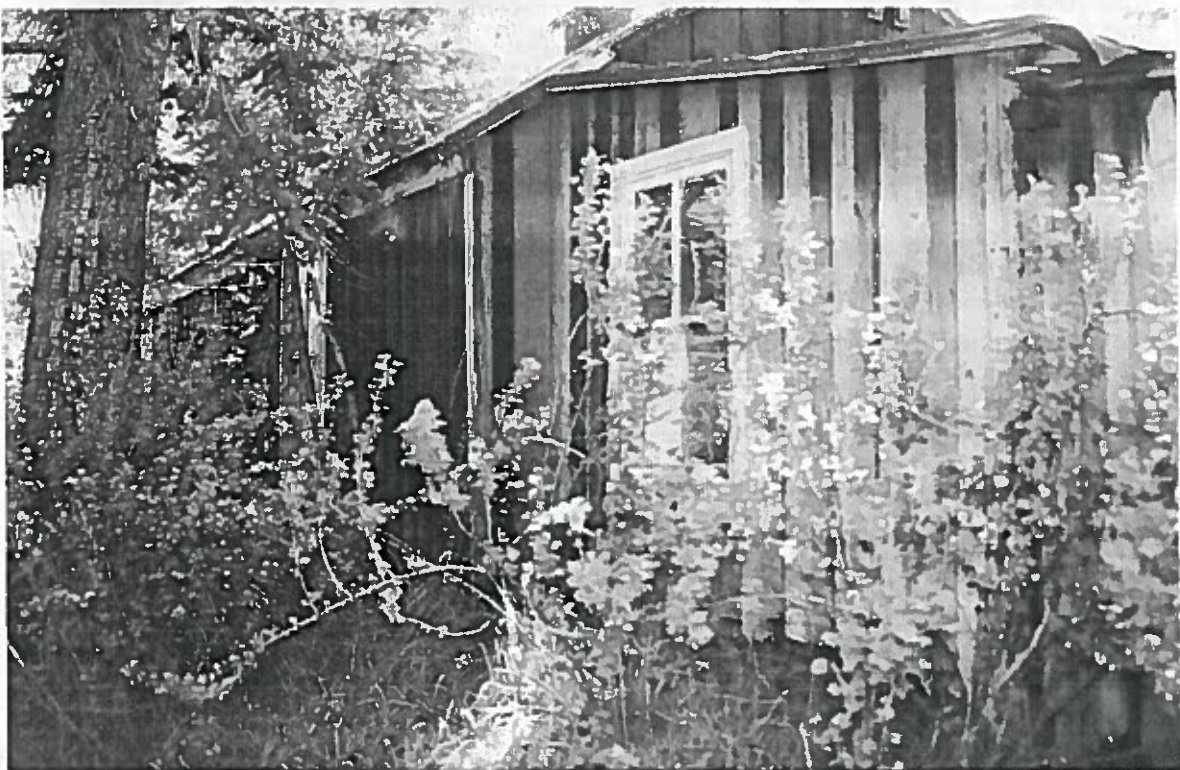
Figure 187: Looking east along the edge of the additions. There is no foundation under these sections of the Cabin.

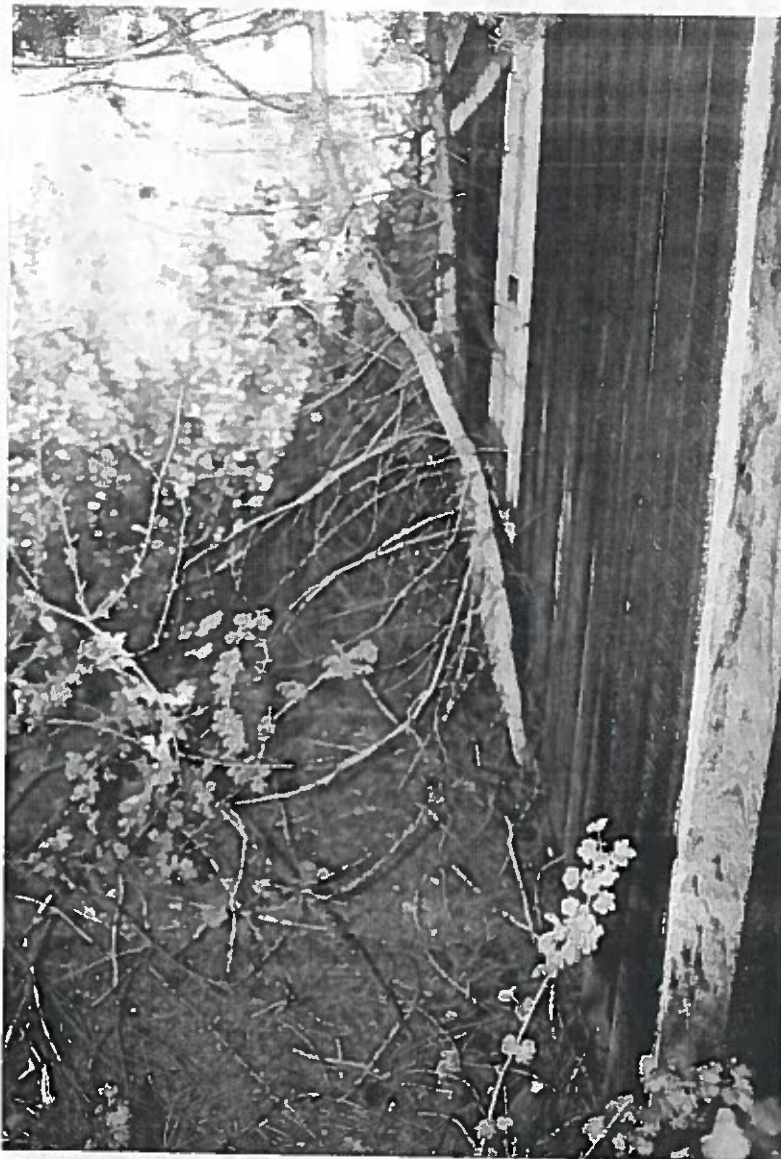
Figure 189: Looking east along the wall of the additions onto the original building showing the buildup of materials and trees where the surfaces are rotting because of water penetration.

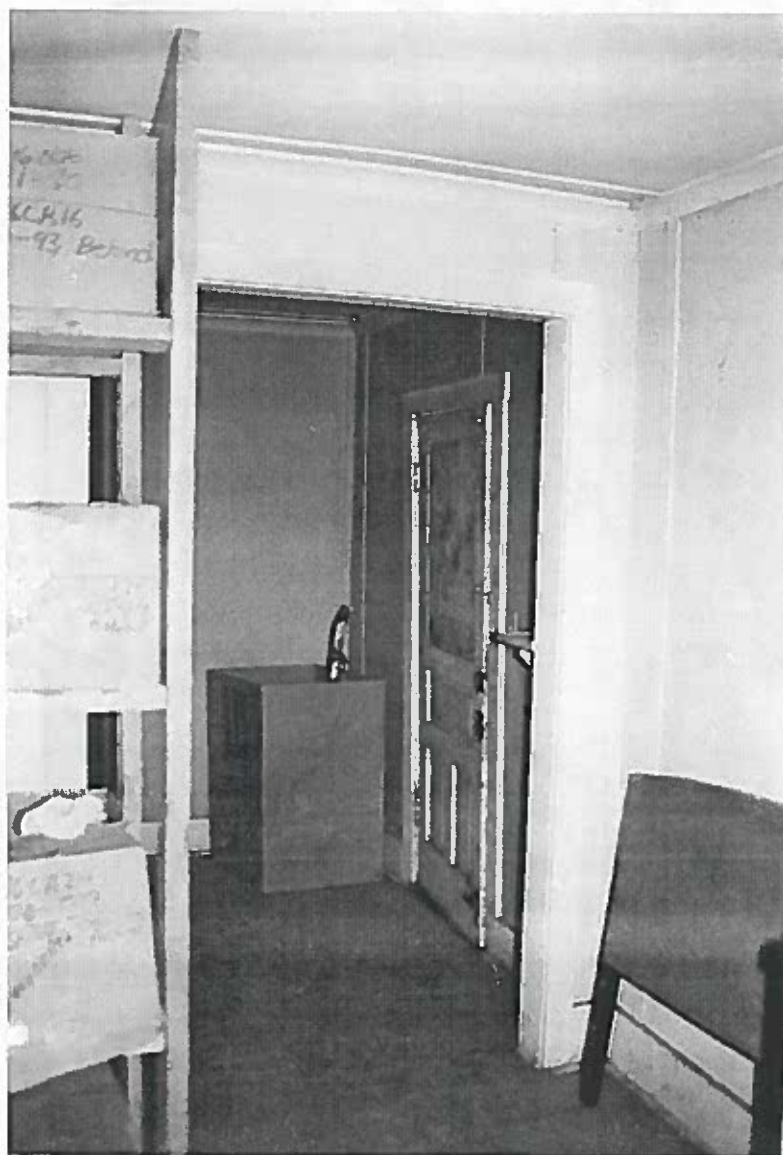
Figure 195: Looking northeast from the living room at the front entrance door into the vestibule. The door is weathered with some rot at the base. Plywood covers the glass area.

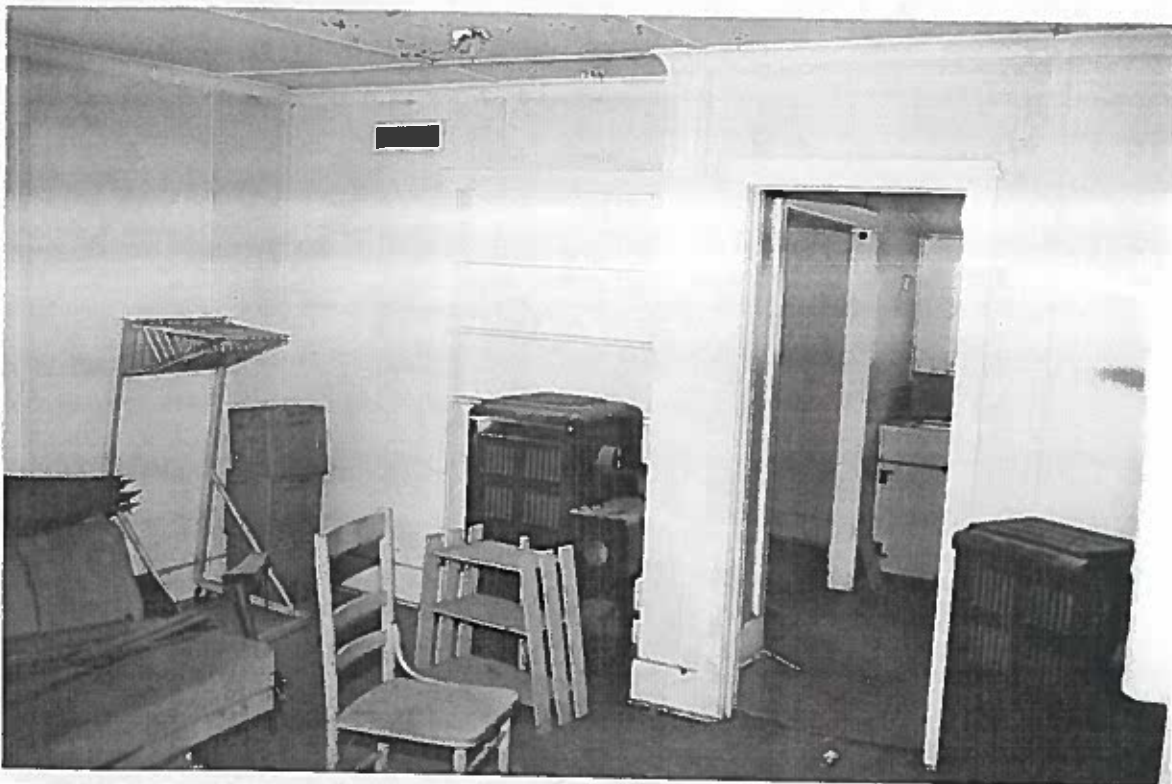
Figure 196: Looking southwest at the front room. The plaster walls and ceiling, wood floors and general woodwork appears to be in good condition.

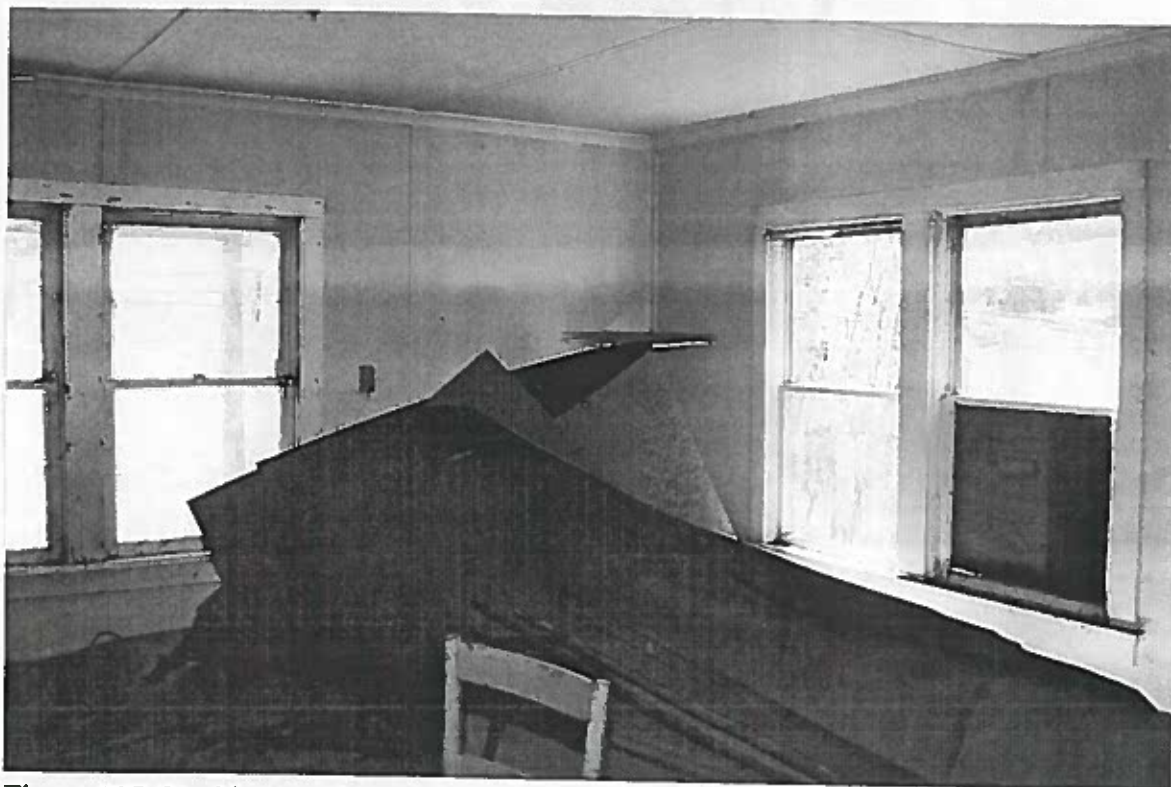
Figure 197: Looking southeast at the windows in the front room. There is some water damage along some of the sills and bottom sash of the windows as well as one piece of glass missing.

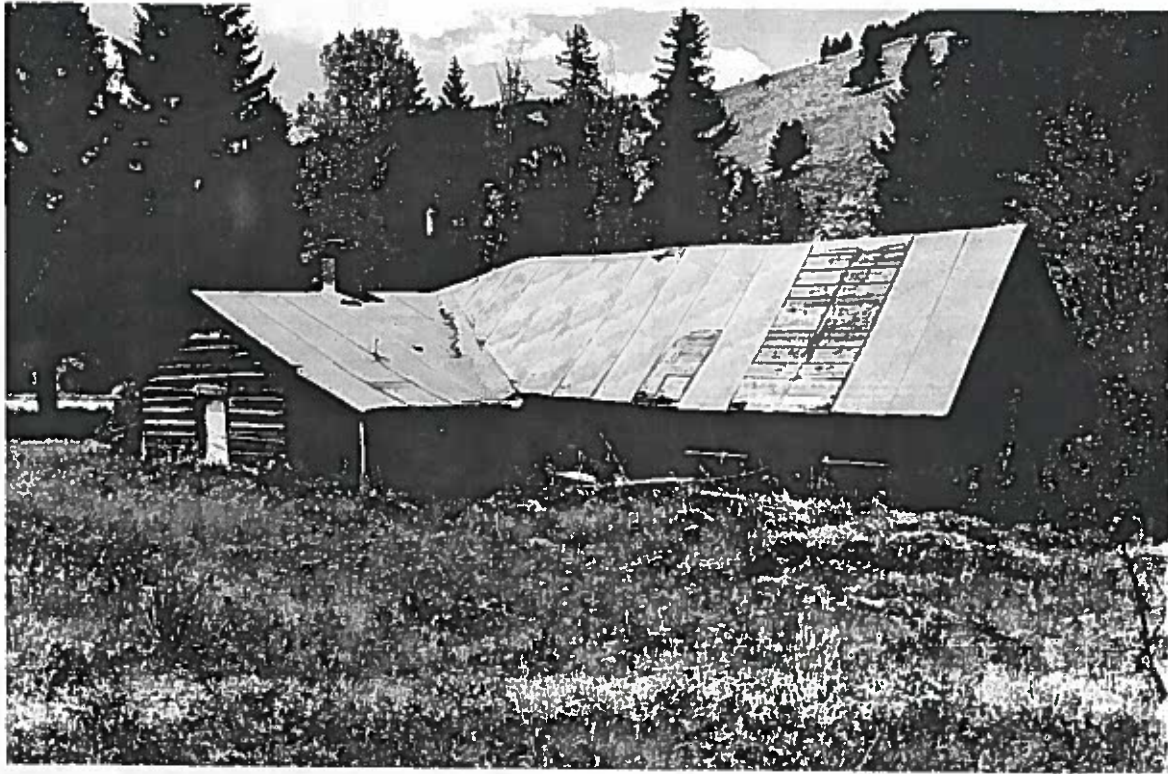
Figure 213: Looking southwest at the Cabin. Note the missing sheet asphalt on the roof, to the right. Also the grade slopes towards the building in this area.

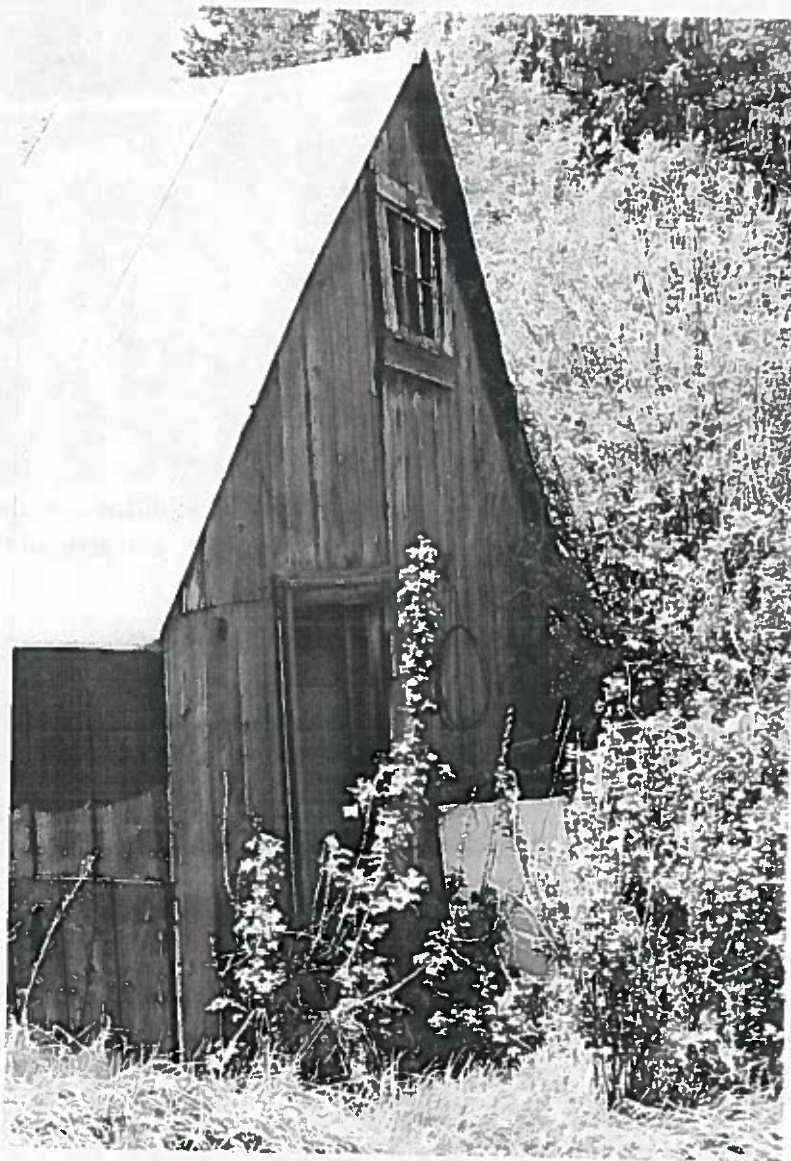
Figure 214: Looking southwest at the north end of the building. Note the weathered wood on the building and the high growth of shrubs and grass around the building.

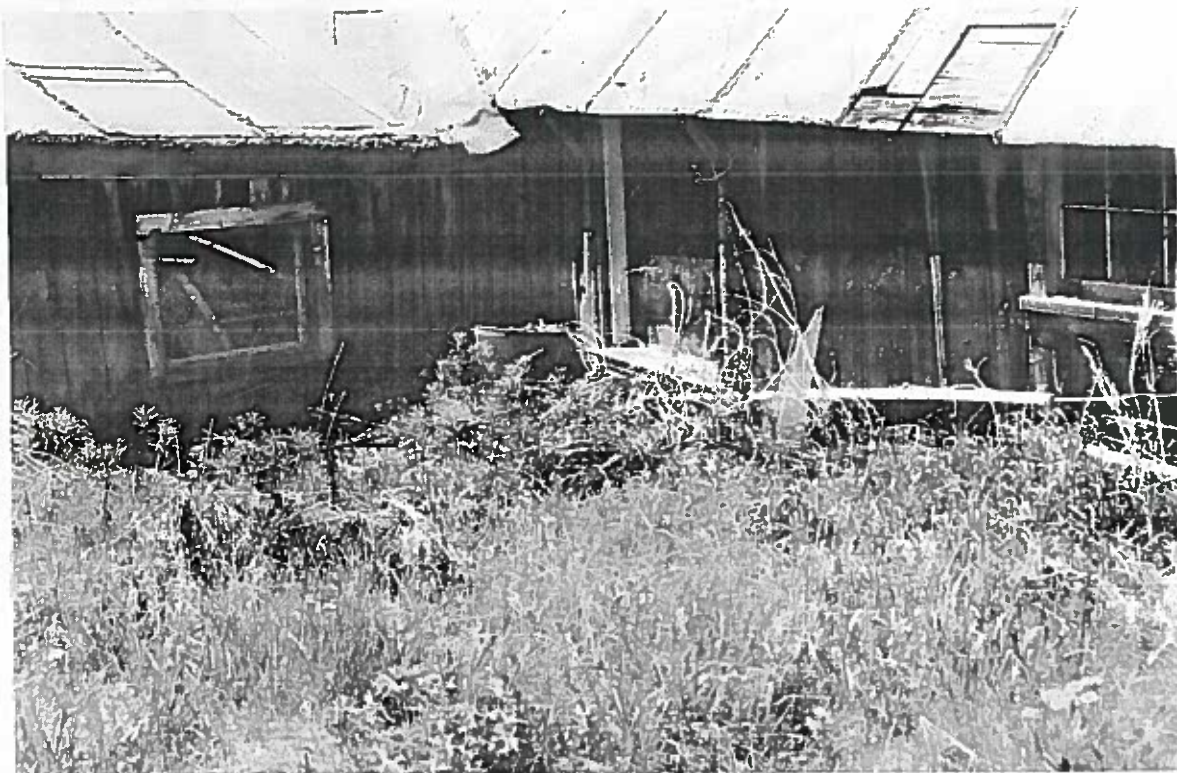
Figure 215: Looking southwest at the intersection of the frame addition and the original log building. Note the deteriorated roof sheathing and the high grade around the building.

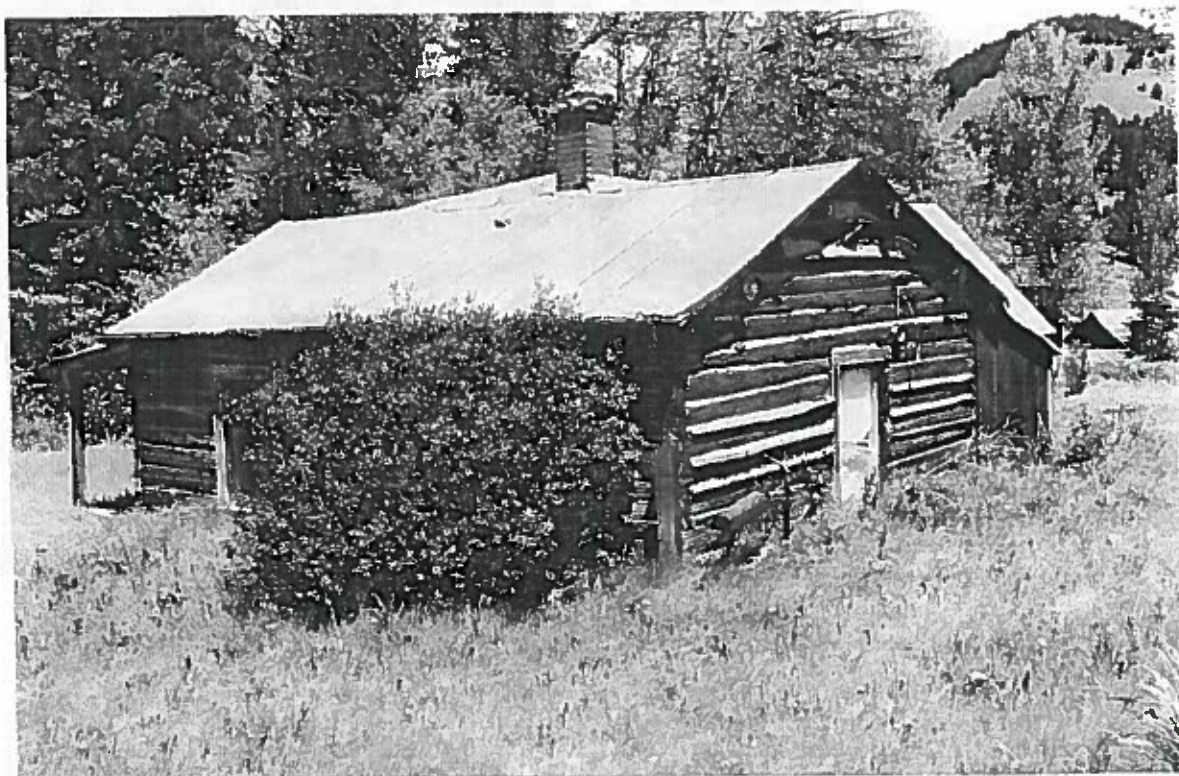
Figure 216: Looking northwest at the building. Note the high grade around this end of the building against the log work. The bottom sill log and at least one to two wall logs are deteriorated and rotted. The top of the brick chimney is also deteriorating.

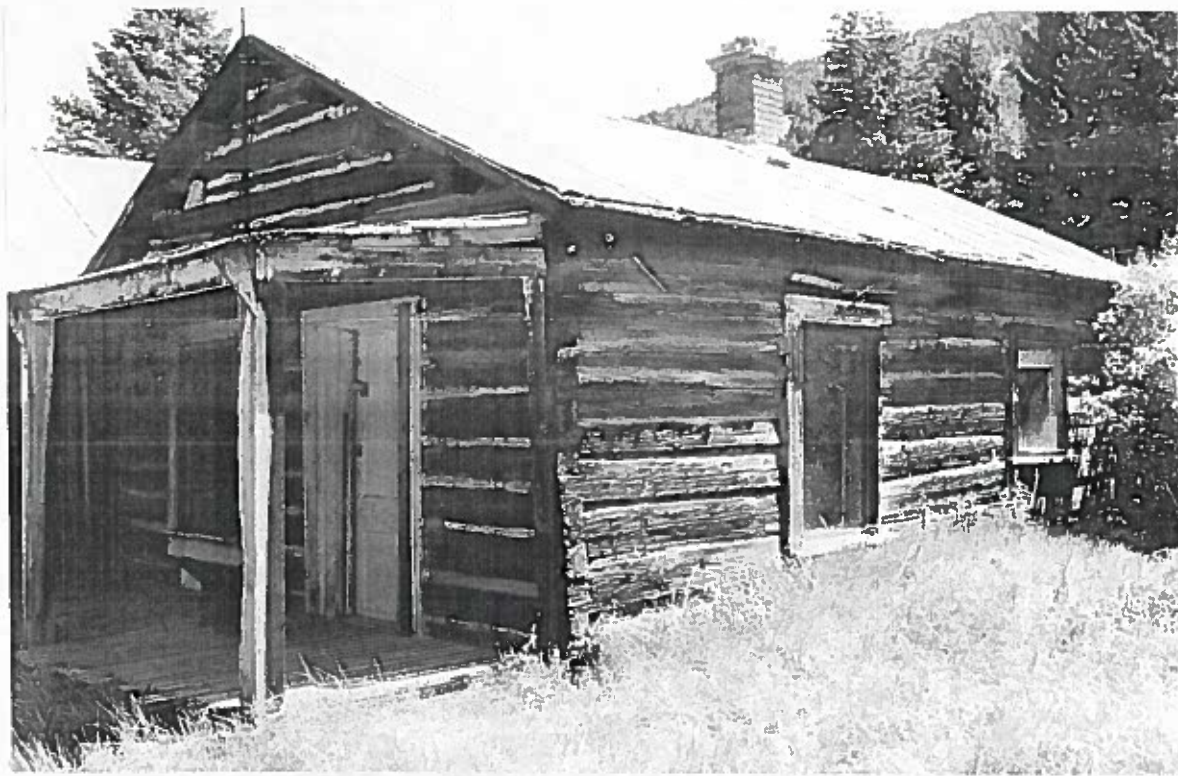
Figure 218: Looking northeast at the log portion of the building. Note the porch which is in poor condition with some rot at the base and in the columns and roof.

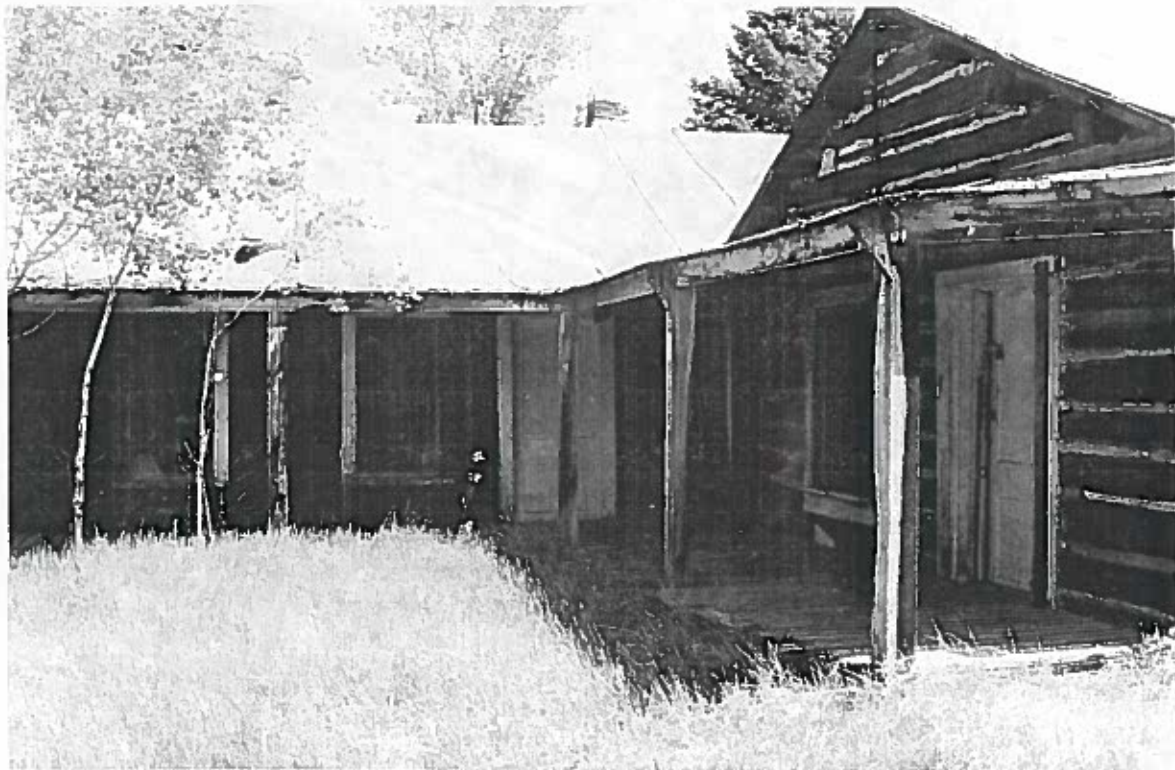
Figure 219: Looking north at the intersection of the porch on the log cabin and the wood frame addition. The sheet asphalt roof appears to be in good condition on this side.

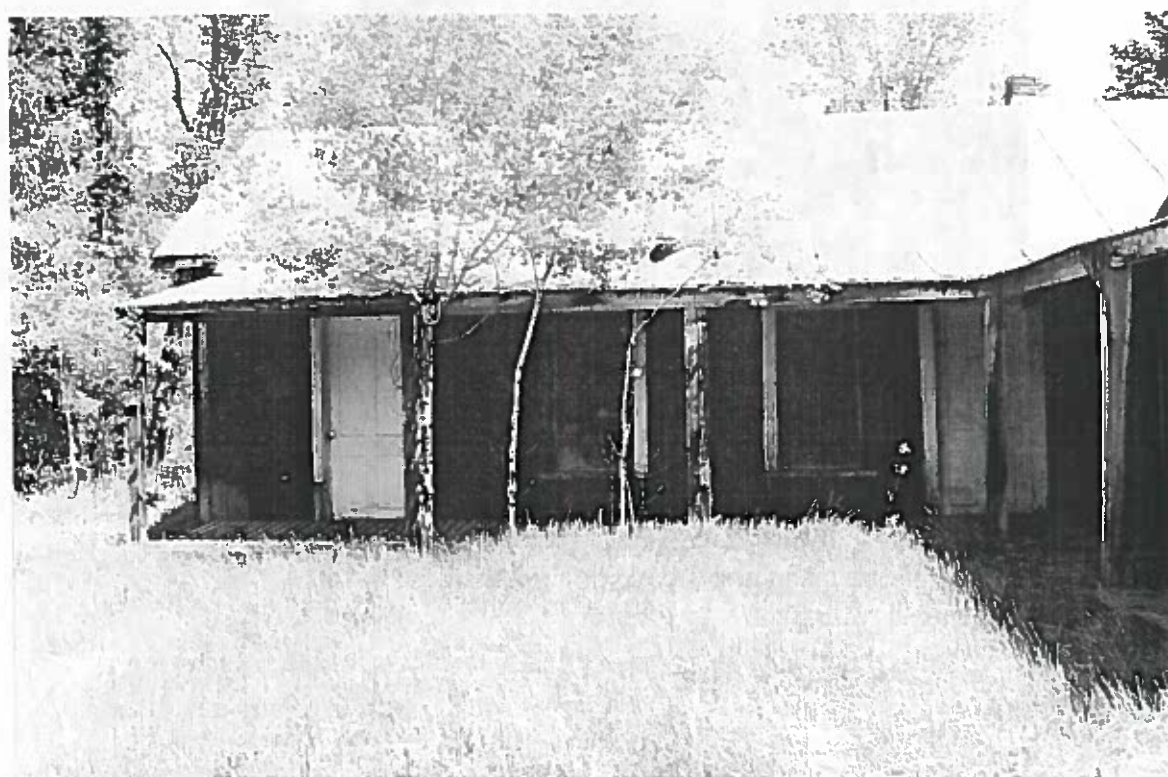
Figure 221: Looking north at the wood frame addition that was built on the ground with no foundation.

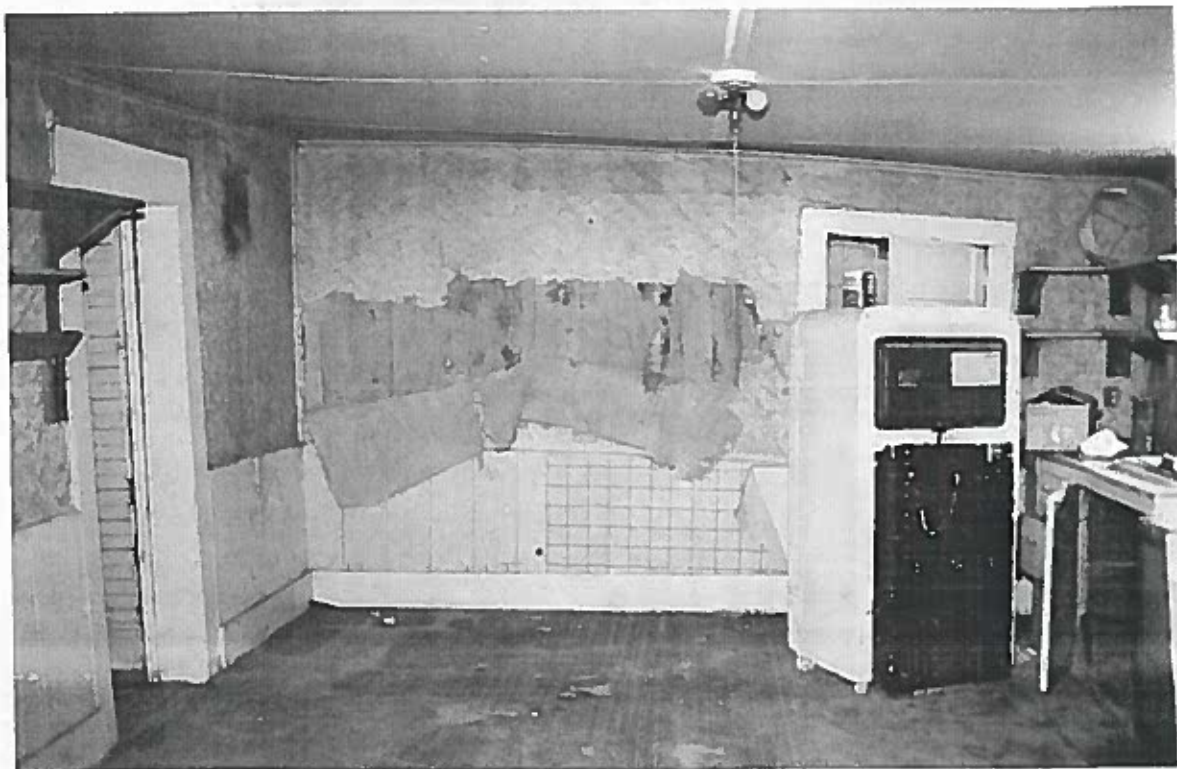
Figure 226: Looking north at the back wall of the original log building with its original layers of wall paper and newspapers. Generally the materials are in fair to good condition.

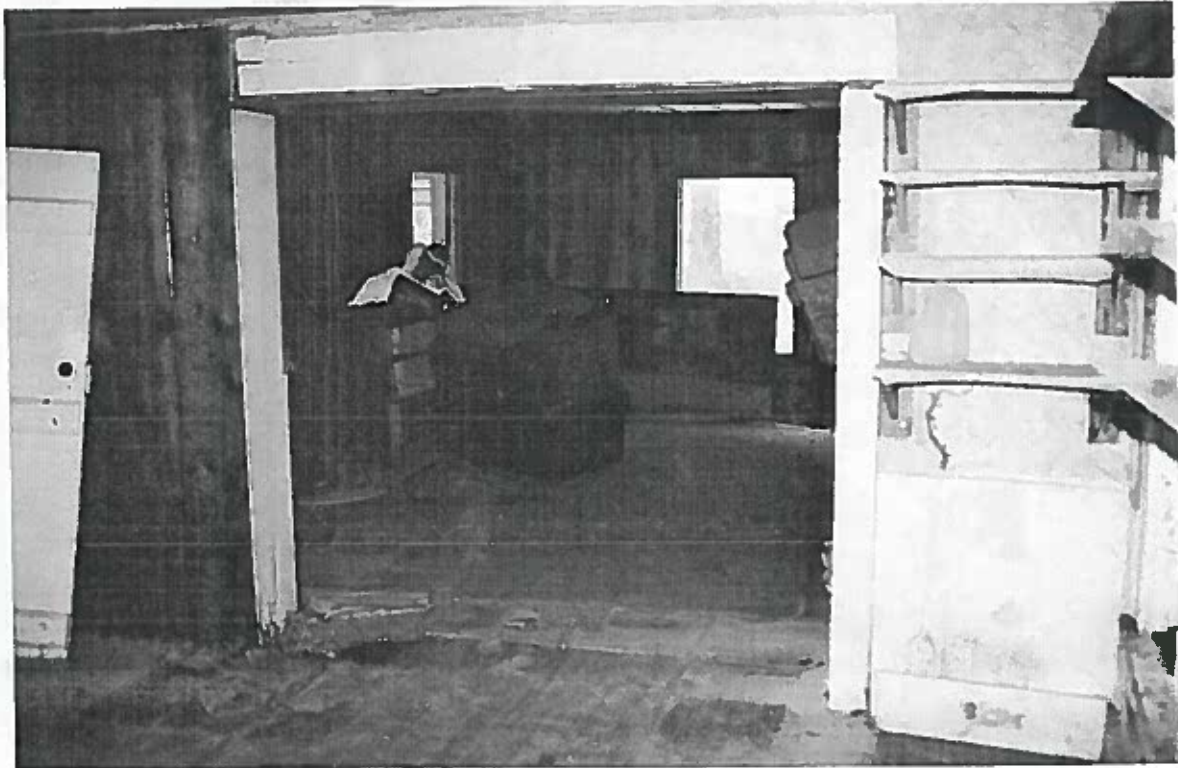
Figure 228: Looking south at the living room from the kitchen. The wall along this area has been opened up over the years. The structure is in good condition even though some of the finish materials are not.
