**ARCHITECTURAL ASSESSMENT, RECOMMENDATIONS & COSTS  
of  
HISTORIC STRUCTURES**

**MINERAL HILL MINE**

**JARDINE, MONTANA**

**OCTOBER, 2000  
(REVISED JANUARY, 2001)**

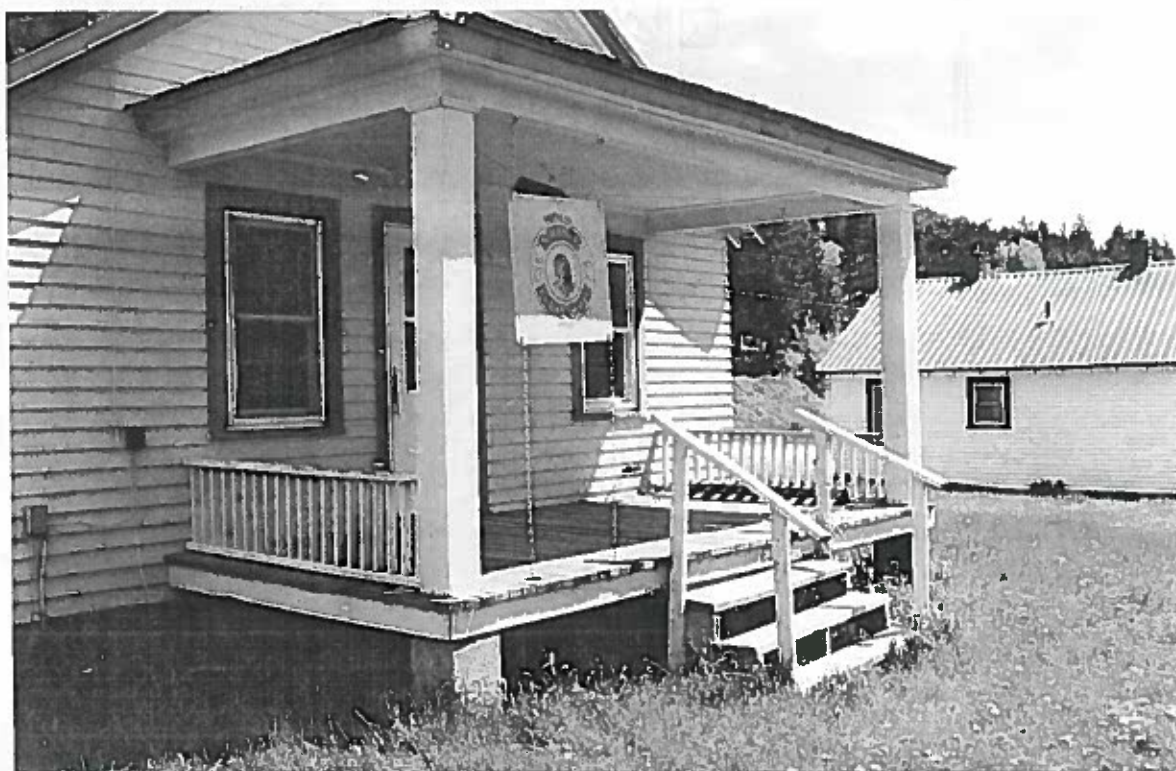
Figure 236: Looking southeast at the front porch. The porch deck has some floor deterioration but is generally in good condition.

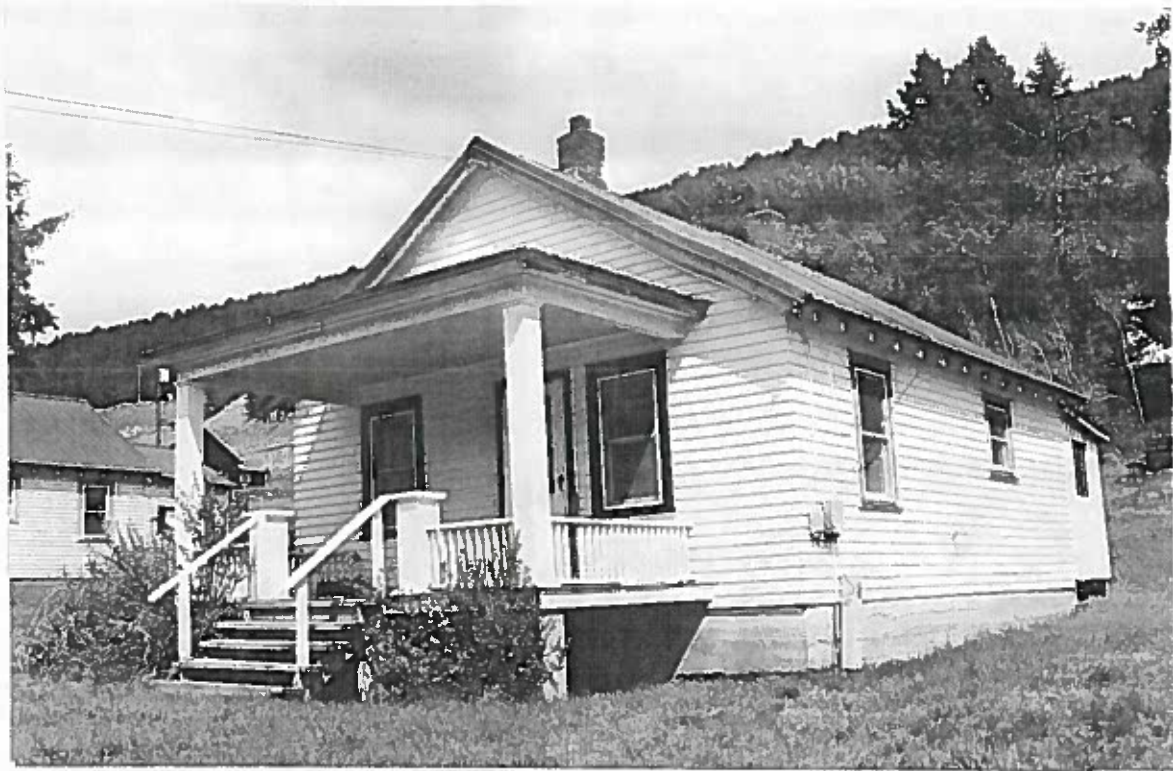
Figure 251: Looking northeast at the Residence. The foundation, walls and roof are in good condition.

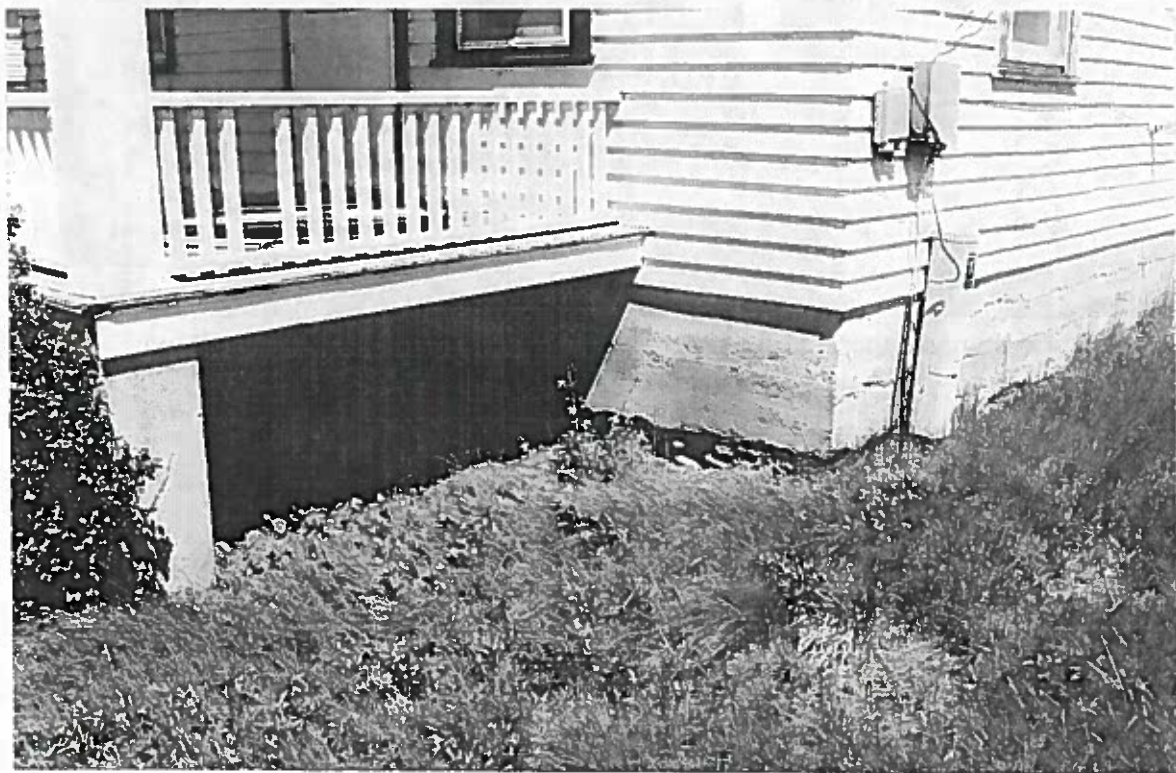
Figure 252: Looking northeast at the building. Note the undermining of the foundation on the front of the building.

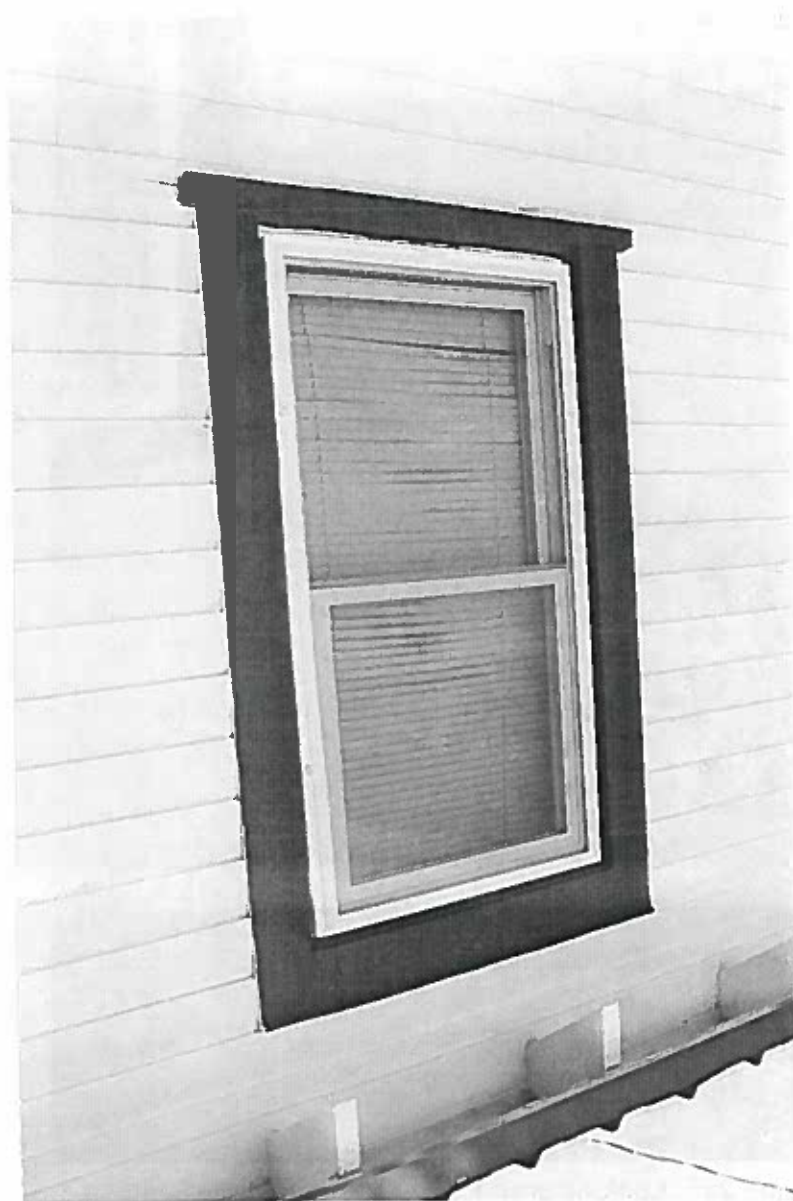
Figure 254: Looking southeast at a typical wood double-hung window. The window and adjacent materials are in good condition.

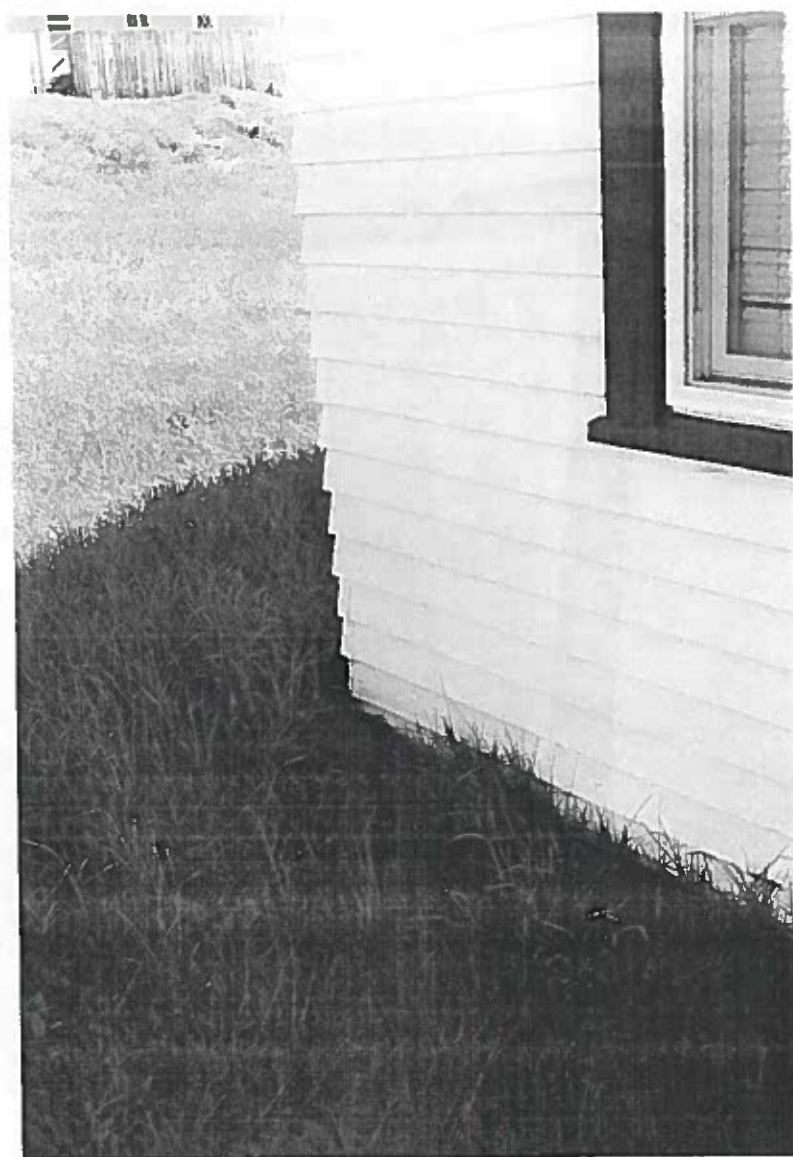
Figure 255: Looking southeast at the base of the building near the back. Note the high grade around the building at this point which is causing some deterioration of the wood materials.

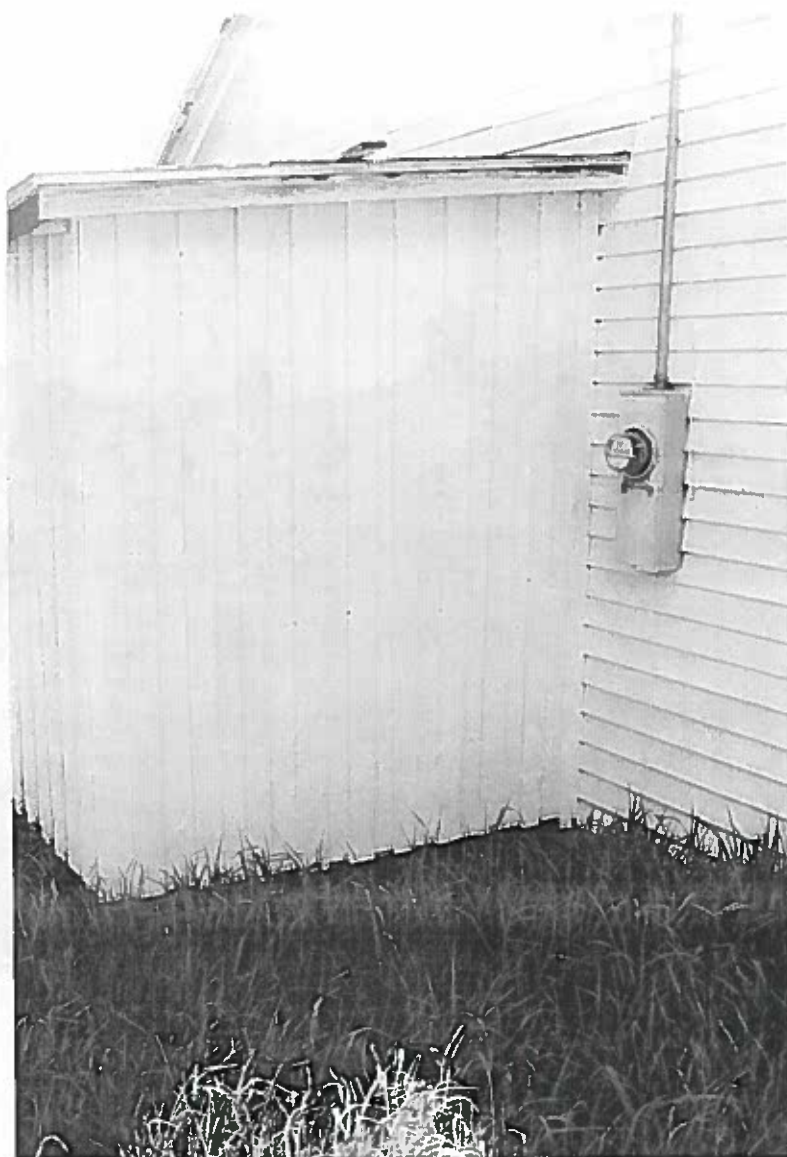
Figure 257: Looking southwest at the addition which is a frame structure with board and batten siding. It is in good condition but has no foundation under it.

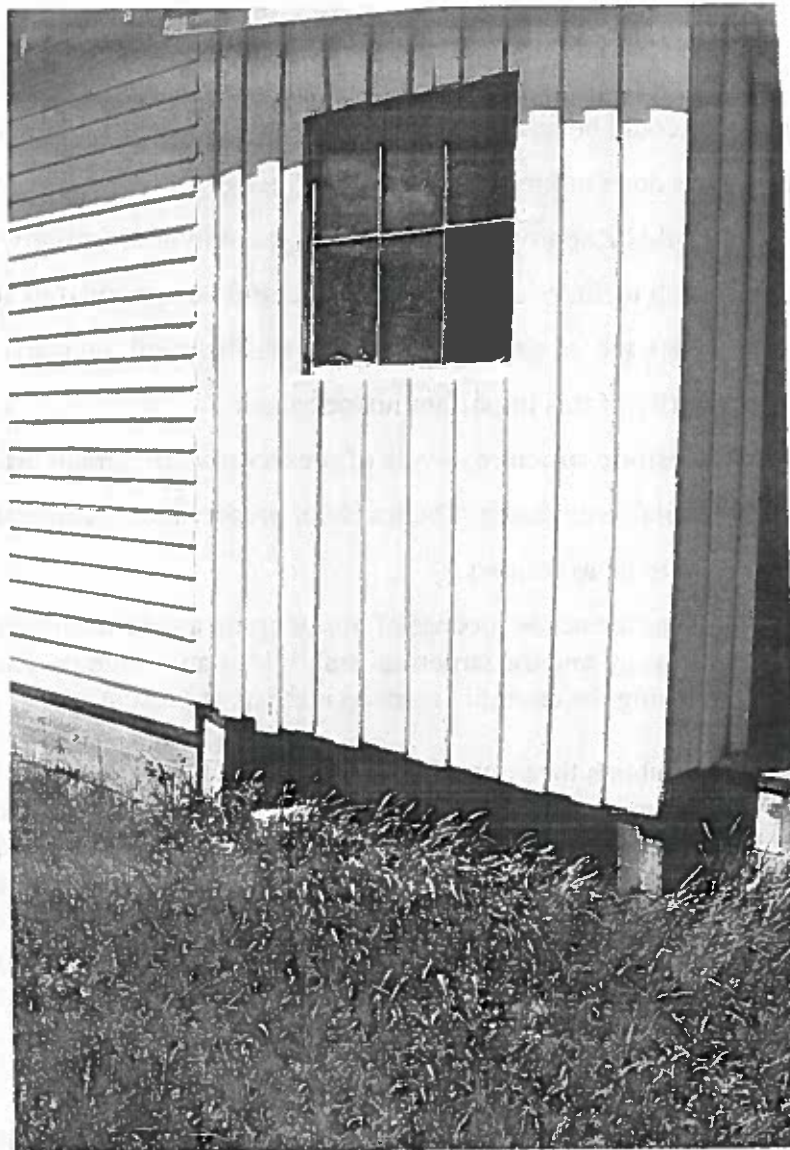
Figure 258: Looking northwest at the addition. The building sits on some wood blocking..
