# **Monument Fire**

## **BURNED AREA EMERGENCY RESPONSE PLAN**

**UNIT:** Coronado National Memorial

**DATE:** July 12, 2011

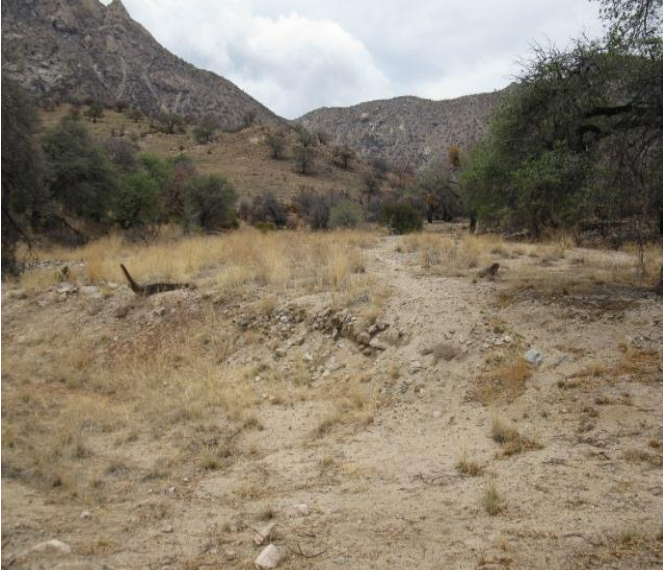
The watershed above these two culverts was modeled as part of the BAER assessment. Although the two culverts are side-by-side in the drainage, the subwatersheds above the culverts were modeled separately by the team hydrologist. The results are shown in the previous tables for the two sites listed as '3 mile wash points A and B'. Results show a significant increase in runoff following the fire and concerns that these culverts will not function. Post-fire discussions with the engineers and hydrologists that worked on the original road improvement contract have raised the issues of the inability of the culverts to handle the predicted flows. They predict the culverts will plug up again and due to the amount of water and debris that will run-off, it could tear out this section of road – leaving visitors and staff stranded in the memorial.

Looking north on 3 Mile Wash

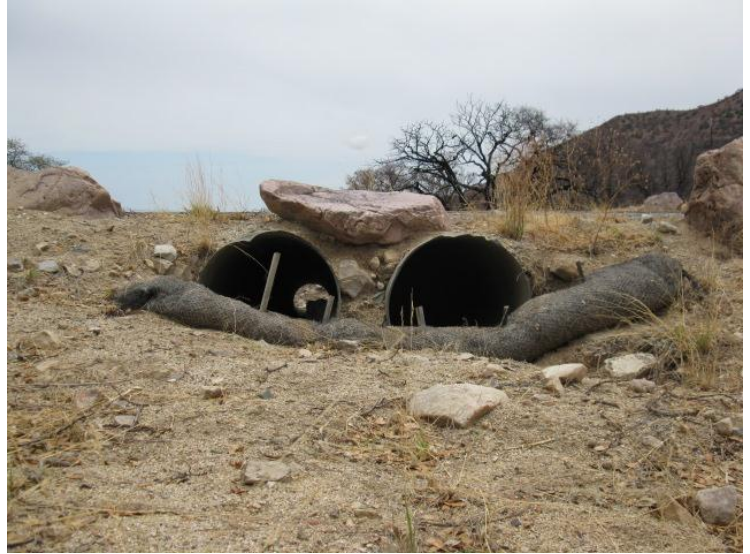
Looking south on 3 Mile Wash

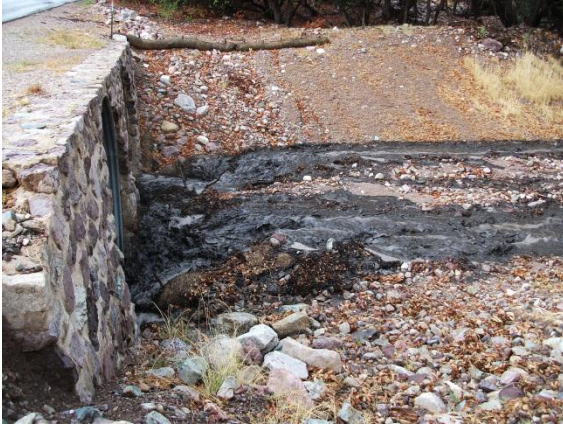
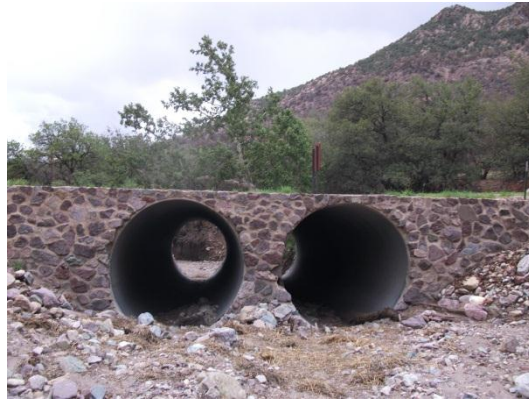
## Visitor Center Culverts

**Visitor Center Culverts.** The paved section of the road is in the lower part of the watershed and thus must withstand the largest flows. These major features include two corrugated metal culverts installed next to each other and measuring 9-feet in diameter. The headwalls surrounding these culverts were built by the CCC. In 2006 these culverts became plugged with debris forming a dam. The water overtopped the road and scoured the channel on the downstream side of the culverts. Evidence of channel scouring and downcutting (3-4') is still evident. In 2008 the channel migrated and no longer flowed through the culverts. Part of the flow went over the road and part stayed in a new channel that drained directly toward the headwall (causing cutting and erosion around the historic wall) and then flowed over the road. In 2010 a road reconstruction project was completed that improved the road surface, installed three new low water crossings, and restored the channel to its original path. The channel was designed to Federal Highway standards and is capable of handling a 25 year rainfall event. It has not been determined if the new channel will withstand post-fire flows. It will depend on the timing and amount of precipitation.

We requested that these culverts be used as a pour point for the watershed modeling, but at this time the data is not available. The culverts are expected to function properly during the model storm event which is approximately 1.5" of rain in 30 minutes. A report, done in 2009 by Natural Channel Design, Inc., evaluated if the existing two 9-foot diameter culverts could pass the predicted 100-year event. It was concluded these culverts could pass the calculated flows but due to the restriction of the channel where the culverts are, the flows exiting the culvert would be highly erosive due to the increase in velocity.

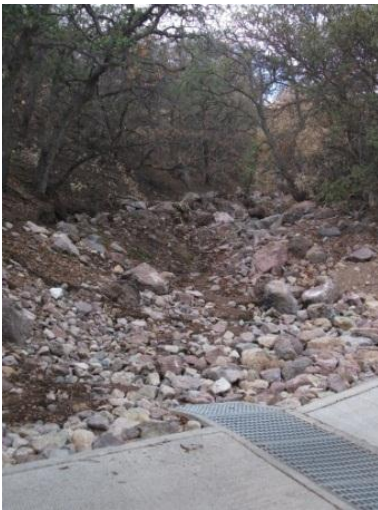
3<sup>rd</sup> Low Water Crossing looking south

New Low Water Crossings. Three concrete hardened low water crossings with open grates were installed along the portion of the road between the Visitor Center and what is known as the First Crossing in 2010. These were installed as part of the road reconstruction in order to better drain the road following the 2006 debris flow event. These structures were designed to pass small flows through the grated box culvert, and larger storms would result in debris on the road that would need to be removed. There are also a number of culverts in this section of road. Data from Youberg (report dated 7/11/11) in the nearby Miller Canyon reports 1.66" of rain fell in approximately one hour, and that .72" of this event fell in 10 minutes triggering debris flows in that canyon. This event triggered flooding along this portion of the road. Debris was removed from the road surface at the 3 new crossings, and other areas. Several of the culverts were overwhelmed and completely plugged.

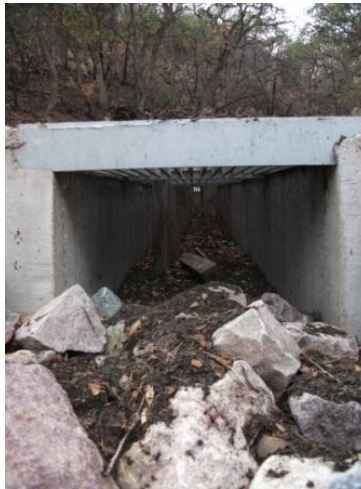
Debris/sediment in grate of 3<sup>rd</sup> Low Water Crossing

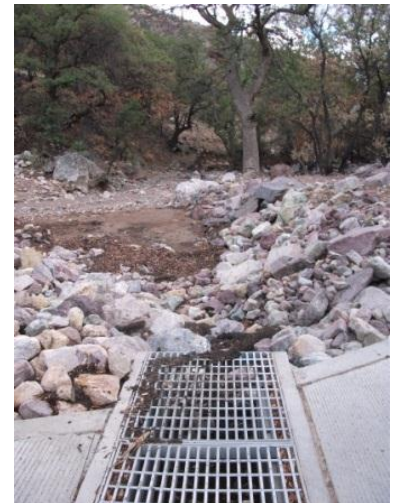
3<sup>rd</sup> Low Water Crossing draining into Montezuma Wash

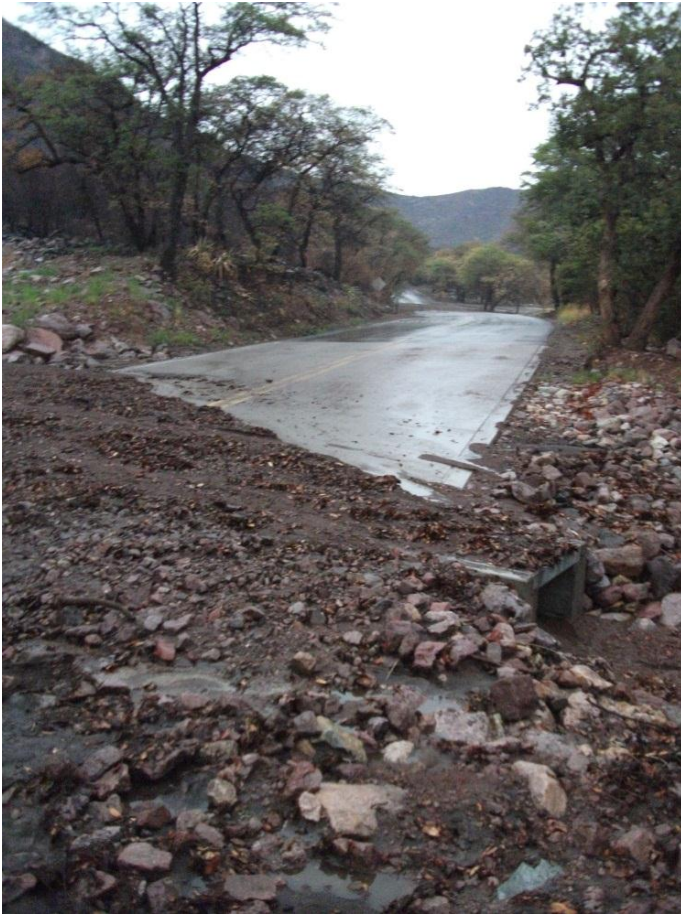
New low water crossing 2-3 hours  
after storm 07/20/2011

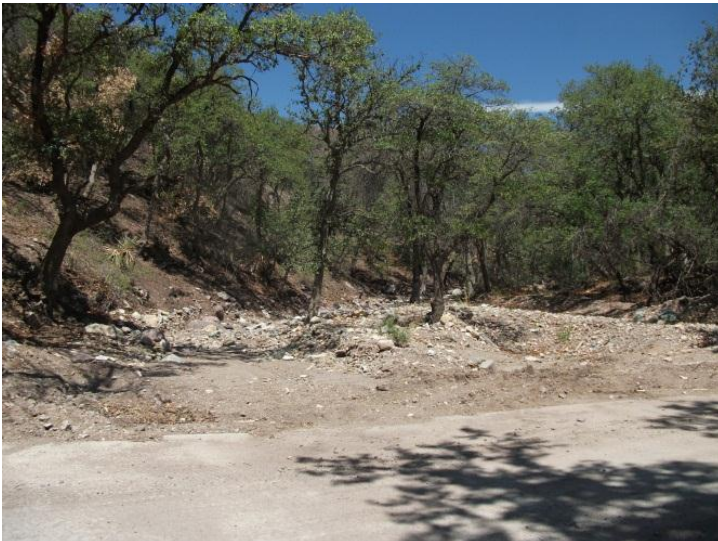
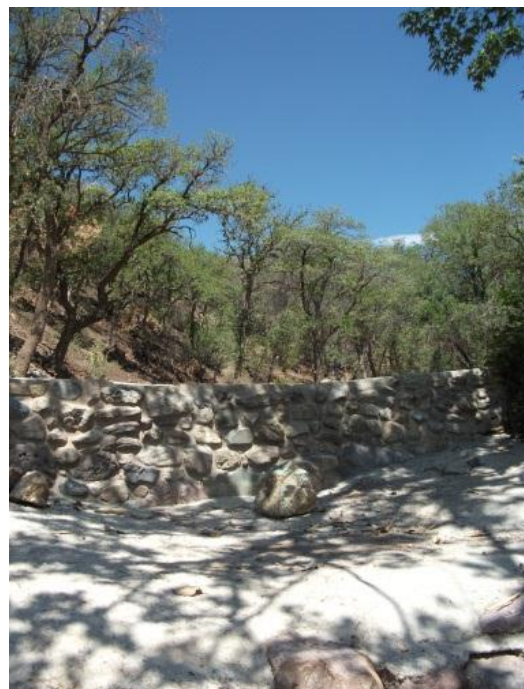
First Crossing. The First Crossing is at the intersection of the paved and unpaved portions of the road. There was damage here in 2006 when the channel migrated to the upslope side of the channel and was cutting along the upper portion of the CCC headwall. A small reach of the drainage was rechanneled and the crossing has subsequently been working as designed.

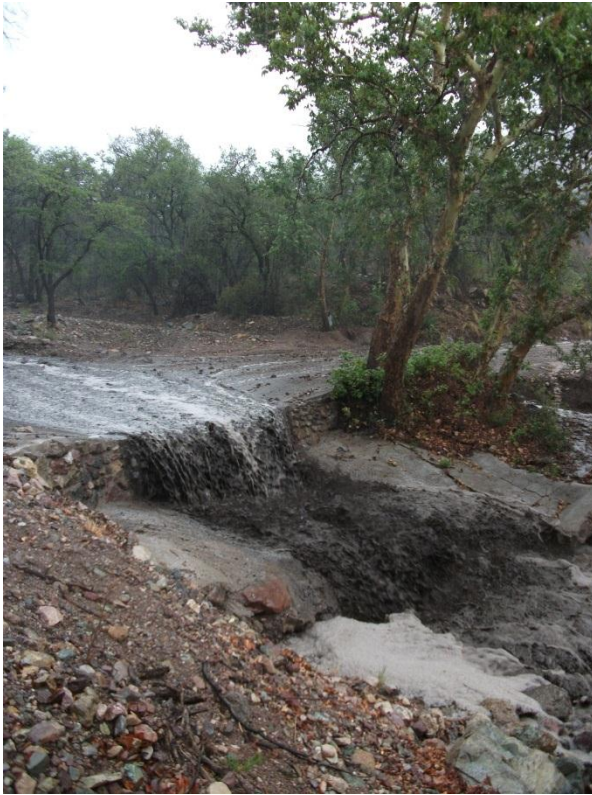
First crossing after 07/20/2011 storm

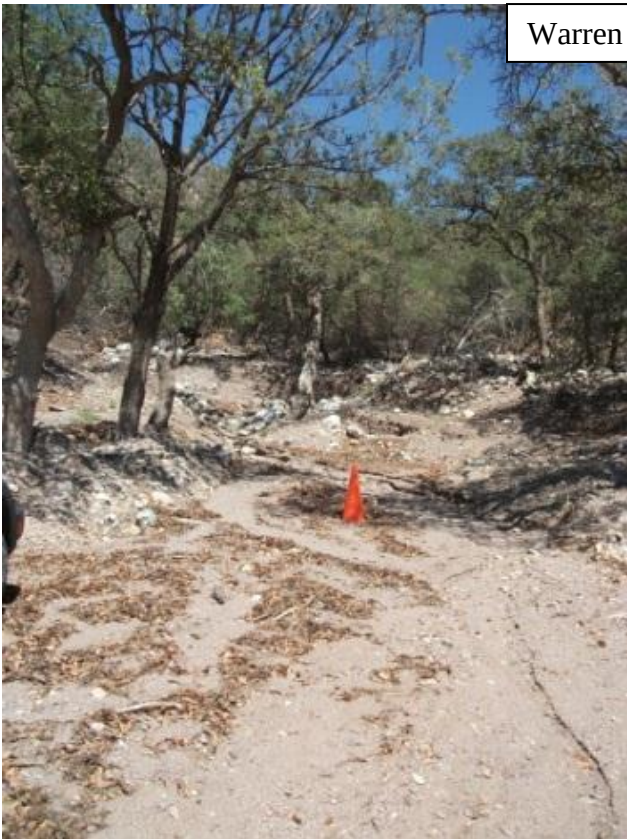
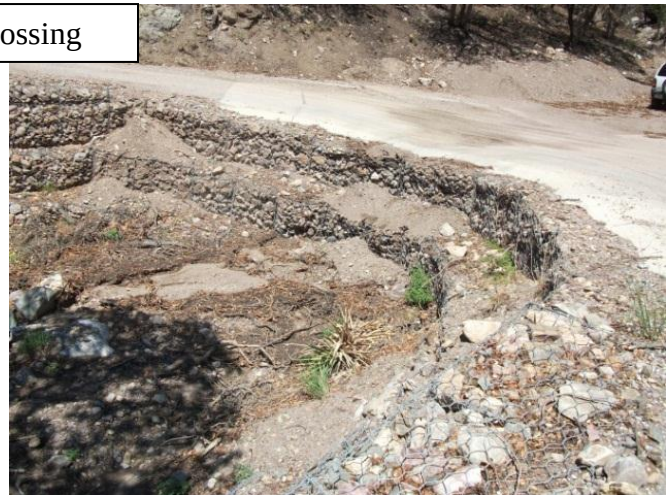
Warren Crossing

Warren Crossing. This crossing sustained heavy debris following the 2006 event. Debris was more the 10' deep on the road. The material was cleared, a new section of concrete apron was installed, and additional gabions were installed on the downstream side of the crossing. Since 2006 the crossing has functioned as designed, but there have not been any large precipitation events in this section of the watershed. The July 11, 2011, event appears to have been more concentrated in the lower areas of the watershed and

road. There is no evidence of recent flooding at this crossing or on the unpaved sections of the road.

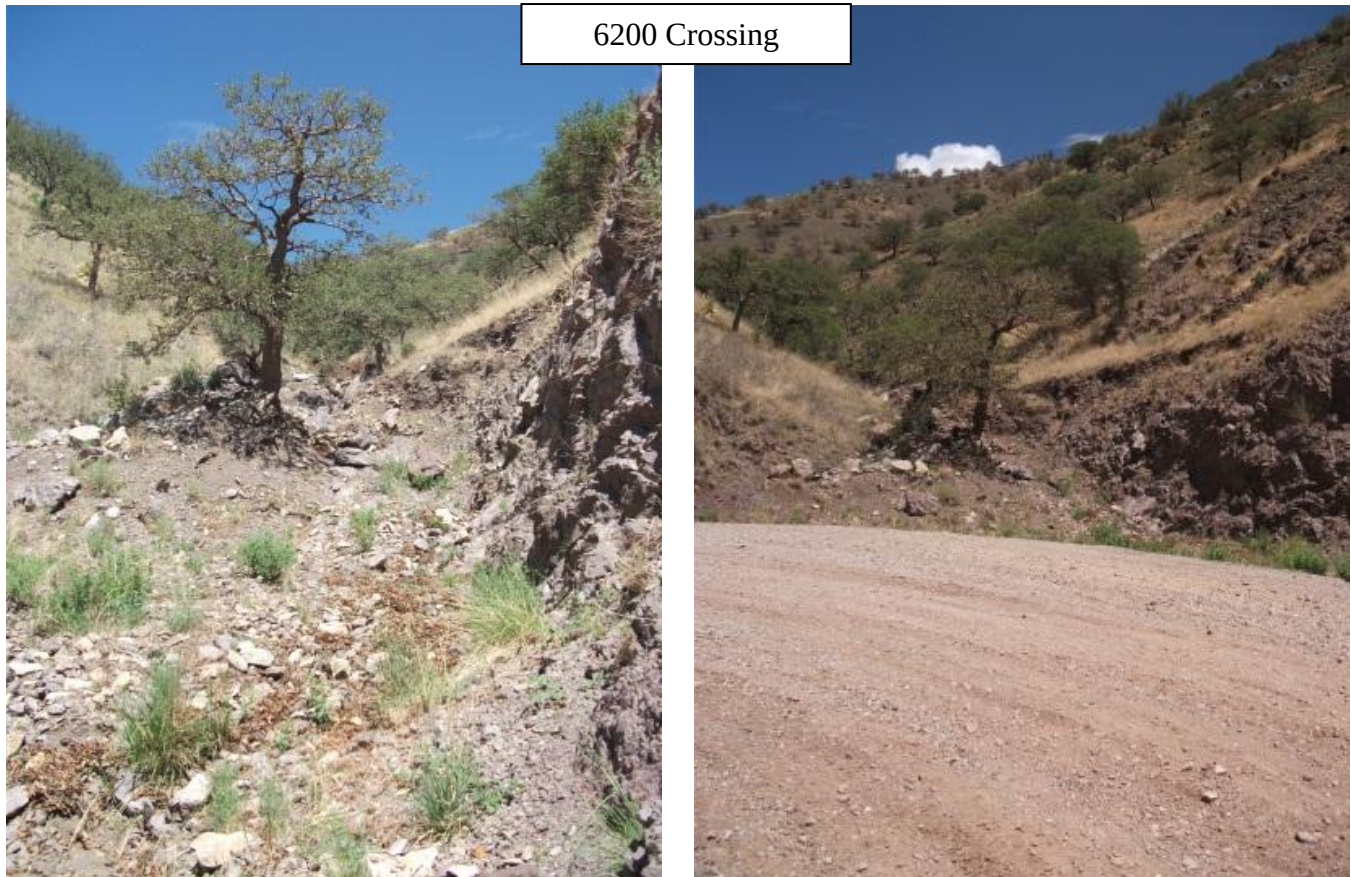
6200 Crossing. This crossing drains a small portion of the upper part of Montezuma Wash. Significant debris accumulated at this site in 2006. Since that time, the crossing has functioned as designed; however, there have not been any large precipitation events (as of yet) in this part of the watershed.

C. Design/Construction Specifications. Additional assessment of this critical resource is needed. Skills of the assessment team should include people with expertise in road engineering, and experience in debris flow environments with an understanding of the hydrology of burned areas in order to determine if the road is properly drained, make treatment recommendations, and to evaluate safety conditions along the road in the post-fire environment.

The road, culverts and low water crossing need to be continually inspected and maintained. Maintenance includes: cleaning the culverts, removing debris from the road surface and adjacent areas, and road grading as needed.
