HISTORIC STRUCTURES REPORT

STONE LIBRARY

Adams National Historic Site

Completion Report

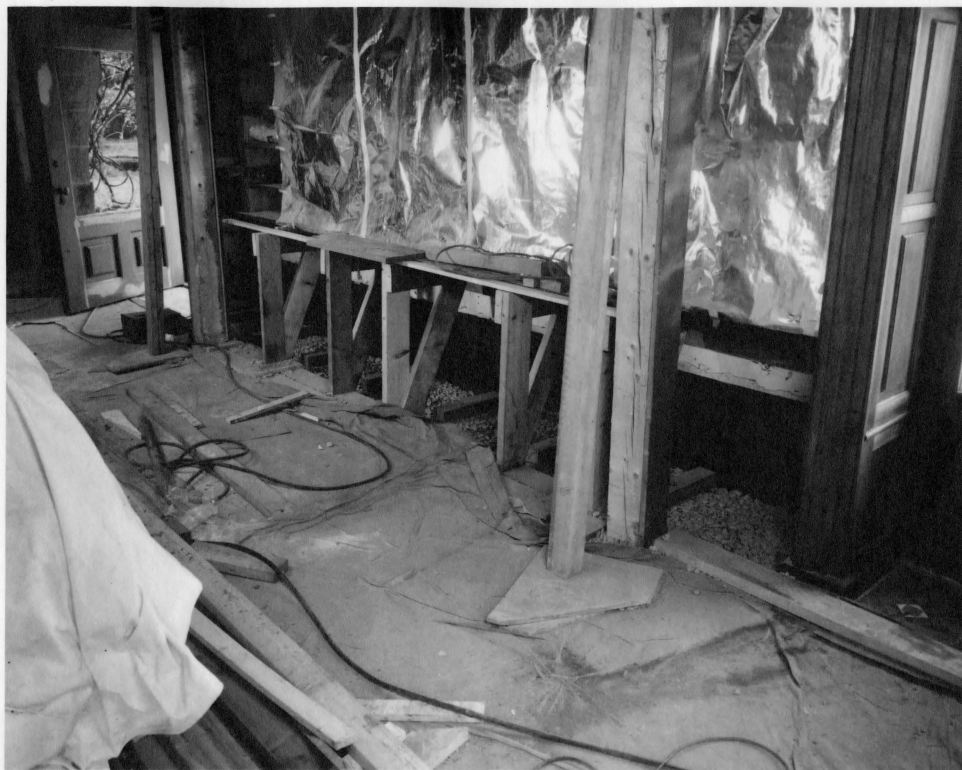
ILLUSTRATION NO. 1

Illustration No. 1 shows the installation of inflammable paper foil to protect the books which remained on the shelves on the south, west and north walls. The photograph also shows the bracing up of the shelves while the foundation was being replaced.

The installation of inflammable paper foil to protect the books which remained on the shelves on the south, west and north walls. The photograph also shows the bracing up of the shelves while the foundation was being replaced.

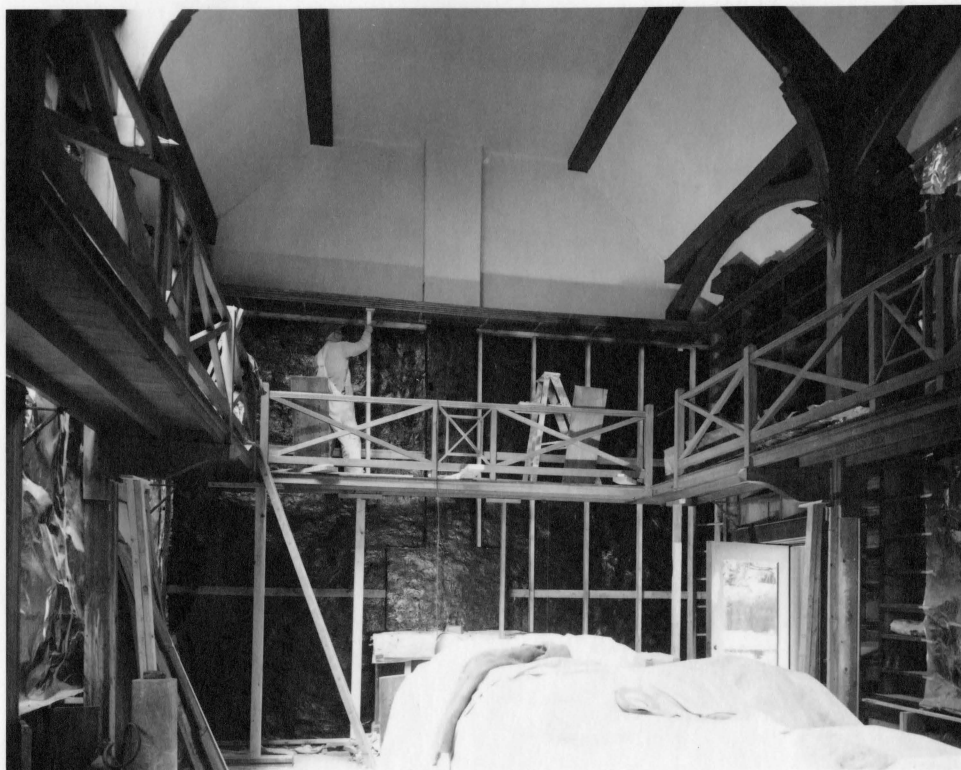
ILLUSTRATION NO. 2

Illustration No. 2 shows the east wall after pointing up had taken place on the inside and weather proofing applied. This was a very gratifying piece of work because for many years the dampness had caused great damage to the east wall of the library.

The east wall after pointing up had taken place on the inside and weather proofing applied. This was a very gratifying piece of work because for many years the dampness had caused great damage to the east wall of the library.

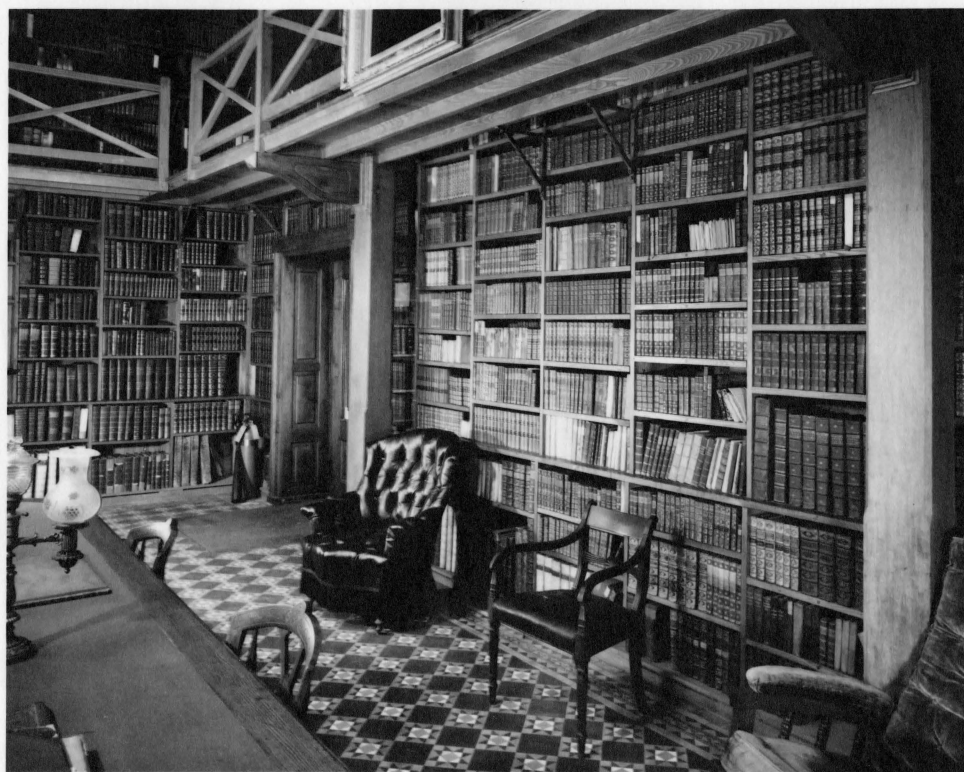
ILLUSTRATION NO. 3

Illustration No. 3 shows the wall after completion.

The wall after completion.

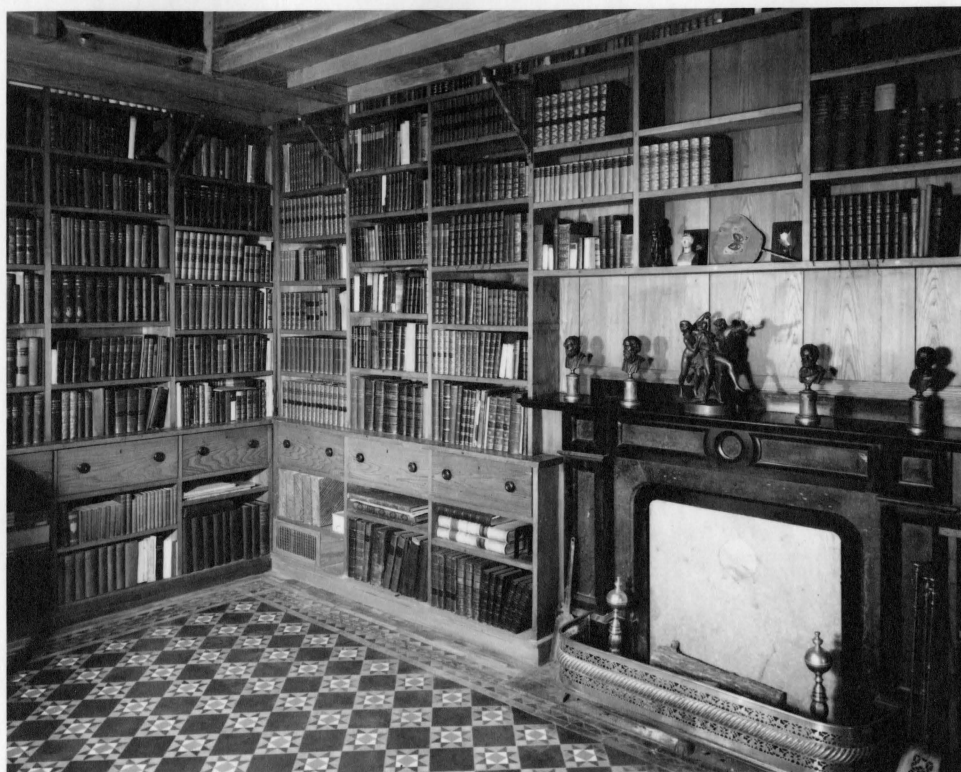
ILLUSTRATION NO. 4

Illustration No. 4 shows panelling over fireplace, the mantel repaired and in the northeast corner the new installation of the heating unit.

The panelling over the fireplace, the mantel repaired and in the northeast corner the new installation of the heating unit.

The broken marble mantelpiece was reset and cemented together with condensed milk. This is a superb piece of repair.

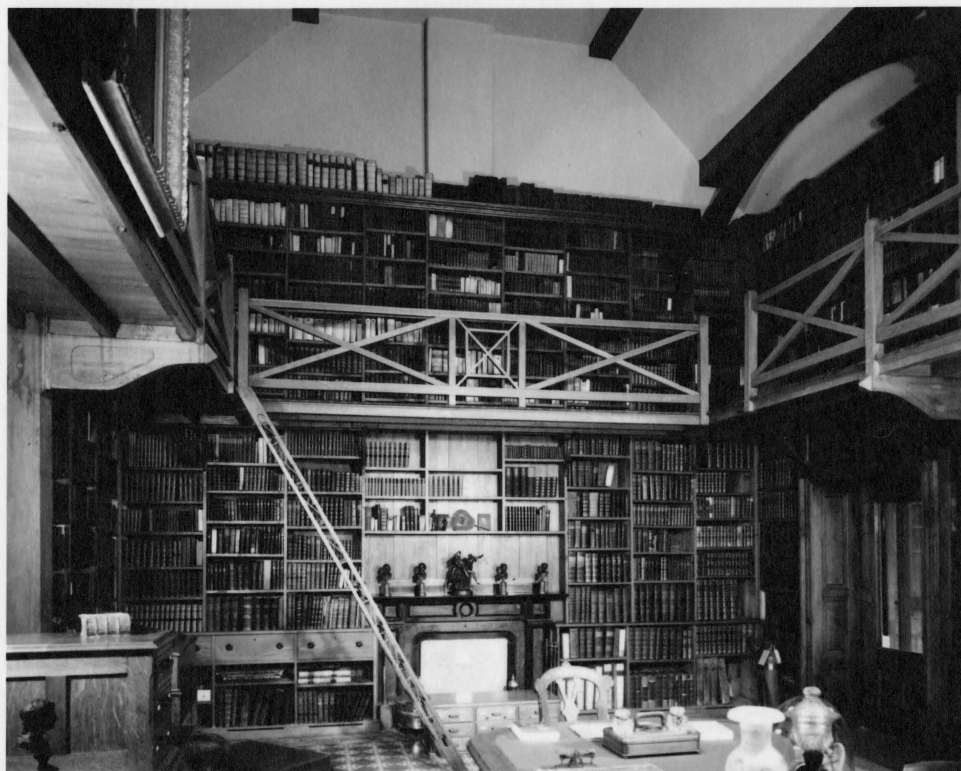
ILLUSTRATION NO. 5

Illustration No. 5 shows the whole east wall as it appears after work was completed and books returned to the shelves.

Supervisor Wistar made his final inspection on June 7, 1962 and Illustration No. 5 shows the library in its completed form. It is gratifying to see that this interesting and important library had been so carefully and so thoroughly done that even members of the Adams Family cannot believe the rehabilitation work was performed.

The whole east wall as it appears after the work  
was completed and books returned to the shelves.
