HISTORIC STRUCTURES REPORT

PART II

PRELIMINARY TO THE REHABILITATION OF  
THE ADAMS LIBRARY

Adams National Historical Site

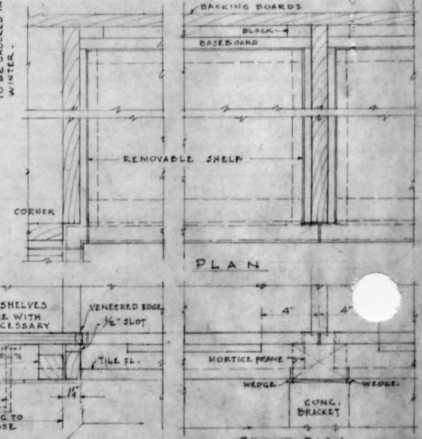
3' DETAILS - BASE OF BOOKCASE

Leaking of the walls below grade has caused a damp condition below and behind the bookcases which line the walls around the room. Condensation running down the inside face of the walls behind the bookcases has added to the dampness. This has resulted in extensive rotting and damage by termites of the framework supporting the bookcases and the base of the gallery posts. Replacement is required here. The shelving bracketed from the wall above the fireplace requires additional support. The marble mantle shelf is cracked through and should be mended.

The bottom shelf and the backing at the base of all the bookcases should be removed. All rotted framing and furring should be removed and the dirt and gravel fill beneath the bookcases should be cleaned out. Concrete bracket footings should be placed below the up-rights and door jambs and new

framing should replace the present members where conditions require it. Replace furring backing boards, bottom of bookcase partitions and door jambs, and bottom shelf where found to be rotted or eaten by termites. Provide slot in baseboard under bottom shelf and behind bottom backing board to provide a passage of air under bottom of bookcases. If structurally possible the furred space behind should be opened at the top of the bookcases. The bottom shelf should be made removable to allow easy access for inspection and maintenance.

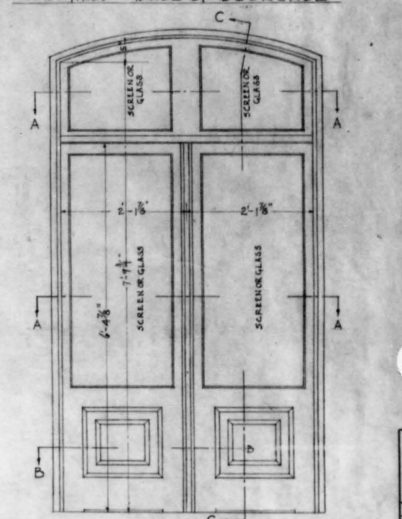
STORM SASH FOR OPENINGS Nos 1-2-3  
SCALE 1/2"=1'-0"

The french doors have cracked due to long exposure and need protection from the weather.

All the doorways, with the exception of the one on the south side which is used for the main entrance, should have outside storm sash installed to match the doors and transoms in design. All the storm sash should be fixed, excepting one leaf in the south door (not the main entrance) which can serve as an emergency exit. All glass panes should be made replaceable with screen panels.
