HISTORIC STRUCTURES REPORT

ADAMS MANSION 1730 HOUSE

Adams National Historic Site  
Quincy, Massachusetts

Prepared by  
George L. Wrenn  
Architect  
June 1966

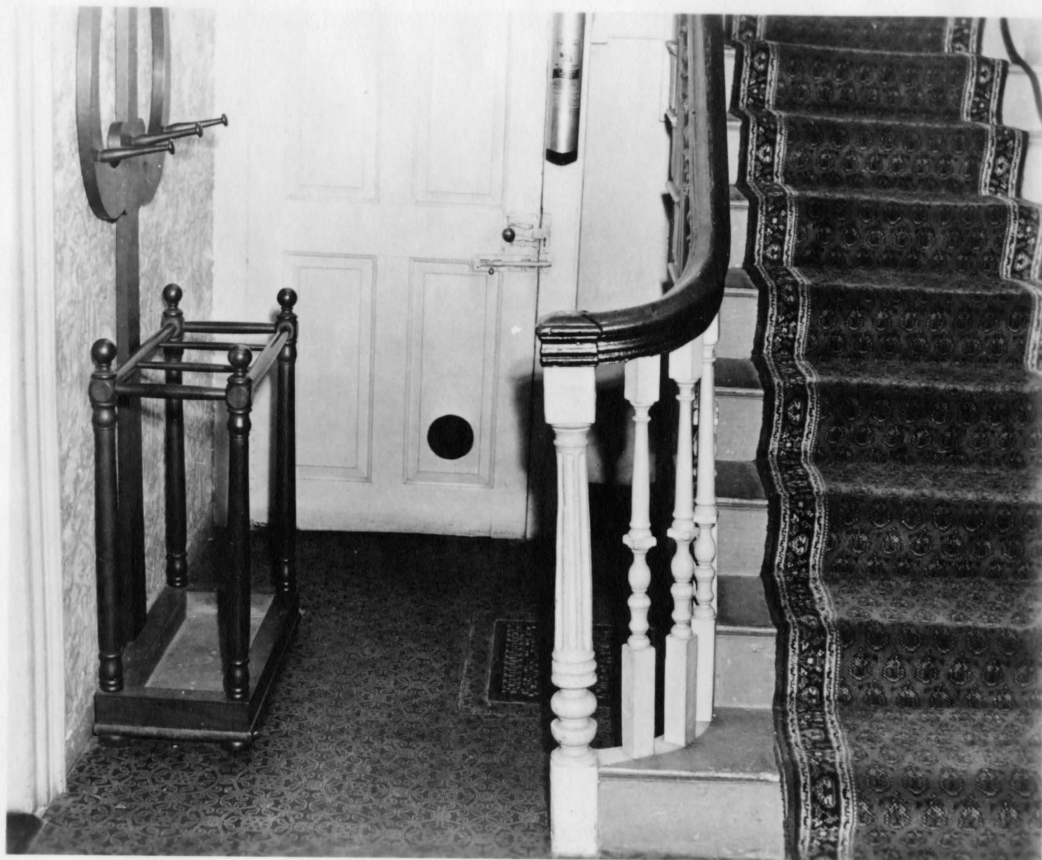
ILLUSTRATION NO. 17

This gray color can still be found under the carpeting on the tread which goes up to the 1836 Passageway (see Illustration No. 17). A Munsell color standard chip No. N4.5/ showing this historic color is on file at the Site.

1730 House, staircase between first and second floors, view looking north at stairs leading up to 1836 Passageway showing dark gray color on tread and riser where carpet is up.

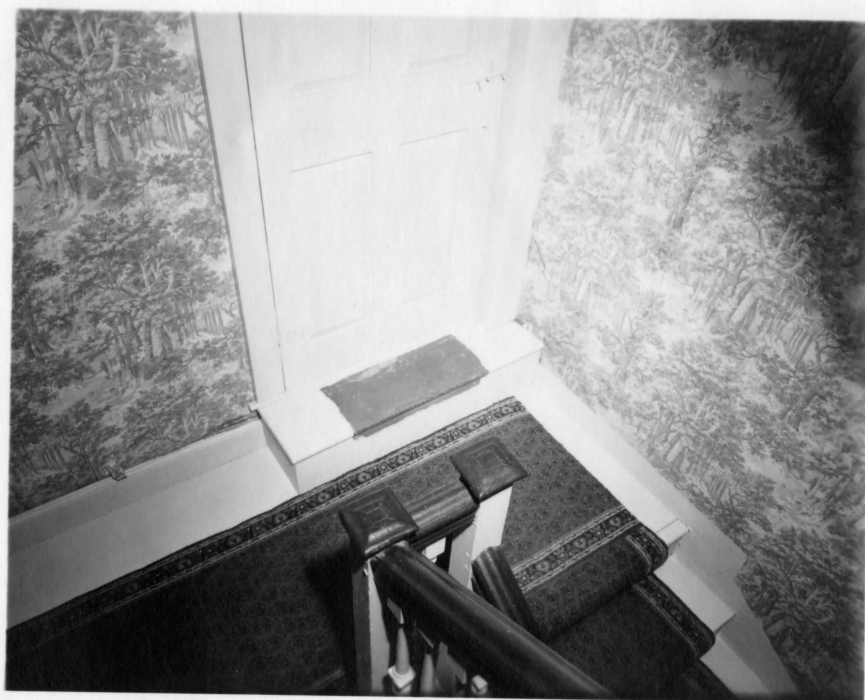
ILLUSTRATION NO. 18

1730 House, second floor, hallway, view  
looking south across floor showing its poor condition  
after removal of linoleum put down by the Adams  
Memorial Society. Remaining piece of straw matting  
which covered the whole floor during the historic  
period can be seen under the clock.

The conditions in the stair hall on the second floor, with the exception of the floor, are similar to those on the first; and the woodwork should be treated in the same way. In the historic period the floor was covered with straw matting--a piece of which remains under the tall clock in the southeast corner. The Adams Memorial Society covered it with a brown linoleum which remained in place until it was taken up in the course of exploratory work. The floor surface is in poor condition (see Illustration No. 18) and should again be covered with the straw matting.<sup>37</sup>

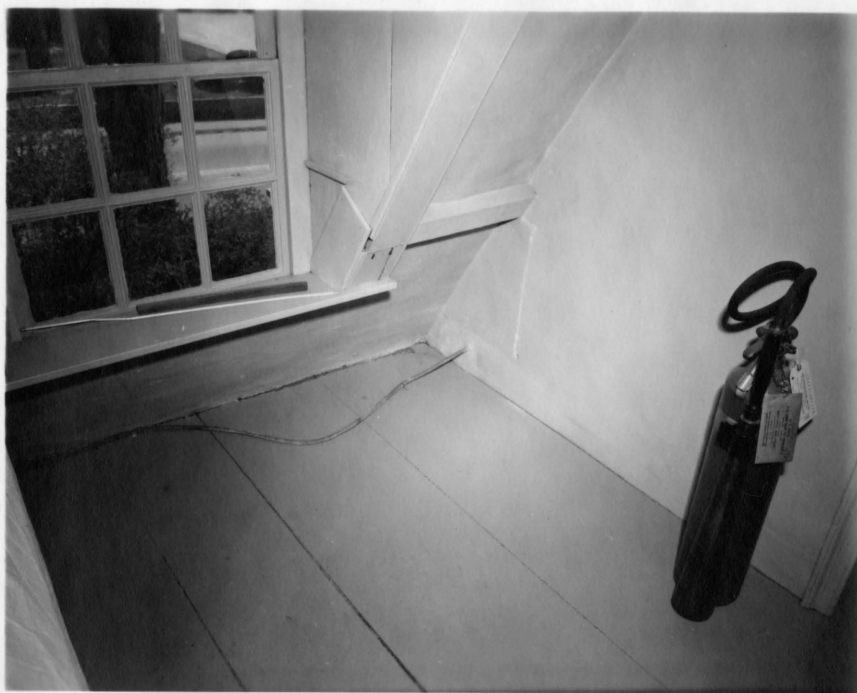
ILLUSTRATION NO. 22

1730 House, third floor, east room,  
view looking east across room showing poor condition  
of wallpaper and large old-fashioned rosette of  
fire alarm system on the ceiling.
