# FISHING BRIDGE MEN'S DORMITORY Yellowstone National Park

June, 2012

Historic Structure Report

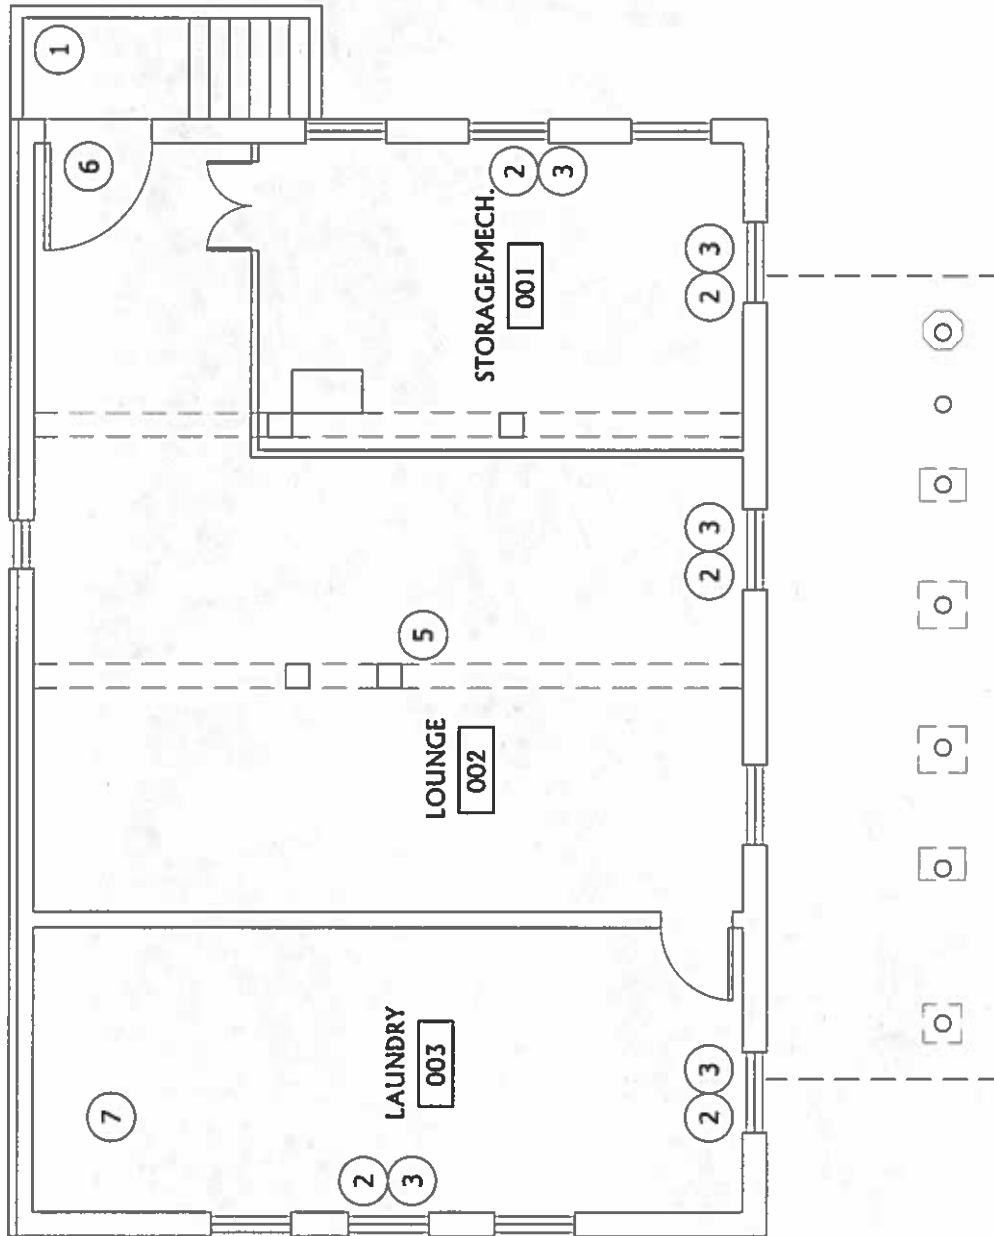
**FIGURE 4 - LOWER LEVEL FLOOR PLAN CONDITION ASSESSMENT**

**INTERIOR CONDITION NOTES:**

1. DETERIORATED CONCRETE WALLS
2. WATER STAINING AROUND WINDOWS
3. STEEL SASH WINDOW PUTTY DETERIORATING
4. PAINT PEELING
5. LIGHTING IS POOR
6. EXITING DOES NOT MEET CODE
7. WATER BACKS UP INTO BASEMENT LAUNDRY

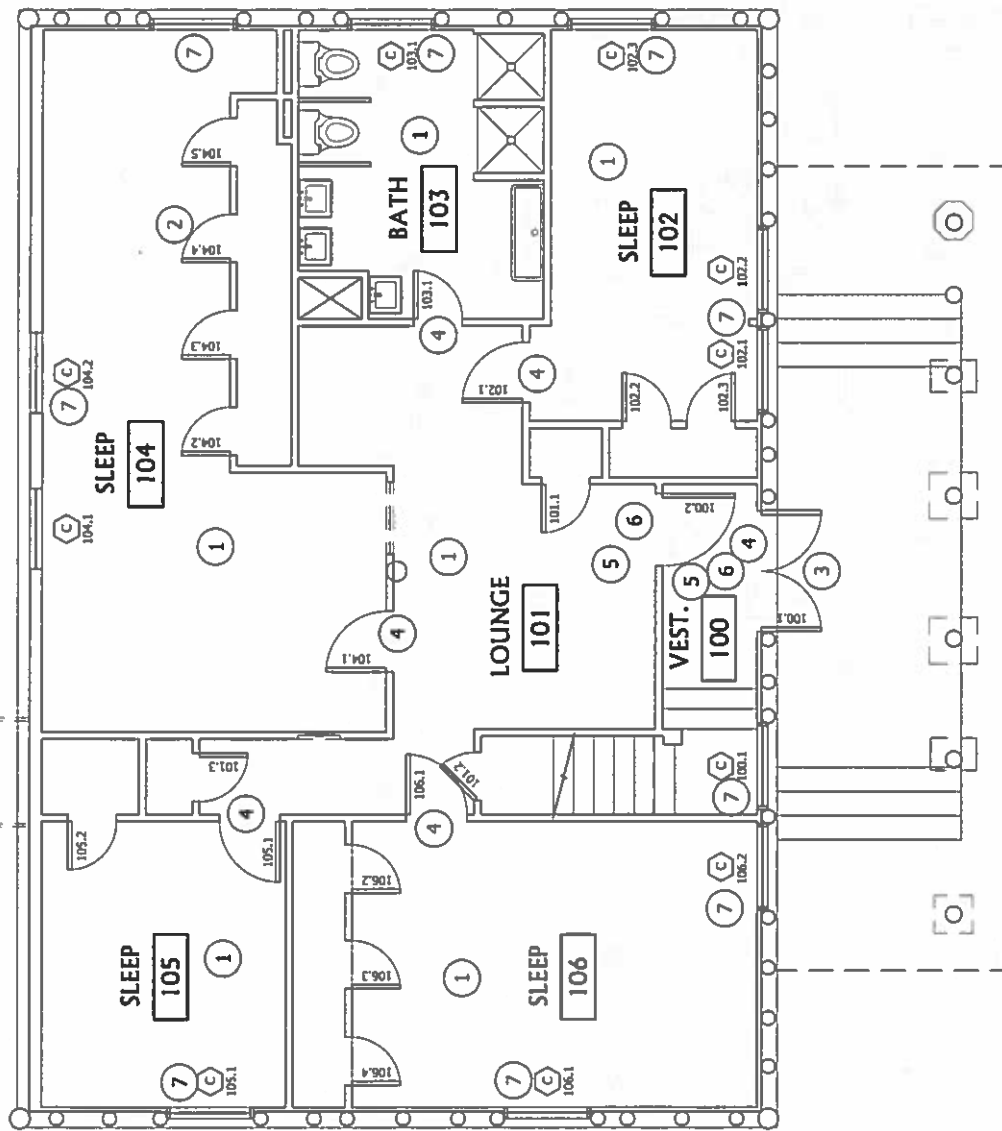
**FIGURE 5 - MAIN LEVEL FLOOR PLAN CONDITION ASSESSMENT**

**INTERIOR CONDITION NOTES:**

1. FINISH MATERIALS WORN THROUGHOUT THE FLOOR
2. MISSING PANELS ON SOME DOORS
3. BATHROOMS AND ACCESS DO NOT MEET ADA 2010 CODES
4. DOORS AND HARDWARE NEED WORK
5. POOR LIGHTING AND EXITING DEVICES
6. EXITING FROM THE FLOORS DO NOT MEET CODE
7. WINDOWS NEED SOME FINISH WORK.

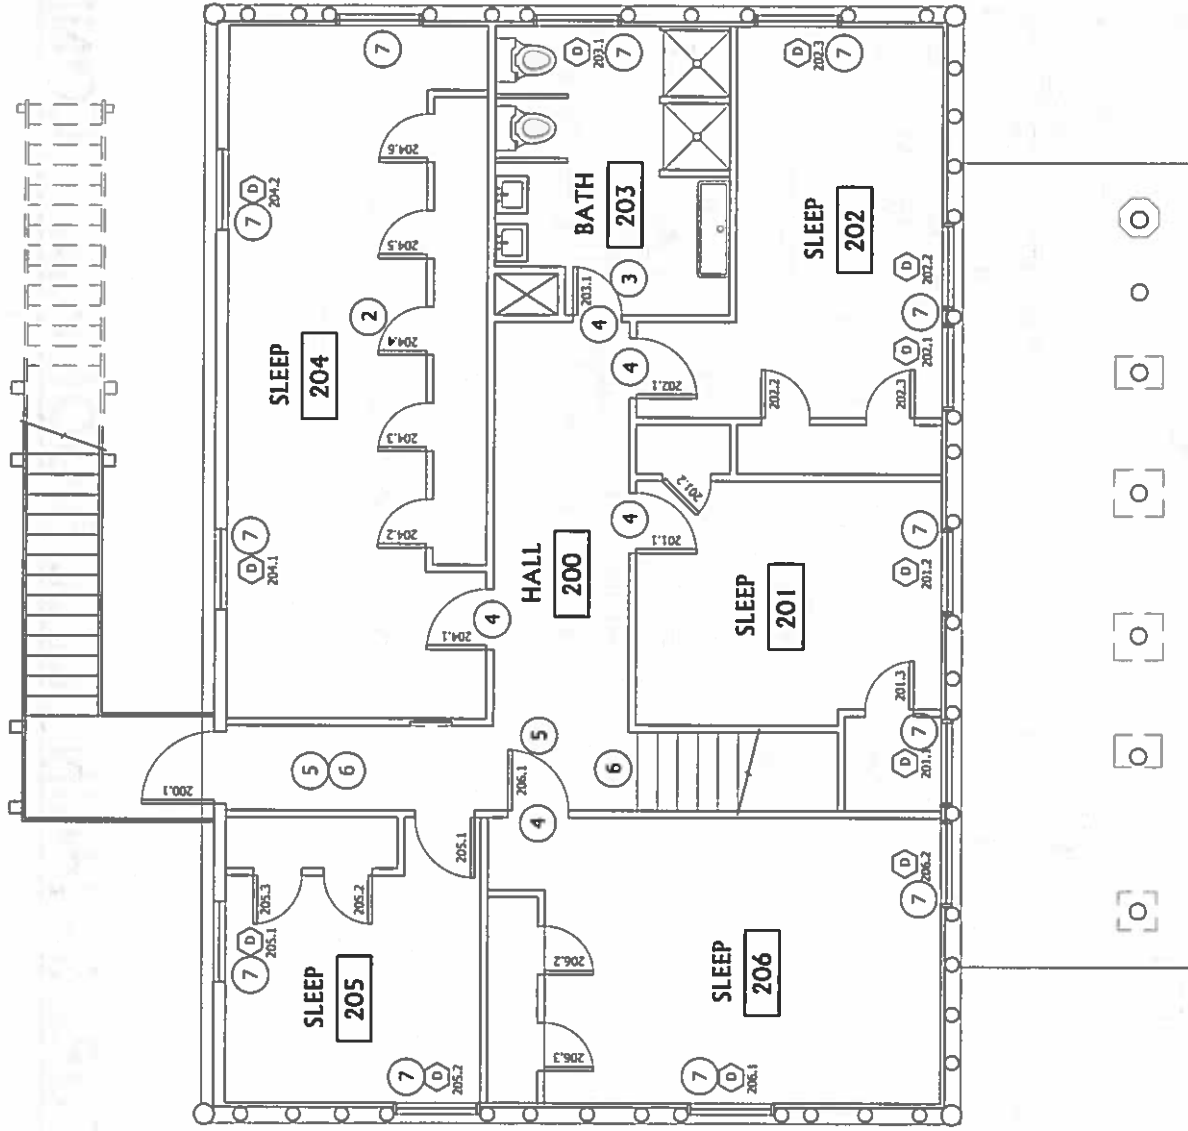
**FIGURE 6 - UPPER LEVEL FLOOR PLAN CONDITION ASSESSMENT**

**INTERIOR CONDITION NOTES:**

1. FINISH MATERIALS WORN THROUGHOUT THE FLOOR
2. MISSING PANELS ON SOME DOORS
3. BATHROOMS AND ACCESS DO NOT MEET ADA 2010 CODES
4. DOORS AND HARDWARE NEED WORK
5. POOR LIGHTING AND EXITING DEVICES
6. EXITING FROM THE FLOORS DO NOT MEET CODE
7. WINDOWS NEED SOME FINISH WORK.

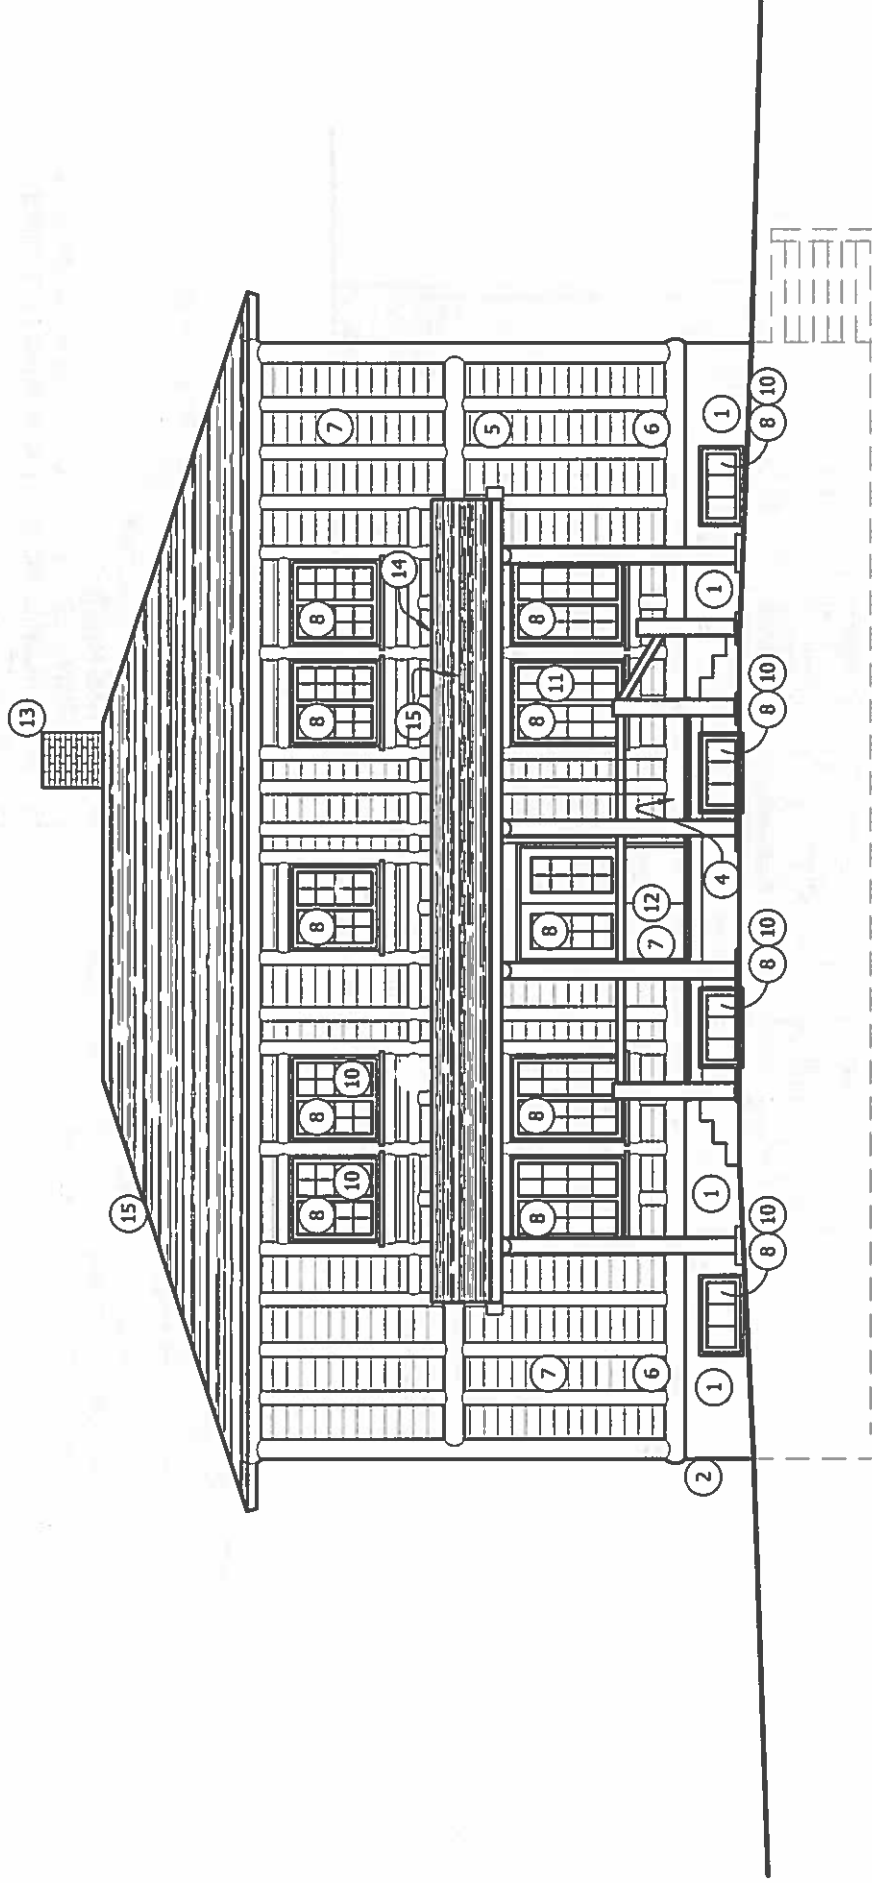
| 2. CONCRETE DETERIORATION | 9. BROKEN OR MISSING GLASS |
| 3. CONCRETE STAIRS TO BASEMENT DO NOT MEET CODE | 10. PUTTY DETERIORATION |
| 4. FRONT PORCH IS WORN AND RAILINGS NEED WORK | 11. MUNTINS MISSING |
| 5. WEATHERED LOGS AND SHEATHING | 12. DETERIORATED STILES AND HINGED AREAS ON DOORS |
| 6. CRACKS IN LOGS | 13. DETERIORATED AND MISSING MORTAR IN CHIMNEY |
| | 15. ROOF HAS CURLLED AND HAS DETERIORATING WOOD CEDAR SHINGLES |

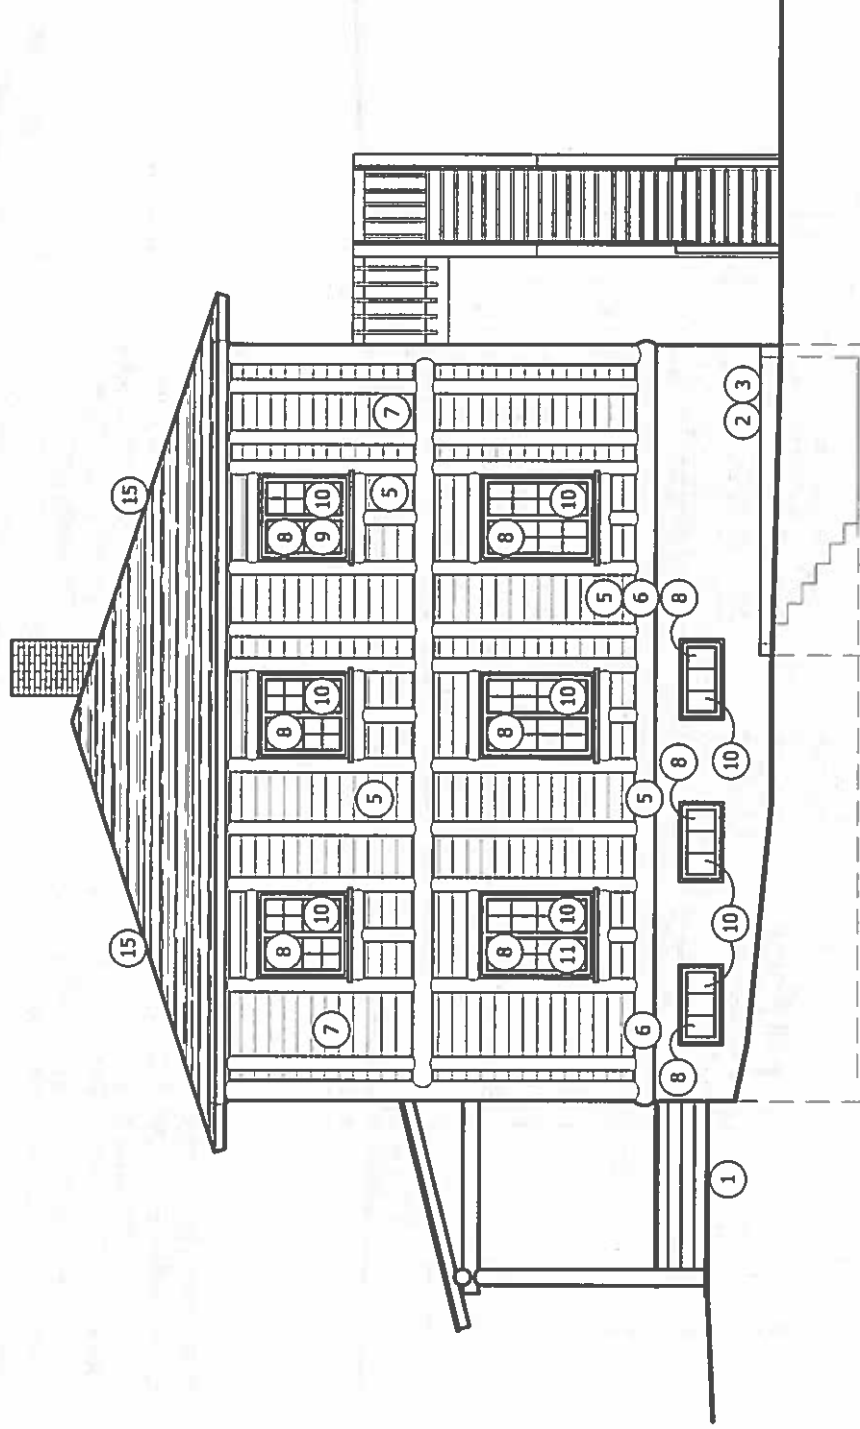
| 2. CONCRETE DETERIORATION | 9. BROKEN OR MISSING GLASS |
| 3. CONCRETE STAIRS TO BASEMENT DO NOT MEET CODE | 10. PUTTY DETERIORATION |
| 4. FRONT PORCH IS WORN AND RAILINGS NEED WORK | 11. MUNTINS MISSING |
| 5. WEATHERED LOGS AND SHEATHING | 12. DETERIORATED STILES AND HINGED AREAS ON DOORS |
| 6. CRACKS IN LOGS | 13. DETERIORATED AND MISSING MORTAR IN CHIMNEY |
| | 15. ROOF HAS CURLED AND HAS DETERIORATING WOOD CEDAR SHINGLES |

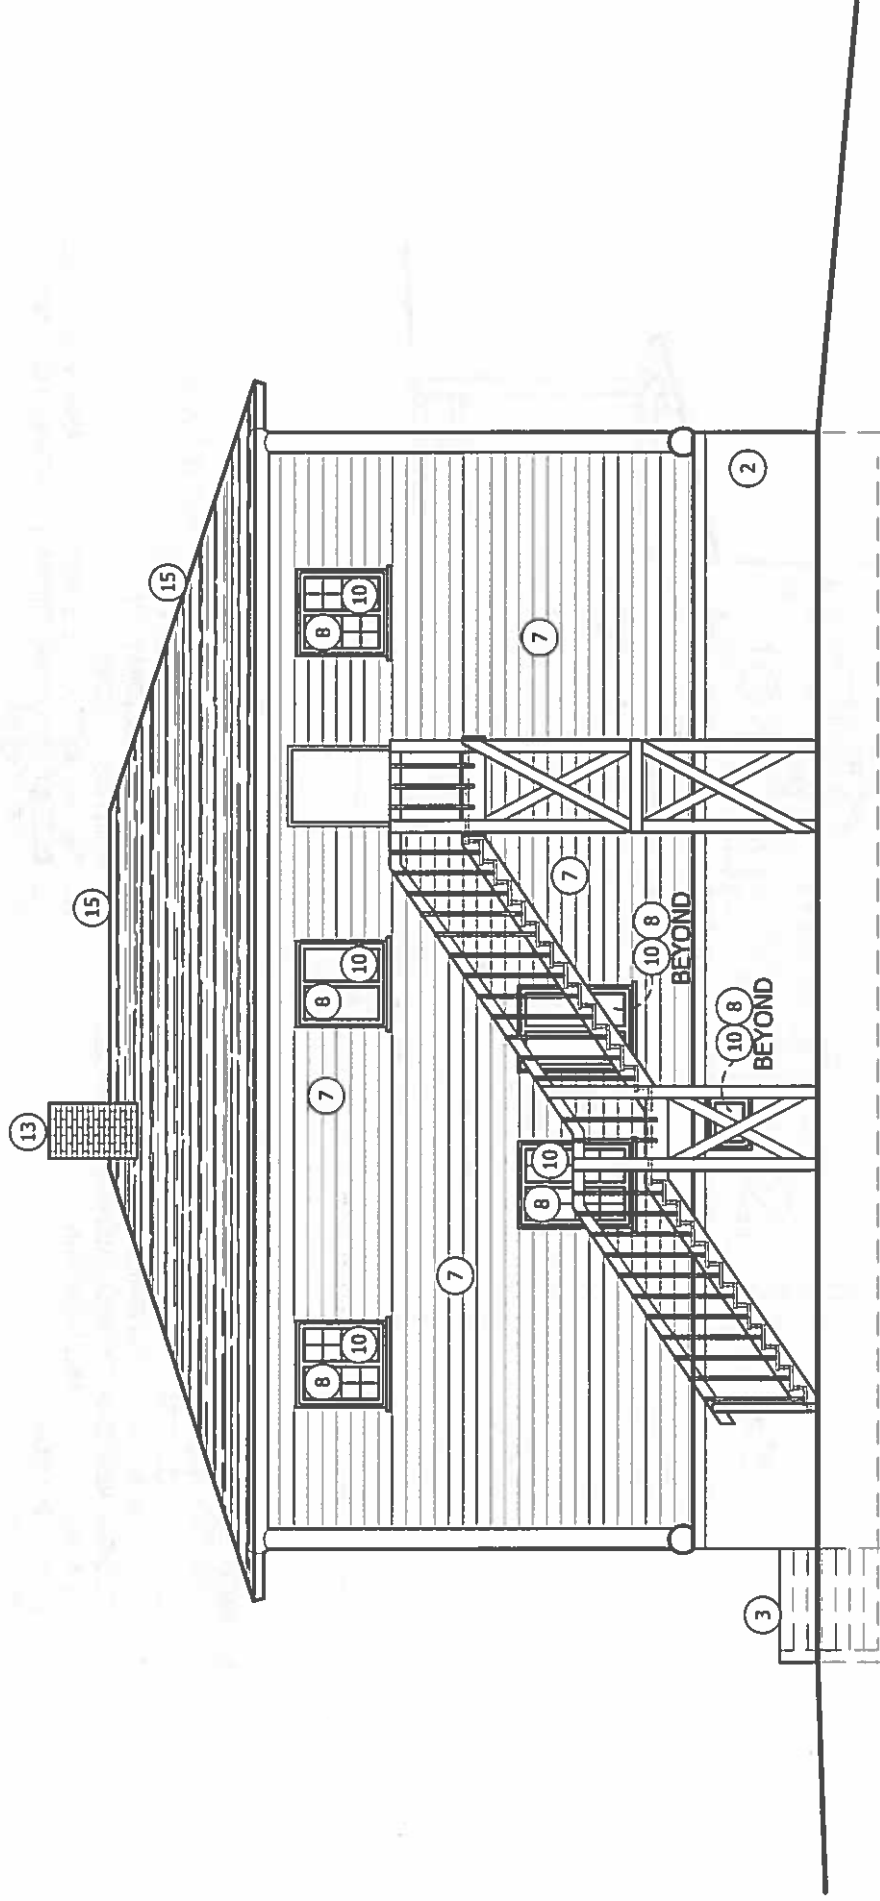
| 2. CONCRETE DETERIORATION | 9. BROKEN OR MISSING GLASS |
| 3. CONCRETE STAIRS TO BASEMENT DO NOT MEET CODE | 10. PUTTY DETERIORATION |
| 4. FRONT PORCH IS WORN AND RAILINGS NEED WORK | 11. MUNTINS MISSING |
| 5. WEATHERED LOGS AND SHEATHING | 12. DETERIORATED STILES AND HINGED AREAS ON DOORS |
| 6. CRACKS IN LOGS | 13. DETERIORATED AND MISSING MORTAR IN CHIMNEY |

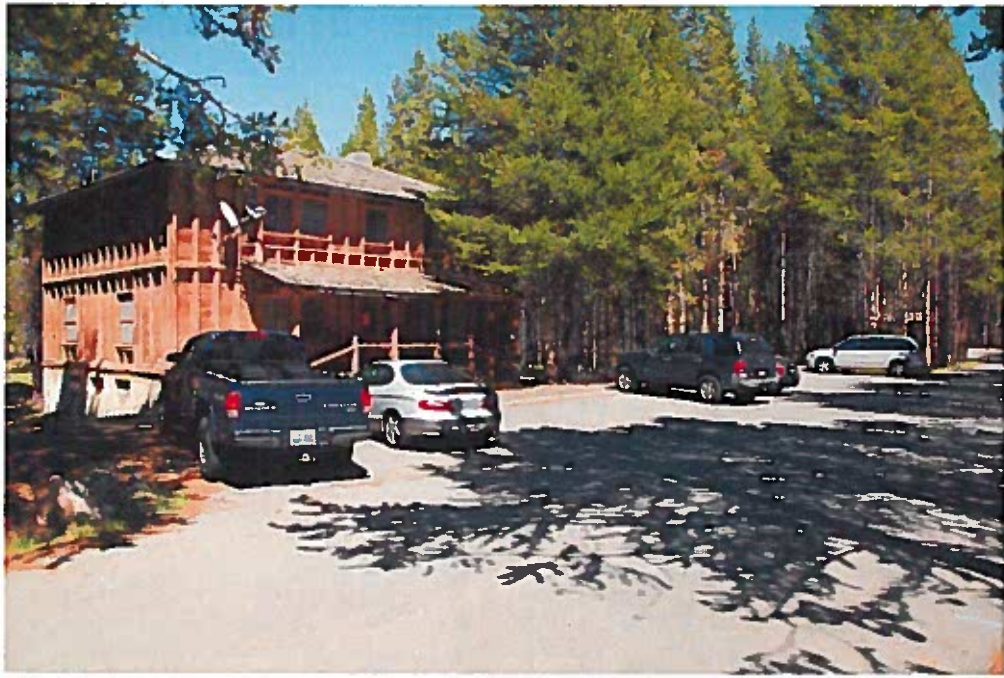
Figure 13: Looking northeast at the Dormitory. The logout walls and sheathing are dry and have some deterioration.

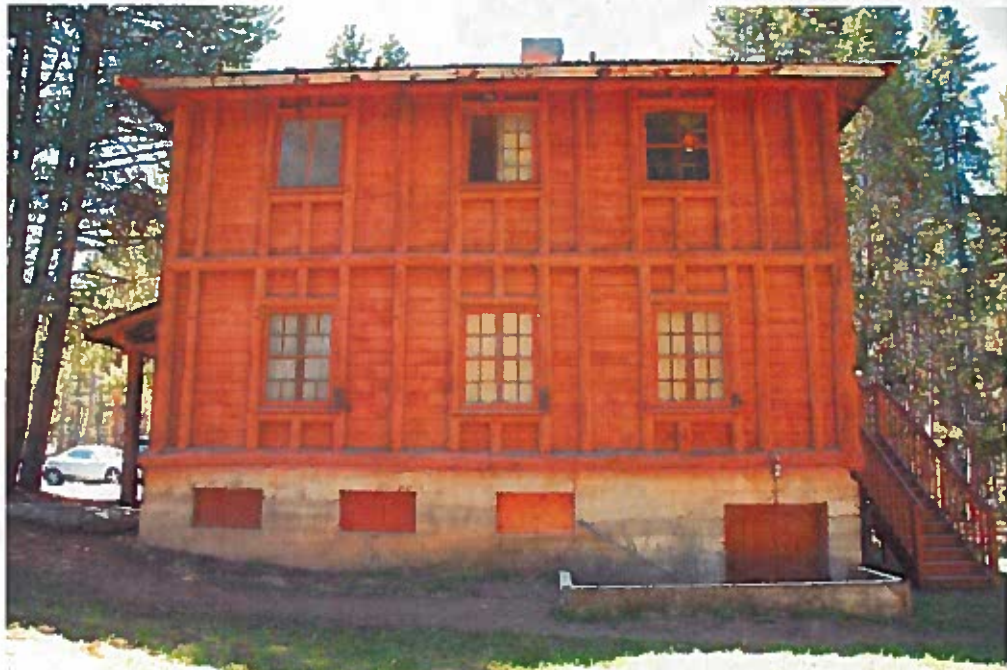
Figure 14: Looking west at log and wood sheathing that is dry and weathered. The windows have some broken panes.

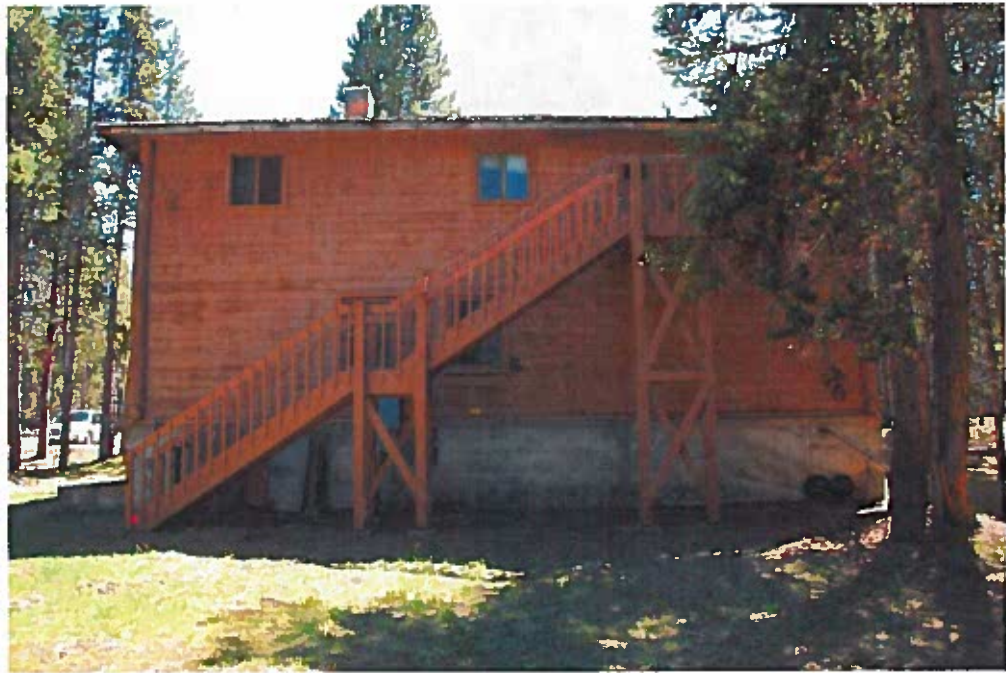
Figure 17: Looking south at the building. The stair on the back of the building is in good condition, but there are code problems with the railing. The wood sheathing on this wall is weathered.

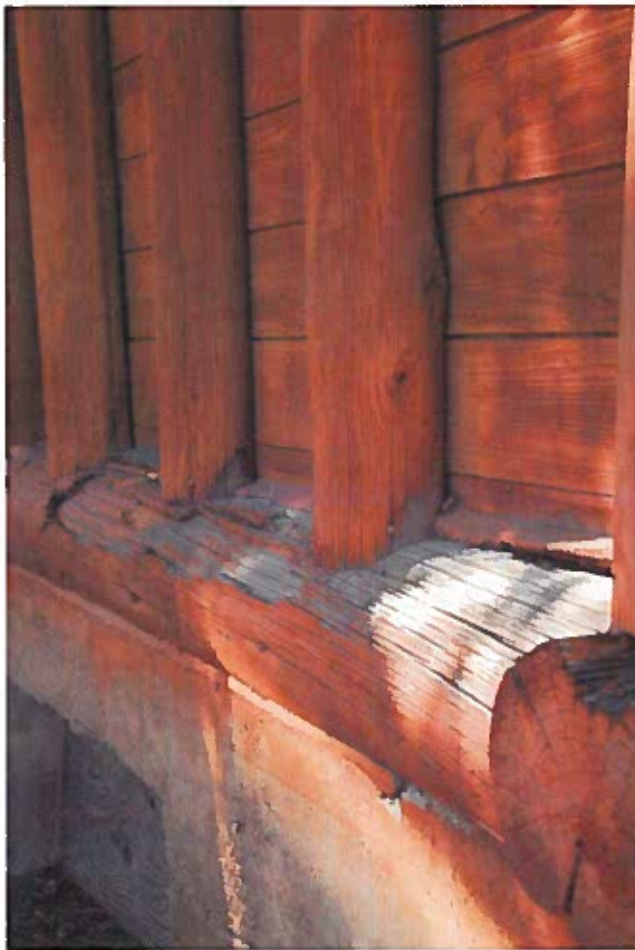
Figure 18: Looking west at a typical base log on the building. Note the weathered and cracked log. The mortar cap is loose and coming apart.

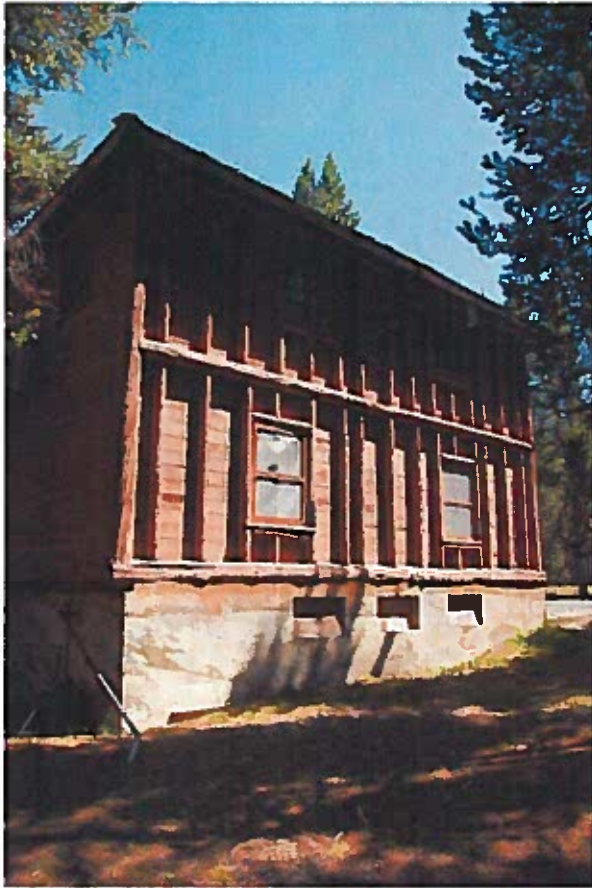
Figure 19: Looking southeast at the building. The west side of the Dormitory is similar with weathered wood and some minor rot in the bases of the columns and horizontal logs. The windows have similar problems.

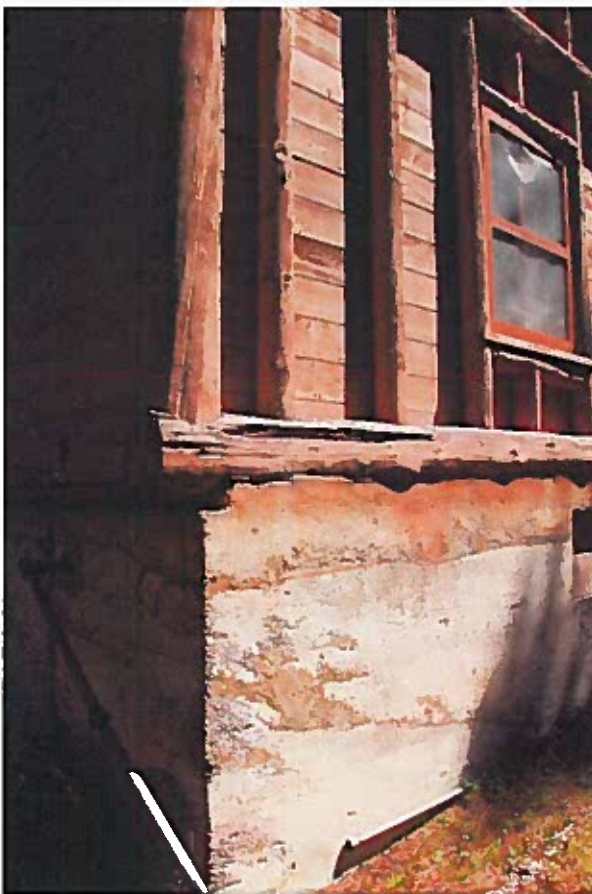
Figure 20: Looking southeast at the concrete foundation. There are some minor horizontal cracks in the foundation wall. Also note the rotted sill log.

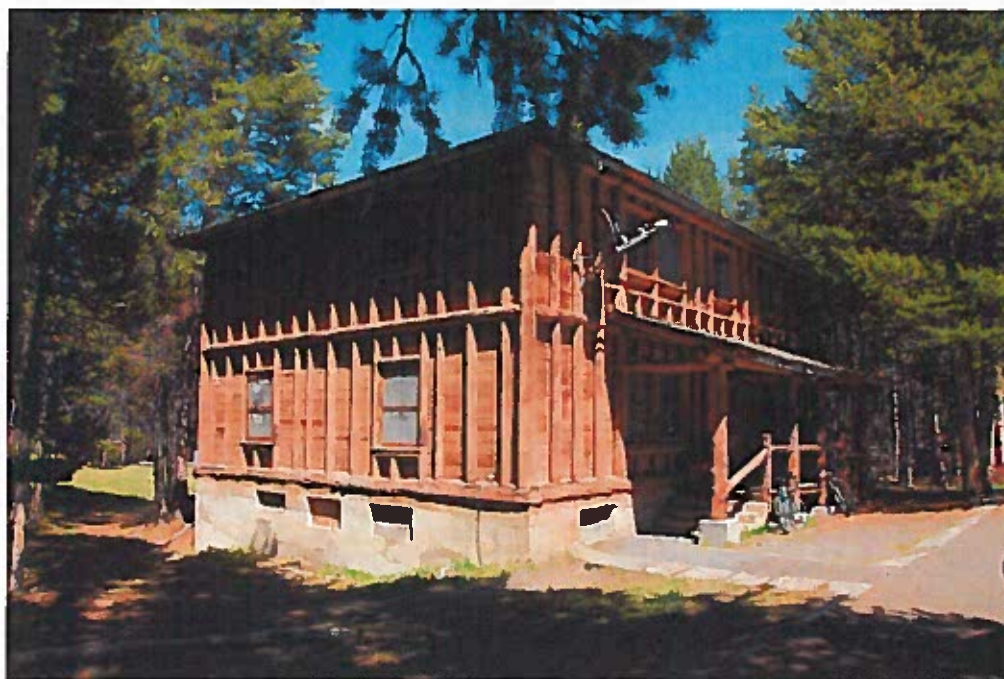
Figure 21: Looking northeast at the building. The roof is in fair condition and is winter-kept during the heavy snow loads. Note the poor drainage and grade at the corner.

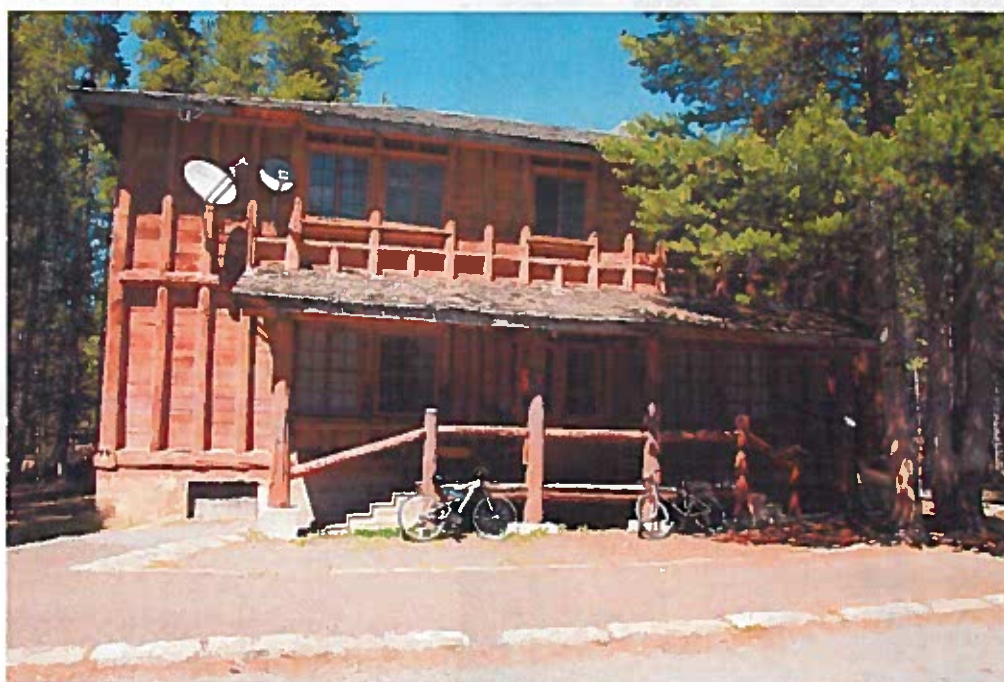
Figure 22: Looking north at the porch at the front of the building and porch railing. Part of the railing has deteriorated and has been removed.

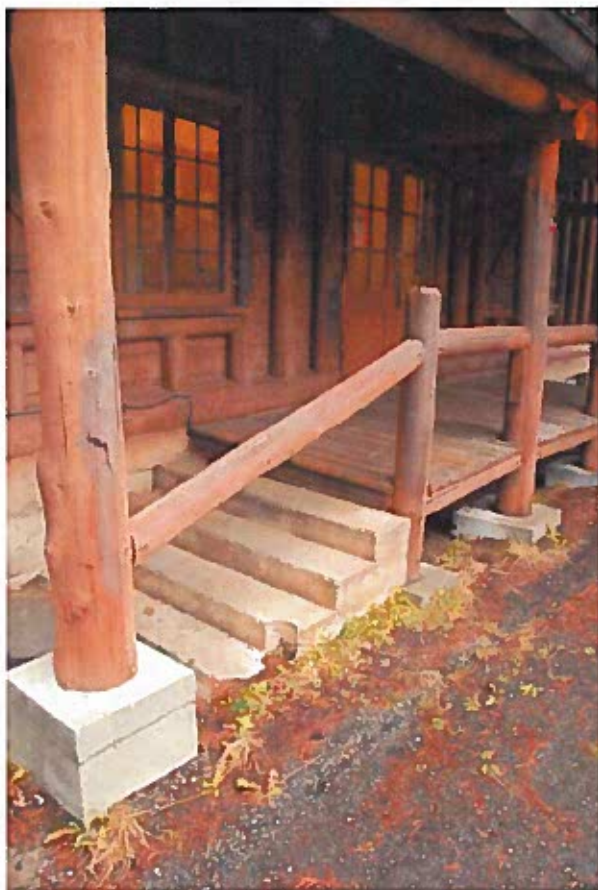
Figure 23: Looking northeast at the front porch. Note the variable heights in the risers of the steps and landing. The deck is in poor condition.

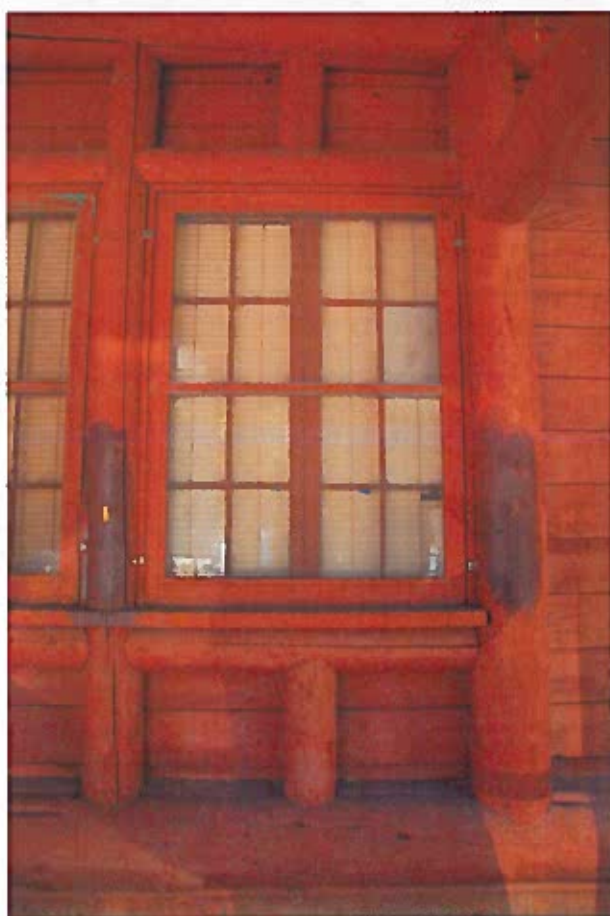
Figure 24: Looking north at a typical window next to the doorway. It is in fair condition but shows signs of weathering and some minor rot.

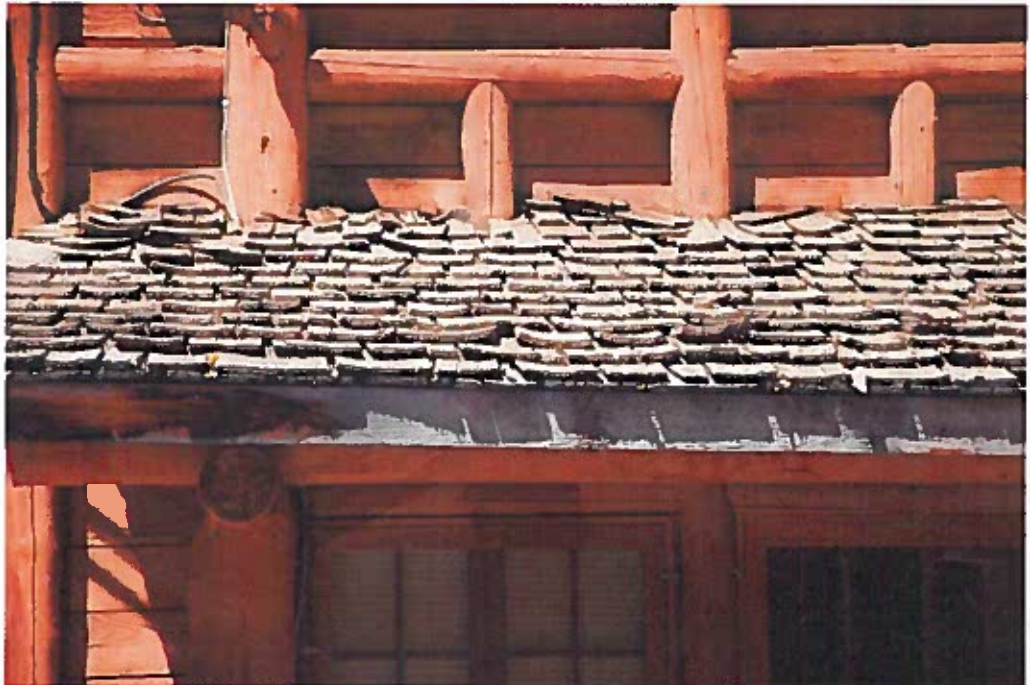
Figure 26: Looking north at the porch roof. The wood shingles are loose and missing. Note the weathered fascia.

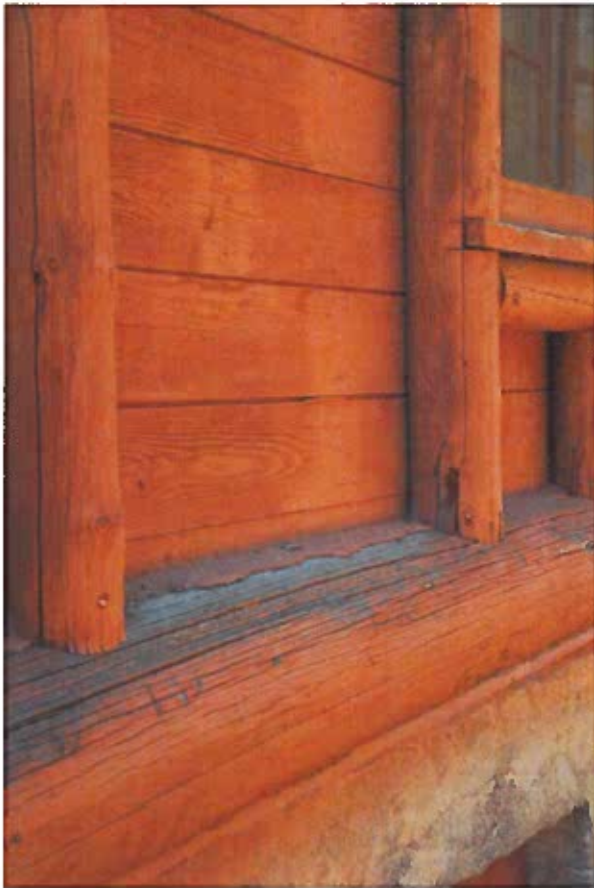
Figure 29: Looking northeast at a typical sill log on the front of the building. Note rot in the base of the columns, the weathered log, and dry wood sheathing.

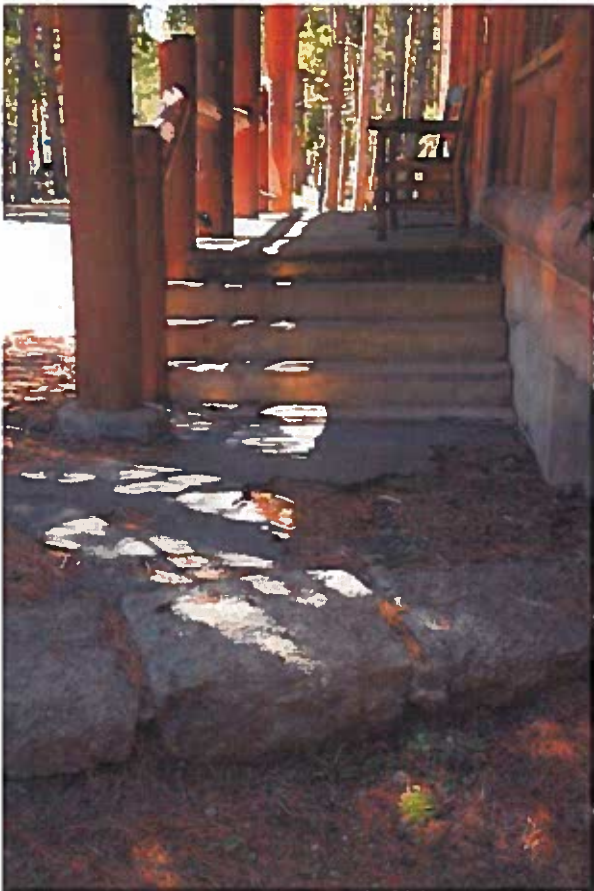
Figure 30: Looking west at the porch. Note the change in the railing and slope of the pathway into the window well.

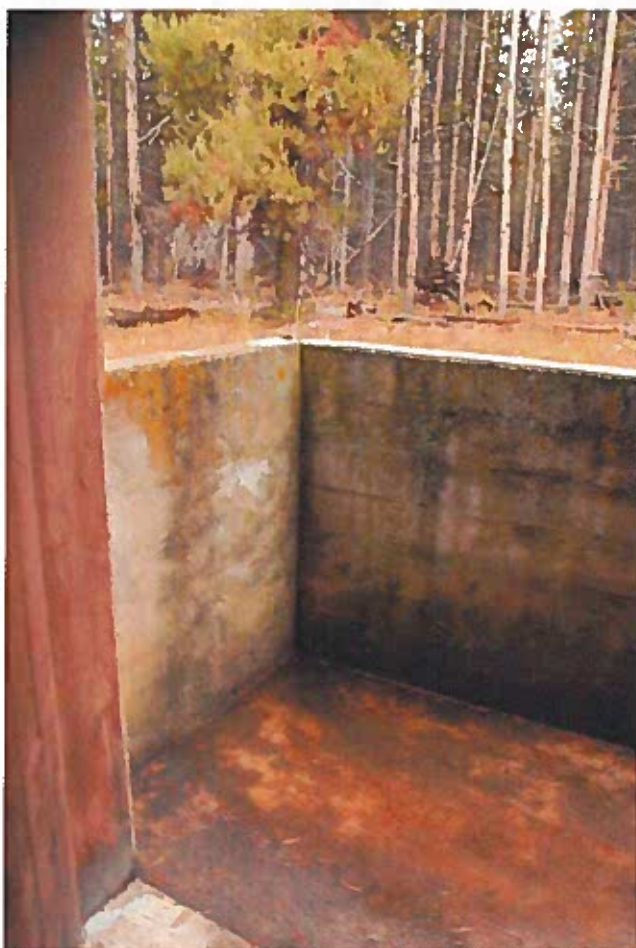
Figure 31: Looking east at the retaining wall with stair to the basement. The concrete along the outside stair is deteriorated and spalling.

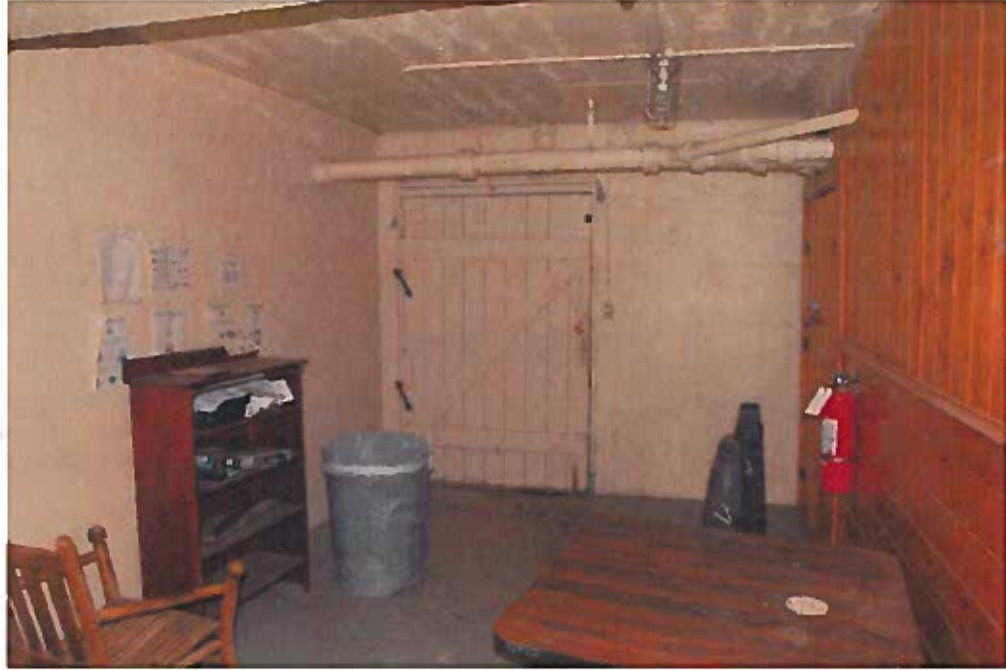
Figure 32: The basement has an outside entrance in the concrete foundation. The space is dry and the concrete walls and floor are in good condition. The door does not meet exiting requirements

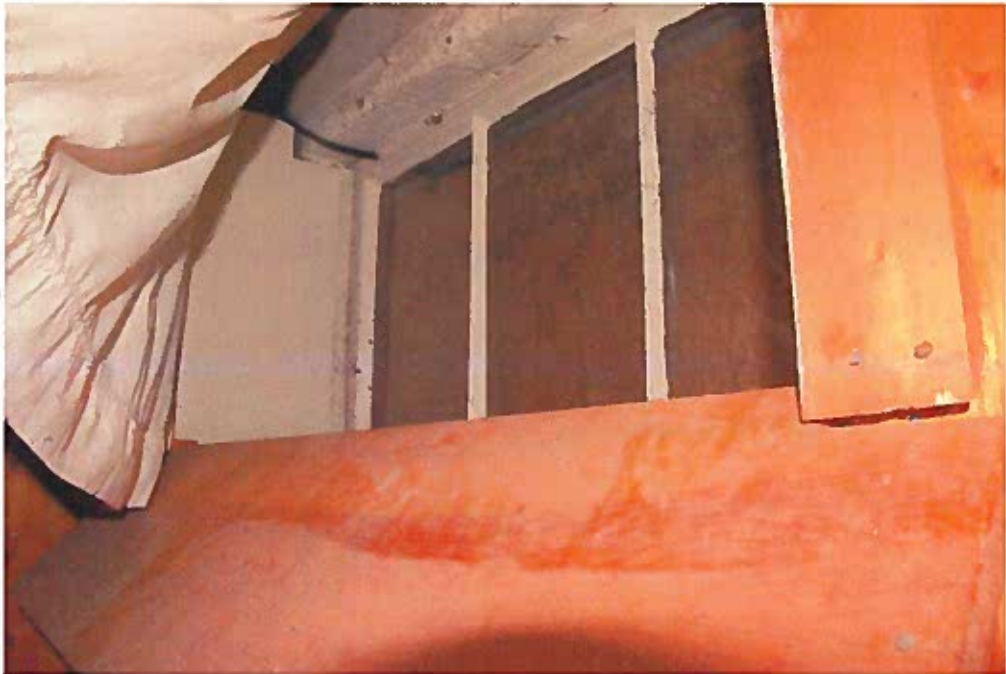
Figure 35: The steel sash windows are in fair condition with some loss of paint and deteriorating putty. There is some water leaking around the frame.

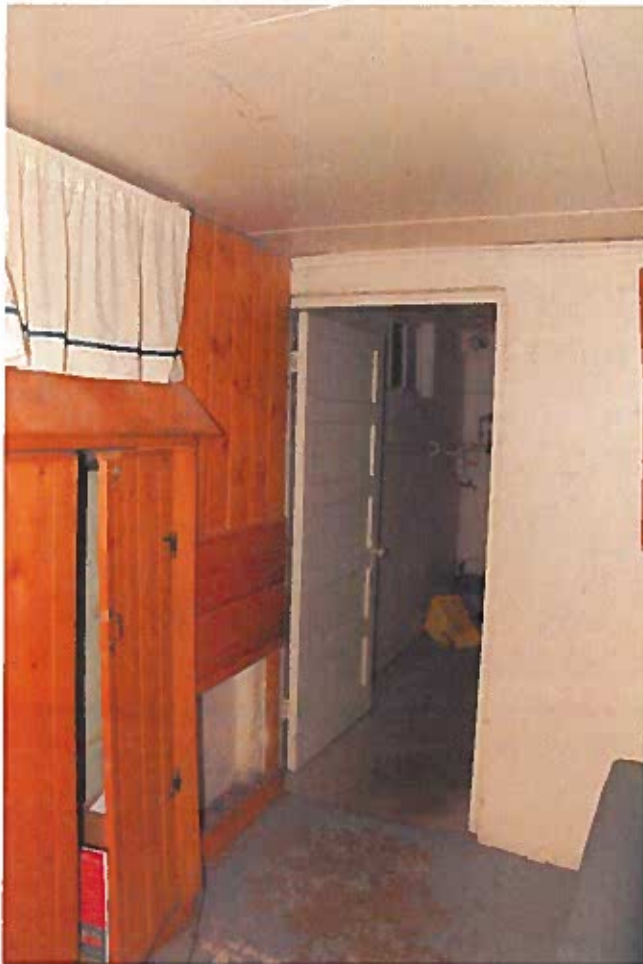
Figure 36: Entering the laundry area from the rec room. The wood panel door is typical of the upper areas. There is no second exit out of the basement.

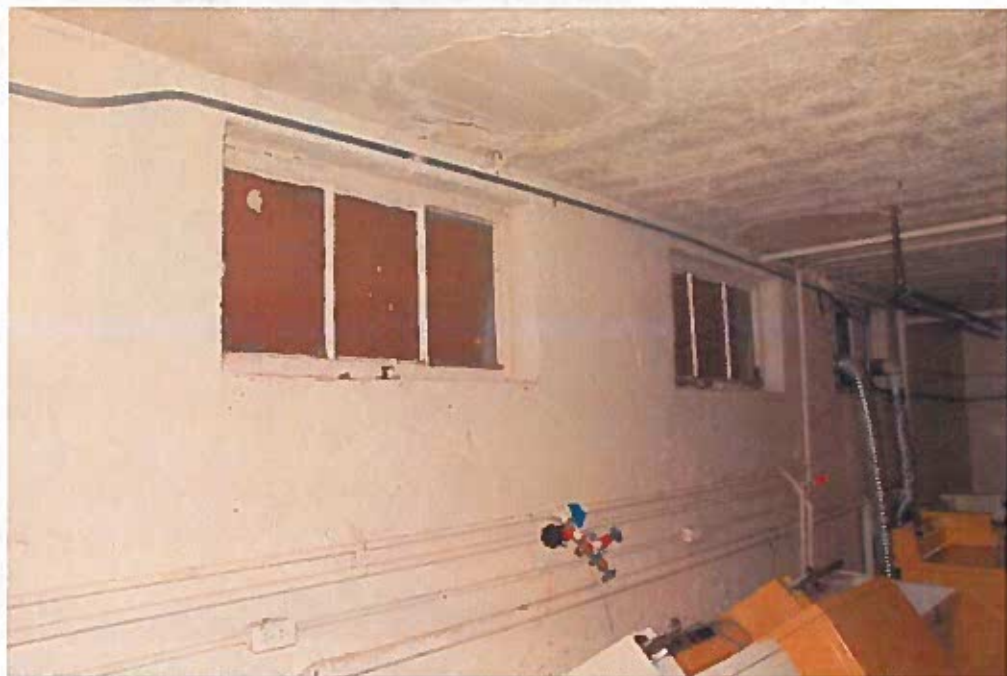
Figure 37: The steel sash windows are in fair condition with some loss of paint and some deteriorating putty.

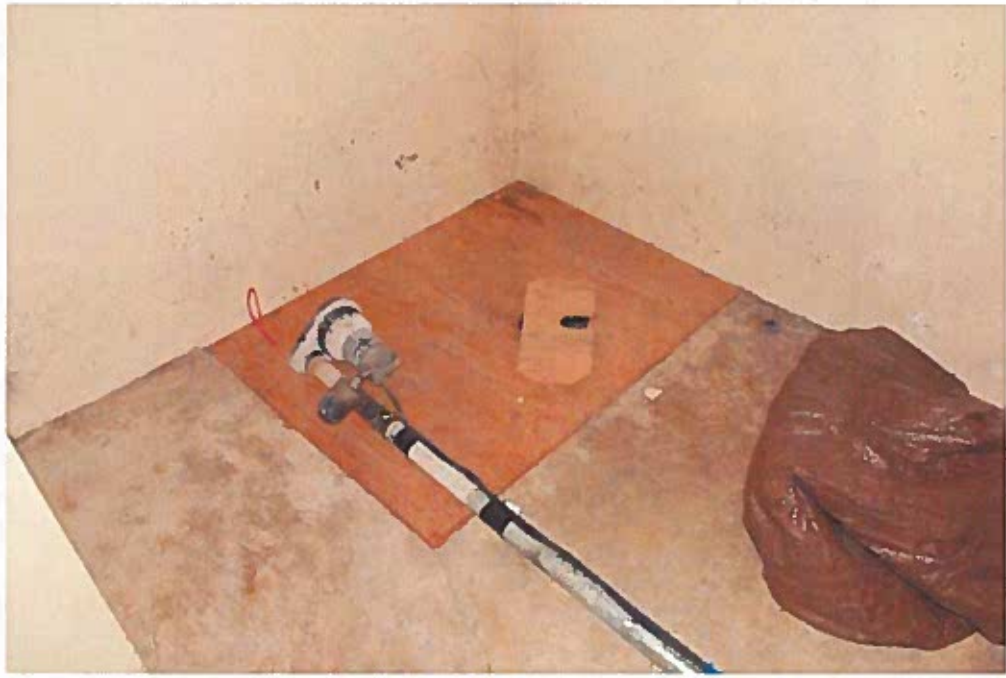
Figure 38: A sump pump is used to pull water out of the room during backup in the drainage systems in the laundry room.

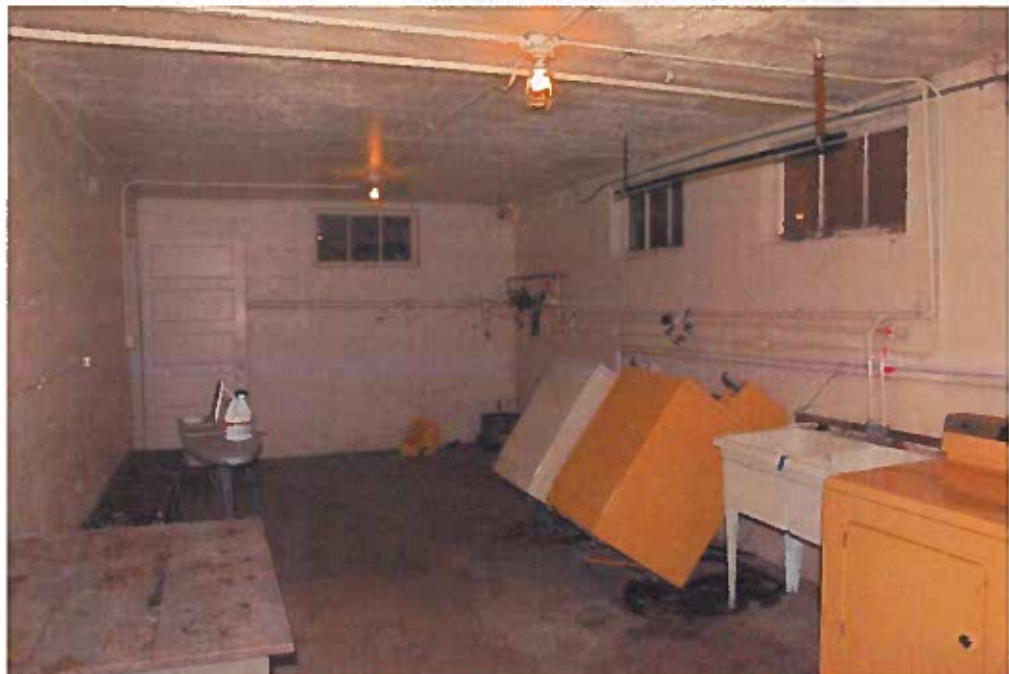
Figure 39: The laundry room has concrete walls and floor. There is some staining on the walls from the windows and from areas above.

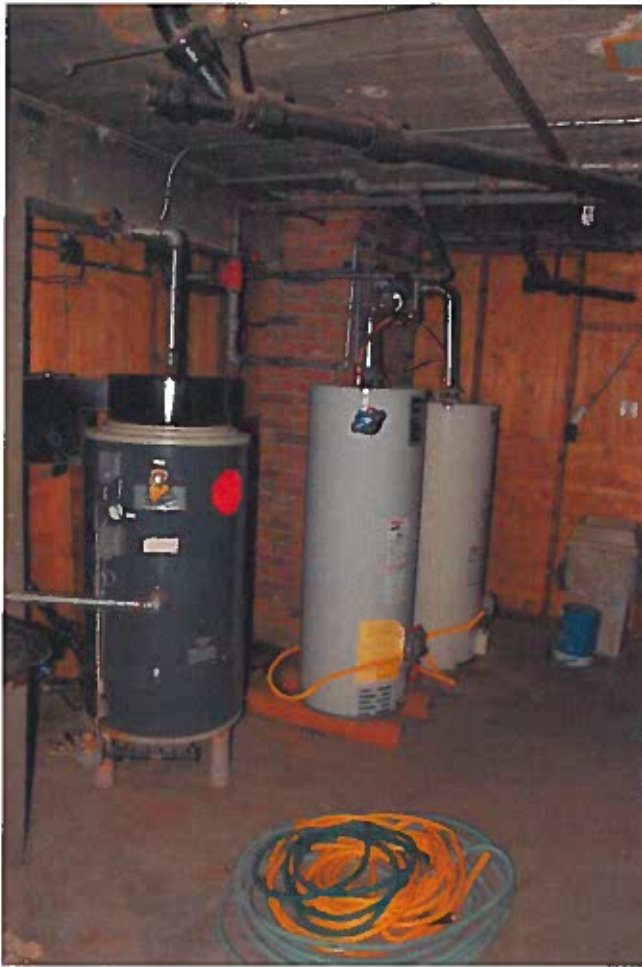
Figure 42: Note the domestic hot water heaters. The piping and electrical conduit is not well organized.
