# FISHING BRIDGE MEN'S DORMITORY Yellowstone National Park

June, 2012

Historic Structure Report

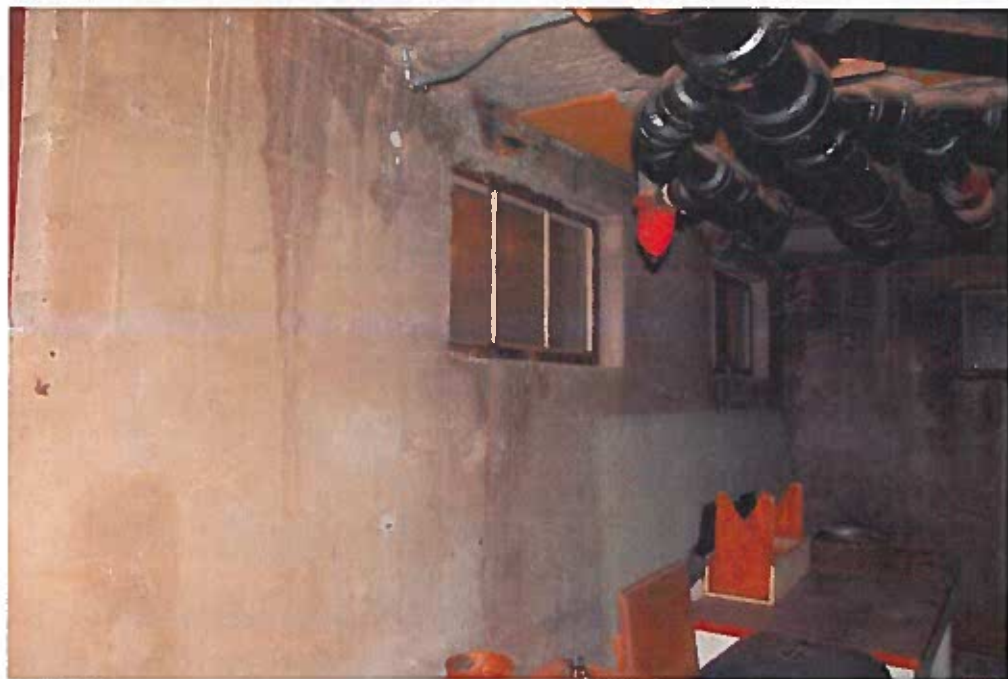
Figure 43: East wall of the mechanical room. Note the water stains on the wall. All of the sewer piping runs through this space from the bathrooms above.

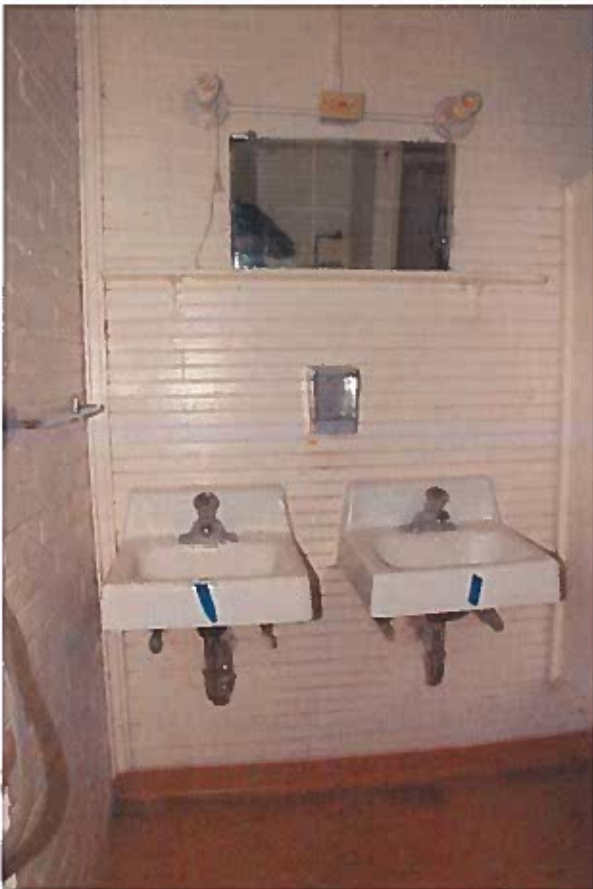
Figure 48: The bathroom fixtures are in fair condition. The bathroom needs to be redesigned to meet ADA requirements and to make it more usable.

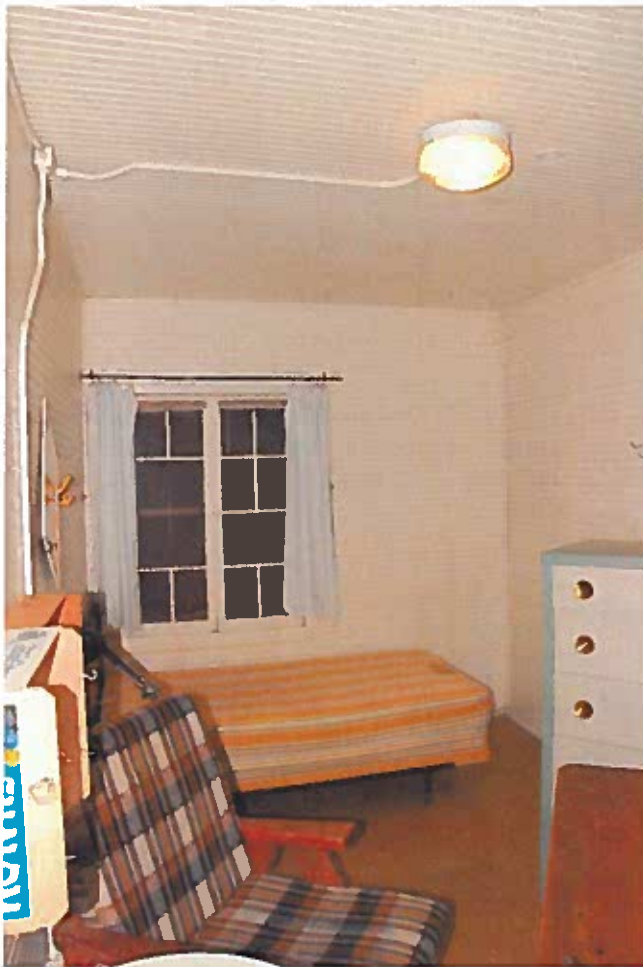
Figure 49: Room number 1 is generally in good condition. Note the missing muntins in the window. Also note the exposed electrical conduit.

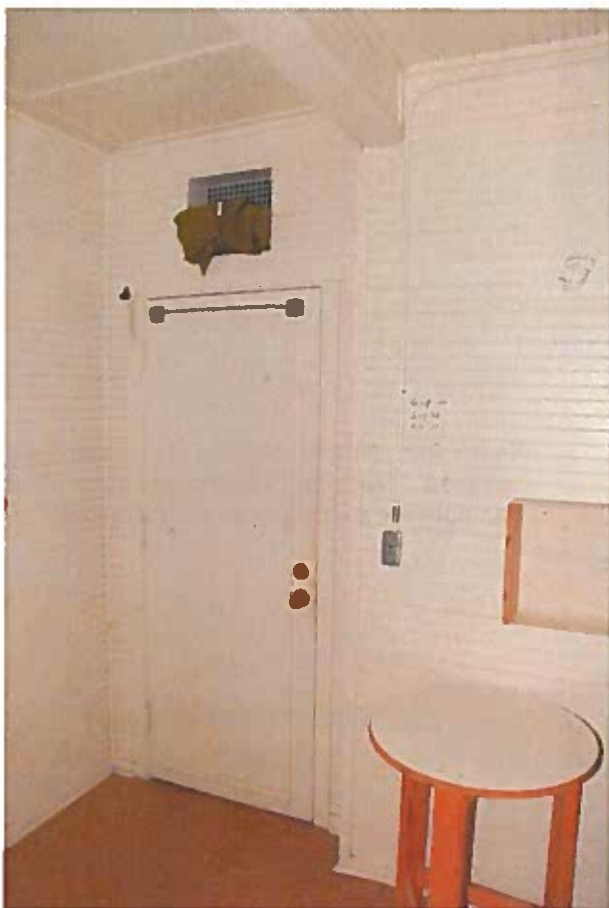
Figure 51: The wood paneled doors do not meet fire codes without a fire suppression system in the building. The ventilation screen also does not meet code.

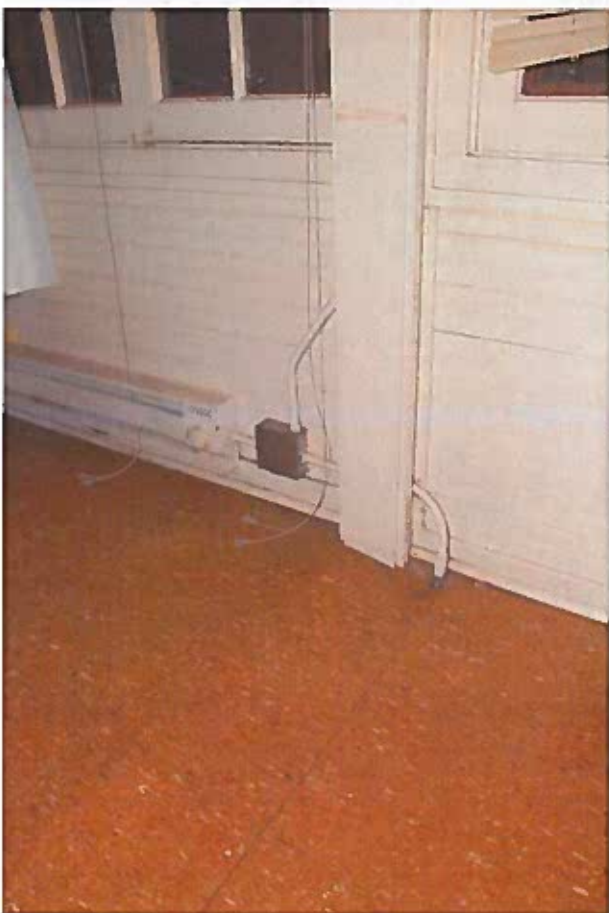
Figure 52: Note the wear on the lower part of the walls and at the base. There is some missing paint and deteriorated wood members.

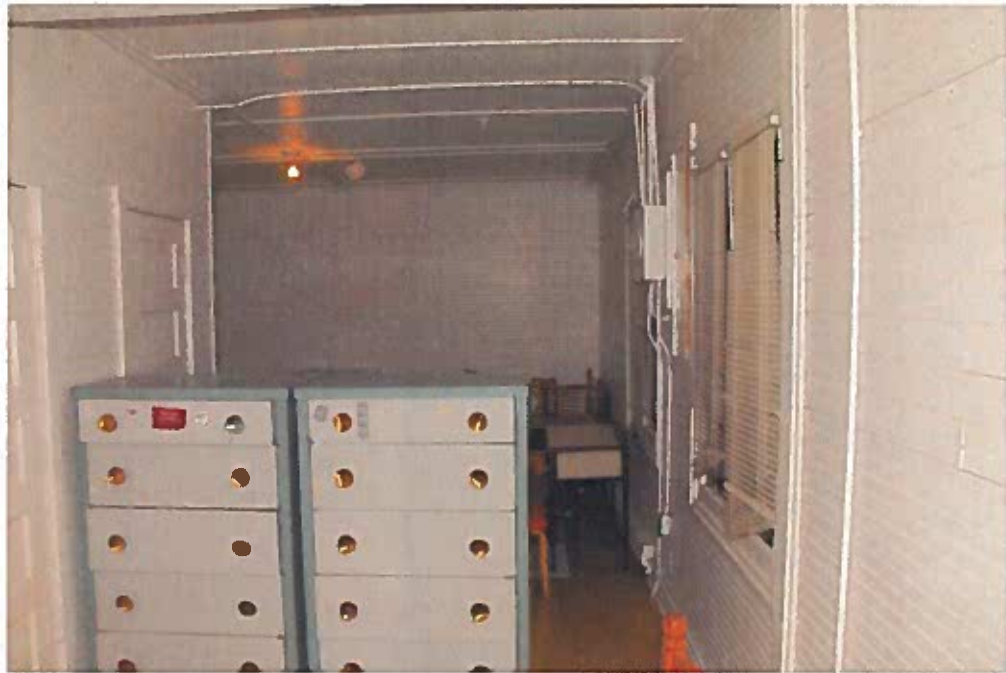
Figure 55: Note the closet doors to the left with original wood paneled doors and the wood bead board on the outer walls and ceiling. The light fixtures are poor and not very energy efficient.

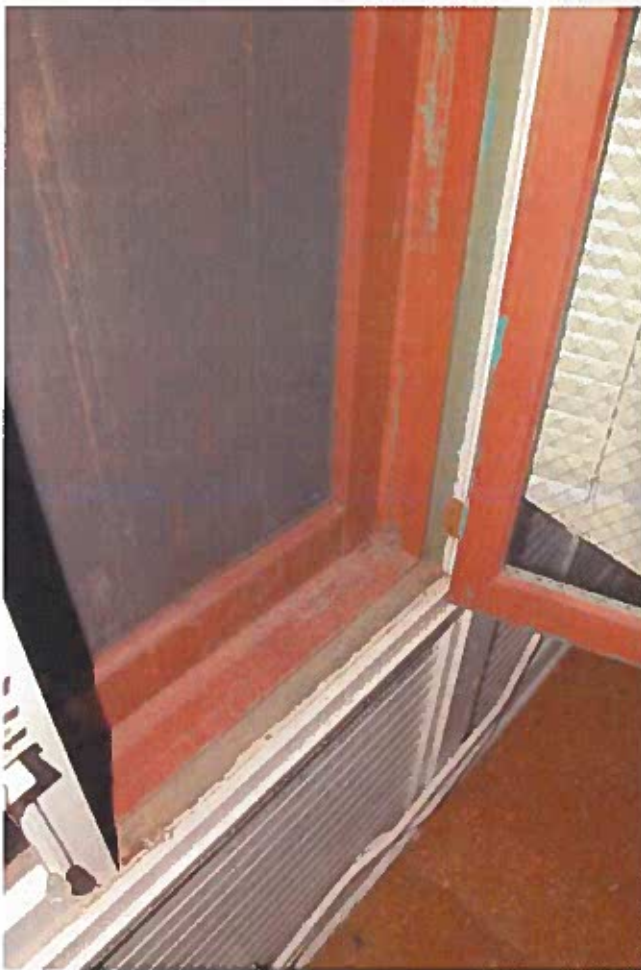
Figure 56: From the inside note some of the weathering of the windows. There is missing paint and some deterioration in the wood sills.

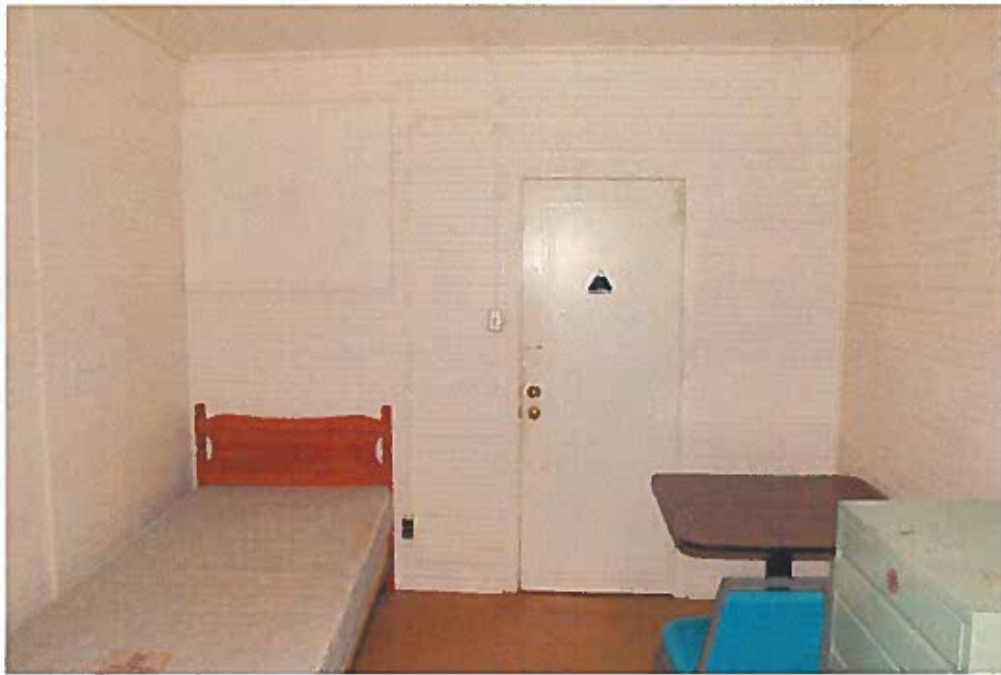
Figure 57: A window has been covered over to the left of the door.

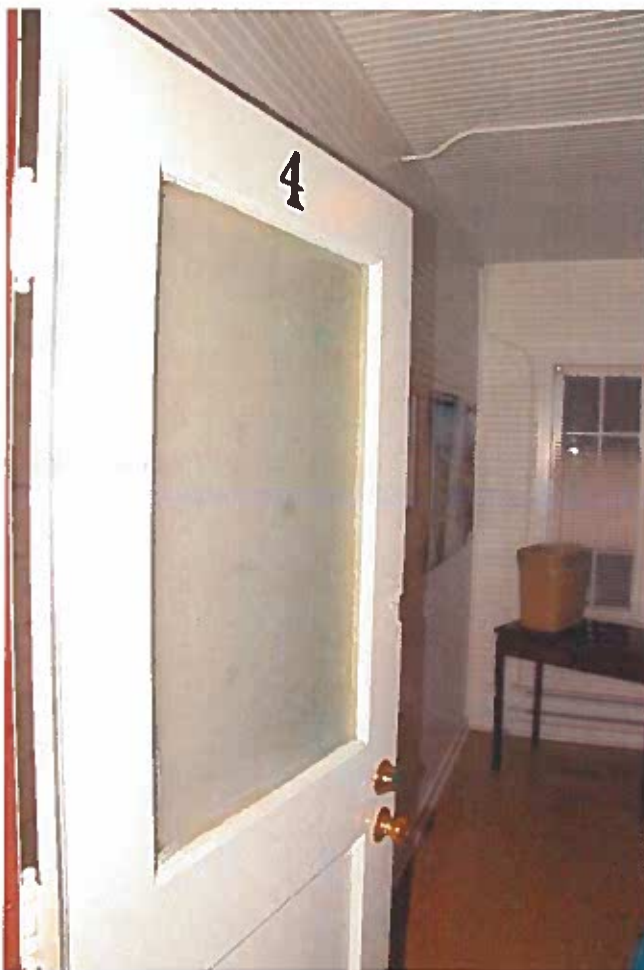
Figure 60: A typical original door on the first floor. Note the original hinges that are in good condition although loose in some cases.

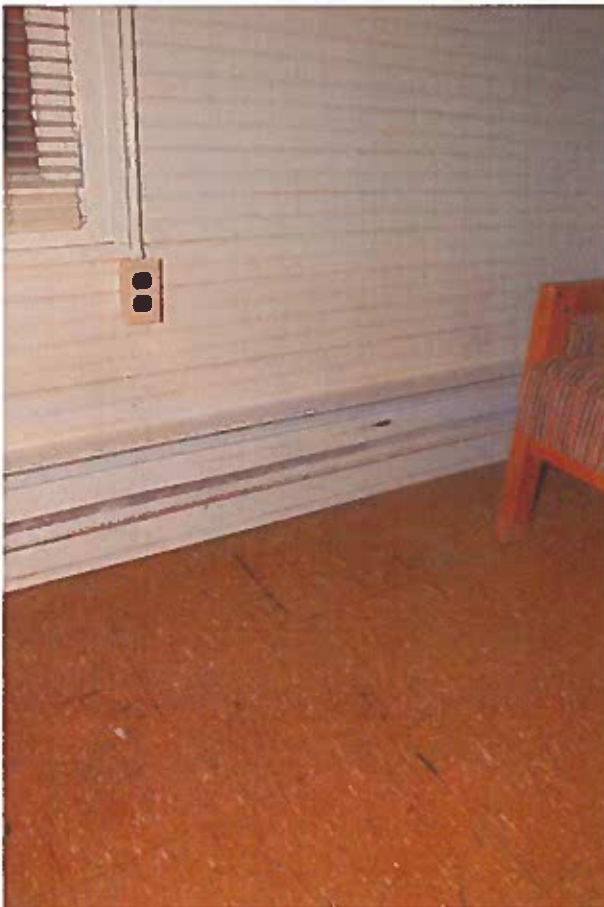
Figure 62: Note the exposed electrical conduit. There is some wear and missing paint in the original base above the concrete wall.

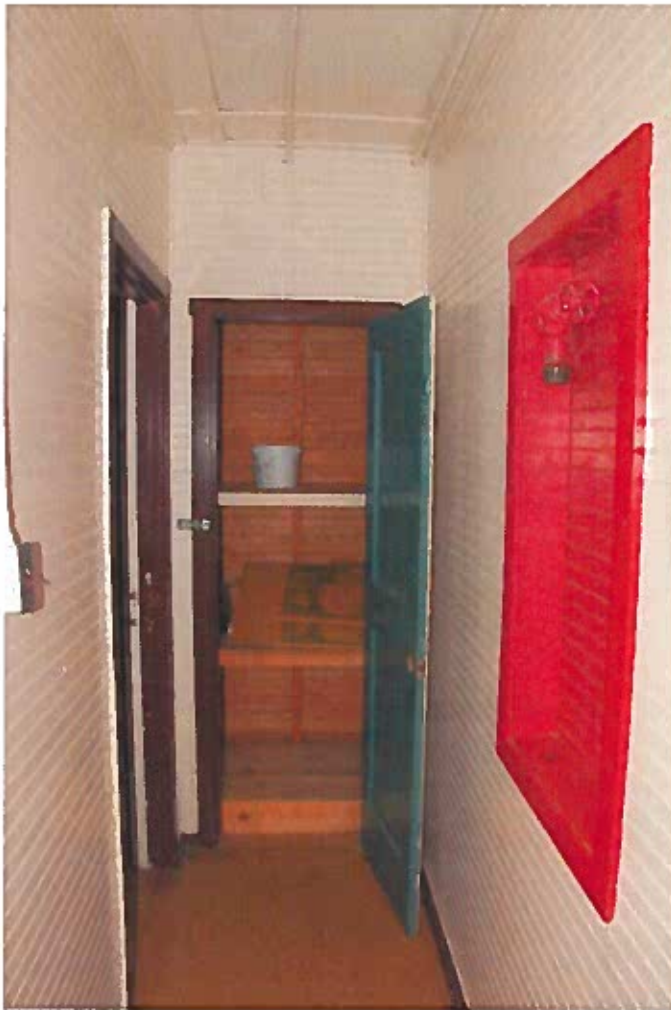
Figure 63: There is no second exit out of the first floor other than the windows. The red hose cabinet does not meet present code and is probably not used.

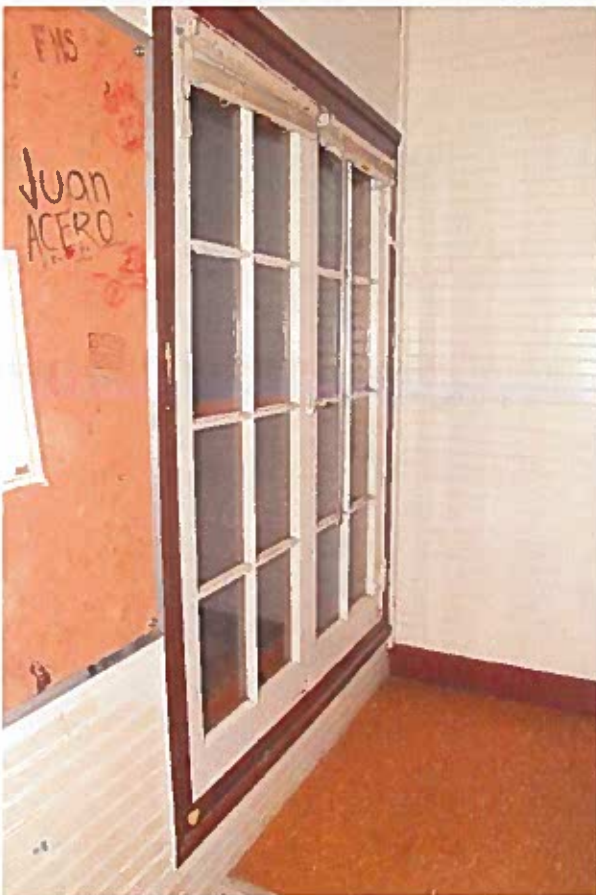
Figure 65: The hinged window appears to be in good condition on the landing but causes problems with stair for exiting.

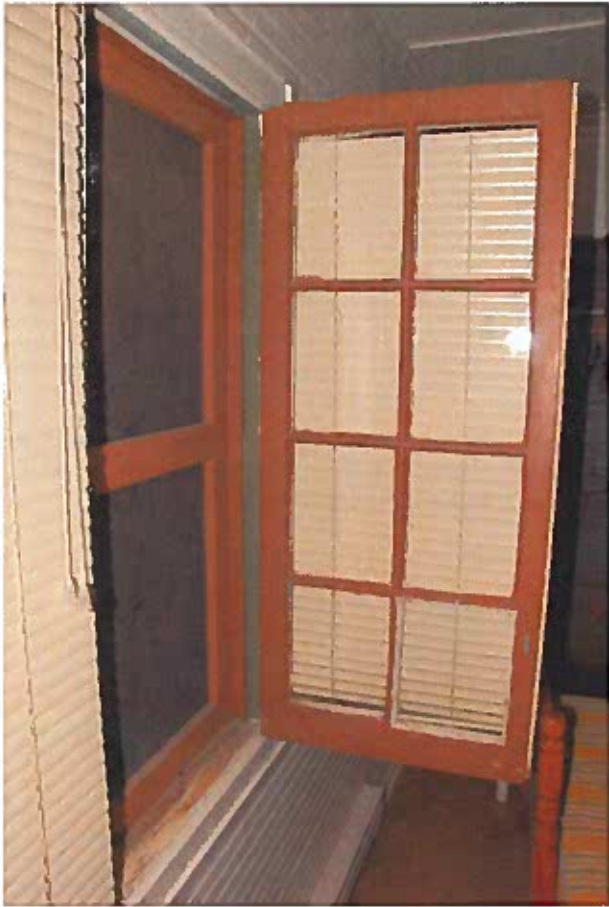
Figure 72: Typical wood hinged window that appears in good condition with some minor wear, some peeling paint, and sill deterioration. Note the repaired pane of glass in the lower right corner where the putty is not painted.

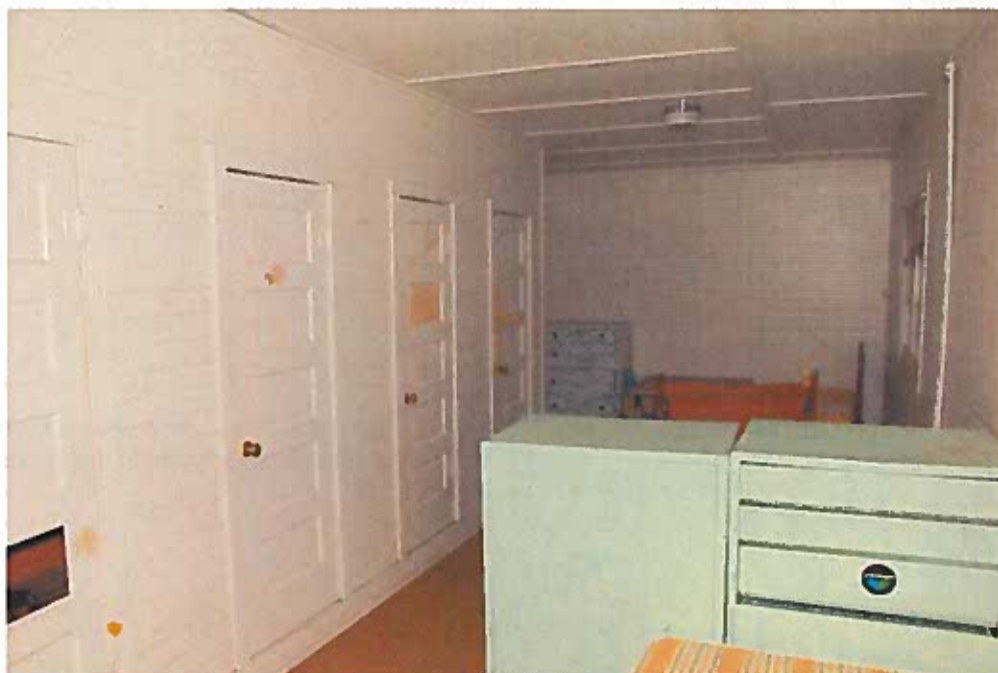
Figure 82: Note the missing panel in the door to the left. All of these doors access storage closets.

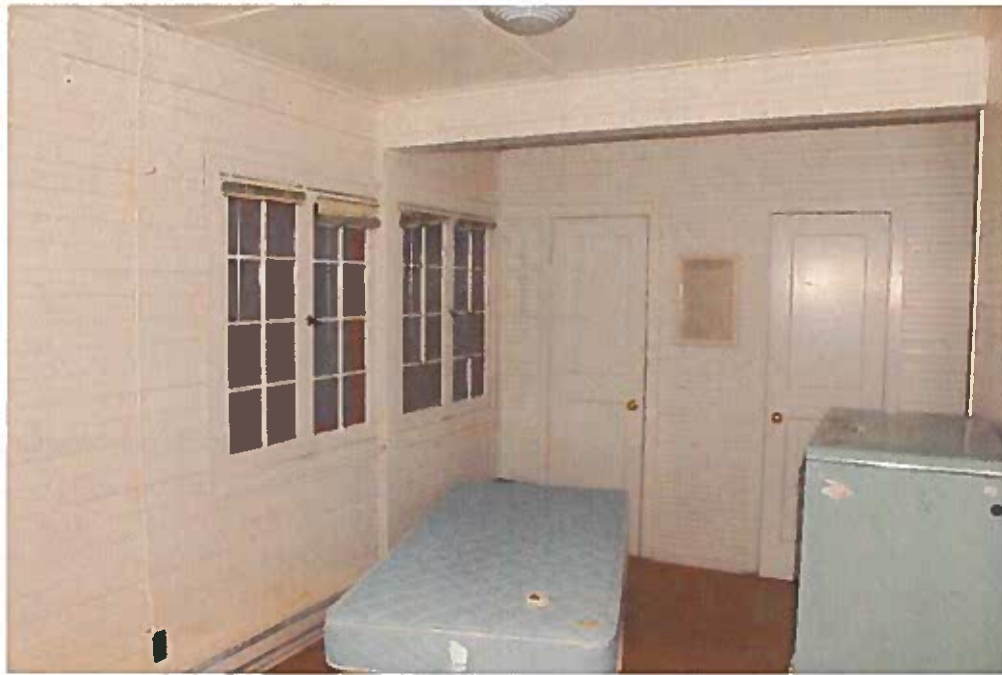
Figure 90: The windows have some missing muntins with some larger glass pieces installed in the larger opening.

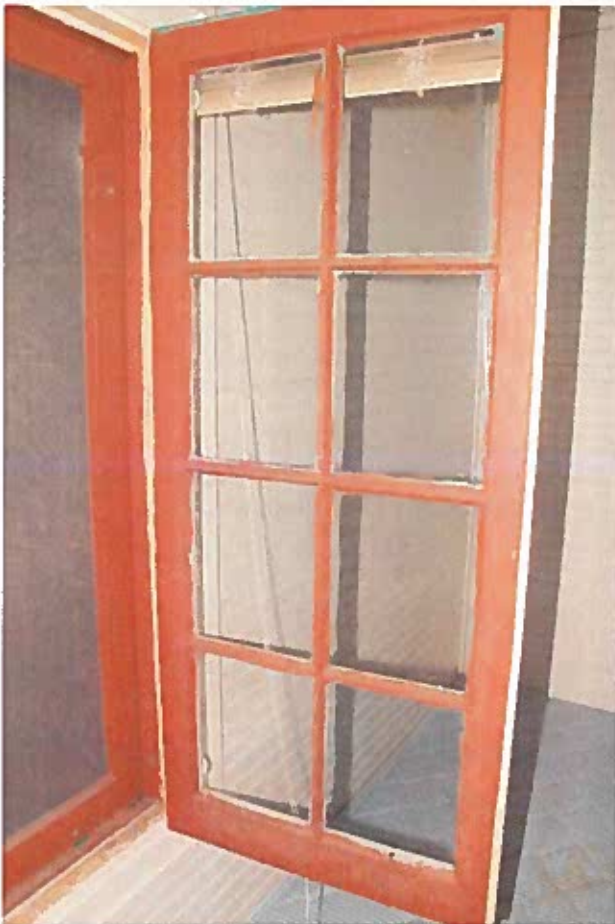
Figure 91: The window exterior shows some weathering, peeling paint and deteriorating window putty.

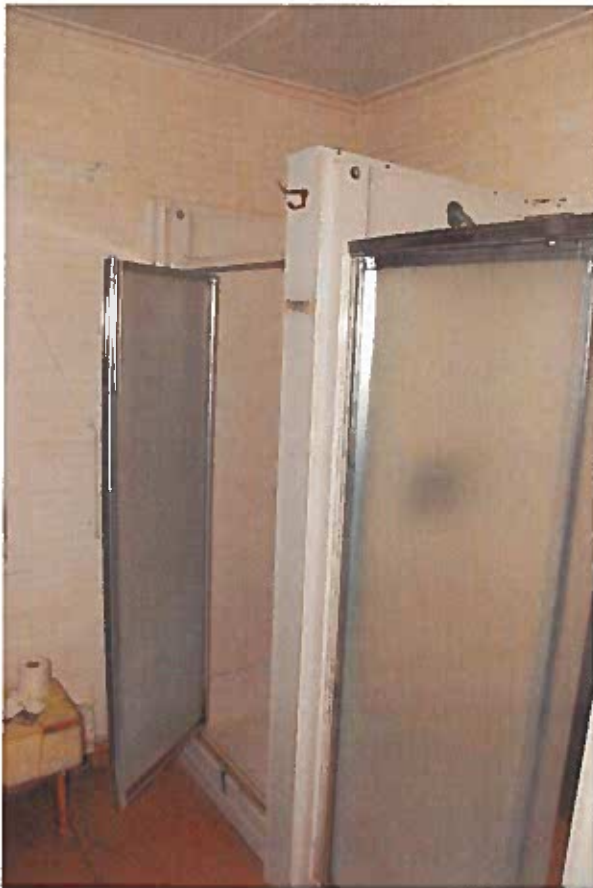
Figure 94: The bathroom showers with some mold and worn areas on the walls and door.
