# **HISTORIC STRUCTURE REPORT**

## **HAYNES AUTO CAMP PICTURE SHOP Old Faithful Yellowstone National Park**

**Department of the Interior  
National Park Service  
Yellowstone National Park**

Prepared by Sievert & Sievert Cultural Resource Consultants  
Great Falls & Bozeman, Montana  
January 4, 2007

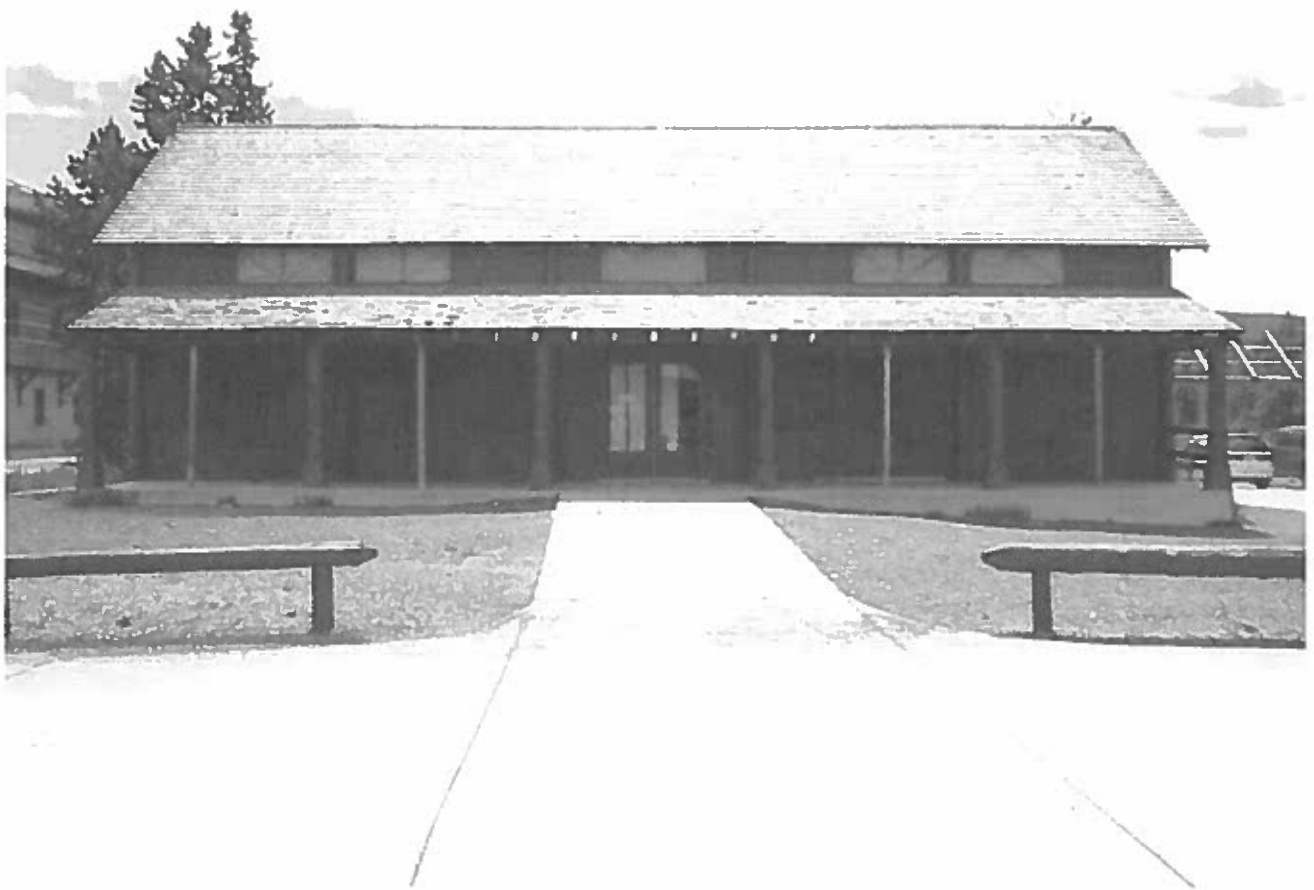
**NORTH ELEVATION - MAIN ENTRANCE INTO STRUCTURE**

**Note that sidewalk is at grade and is accessible; large retail windows on first floor are covered with shutters (winterized).**

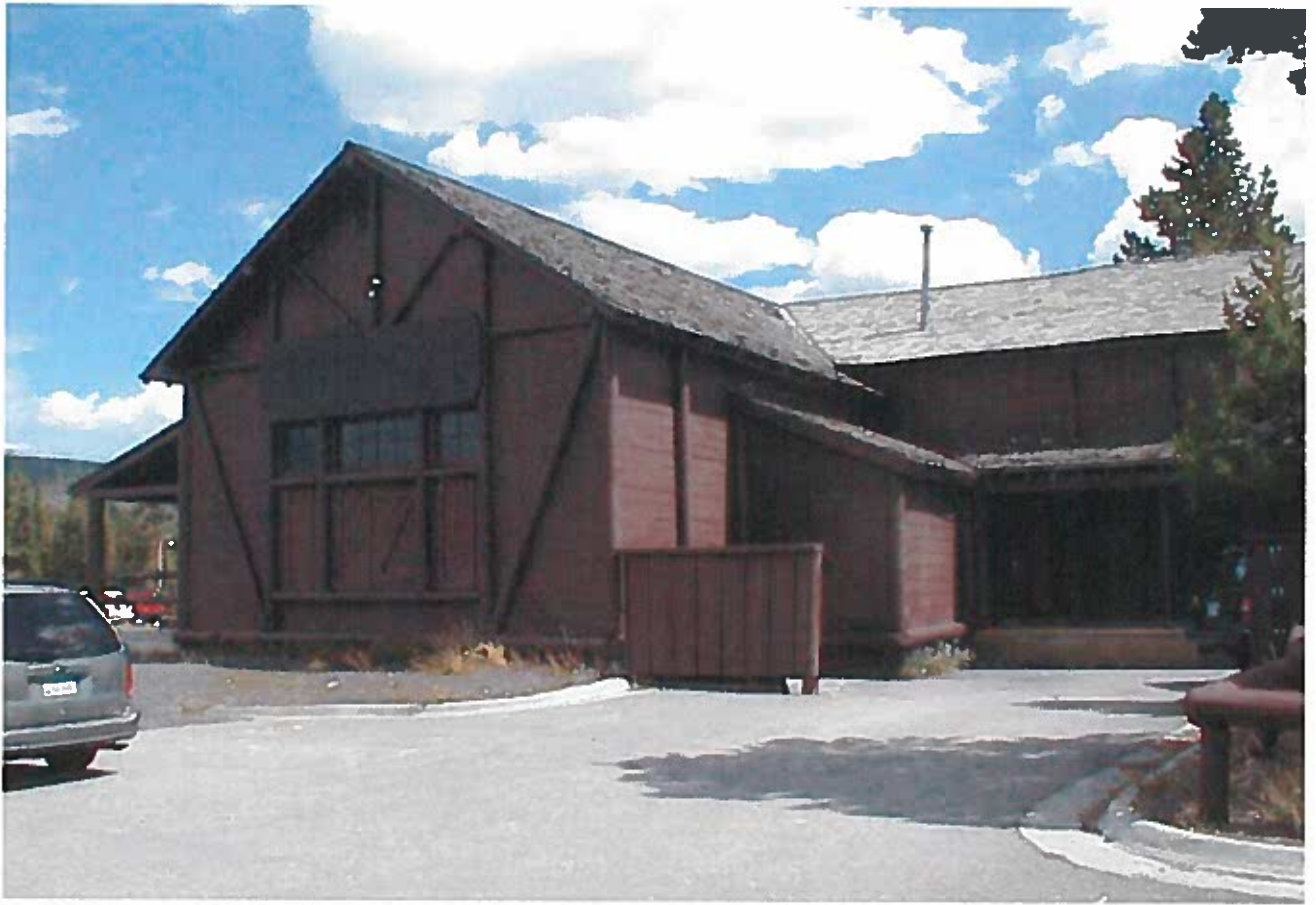
**WEST ELEVATION - SIDE ENTRANCE/EXIT AND FORMER DELIVERY ENTRY INTO STRUCTURE**

Shed roofed projection at the corner of the retail wing and the dormitory wing is a 1971 addition.

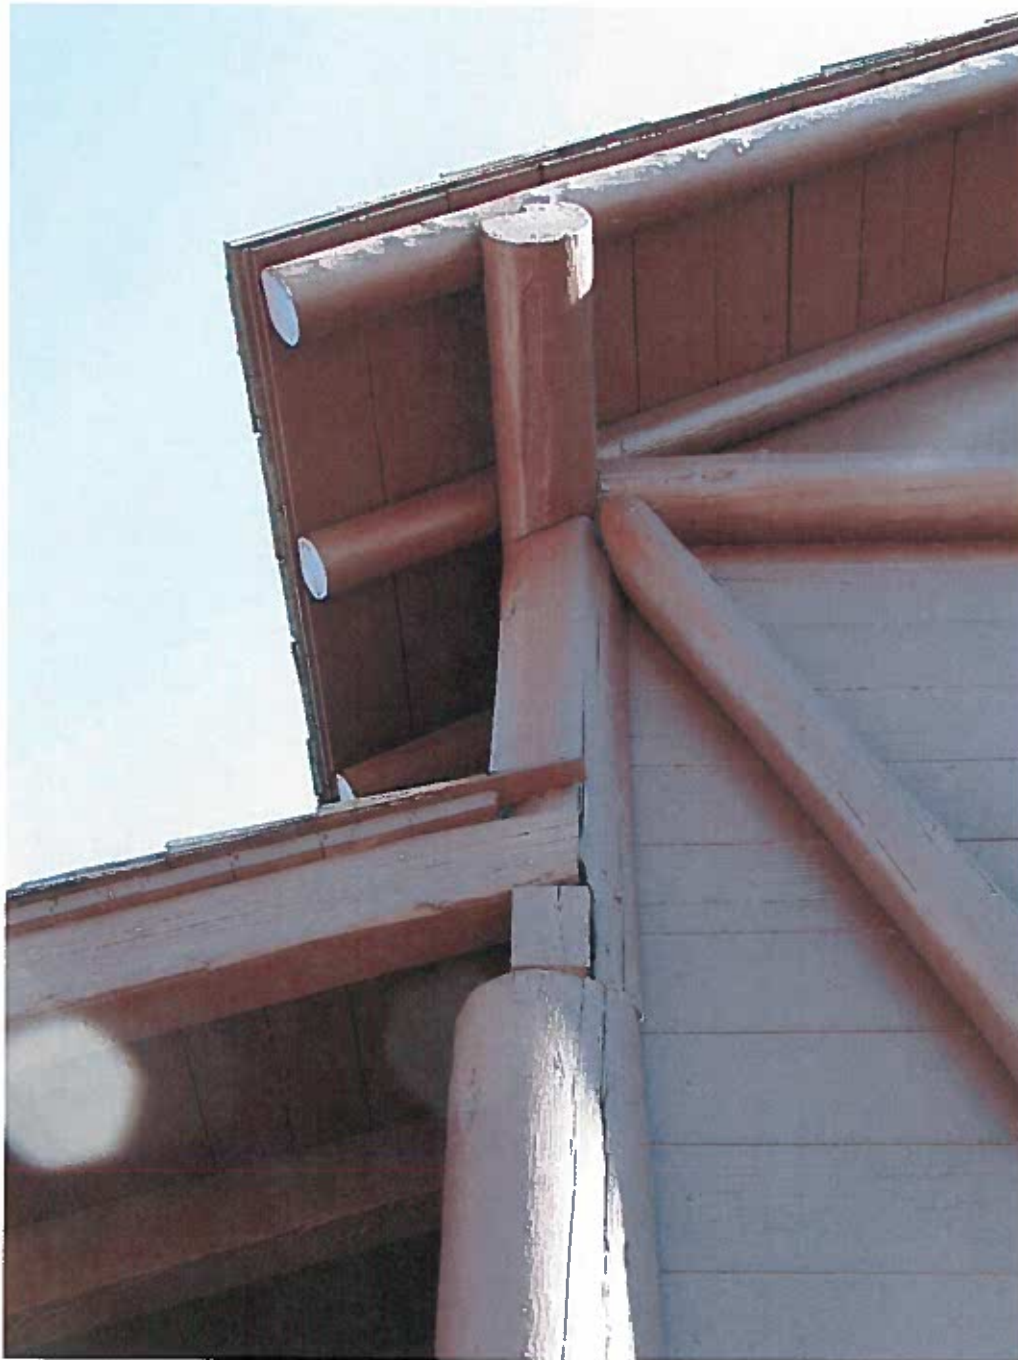
#### DETAIL OF APPLIED LOG FENESTRATION AT THE FRONT ENTRY PORCH

Note that the applied log members are non-structural and are decorative elements applied to the exterior of the structure - as shown on following pages selected portions of these members need to be replaced.

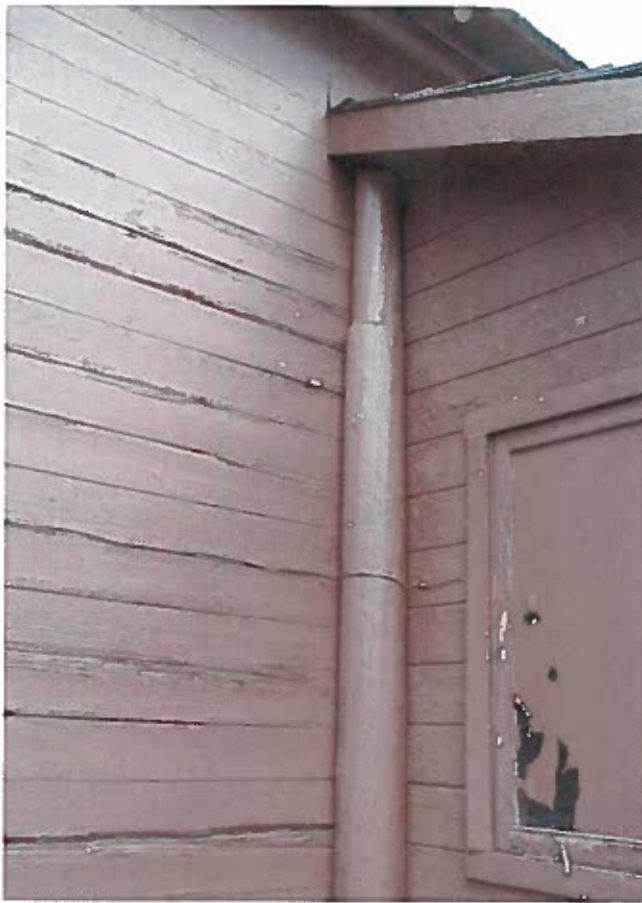
**DETAIL OF LOG "APPLIQUE"**

Note splice in applied decorative log work.

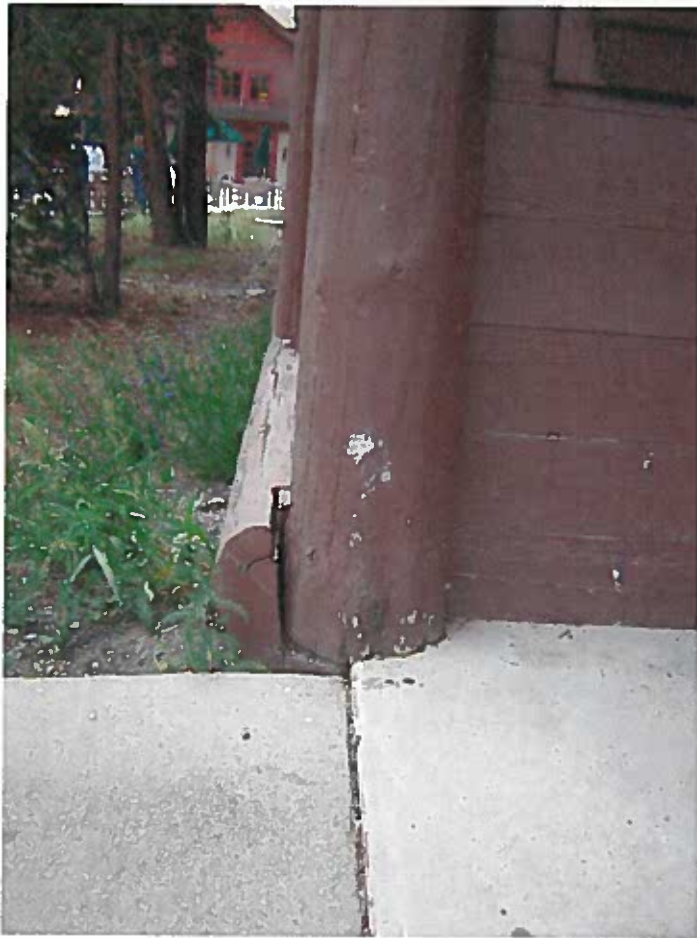
INTERSECTION - APPLIED LOG SILLS  
AND COLUMN

NE corner of Retail Wing of building.

EXAMPLE OF APPLIED COLUMN  
TO BE REPLACED WITH NEW  
LOWER SECTION.

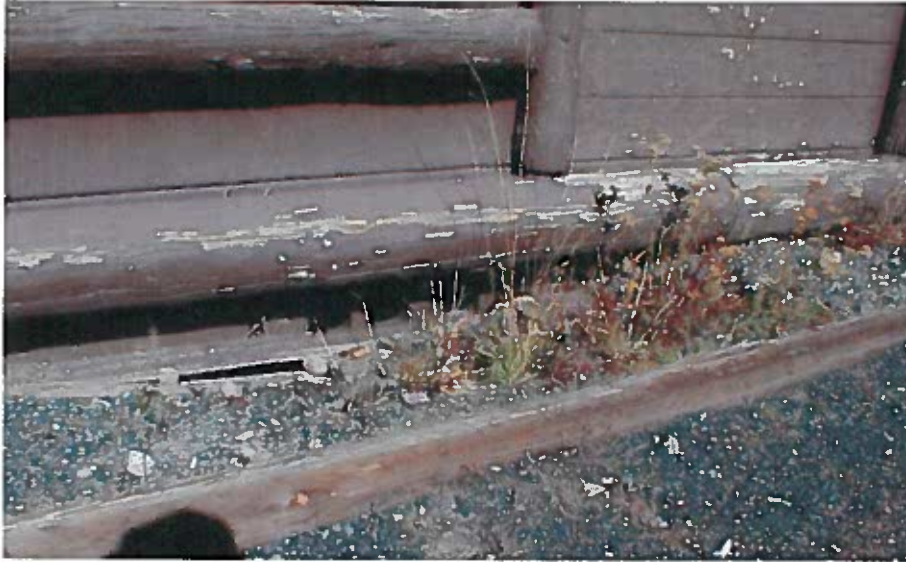
**NEGATIVE DRAINAGE -  
SE PORTION OF  
STRUCTURE**

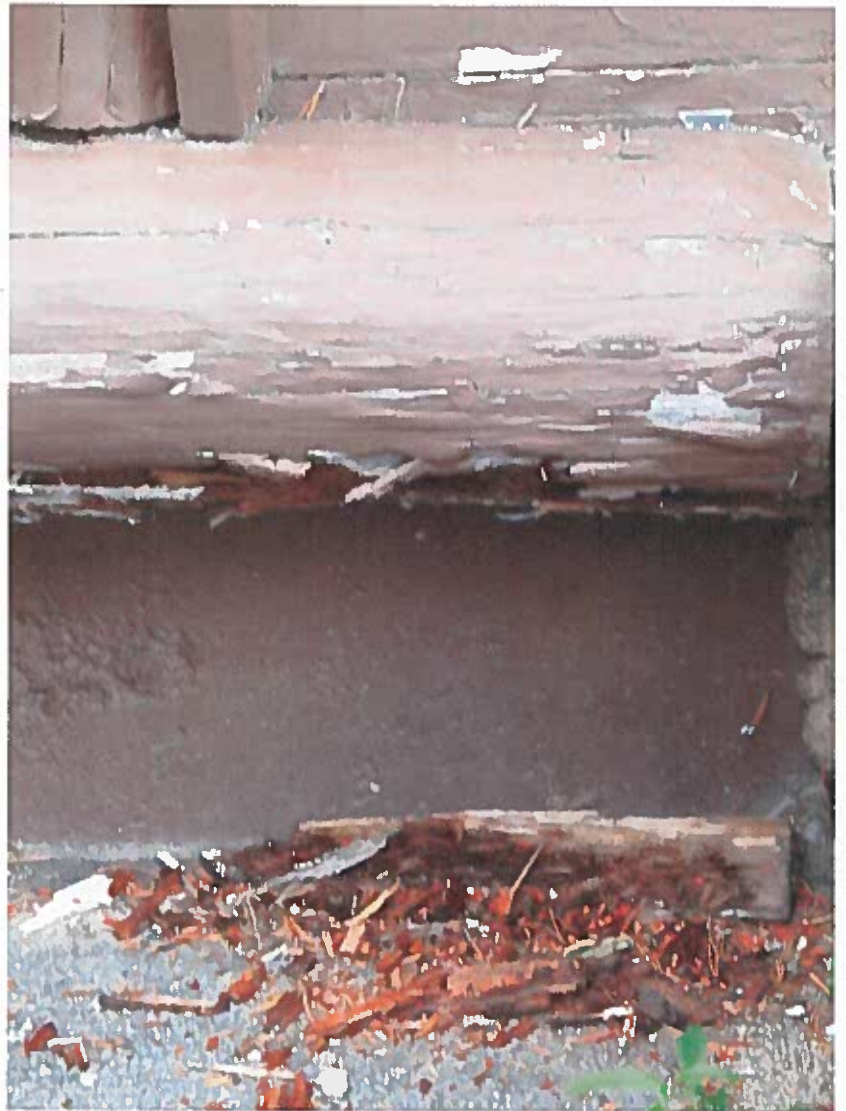
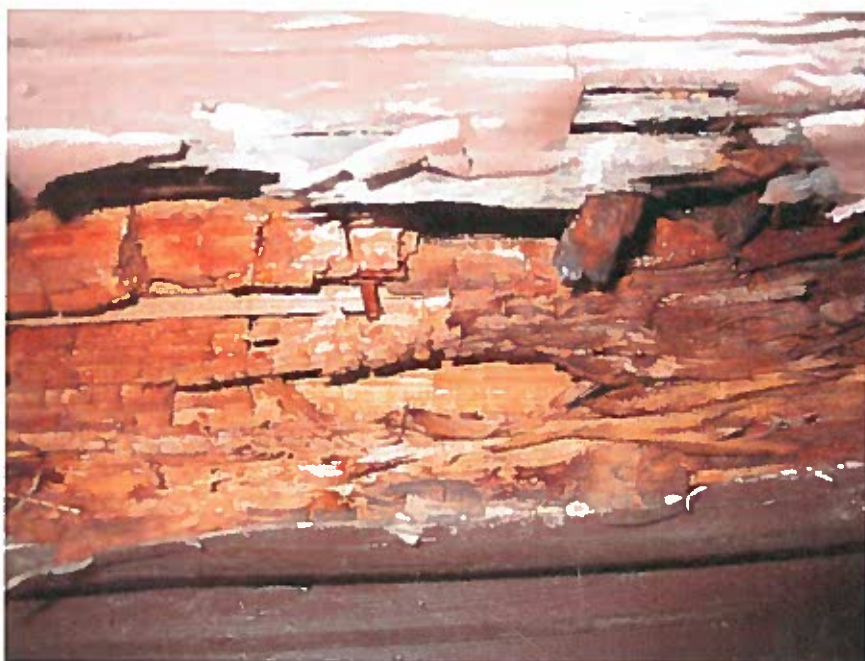
DETAILED PHOTOS OF LOG  
DETERIORATION IN THE  
APPLIED DECORATIVE SILL  
LOGS.

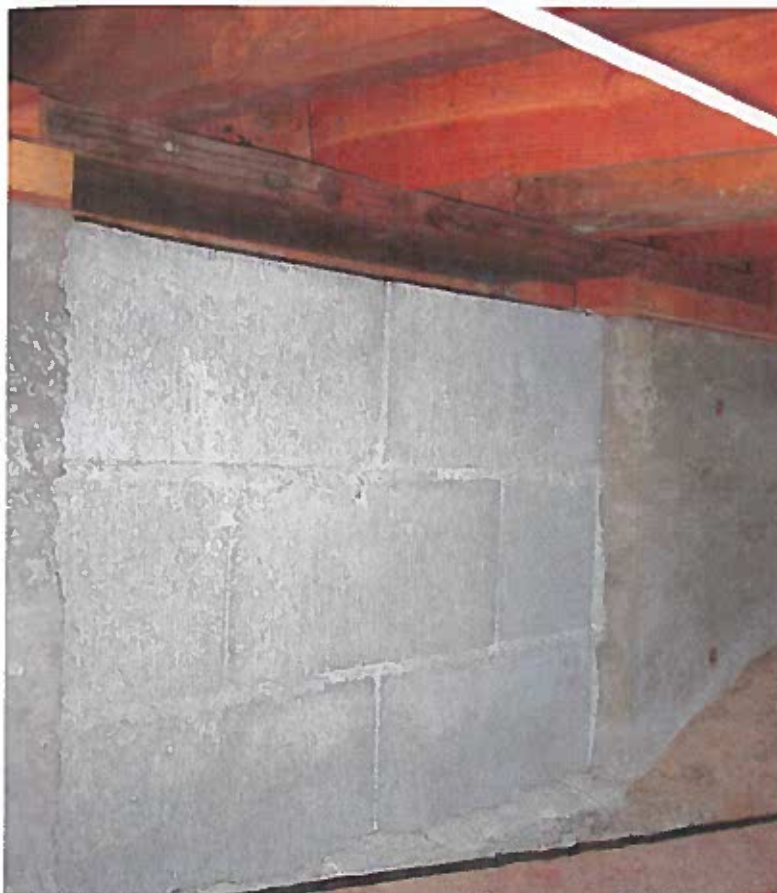
REMOVEABLE PANEL IN NEW FOUNDATION WALL.

CMU could be removed in this area of foundation if required. Note the good condition of the existing floor joists as well as the new wood framed cripple wall in the upper photograph. These CMU blockouts are thought to have been used as pockets for girders during the moving process for the building.

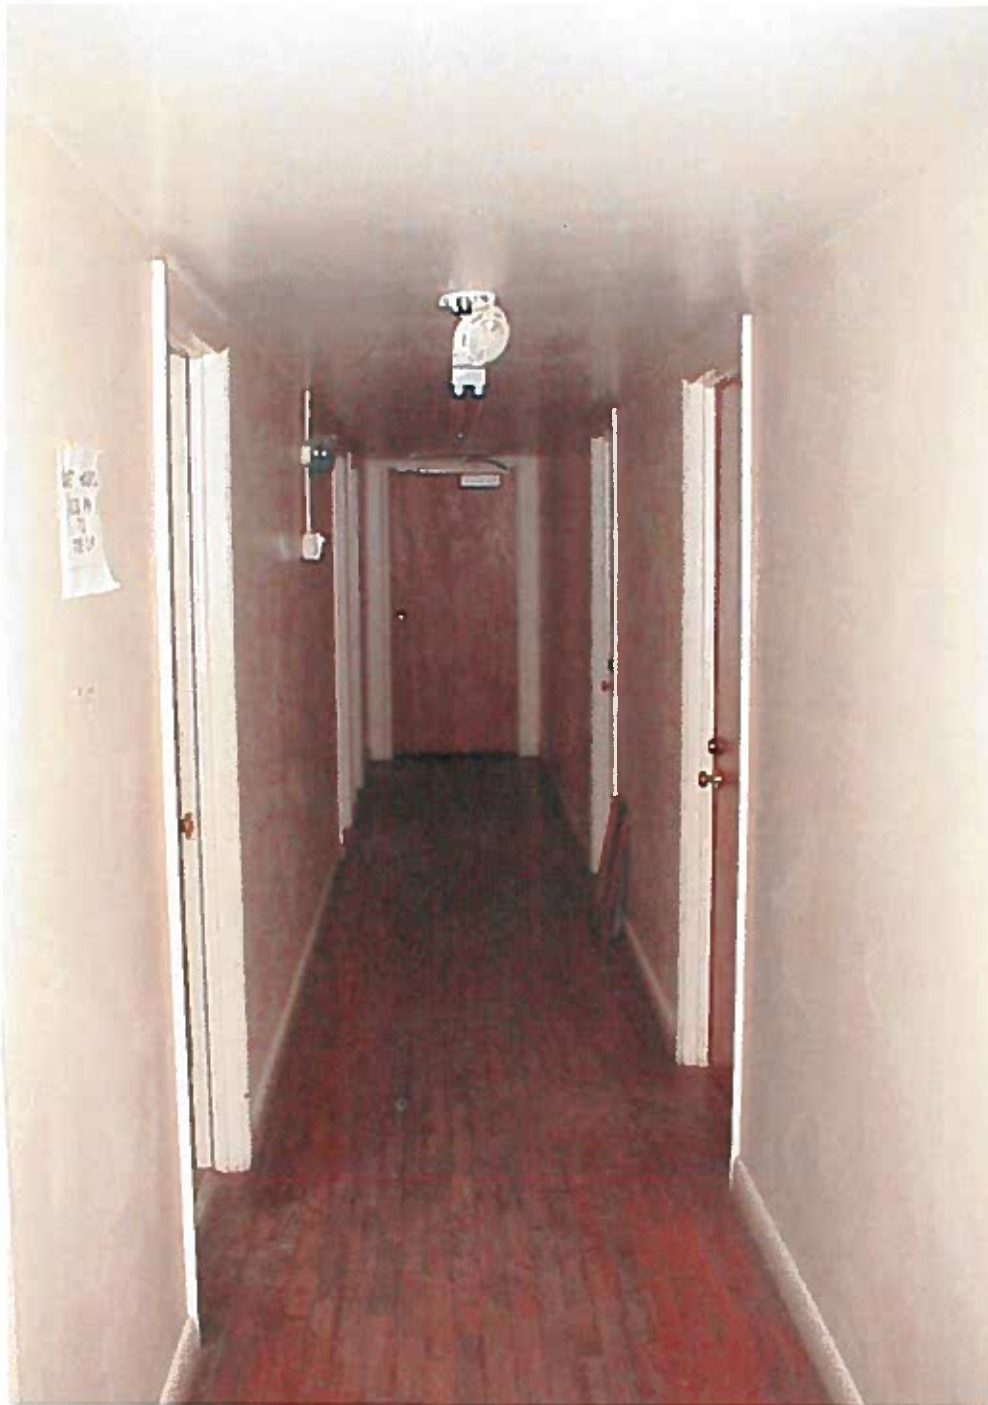
#### **SECOND FLOOR CORRIDOR - DORMITORY WING**

**Note: All walls and ceilings on this level are non-combustible (GPDW) materials and are in good condition; hardwood flooring on this level appears to have been water damaged and will require rehabilitation.**

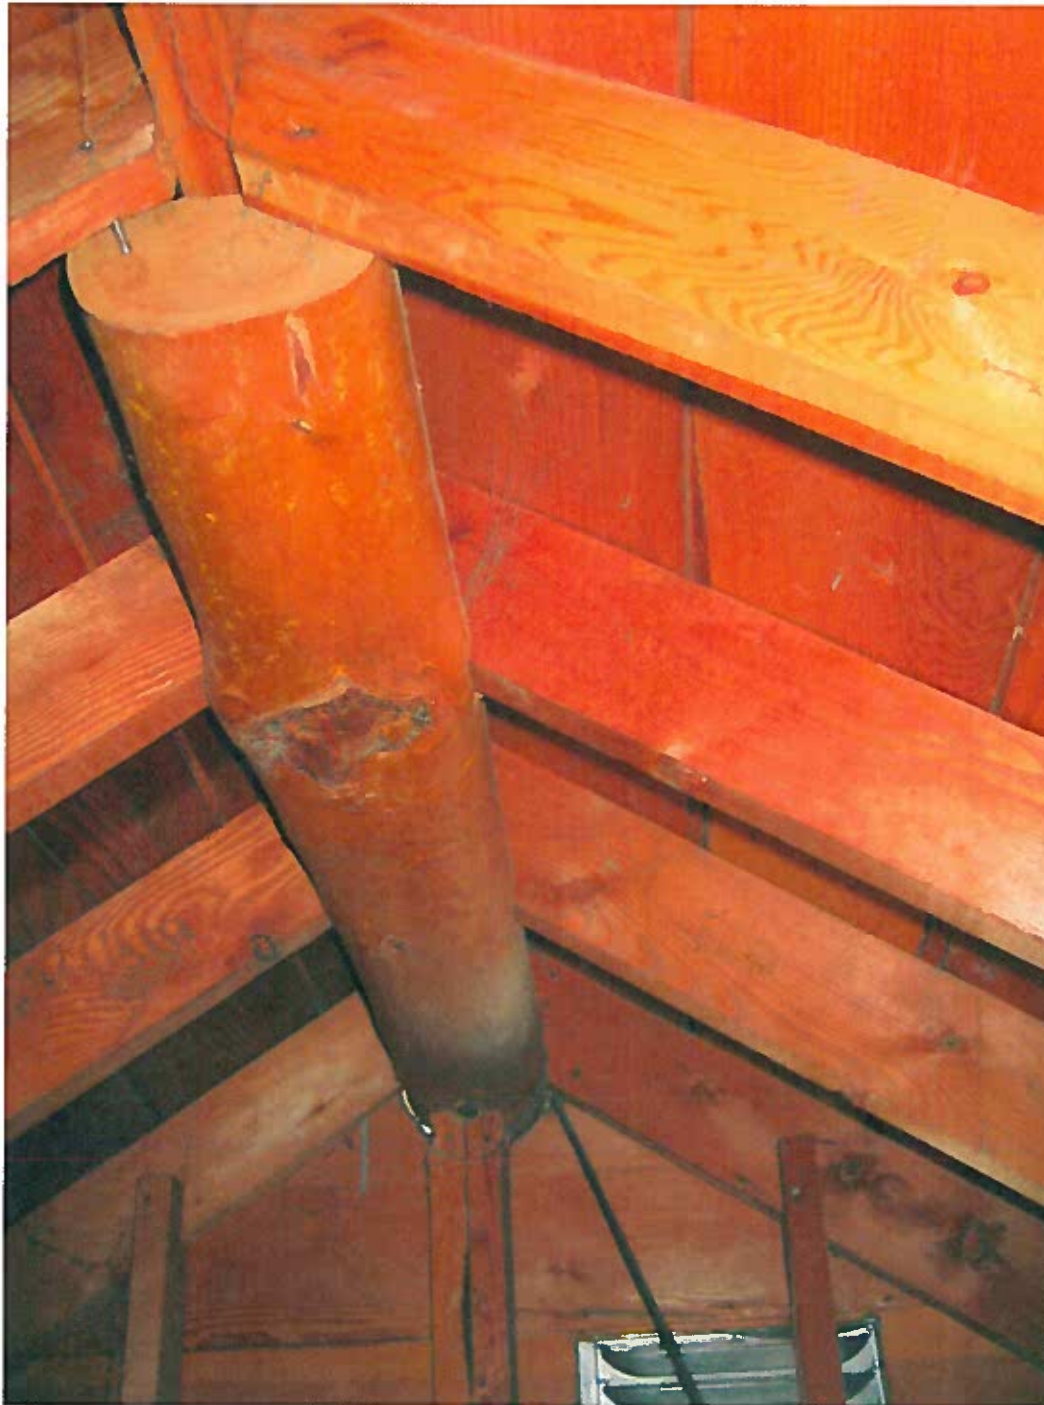
RETAIL WING - ATTACHMENT OF THE DECORATIVE LOG ROOF RIDGE PURLIN THAT CAN BE SEEN FROM THE EXTERIOR OF THE FACILITY.

Note the extremely good condition of all of the wood members.

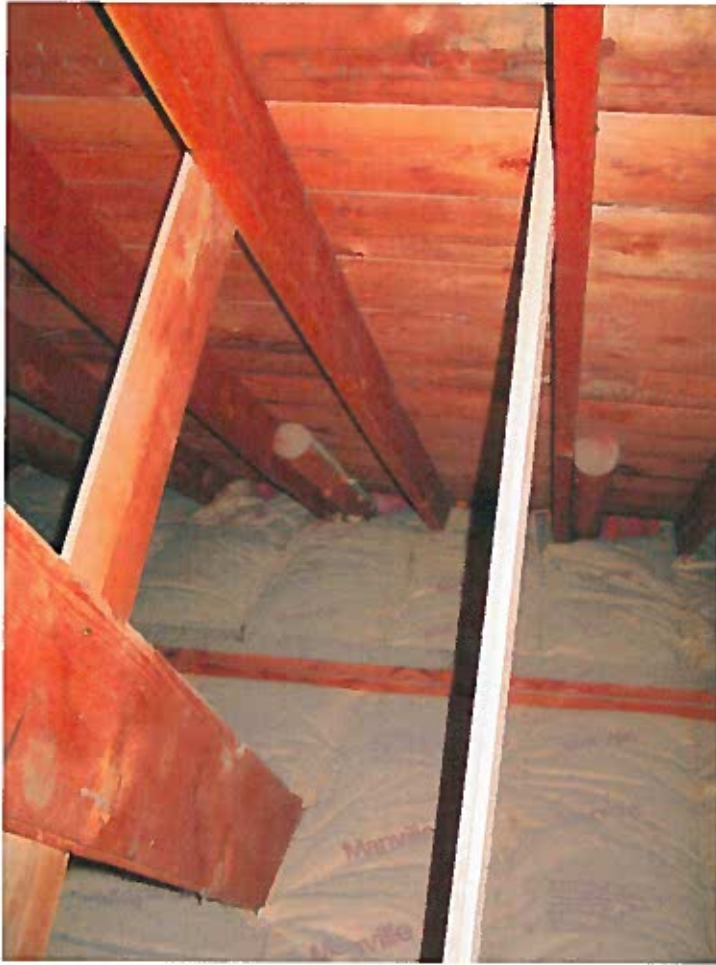
**RETAIL WING - PATTERN OF WOOD BRACES AND TIES WITHIN THE ROOF FRAMING ASSEMBLY.**

**Note the R-19 roof insulation, condition of the structure & sheathing, and the false decorative log rafter ends along the eave line.**

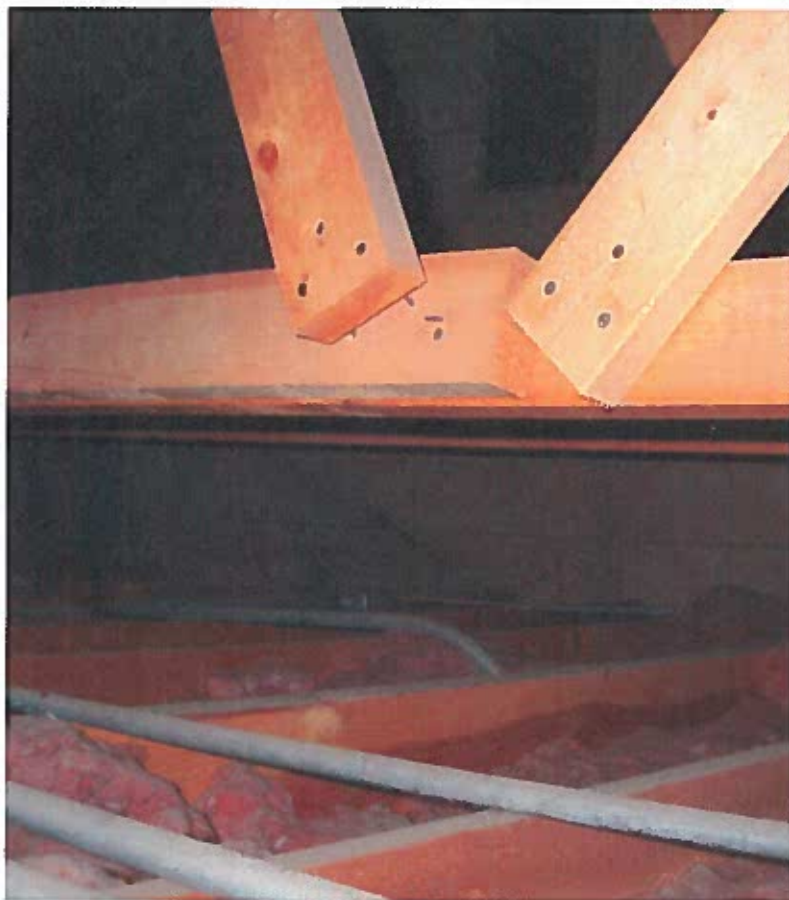
Note: the bent web in the adjacent photo is from distortion - not from being overstressed.

TRANSITIONAL SECTION OF STRUCTURE - THESE ARE EXAMPLES OF TRUSS TYPE CONNECTIONS THAT REQUIRE ADDITIONAL NAILING AND GUSSETING. WORK ENVISIONED FOR THESE MEMBERS CAN BE DONE IN-PLACE.

Note the presence of insulation in this section of roof and the electrical work in the form of metallic conduit. It is recommended that the insulation be added to in the interest of energy conservation.

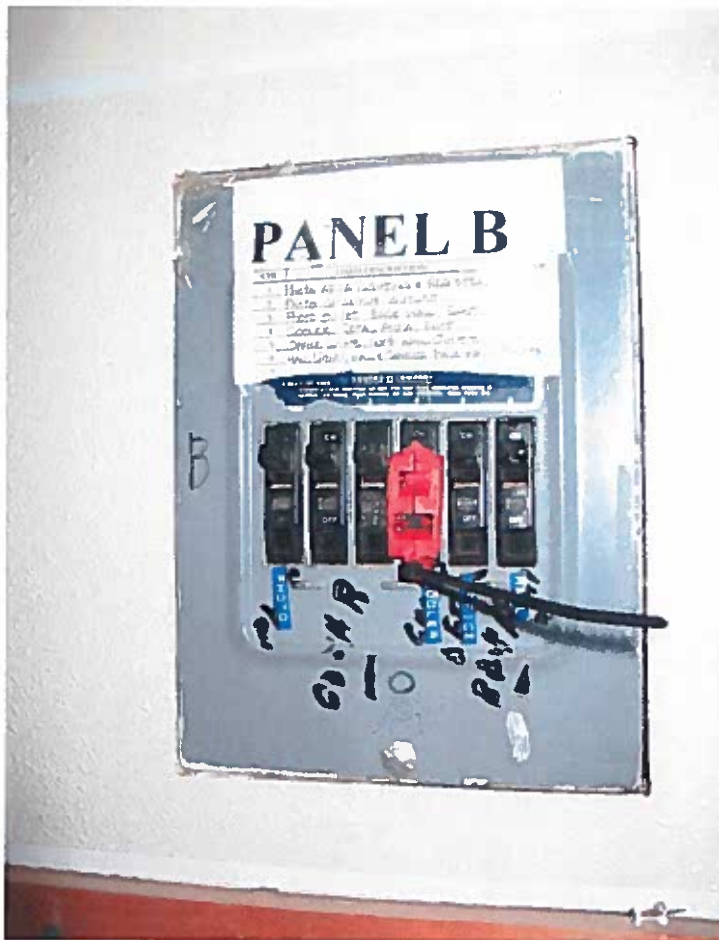
CIRCA 1971 ELECTRICAL PANEL; IT IS NOT KNOWN IF PANELS WILL REQUIRE BEING REPLACED. IT IS BELIEVED THAT THE CONDUIT AND CONDUCTORS WILL COMPLY WITH CURRENT CODES.

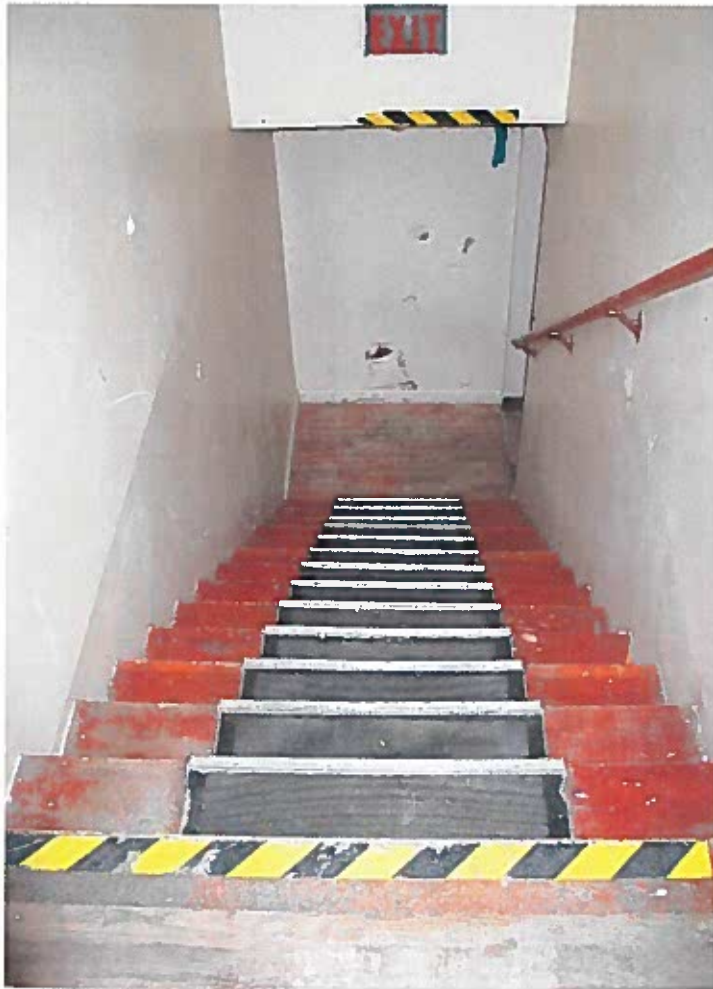
VIEWS OF THE CENTER EXIT STAIR  
BETWEEN THE TWO FLOORS OF THE  
DORMITORY WING.

Note the damage to the walls of the stairway from moving equipment and belongings up and down the stairs. All walls and ceilings of the stair are of fire-resistive materials. The South stair is similar in construction to this stairway albeit in better condition.

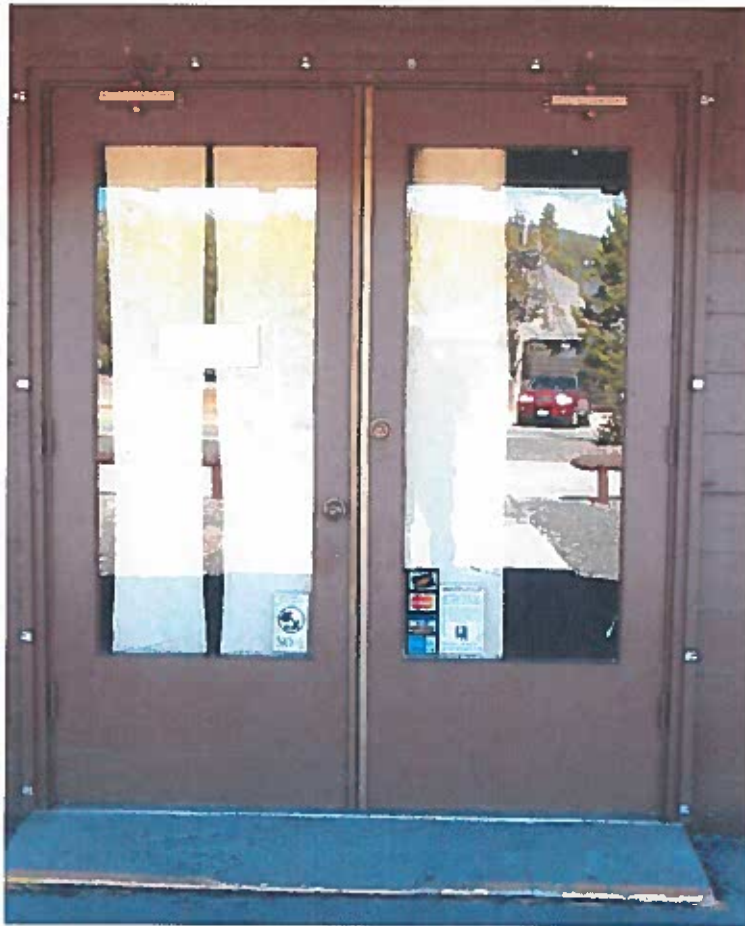
#### **HARDWARE DETAIL - MAIN ENTRANCE**

Doors comply with ADA clearances, swing, and direction of travel; automated closers could be added and the doorknob may have to be replaced with a lever lock.
