# **HISTORIC STRUCTURES REPORT**

## **U.S. COMMISSIONER'S HOUSE**

**Mammoth, Yellowstone National Park**

**April 2011**

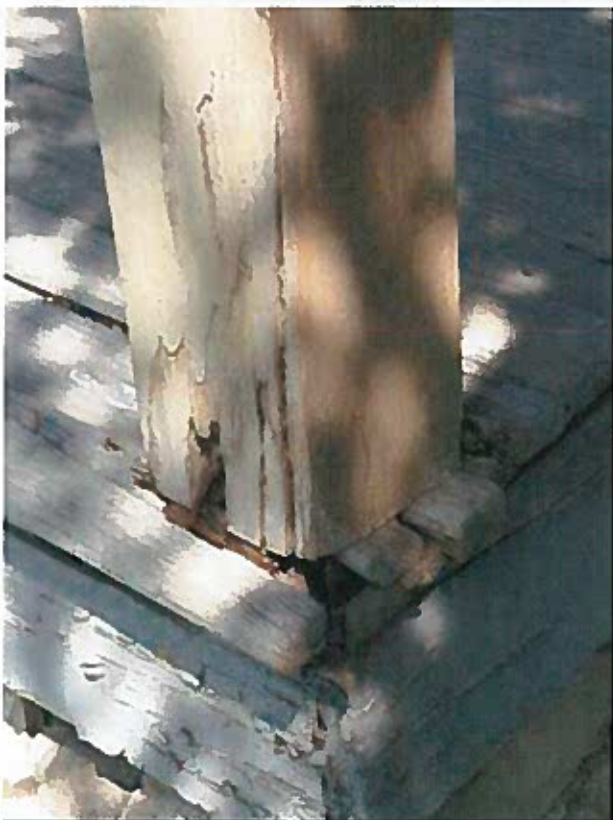
Condition at base of SE porch column.  
Photo Credit: Herb Dawson, NPS.

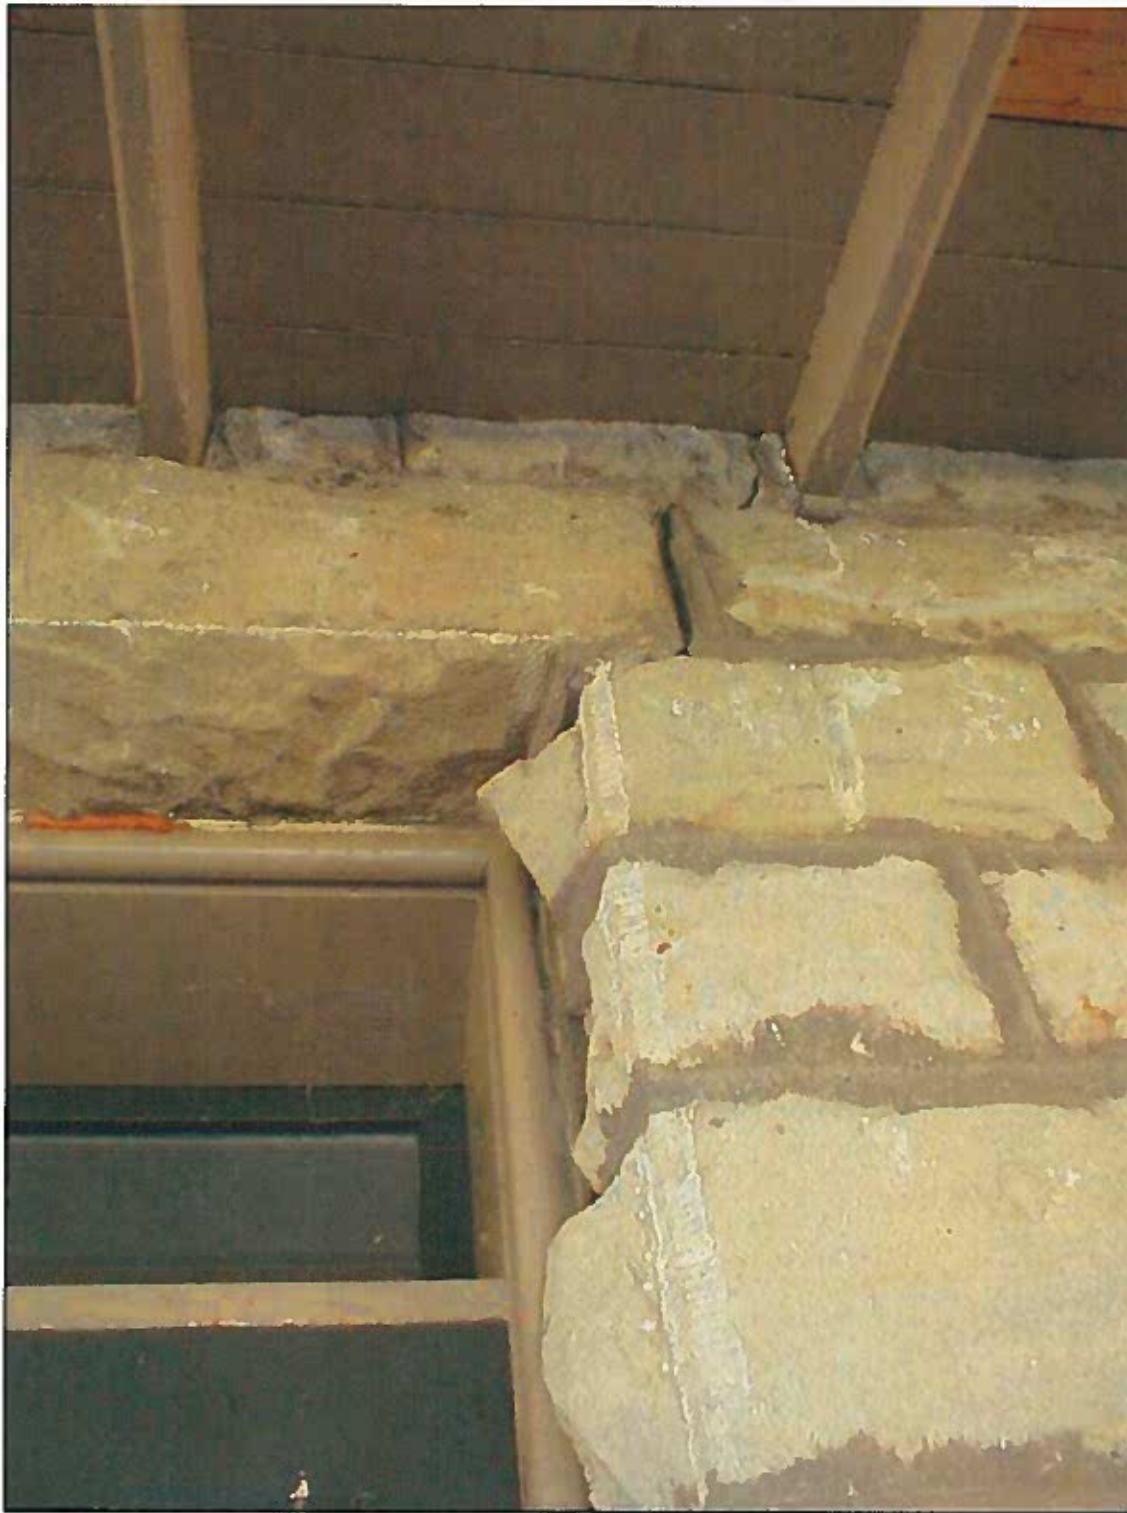
Recent repair of stone lintel above main entrance door in east wall. Photo Credit: Ken Sievert

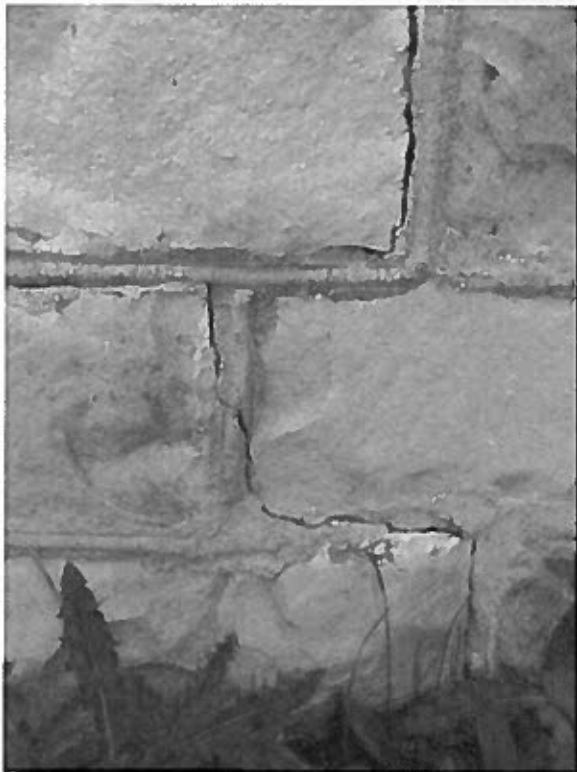
Crack at base of north wall. Photo Credit: Herb Dawson, NPS.

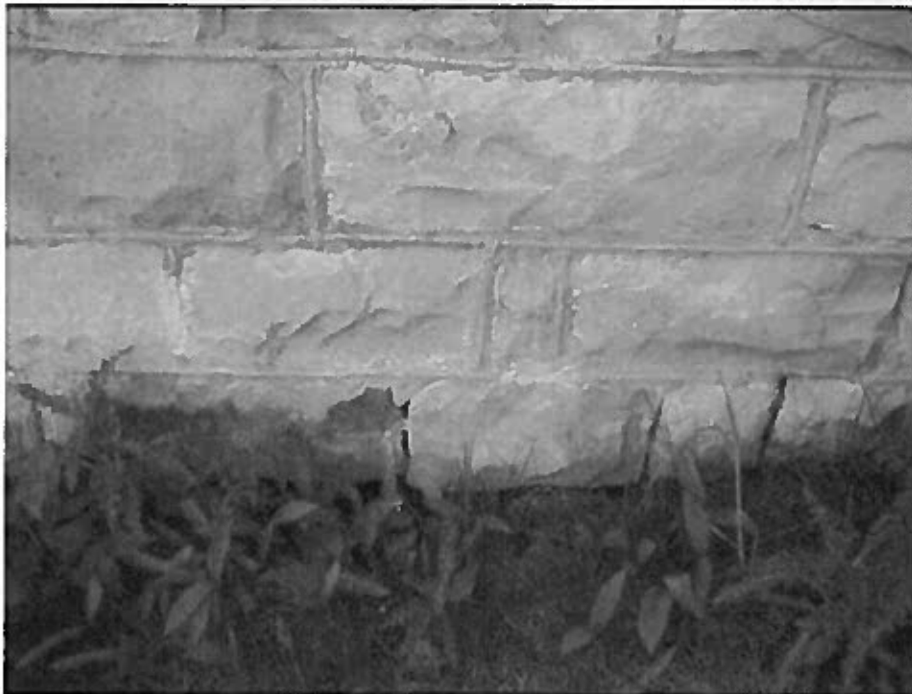
Degradation – base of north wall; east end. Photo Credit: Ken Sievert

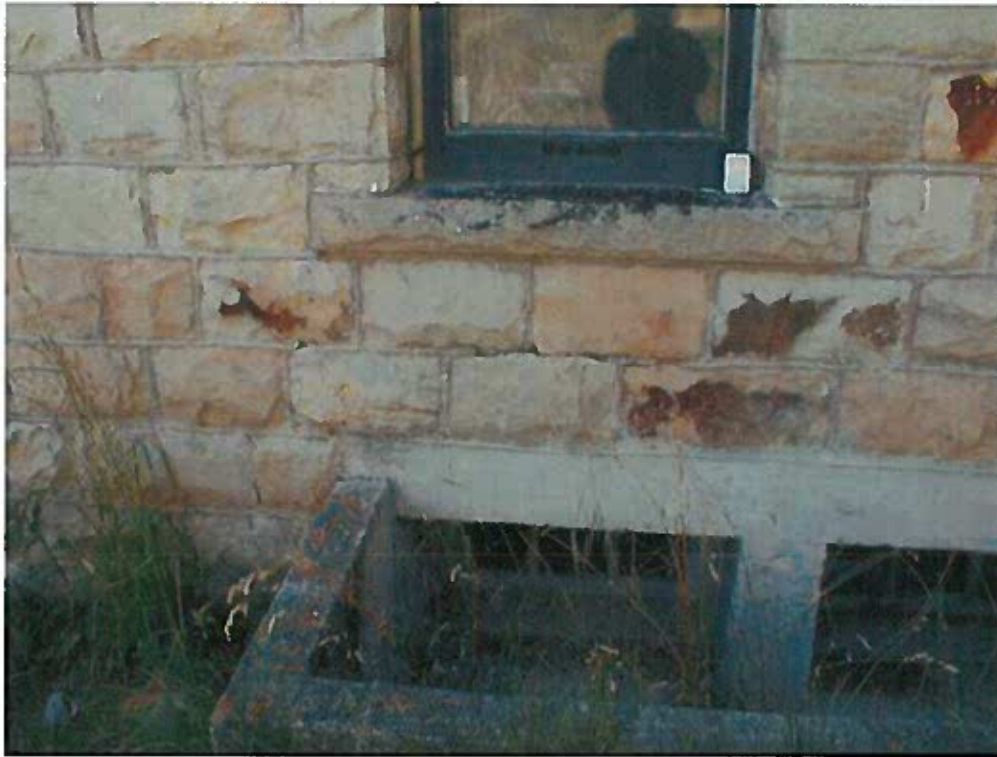
Stonework next to areaway along north wall. Note moss & lichen on concrete Areaway and window sill. Photo Credit: Ken Sievert

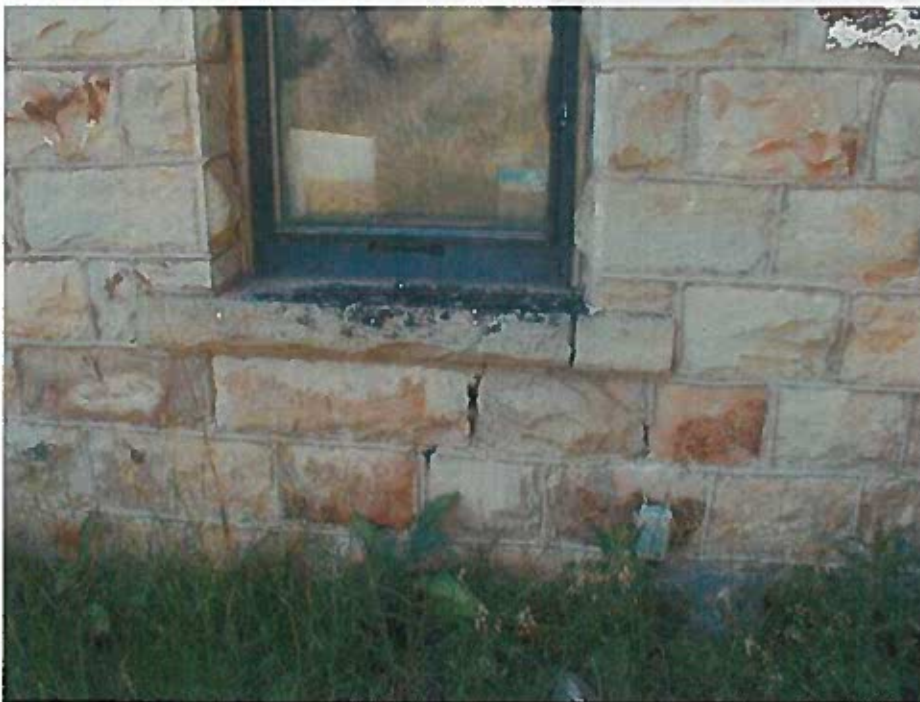
Failed mortar joints below north kitchen window; note crack in window sill. Photo Credit: Ken Sievert.

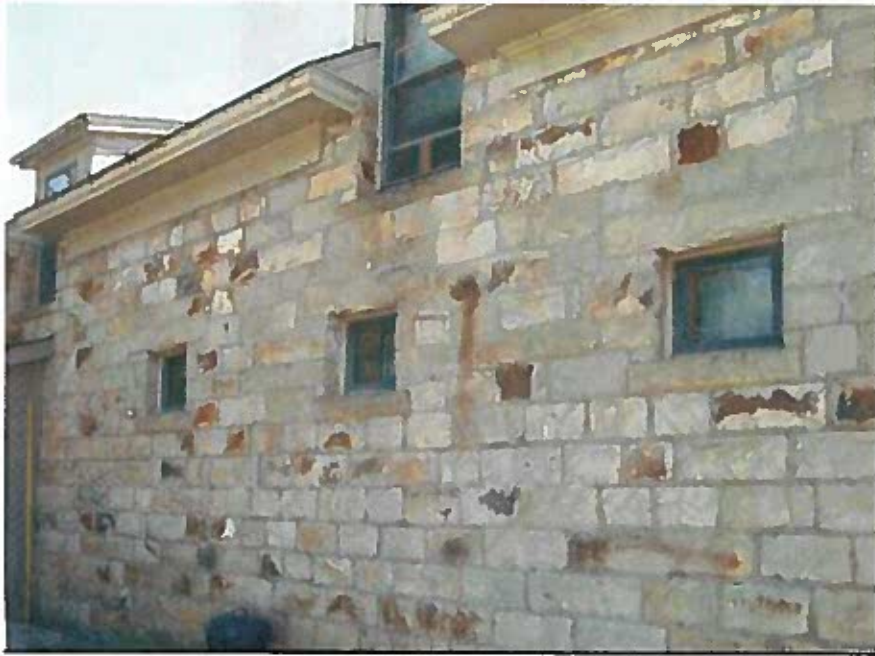
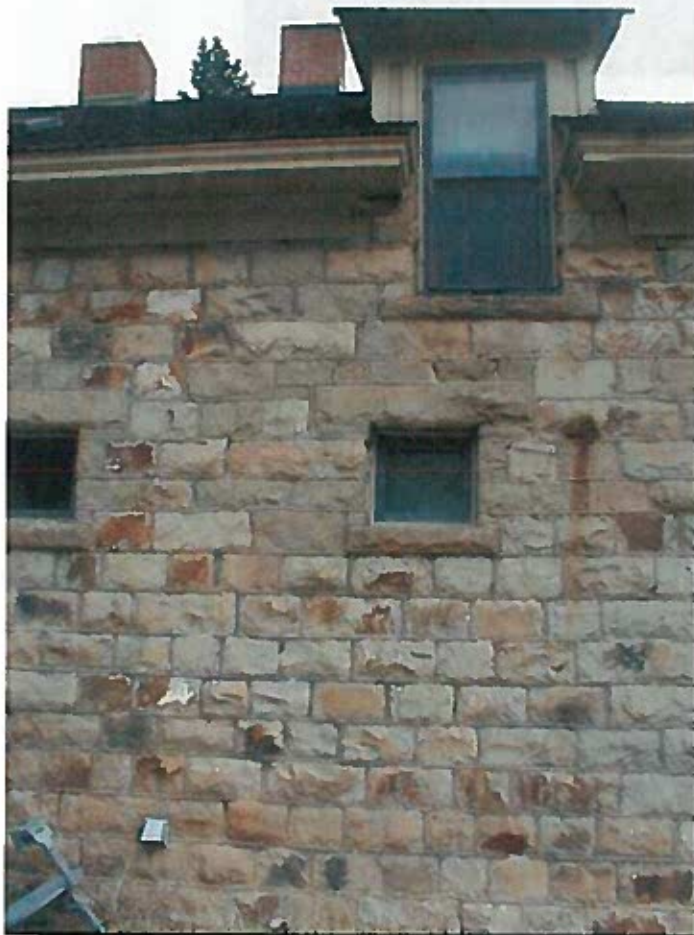
General views of the west stone bearing wall adjacent to the small square cell windows. Note the failed mortar and cracks above the right window. Stonework close to this window and around the perimeter of the left window is of a slightly different hue than the remainder of the wall suggesting that it came from a different location in the quarry or that it has been replaced.

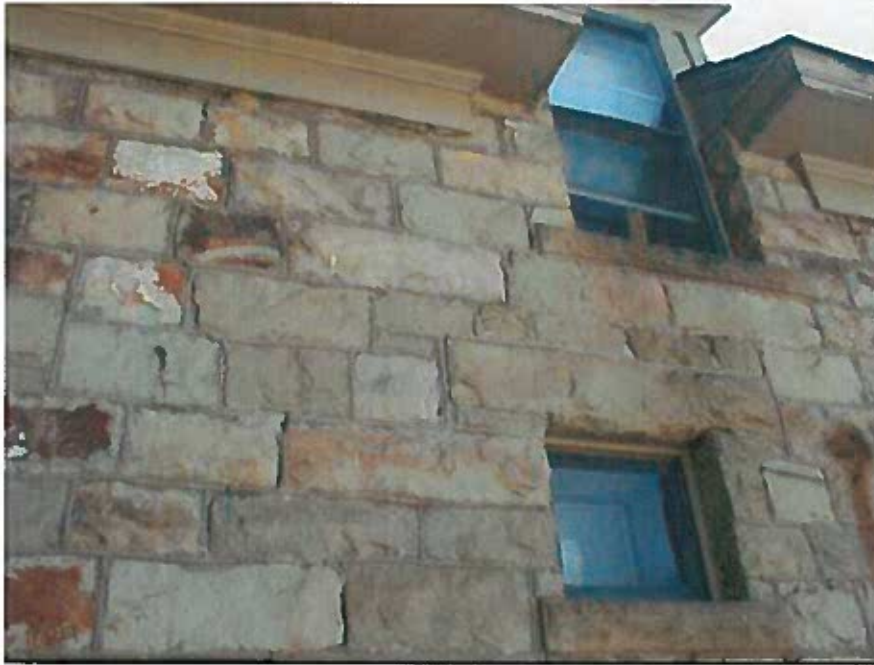
Closer view of cracks described on previous page. Photo Credit: Ken Sievert

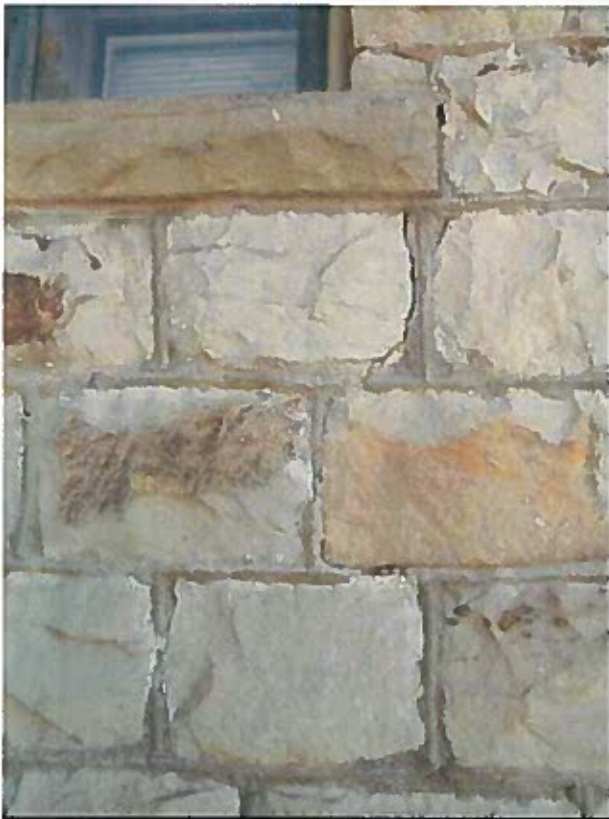
Slight crack below sill of west window; following the coursing of the stonework. Selected areas of the masonry joints have been repointed as can be seen near the bottom of the photo. Photo Credit: Herb Dawson, NPS.

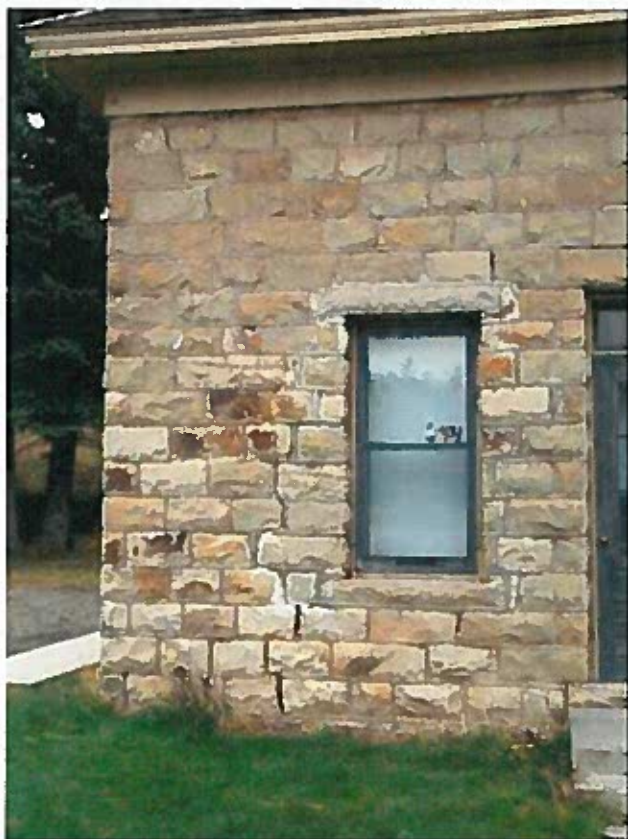
West end of south stone wall; this area of the structure exhibits the greatest amount of failed stone masonry in the building with significant cracks, spalls, and minor movement. Evidence of past repairs can be seen in some of the mortar joints in the detailed photos below, but deterioration has continued since the repairs. Photo Credits: Ken Sievert & Herb Dawson, NPS.

2. Perform Fundamental repair of exterior stone masonry. Selected areas of the exterior stone exhibit significant degrees of deterioration that must be addressed.
3. Restore the front porch supporting system in-total.
4. Introduce additional heating (and cooling) capabilities within the house.
5. Exterior rehabilitation of windows and doors.

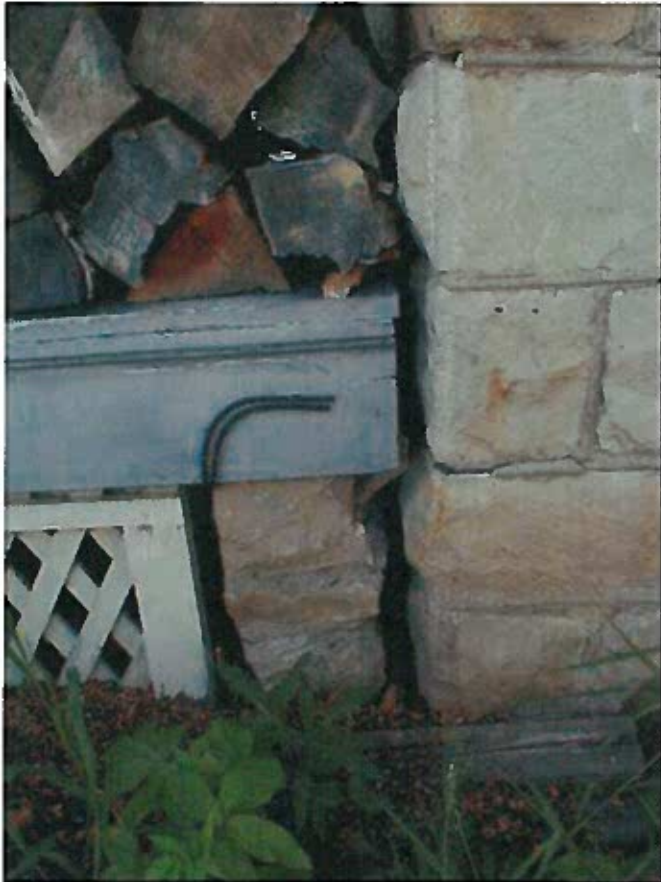
Stone porch piers along the north side of the entrance porch deck. Both piers are leaning and require stabilization. The latticework wood barrier adds architectural delicacy to the use of the structure as a place of residence, but is in need of repair. Photo Credits: Ken Sievert

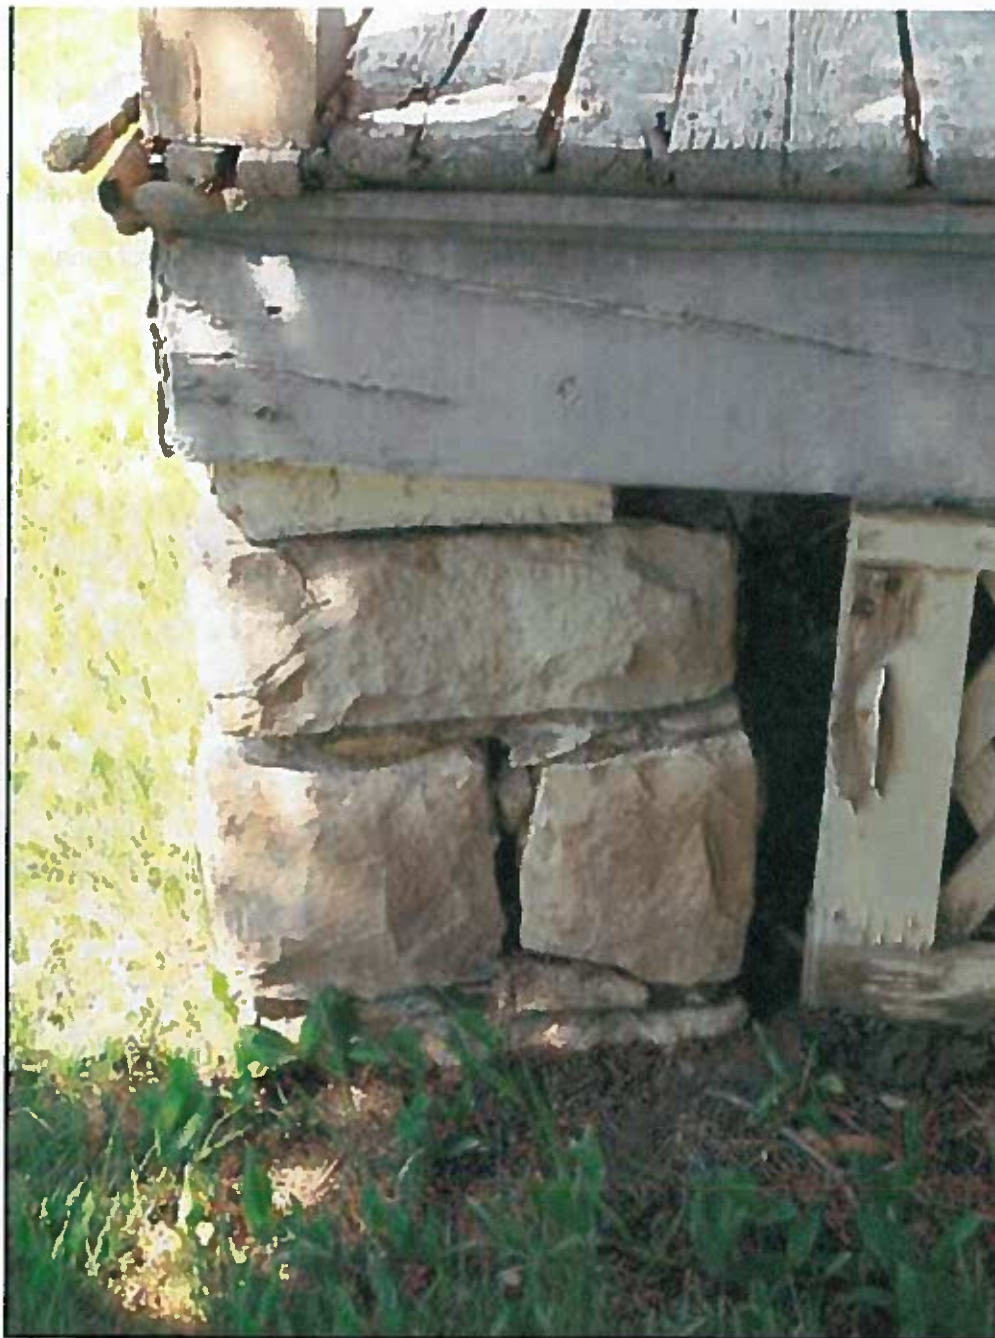
Stone porch pier at the SW corner of the entrance porch deck. The pier is rotated, fractured, and requires stabilization. Photo Credits: Herb Dawson, NPS.

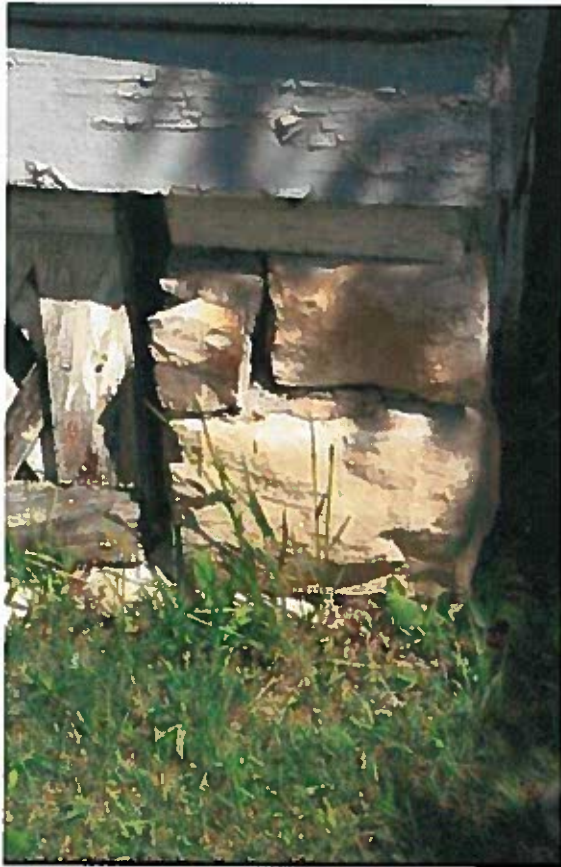
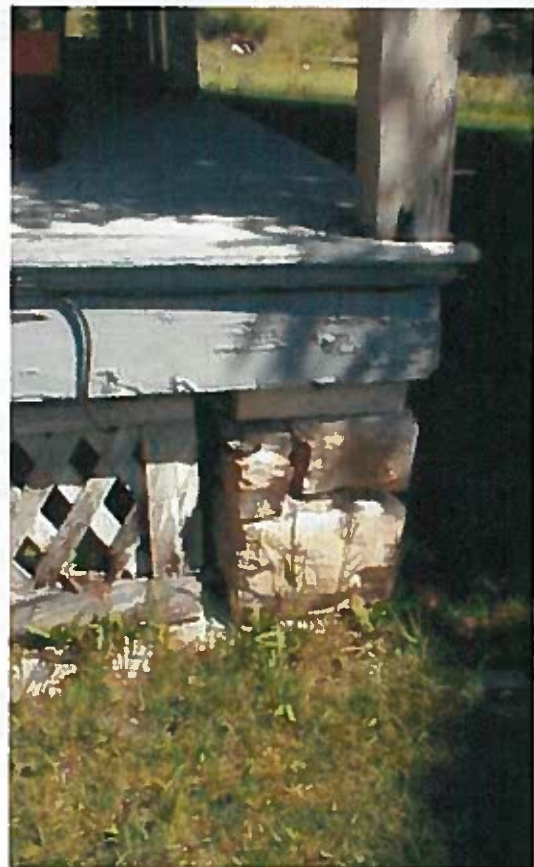
Other angles of stone porch pier at SW corner entrance porch deck. Photo credit: Herb Dawson, NPS.
