**Historic Structures Report**  
**Fort Yellowstone Power House**

**Historic Structures Report  
Fort Yellowstone Power House  
Final Document**

prepared by:  
**James R. McDonald Architects  
and  
Historical Research Associates, Inc.**

prepared for:  
**National Park Service  
Rocky Mountain System Support Office  
and  
Yellowstone National Park**

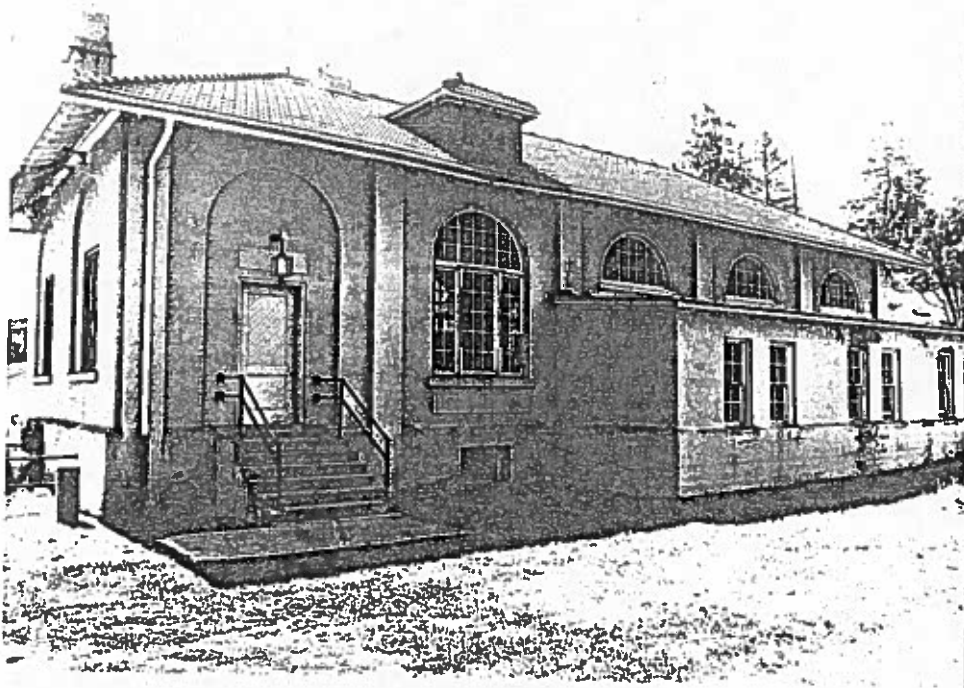
Figure 21. Looking south at the main entrance. The concrete steps have some deterioration and there is some surface spalling along the concrete base due to poor drainage.

4. The exterior concrete stairway is starting to deteriorate and will need to be repaired.
5. Provide ongoing general preservation maintenance.
6. Develop and implement an Integrated Pest Management Plan for the building to deal with the swallows' nests and other problems.

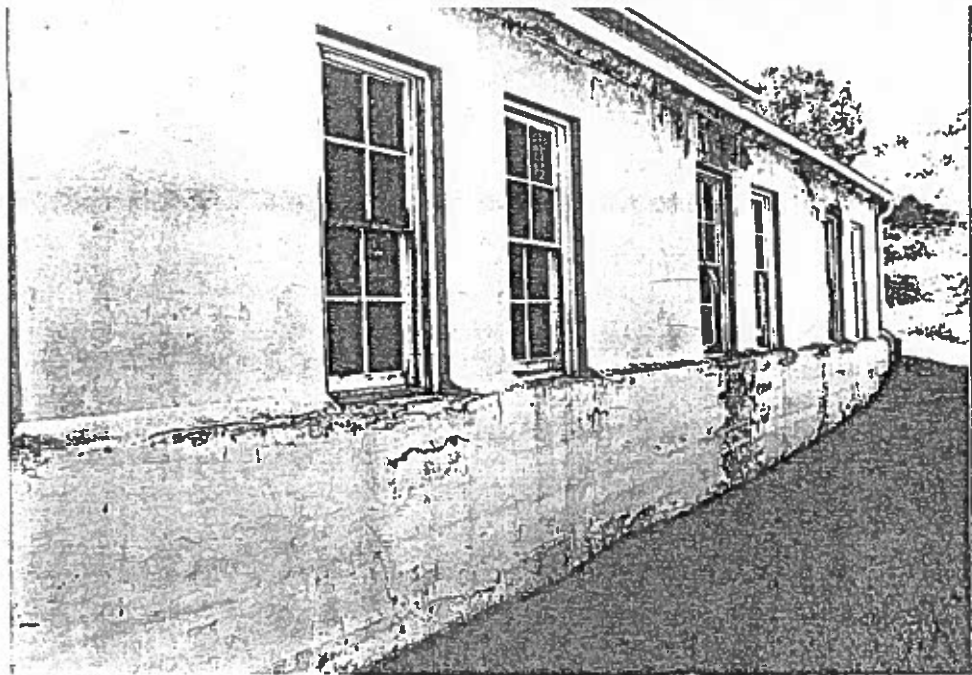
Figure 24.

Looking south at a window in the middle of the shed roof wing. This window is in very poor condition due to water coming off the roof above. The window is weathered and rotted in some areas and the concrete around the window is spalling due to the moisture.

2. Replace the roof on the wing with a single-ply roof membrane, and provide gutters to keep the water away from the surface of the concrete. Repair or replace gutters and flashing in-kind to existing, to prevent water damage to eaves and soffits.

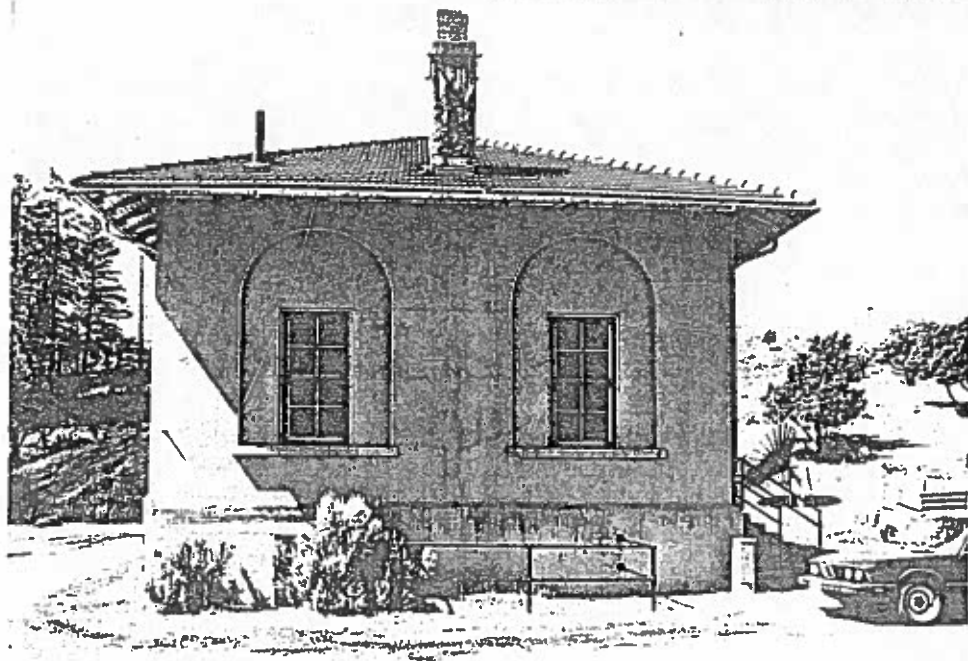
Figure 25.

Looking west at the power house. This elevation appears to be in good condition. Note some deterioration of the chimney that is cracked and spalling.

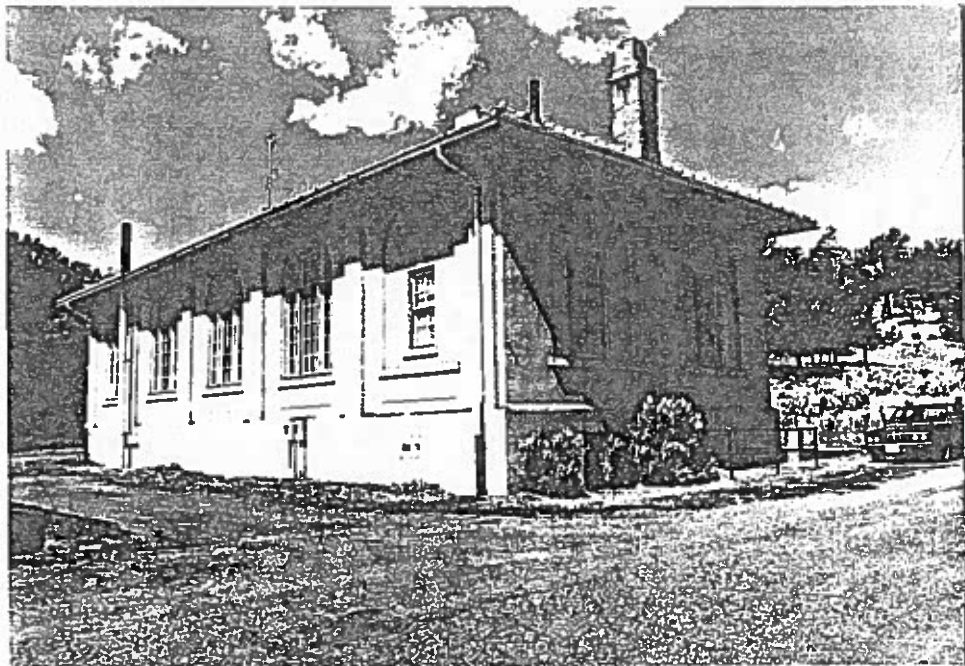
Figure 26. Looking northwest at the power house. Note the shrubbery up against the building. Most of the walls are in good condition.

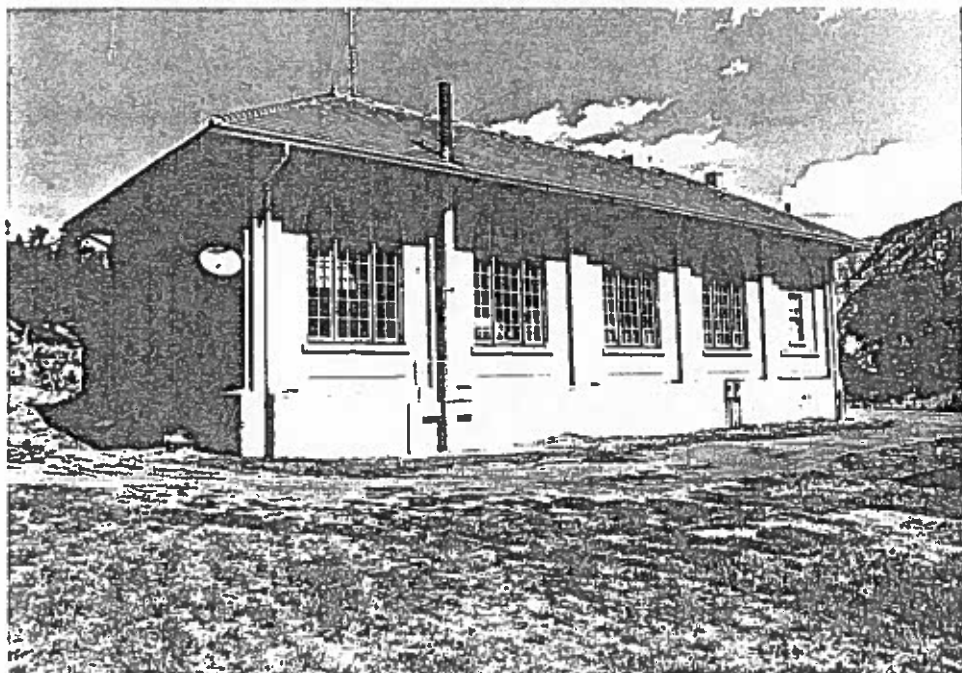
Figure 27. Looking northeast at the power house. Note the low area along the building where some of the site water drains into the foundation. There is minor concrete base deterioration at this point.

1. Regrade the area around all sides of the building (especially on the north side) to provide positive drainage around the building thus eliminating the deterioration of the concrete base.
2. Define organized parking areas around the building; design a parking plan for the north side of the building that maintains the view of the historic building as much as possible.
3. Inspect the water entrance to the penstocks to make sure that the water source is closed off from the building.
4. Monitor and maintain the wet areas and streambed to make sure that the water continues to flow away from the building.
5. Maintain the wood structure that extends from the tail race over the discharge area to make sure that it is stable and does not become a potential hazard.

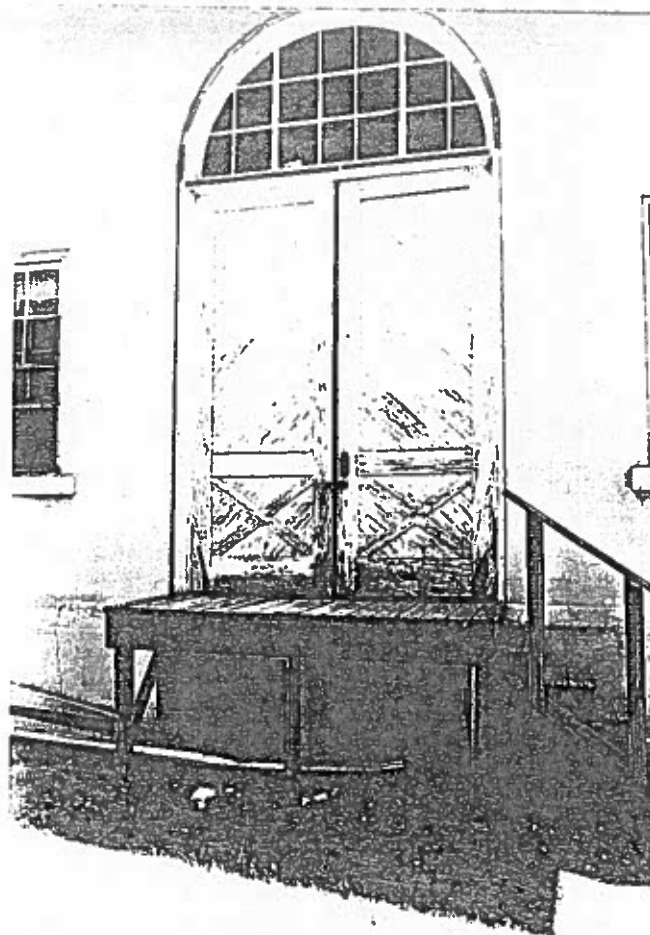
Figure 28.

Looking east at the loading dock and doors on the west side of the power house. The doors are slightly weathered.

3. All windows and doors need some degree of preservation maintenance including reglazing and painting of the frames, doors and sashes. All of the trim around the windows and doors needs to be sanded and repainted. All exterior doors need to be reworked with repair of weathered or worn wood, adjustment of hardware, and the refinishing of the wood.

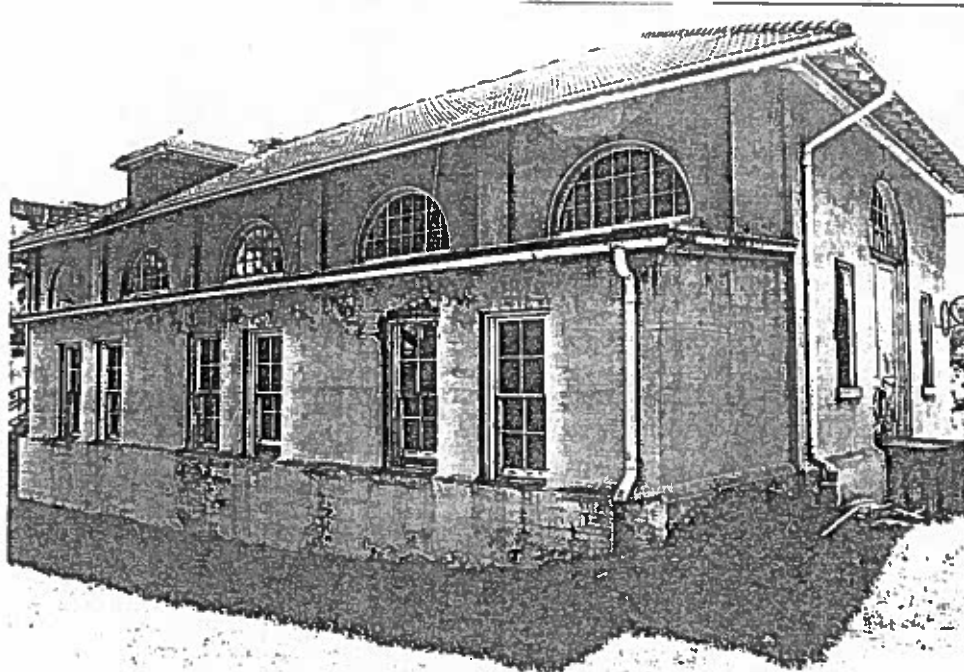
Figure 29.

Looking southeast at the power house and shed roof wing. This side appears to have the most deterioration including poor grade for drainage around the building, concrete spalling, weathered and rotted windows, broken glass, gutter leaks and downspout leaks and a poor roof on the wing.
