# Haynes Picture Shops Headquarters at Mammoth

## Historic Structure Report

Prepared by Sievert & Sievert Cultural Resource Consultants  
Great Falls and Bozeman, Montana  
August 20, 2008

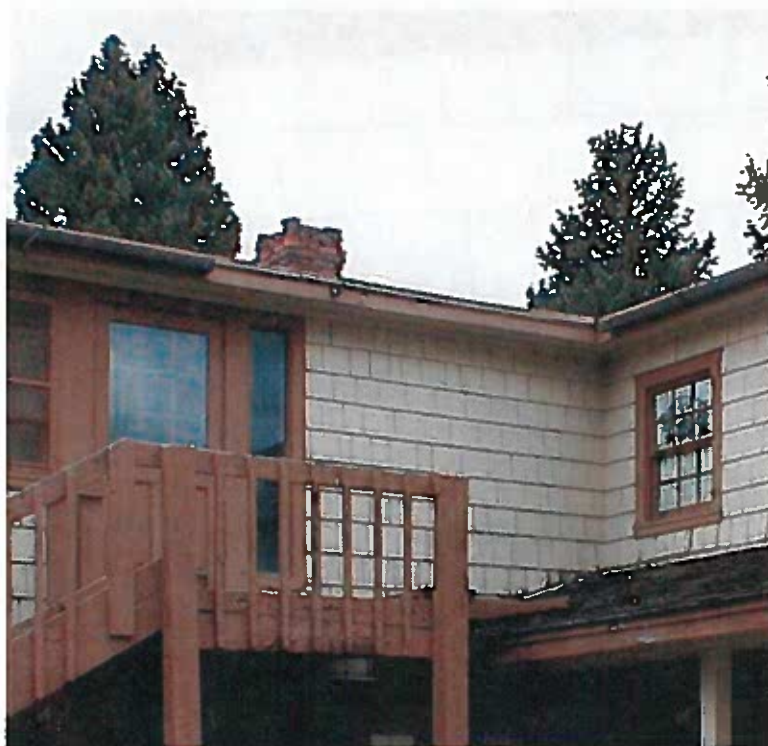
Re-entrant southeast corner; the exterior stair serves as a fire exit from the 2nd floor. Note the poor condition of the top of the brick chimney.

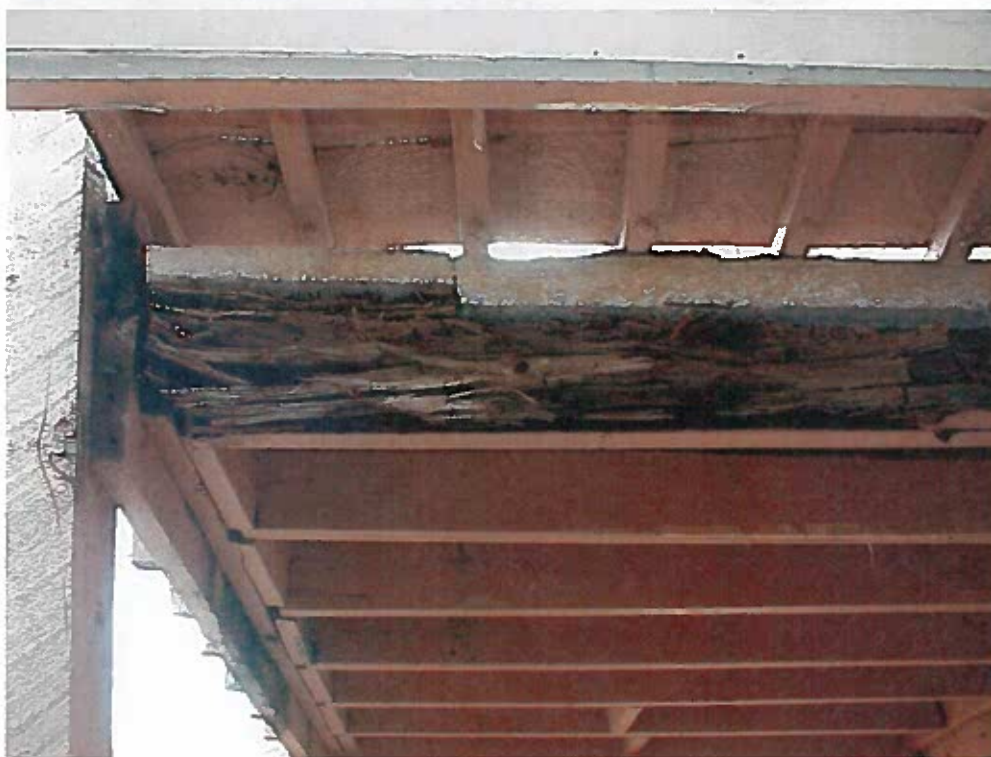
Close-up of the end (north) structural member beneath the exterior stair shown above. This member is beyond repair.

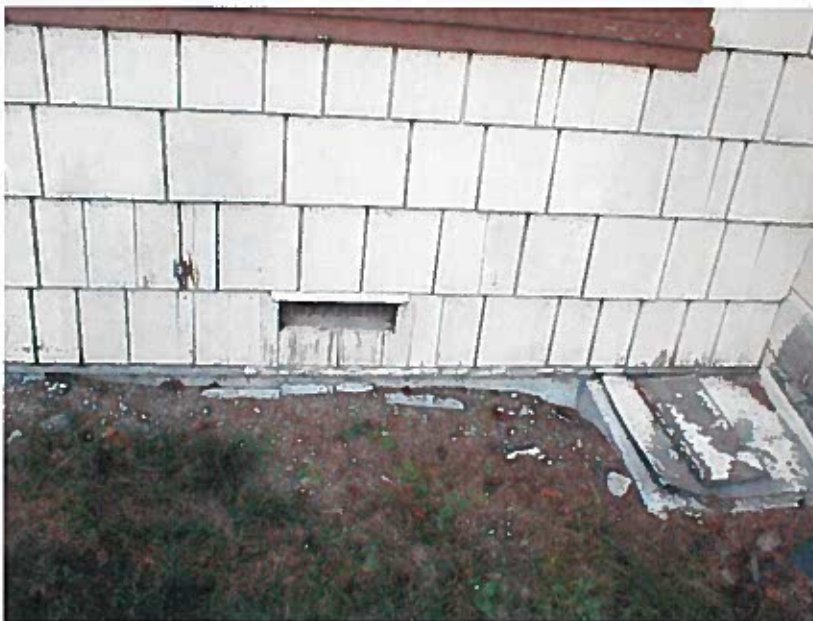
Condition of the wall shingles at the base of the exterior wall. This particular location has suffered from the long-term effects of snow drifts or piled snow.

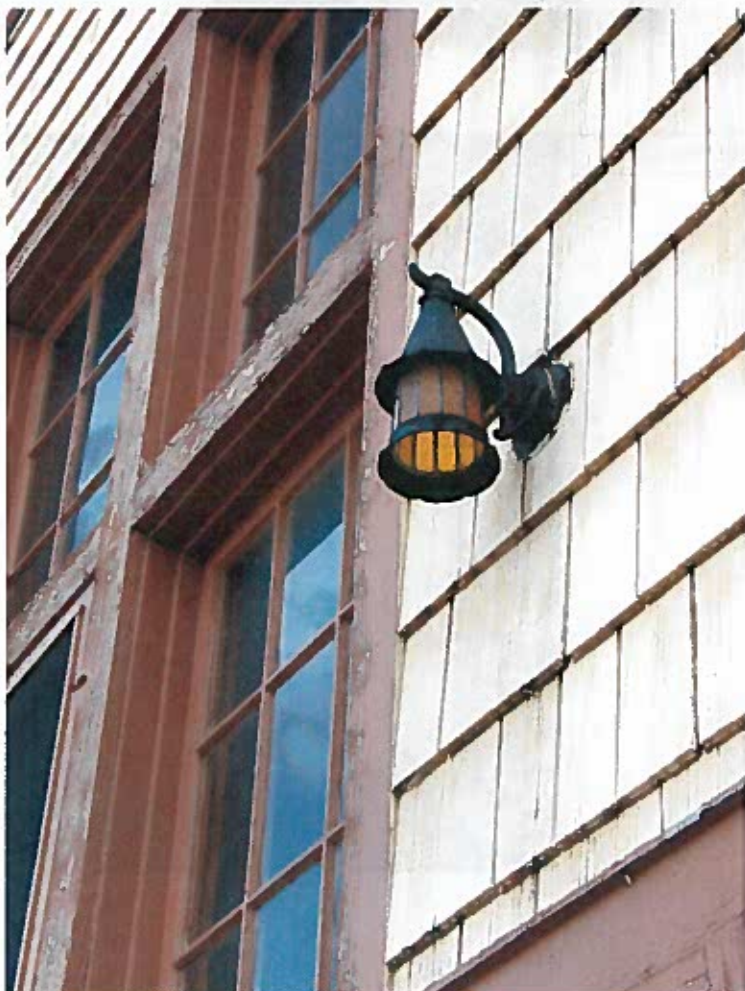
Exterior light fixture at the retail wing. It is not known if this is an original fixture; however, it is recommended that it be retained.

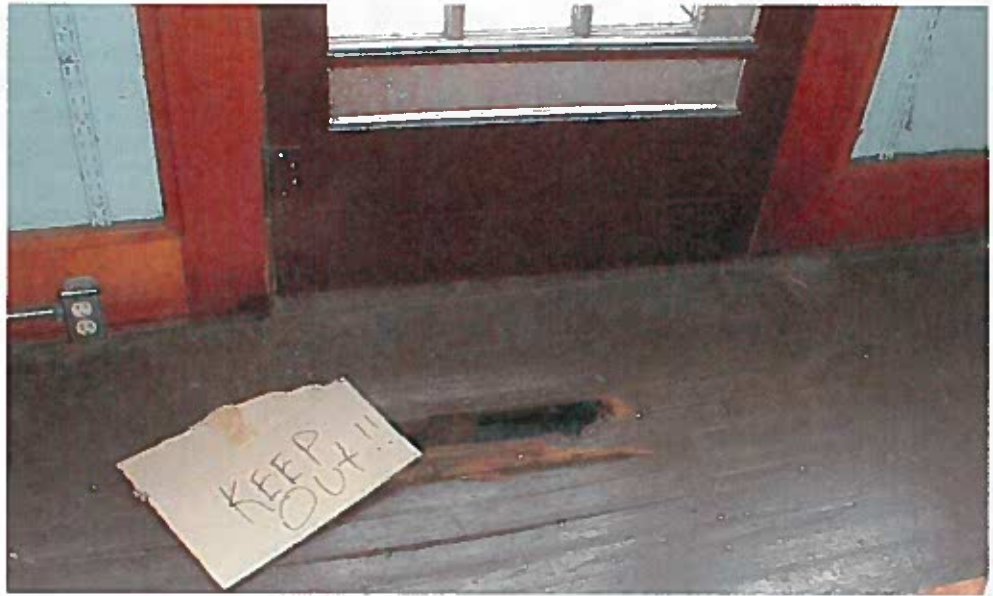
During preparation of this report, an area of deteriorated flooring was noted (and posted) immediately inside the north entrance into the retail sales area. On November 6, 2007, the floor was opened up for inspection by the consultant and NPS personnel. The photographs on the following pages document conditions found in this area of the first floor structure.

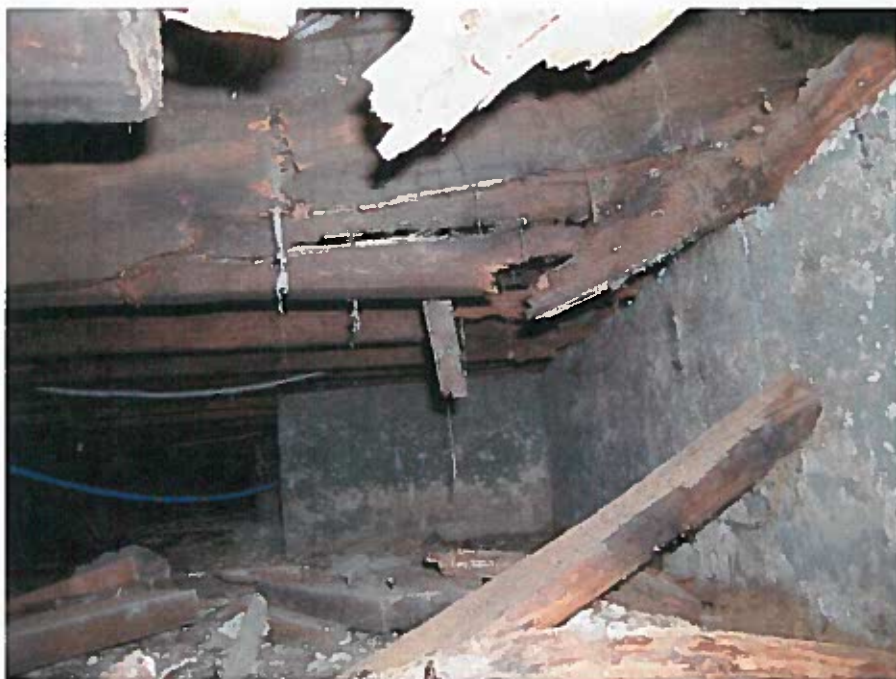
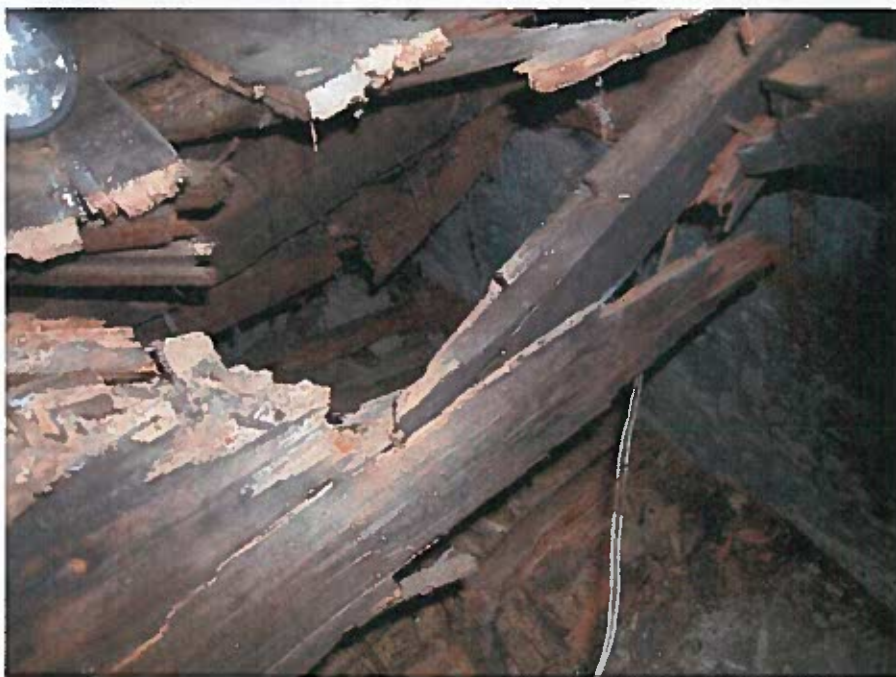
A number of rotted joists and supports were found in this immediate vicinity; deterioration was extensive at the affected members and was confined to this immediate locality. Due to the unusual and localized conditions, the NPS geologist was consulted. His office ruled out any ground-related phenomena (including geothermal) that may have contributed to this deterioration. These photos illustrate the completeness of the deterioration within the localized area.

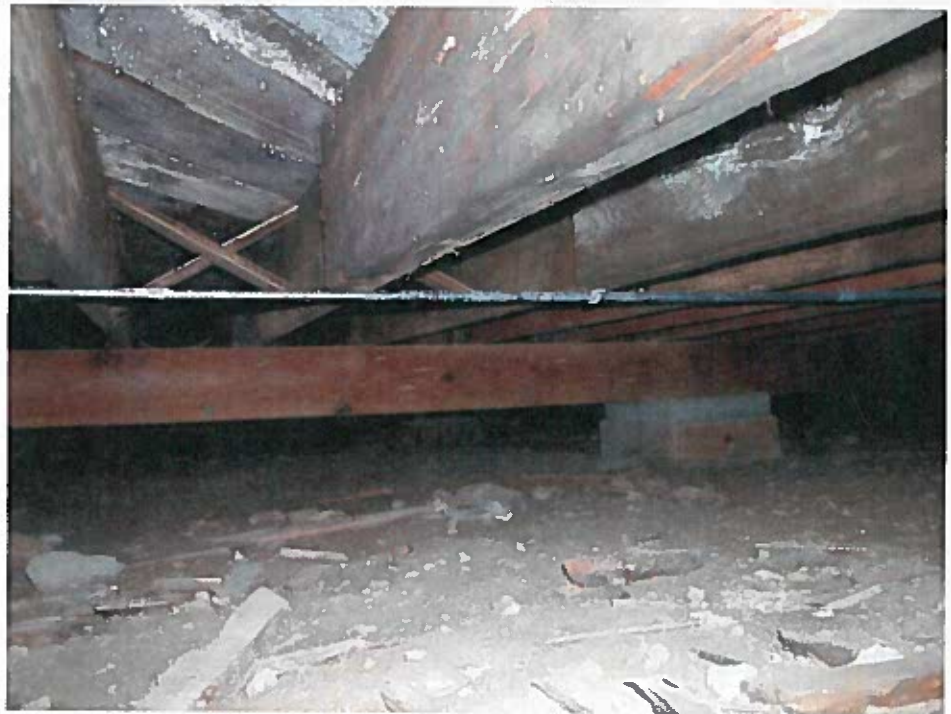
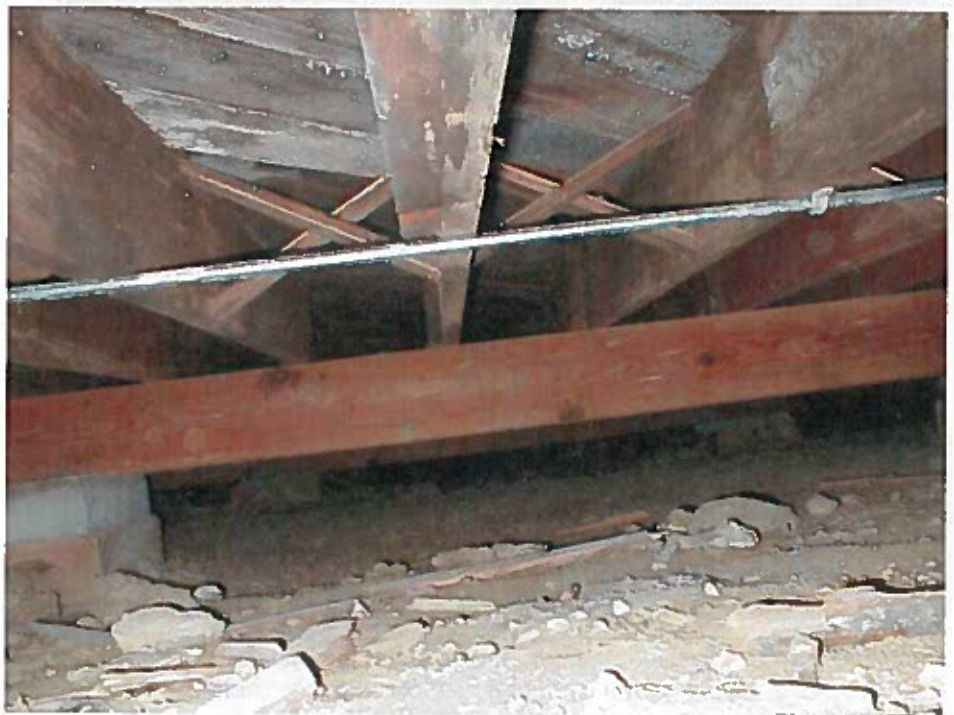
As can be seen in the upper photo, the deterioration extends several feet toward the interior of the building from the exterior wall. However, it does not extend to the first interior girder (shown more clearly in the lower photo). That girder and supports in the proximity of the girder exhibit good visual characteristics and appear to be unaffected.

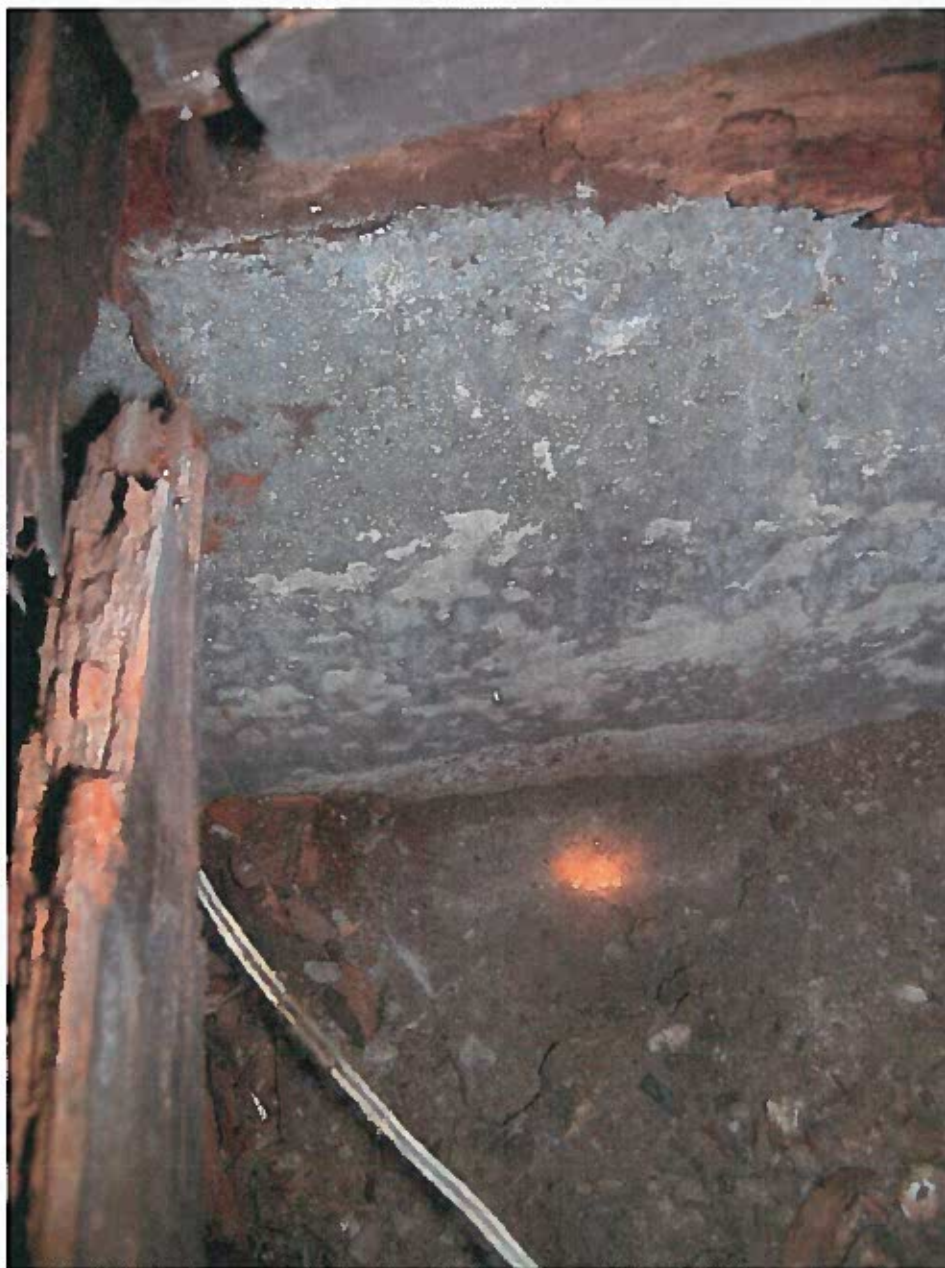
This photo illustrates the condition of the foundation wall adjacent to the point of entry for the floor investigation noted on the previous two pages. Although the wall exhibits some scaling, the concrete is sound. The top of the footing supporting the foundation, floor structure, and walls above is visible in this photograph where the dirt has been brushed aside and the beam from the flashlight is concentrated. The footing offset was measured and recorded on the drawings attached to this report.

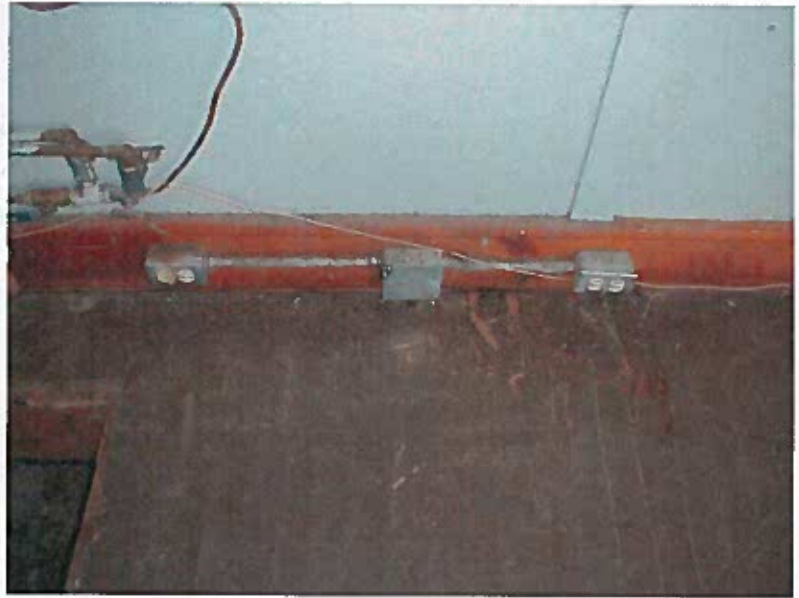
Deteriorated flooring was also noted in the southwest corner of the retail area adjacent to the convenience outlets shown in this photo). An access panel located adjacent to the deterioration (left side of the photo) was used to investigate the damage.

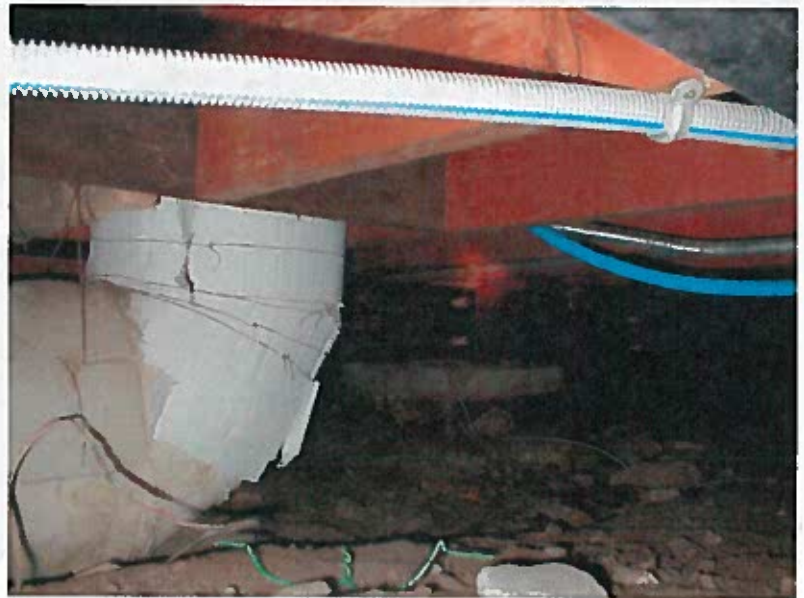
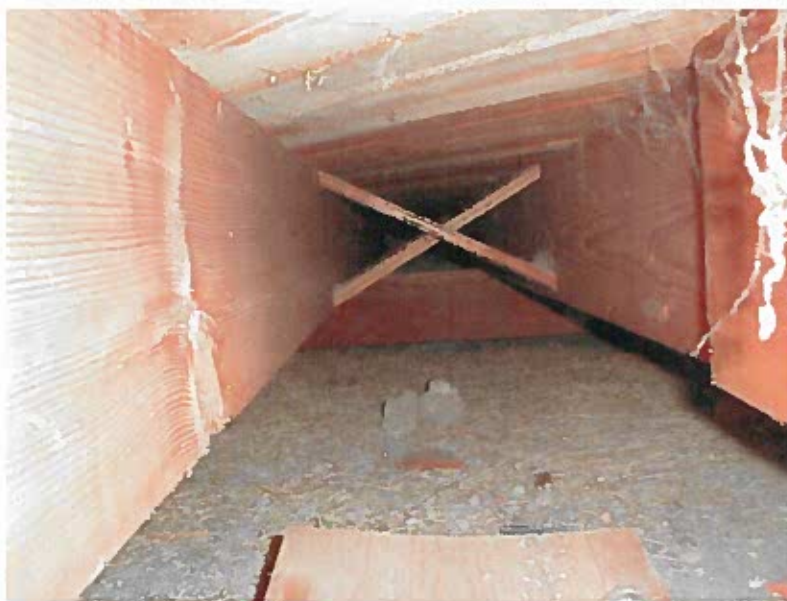
As exhibited in this photo, wood members next to the deteriorated surface flooring at this location are in good condition. This deteriorated flooring is attributed to the installation of water coolers and soda dispensing cabinets which are known to have existed adjacent to the outlets.

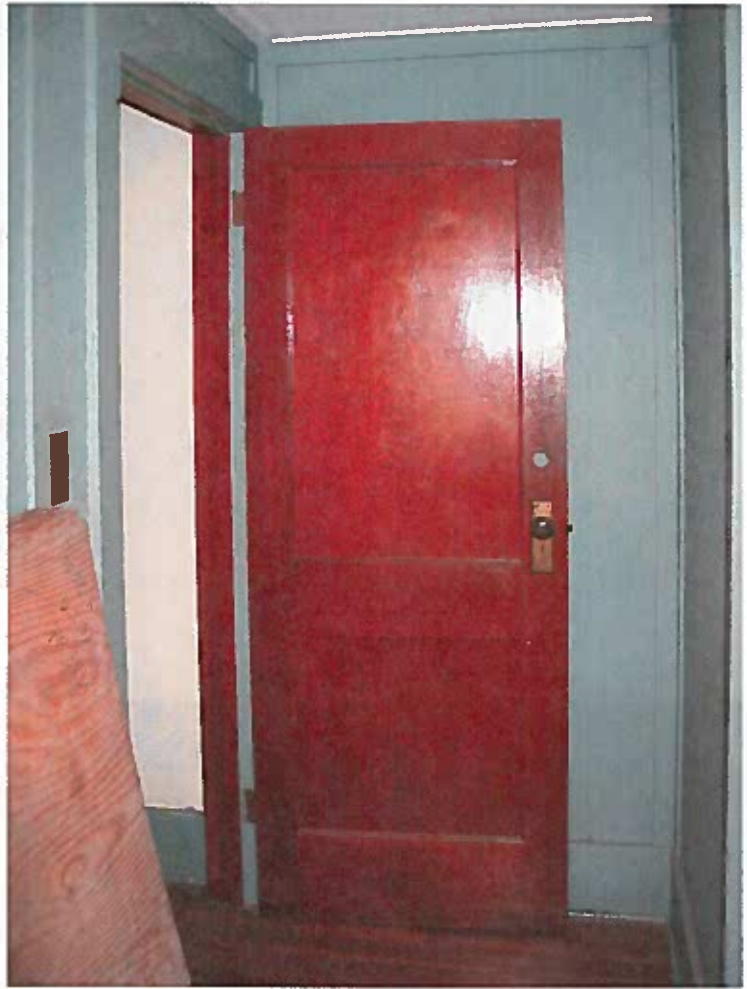
A noticeable heave was observed in the floor between first floor dormitory room 126 and the adjacent closet. The cause is unknown and there were no accesses in the immediate area from which to conduct an investigation. It is known that the common wall between the room and the closet is located above the foundation wall for the partial basement below.

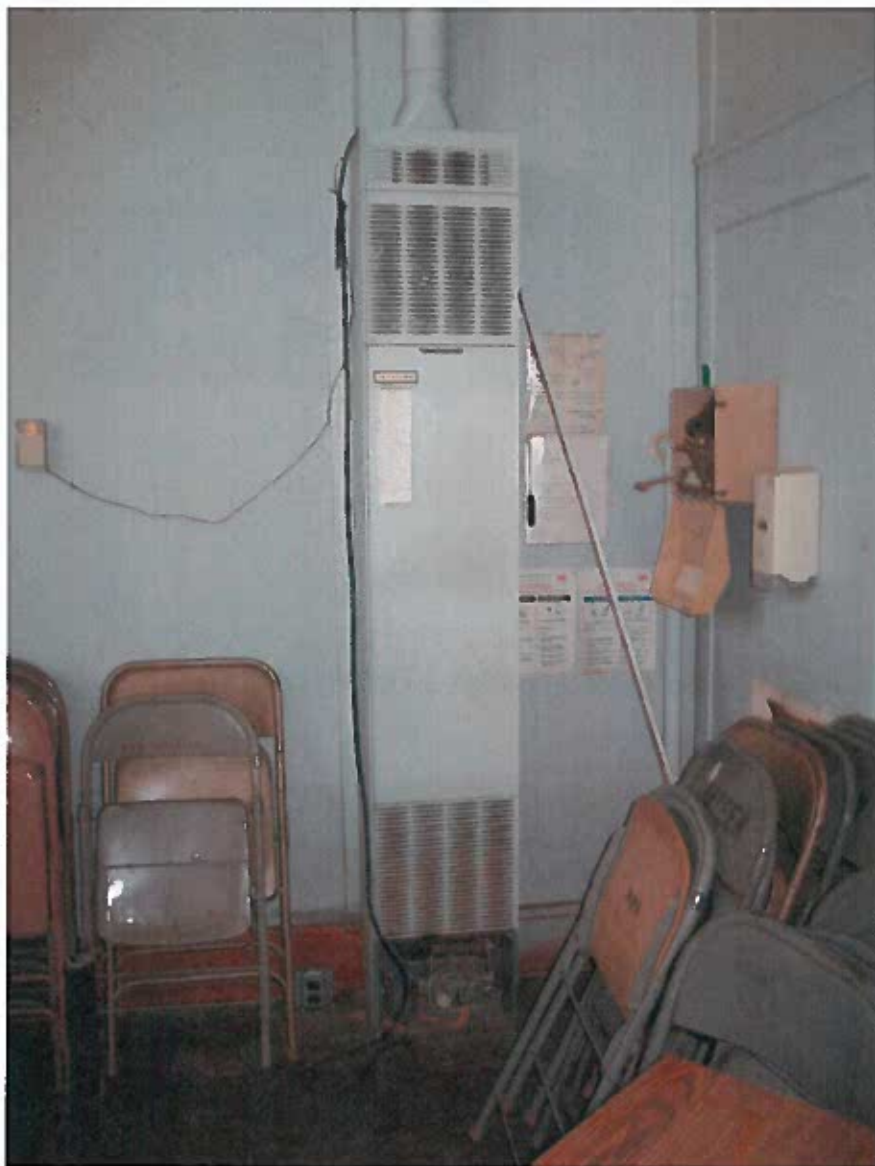
This cabinet heater is located at the southwest corner of the retail sales area; its condition is unknown but it is unlikely that it would be suitable for use again.

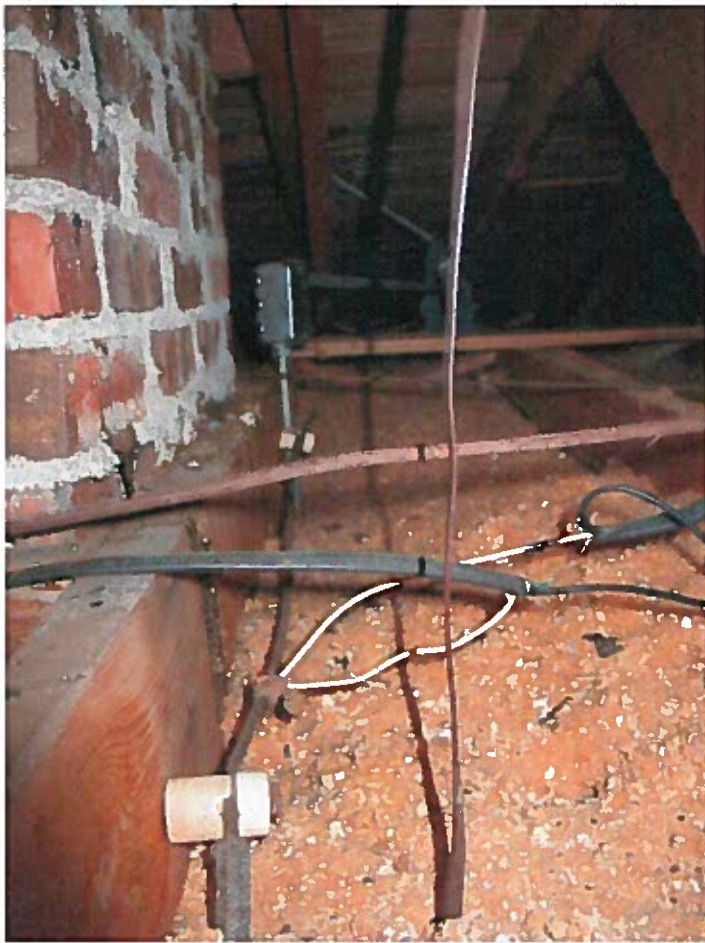
Numerous eras of electrical wiring—knob-and-tube, braided wire, romex, and metallic conduit—are evident next to the brick chimney in the attic.

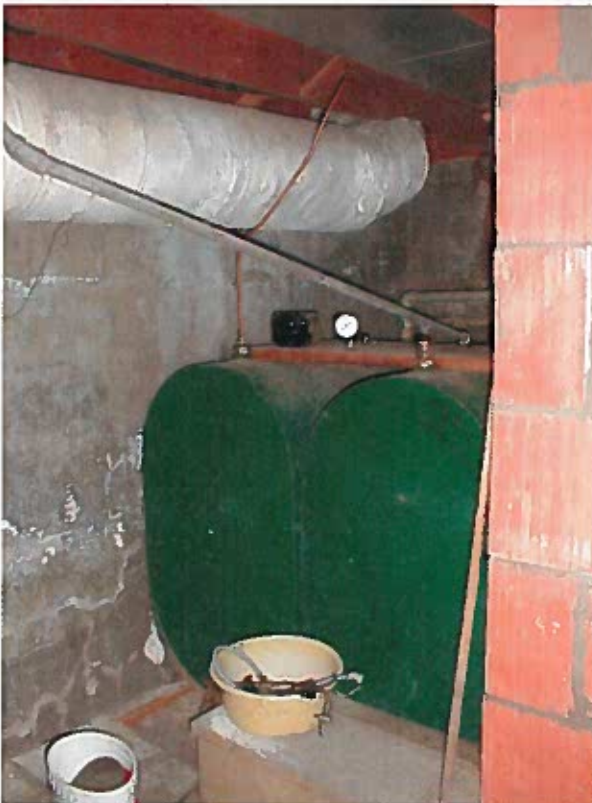
The presence of these heating oil tanks indicates that the building was once heated with an oil fired appliance. It is recommended that the tanks be removed.

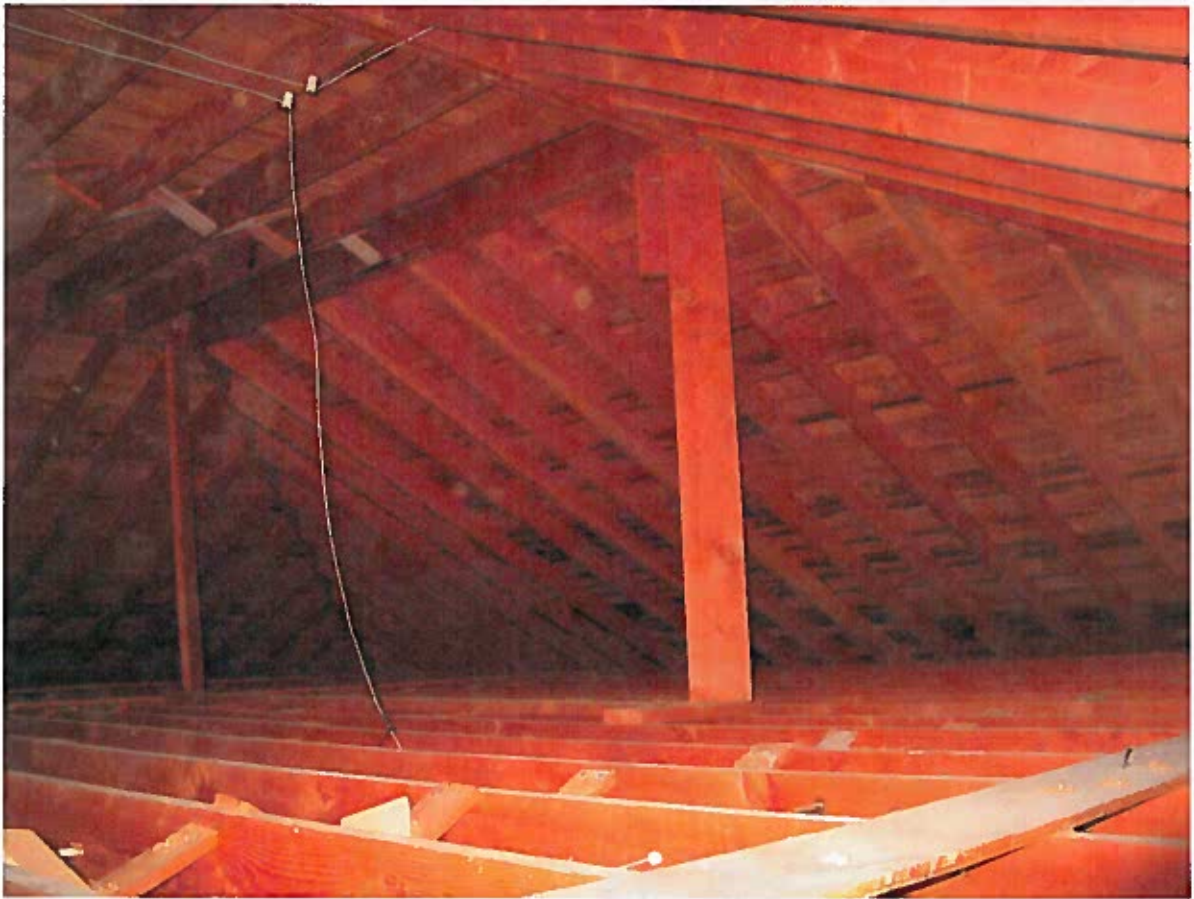
Ceiling and roof framing above the retail sales area. Note the extremely good condition of the wood framing materials. Vertical members supporting the center flat roof area need to be stiffened and steel (seismic resistant) connectors need to be incorporated in their attachment to beams and joists.

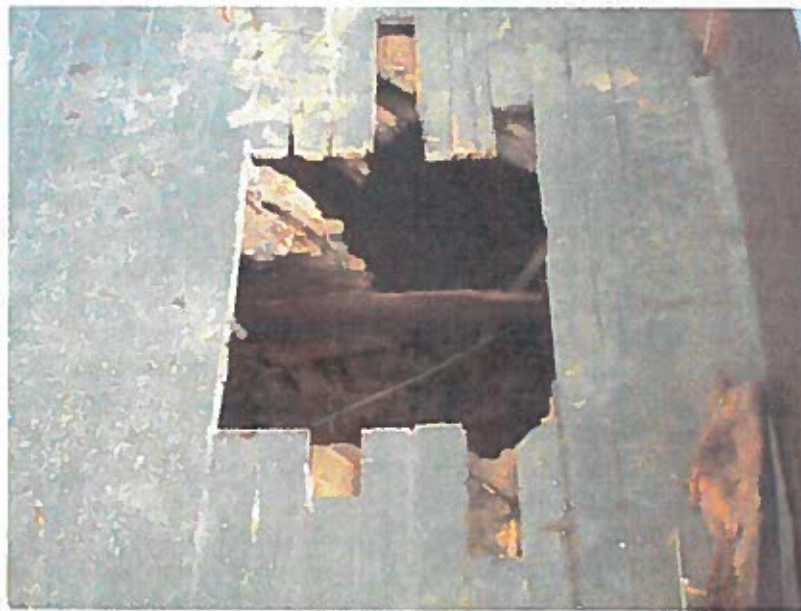
Figure 1. A hole had been cut in the floor near the main northeast door of the Nature Store. Notice the door base on the right (north) of the photo. View to the west taken January 16, 2008, 10:31 am MDT.
