Building 36  
Mammoth Hot Springs, Wyoming

Historic  
Structures  
Report

AUGUST 2003

**ADMINISTRATION BUILDING**

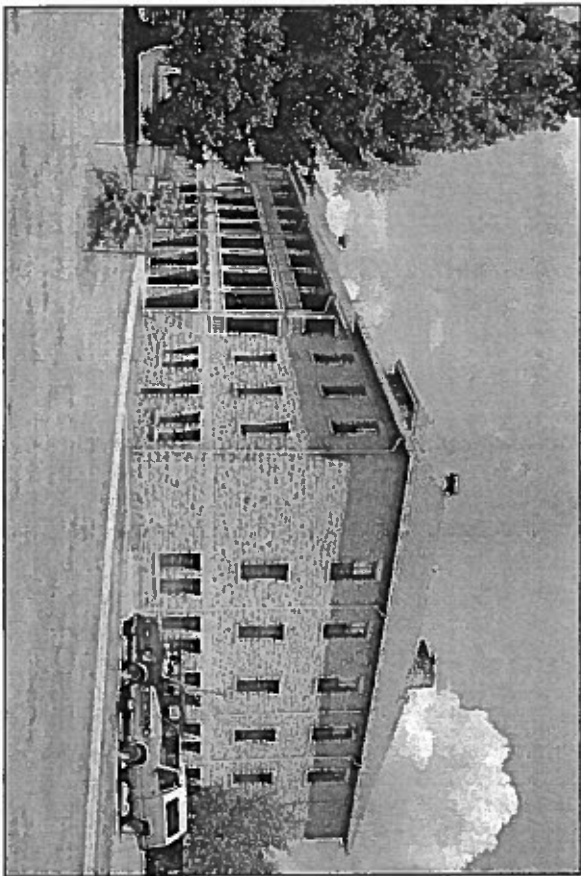
Figure 15: Looking northeast at the main facade of the Administration Building. The exterior of the building has remained intact since it was built in 1909. The exterior stonework is generally in good condition as are the balconies, windows, doors and the roof.

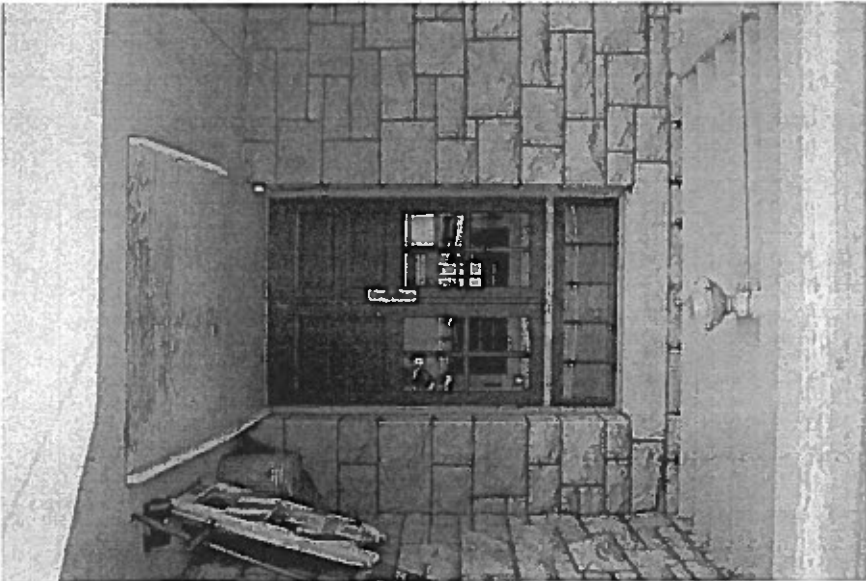
Figure 16: Looking east at the entrance to the southern half of the building. The doors and transom appear to be original to the building.

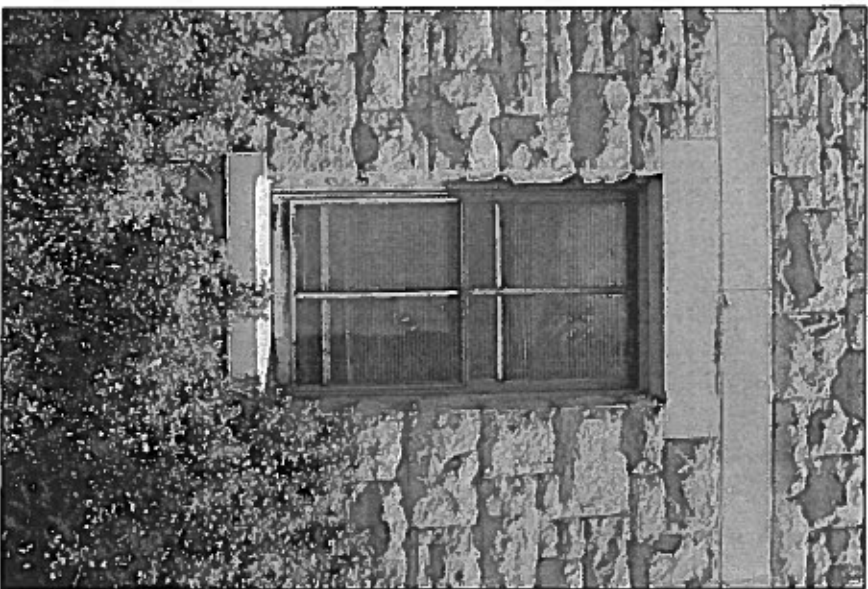
Figure 19: Looking east at a typical single wood double-hung window. The windows are original to the building.

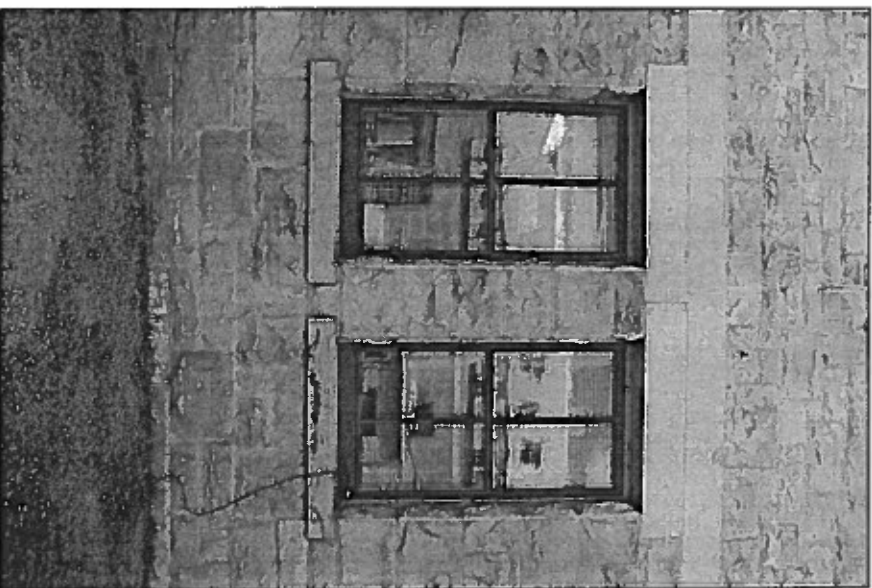
Figure 20: Looking south at a typical set of wood double-hung windows. The windows are original to the building.

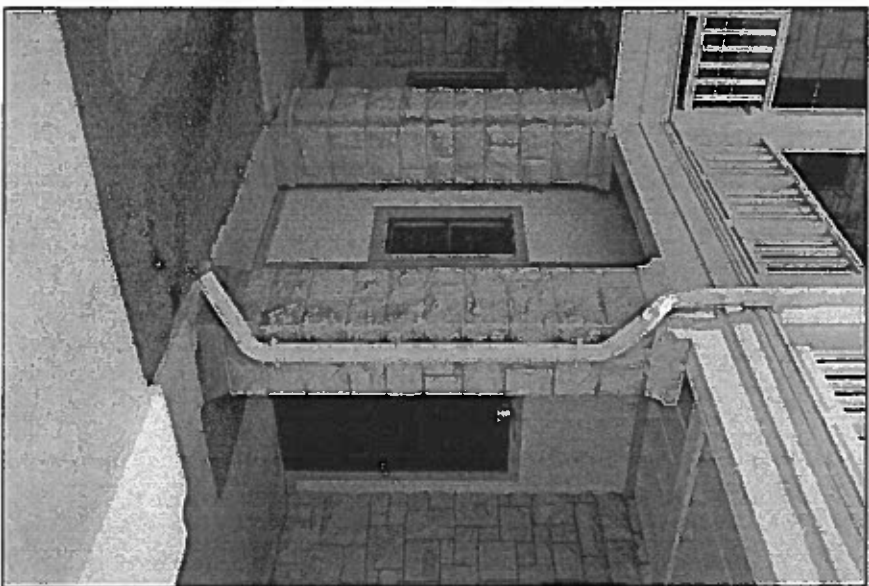
Figure 24: Looking southwest at the rear entrance to the south half of the building. These doors are original to the building.

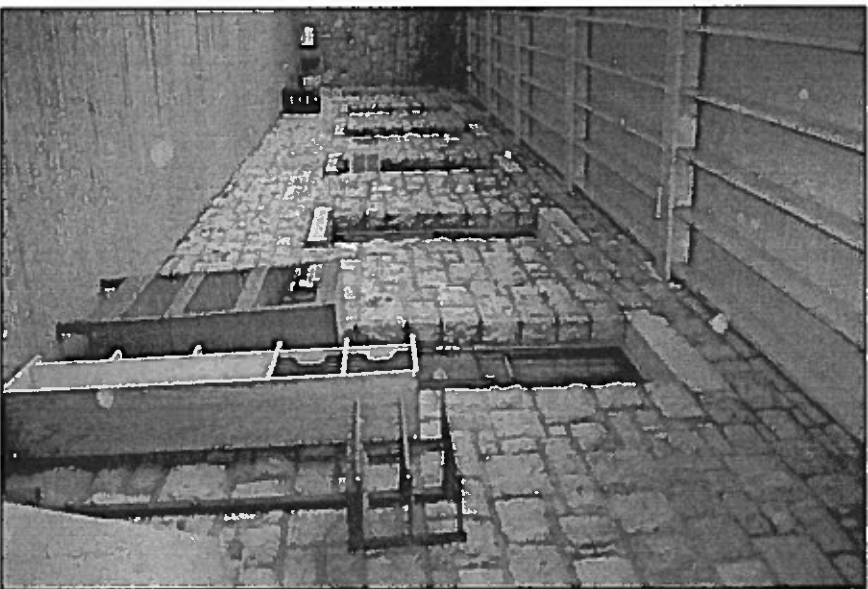
Figure 27: Looking southwest at the second floor balcony and structure. Additional connections were placed at the balcony and stone wall after the 1959 earthquake.

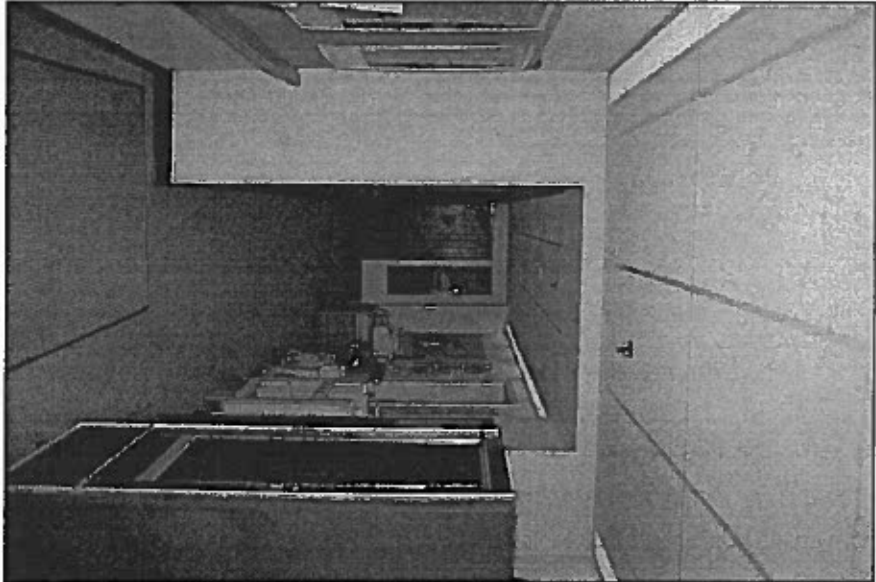
Figure 36: Looking north at the connecting hallway between the south and north halves of the building. Originally there was never a connection between the two wings on the interior. All of the materials are new to the building.

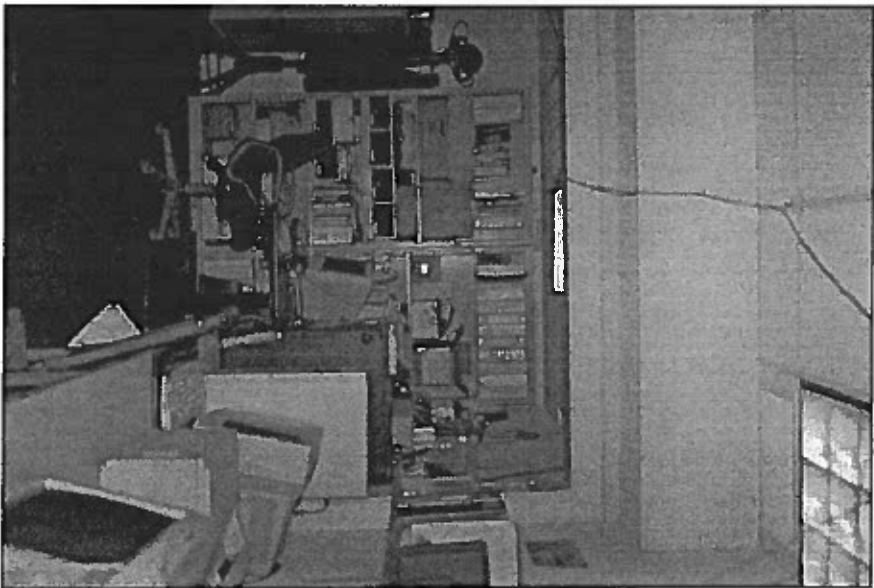
Figure 38: Looking south at room 118. A series of original small rooms have been opened up into a larger room with very little historic fabric left in the room.

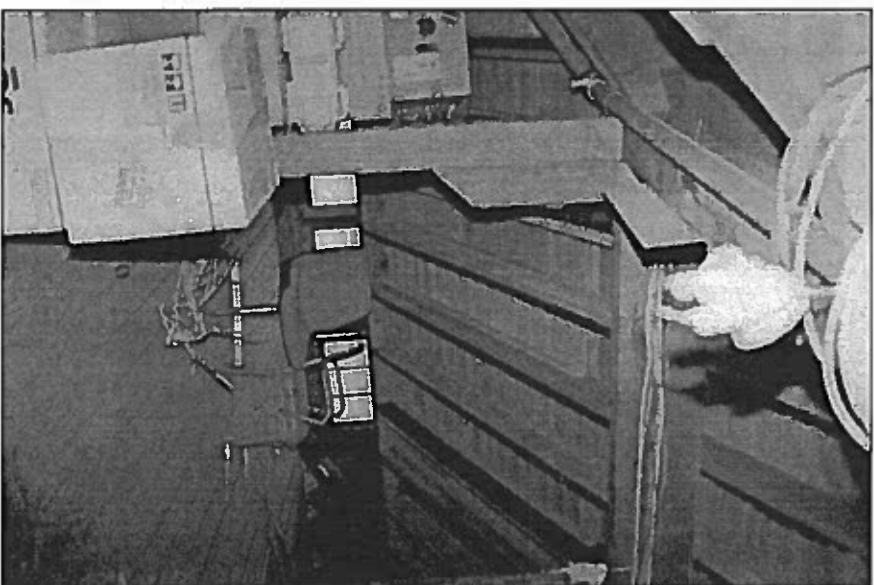
Figure 109: Looking west at the dormer windows in room 406. Note the structural replacement members added after a fire in 1911.

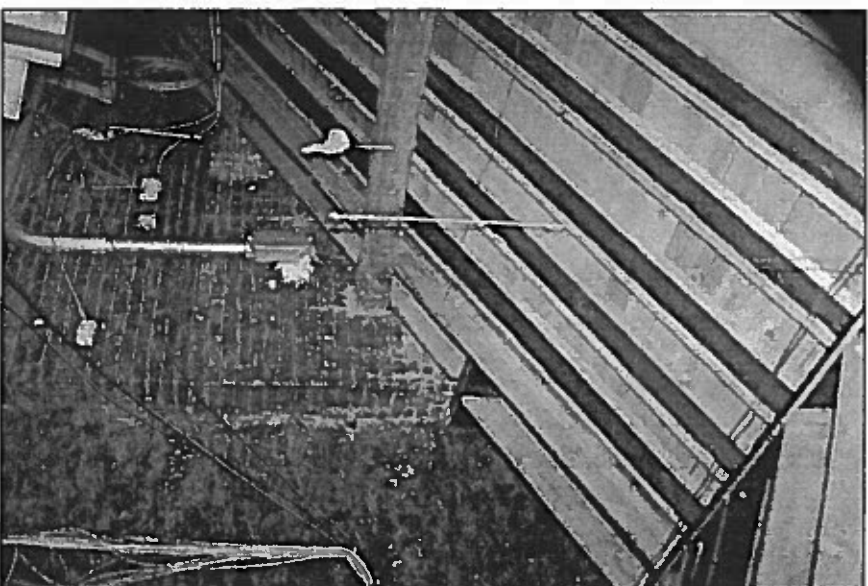
Figure 110: Looking south at room 406 and evidence of the fire in 1911. The brick and stone walls are scorched and there are remaining burnt rafters. New rafters were placed beside them.
