HISTORIC STRUCTURES REPORT

**LOWER & UPPER SERVICE STATIONS  
AT OLD FAITHFUL**

**YELLOWSTONE NATIONAL PARK, WYOMING**

**August 1998**

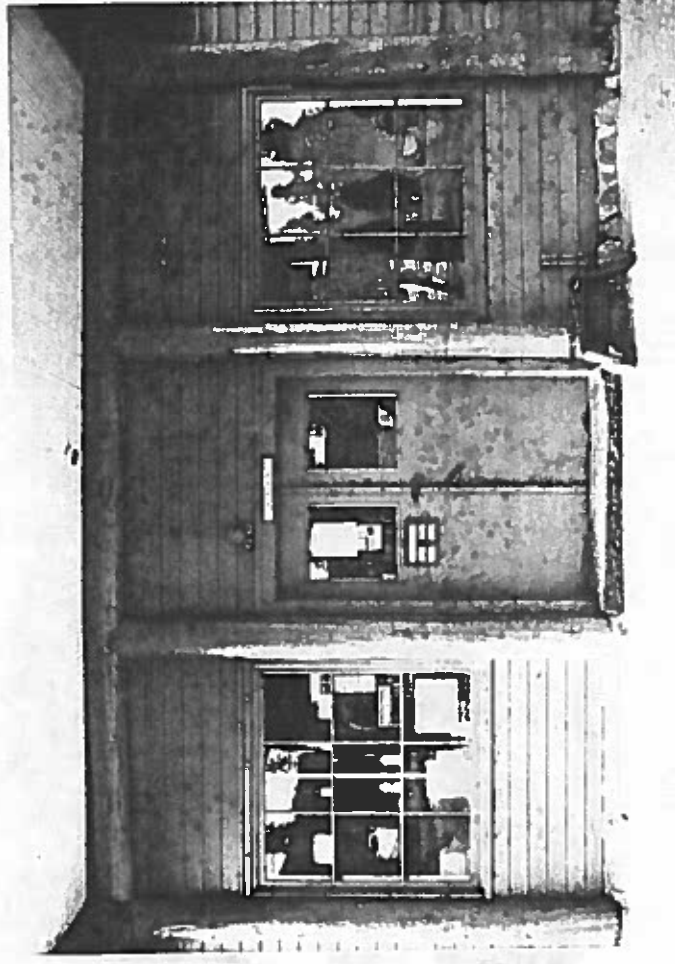
Figure 8: Looking south at the front entrance to the station. The windows are original, but the doors have been changed from the original full length lights. The materials are in good condition with the exception of some sill rot.

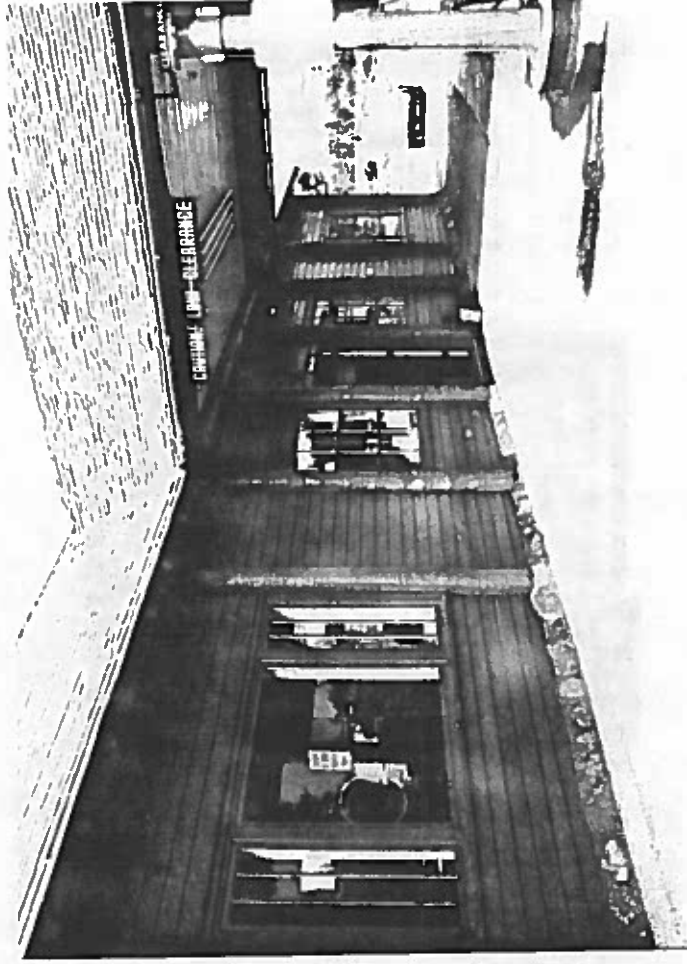
Figure 10: Looking southwest at the front of the station towards the front entrance. Note the good windows and the stone base. Also, note the rotted roof rafter and the condition of the shingles on the roof at the right.

6. Repair and/or replace the rotted log rafter tips with a new bolted on tip to match the existing.

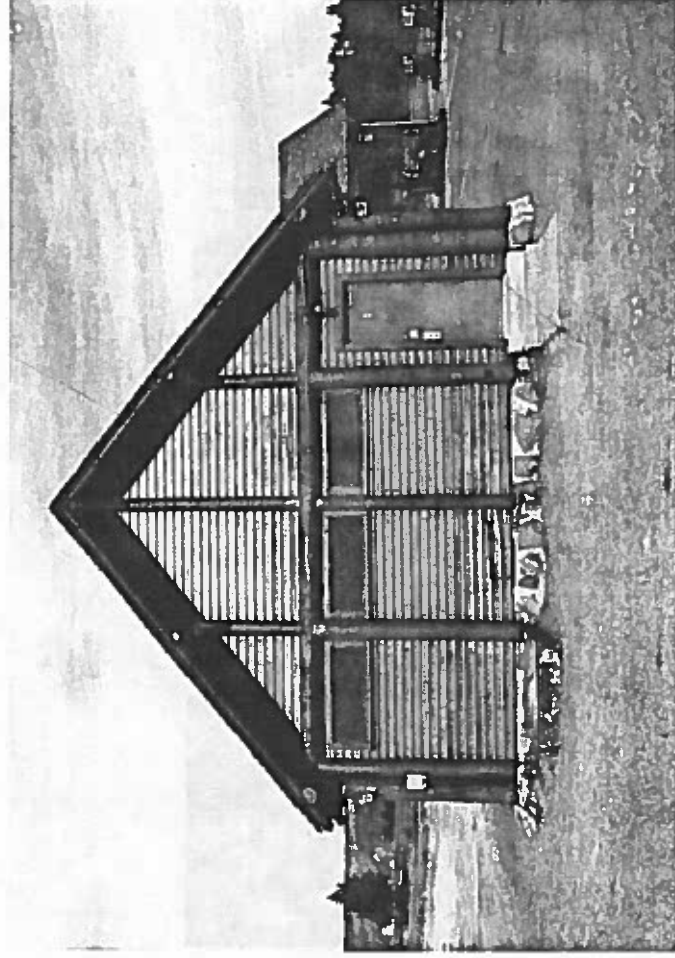
Figure 14: Looking west at the end of the station. The walls are in good condition with the exception of some rotted boards at the base of the wall. The stonework is in good condition.

4. Provide parking for handicap access to the bathrooms as well as parking for the bathrooms.
- ## Exterior
5. Replace the rotted, broken or cupped wood siding in-kind. Paint to match.

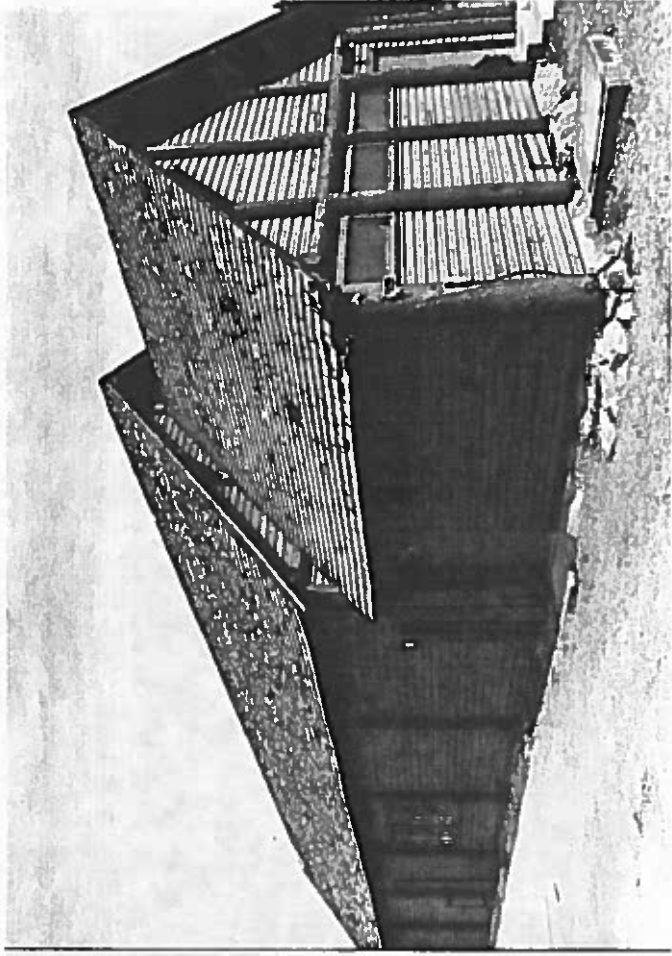
Figure 15: Looking northwest at the station. Note the broken corner of the roof, and broken shingles throughout the roof area. The doors to the bathrooms have been changed to a flush door.

9. Repair original doors and replace the new flush doors to match the originals. The main doors are wood door with a full light made up of small panes. The doors to the restrooms were a wood paneled door. Replace hardware to make more compatible in color and finish to the original. Repair all other hardware.

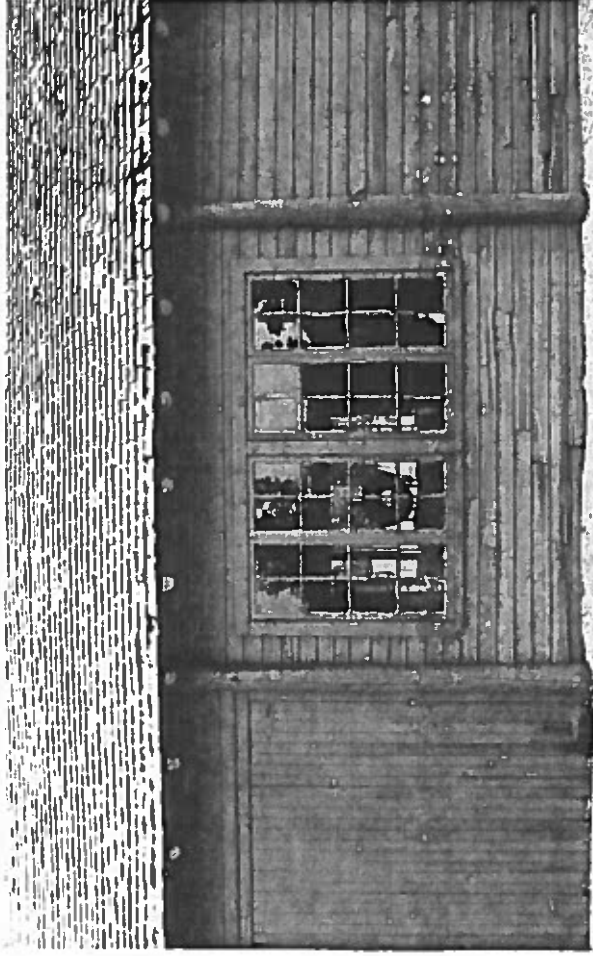
Figure 16: Looking north at the windows on the back of the station. The windows need some work. Note the high grade around the base of the building which is causing some of the wall boards to rot.

2. Prepare a landscape plan for the screening of the tanks and the back of the building along with some additional vegetation around the building.
  3. Grade around the building to provide for positive drainage away from the building especially on the south side. This may require the replacement of the concrete slab to the back service doors.

8. Repair windows and paint. All of the windows which are original shall be repaired in-kind.

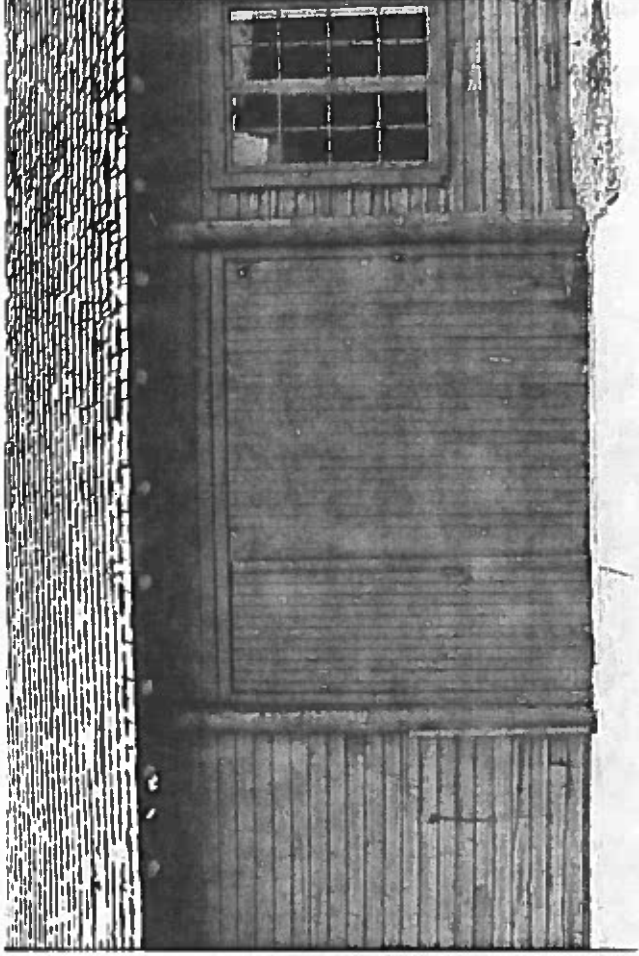
Figure 17: Looking north at the service bay doors on the back of the station. The doors are not original to the building and are in poor condition. Note the broken and missing shingles on the roof.

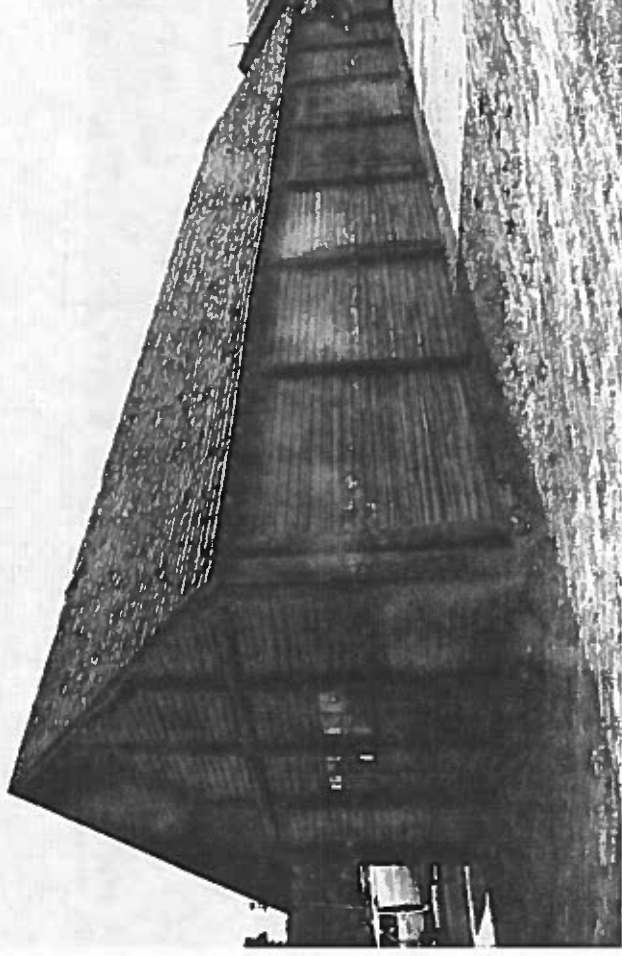
Figure 18: Looking northeast at the station. Several of the boards on the west and south sides of the building are broken or rotted.

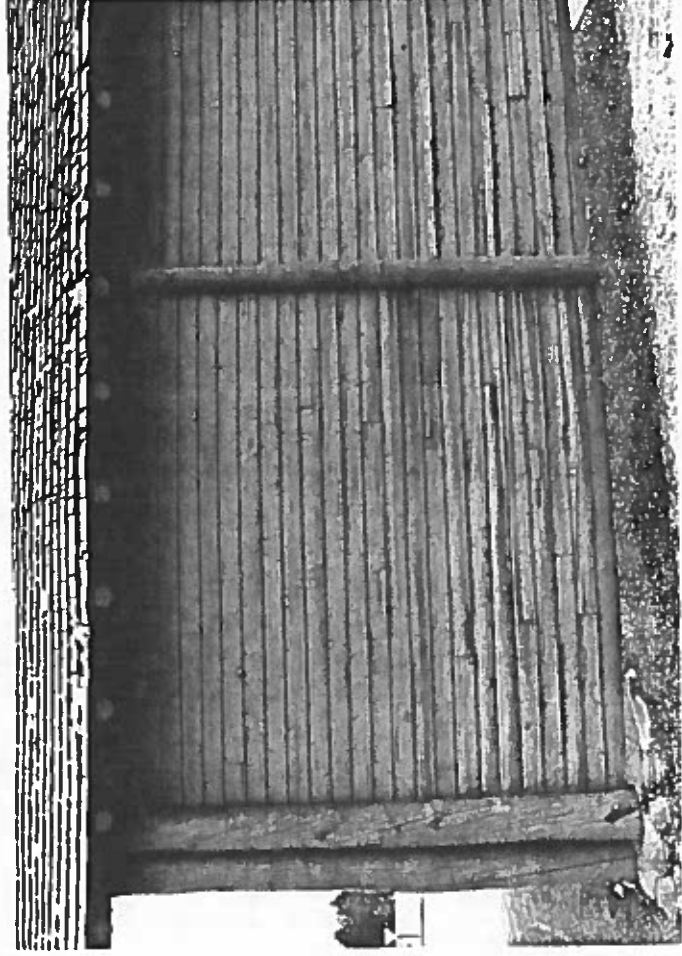
Figure 19: Looking north at a section of the wall on the south side. Note the broken boards on the wall, and the broken and missing shingles on the roof.

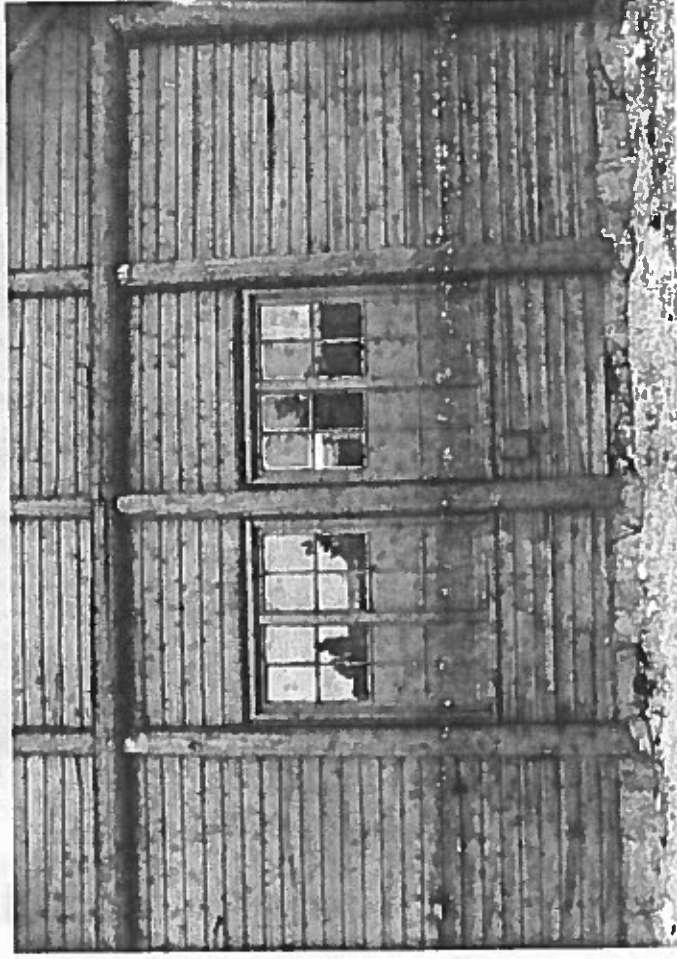
Figure 20: Looking east at the windows and wall surface of the station. Note the broken and cupped boards on the wall. Some of the stonework is missing mortar and is loose.

7. Reset the stones and tuckpoint the loose stones in the foundation.

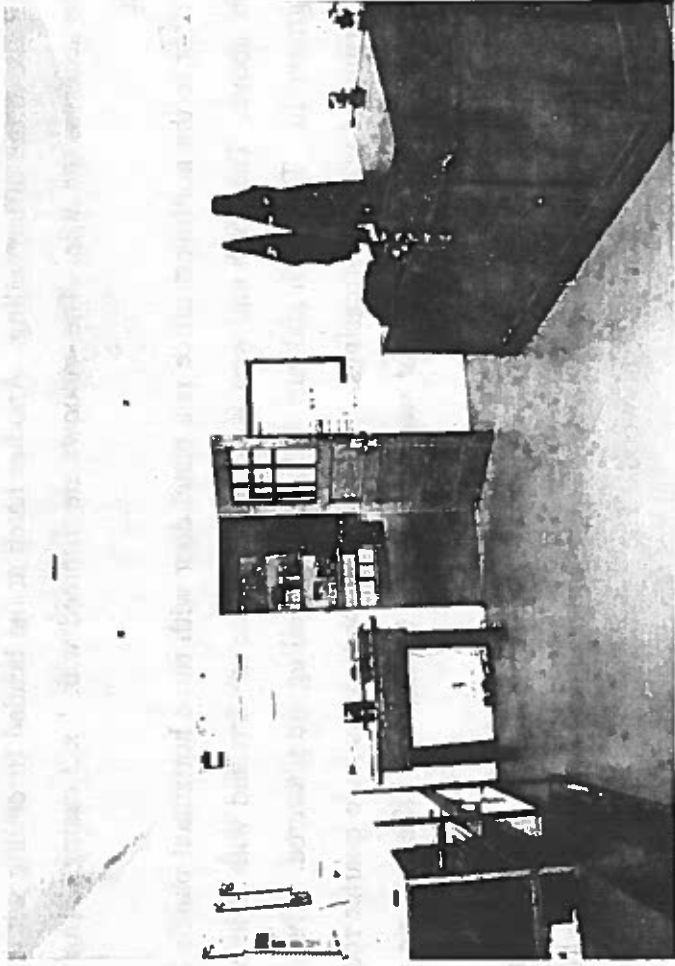
Figure 23: Looking east at the entrance to the service bay of the station. Note the door which appears to be original. This door needs some refinishing work.

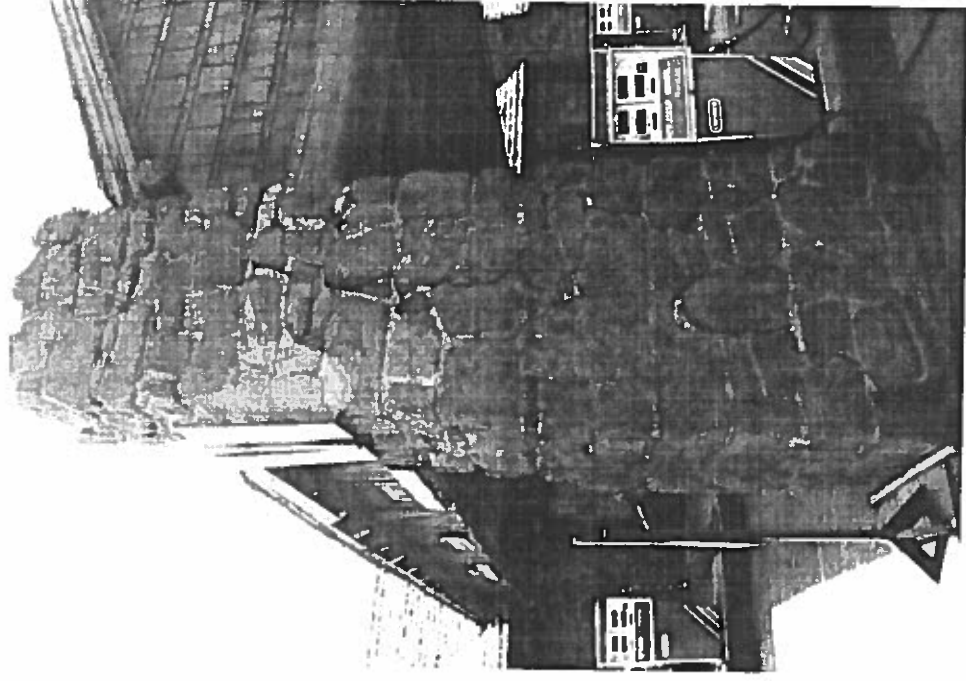
Figure 32: Looking southeast at a typical stone column at the station. Note the missing mortar and loose stones due to water penetration from the top.

The Upper Service Station is in good condition. The main problems relate to the poor condition of the roof and the cracks occurring in the stone columns due to moisture penetration from the top of the columns. The roof is not leaking at this time but has perhaps only a few years left, depending on the winters. There are a lot of missing, broken, and curled shingles--especially on the west side of the building; and there are some rotted log rafter tips. Some of the vertical log slabs under the eaves of the open bays are loose or missing. The concrete base appears to be in good condition. The stone columns at the corners of the building and the open bays have loose stones, mortar missing, or large cracks throughout the face. This condition occurs at the end of the east and south bays though most prevalent on the west side. Water appears to be penetrating the tops of the columns going down into the structure and, with the freeze/thaw cycle, forcing stones out from the structure. The overall structural elements appear to be in good condition as there are no obvious settlement or cracks in the building. The log beam in the south bay has some rot in the center. Also, there appears to be some settlement or potential for settlement in part of the east bay due to water penetrating into the concrete. The windows and doors are in good condition but need some minor maintenance in the form of paint and some adjustment of hardware.

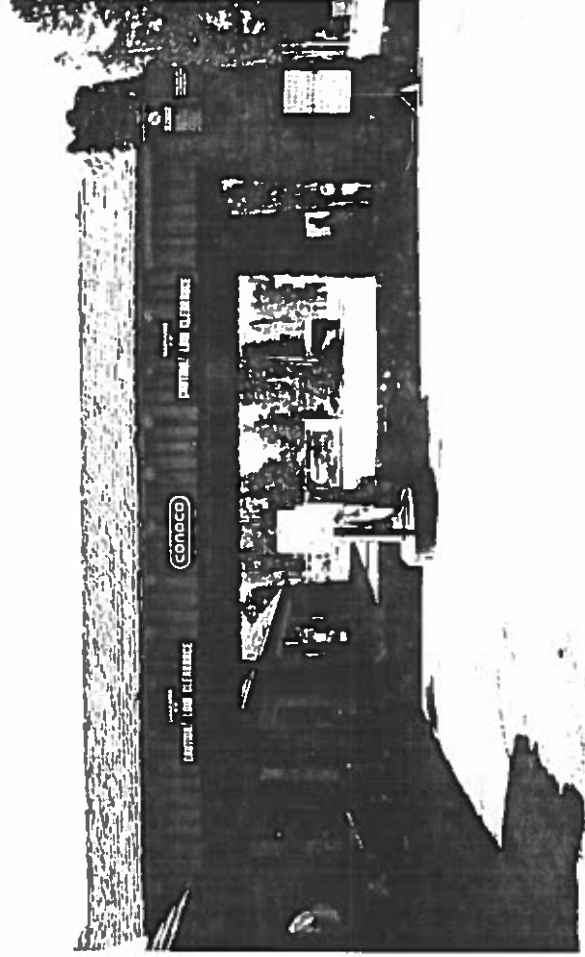
Figure 34: Looking south at the pump bay of the station. Note the poor condition of the roof, and the missing or loose vertical log slabs under the eave.

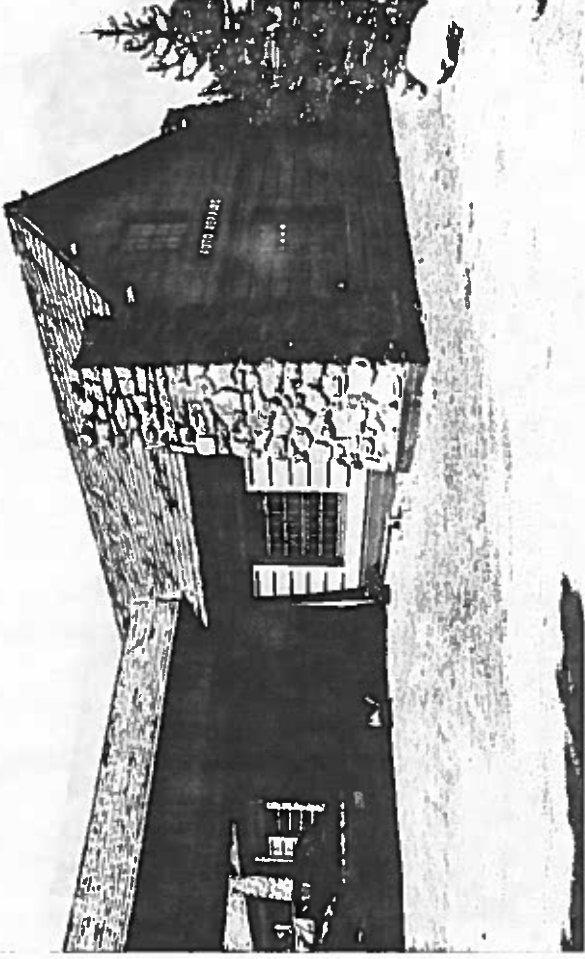
Figure 37: Looking southwest at the station. The small paned windows are in good condition but need some maintenance. Some of the rafter tips are rotted.

5. Repair and/or replace the rotted log rafter tips with a new bolted on tip to match the existing.

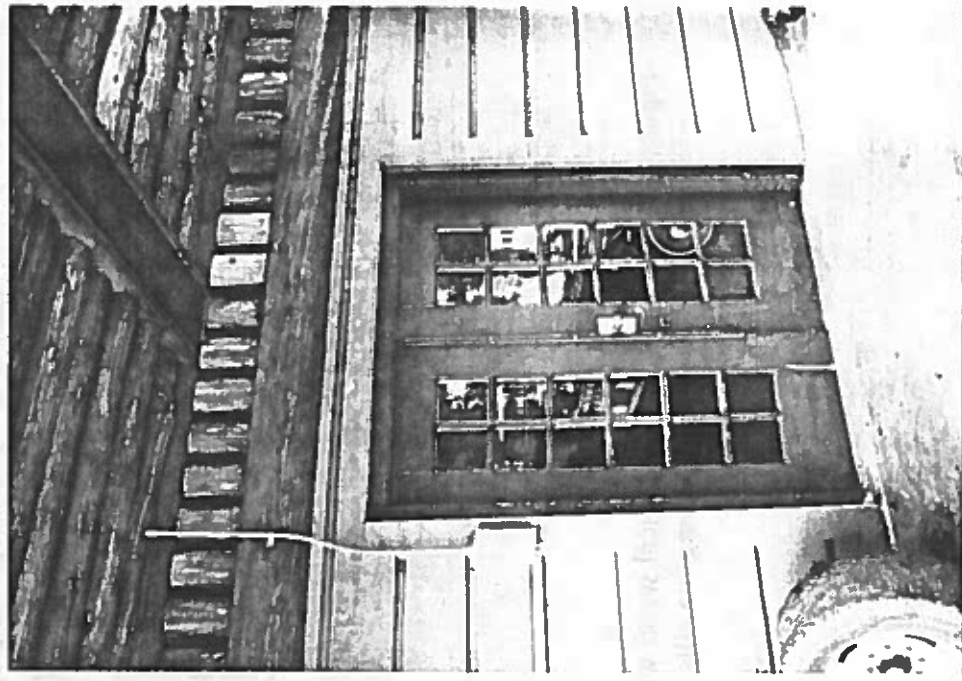
Figure 39: Looking northwest at the end of the east bay of the station. Note the missing log under the shingles, and the loose and missing stonework in the columns.

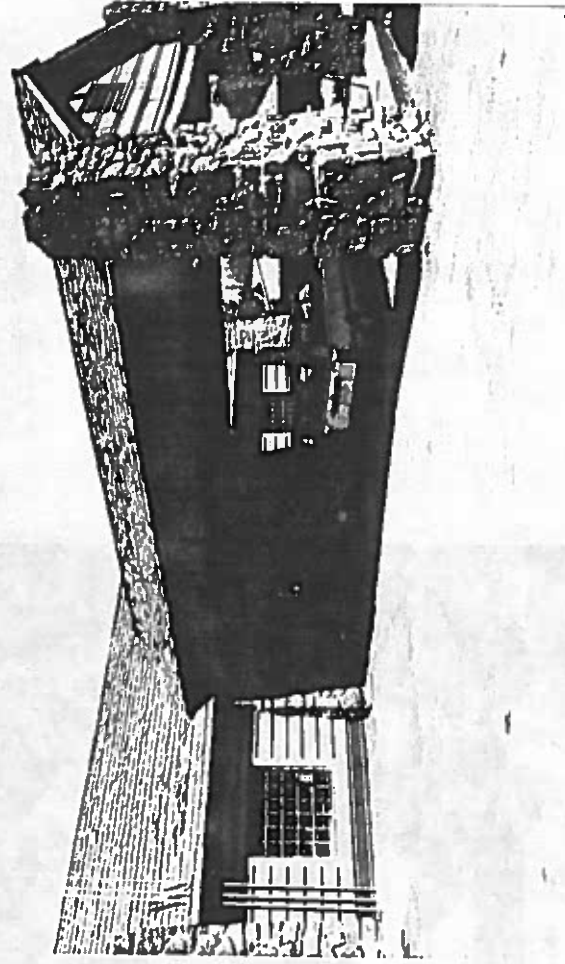
Figure 41: Looking northwest at the station and the east bay. Note the missing and cupped roof shingles, and the missing vertical log slabs under the eave.

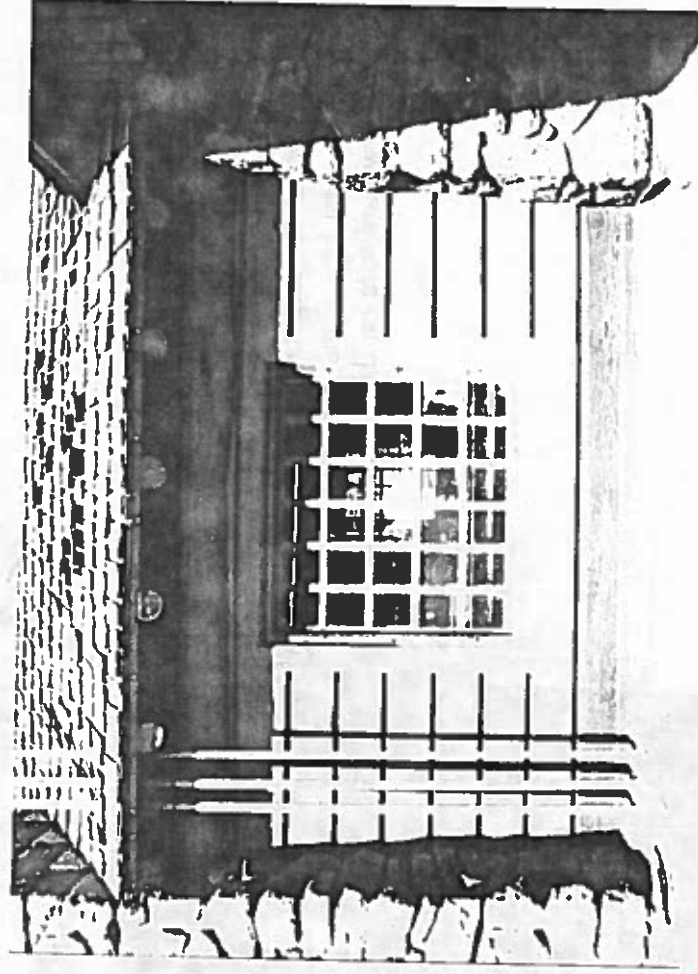
Figure 42: Looking west at a typical wood window on the station. Note the missing paint, and the weathering along the sills and jamb. The concrete walls appear to be in good condition.

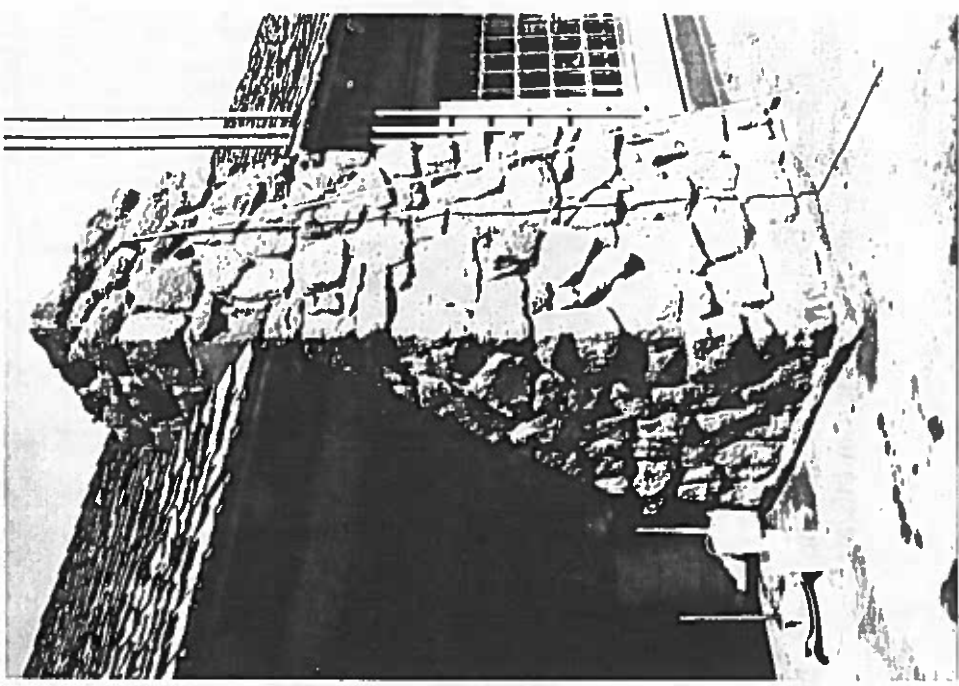
Figure 43: Looking northwest at a typical stone column on the east side of the building. With the exception of the top of the columns, this stonework appears to be in good condition.

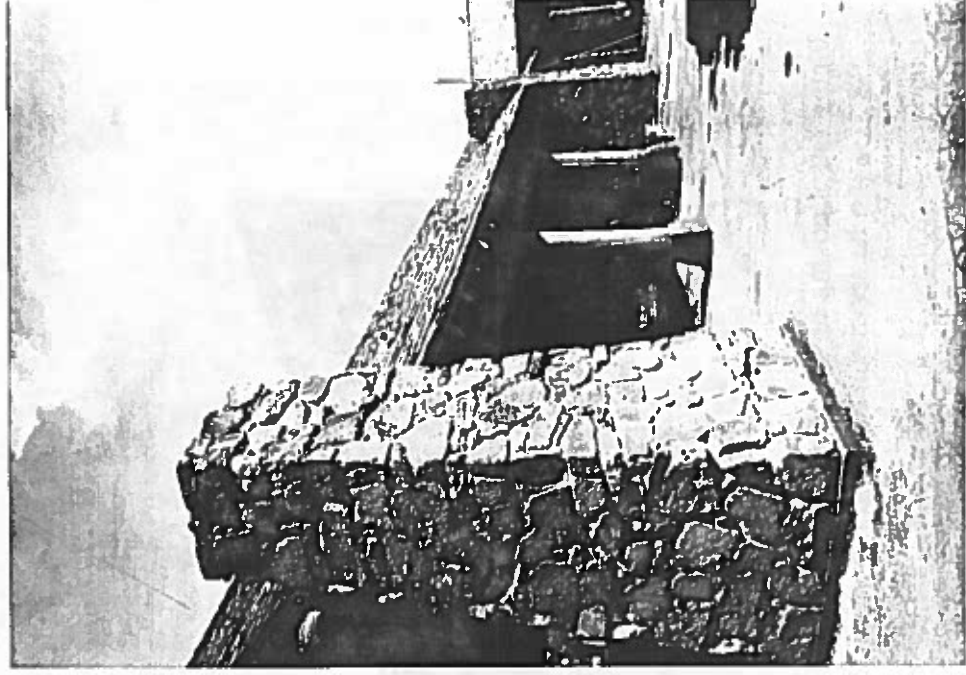
Figure 46: Looking northwest at a typical stone column in the service bay of the station. There is some (minor) missing mortar.

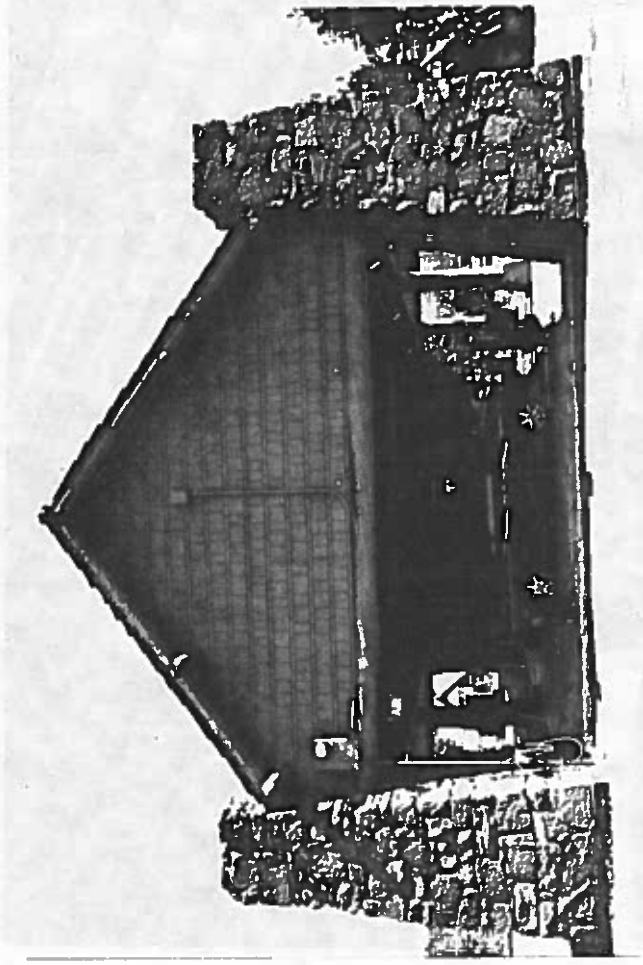
Figure 47: Looking north at the south end of the service bay. Note the checked and cracked log center. The shingles and log purlins are in good condition.

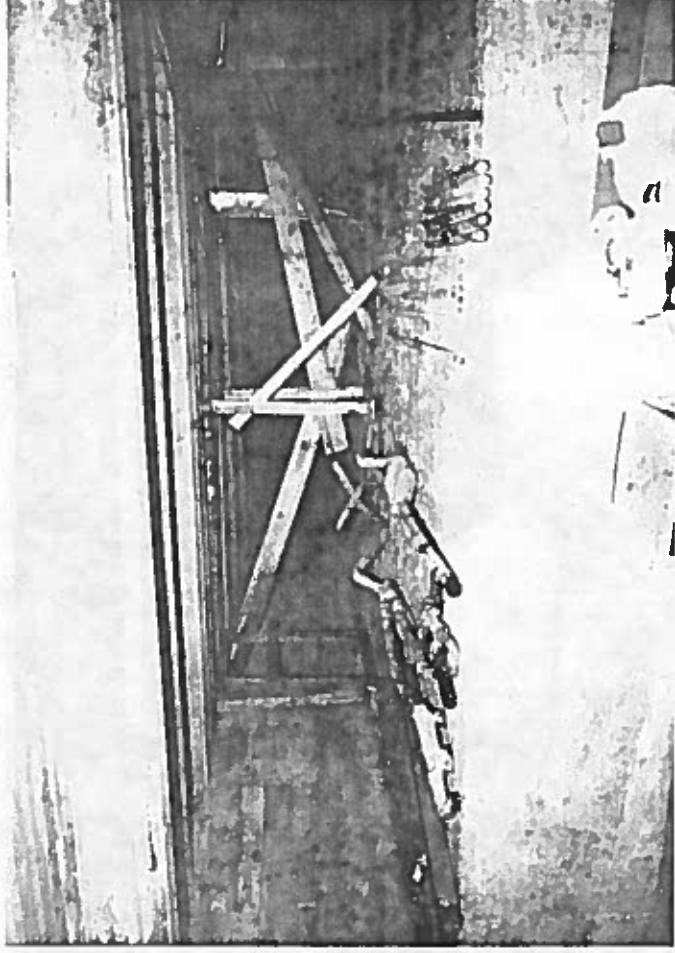
Figure 57: Looking east at the area under the east bay (original pump bay) of the station. There is some support of the concrete at this point because of some deterioration and settlement.
