**HISTORIC STRUCTURE REPORT**

**Architectural Data Section**

**THE ATWOOD-HIGGINS HOUSE**

**Cape Cod National Seashore**

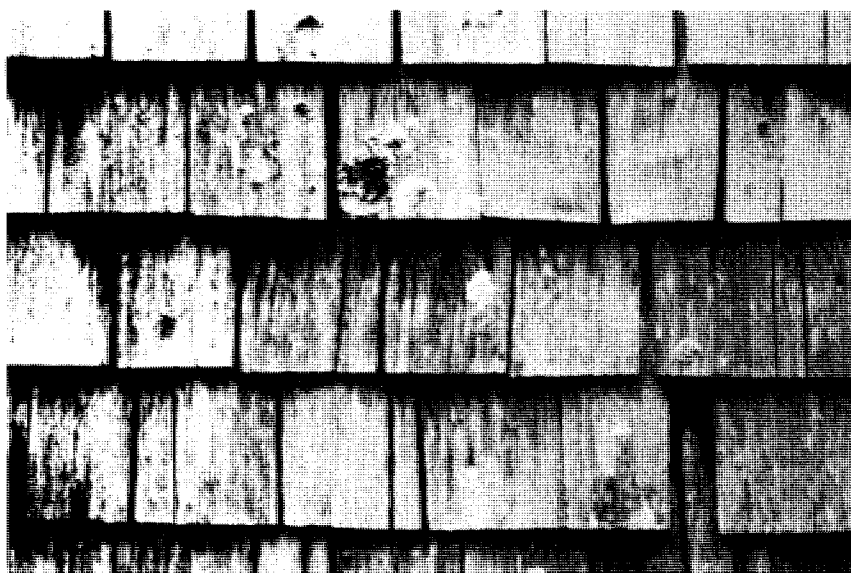
**Illustration 102.** Atwood-Higgins House: East-Elevation  
Shingles, Fungal Growth.

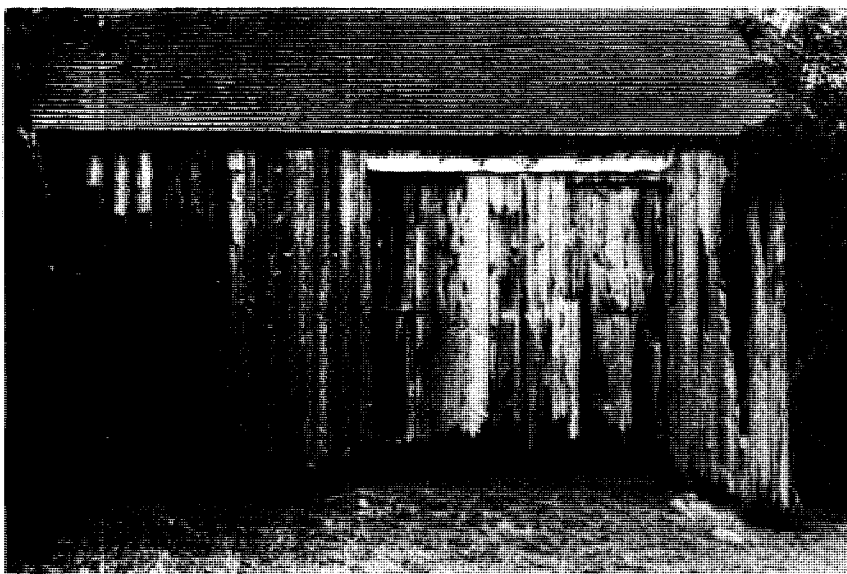
**Illustration 103.** Atwood-Higgins Barn: Rising Damp.

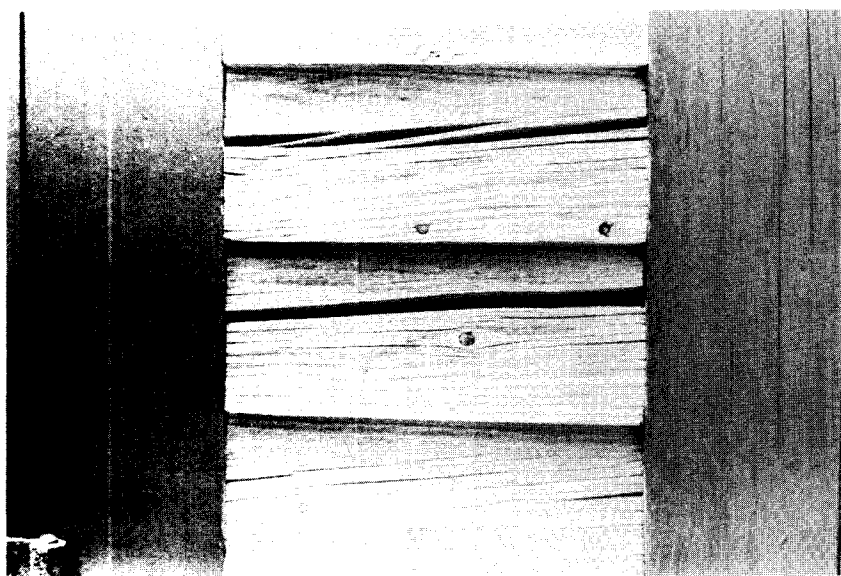
**Illustration 106.** Atwood-Higgins Country Store: Split Clapboards.

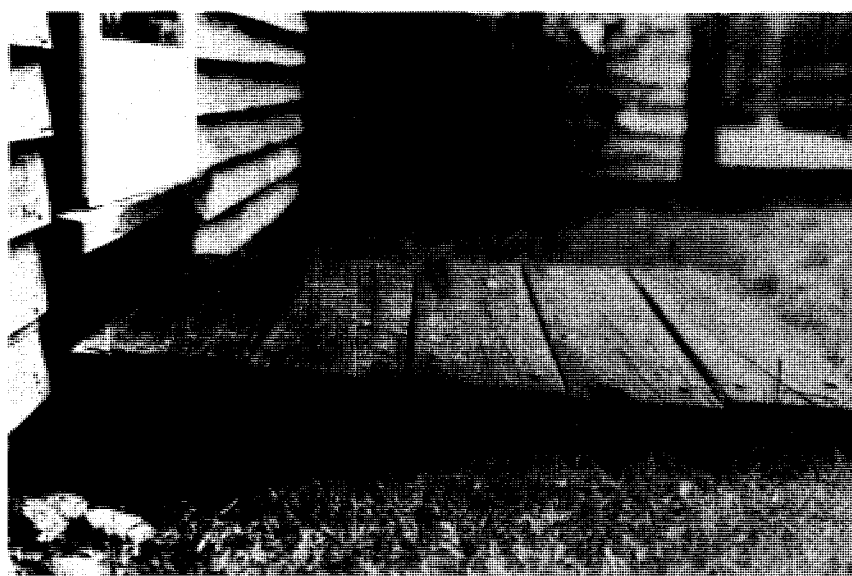
**Illustration 108.** Atwood-Higgins Country Store: Worn Entrance Steps.
