HISTORIC STRUCTURES REPORT

ARCHITECTURAL DATA SECTION

THE ROSTRUM

Antietam National Battlefield Site

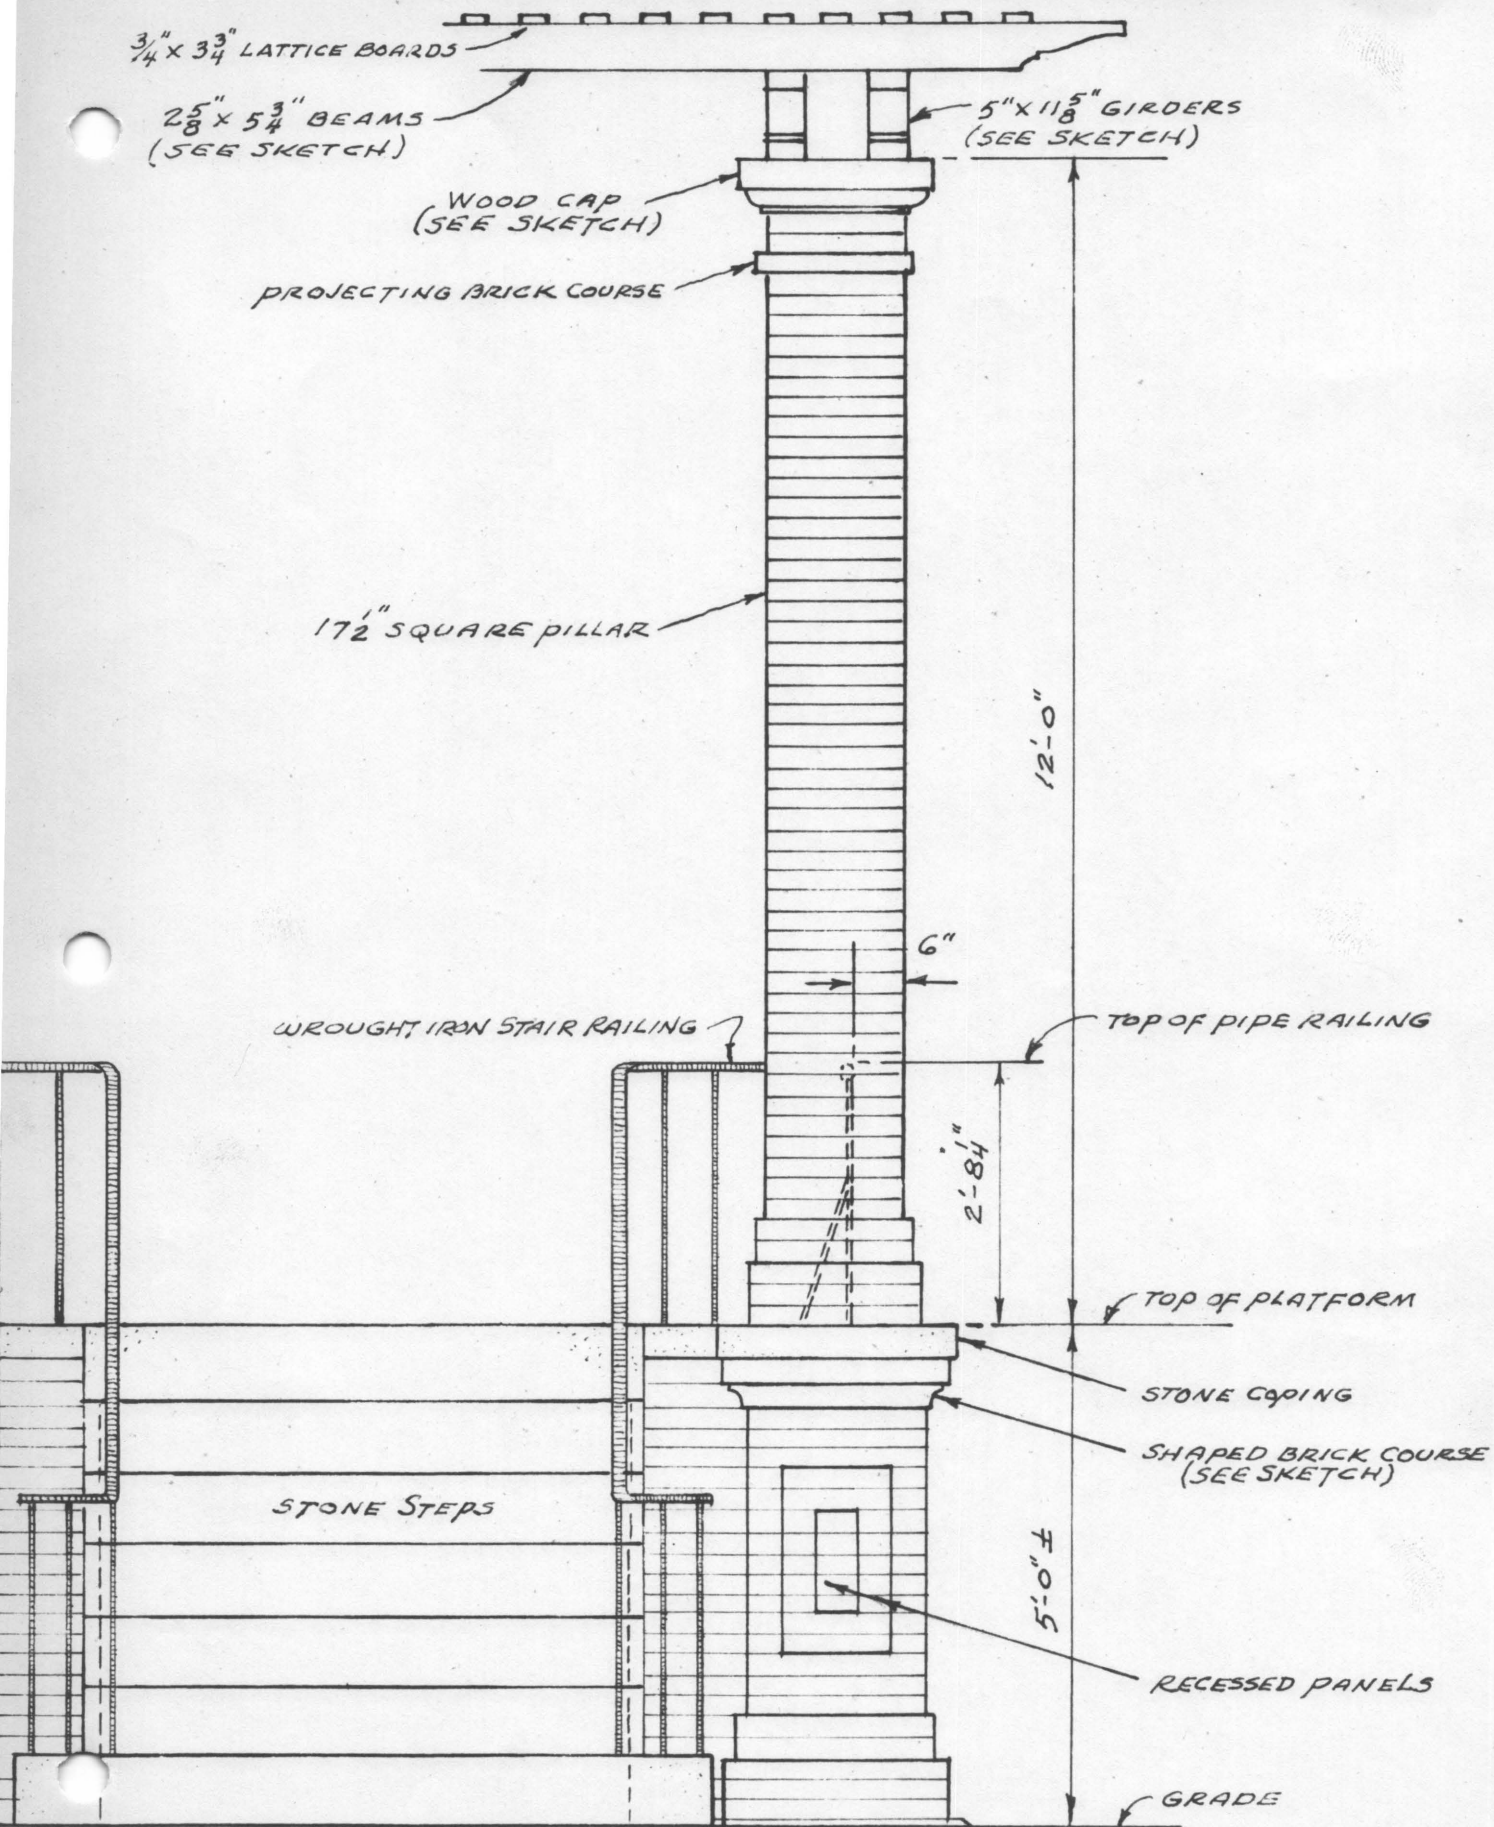
PARTIAL ELEVATION OF ROSTRUM  
 SCALE  $\frac{1}{2}$ " = 1'-0"

The brick walls of the platform have been patch pointed at different times. This was necessitated by water seeping down through the planter spaces in the platform and into the brick joints from behind. Vines have crept into some of the joints and have dislodged a number of brick. It appears that a few of the original brick have been replaced when they deteriorated or broke because of plant growth or freezing.

The pillars above the platform level have been painted red, probably to give them a cleaner appearance. The platform walls are unpainted.

The brick joints of the platform walls and the pillars should be raked and repointed. Loose brick should be reset and any missing brick replaced. The brick are approximately two and a quarter inches by four and an eighth inches by eight and five eighths of an inch in size and have been laid with a three eighths inch mortar joint. The second course below the stone coping is a shaped brick and an illustration of its cross section is appended. The joints between the coping stones should be caulked.

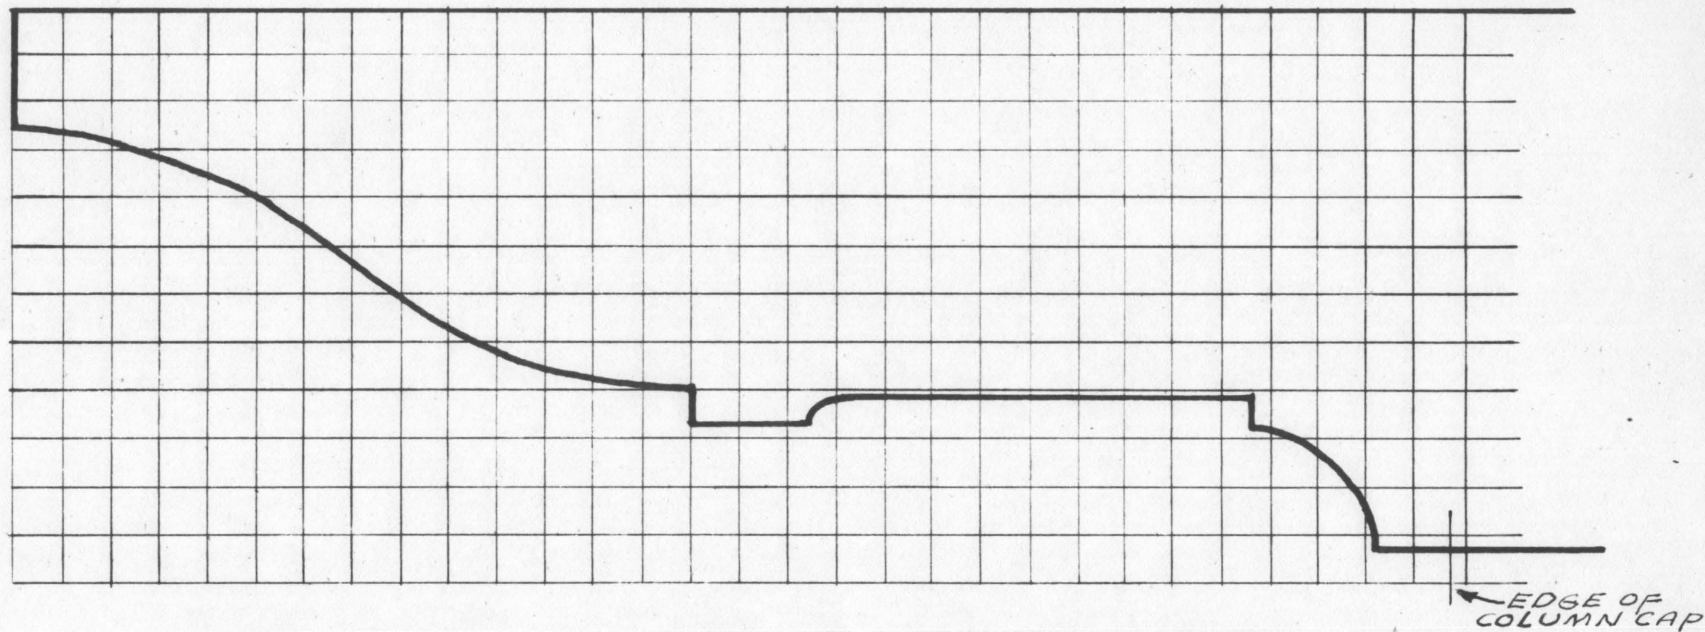
PROFILE OF EXISTING TREILLAGE GIRDER ENDS

Some of the present timbers of the arbor treillage appear to have checked and rotted, but because of the heavy paint coats it is hard to determine to what extent.

Should the timbering and boards be replaced they should be sized to match the sizes called for on the original drawing. It would be advisable to provide a shallow peaked wash on the girders and beams so moisture could not lay on top of them and, their ends should be cut to a Victorian styled profile. The lower edges of the girders should be chamfered as indicated on the original drawing.
