HISTORIC STRUCTURES REPORT 601437

PART II  
ON  
COUNTY JAIL

Appomattox Court House National Historical Park  
Appomattox, Virginia

by  
Orville W. Carroll  
Architect  
September 1963

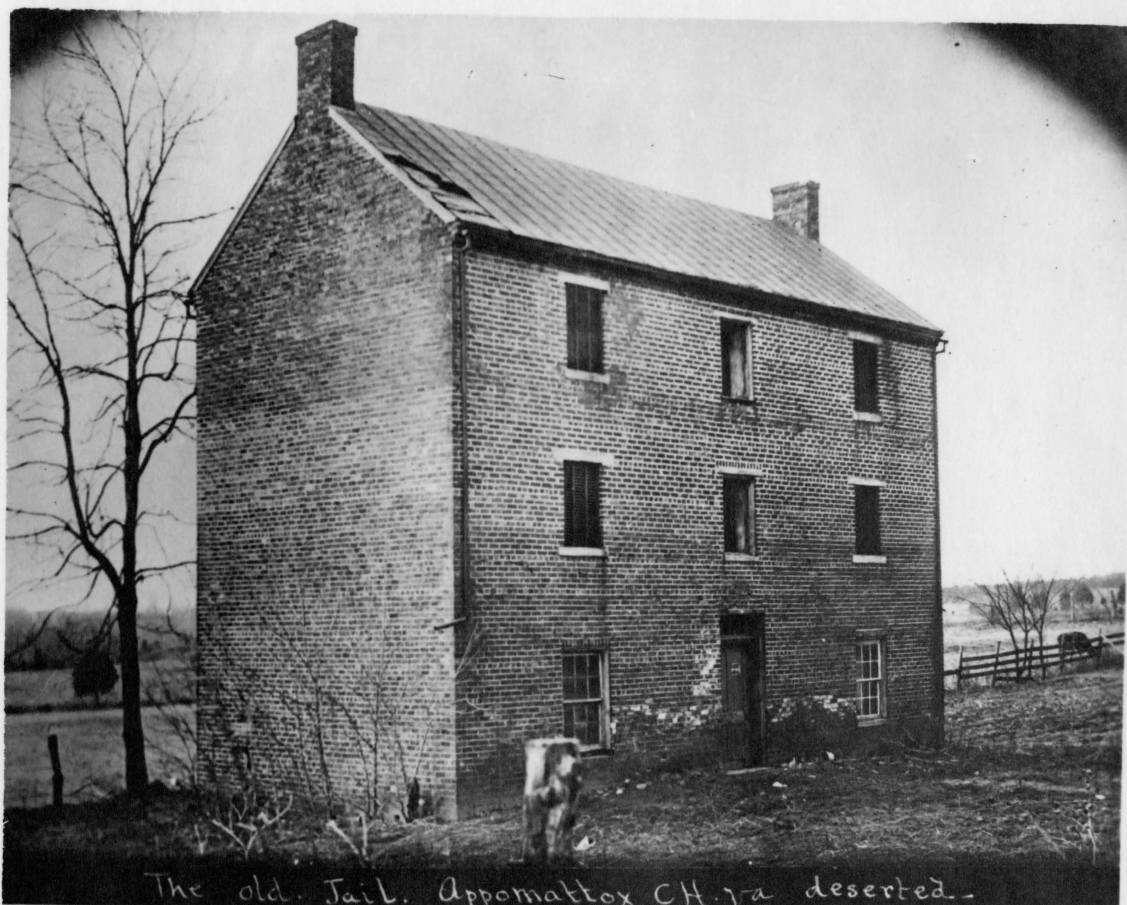
ILLUSTRATION NO. 2

A view from the southwest showing the rear portion of the jail prior to stabilization work in the 1950's.

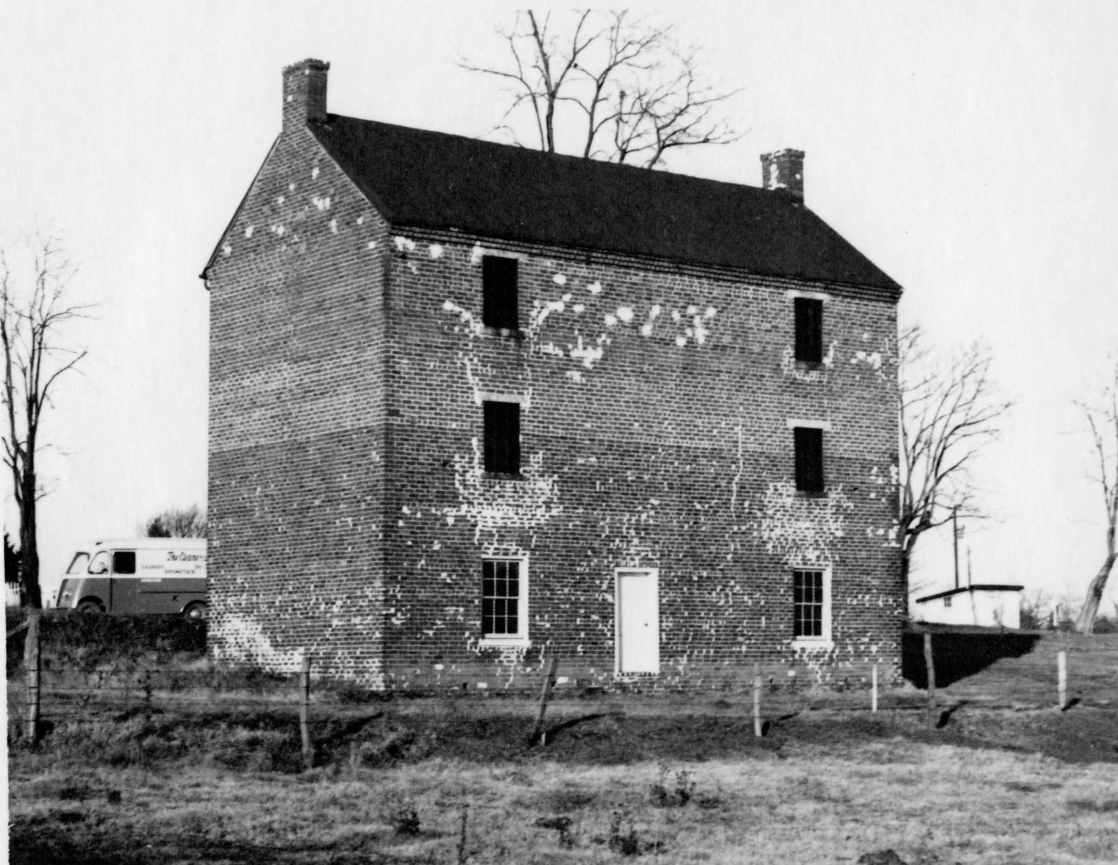
ILLUSTRATION NO. 3

Present day view of the north wall. The north facade was the principal entrance to the jail and faced the village square. This building was constructed in the southeast corner of the original two acres of public land, probably around 1870. It replaced the first jail built across the old stage road some 100 feet to the north. Much of the stabilization work dates from 1954.

Repointing of some brick work will be required. Most of the masonry work is in good condition and will require a minimum of attention. It is recommended that the mortar joints between brick courses be penciled with a 1/4" white lead stripe. The exterior masonry walls should be waterproofed to help resist further erosion of the brick and mortar.

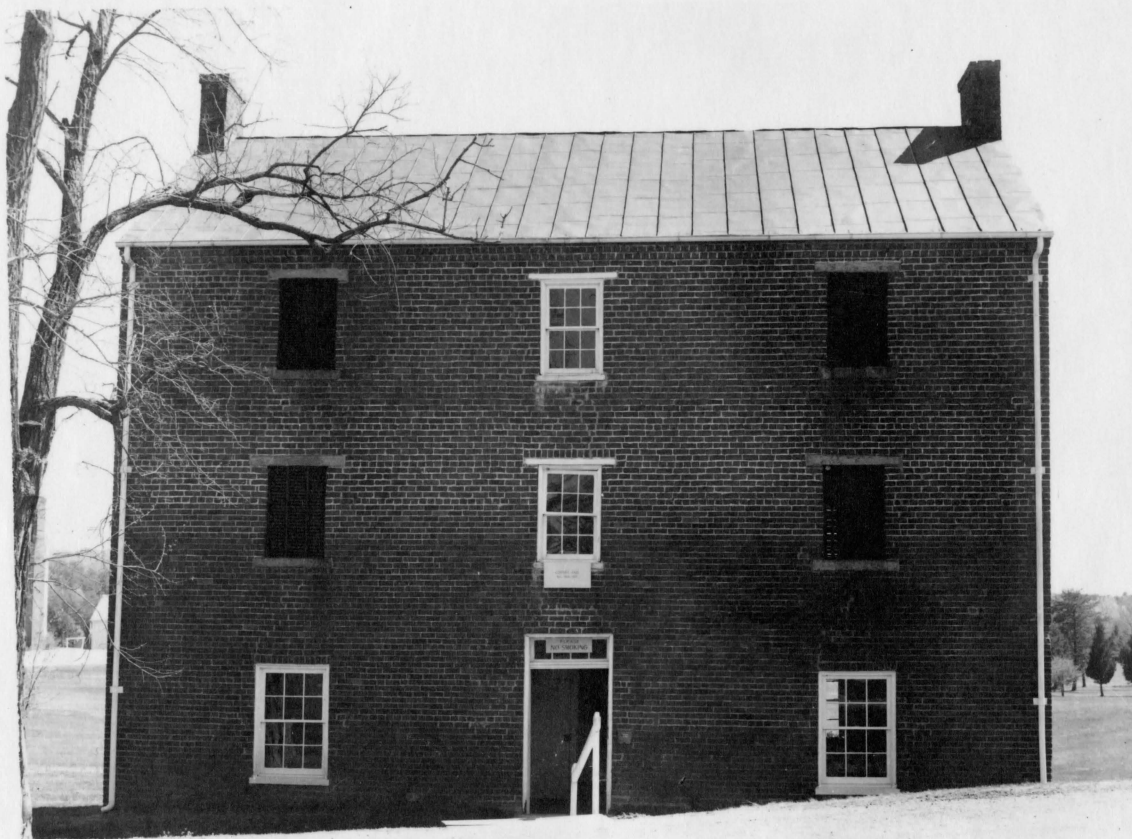
ILLUSTRATION NO. 4

West elevation of the jail.

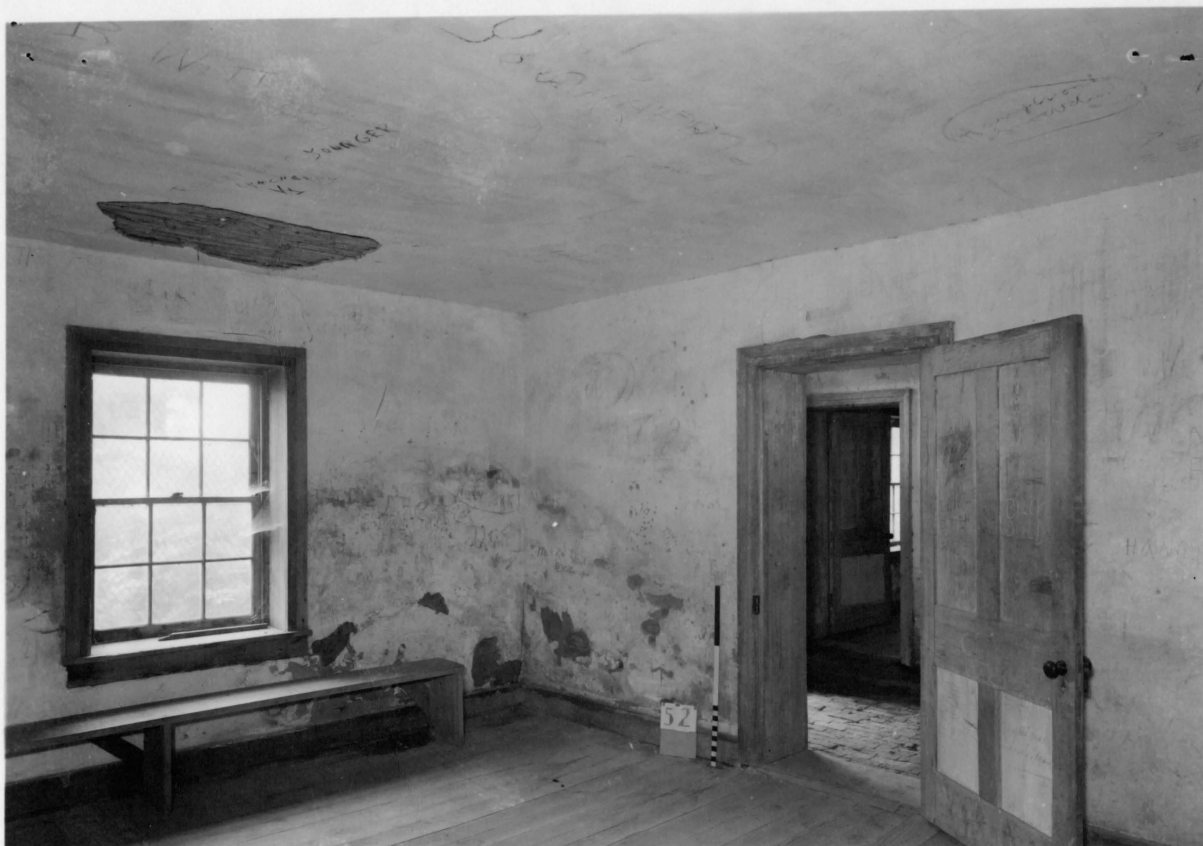
ILLUSTRATION NO. 7

West room, first floor, looking southwest. What may be considered the original appearance of the ca. 1870 jail can be seen in this view, prior to work in 1941 and the eventual removal of all the lath and plaster.

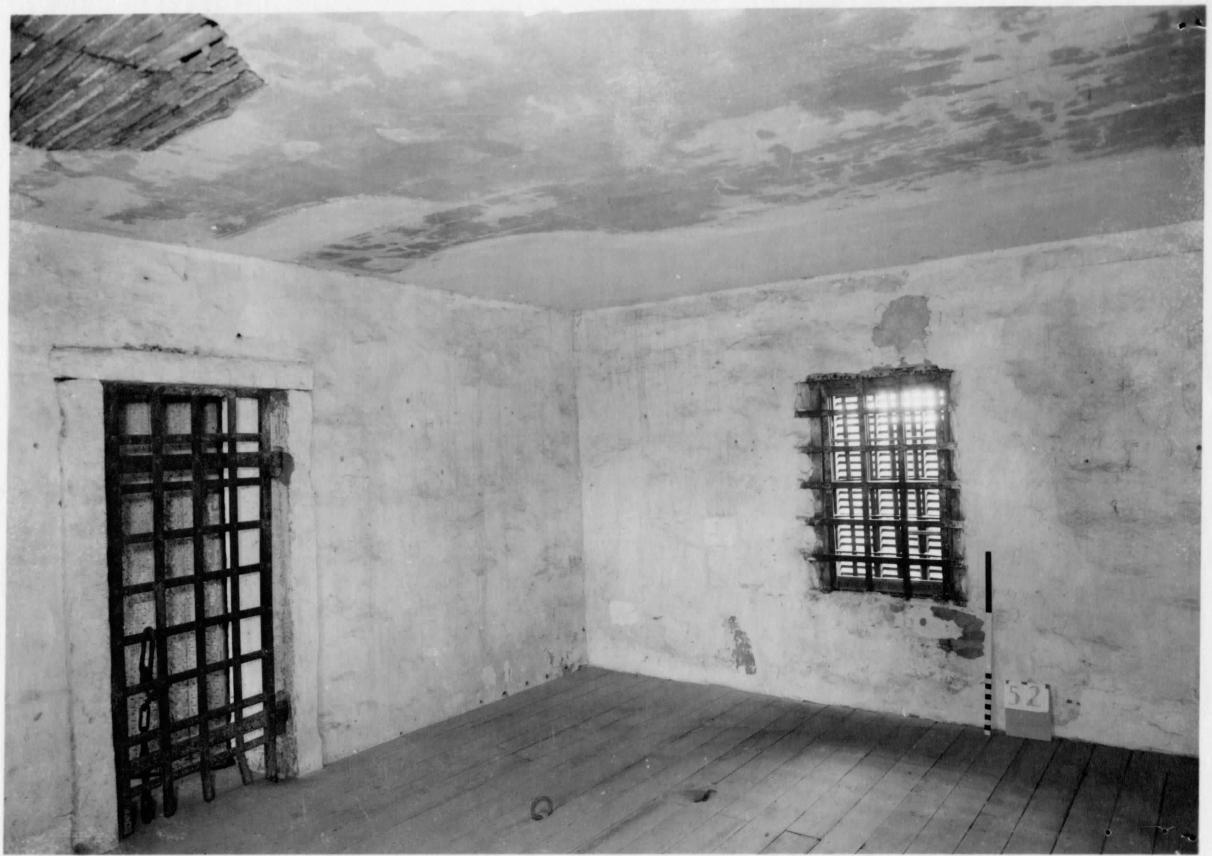
ILLUSTRATION NO. 9

A good study photograph showing the original plaster finish in the second and third floor cell rooms. Notice the absence of wooden baseboards and window trim. West cell, second floor.

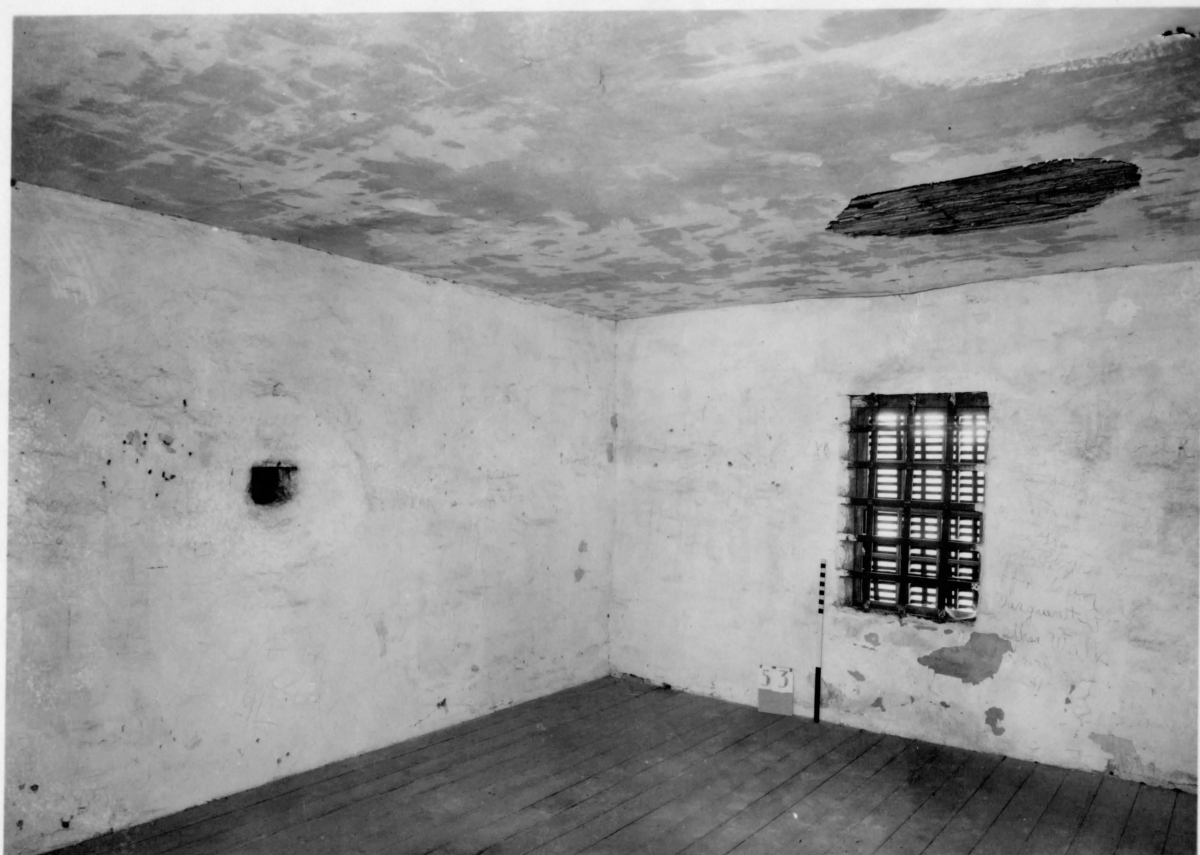
ILLUSTRATION NO. 10

The removal of all the original plaster was done by the C.C.C. in 1941. This in effect exposed the most interesting building features of the structure, the metal grillage on both wall and ceiling surfaces and the size and spacing of the ceiling joists.

It is recommended that the one cell room and hallway on the second floor be restored to their original condition. Leave the west cell in its present condition with the exposed iron grille work on the walls and the metal reinforced ceiling joists. Note: a small section of the stairway soffit will necessarily be left unfinished to allow the board and batten door to swing against the wall in an open position at all times.

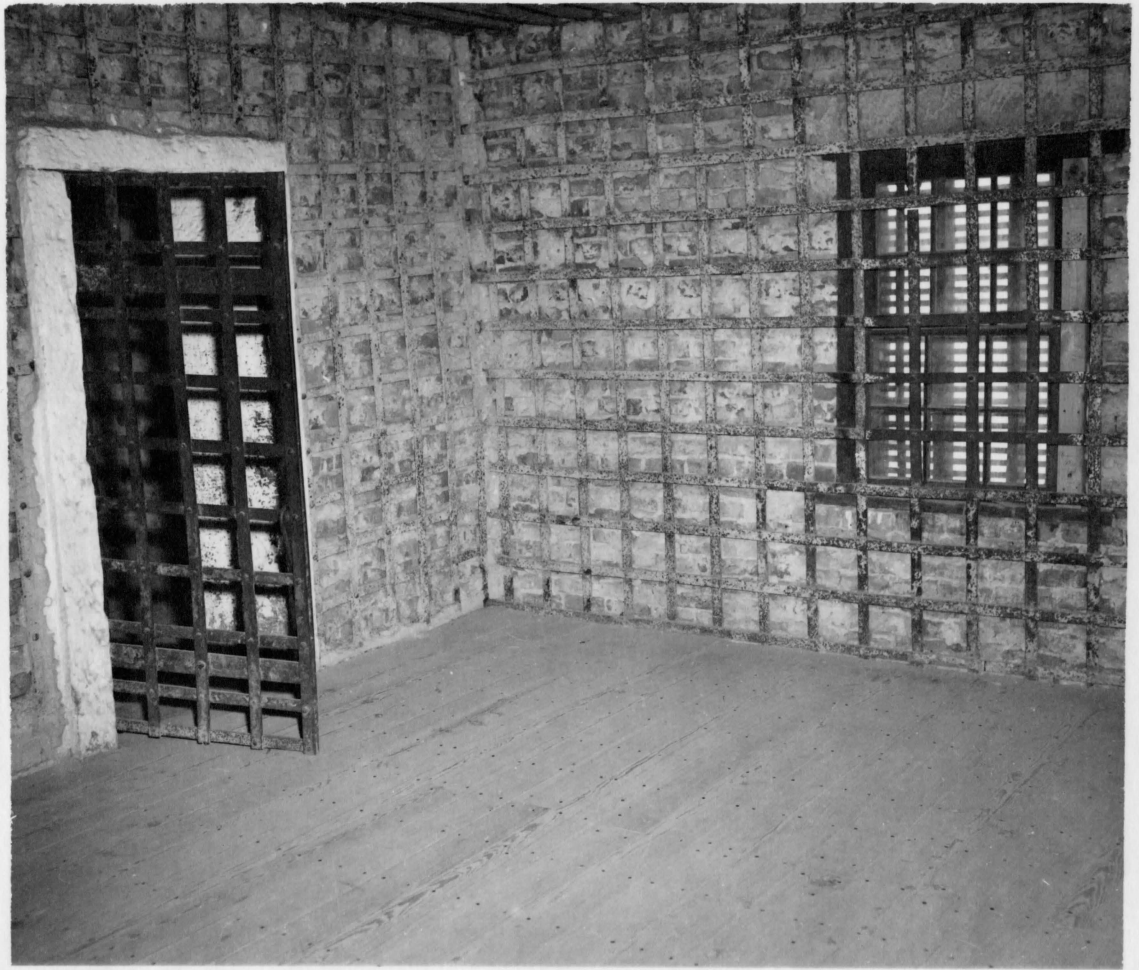
ILLUSTRATION NO. 12

All four cell rooms were equipped with an outer board and batten door hung on a wooden frame, and an inner metal grille door mounted to granite door jambs. Looking into the east cell from the hallway, third floor.

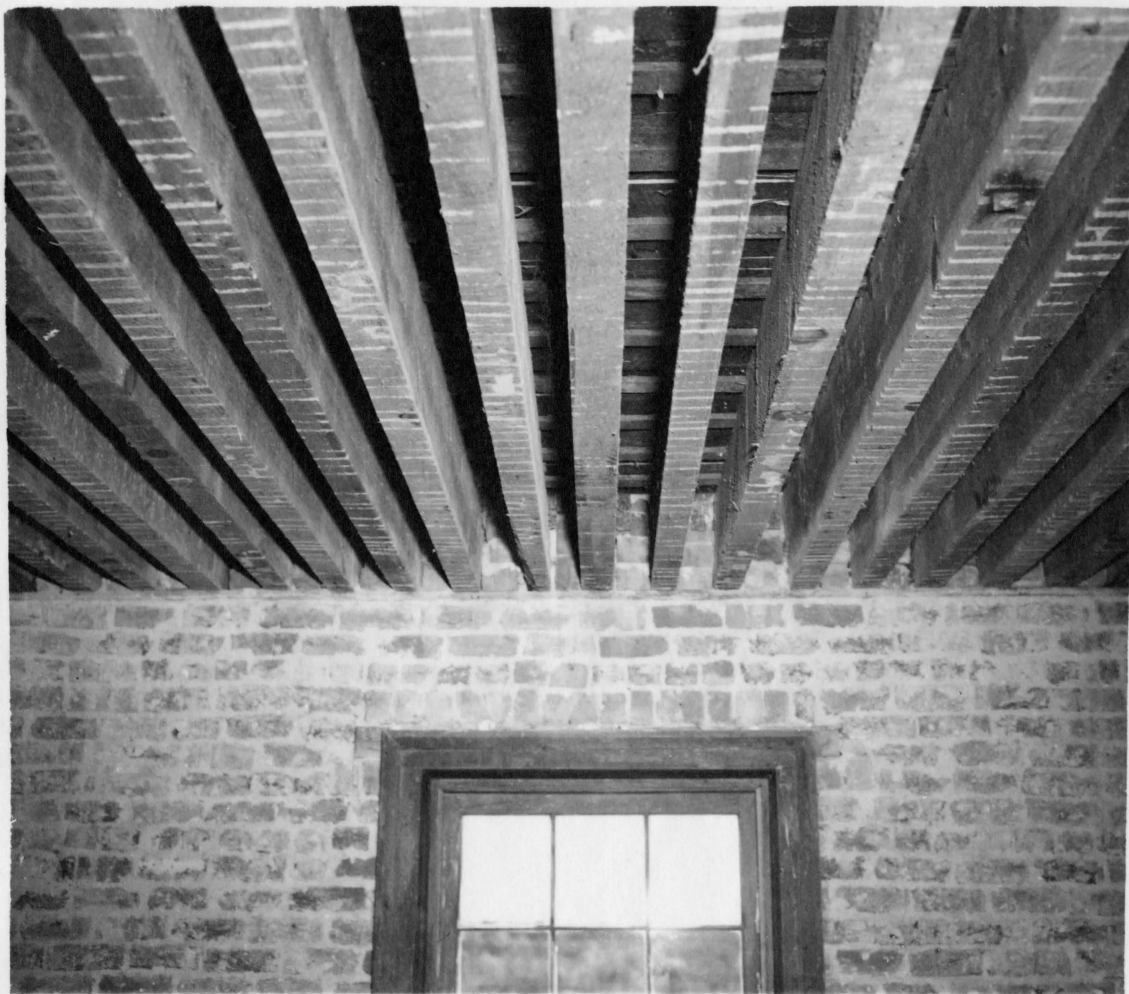
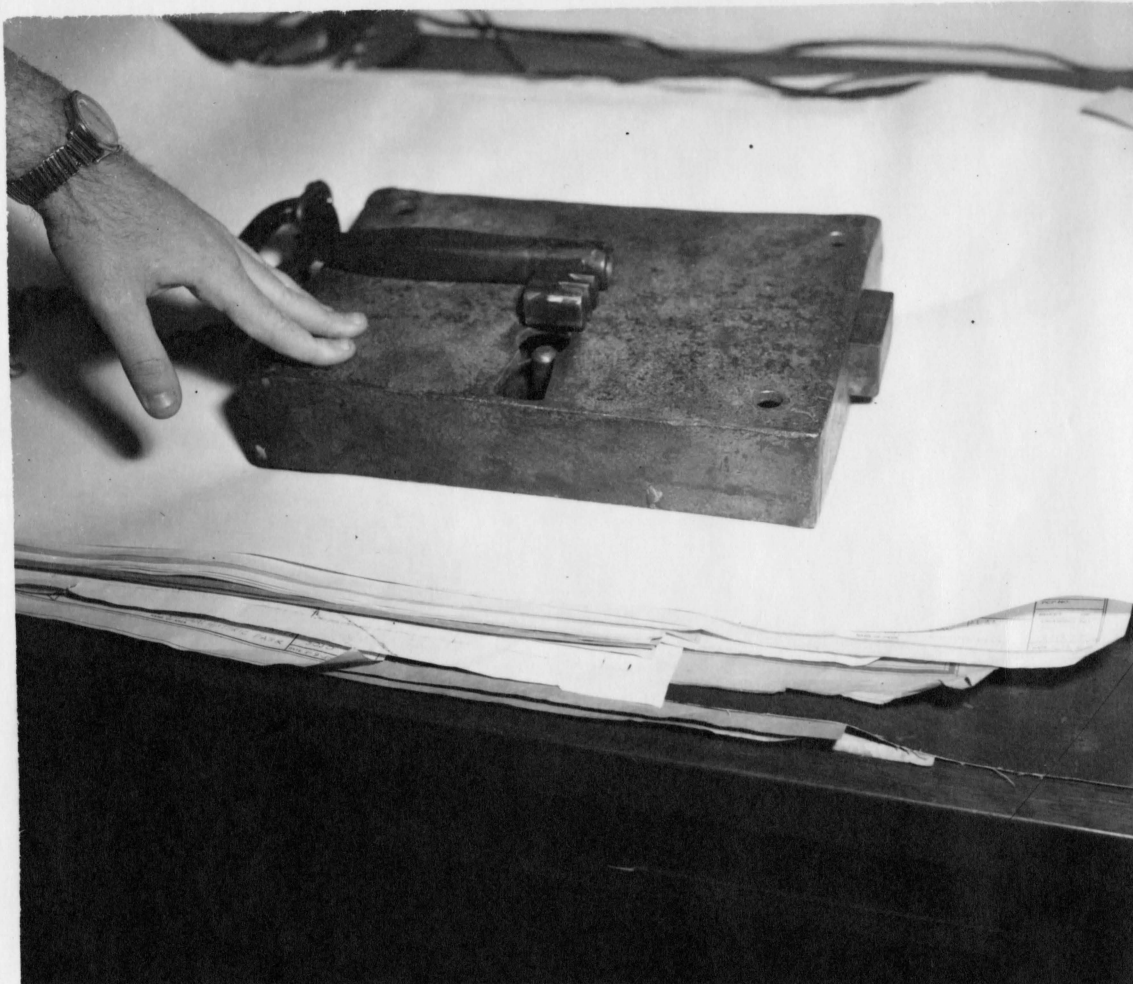
ILLUSTRATION NO. 14

One of the four original cast iron locks remaining from the initial jail construction, removed and now on display at the Clover Hill Tavern, ACHNHP. This lock was mounted to the outer side of the board and batten door.

It is recommended to replace all hardware that is not original with authentic reproductions.
