HISTORIC STRUCTURES REPORT 001438

COUNTY JAIL

Appomattox Court House National Historical Park

Prepared by  
Orville W. Carroll  
Architect  
July 1965

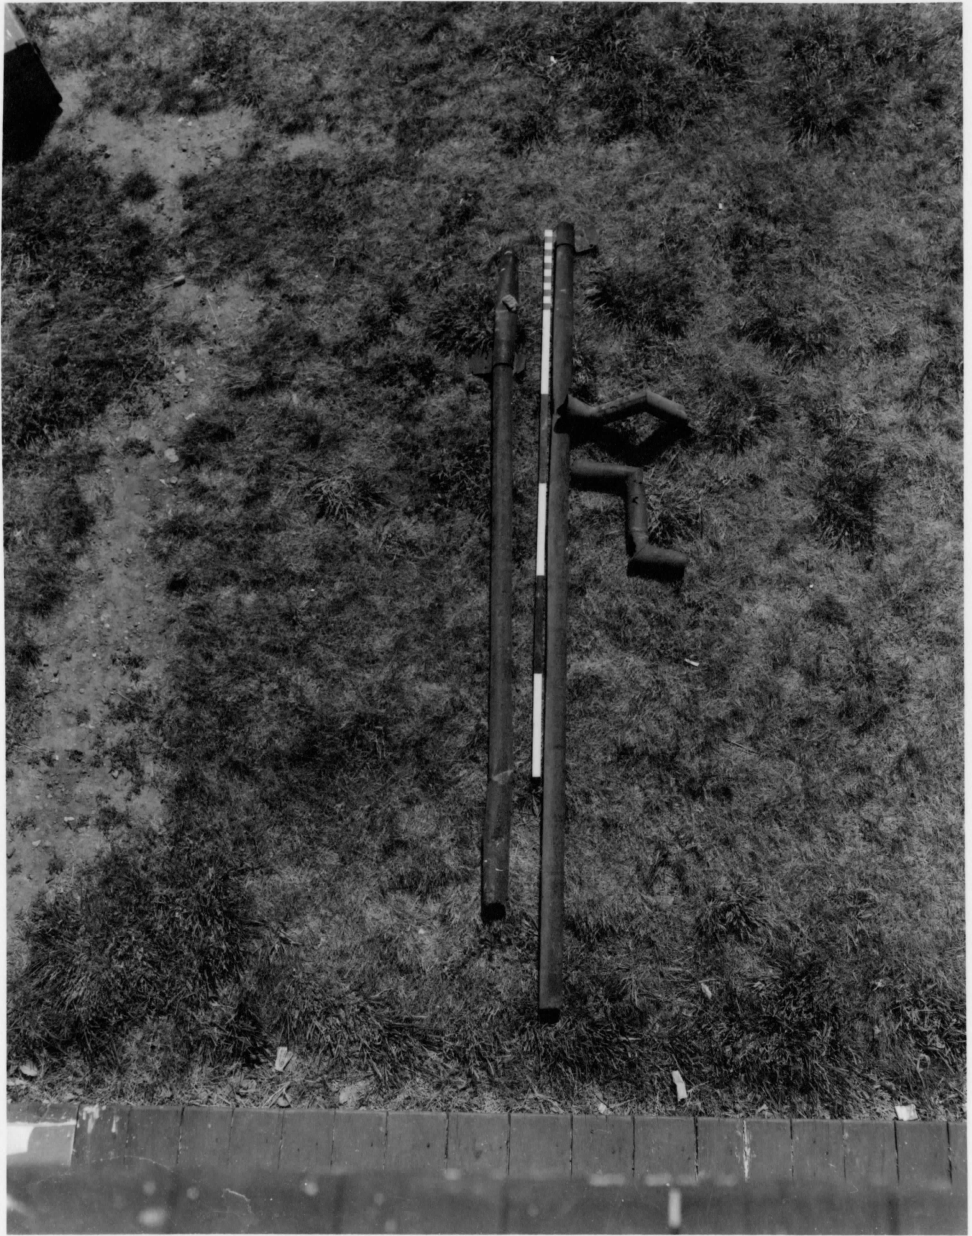
ILLUSTRATION NO. 1

The original downspouts, brackets and elbows from the existing County Jail, which were removed and stored in the attic, furnished the dimensions and information needed to fabricate the new pieces.

The existing raised seam tin roof which is still in good condition was not removed, but repainted with Dixon's black roof paint. This work was done by George Farrer of Appomattox, Virginia. The modern gutters and downspouts were replaced with new material fabricated from galvanized metal with a double rolled bead (a bead on each side of the gutter) and strengthened with concealed straps. These were made by the Consumers Company of Lynchburg. A soldered bead was placed every 14" along its length to simulate fabrication techniques of the mid-nineteenth century. The downspouts, elbows

and brackets were fabricated to match the original ones removed from the building and stored in the attic some years ago (See Illustration No. 1). These pieces were returned to the Jail attic to prevent them from being indiscriminately discarded.

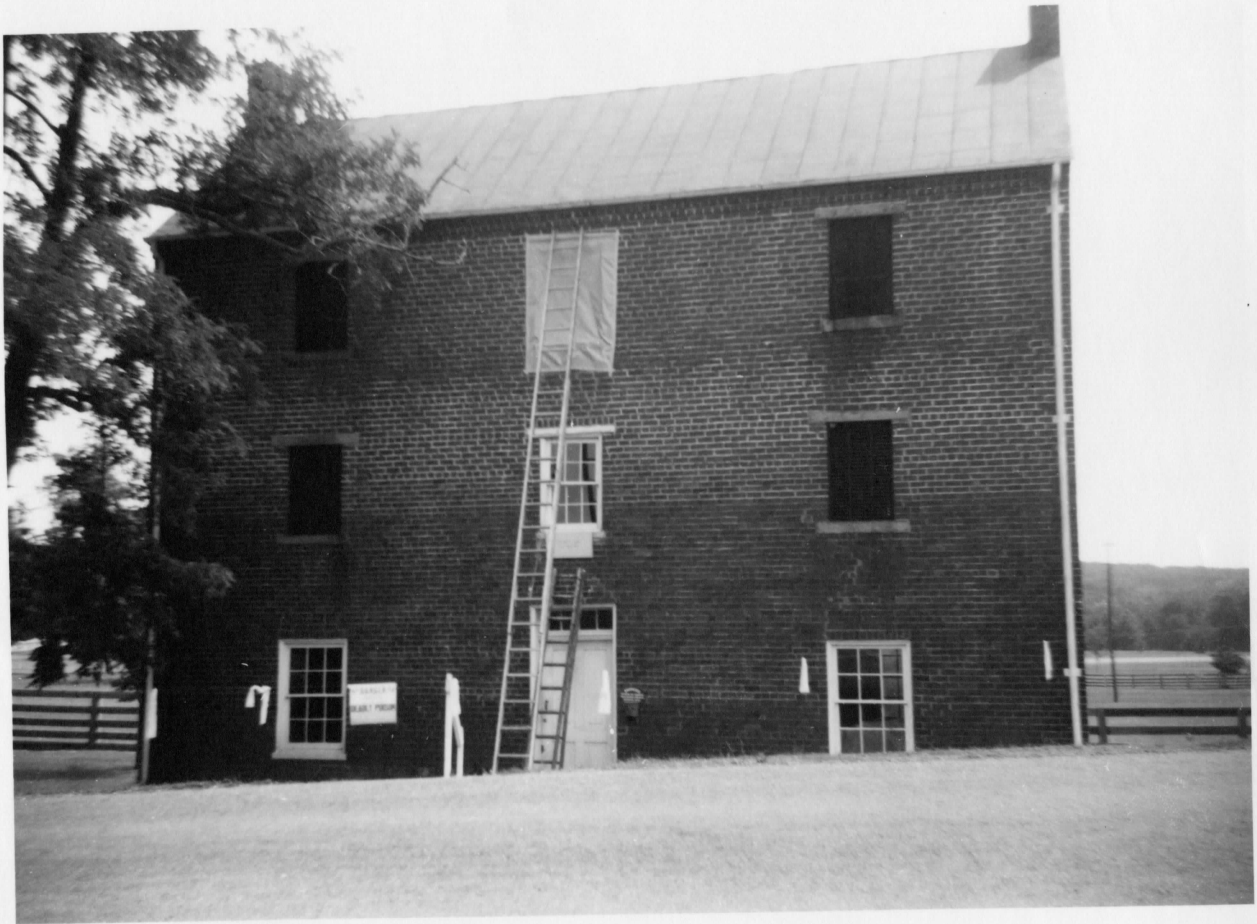
ILLUSTRATION NO. 2

Fumigation of the building was accomplished August 7 & 8. All of the window and door openings were sealed from the exterior and the gas remained in the structure 24 hours. This view shows the Jail before the Stage Road was lowered to its original grade in 1964.

Fumigation of the County Jail building was accomplished August 5-6, 1963 and spray treatment of the interior floor joists on all floors was completed August 7-8. Rodding of the exterior grounds and application with a prepared chlorodane solution was accomplished in March 1965. This work was done by the Orkin Exterminating Company of Lynchburg, Virginia. Termite treatment of the replaced floor joists, first floor, was done by spraying with pentachlorophenol as the job progressed.

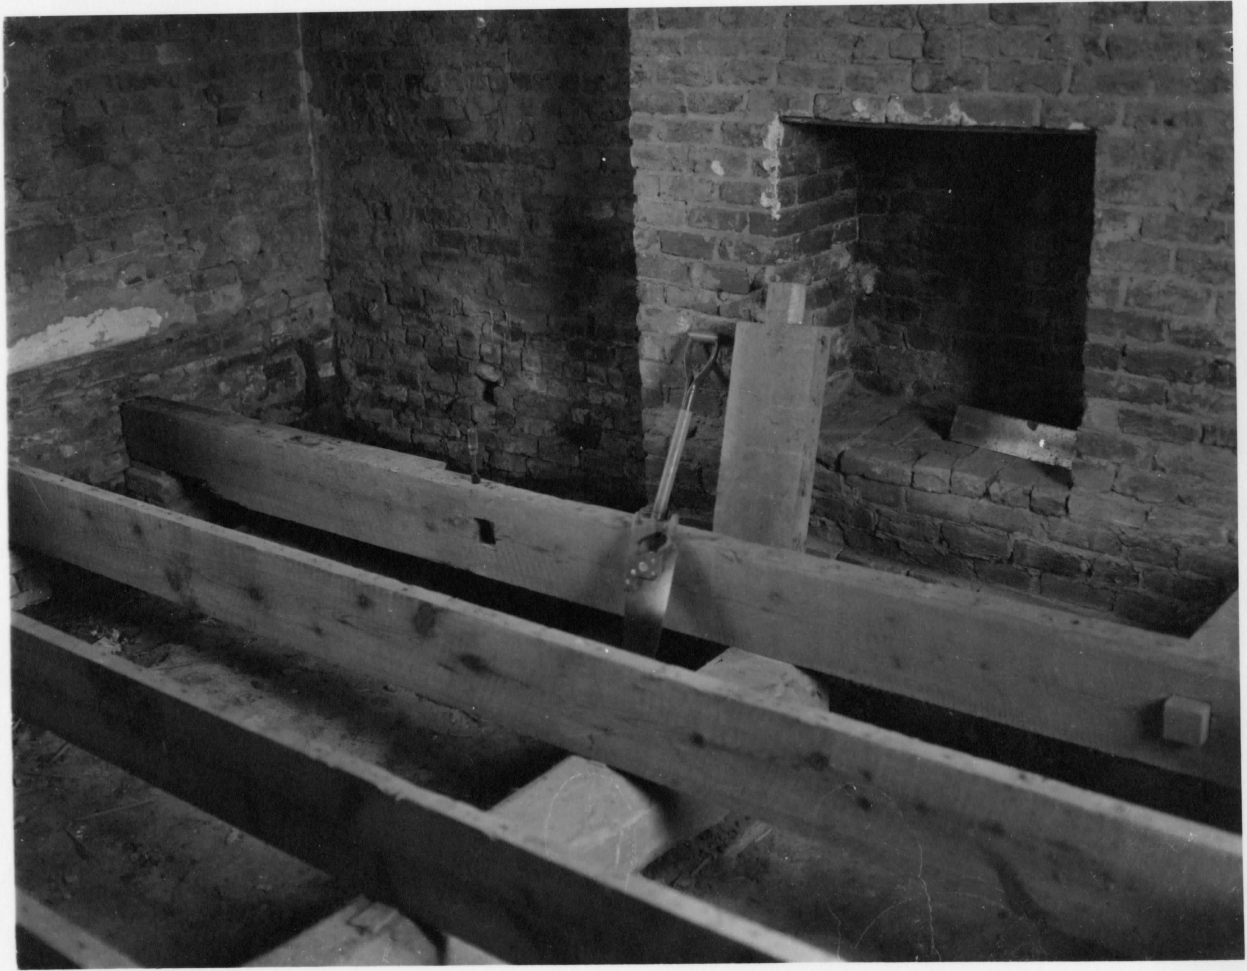
ILLUSTRATION NO. 3

After rehabilitation work started in 1964, close inspection of the floor boards and floor joists in the east and west rooms disclosed termite damage to these members far in excess of the 1963 examination. All of the floor boards and practically all of the floor joists were replaced. Many of the floor joists were

found to be replacements, probably earlier work of the Park Service. These newer members were also damaged by termites and required replacement. The new joist ends which pocketed into the brick masonry wall were protected from moisture by nailing on a 40 pound tin cap. All of the floor boards, floor joists, the surrounding masonry work and soil under the floor were heavily sprayed with pentachlorophenol.

Interior view of the east room, first floor, after the removal of the floor boards. Like the floor boards, most of the floor joists were replaced because of termite damage.

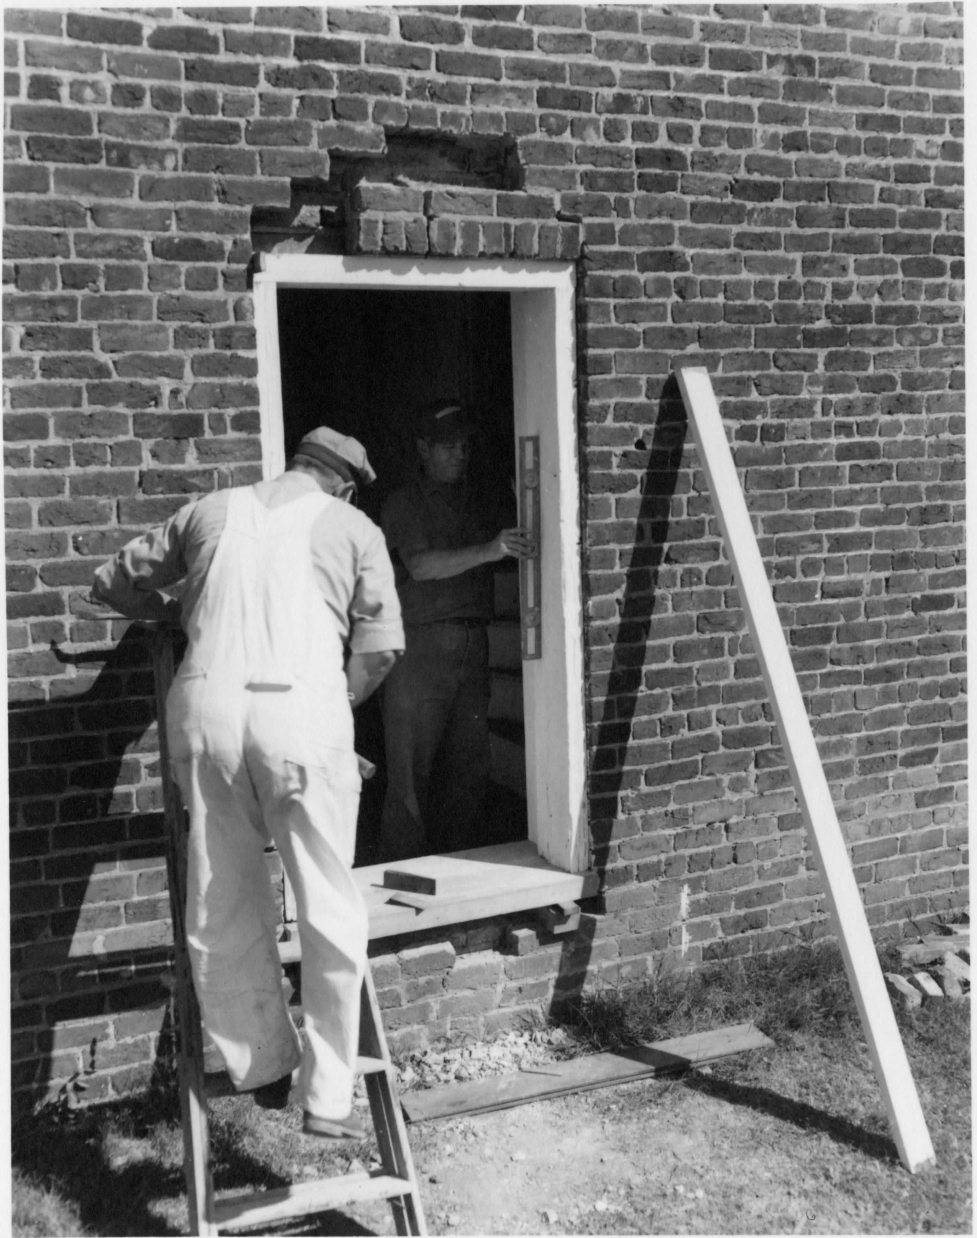
ILLUSTRATION NO. 4

The south door involved more work than originally thought. The door frame was originally constructed with a wooden

door sill, long removed and replaced with bricks. This was replaced. A weak section of brick masonry wall above and below the door frame was taken out and relaid (See Illustration No. 4). A small wooden platform with two steps was constructed at the exterior of the south door.

Replacing the wooden door sill, south wall, first floor. The small brick section above and below the door frame was removed but replaced in the manner found. Carpenter, George Page, left, and helper, Hampton Hunter.

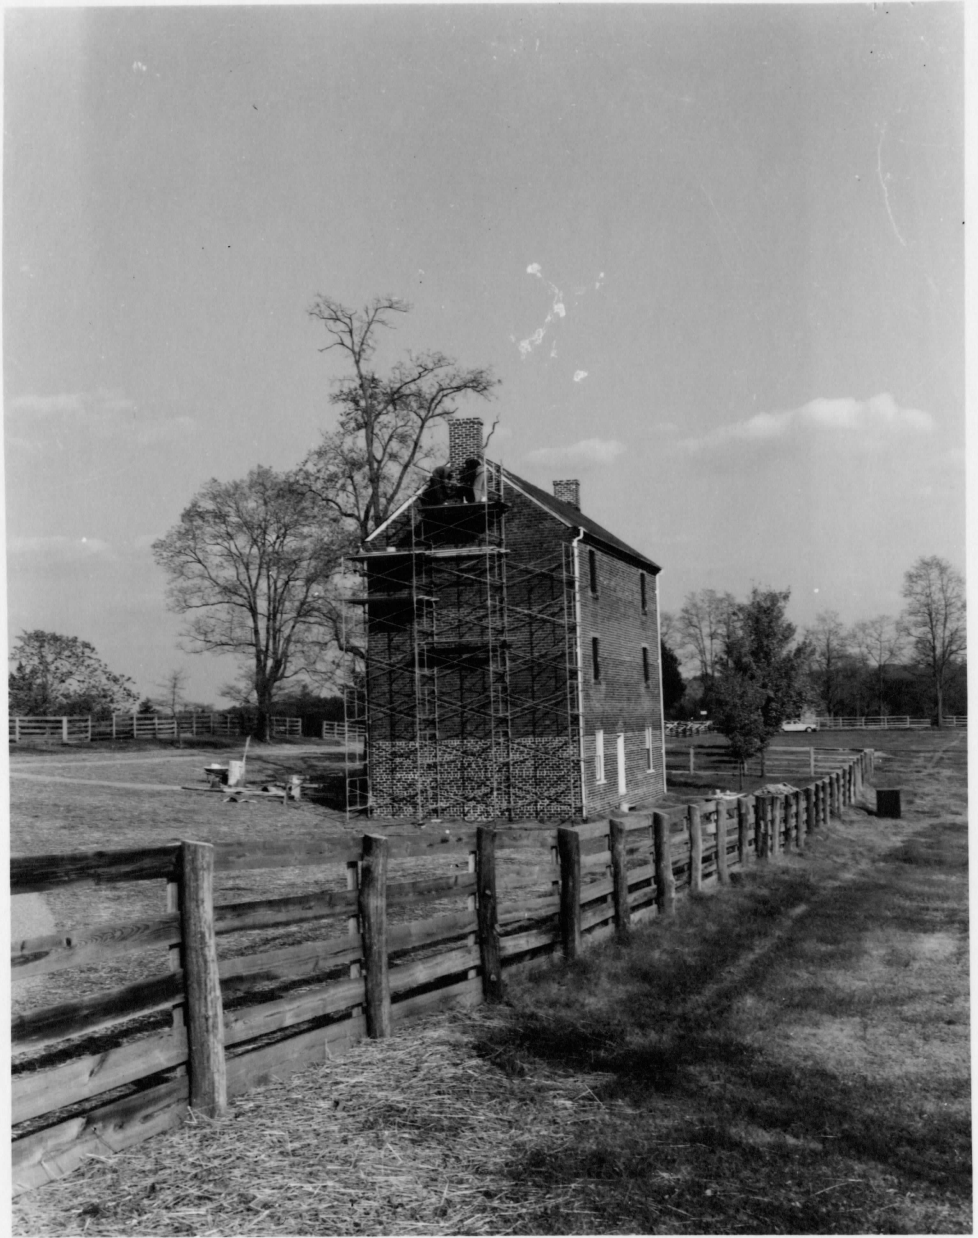
ILLUSTRATION NO. 5

The workmen are penciling the brick mortar joints on the west wall. Scaffolding was rented from a Lynchburg company to do this job. "Hydrozo" waterproofing was sprayed over the entire surface of the south and west walls.

The brick mortar joints were penciled with a one-quarter inch wide white lead stripe, both vertical and horizontal directions. Illustration No. 6 shows the original penciling that remained on the west wall.

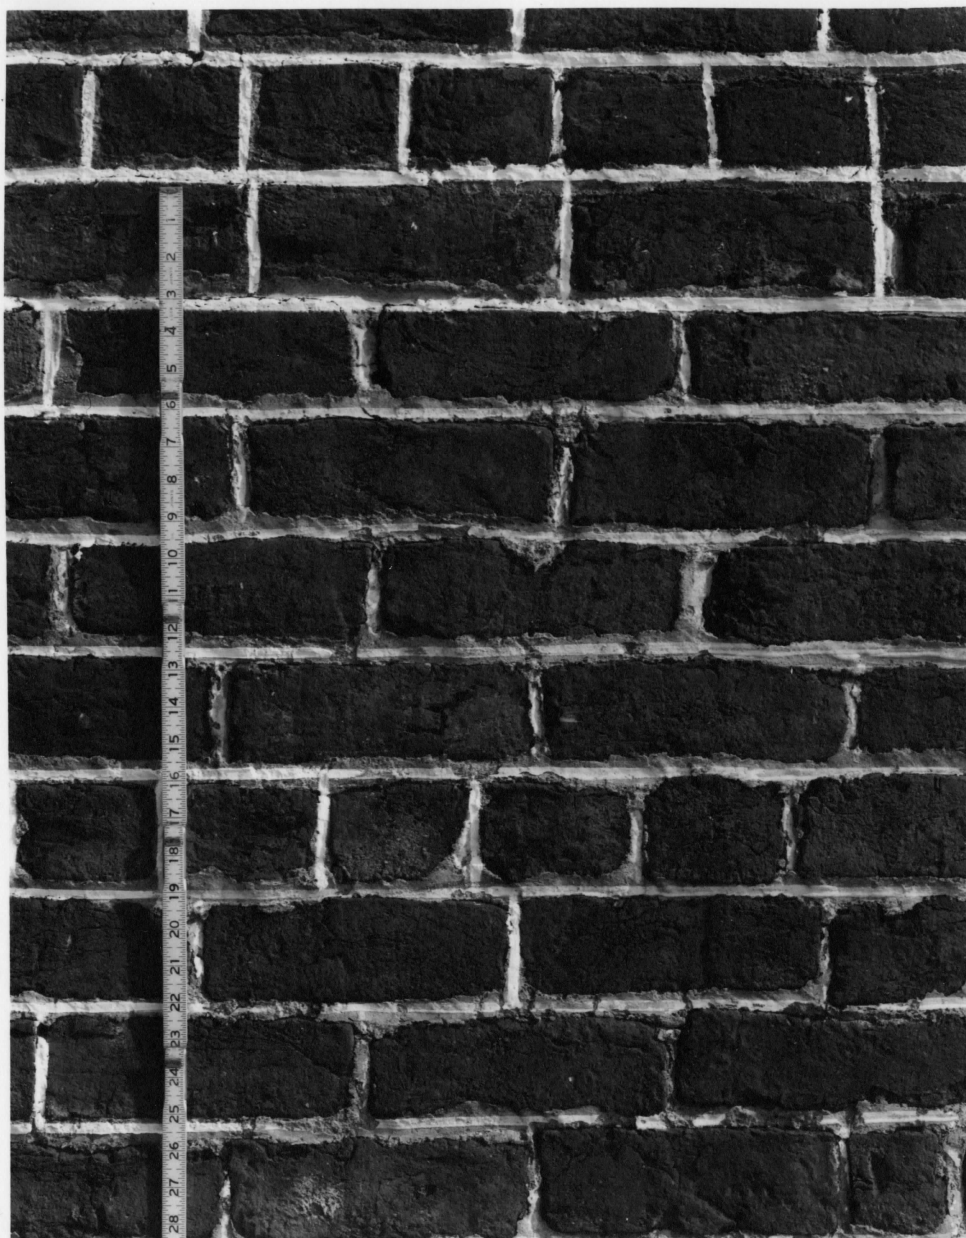
ILLUSTRATION NO. 6

Good evidence remaining from the original penciling job on the west wall. No straight edge was used to stripe the joints. The use of pencil work over the brick joints achieved a "dressed-up" look with the use of a 1/4" wide stripe applied to the horizontal and vertical joint. The top three mortar joints were penciled the same day the photograph was taken, October 27.

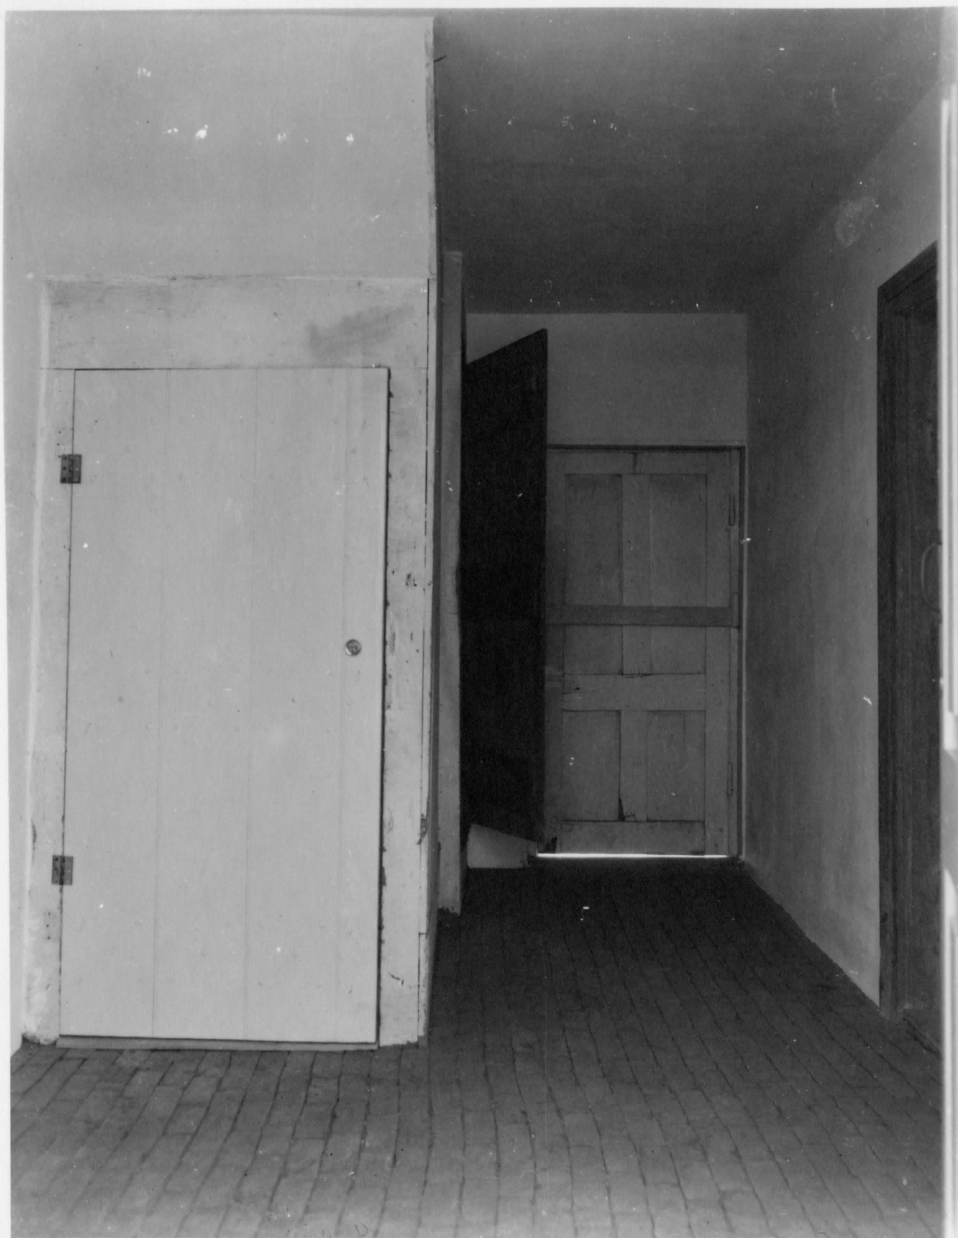
ILLUSTRATION NO. 7

The deteriorated brick floor in the hallway was removed and replaced with hand-made bricks from the Locher Brick Company. The original brick pattern was recorded prior to removal and retained when the new floor went in place. All of the useable bricks salvaged from the original floor were used for paving the closet floor under the stairway (this was always an earthen floor). The bricks were laid on edge over a bed of cement and sand.

Hallway, first floor, looking south. The floor was replaced as shown with new hand-made bricks. The salvaged bricks from the original floor were used for paving the floor of the closet. Closet door is new.

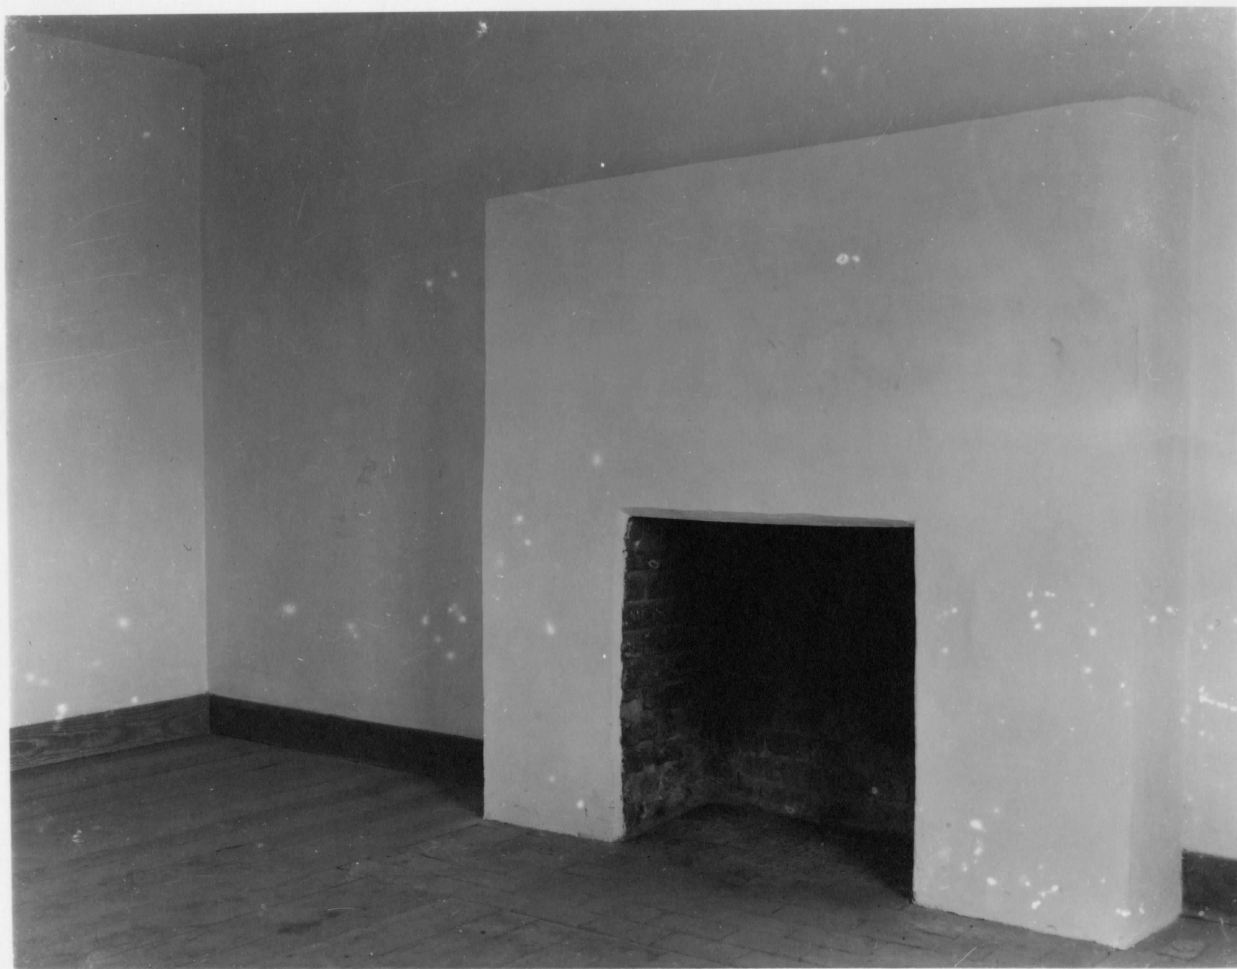
ILLUSTRATION NO. 8

East room, first floor, after the  
hearth, plaster walls and ceiling and floor  
boards were replaced.

New bricks were used to relay both first floor fireplace hearths. The bricks were laid dry over a cement and sand bed.

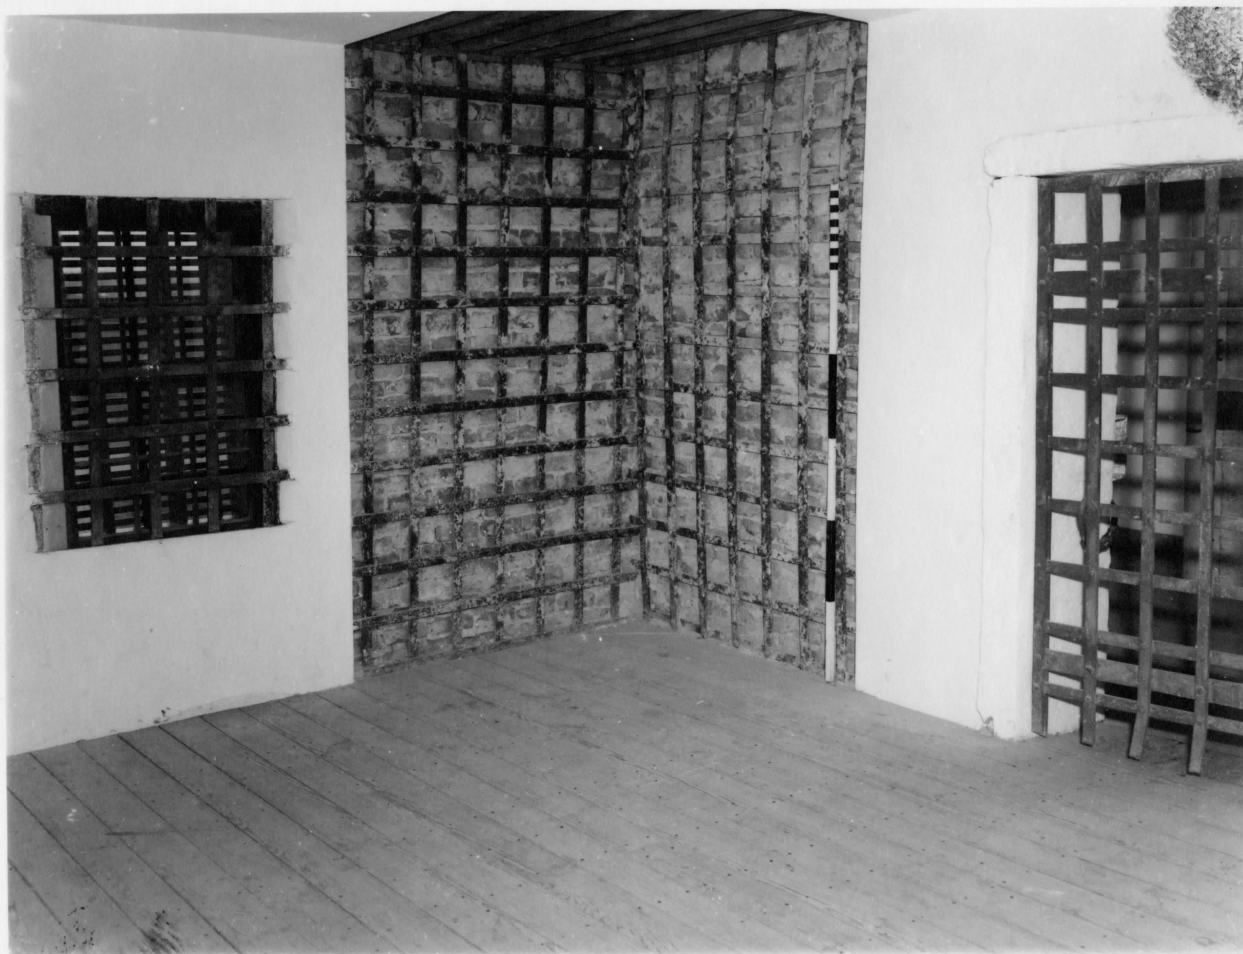
ILLUSTRATION NO. 9

It was recommended in the Architectural Data Section of the Part II Report, that the west cell remain in the condition left by the C.C.C. stabilization job of 1941, that is, with the iron grille work on the walls and the (metal reinforced) ceiling joists to be unplastered. During progress of the job it became apparent that this situation would present a daily maintenance problem with bits of mortar spalling off onto the floor. The writer recommended to the Superintendent that the entire room be plastered with the exception of a small section of wall and ceiling area which would serve to illustrate to the public the type of materials used throughout the construction of the cell rooms and the building methods employed during its erection. This effect would have to be reinforced with written material, possibly placed on a placard or by an audio station. This proposal was agreed upon as a satisfactory solution, whereupon a small section of wall and ceiling area was left unplastered in the northeast corner of the room (see Illustration No. 9).

West cell room, second floor, where a section of the iron work, sheathing the wall, was left exposed to view. A portion of the ceiling structure was also left visible to help interpret the Jail story.
