HISTORIC STRUCTURES REPORT

REHABILITATION OF THE TAVERN GUEST HOUSE

CLOVER HILL TAVERN GROUP

APPOMATTOX COURT HOUSE NATIONAL HISTORICAL PARK  
Appomattox, Virginia

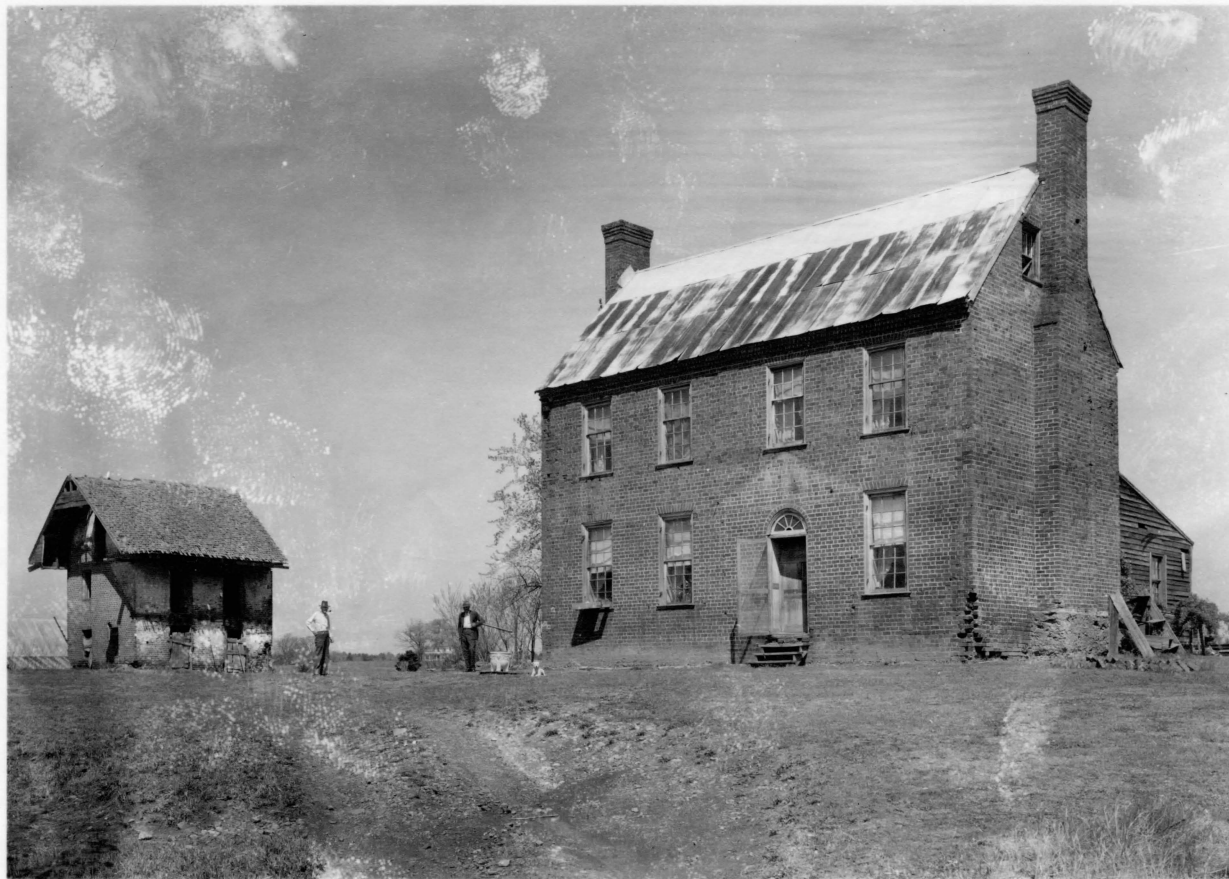
ILLUSTRATION NO. 1

Early view showing the relationship of Clover Hill  
Tavern (right) and the Tavern Guest House (left). Both  
structures are assumed to have been built in 1819. Note  
serious deterioration of the building.

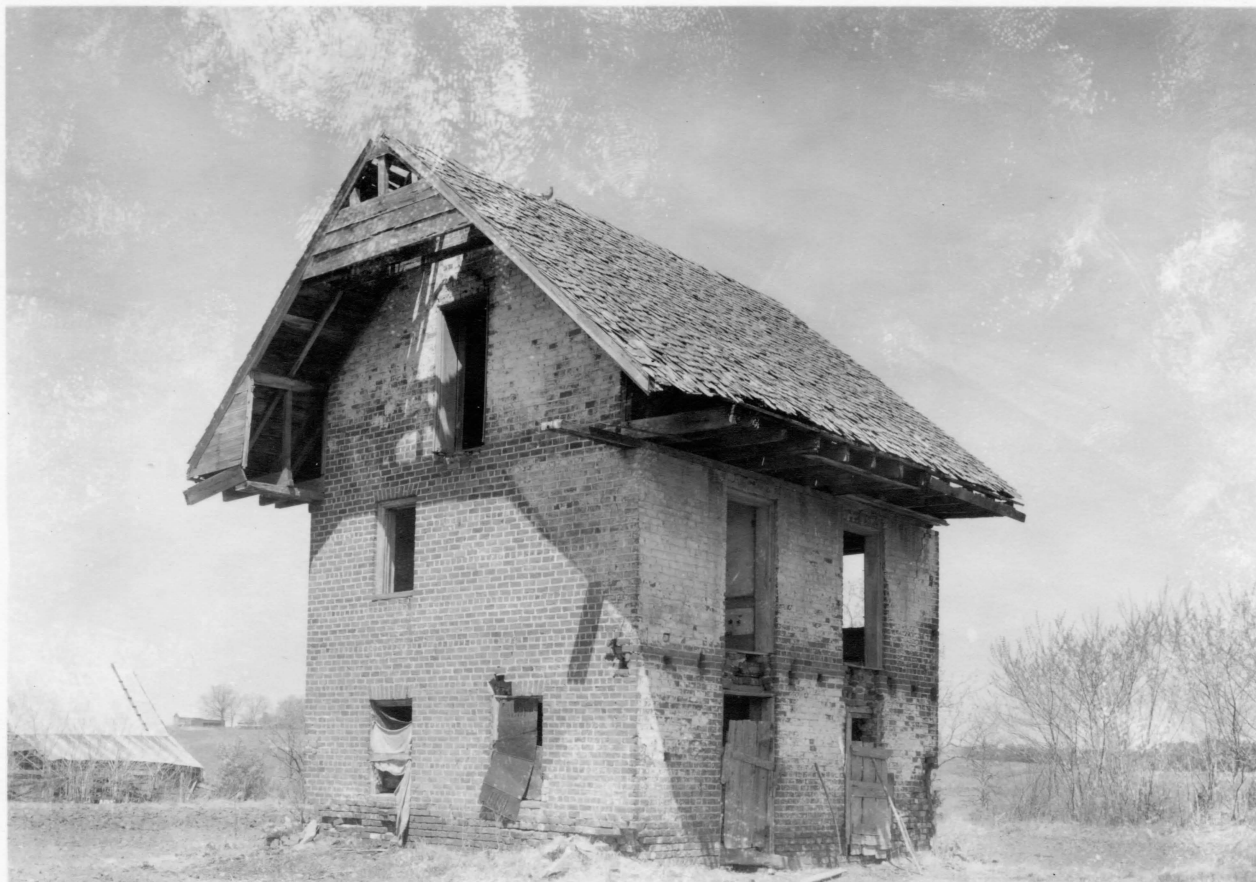
ILLUSTRATION NO. 2

Structural evidence existing in masonry work that helped in determining porch locations can be seen by the beam pockets on the east wall just below the door openings on the 2nd floor. Also, a beam pocket that once supported the stairway to the 3rd floor is visible at the junction of the whitewash line and the wall corner near the center of the photograph. The deteriorated condition of the structural members is evident from this view.

Nothing remained of the original porches except joist pockets and an outline on the wall indicating the floor and ceiling levels and the location of the stairway leading from the second to the third floor. (See Illustration No. 2). The reconstruction of these porches is largely conjectural. The post detail was patterned from a post on a building of similar age on Main Street in Amherst, Virginia. Porches of this type are very vulnerable to weather and only a limited life can be expected. To protect our investment for these porches, very rigid specifications for materials were prepared. Unfortunately such material was difficult to locate and permission was given to the suppliers to downgrade. When these porches are again rebuilt we should make no concession on material quality.

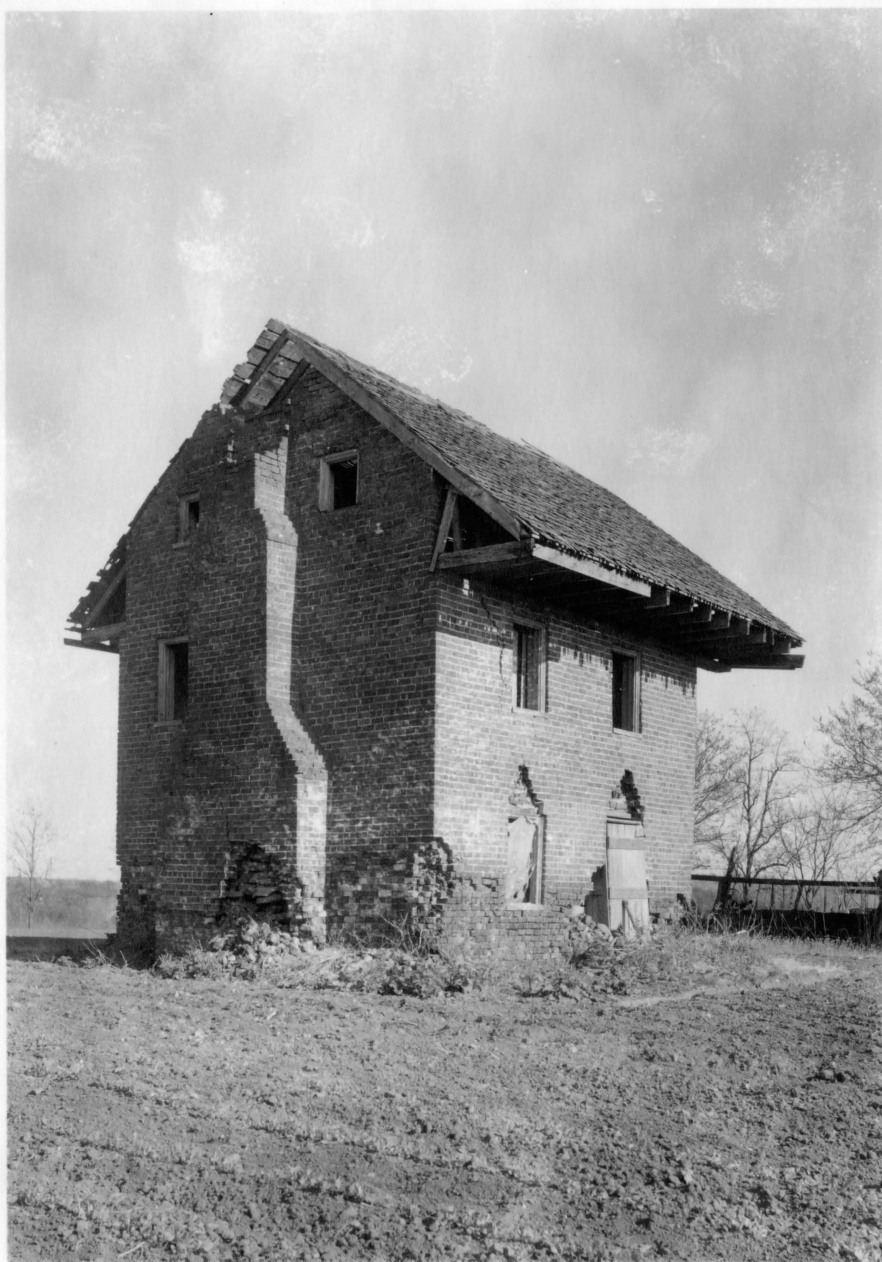
ILLUSTRATION NO. 3

View prior to stabilization by CCC Job  
No. 37. Structural failure in the masonry work  
can be seen clearly above the door and windows  
and at ground level. The chimney stack is partially  
missing and its base was failing rapidly.

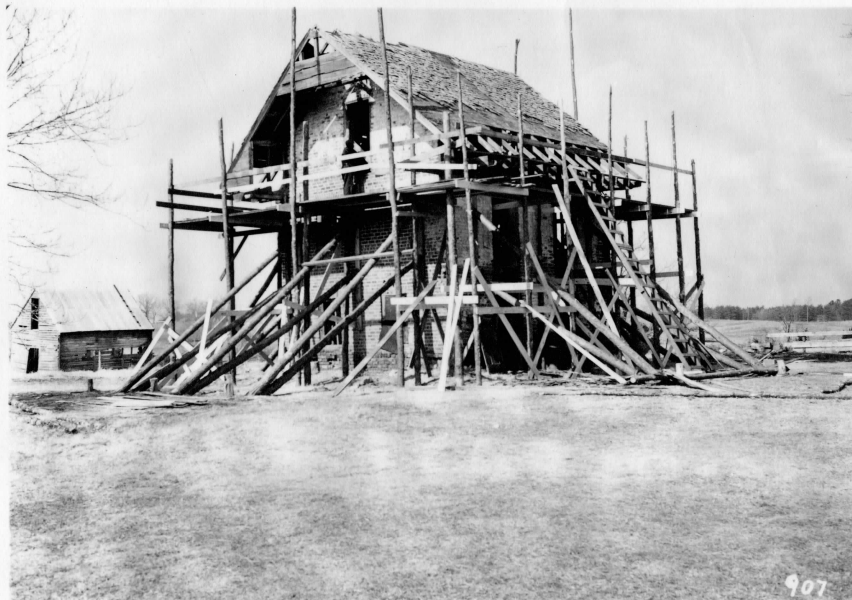
ILLUSTRATION NO. 4

Photograph taken February 1942, during  
stabilization supervised by Earl Carner, CCC Job  
No. 37.

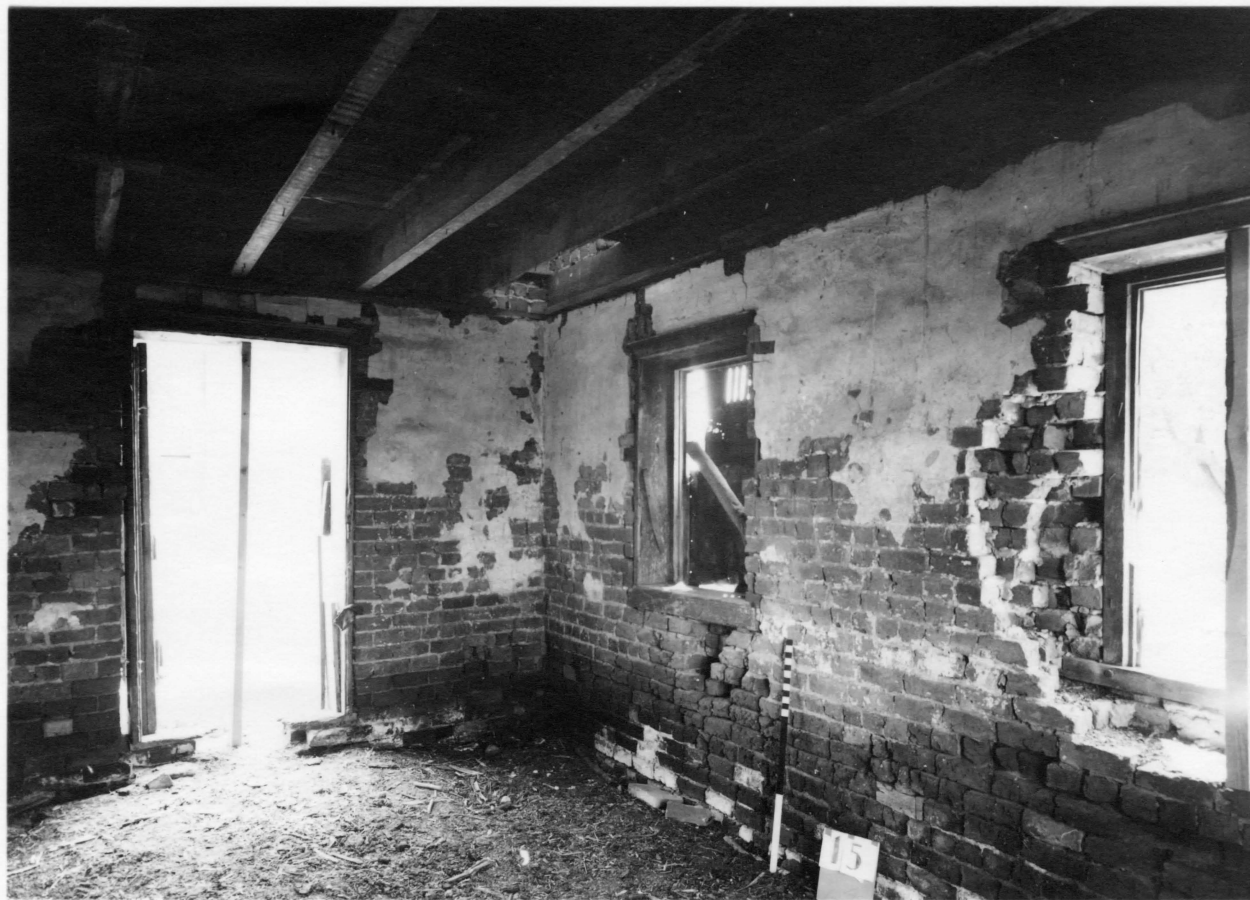
ILLUSTRATION NO. 5

Condition of interior room on ground floor.

The masonry work was found to be in such poor condition that the entire inner wall was removed and replaced with new work. A new brick floor was installed when evidence uncovered proved it superceded the wooden floor found in place.

The interior three courses of brick were removed small sections at a time and relaid to provide a bond and to fill the voids caused by the many cracked or rotted areas. A chase was made to run the modern electric service, water and sewerage lines to the upper floors within the wall area.

No conclusive evidence of the original flooring was uncovered. Mrs. Mary Ellen Hickok stated "It had a dirt floor with scattered brick inserts."<sup>1</sup> Such a floor was unsuitable for modern use as a display area. We have installed a brick floor over the entire area which can be removed if a future change is desired.

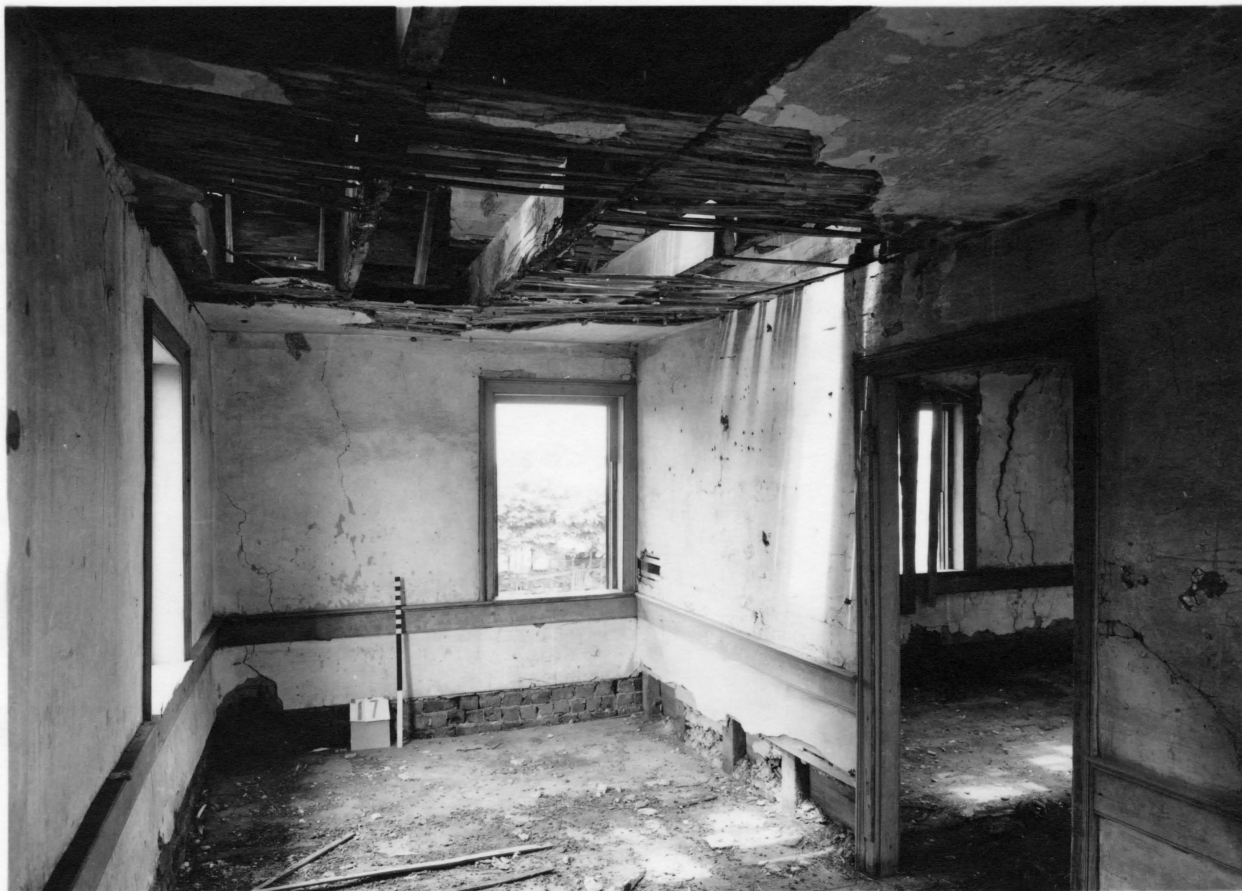
ILLUSTRATION NO. 6

Interior photograph showing 2nd floor rooms as found in 1940. These two rooms were converted into living quarters and required all new interior work. Interior partition and door were left in their original locations.

In converting the second floor into quarters for seasonal personnel, care was taken to preserve original woodwork and the original partition and inside door location. The room to the north was retained in its original form while the room to the south was divided into a closet, kitchenette, entry and bath. (See plan Drawing No. NHP-ACH 3003A Sheet 1).

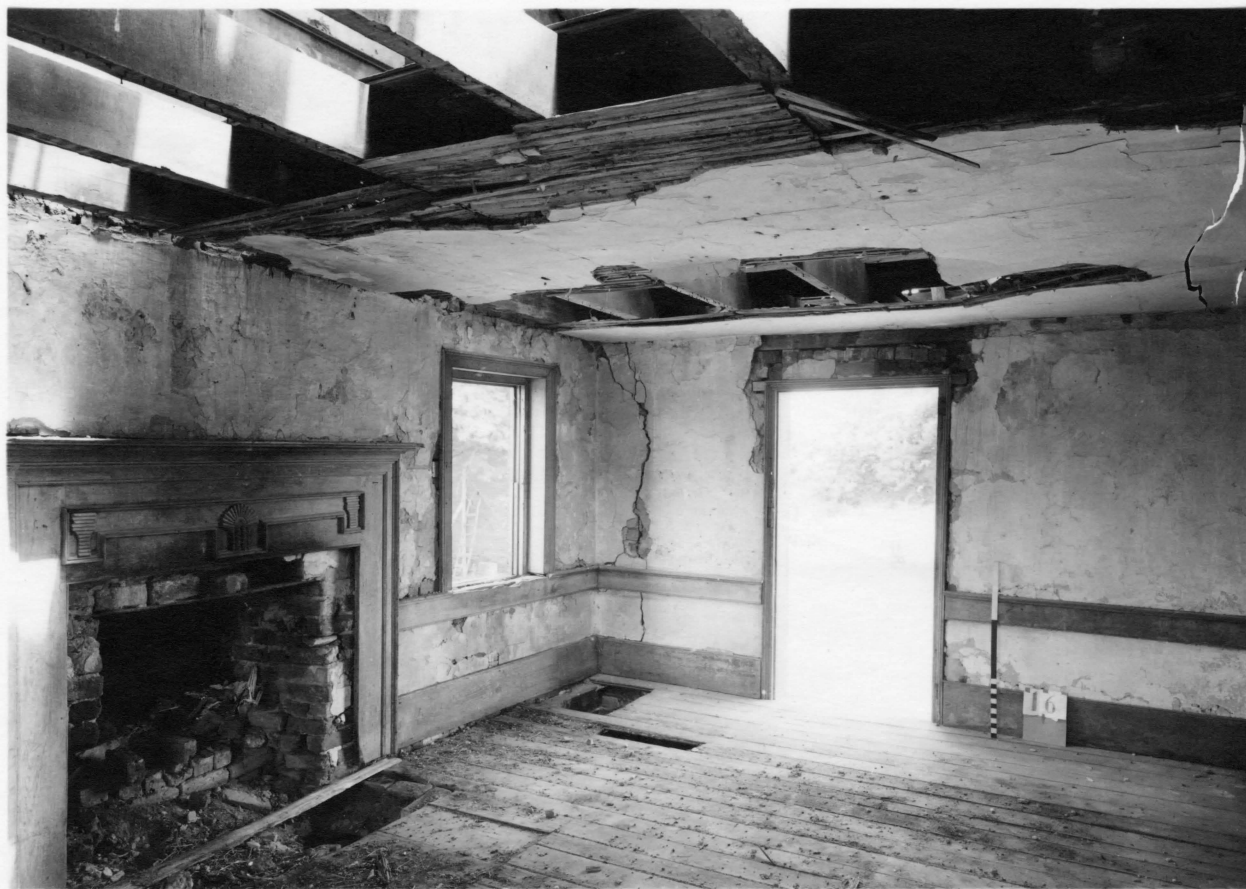
ILLUSTRATION NO. 7

Condition of room 210 is evident from this photograph giving some indication of the problems encountered in its rehabilitation. A large portion of the wall areas required removal and replacement with new material. Original woodwork including the mantel were retained where possible.

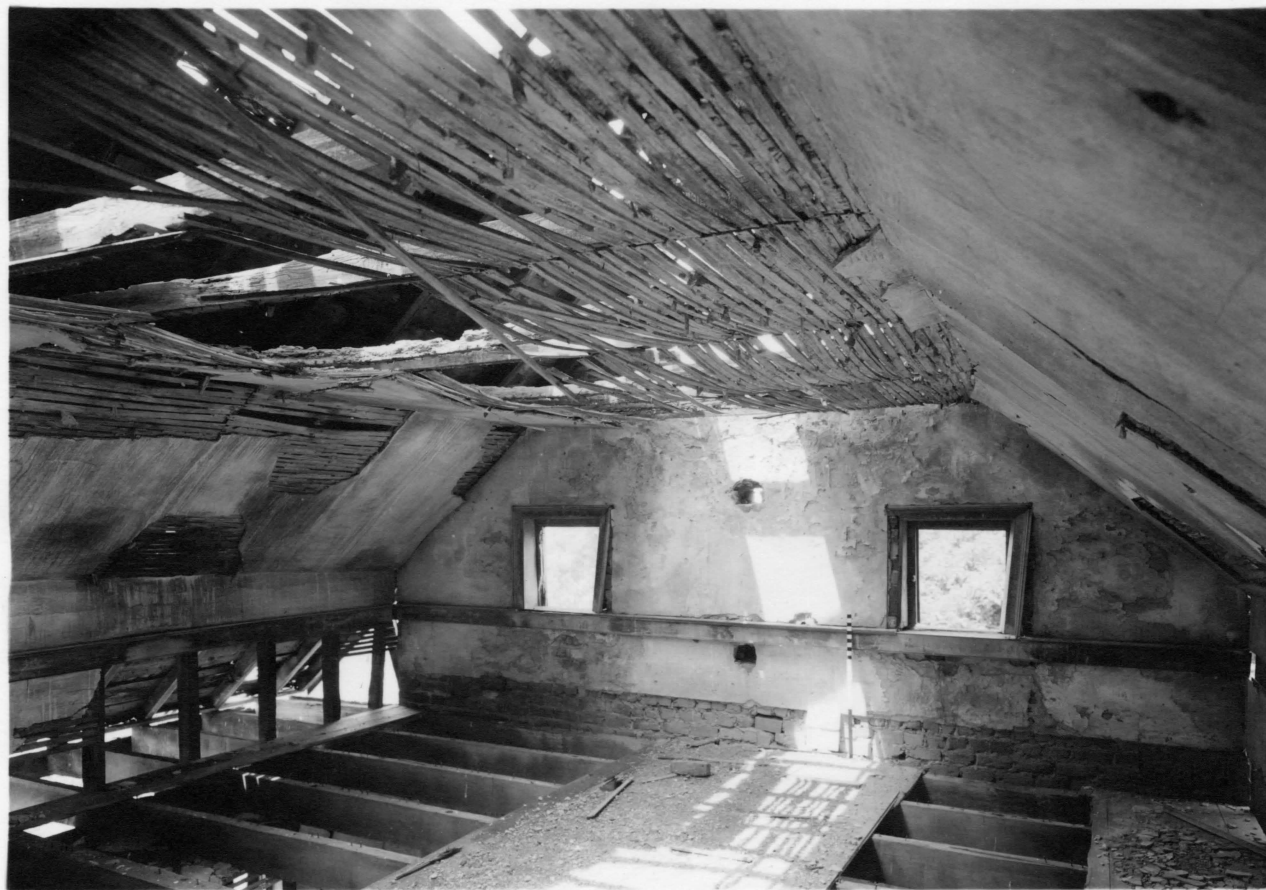
ILLUSTRATION NO. 8

The physical extent of deterioration is best shown in this photograph taken in the single loft room on the 3rd floor. Many of the joists and rafters no longer were able to do their work and required reenforcing or replacement.

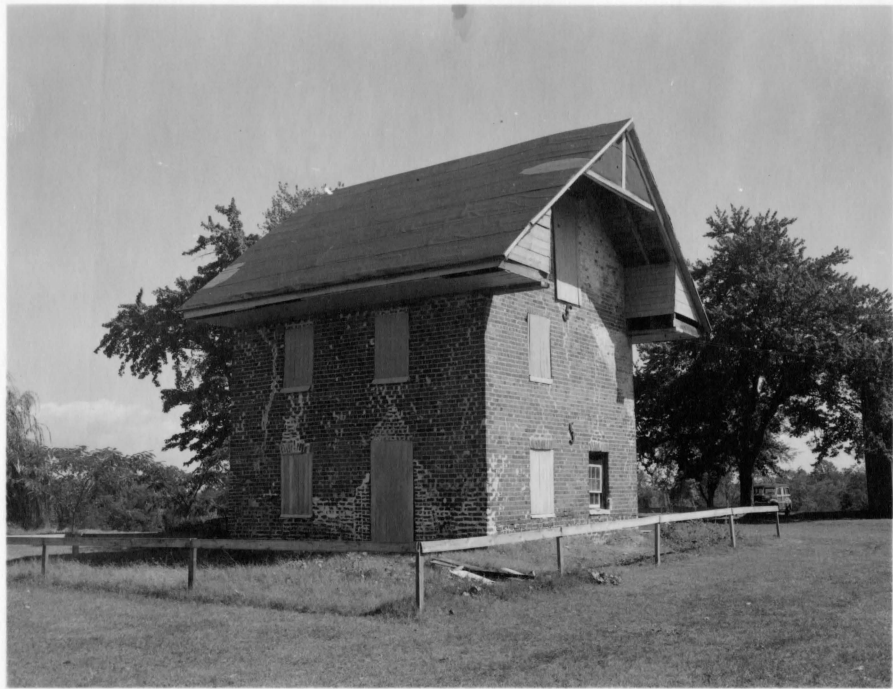
ILLUSTRATION NO. 9

Condition of building in 1956 prior to rehabilitation work. Tie rods were placed through the building on both floors in 1942.

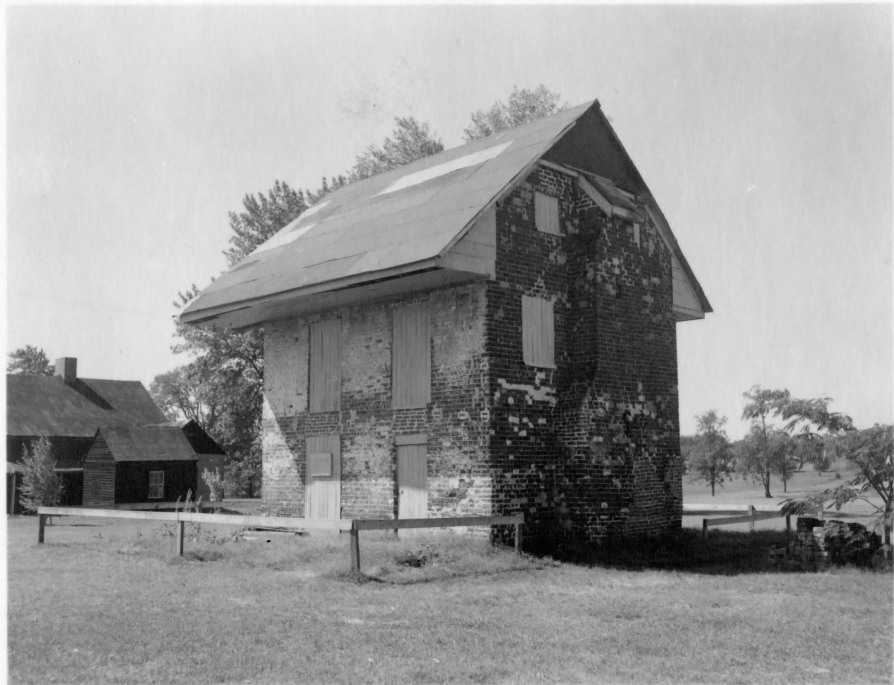
ILLUSTRATION NO. 10

Condition of building in 1956 prior  
to rehabilitation work.

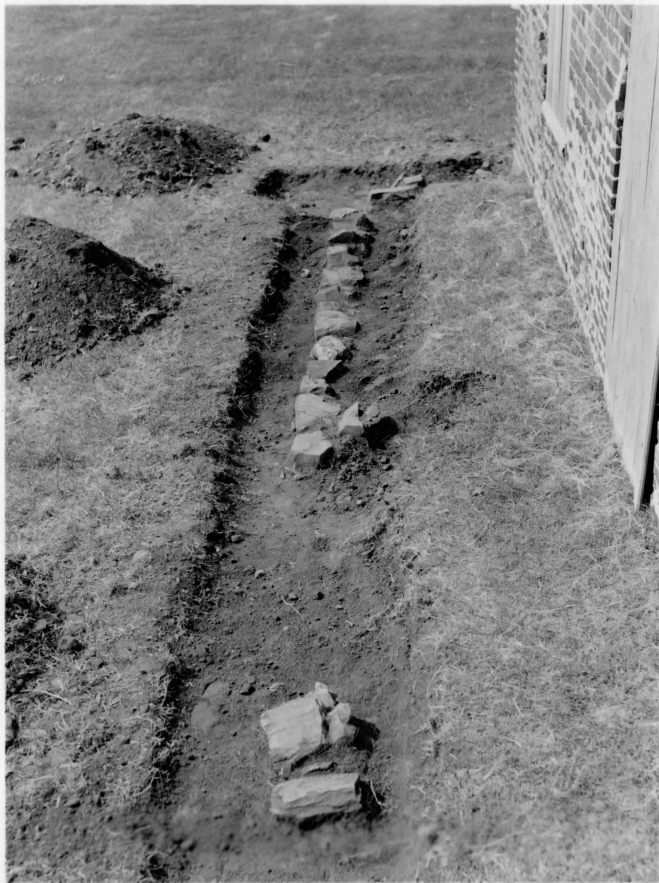
ILLUSTRATION NO. 11

Widths of porches were established by these  
excavations begun June 28, 1956, by J. D. Harrington.

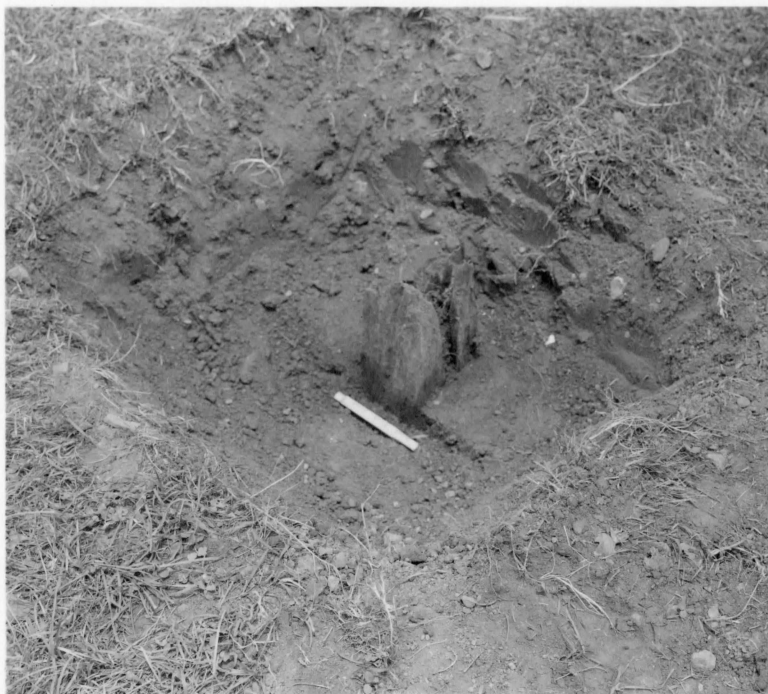
ILLUSTRATION NO. 12

Remains of a 4" by 6" wooden post uncovered  
by J. C. Harrington, 1956. Evidence such as this  
determined porch widths and position of posts.

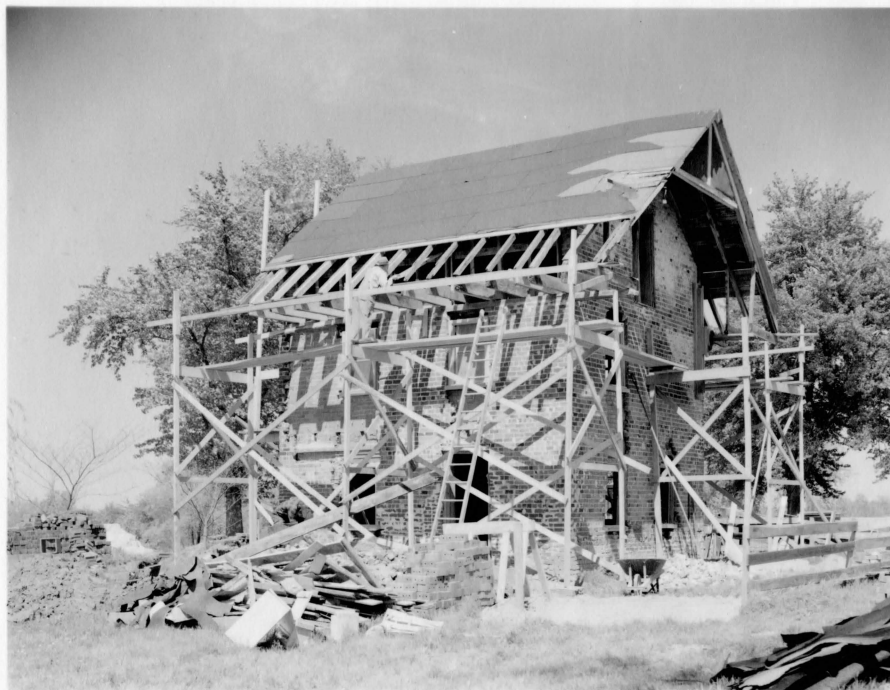
ILLUSTRATION NO. 13

Photograph taken during the early part of 1958 showing progress on the Tavern Guest House during restoration work. Original rafters and joists were reinforced and roof sheathing repaired.

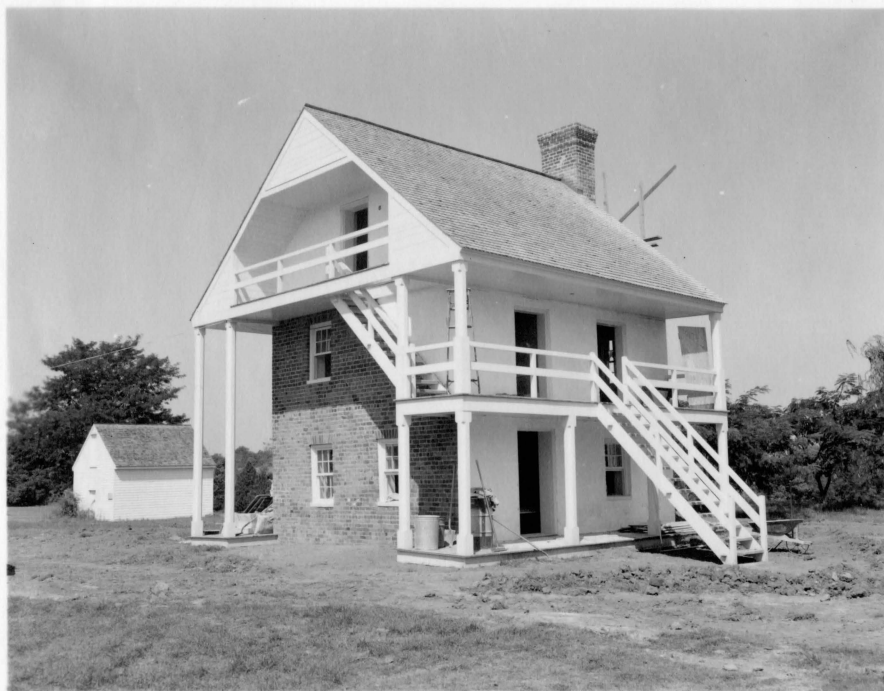
ILLUSTRATION NO. 14

View showing progress made within a few months after photo illustration No. 13. The chimney has been reconstructed and all faulty masonry work has been replaced or repaired and repointed.

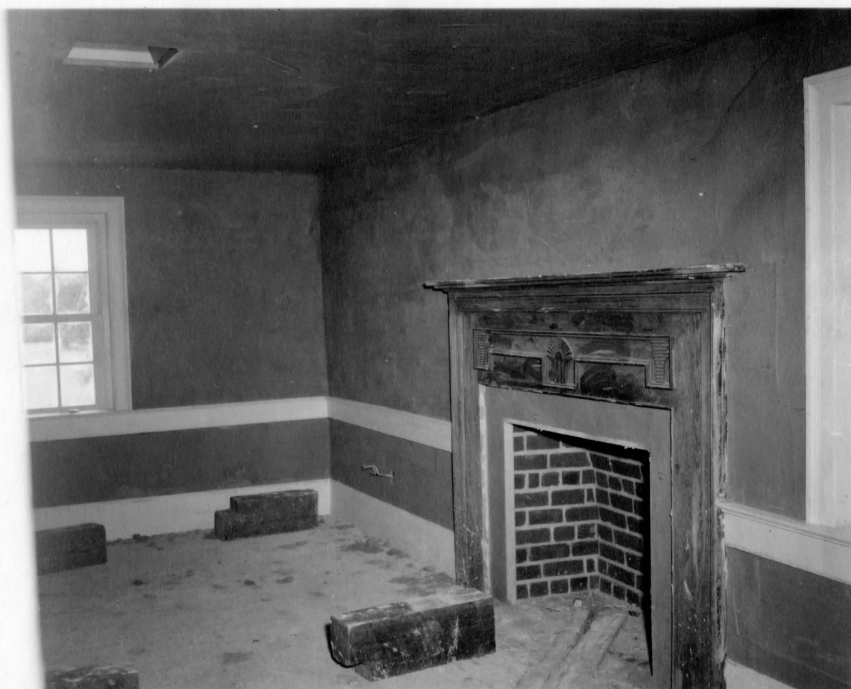
ILLUSTRATION NO. 16

View looking northwest on 2nd floor during process of plaster work. The 2nd floor of the Guest House was converted into living quarters with an operatable fireplace. A plywood subfloor was laid as a base for a vinyl-rubber tile finish floor.

Joists were replaced or reinforced as necessary and covered with a 5/8 inch plywood sub floor. A vinyl-rubber tile floor was installed in this area used as modern quarters.

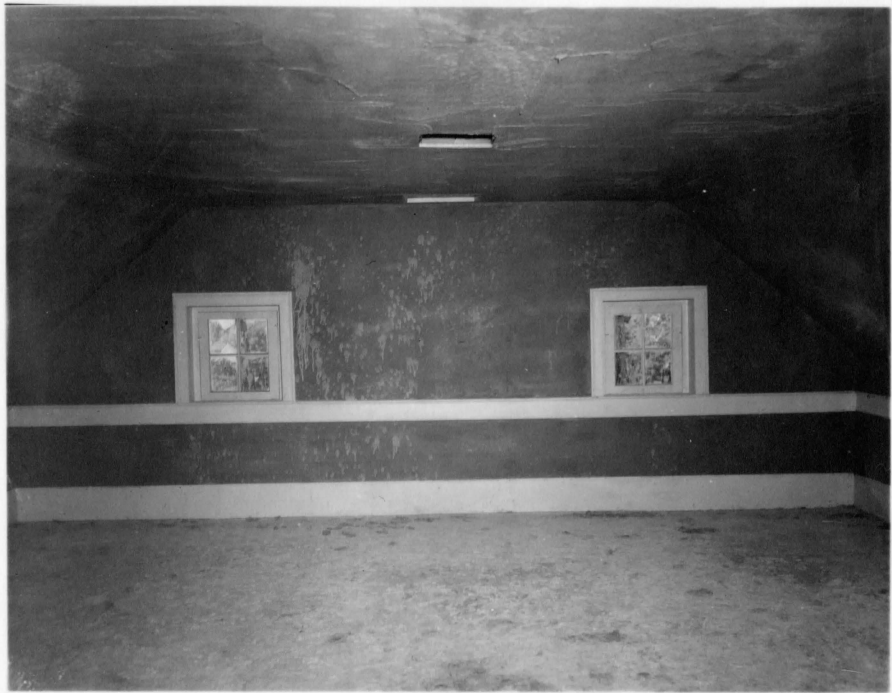
ILLUSTRATION NO. 17

View of plastering job about half finished. The third floor was plastered for easier maintenance and fire safety. The plywood subfloor remains unfinished.

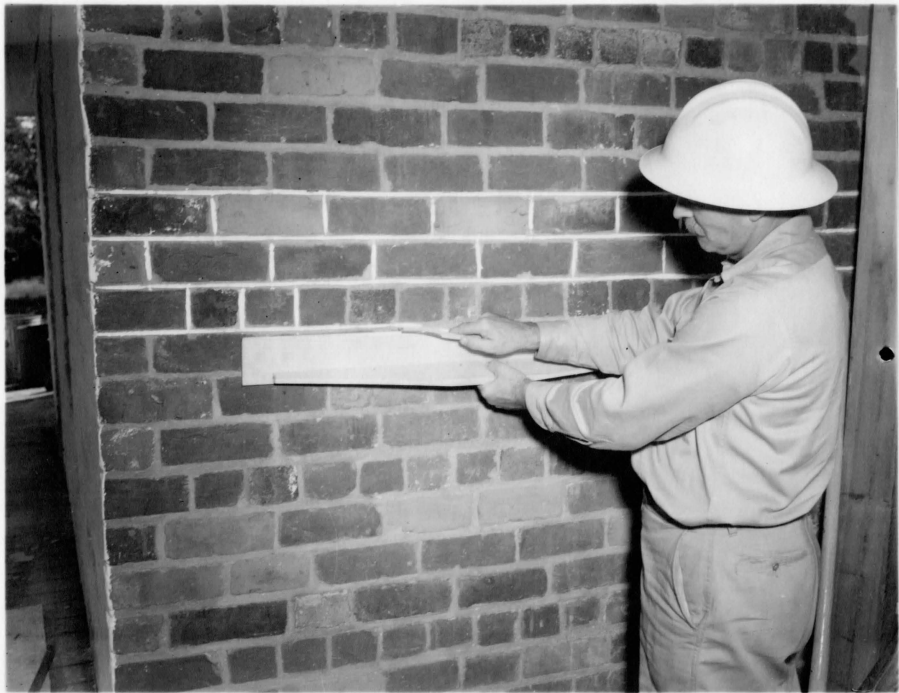
ILLUSTRATION NO. 18

The technique of penciling brick mortar joints is illustrated by H. V. Martin, BRS, EODC, on the walls of the Tavern Guest House. A special striping brush is made for this purpose.

Mortar joints on the brick walls were penciled with 1/4 inch stripes of white lead cut to a creamy consistency and applied with a special brush called a brick stripper.

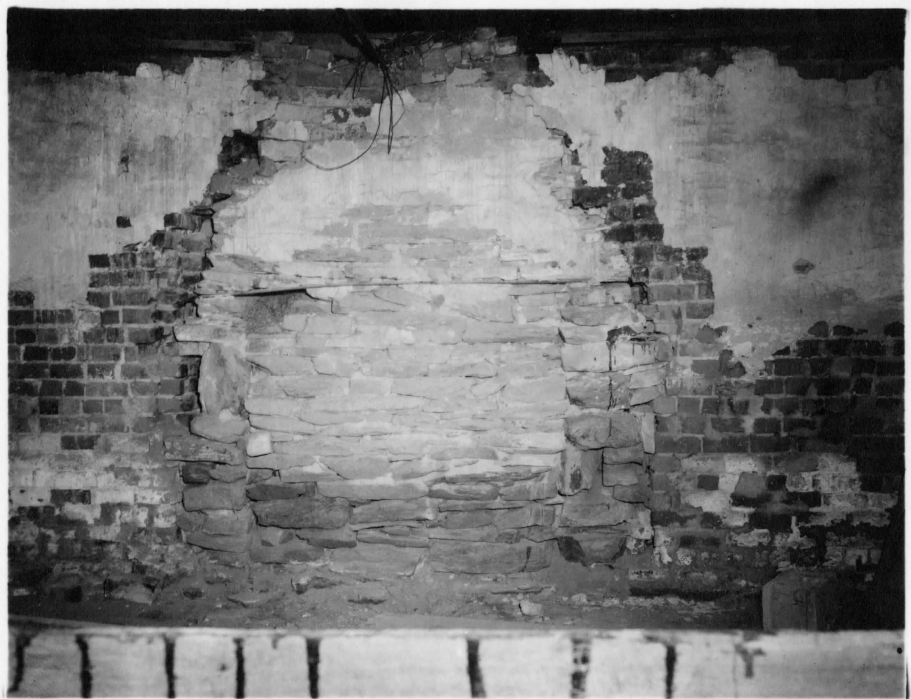
ILLUSTRATION NO. 22

The original fireplace was in ruins and the area shored up by filling with stone. No clear outline remained above grade to indicate the opening size (See Illustration No. 22). While checking the condition of the foundation and footings we found an outline indicating the width and depth of the fireplace. Broken brick on the wall face gave an outline which may have been the location of the jack arch over the opening. A small section of flue remained giving a fair idea of the throat area. Drawing No. NHP-ACH 3068 shows details of the fireplace as reconstructed. The flue was not carried above the first floor ceiling level.

Condition of first floor fireplace  
as found prior to the restoration.
