HISTORIC STRUCTURES REPORT:  
PHYSICAL FABRIC SECTION

THE CHARLES SWEENEY CABIN  
APPOMATTOX COURT HOUSE  
NATIONAL HISTORICAL PARK  
APPOMATTOX, VIRGINIA

by  
REED L. ENGLE  
January, 1988

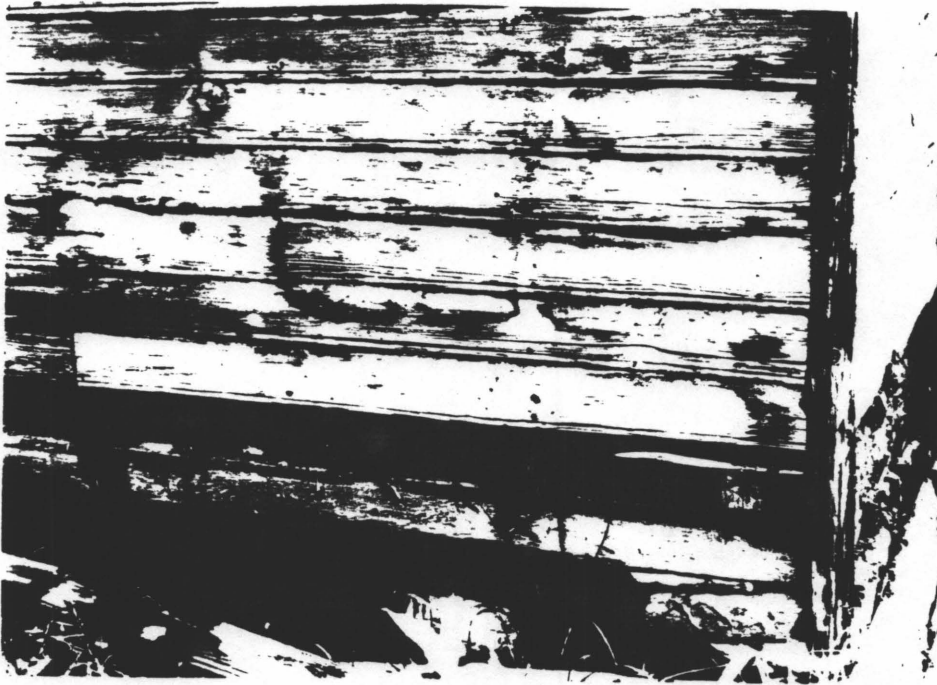
PHOTOGRAPH 9  
DETAIL OF THE  
REPLACEMENT SILL  
NORTHWEST CORNER OF  
THE NORTH ELEVATION,  
OF ORIGINAL CABIN.

The entire length of the original northern plate has been replaced by a 5 3/4" high by 7 3/4" wide, circular-sawn oak member. The studs are no longer jointed to the sill, but toe-nailed; their tenons were cut off when the new sill plate was installed. The new sill, as it is some 3 3/4" thinner than the original, has a similarly dimensioned gap with the west elevation sill plate.

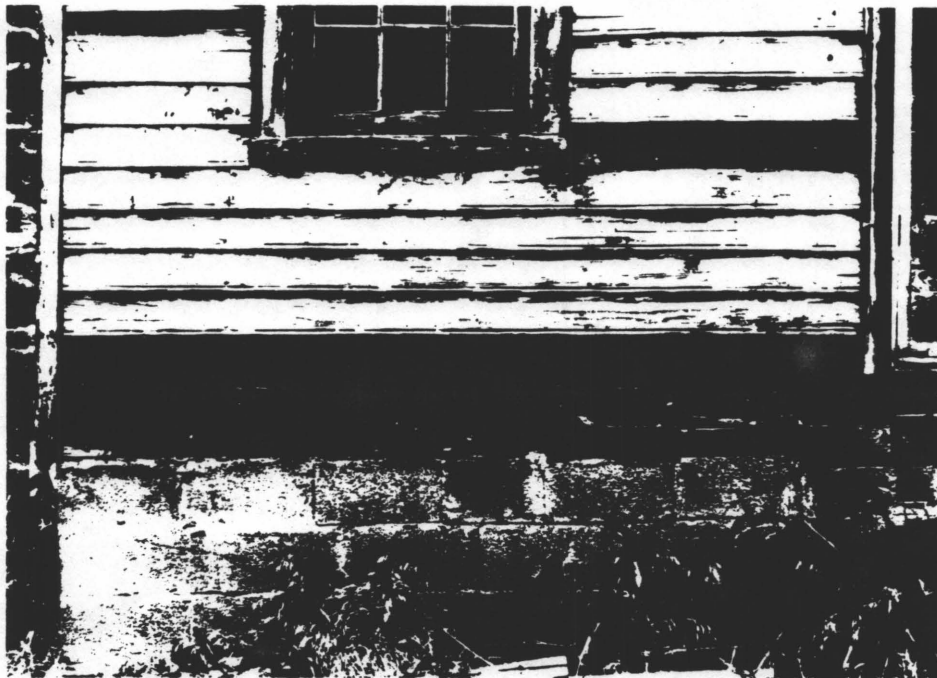
PHOTOGRAPH 10  
ORIGINAL CABIN,  
WEST END OF THE  
SOUTH ELEVATION  
SILL. THE ORIGINAL  
SILL (WEST OF THE  
DOOR) IS UNDERPINNED  
BY CONCRETE BLOCK  
DATING TO THE 1940s.

This replacement must have occurred when the existing CMU footing was installed as the block under the replacement portion of the sill is turned on its face to allow for the greater depth of this beam; the blocks under the original sill are laid correctly.

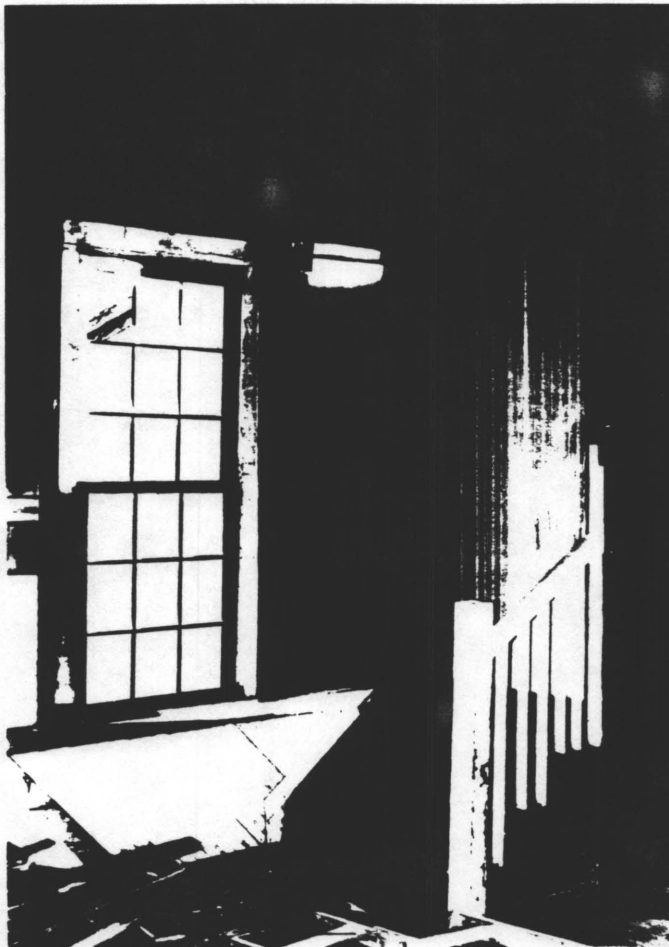
PHOTOGRAPH 24  
ORIGINAL CABIN,  
EXISTING STAIRCASE  
IN NORTHEAST CORNER.

The original staircase, though missing fifteen balusters, a section of rail, and the trim on the stringer parallel to the east wall, is in excellent condition.

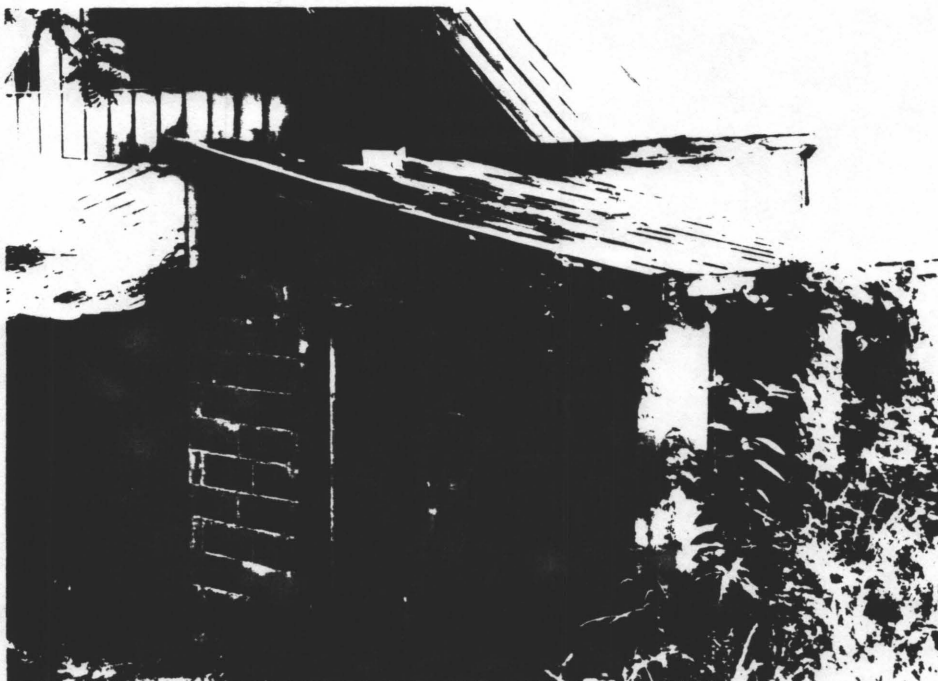
PHOTOGRAPH 32  
NORTH ADDITION,  
EAST AND NORTH  
ELEVATIONS.

The north addition is structurally sound but visually inappropriate. It is not "historic" by definition and will have to be removed to allow for the replacement of the north and east sills and the adjacent studs.
