## COMPLETION REPORT

APOSTLE ISLANDS NATIONAL LAKESHORE  
STABILIZATION OF HOKENSON'S FISH DOCK AND BUILDINGS

STABILIZATION ON HS-01-138B, HS-01-138A, HS-01-153A

STABILIZATION OF HOKENSON'S FISH DOCK AND BUILDINGS

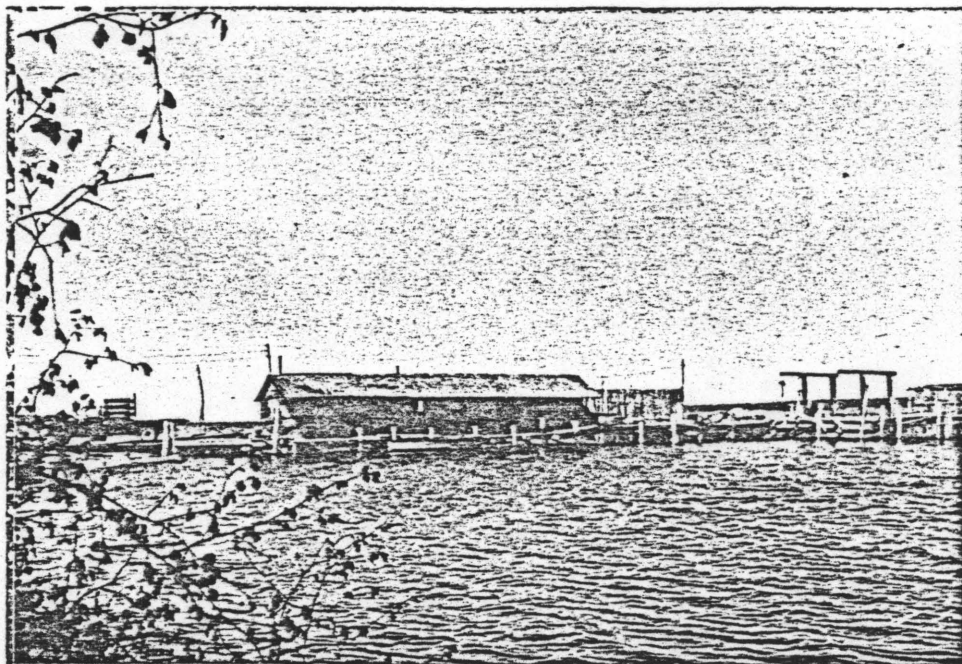
Photo showing the east view of the fish house and the docking facility. HS-01-138A

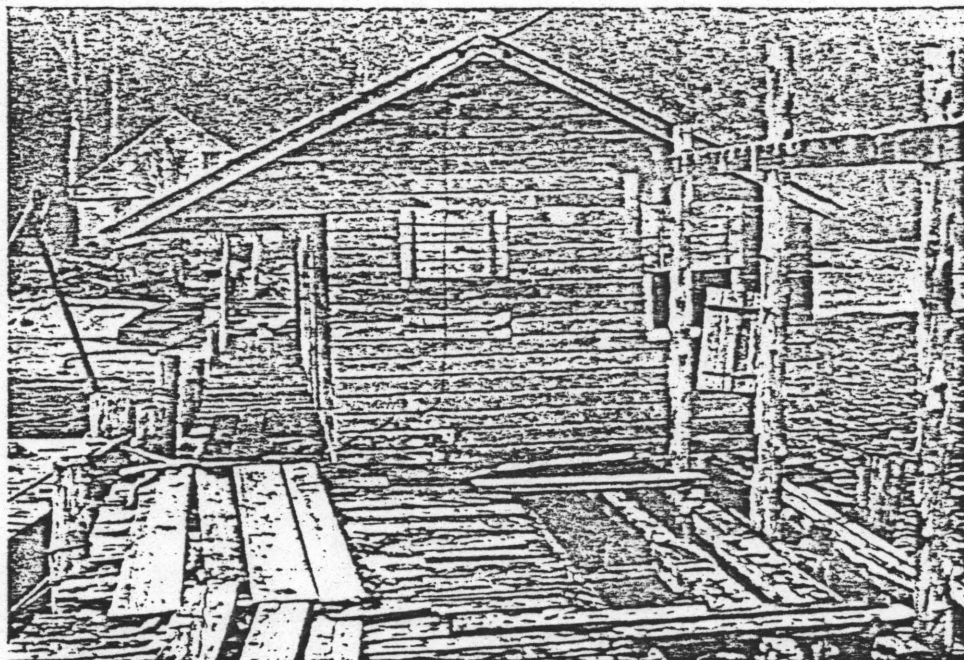
Photo showing the north wall of the fish house. All deteriorated decking, cross logs (stringers) and piling were replaced. About 20 feet of the decking from the fish house needed replacement.

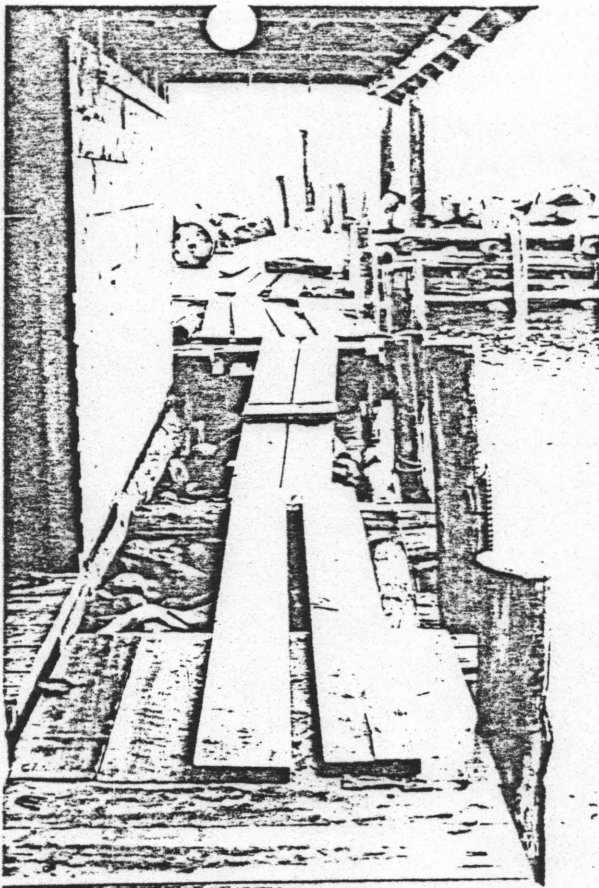
Photo showing walkway under construction. Old decking material had been removed and any deteriorated logs were replaced.

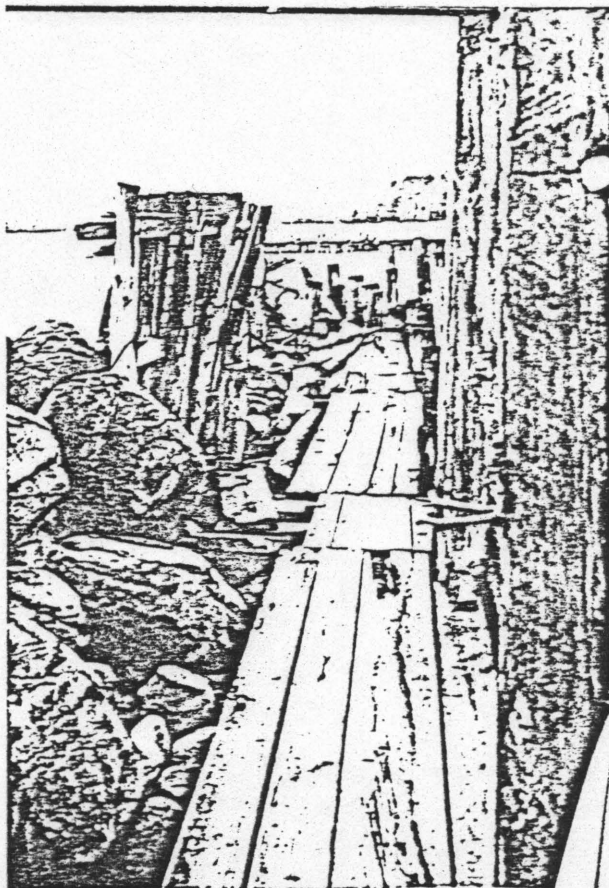
Looking east on the north section of the dock. This area of the dock had not been worked on.

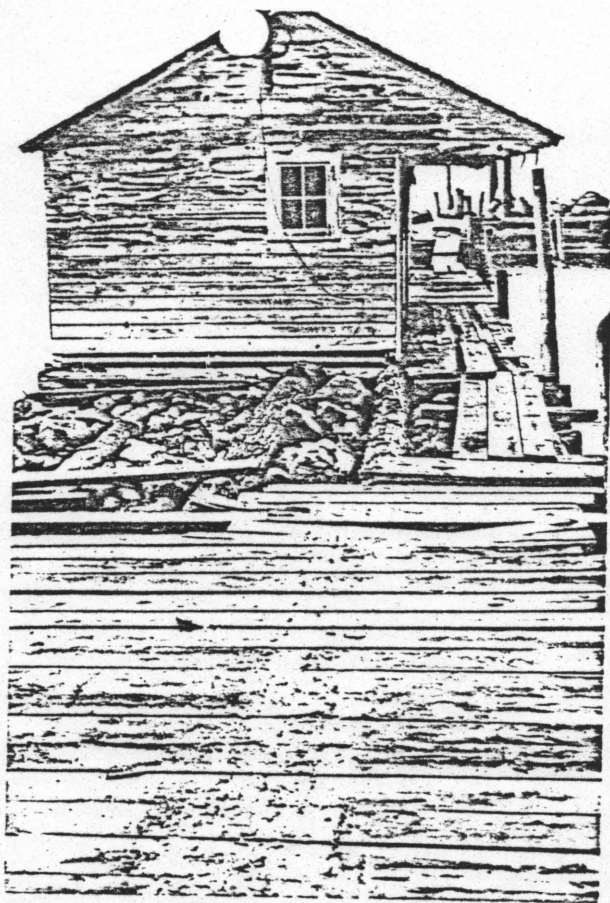
South view of the fish house and main approach to the dock. Majority of the planking needed to be replaced along with a few main log stringers.

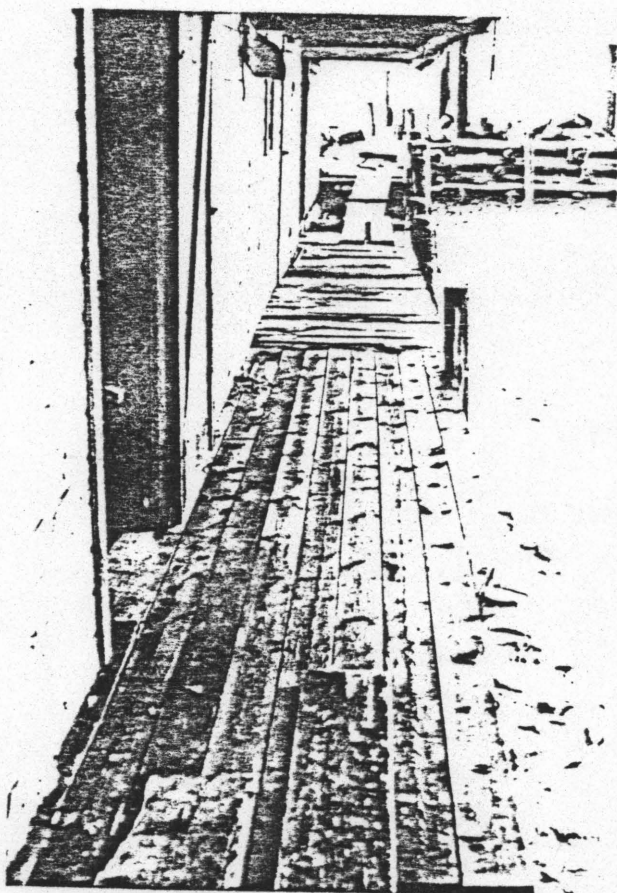
Photo showing the plank walkway along the fish house 95% completed. The new planks were laid back in the same manner and design as the existing.

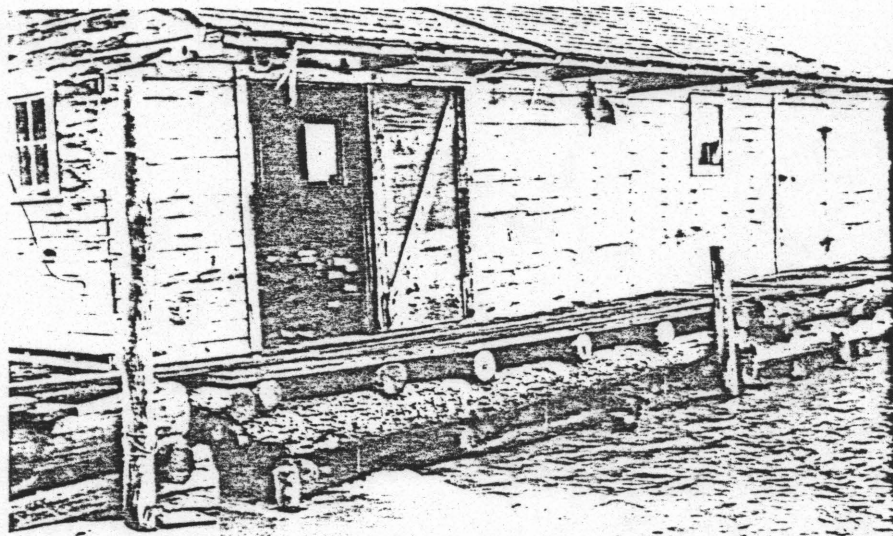
East view of the fish house and dock showing the new crib logs and decking in place. Majority of the logs from the water line to the floor line needed replacement.

1) Work began by raising the structure off from the crib foundation.  
All flooring and plank walkway were removed to work on the replacement of  
the deteriorated logs. Majority of the logs above the water line were  
replaced. Some of the original logs that were structurally weak, another  
log was bolted with threaded 5/8 rod to the old crib logs below the water  
line. 2) all decking material from the main approach to 20 feet past the  
fishhouse had been replaced. 3) All deteriorated 2 X 4 framing members had  
been stabilized temporarily by nailing a common grade 2 X 4 alongside.

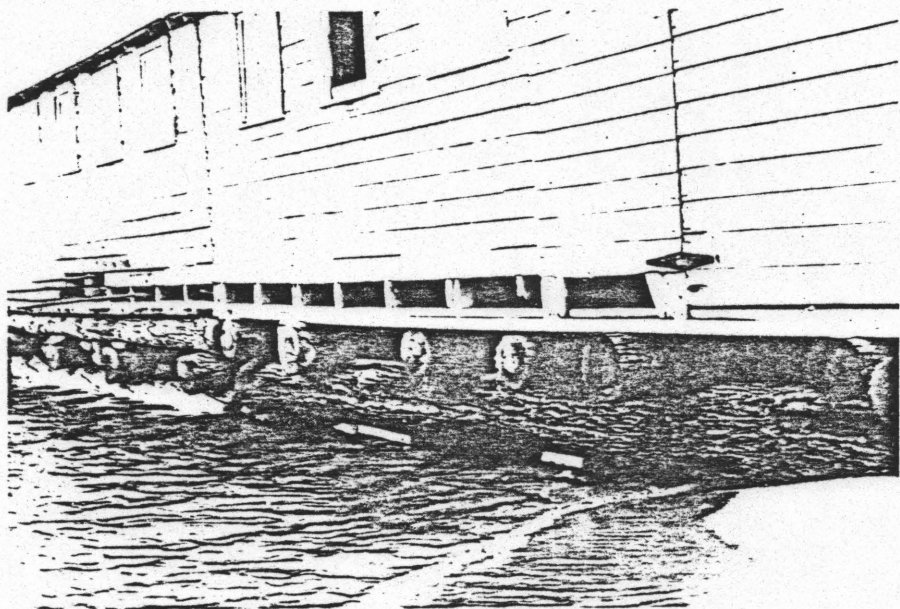
West view of fish house showing new crib logs in place. All deteriorated siding had been removed and replaced with period type.

- 4) Replacement of the 1 plate was needed on the west side of structure.
- 5) All exterior siding that was deteriorated or missing had been replaced with duplicate or period type.
- 6) Entire roof had been shingled, applying the new cedar shingles over the existing roofing material.
- 7) Replacement of two missing window sashes on west side with period type design.

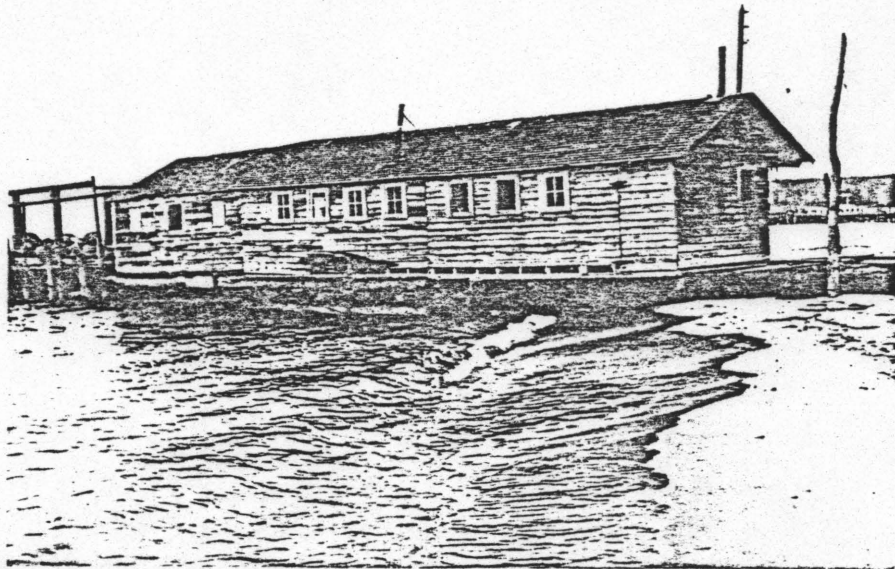
West view of the fish house. All deteriorated siding and window sashes had been replaced with period type material.

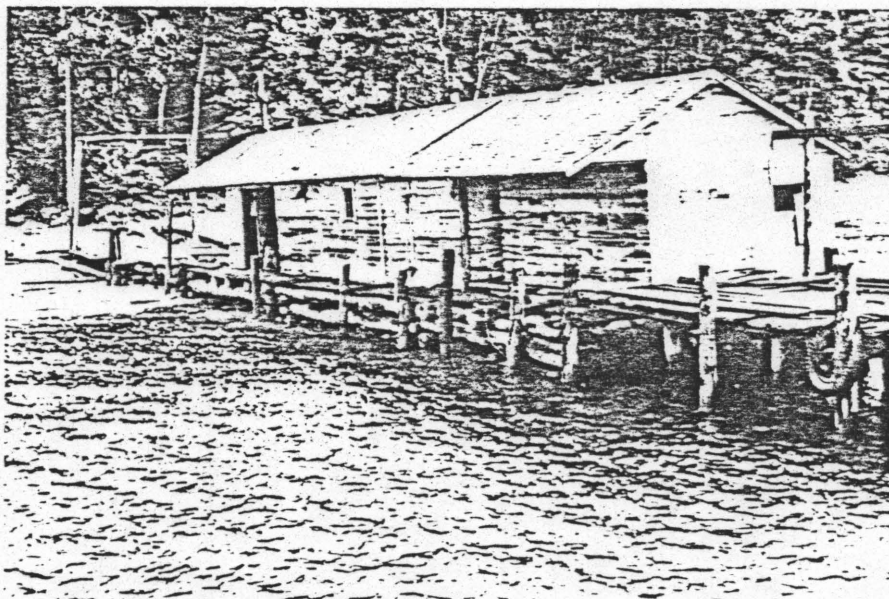
Northeast of fish house and docking area.

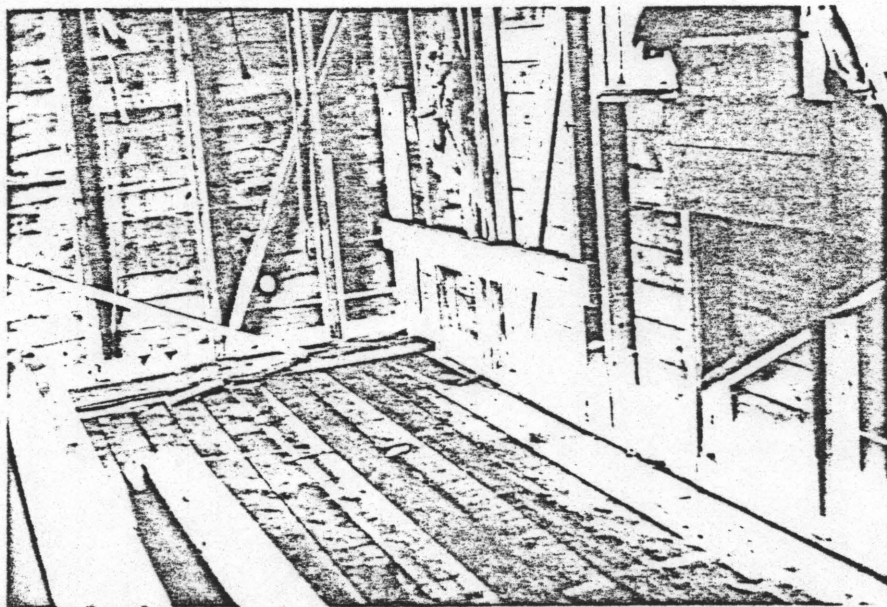
Interior view of the fish house showing wall studs being temporarily braced. All deteriorated sill plates had been replaced with a construction grade material. New floor boards were needed throughout the interior.

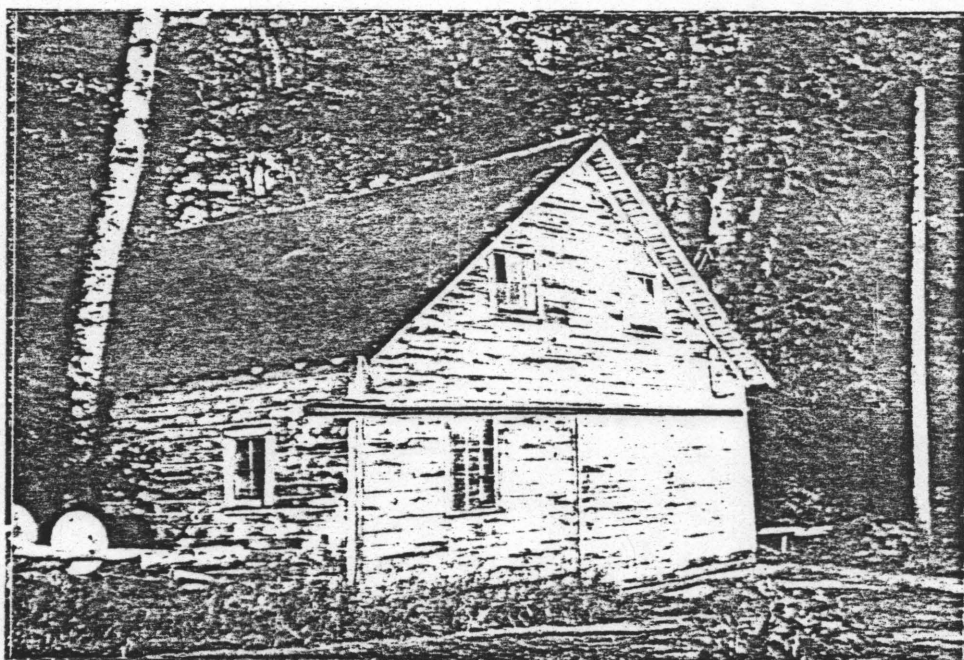
Northeast view of the ice house, HS-01-138B. Photo taken before stabilization work was started.

- 1) Interior and side wall were temporary braced with 2 x 4 to prevent the structure from collapsing.
- 2) The entire roof had been reroofed, applying the roll asphalt material over the existing roofing material.

(3) The exterior siding was treated with one application of cuprinal.

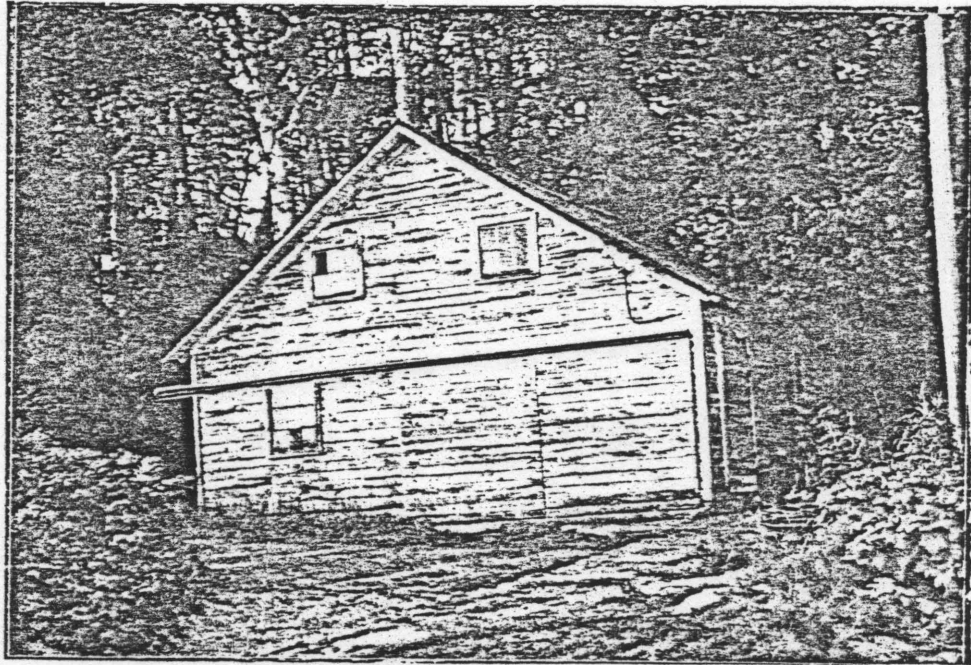
Northwest view of the ice house. The interior and exterior walls were temporarily braced to stabilize the structures. The exterior siding has been treated with a wood preservative. New roofing material was applied over the old roof.
