COMPLETION REPORT

APOSTLE ISLANDS NATIONAL LAKESHORE  
STABILIZATION OF THE MICHIGAN ISLAND LIGHTSTATION

STABILIZATION HS-23-103A, HS-23-103B, HS-23-103C,  
HS-23-103D, HS-23-103F, HS-23-103G

MIDWEST REGIONAL OFFICE  
RAY KUNKEL AND JOHN OCHMAN, PROJECT SUPERVISORS

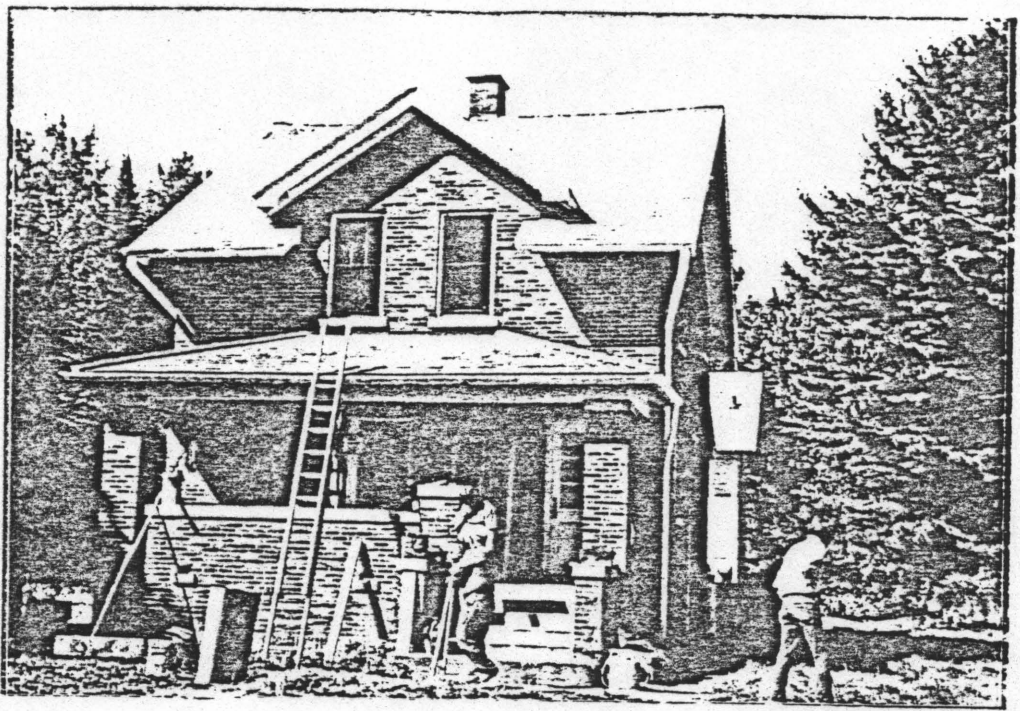
South view of the Keeper's Quarters, HS-23-103G. Majority of the masonry problems had been corrected along with painting the exterior trim, reinforcing the interior floor joists and controlling the drainage along the structure.

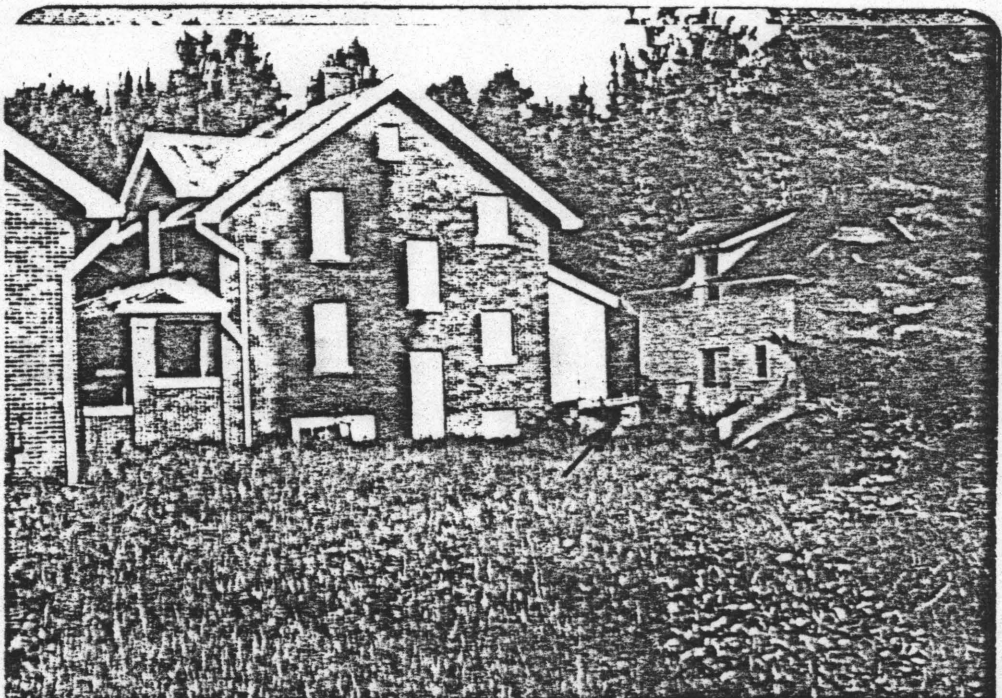
East view of Keeper's Quarters. Arrow shows the deterioration in the rear porch.

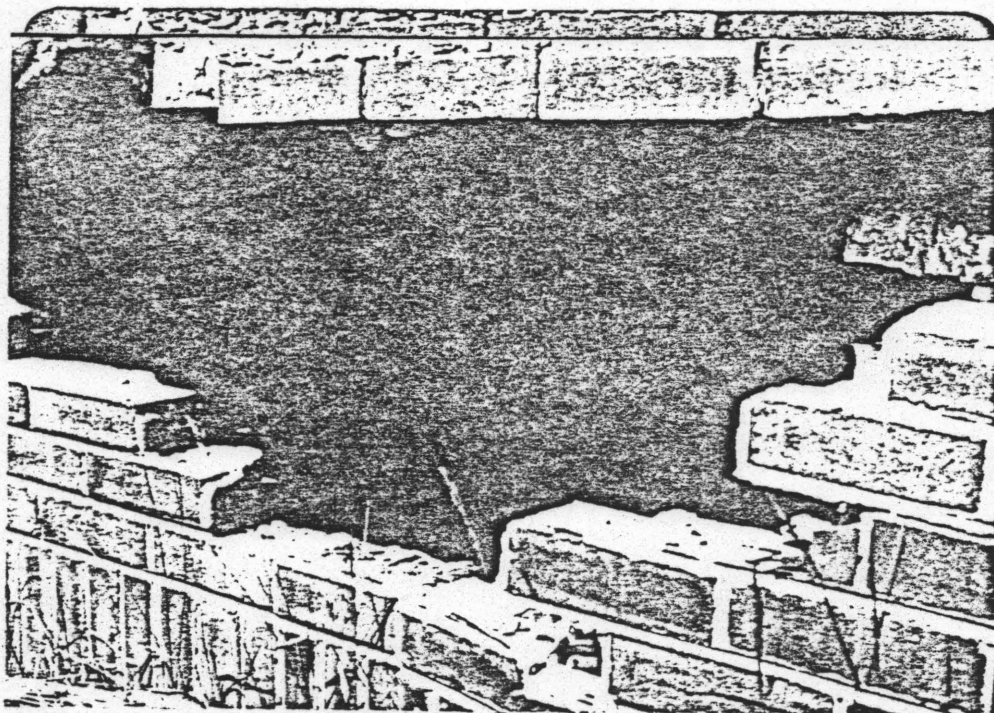
Photo showing condition of rear porch before work was started. Extensive masonry was needed to correct this problem.

Portions of the rear concrete porch landing had been broken off and were missing. A form was constructed to the original site and filled with concrete. The job looked beautiful. Also, the brick wall along the porch landing (rear) and the front porch sidewall needed to be replaced and corrected. Portions of wall had missing and deteriorated bricks. In these areas, the deteriorated bricks were removed to the solid course and bricks duplicate of kind were used. The deteriorated walkways along the north and west side of the house were also replaced.

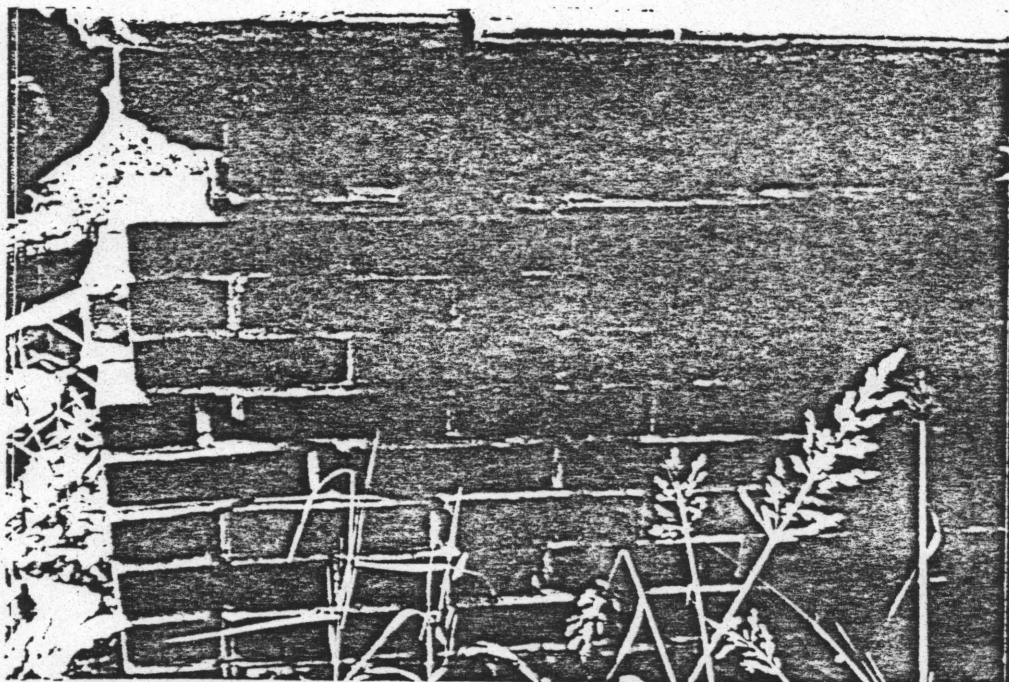
A typical condition showing the masonry problem on the Keeper's Quarters. The structure had several areas in this badly deteriorated state.

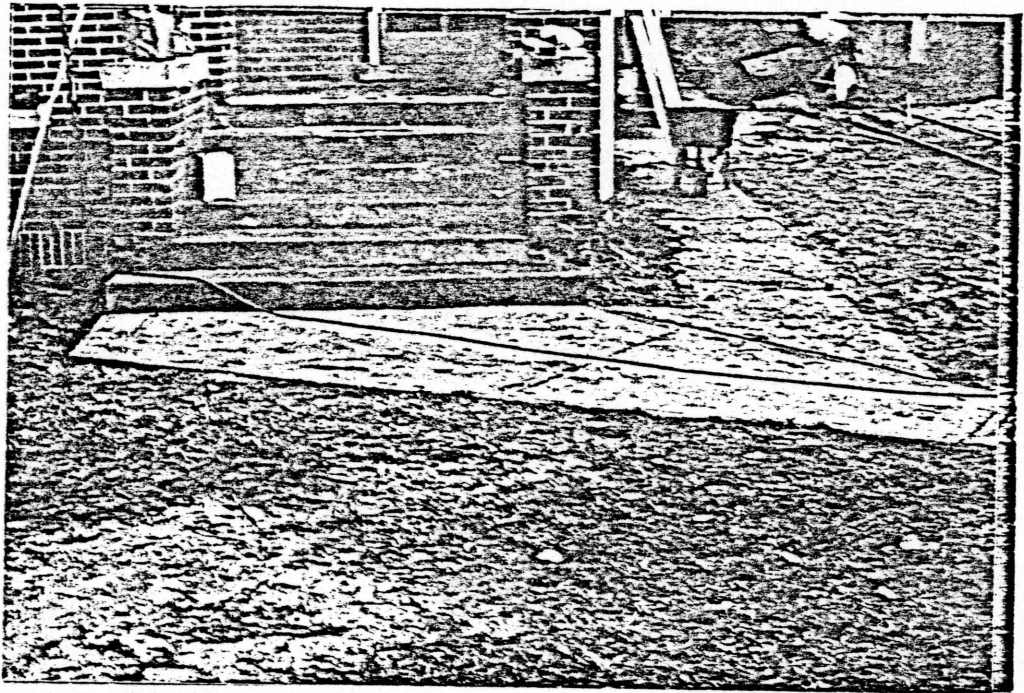
Photo showing the deterioration in the brick work along the front approach. Also, the sidewalk along the front and to the rear entry had been replaced.

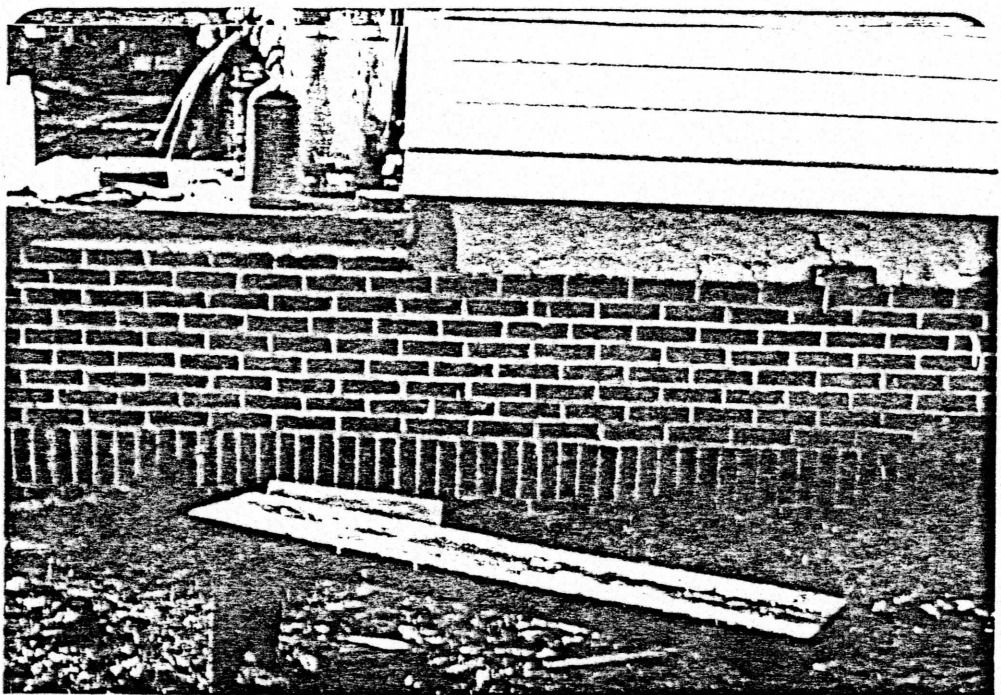
Bricks being layed back along rear porch. Duplicate bricks were used and matched very well to the existing.

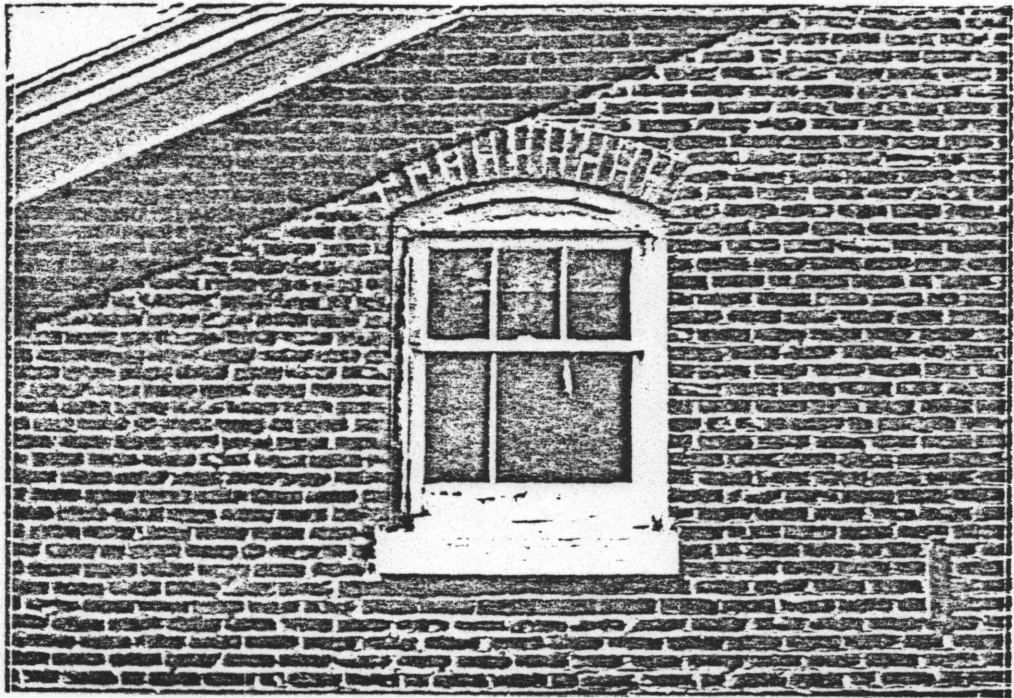
Photo showing a sash vandalized and historic material destroyed. Windows in these conditions were temporarily repaired and new glass installed.

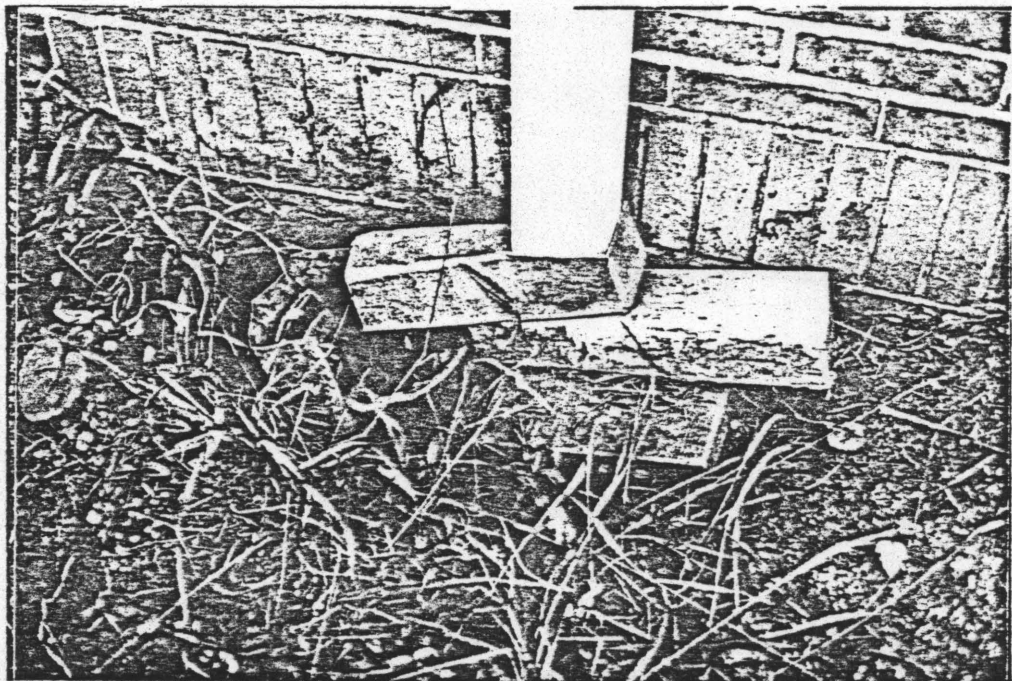
Photo showing temporarily correcting the drainage problem along the Keeper's Quarters. Later, drain pipe was dug up and centered under down spout.

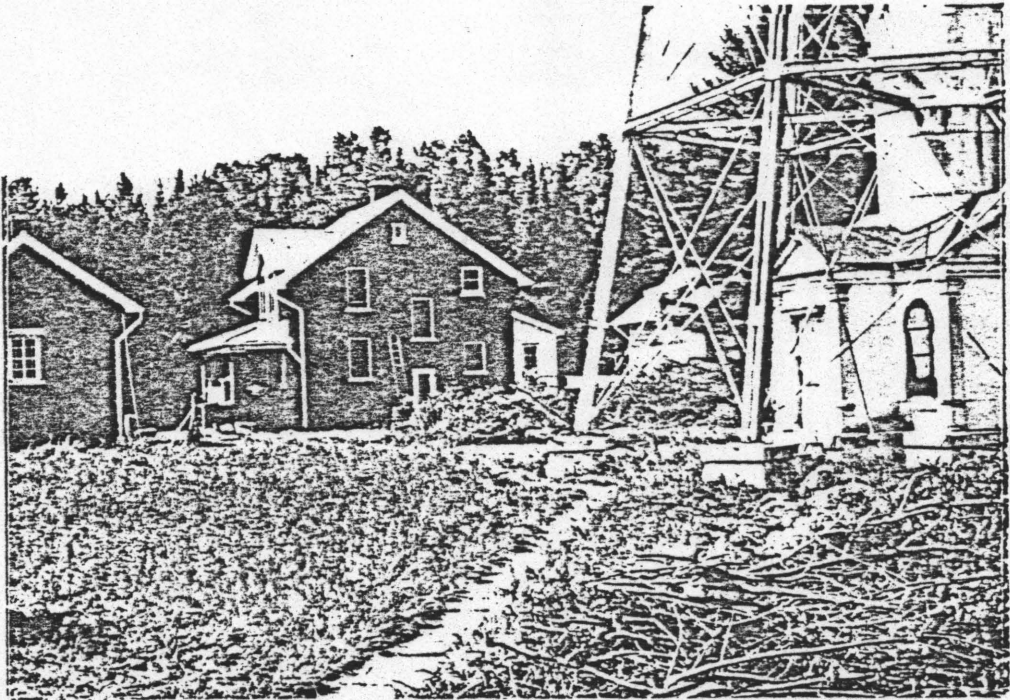
Photo showing debris and brush piles which was gathered during the general site clean-up.

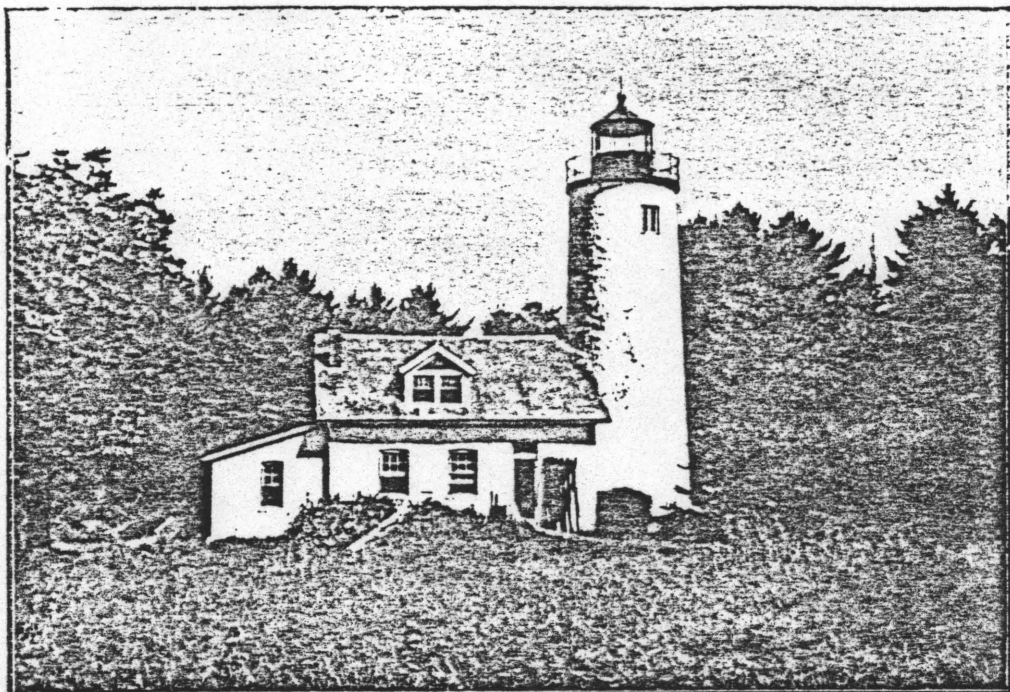
West view of the old lighthouse HS-23-103A showing the condition of the structure before the stabilization project was started.

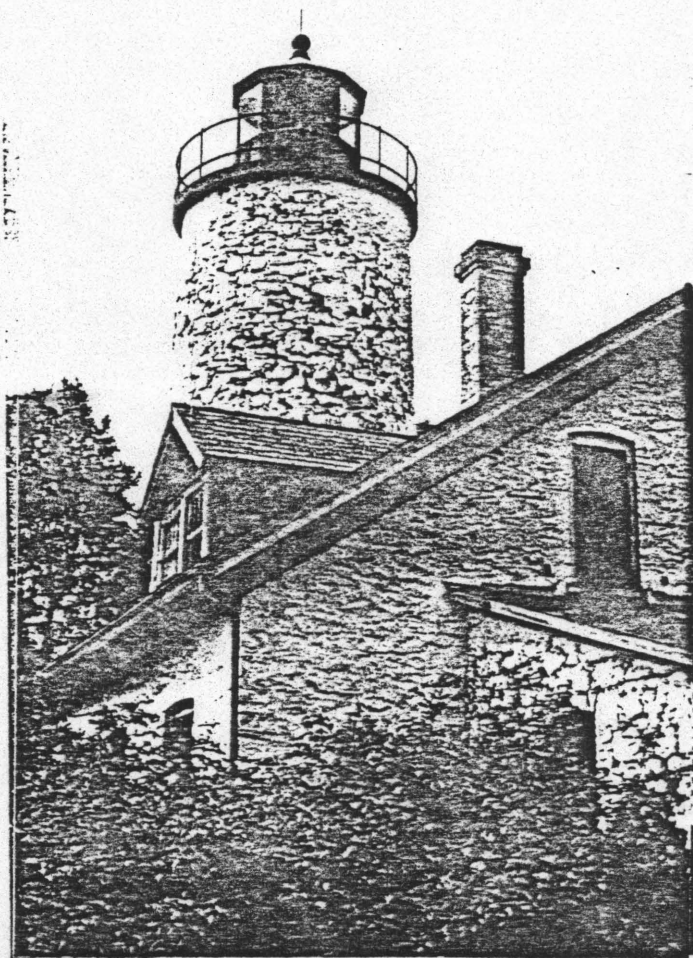
Northeast side of lighthouse showing the high brush and small trees growing along side of the structure. This was one of the problems causing the deterioration in the masonry wall.

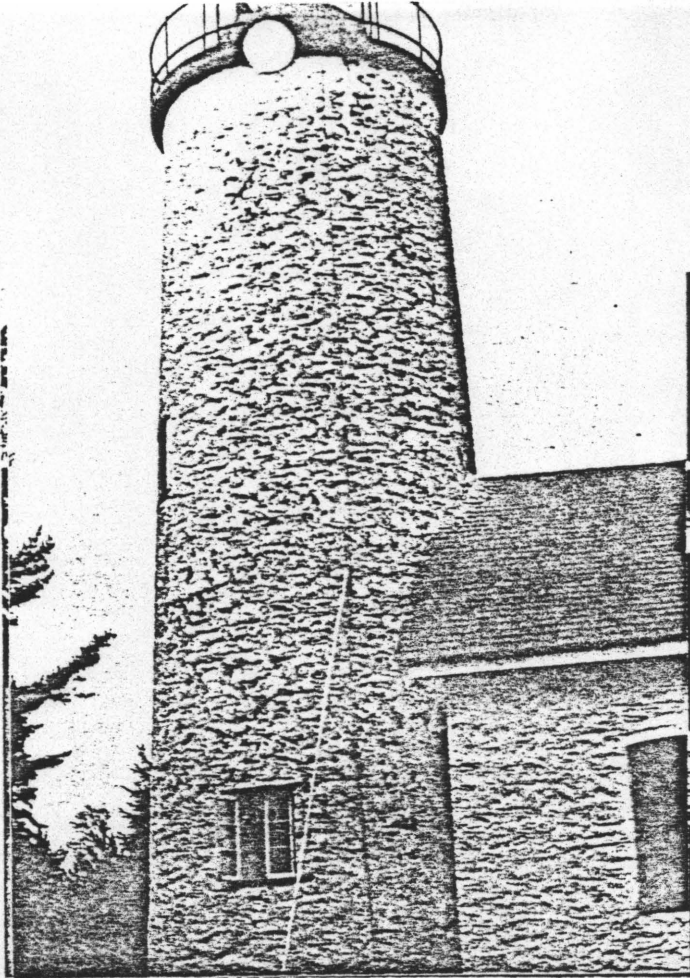
East view of lighthouse and tower. Photo showing corner of house which had been tuck-pointed and whitewashed compared to the condition of the light tower.

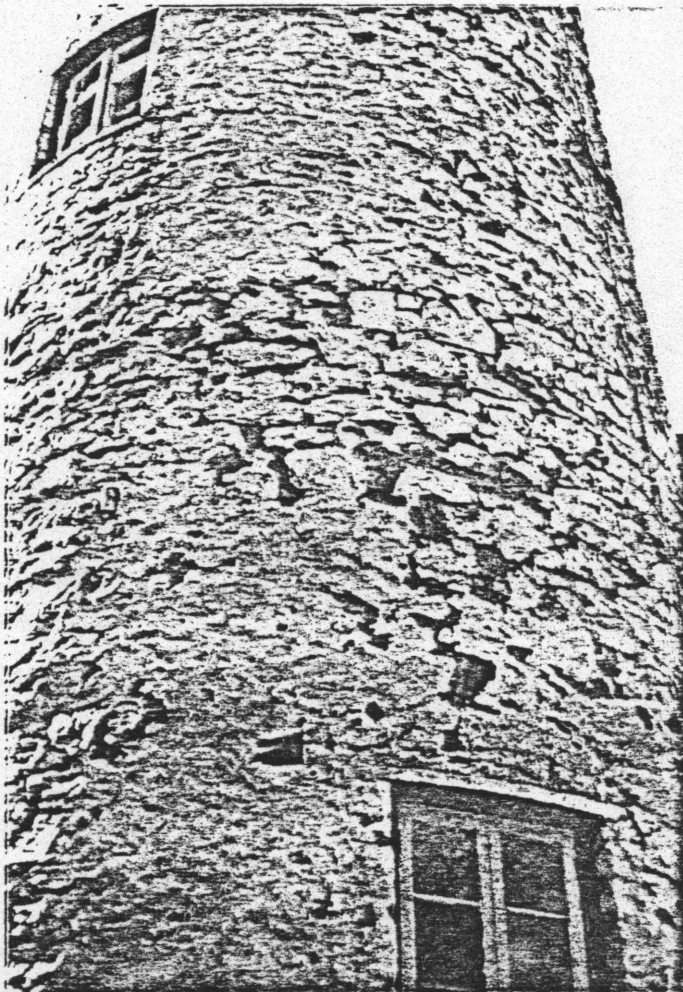
Photo showing general conditions of the deterioration in the tower. All major joints were corrected along with resetting of some of the stones.

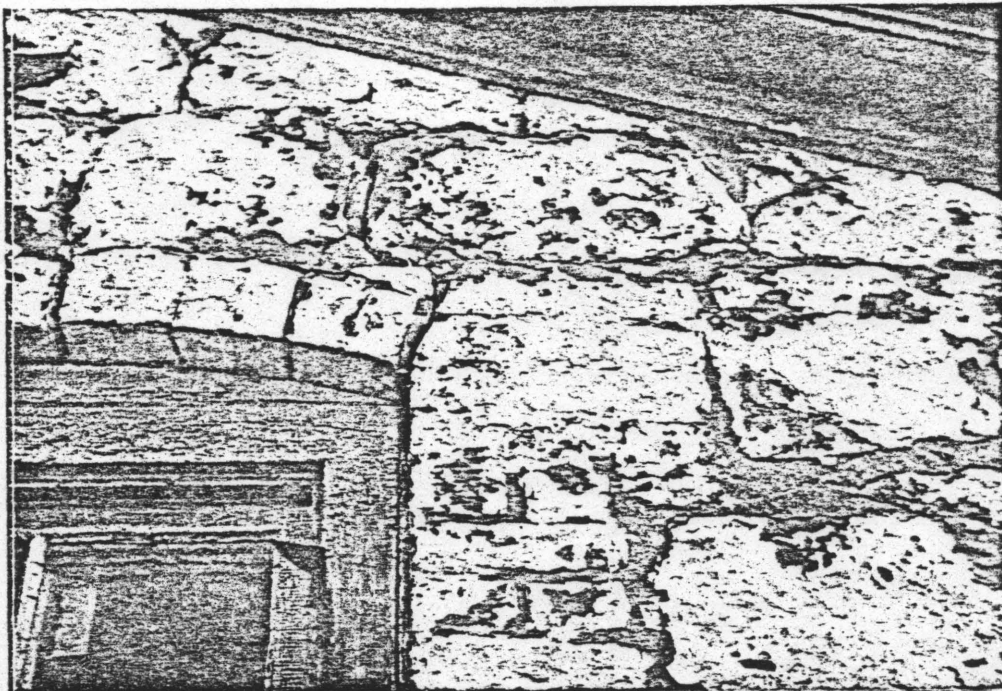
The entire structures of the old Lighthouse had major masonry deterioration. This photo shows deterioration between the window and fascia trim.

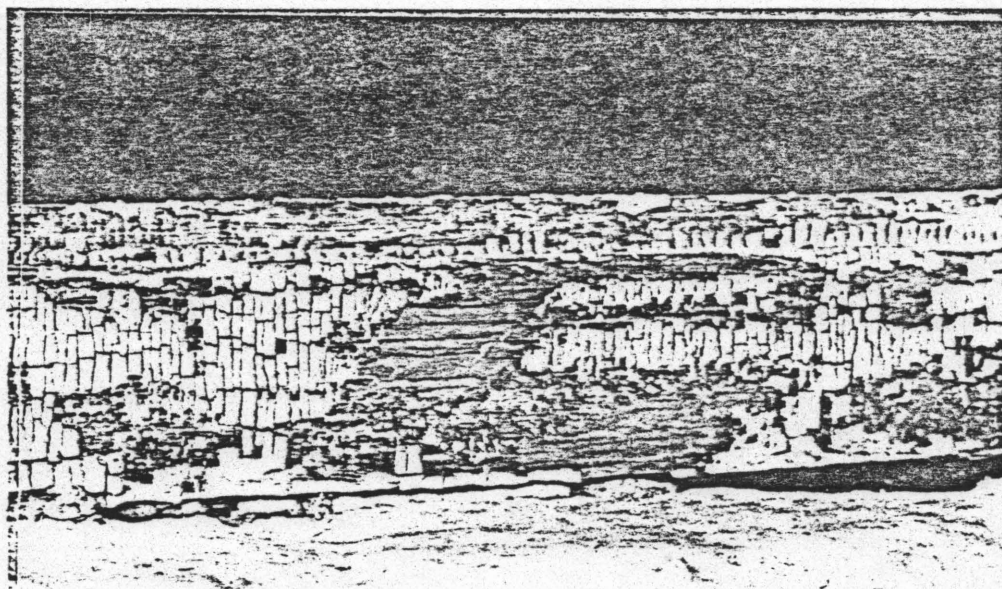
Typical window jamb showing the build up of paint and the extense of paint checking. All old paint had been scraped and burned off before painting.

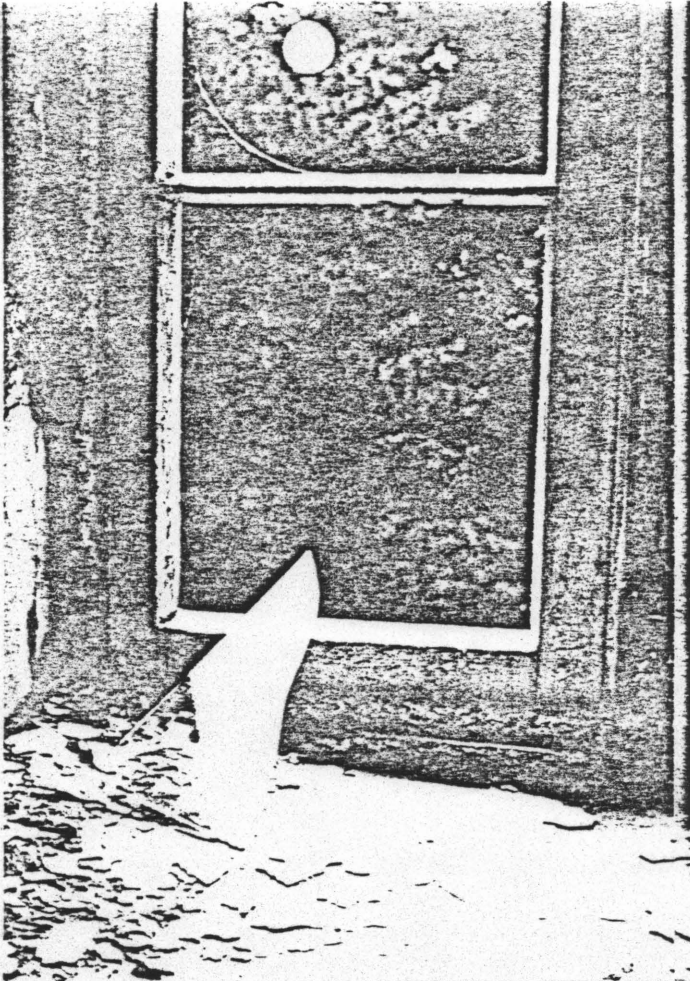
Photo showing condition of the windows of the old Lighthouse. All missing or broken glass had been replaced to prevent further damage to the interior of the structure.

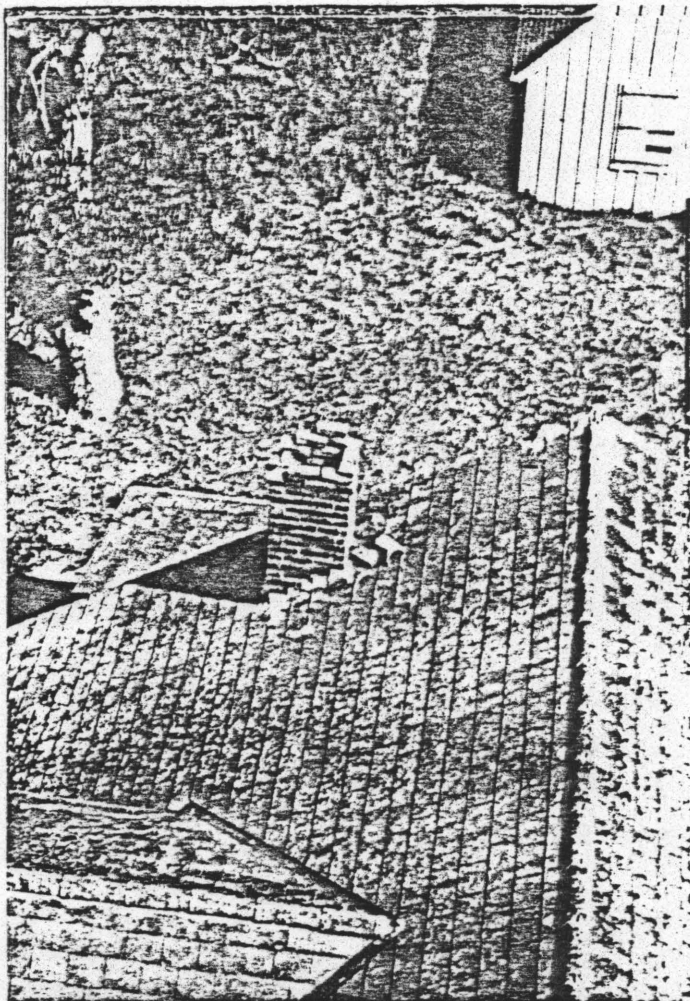
Photo looking down on to the roof of the old Lighthouse. The chimney problem was stabilized along with replacing any missing slate roofing material.

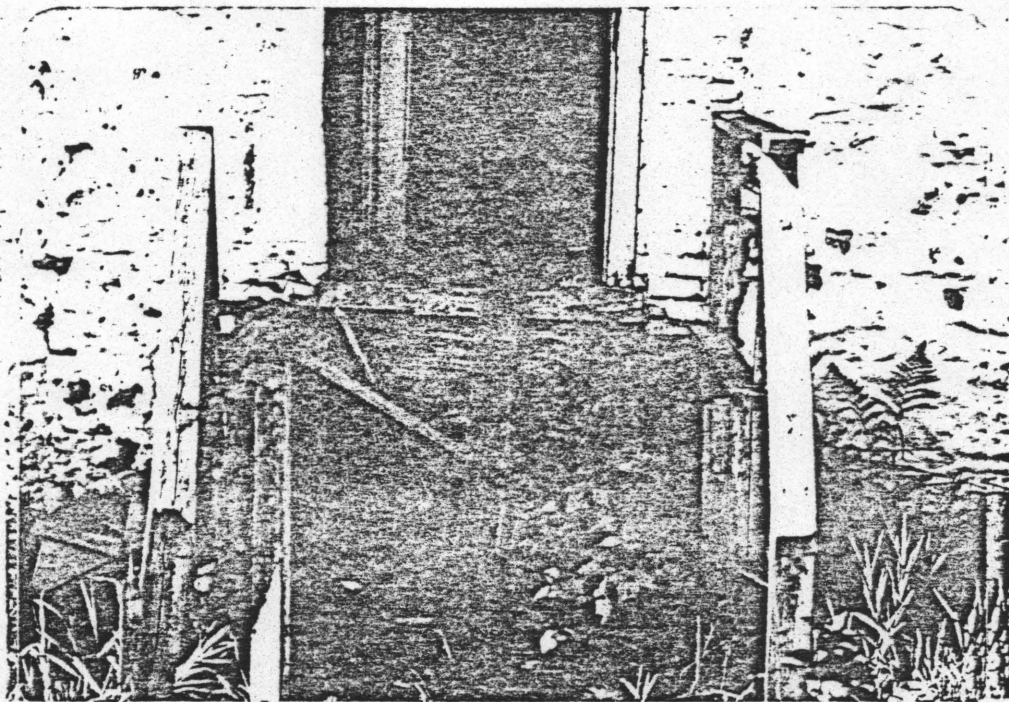
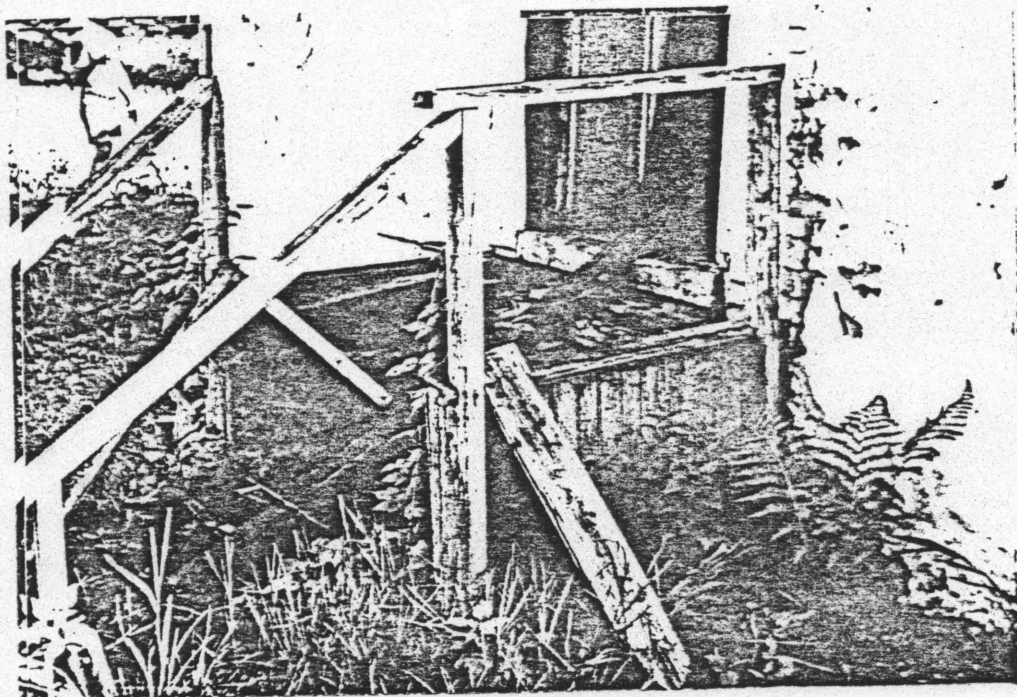
Photos showing the deterioration of the rear stair case of the old Lighthouse.

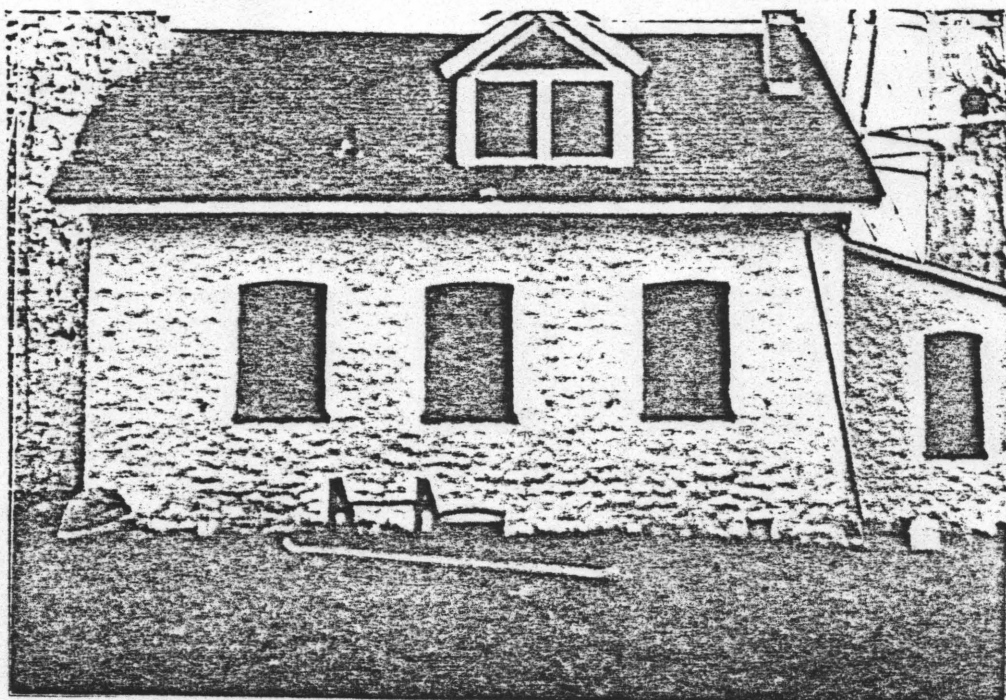
Photo shows east side of Lighthouse after whitewash was applied. Temporary shutters were constructed for all windows and door openings.

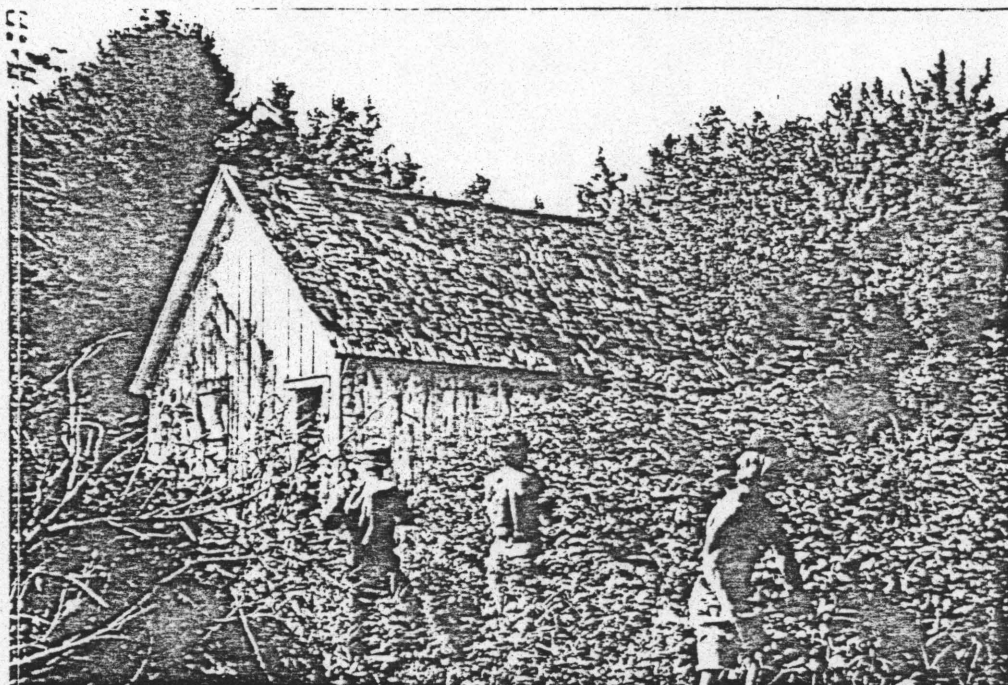
Photo showing workmen removing overgrown brush along storage shed (HS-23-103B). Note the deterioration in the cedar shingles. A temporary corrugated metal roof was installed to prevent further damage.

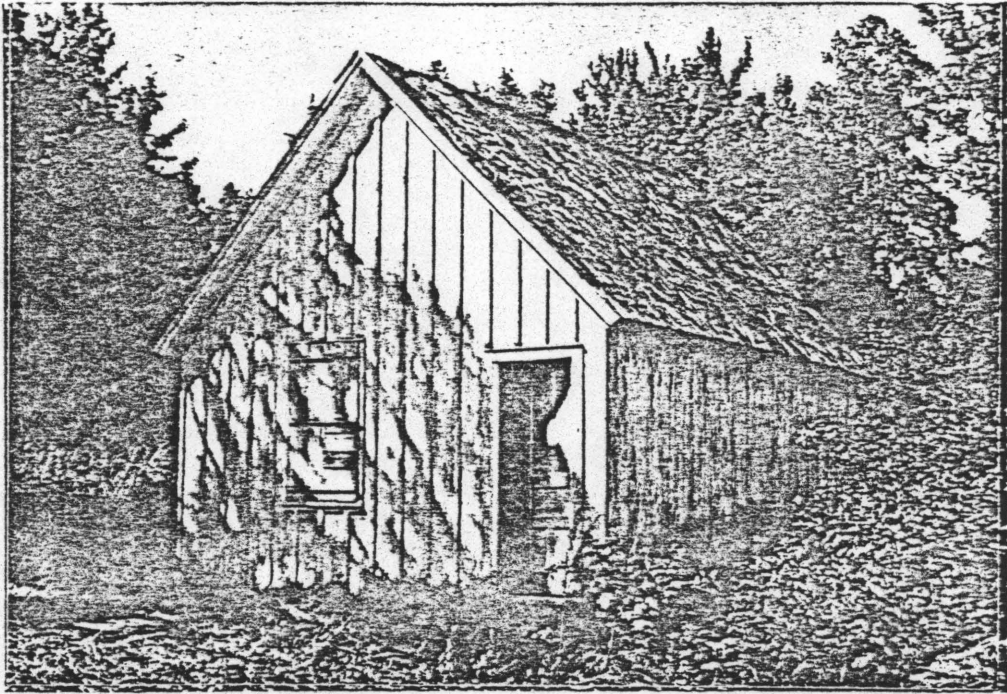
Majority of the overgrown brush and debris has been removed away from the storage shed.

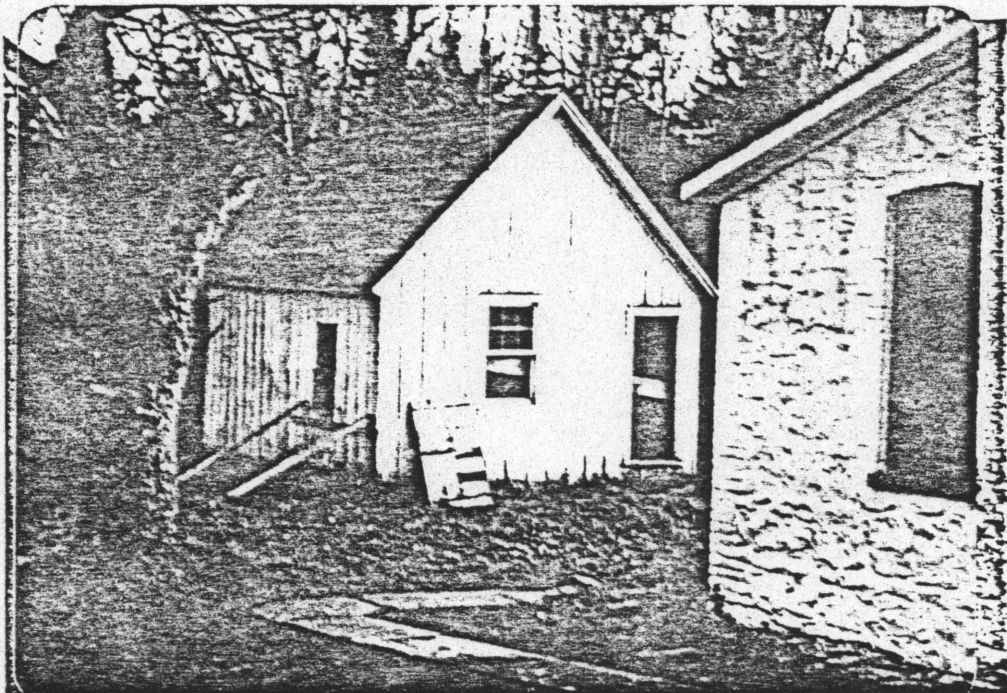
Photo showing storage shed HS-23-103B. Structure had been raised to prevent further deterioration to siding and frame work. Interior and exterior had been temporarily braced.

deteriorated along the lower plate. The structure was raised and temporarily braced until the new foundation is constructed. The original base is in a serious state of deterioration. The roof was also in a bad state of deterioration and a temporary galvanized corrugated roof was installed to prevent any further damage.

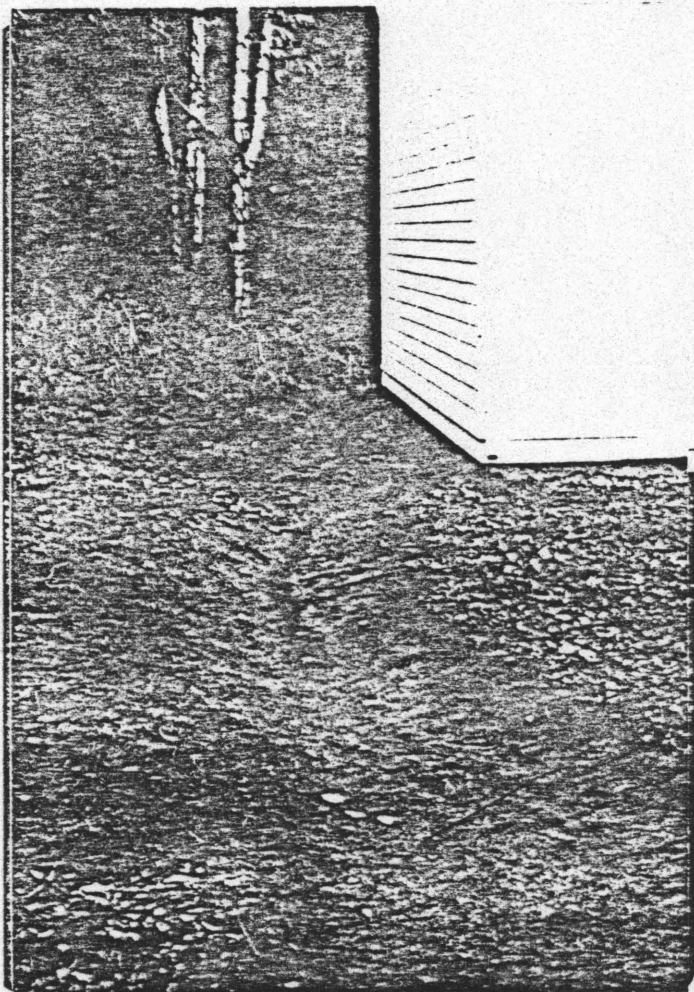
Photo showing a trench which was constructed to divert the water away from the Assistant Lightkeeper's House.

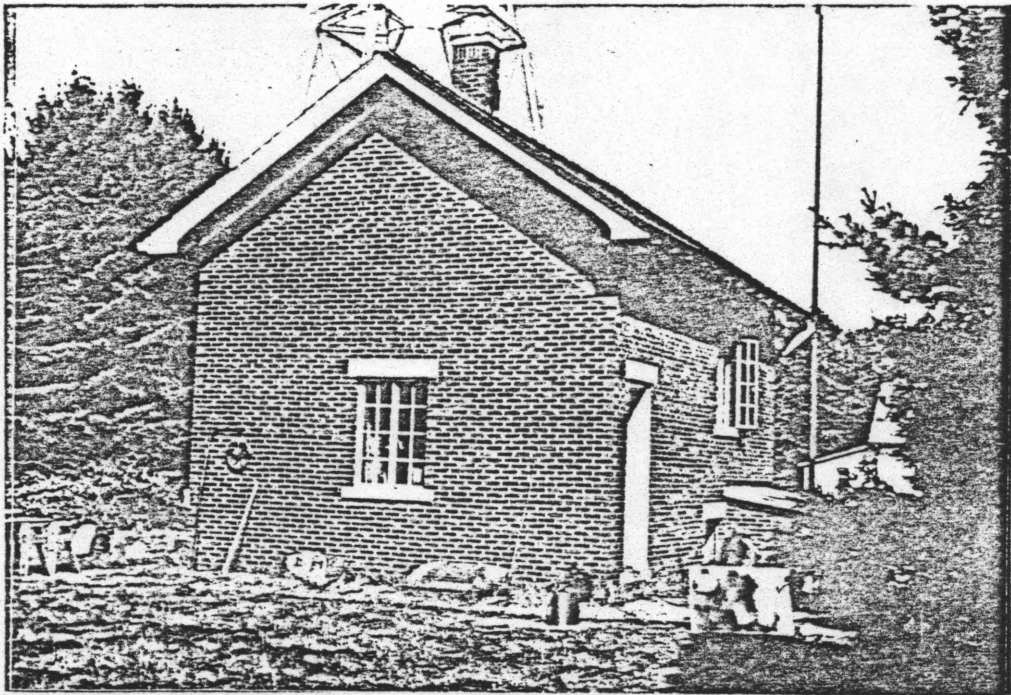
Southwest view of the generator shed HS-23-103D structure was basically in sound condition. All missing or broken glass had been replaced along with painting of all exterior windows and trim.

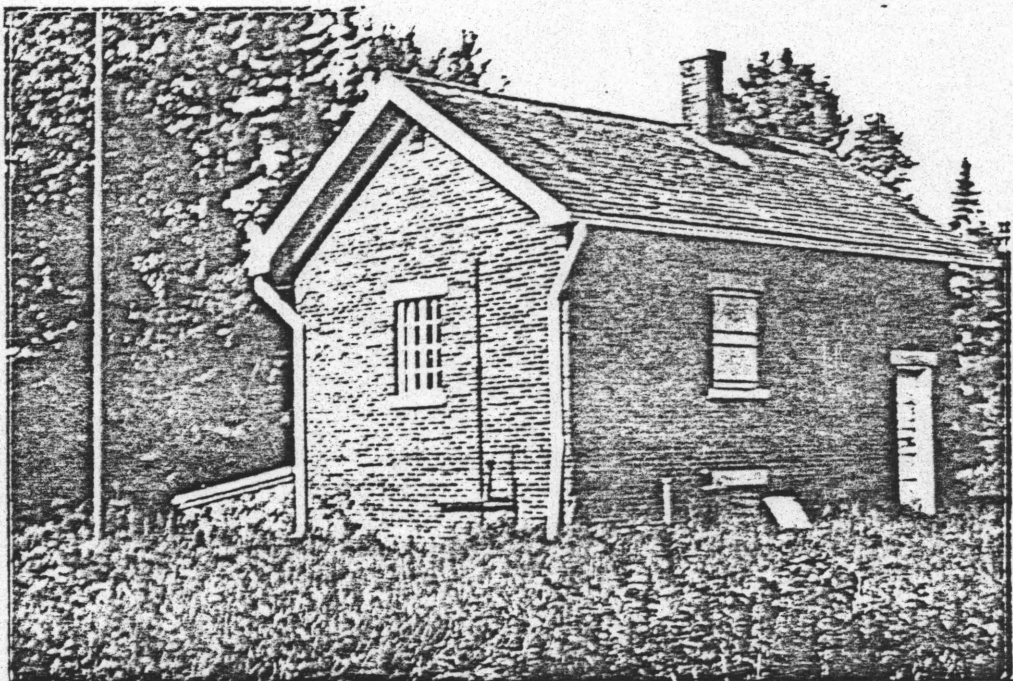
Northeast view of the generator shed. All overgrown brush and debris had been removed. Drainage problem had been controlled along with connecting all downspouts.

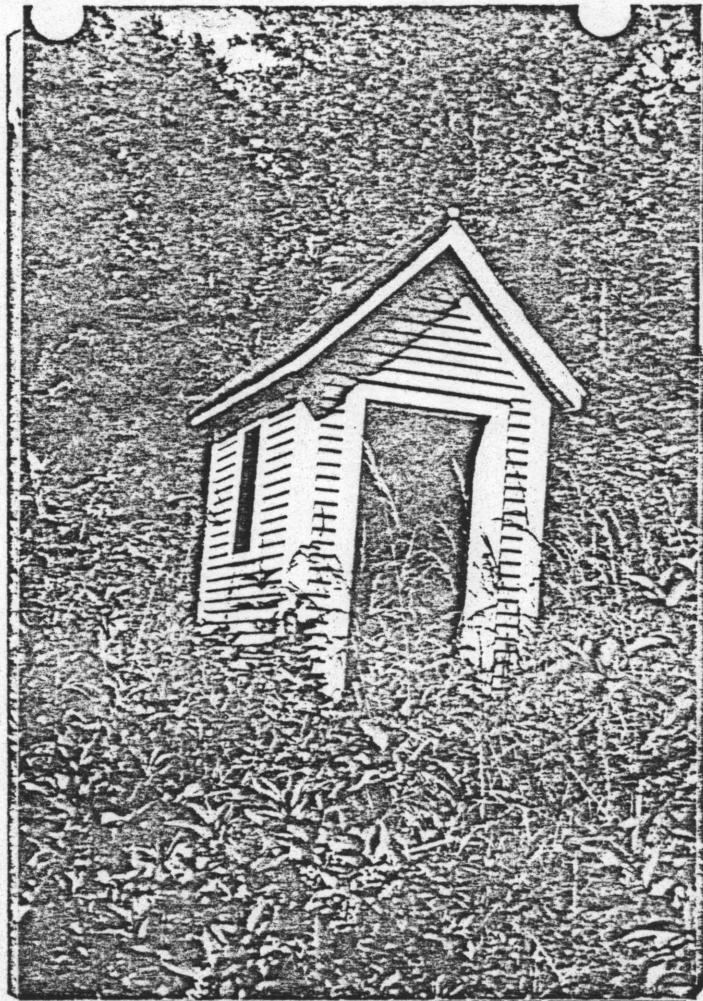
Photo showing privy HS-23-103C. Structure was in sound condition.
