**COMPLETION REPORT**

APOSTLE ISLANDS NATIONAL LAKESHORE  
STABILIZATION OF THE RASPBERRY ISLAND  
LIGHT STATION

Stabilization of Raspberry Island Light Station

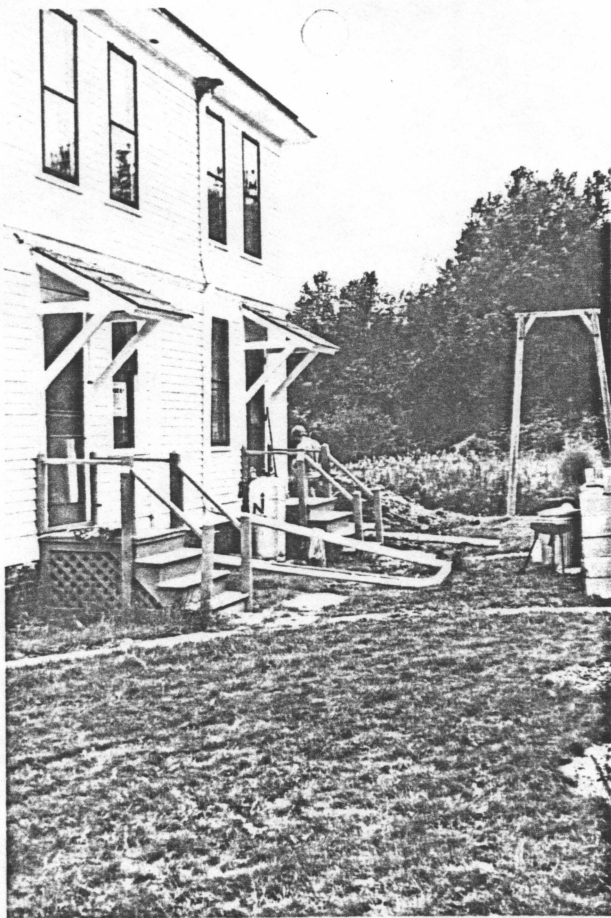
- 1) North side of lighthouse before the construction of the retainer wall.  
(A) Shows temporary drainage system

- 1) Construction of a concrete block retainer wall on the north  
side of the basement. The work was started by excavating the  
ground down to the old footing. A concrete footing was poured  
alongside the old, and the wall was constructed using 12" block  
with reinforcing rods added for additional strength.
- 2) A masonry waterproofing was applied to the exterior existing  
brick wall and to the new block wall, before the backfill was accomplished

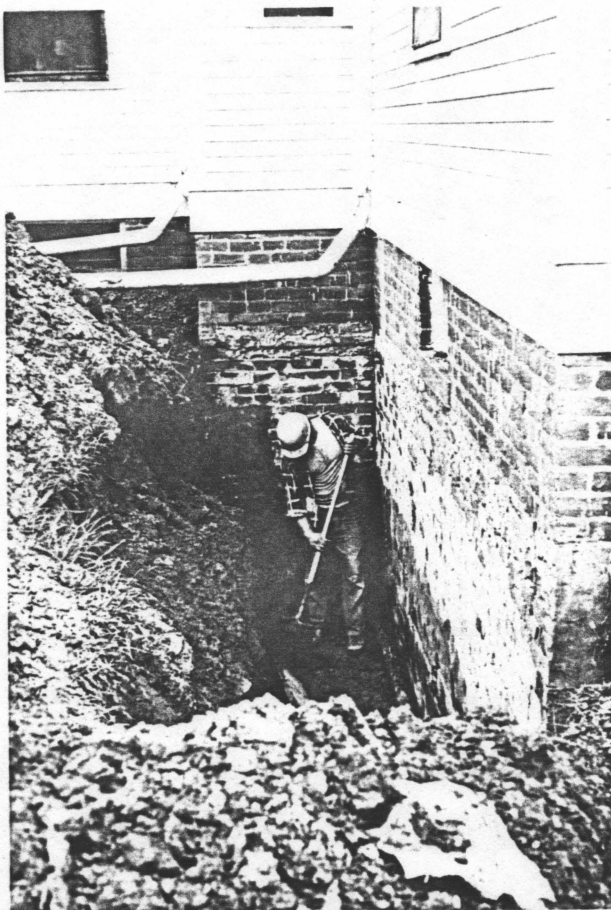
- 2) Workman excavating along north wall of lighthouse. All work was accomplished by hand methods.

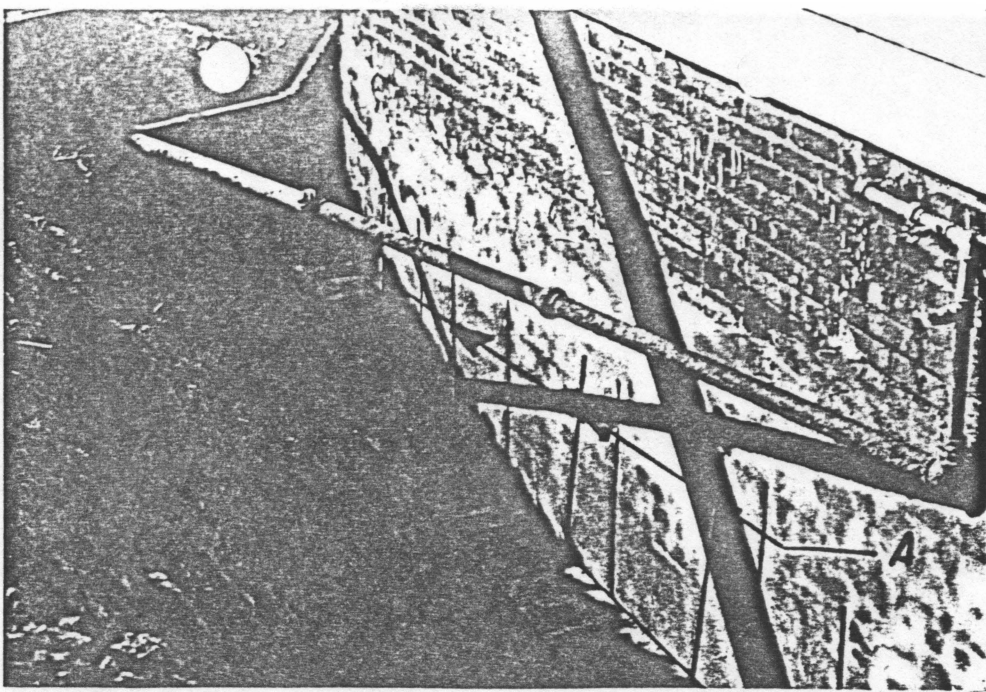
- 3) Note deterioration of exterior basement wall. A skim plaster was applied to the brick wall before the retainer wall was constructed.

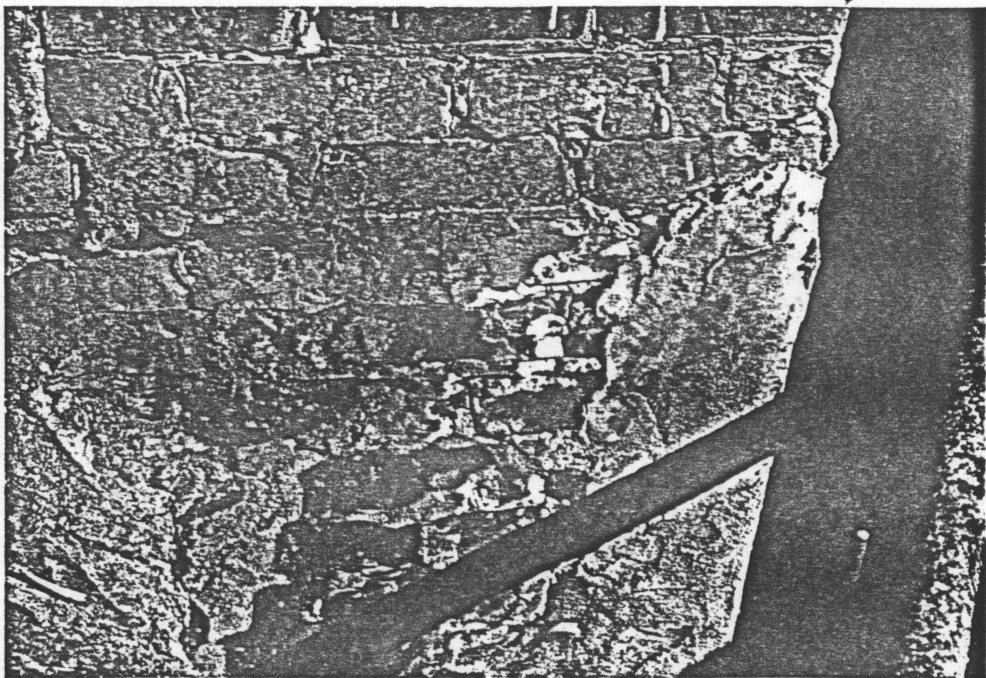
- 4) Photo showing the start of constructing the retainer wall. Reinforcing rods were placed 24" on center (A). Existing brick wall had a cement plaster applied along with a waterproofing agent.

7) Waterproofing agent used on the retainer wall consisted of a mixture of Portland Cement, water and sodium silicate.

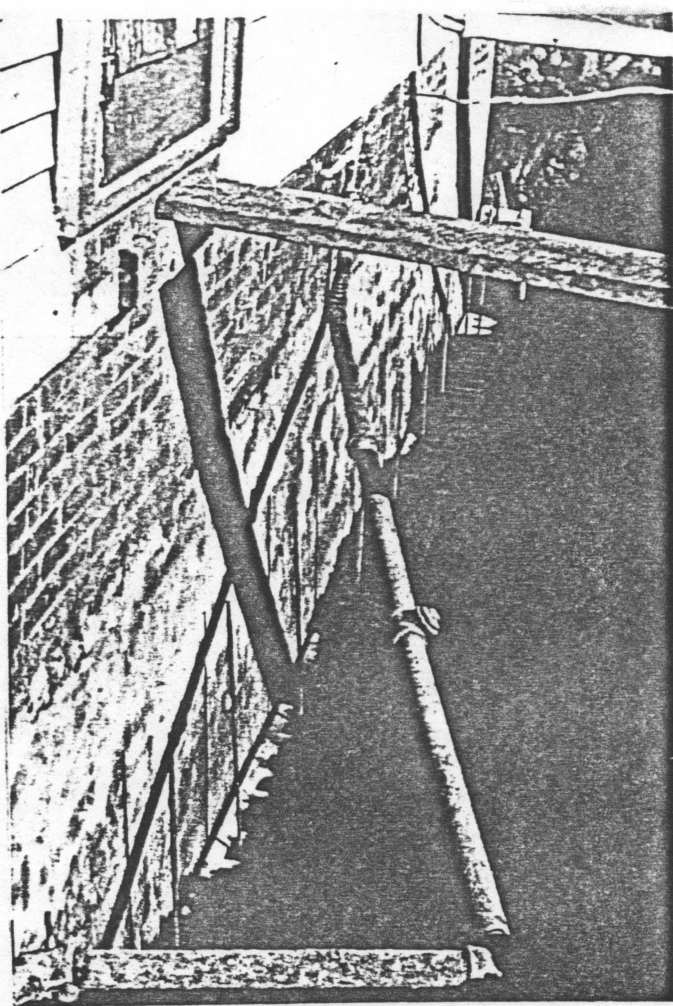
- 5) Another view showing the construction of the retainer wall.

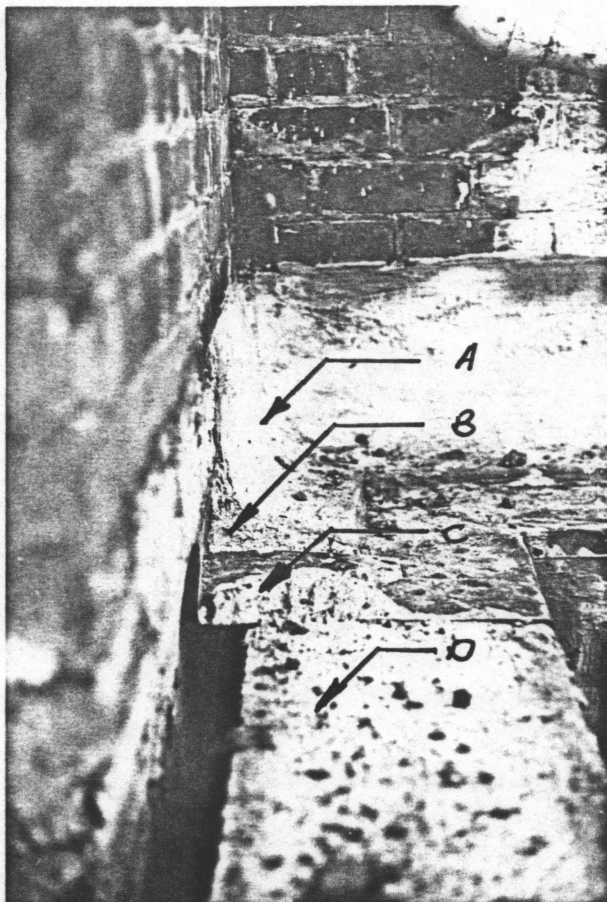
- 6) Photo showing side view of flashing detail.
- A. Sodium silicate water proofing
  - B. Cant
  - C. Copper flashing.
  - D. Retainer wall

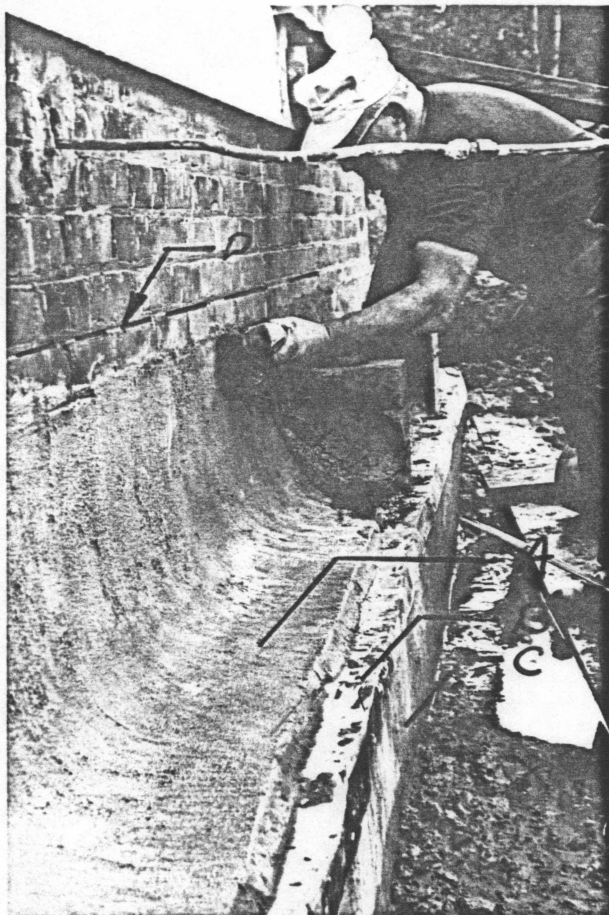
7) Photo showing the water-  
proofing being applied to  
the cant.

- A. Cant
- B. Flashing
- C. Retainer wall
- D. Grade line

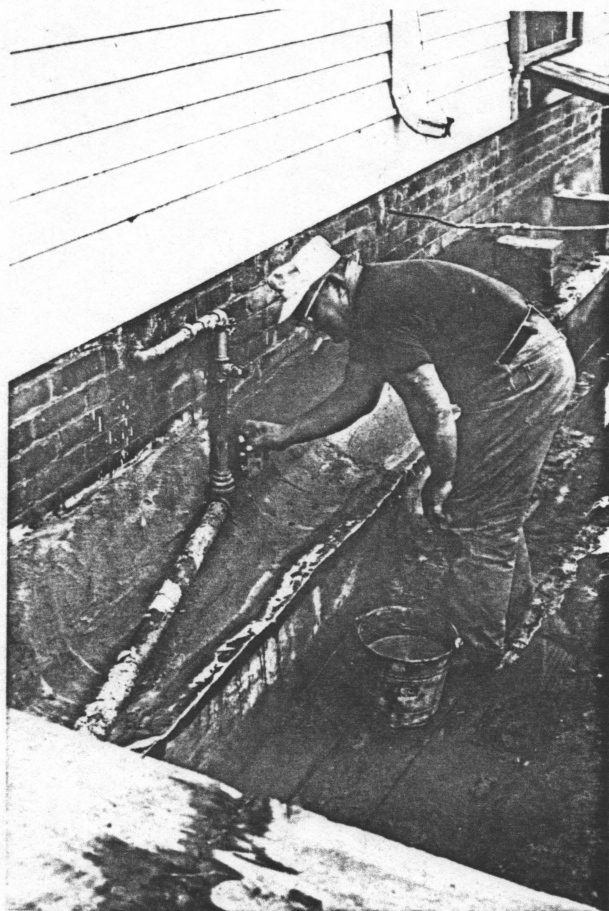
8) Photo showing workman apply-  
ing the waterproofing to  
the cant section of the wall

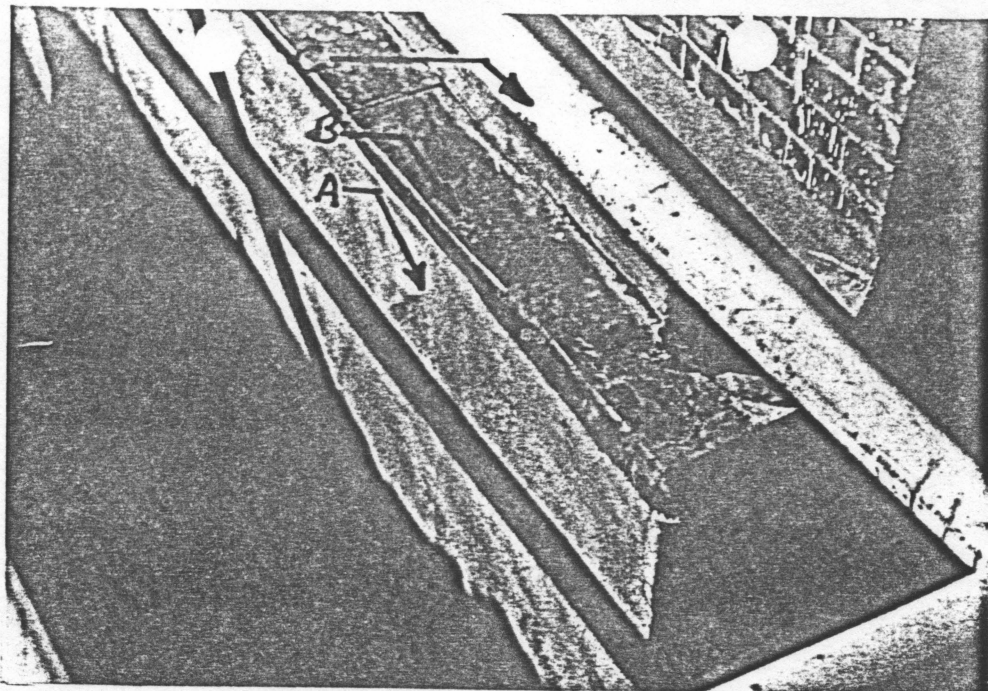
- 9) Photo showing: A. Retainer wall, B. Copper flashing and, C. Drain pipe, which will all be buried.

3) Additional drain pipes were connected to the existing downspouts and buried below grade with a  $\frac{1}{4}$  inch drop per foot.

8) Solid four inch plastic pipes were used for the underground drainage system.

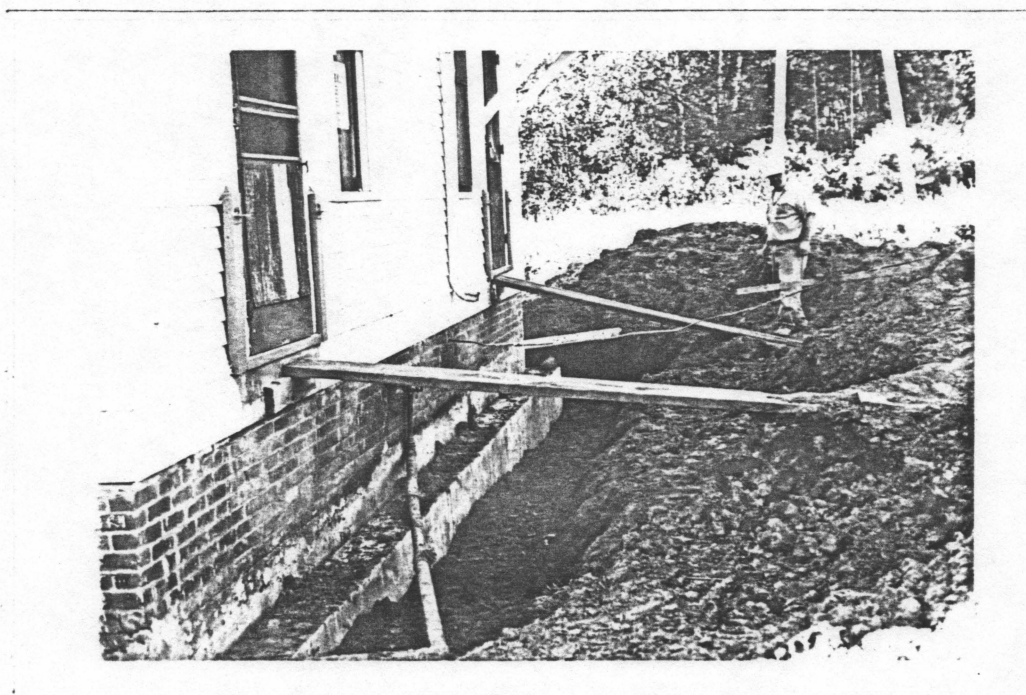
- 10) North side of house being backfilled.

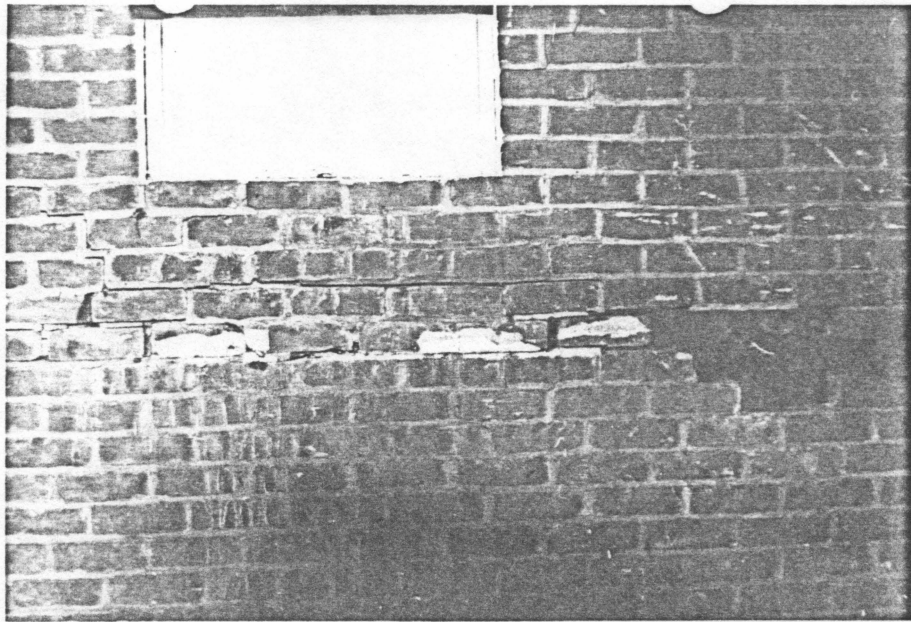
11) Photo showing interior of basement wall. Note damage caused by the outside pressure. (North Wall)

4) The interior basement wall (north wall) had extensive tuckpoint done to correct the damage caused from the outside pressure. Areas of the wall that were badly damaged, the bricks were relaid. This work was accomplished after the retainer wall was constructed.

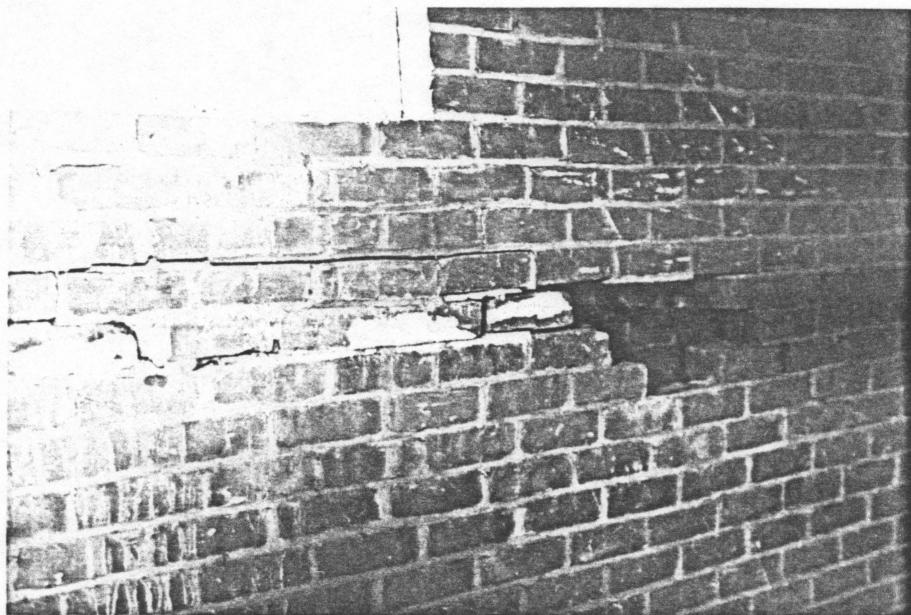
12) Another view showing the extent of damage to the interior basement wall.

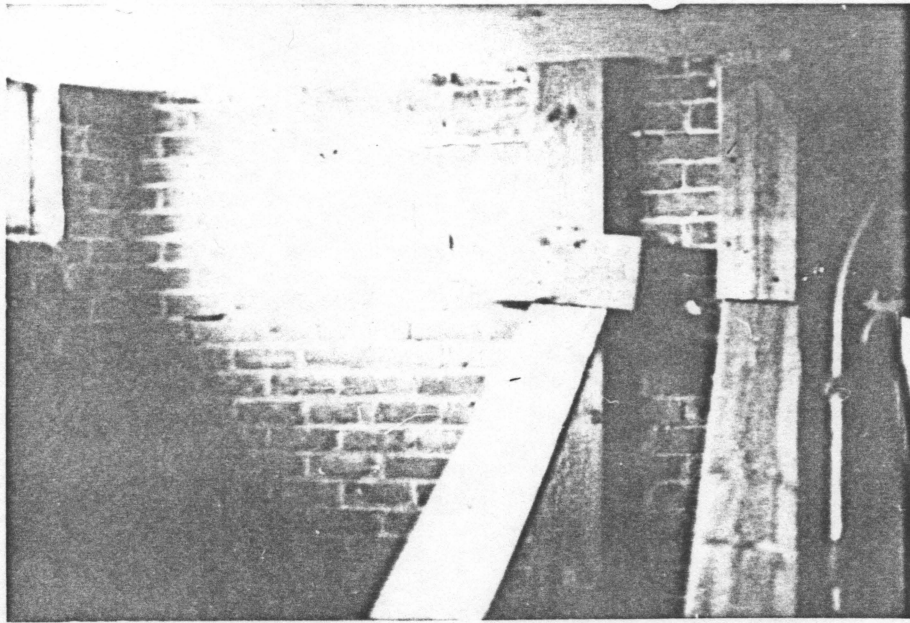
- 13) Temporary supports were used to prevent any further damage from accruing.

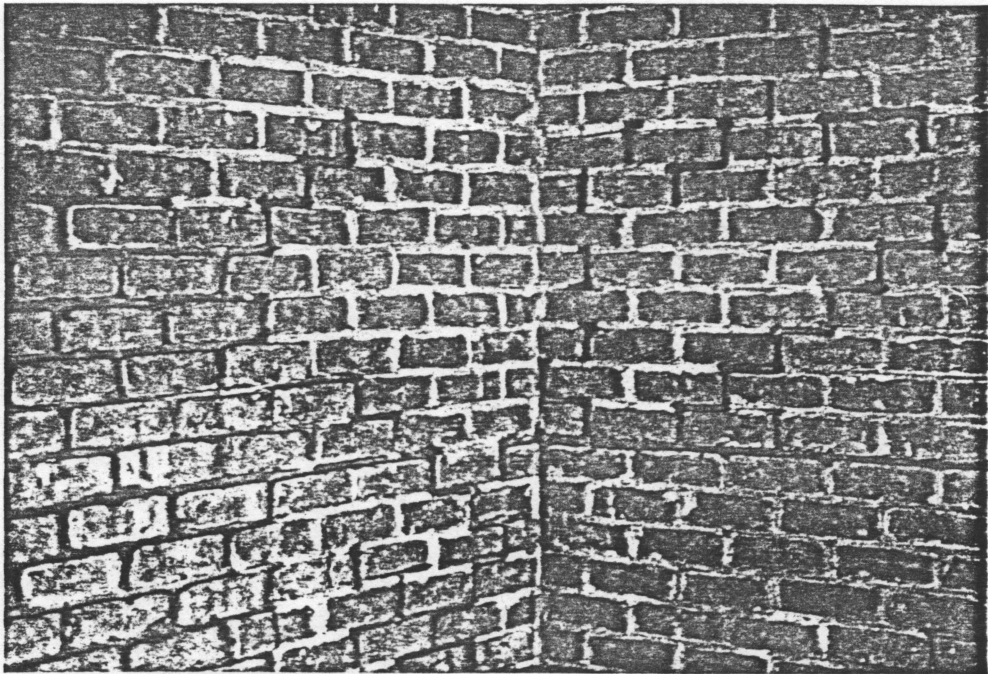
- 14) Photo showing interior of the north wall after tuckpointing. Mortar was not fully cured when photo was taken.

4) Mortar mix used for tuckpointing was of a soft texture. This was used only until a complete mortar analysis has been accomplished.

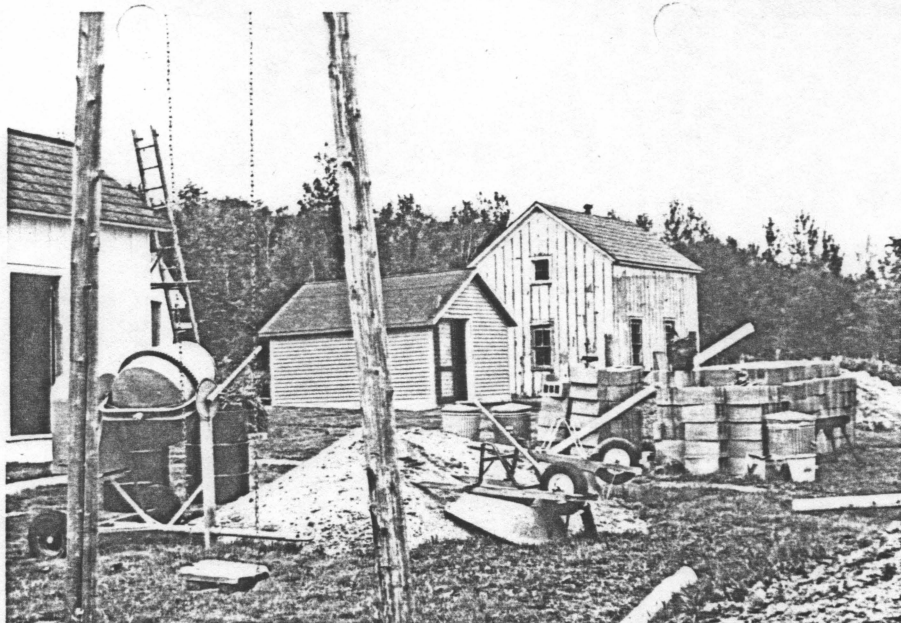
15) Photo showing the rear of lighthouse during construction.

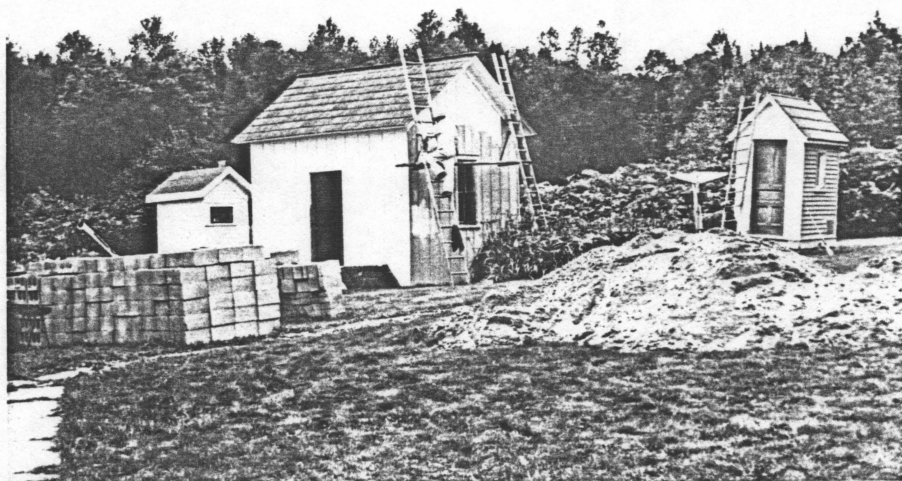
16) Photo showing primer being applied to the shed HS-08-102F. The building to the left is Privy HS-08-102E and to the right the small privy HS-08-102D.

SHED HS-08-102F 1) All exterior wood surface had been scraped, primed and painted. 2) The metal shingle roof had been painted to eliminate further deterioration.

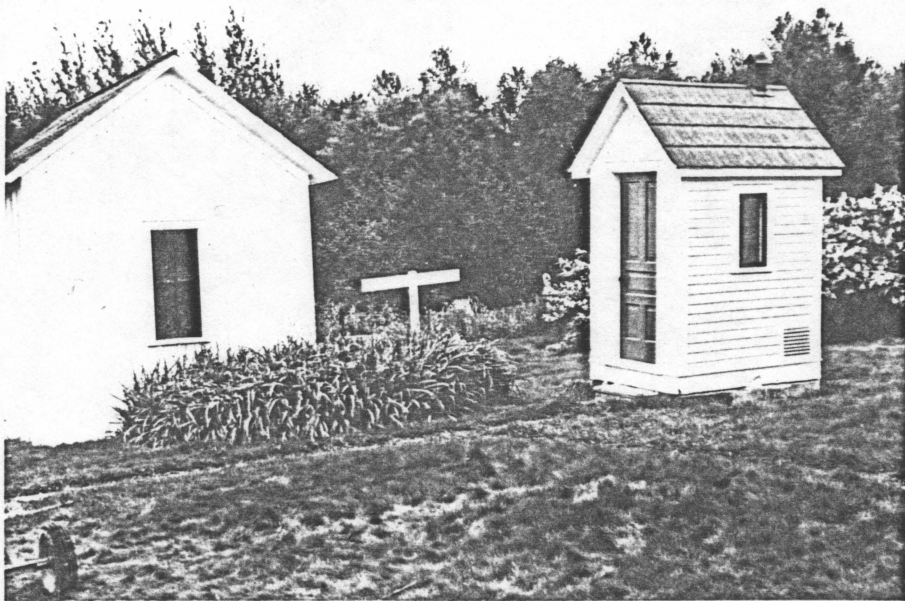
17) Both the shed and small privy is shown here after structures were painted.

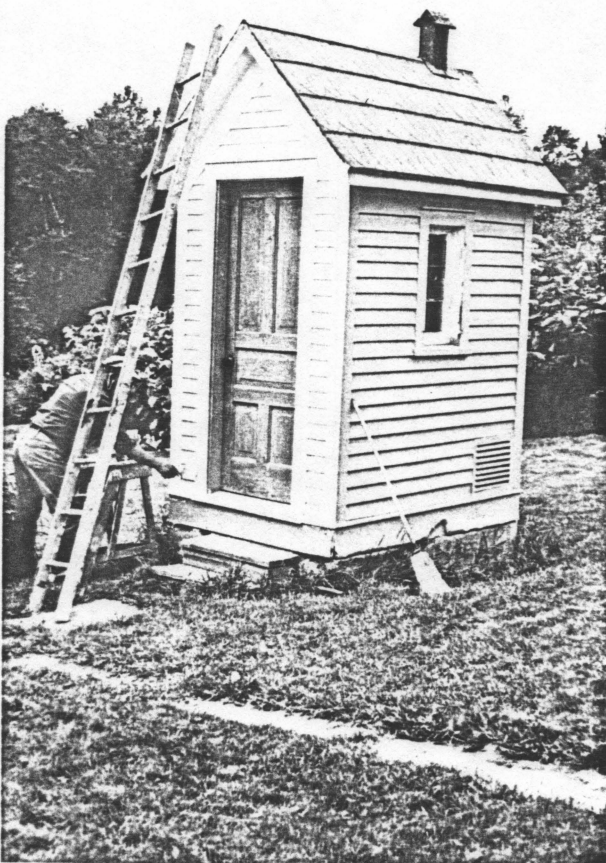
18) Small privy HS-08-102D is shown here receiving its final coat of paint.

SMALL PRIVY HS-08-102D 1) Basically the same painting procedures were applied to the exterior wall and metal shingle roof.

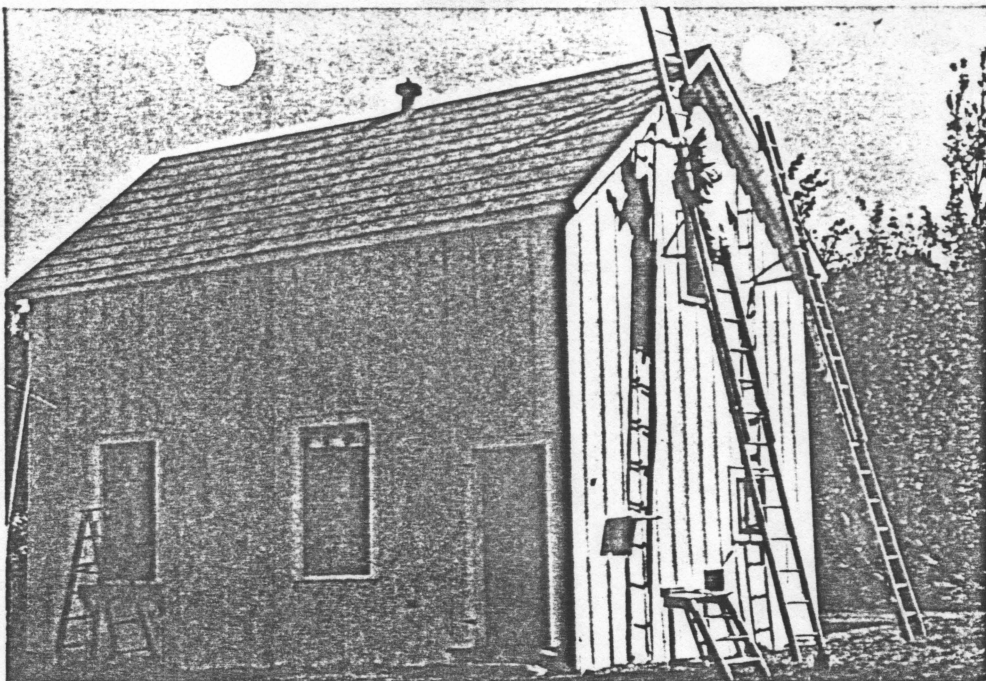
19) Final coat of paint being applied to first quarter resident.

1) Exterior of the structure had been scraped and painted. A primer was applied, followed by a top coat to the wood surfaces. The same procedure was applied to all windows, doors and trim work.

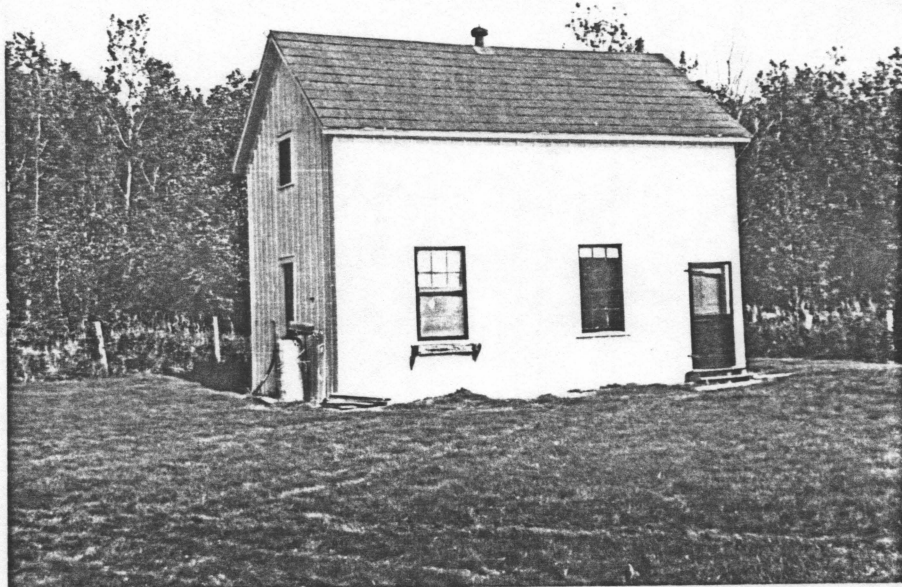
20), Photo shows work on the first quarter resident completed.

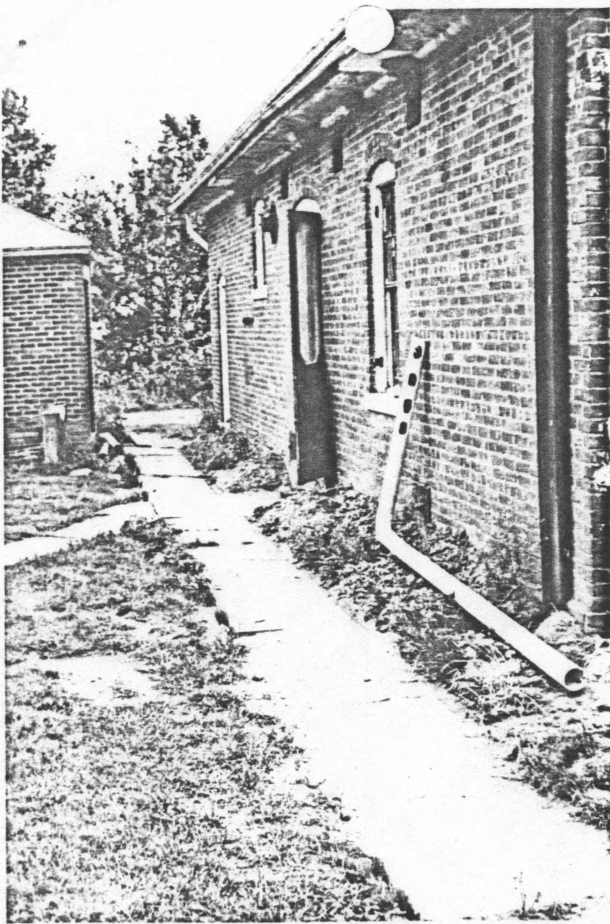
21) North side of generator building before drainage and sidewalk were corrected.

NOTE: 1) Replacement of the deteriorated walkway on the north side of the

Generator House HS-08-102B.

2) Improvement of water drainage and grade along main lighthouse and generator building.

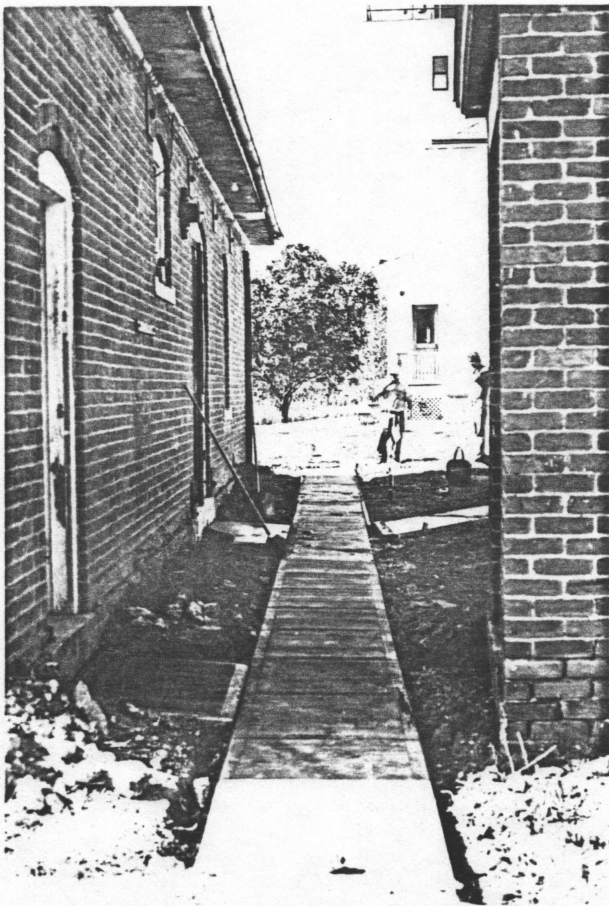
22) View showing the sidewalk and drainage problem corrected along generator building

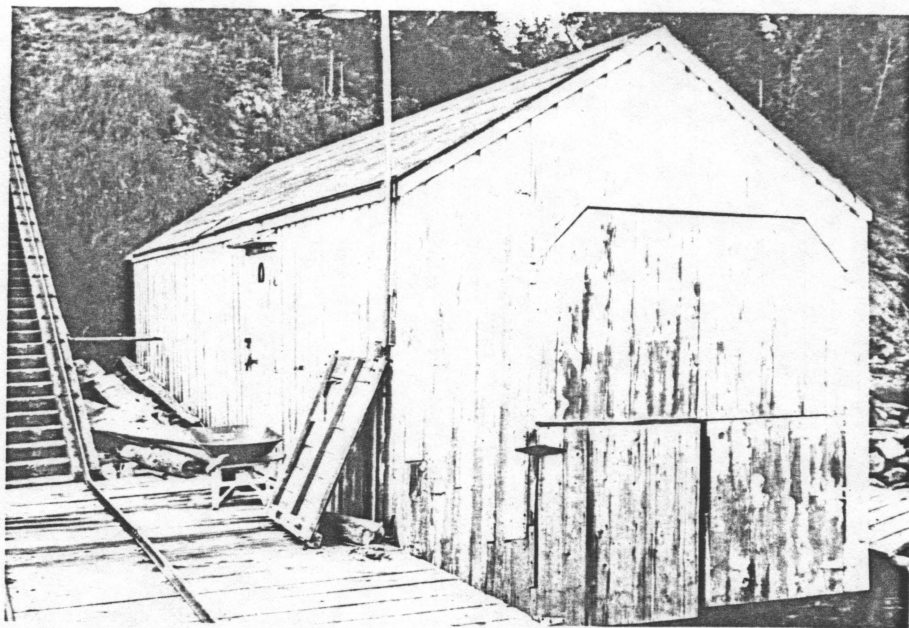
23) Photo showing the condition of the boat house before stabilization took place.

BOATHOUSE - HS-08-102A 1) entire exterior structure had been scraped and painted. A primer was applied, followed by a top coat to the exterior surface.

2) A roll asphalt roofing material was installed over the existing roof.

3) All board and batten siding material was re-nailed wherever needed.

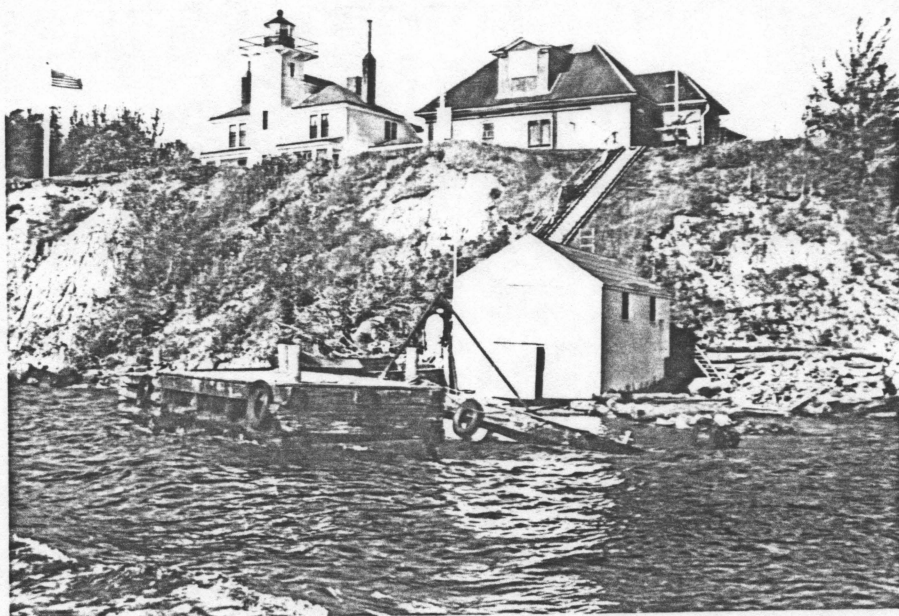
24) Photo showing the approach to the Raspberry Lightstation. Note boat house below had just been painted.

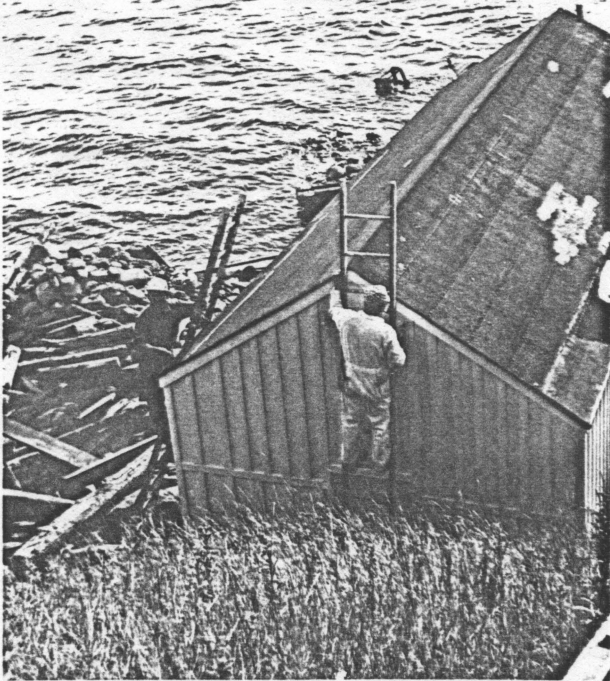
25) Workman applying rolled roofing over the existing roof of the boat house.

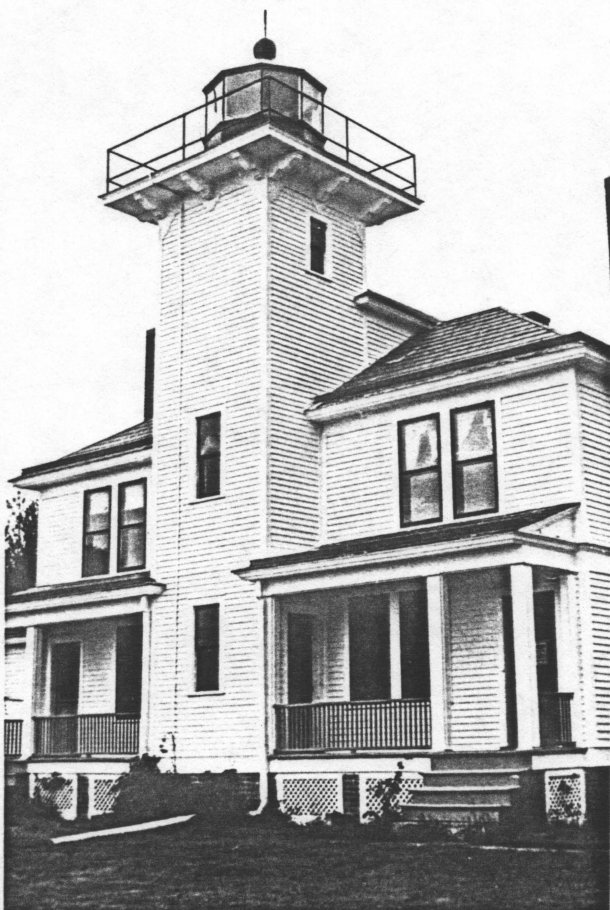
26) South view of the light house showing the project completed.
