COMPLETION REPORT

APOSTLE ISLANDS NATIONAL LAKESHORE  
STABILIZATION OF THE SAND ISLAND LIGHT STATION  
(work order title)

STABILIZATION ON HS-06-142A, HS-06-142C

STABILIZATION OF SAND ISLAND LIGHT STATION

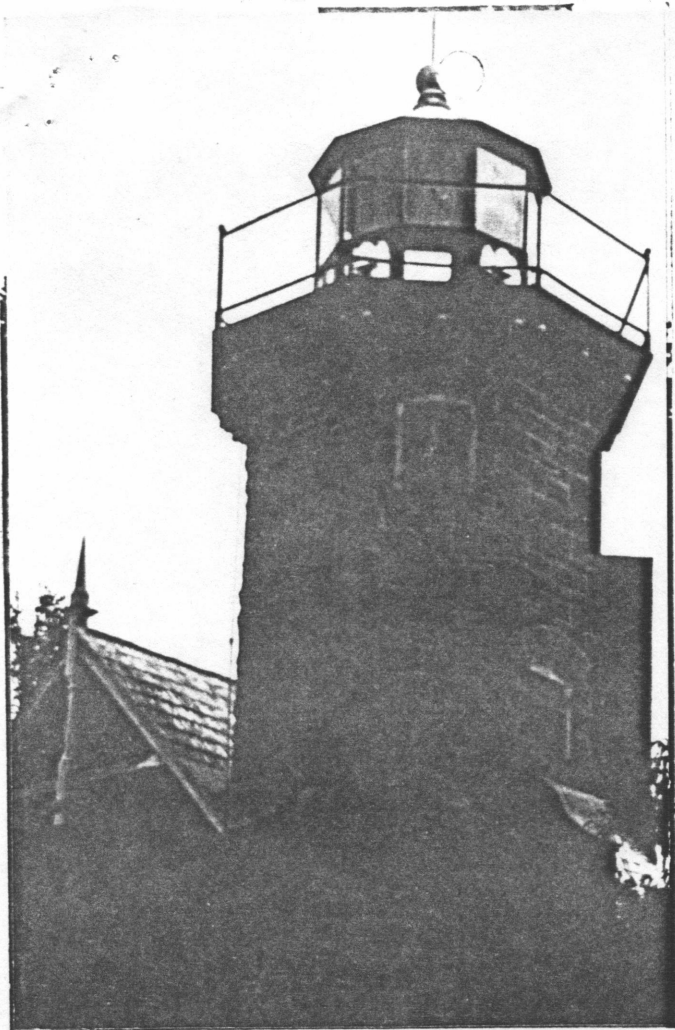
- 1) Photo showing the condition of the north side of the lighthouse before stabilization took place.

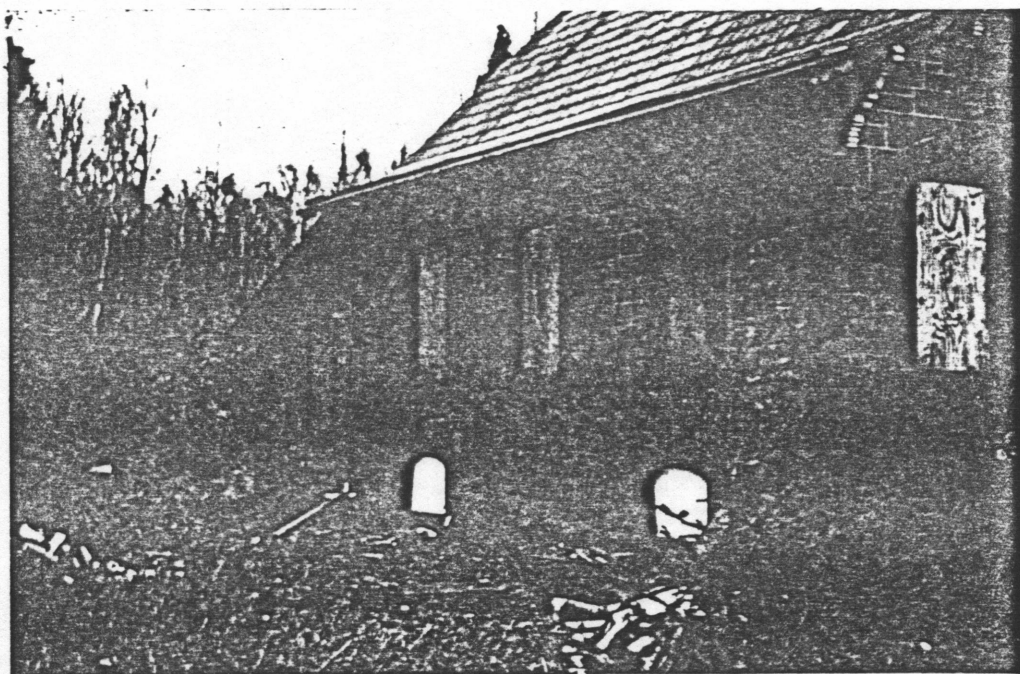
- 2) East view of lighthouse showing debris being cleaned up around structures. Fill was needed along this east side to correct the water drainage problem.

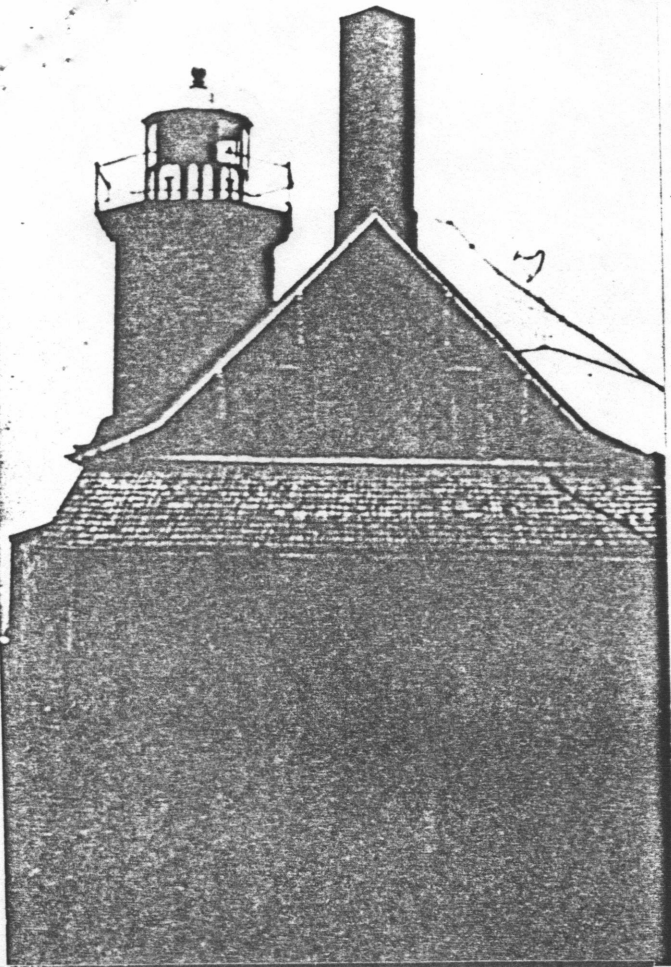
- 3) South view show the condition of lighthouse before project got started.

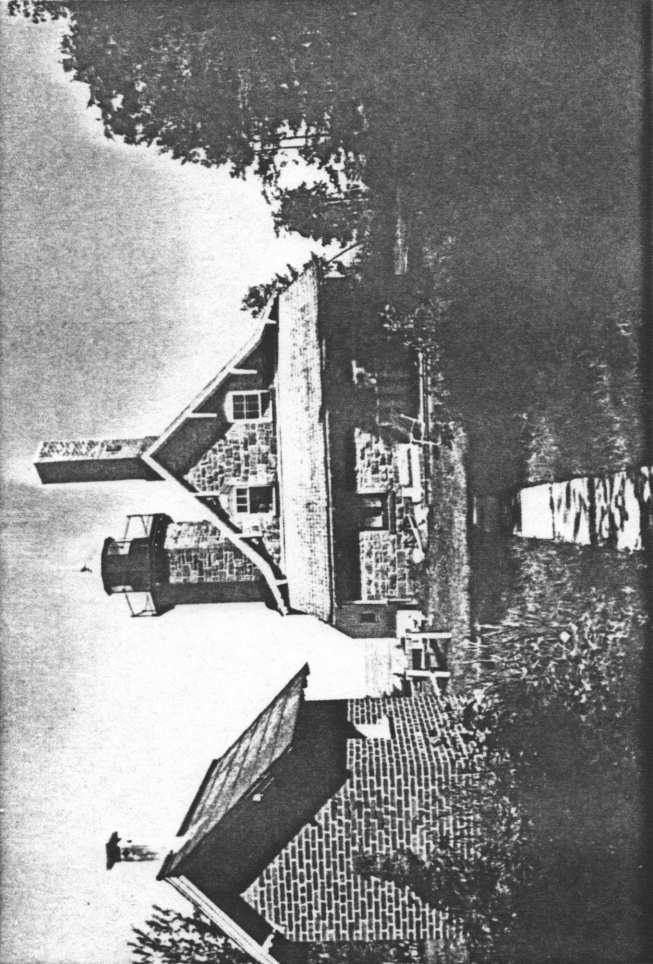
- 4) Photo taken during the construction stage. Majority of the painting had been accomplished in this photo (south side of lighthouse)

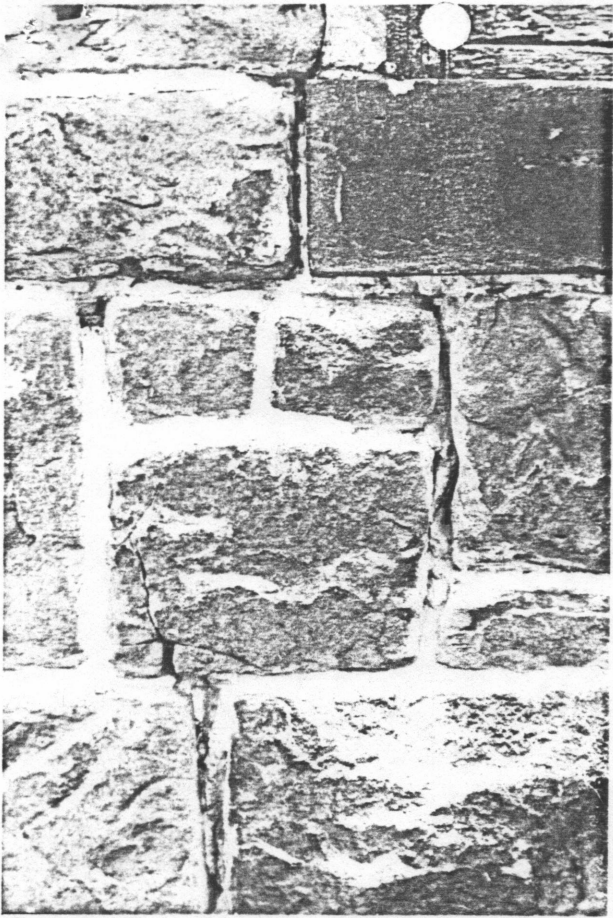
- 5) View showing the condition of the exterior sandstone wall of the lighthouse.
  - A) Closeup view showing condition of joints before tuckpointing.
  - B) Shows new mortar in place.

6) Mortar mix used for tuckpointing:

One part of white masonry cement

One part of hydrated lime

Seven parts sand

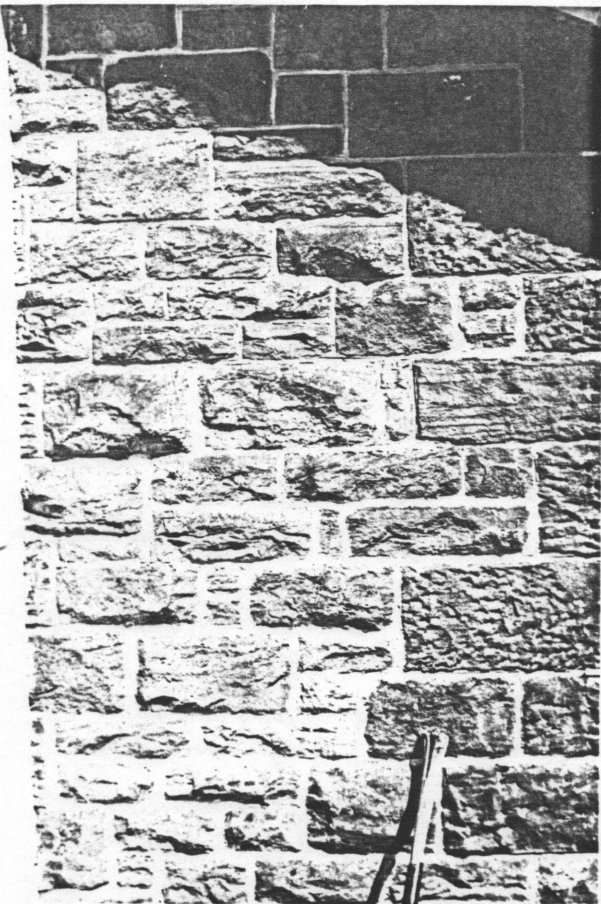
- 6) Photo showing an area of the sandstone wall of the lighthouse after the tuckpointing technique was used.

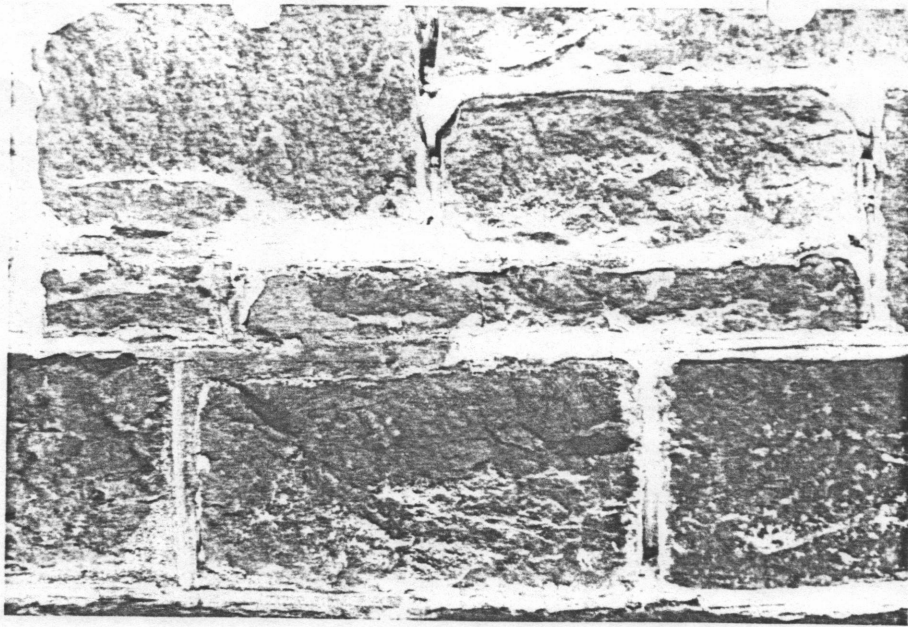
- 7). Photo showing condition of the sandstone wall of the lighthouse. All major deteriorated joints were tuckpointed. Arrow shows an area which at one time was repaired using a rich mortar mixture. The result of the rich mixture is causing the joints to be harder than the sandstone; therefore, if any movement occurs, the stone will crack. We recommended use of a 6-1-1 mixture until a mortar analysis was made.

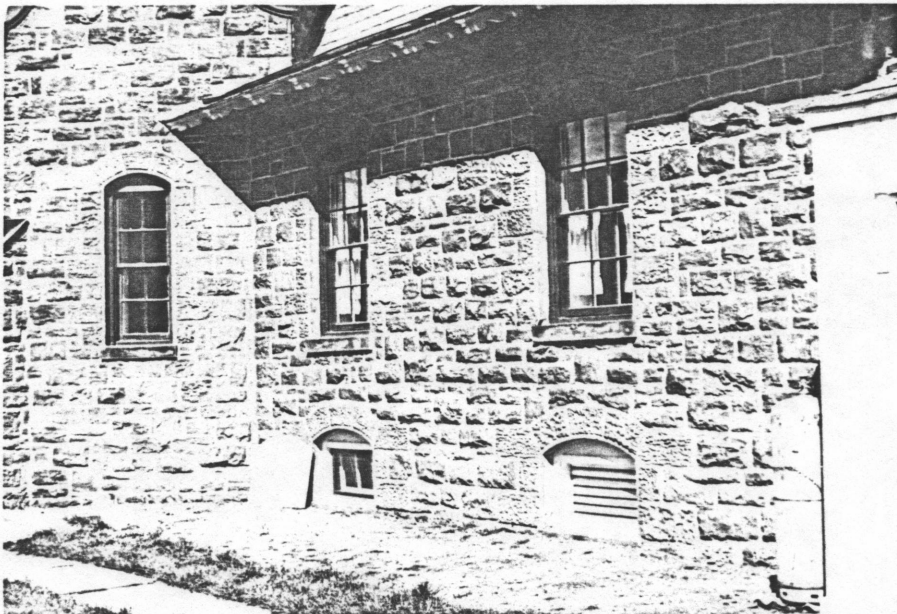
- 8)- West side of lighthouse showing condition of walls after tuckpointing.

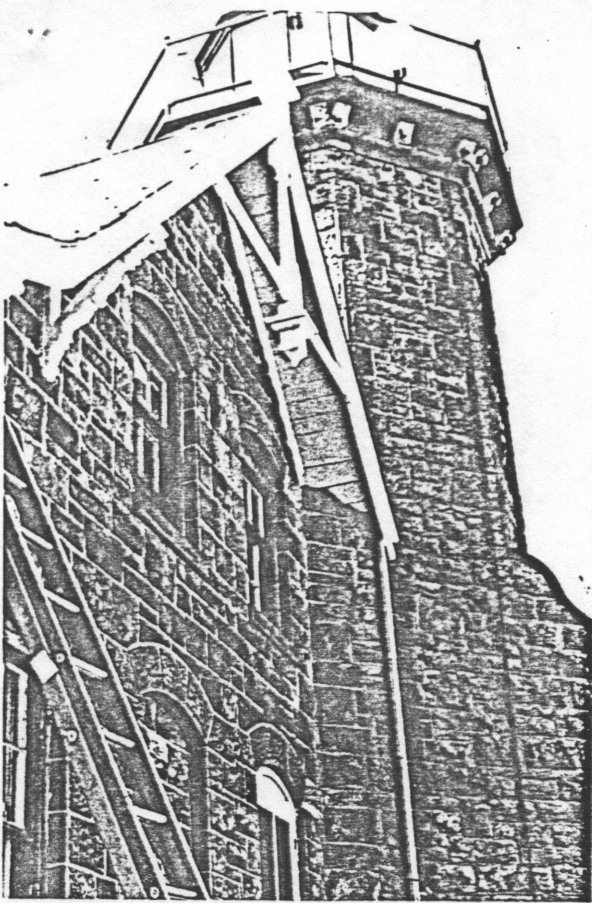
9) North view of lighthouse and tower showing window and eaves painted.

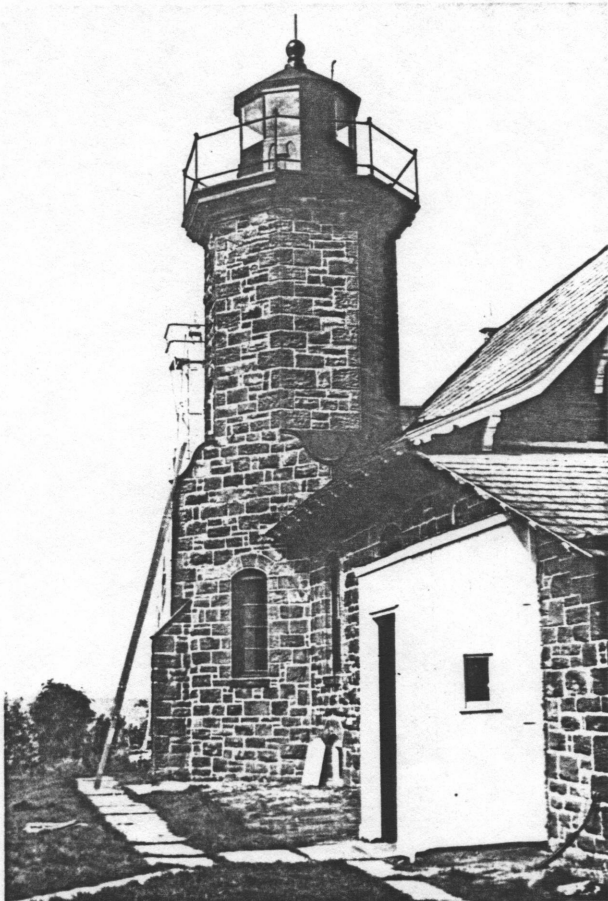
10) Southwest view showing lighthouse stabilization work near completion.

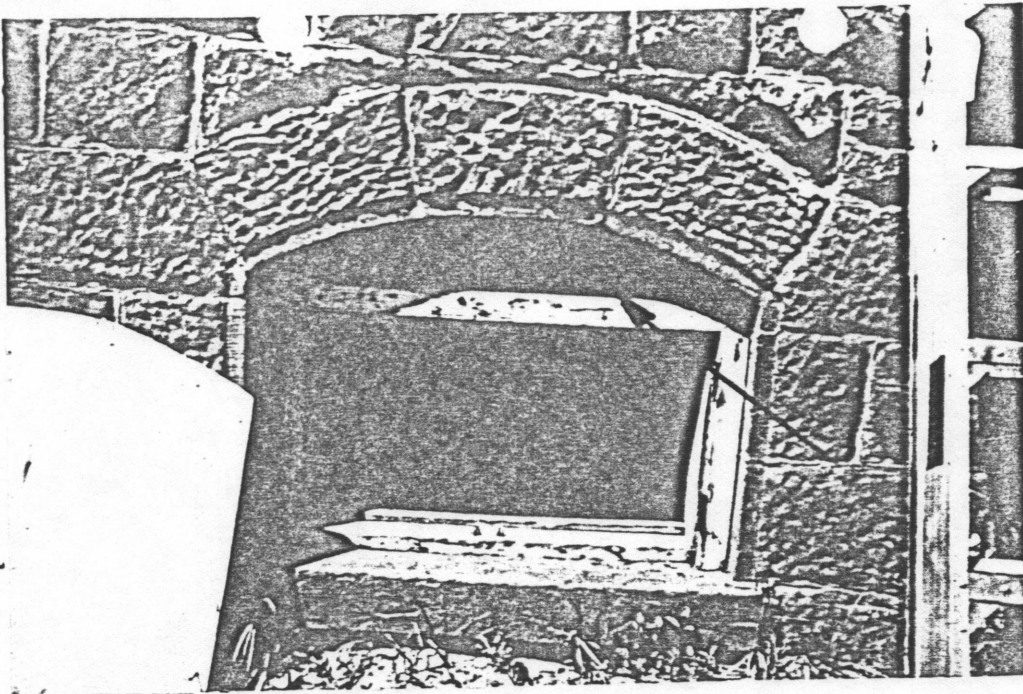
- 11) Photo showing deterioration in the upper section of window area. A new frame was constructed in the same design. Portion of the old frame was used to repair other window sashes. (Northeast basement window of lighthouse)

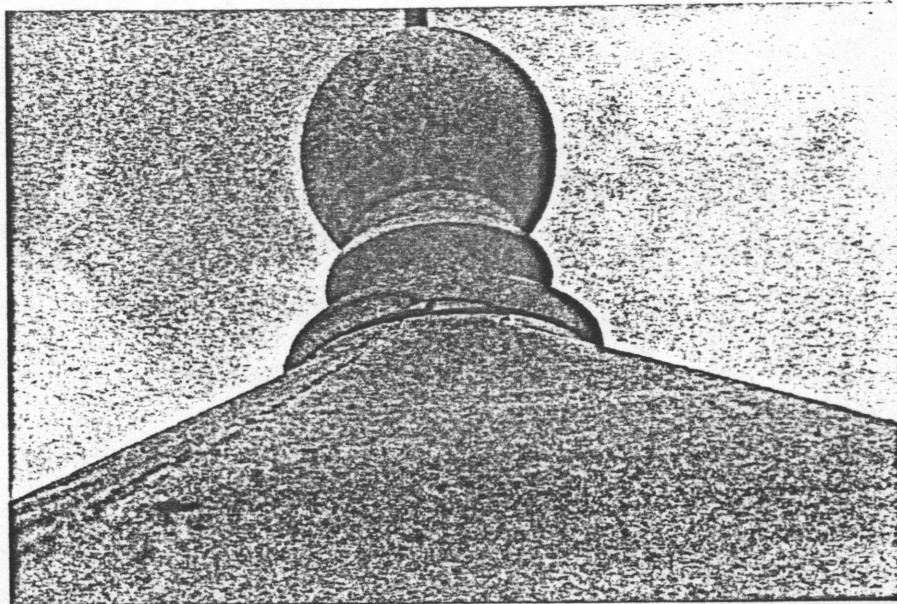
- 12) Photo showing cracked cylindrical vent on top of the light tower. Vent was repaired by using structural epoxy and then primed and painted.

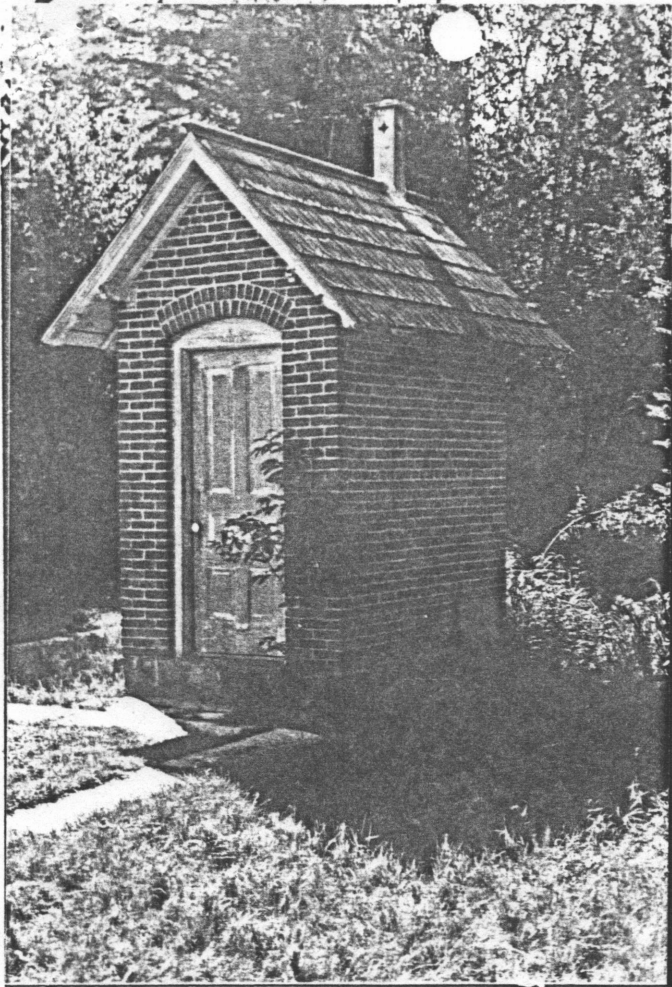
13) North view of privy showing condition of structure before work was started.

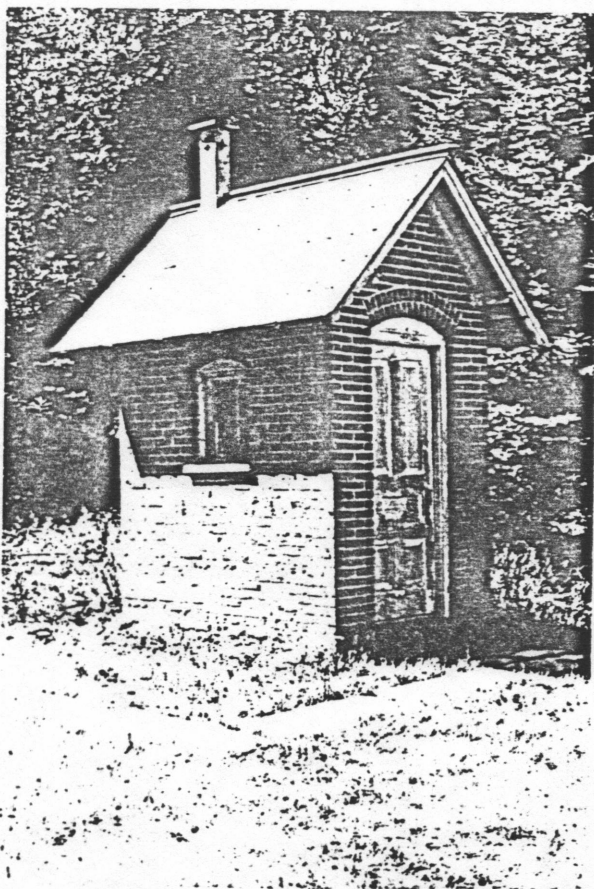
14) Northeast view of privy HS-06-142c. Photo showing all wood surfaces has been prepared and was ready for painting.

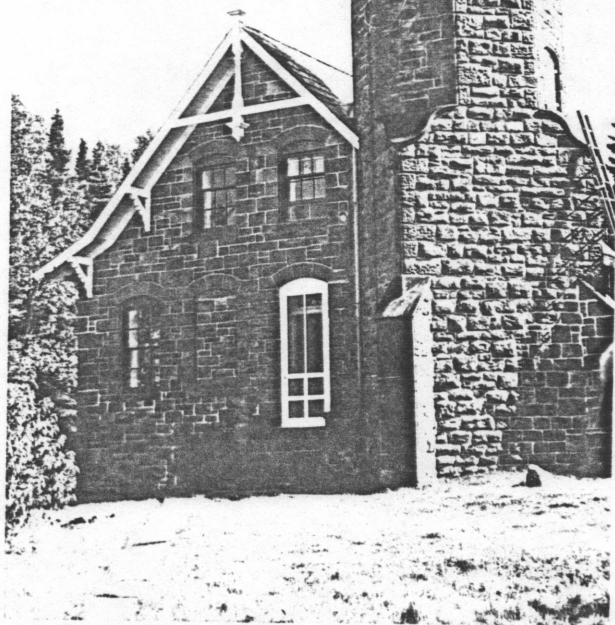
15) Photo showing stabilization work  
completed on the lighthouse (north  
view) HS-06-142A
