COMPLETION REPORT

APOSTLE ISLANDS NATIONAL LAKESHORE  
STABILIZATION OF THE OUTER ISLAND LIGHTSTATION  
(work order title)

STABILIZATION ON HS-22-105A, HS-22-104B, HS-22-104C  
MIDWEST REGIONAL OFFICE  
RAY KUNKEL AND JOHN OCHMAN, PROJECT SUPERVISORS

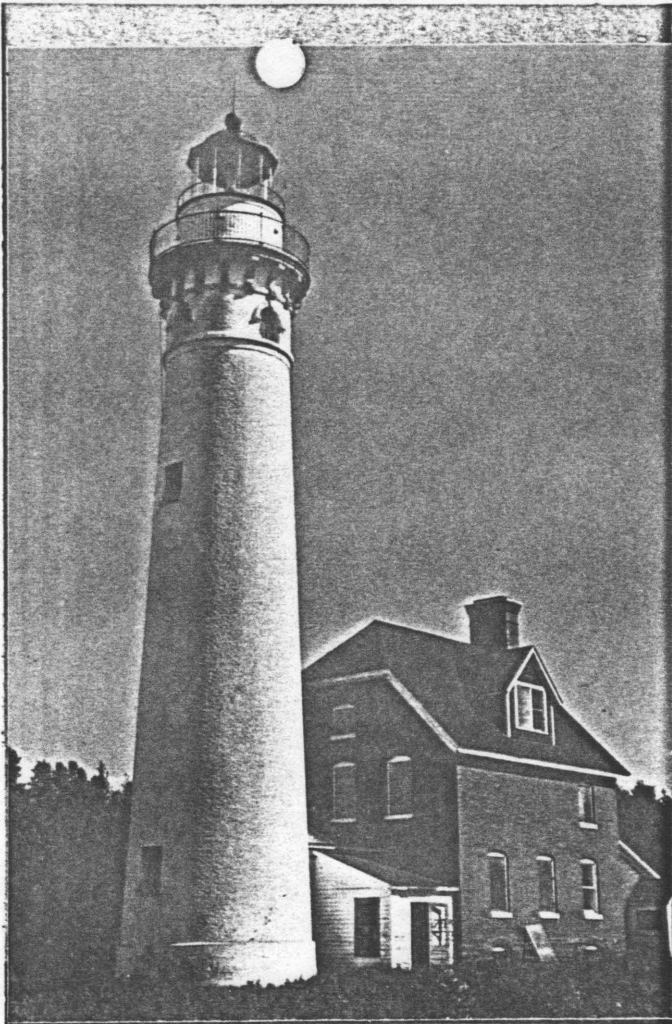
Lighthouse and tower, HS-22-105A, before stabilization project was started. Photo showing west side of the lighthouse.

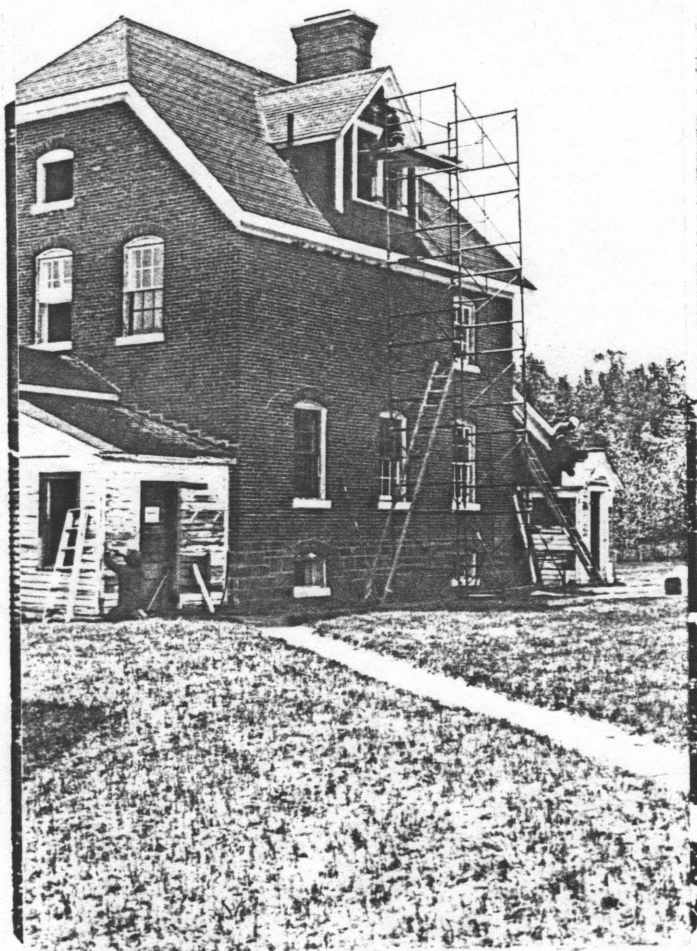
Workman preparing the lighthouse for painting, HS-22-105A.

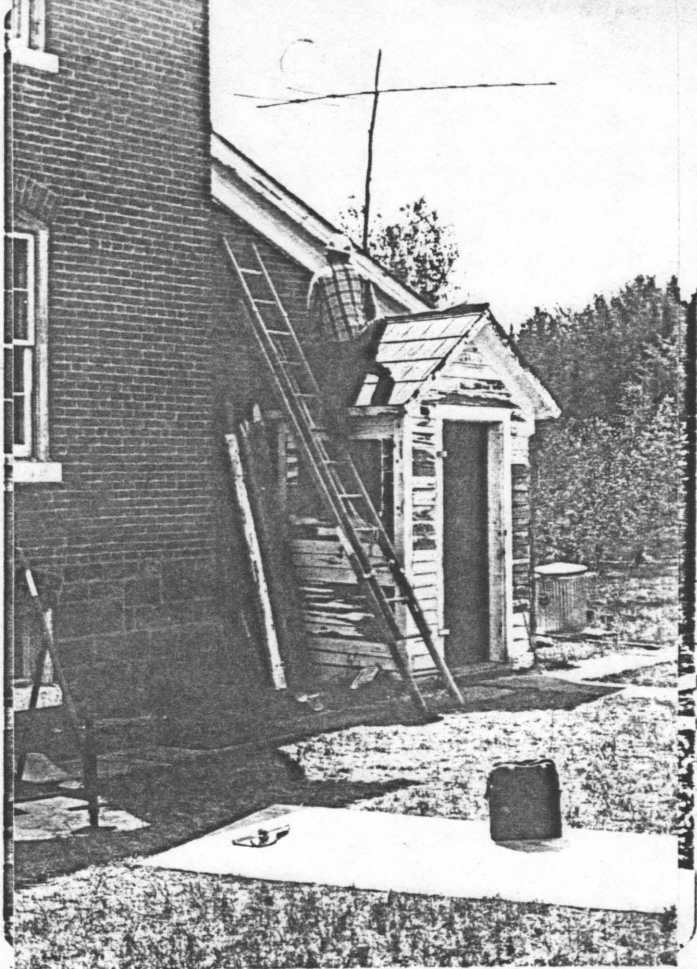
Entrance wing is being prepared for painting. Metal shingle being wire brushed while on the siding. Only loose and scaling paint was removed.

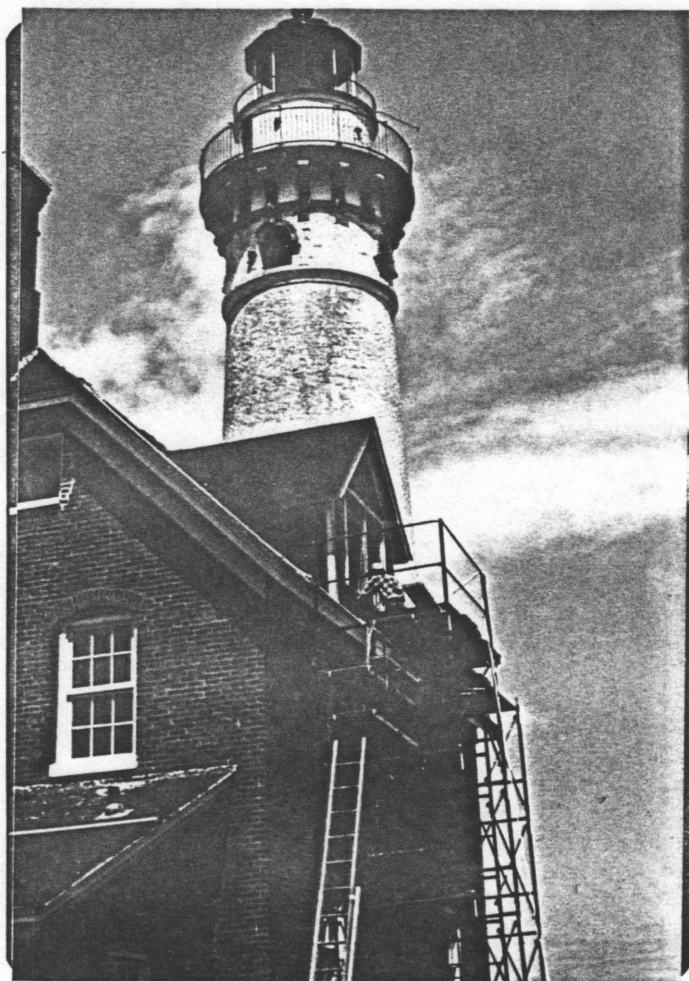
Southeast view of the lighthouse. East side of roof was being reroofed.

4. The entire roof had been reroofed.

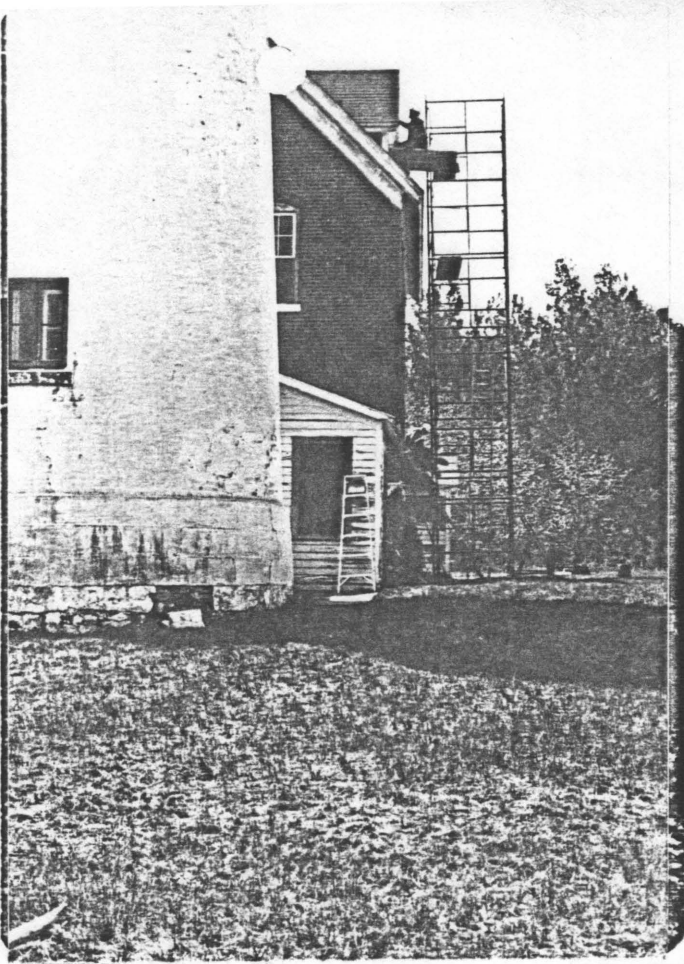
North side of lighthouse. (A)  
shows some of the deterioration  
along the base of the light tower.

4. Tuckpointing of the deteriorated areas of the tower.

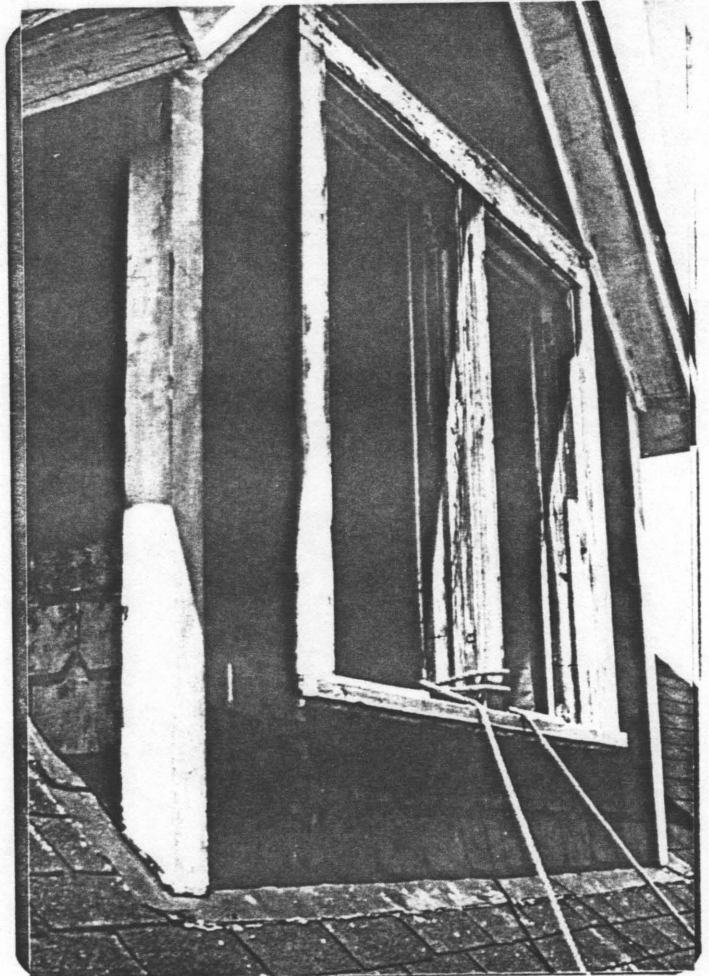
Typical window and dormer detail  
showing the condition before  
work was started. Photo taken  
of west side dormer of light-  
house.

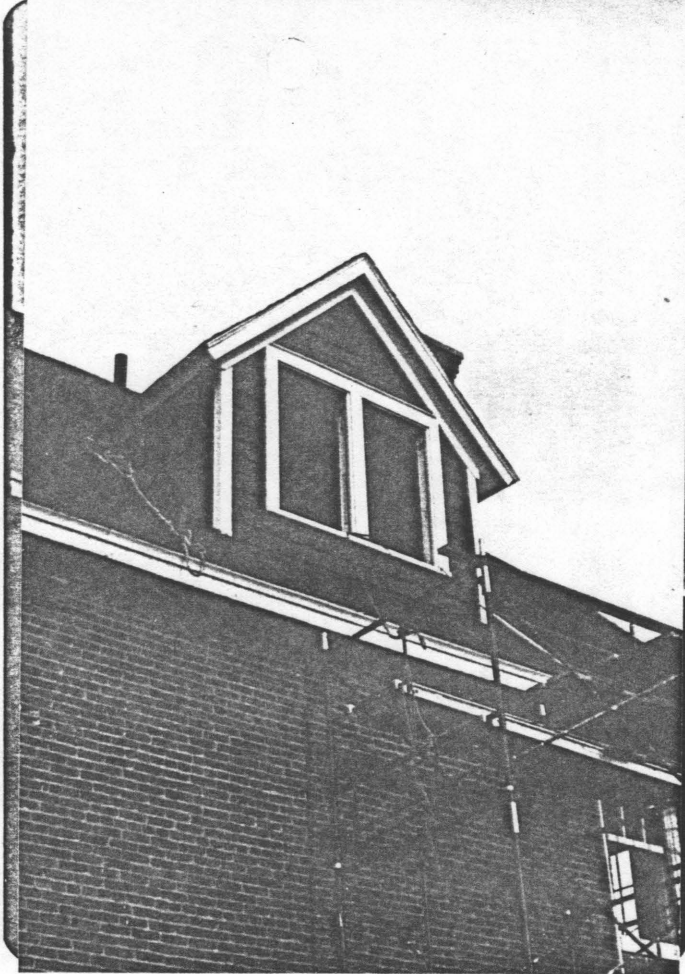
Photo showing dormer after surface has been prepared and painted. Photo taken of west side dormer of lighthouse.

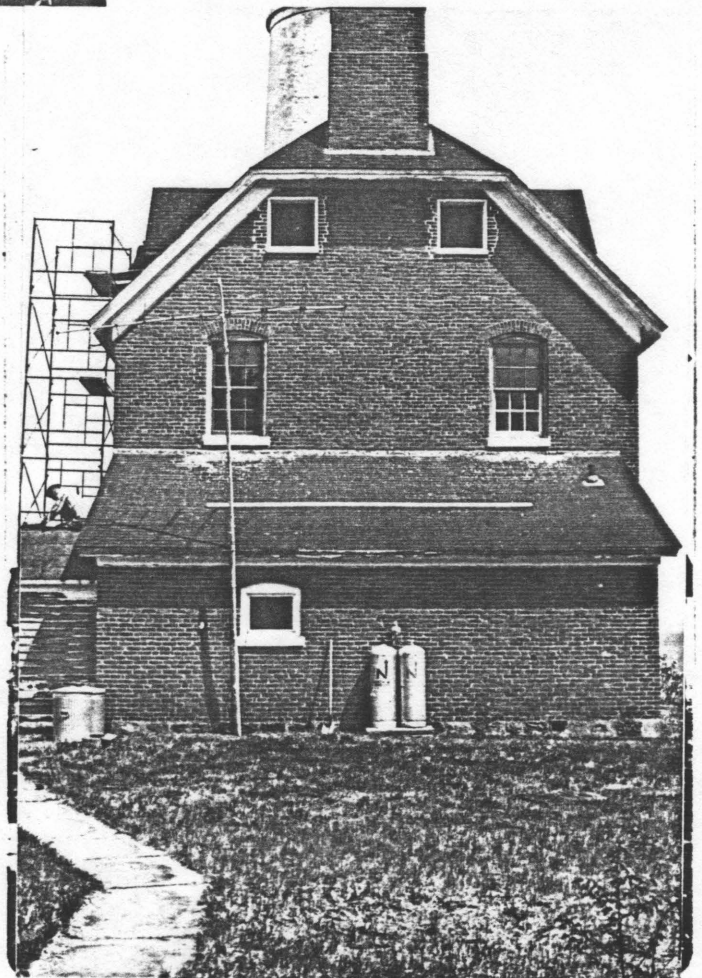
View showing the conditions of the south side of the lighthouse during the beginning stabilization stage.

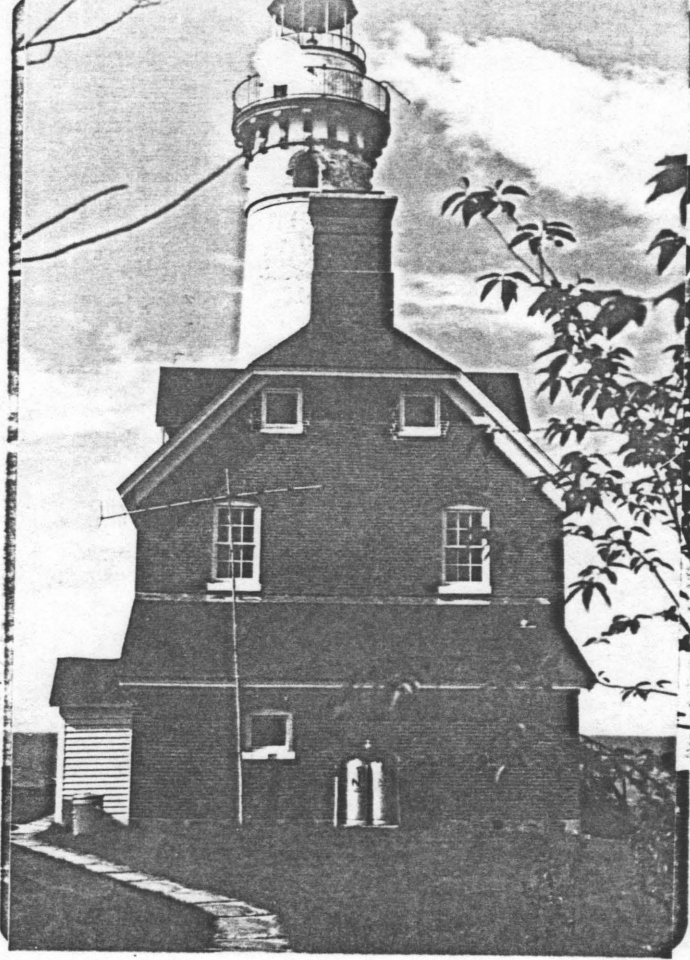
South side of lighthouse after stabilization work was accomplished.

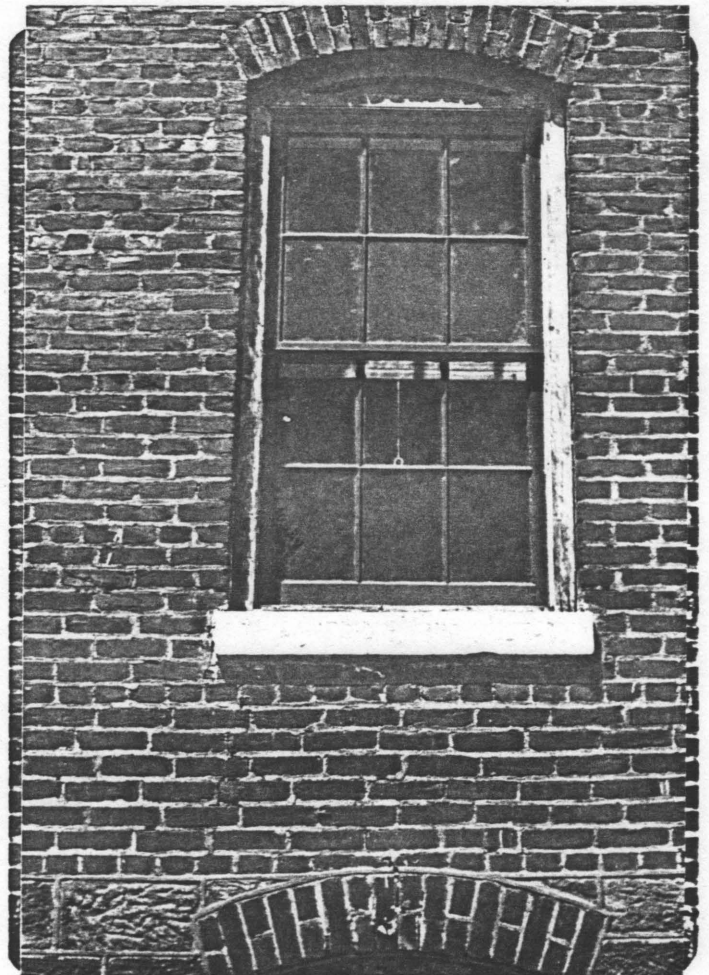
Typical window detail of main lighthouse.

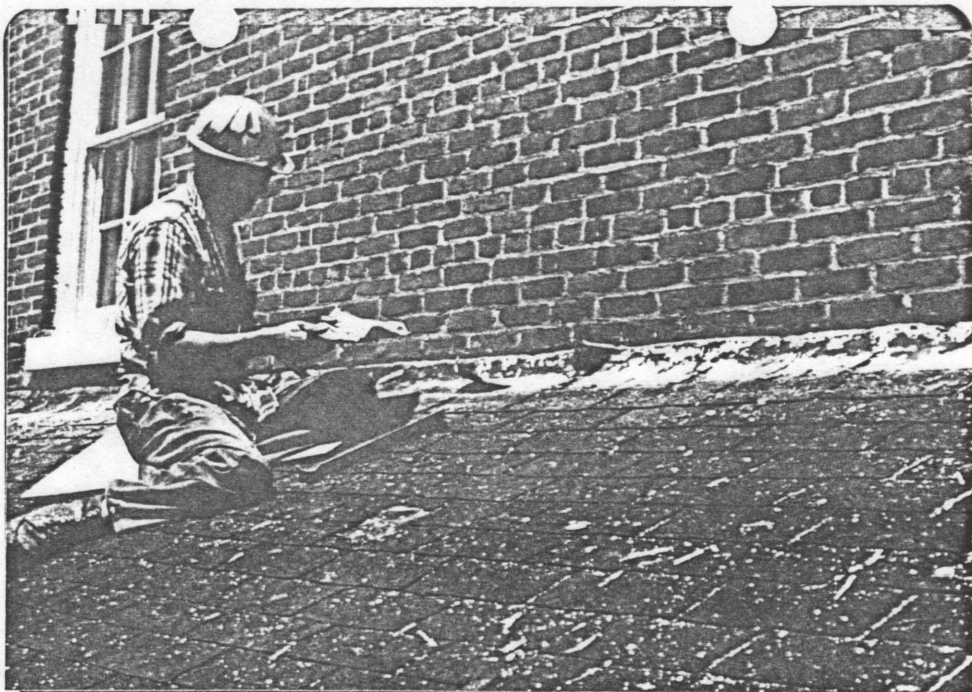
New flashing being installed along lean-to section over kitchen wing (south side).

7. Corrected flashing over kitchen section.

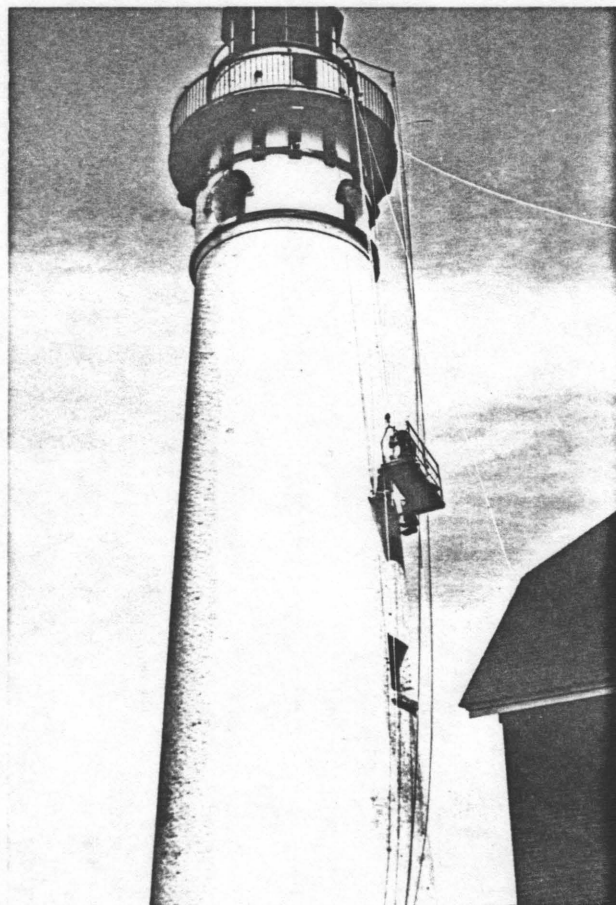
Decorative trim has been painted and workmen proceeding in the white-washing of the tower.

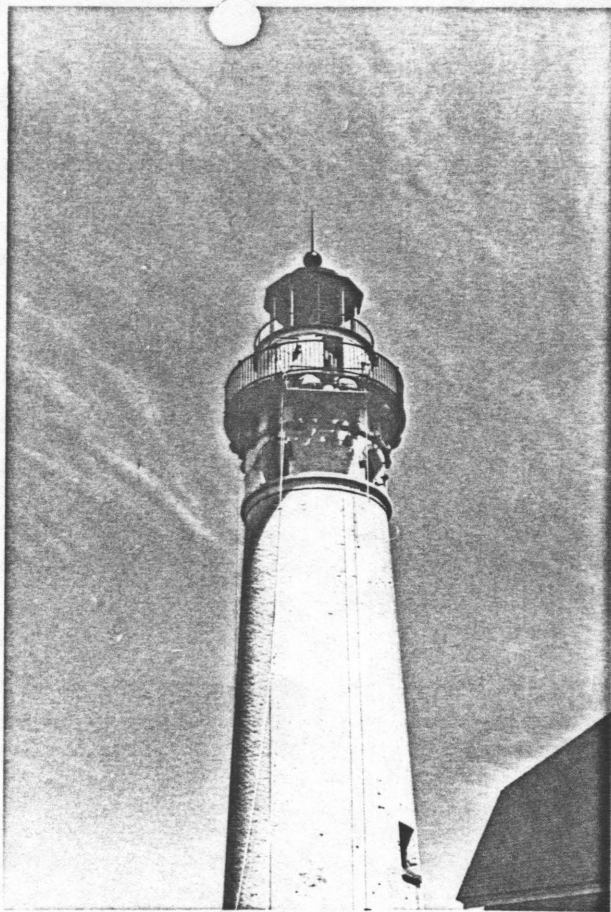
Workman preparing the painting surface along underside of the observation platform.

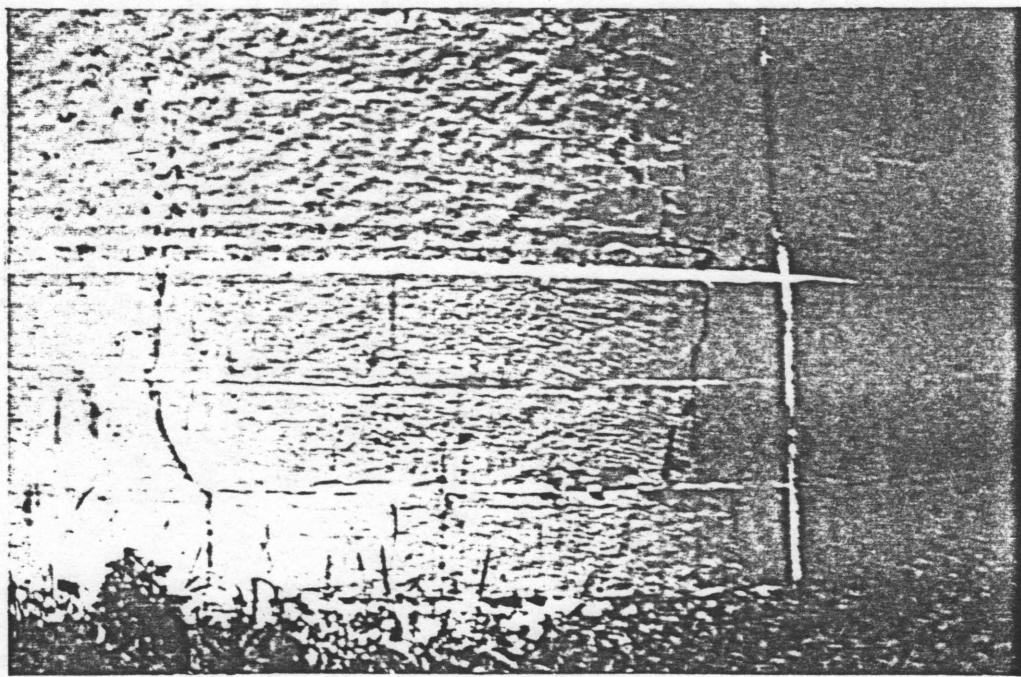
Showing the deterioration in the masonry wall of the light tower.  
Photo was taken at the base of the tower.

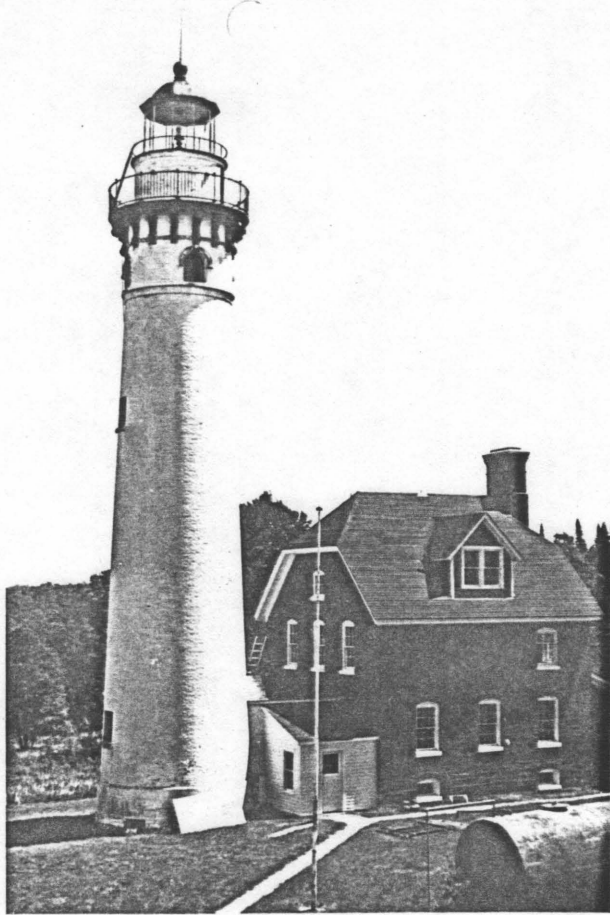
Northwest view of the lighthouse during one of the construction stages. Majority of the work had been completed on the house.

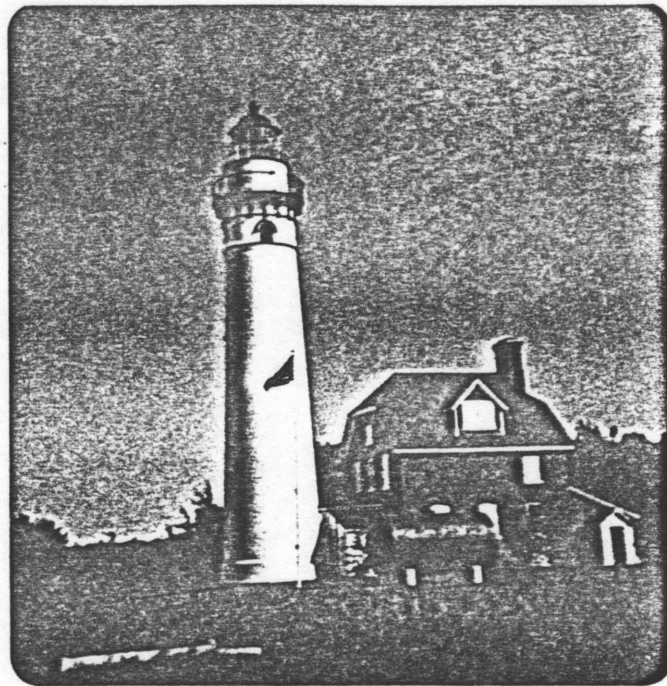
West view of the lighthouse after work was completed.

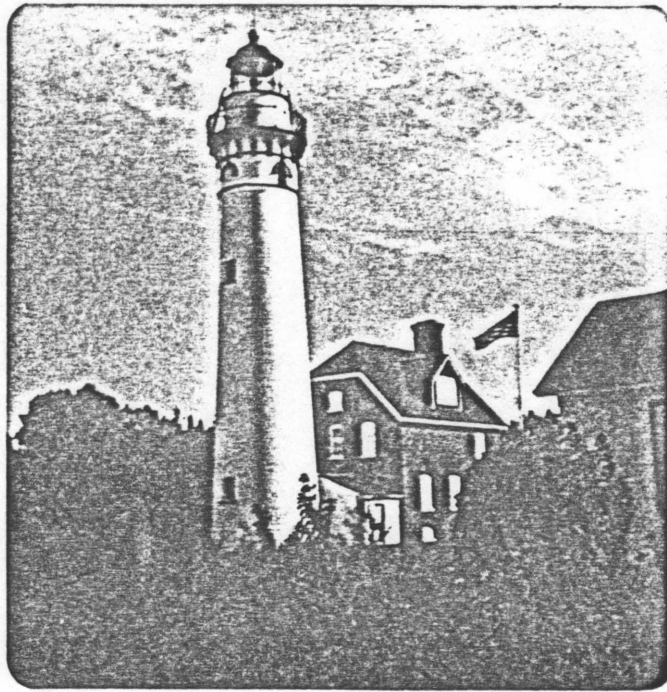
Northwest view of the lighthouse after work was completed.

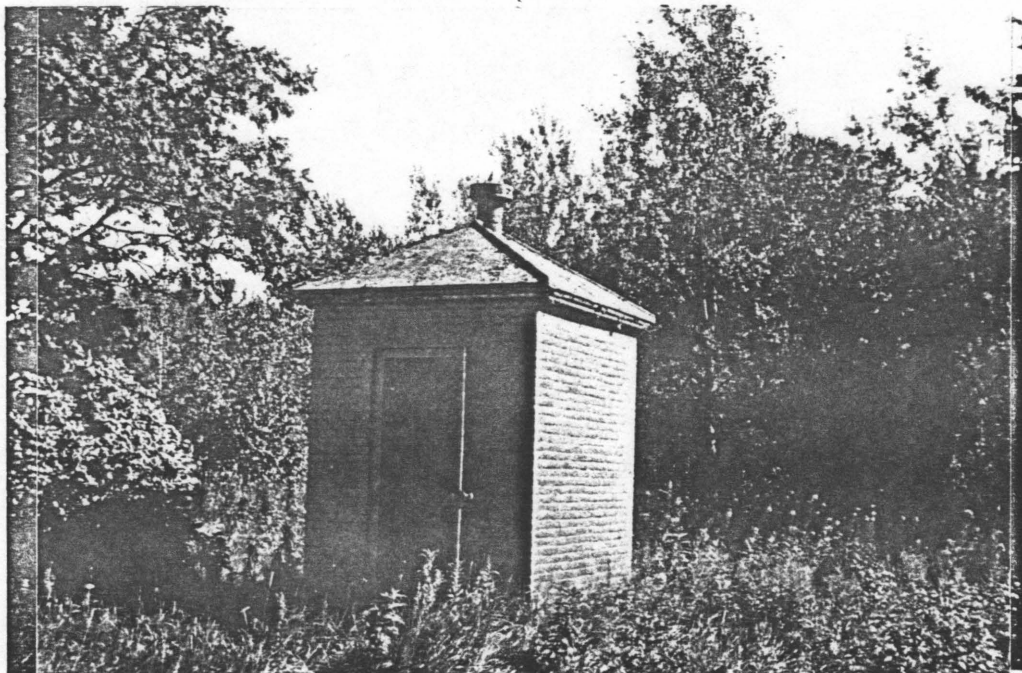
Magazine HS-22-14C. Condition of structure before work was started (north side).

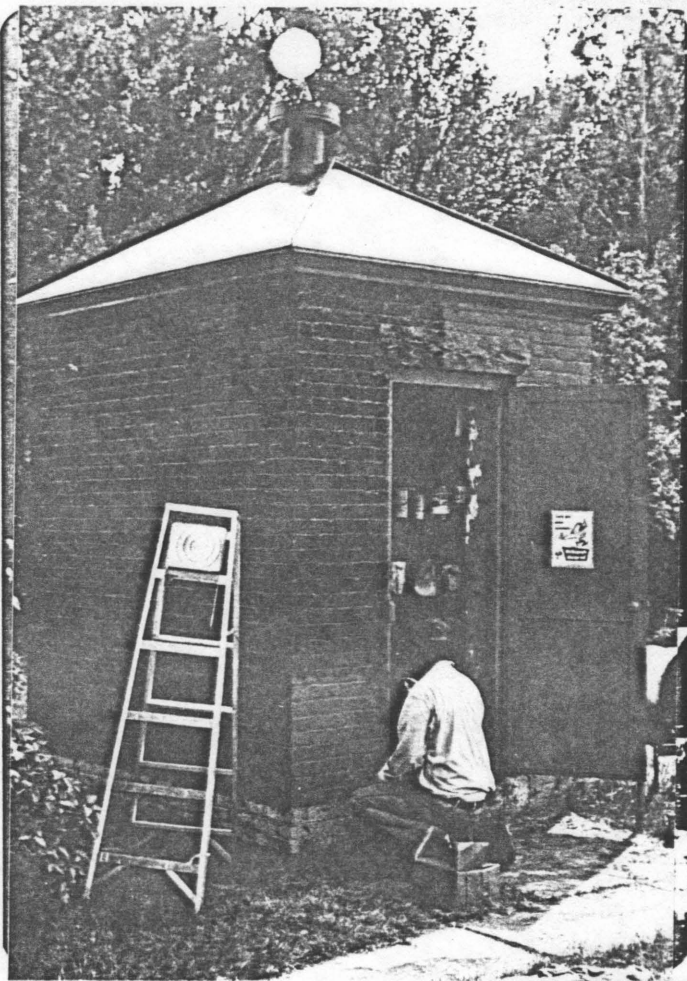
Exterior surface had been prepared and being painted.

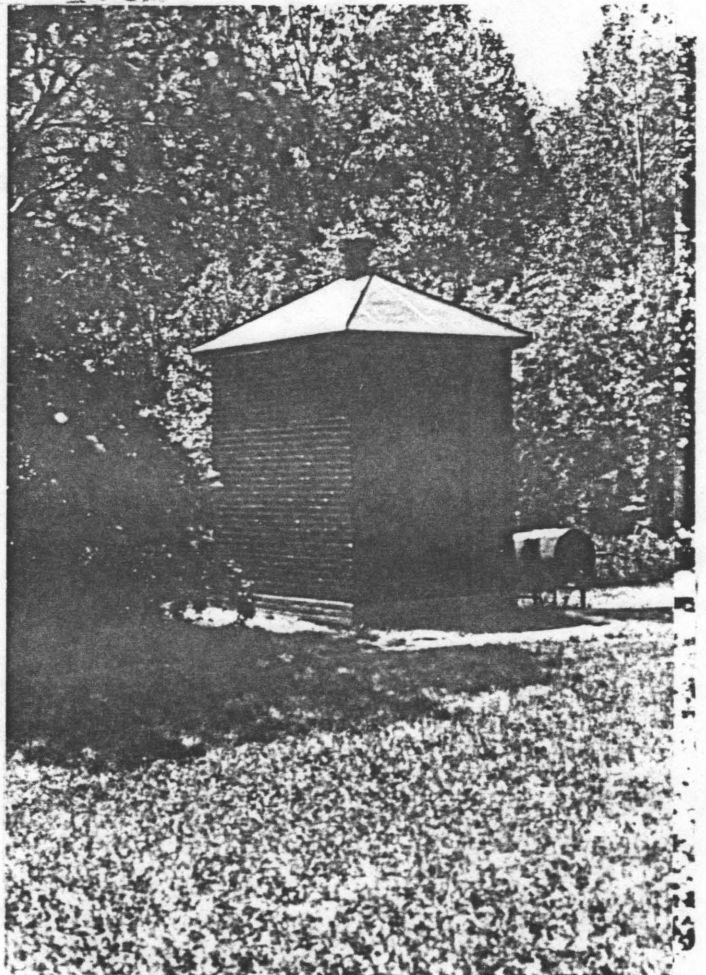
Photo showing the work completed on the magazine building.

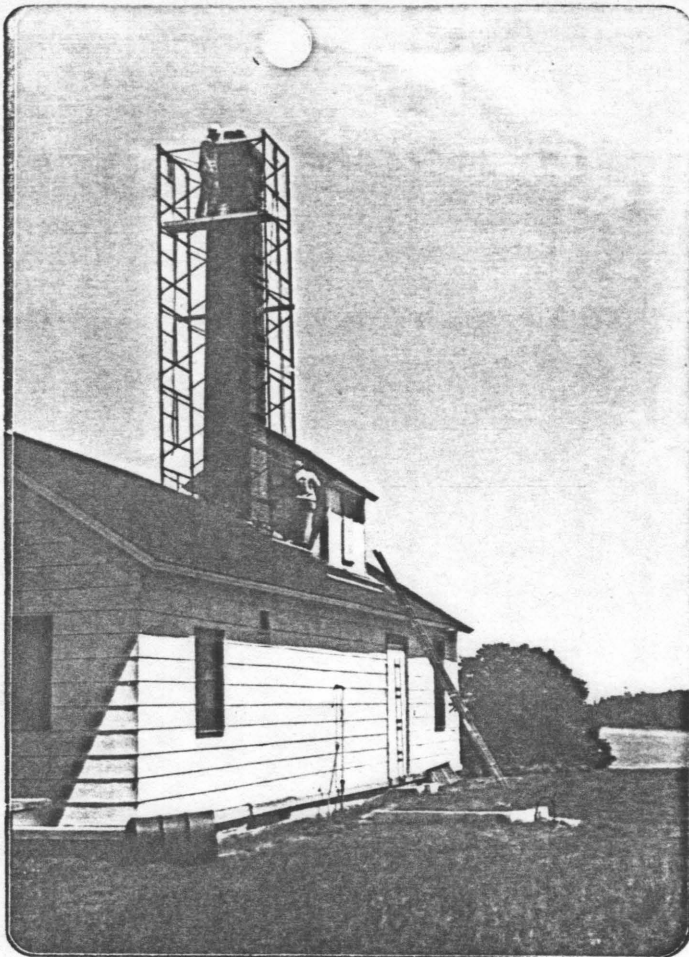
South side of generator building showing dormer being prepared for painting and tuckpointing, which is underway.

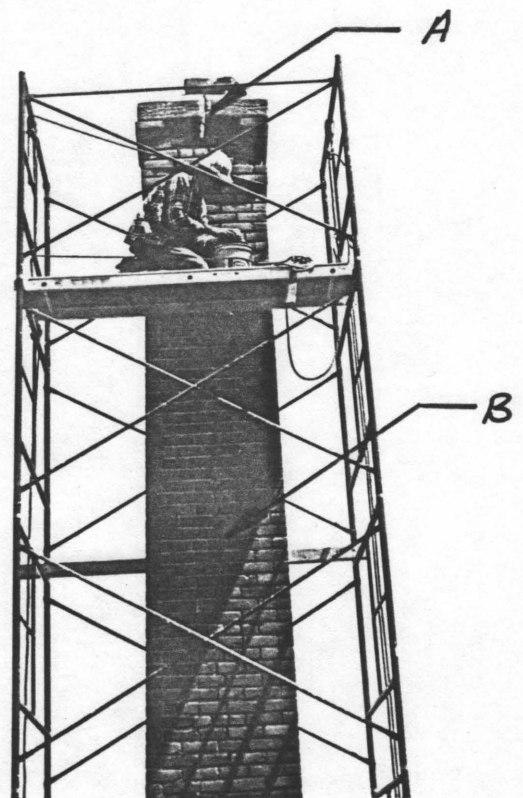
Workman starting tuckpointing the badly deteriorated chimney of the generator building.  
 (A) Shows the break in the cap.  
 (B) The break from the cap follows through down to the roof line.

4. All wood and metal surfaces had been primed and painted.
5. The entire chimney had been tuckpointed and a new cap had to be made to correct the badly deteriorated cap.
6. Foundation wall along the exterior was tuckpointed and then a thin cement mix was plastered over to match the existing construction design.
7. New flashing was installed around the entire chimney.
8. A new roof was installed over the entire building.
9. Shutters were constructed over all windows and door openings.

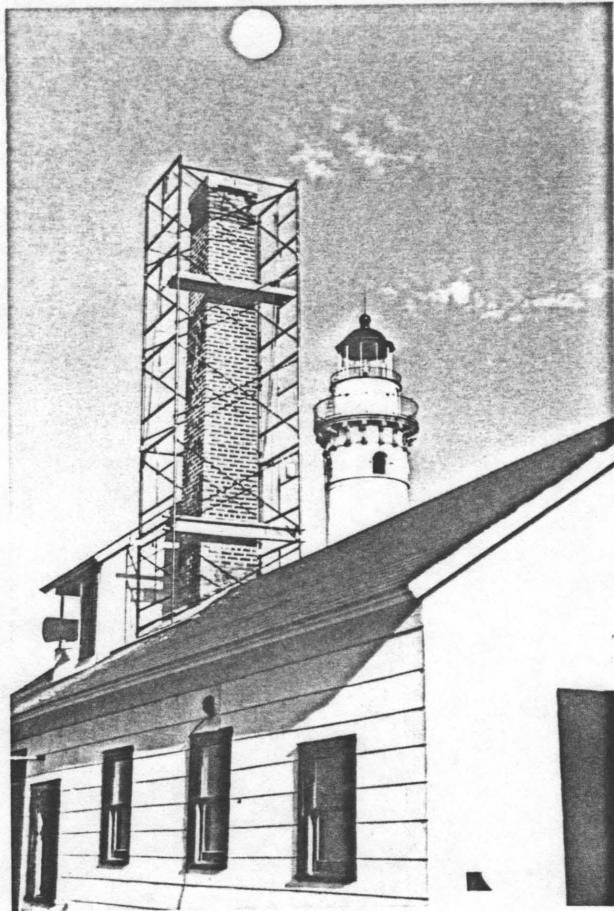
Majority of the tuckpointing had been completed on the generator building chimney. The top 8 courses were relaid and a new cap was constructed in place.

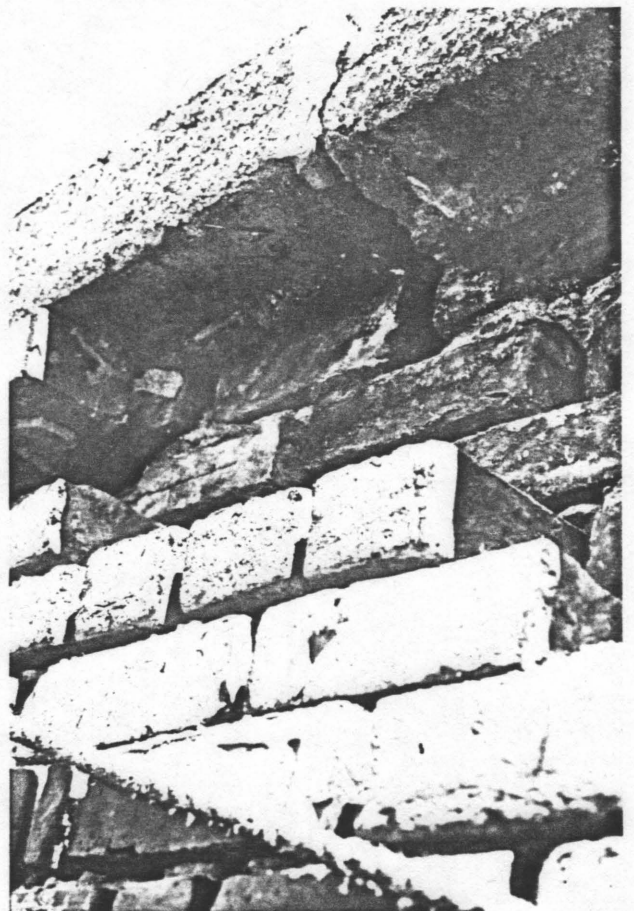
Detail showing conditons of the top 7 courses of brick of the generator chimney.

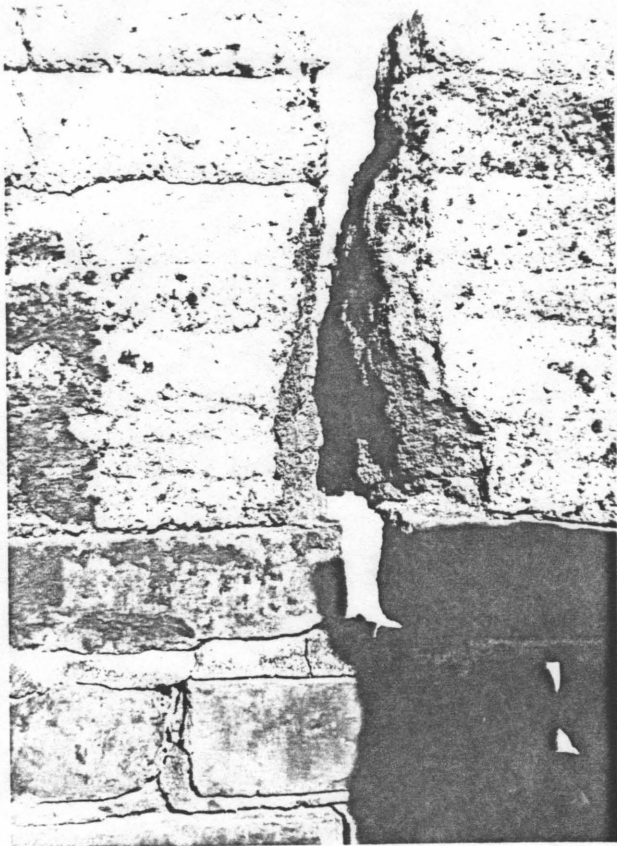
Detail showing deteriorated area of chimney cap and bricks of the generator building chimney. Interior view.

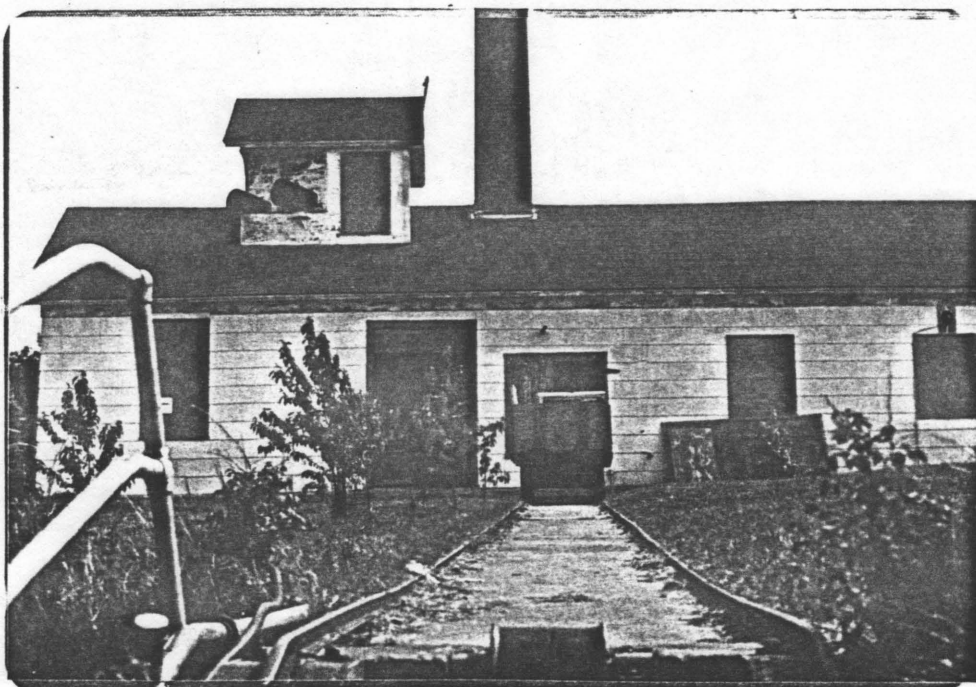
View showing the condition of the north side of the generator building before stabilization work took place. H-22-104B

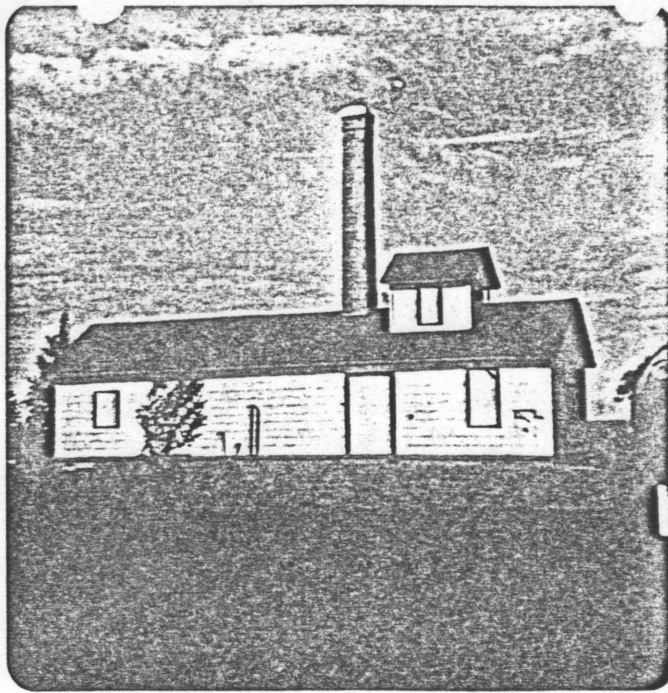
South view of the generator building after work was completed.
