# United States Department of the Interior

## Memorandum

Subject: Report for Travel to Katahdin Woods and Water National Monument (KAWW)

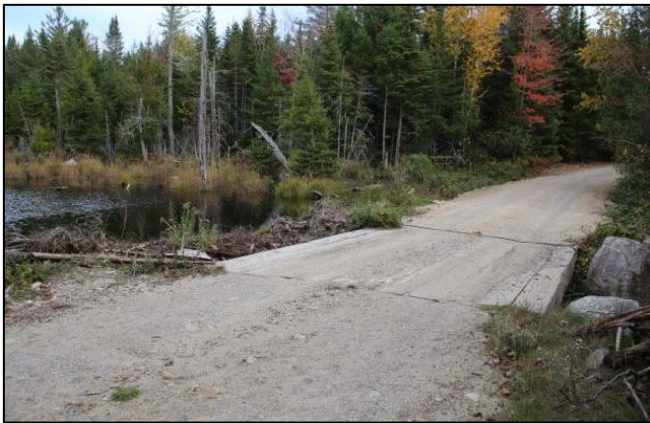
Beaver activity was observed throughout the monument. However, based on field observations and discussions with the KAWW staff the southern parcel is the top priority for beaver management because of its proximity to monument infrastructure. According to Tim Hudson, beaver activity along portions of the Loop Road (Southern parcel) have created some minor flooding issues in the past and continue to present a potential for future flooding along with erosion and sedimentation of roadways, and limiting visitor access to portions of the monument. Two sites in particular were noted as areas of more immediate concern. One site is located on the section of Roberts Road in the monument, and the other is at the bridge on Neck Road. At the time of the visit standing water was observed on the road at the Roberts Road site, while the damming on the entrance to Loop Road was reasonably managed. Material has been repeatedly removed from the dam on the entrance Loop Road in order to keep water levels below the road. If the dam can be maintained at its current height flooding will likely not present a problem and the beaver may continue to occupy the site.

**Photo 2: Entrance to Loop Road Bridge and Beaver Dam**

As discussed with park staff during our field view the most suitable management approach towards the beaver would be to discourage residency with the use of structures like a "beaver deceiver", failing that it is possible to capture and relocate them to sites within the monument that are more remote and less likely to result in infrastructure damage. If relocation is not feasible, trapping would be an alternative management option. In certain circumstances where site conditions allow, water control devices may be installed to control water levels and reduce flooding potential.

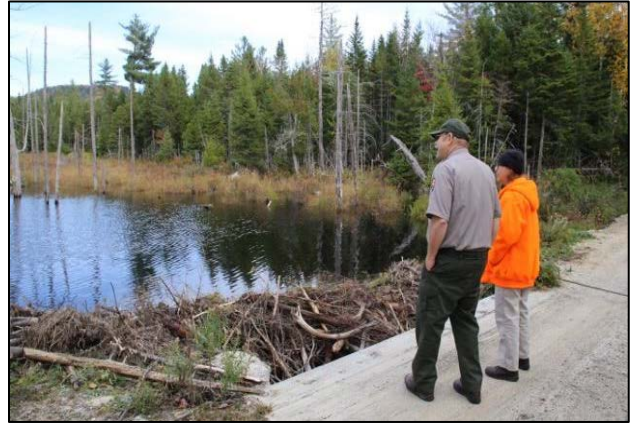
**Photo 3: Entrance to Loop Road Beaver Dam**

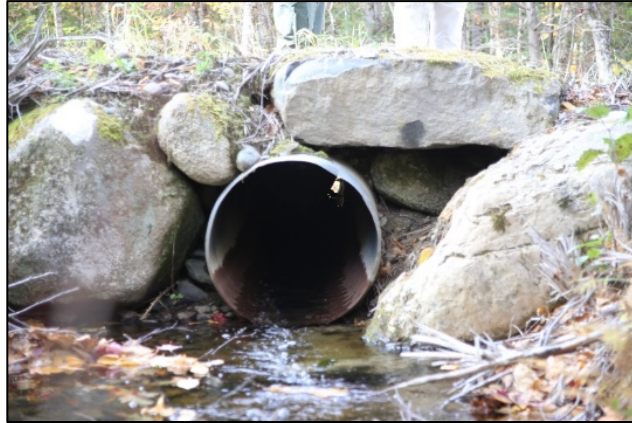
Several culverts have been identified as needing repair or maintenance. These structures present road hazards as portions of the tops of some of these culverts are significantly above road grade, they were not properly sized when initially installed, or have been obstructed and are impeding flow.

**Photo 4: Obstructed Culvert on Loop Road**

While some of these culverts do not necessarily present a natural resources concern, improperly sized or plugged culverts may result in longer-term issues with flooding and erosion and sedimentation of roads which will adversely impact water resources. Many culverts may need compliance as they are associated with drainages that have been stocked with Atlantic salmon as part of a species restoration program.

2. Improperly sized and installed culverts should be replaced or reinstalled at the proper stream gradient elevation and ensuring that they are appropriately sized for streamflow and backfilled with sufficient cover to prevent humps in the road, and blocked culverts cleared of all obstructions. Culvert replacement should consider future climate scenarios which may include more intense periods of rainfall that would require larger drainage capacity. When possible, the culverts in fish habitat should be replaced with open-bottomed culverts or small bridges.

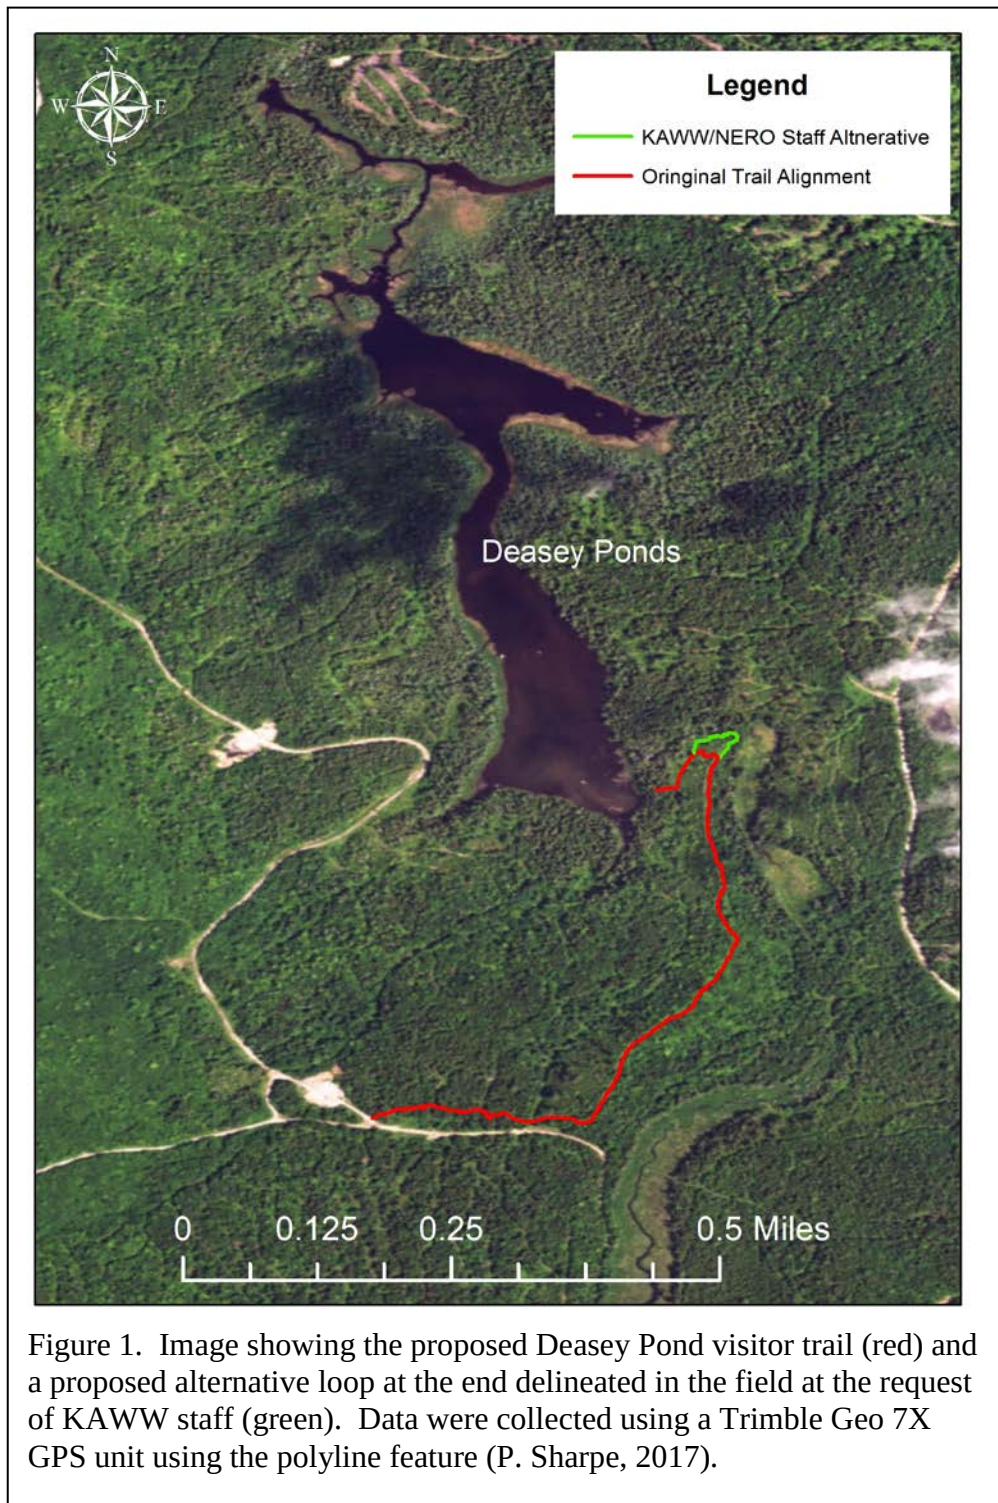
The Proposed Deasey Ponds trail appears to avoid any wetland and waterway encroachments along the entire alignment shown on Figure 1. Near the northern terminus of the trail park staff were concerned that the originally proposed trail traversed too steep of a gradient. To address this concern NERO and KAWW staff mapped an alternative alignment (green line on Figure 1) which utilizes more gradual terrain features before looping back into the original alignment near the toe of slope of the hill to the southeast of Deasey Ponds.

1. At Deasey Ponds the proposed trail appears to have no obvious signs of water resource impacts. The KAWW staff directed realignment (green line - Figure 1) should be considered the preferred route to traverse around the southeast hill at the Ponds.
2. At Twin Ponds the proposed trail alignment shown in blue Figure 2 should be utilized as the preferred alternative to the existing alignment as it will eliminate current wetland impacts.

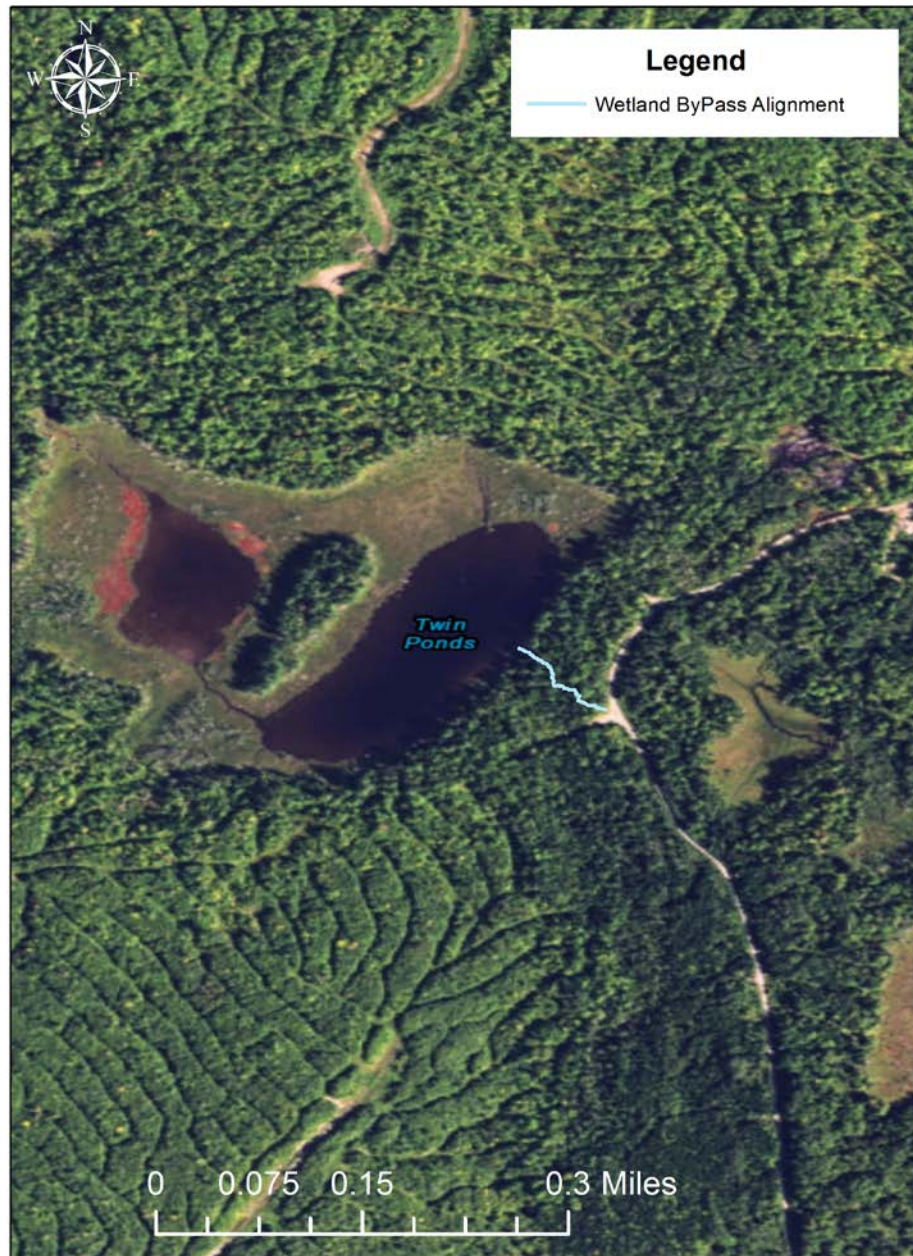
Figure 2. Image showing the proposed realignment of the Twin Ponds visitor trail (light blue). This route will avoid wetland encroachments while still providing visitor access to the pond. Data were collected using a Trimble Geo 7X GPS unit using the polyline feature (P. Sharpe, 2017).

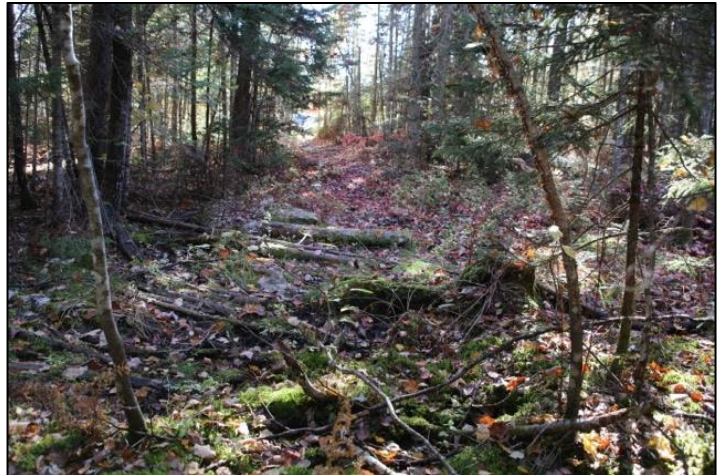
Photo5: Twin Ponds Trail - Corduroy east view

The trail at Twin Ponds runs through a wetland area that has had some corduroy placed in it in an attempt to reduce impacts and facilitate a dry crossing on foot. KAWW and NERO staff identified an alternative trail alignment (see Figure 2) which will bypass the wetland entirely thereby eliminating the existing wetland impact and still allow for visitor access to the site.

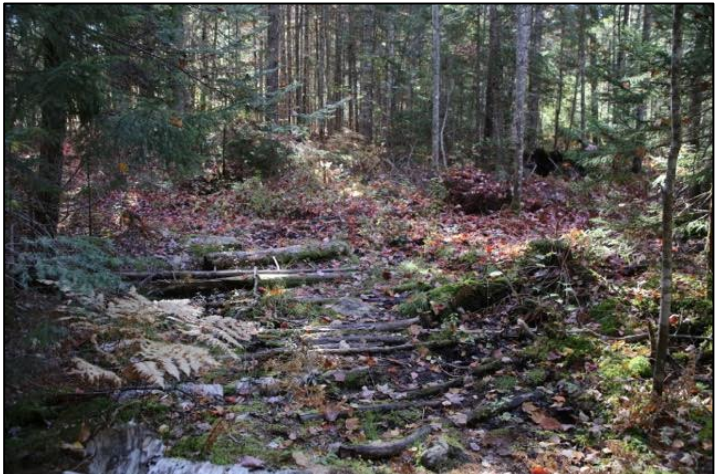
Photo6: Twin Ponds Trail - Corduroy west view
