HISTORIC STRUCTURES REPORT  
NORTH SERVANTS' QUARTERS  
CUSTIS-LEE MANSION, VA.  
(Part II)

HISTORIC STRUCTURES REPORT

NORTH SERVANTS' QUARTERS,

CUSTIS-LEE MANSION, VA.

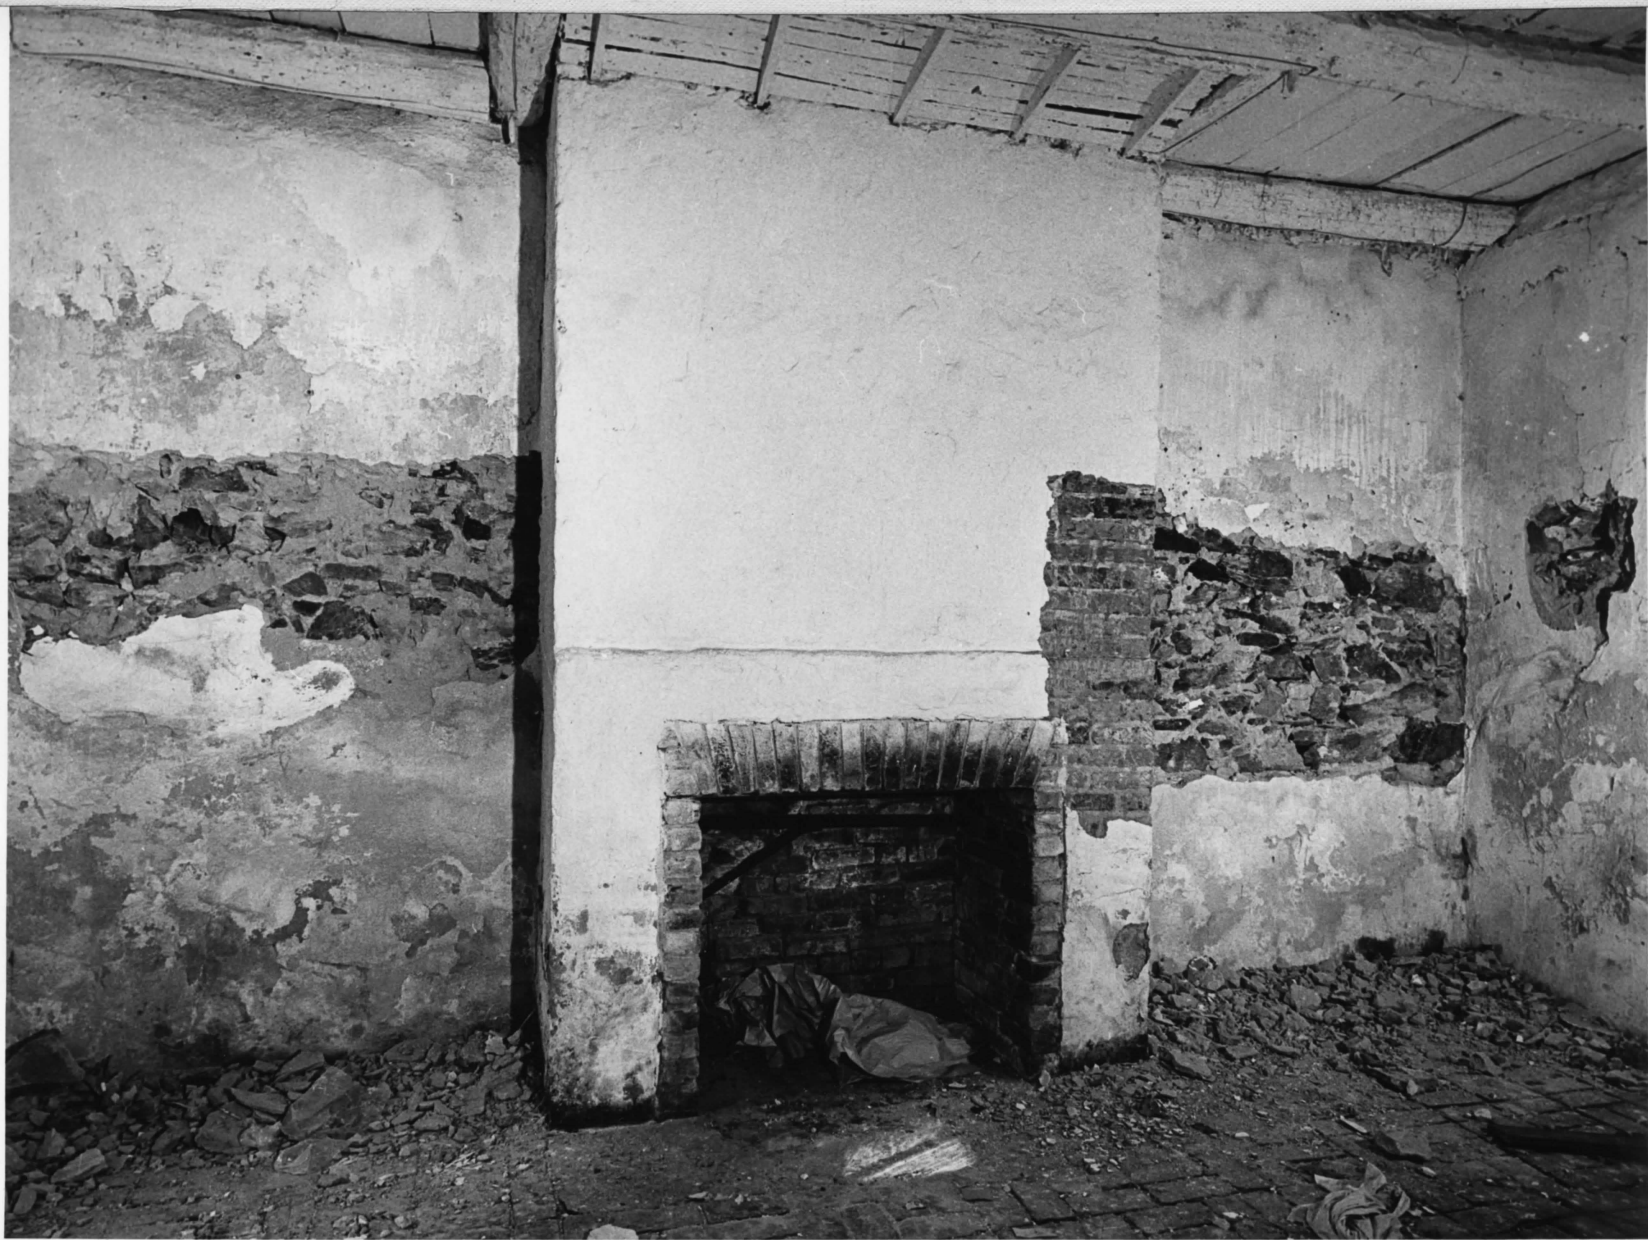
ILLUSTRATION NO. 1

Ground floor, west room, west wall.

Showing fireplace in the Coachman's bedroom as restored by the Quartermaster Corps under the supervision of Mr. L. M. Leisenring. This is as the room probably appeared when Donald Dobson occupied it during the time that George Washington Parke Custis resided in the mansion.

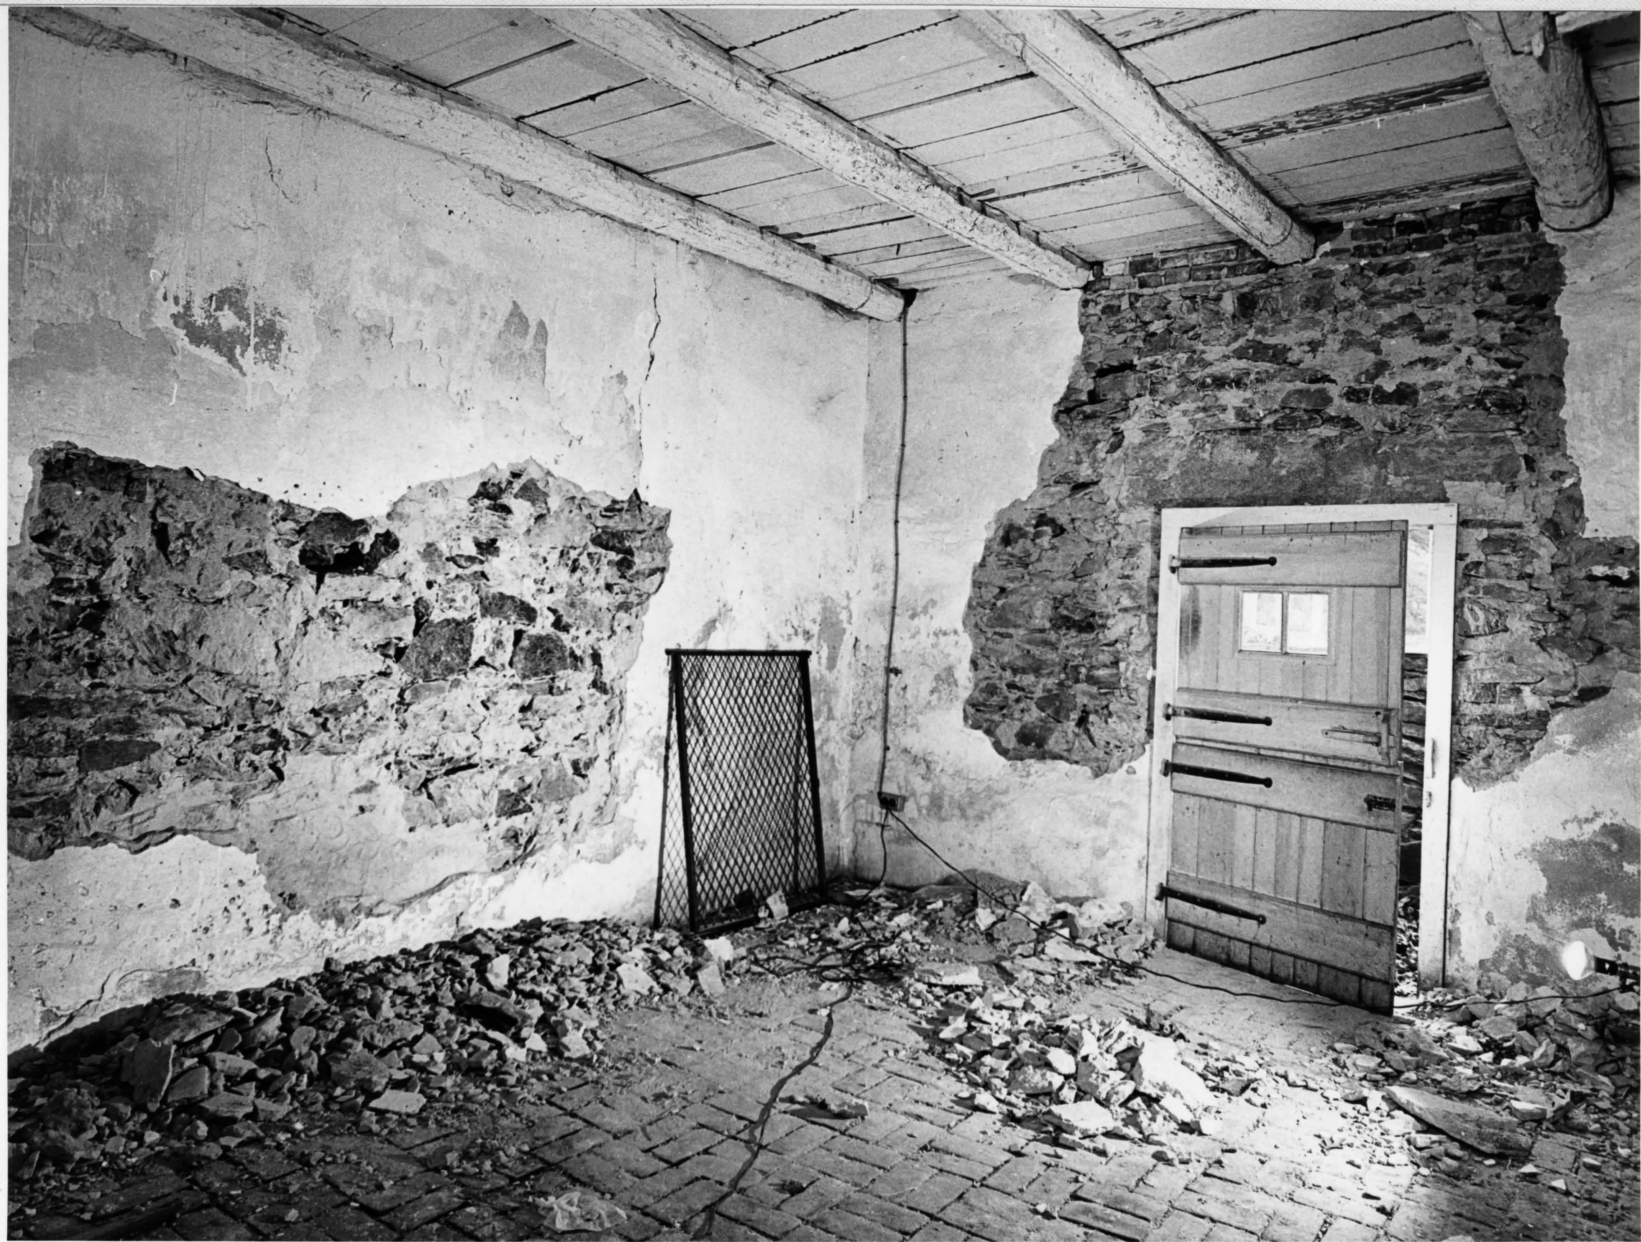
ILLUSTRATION NO. 2

Ground floor, west room, southeast corner.

Showing portions of plaster removed in order to determine the former floorline as it existed at the time that Robert E. Lee resided in the mansion, and as shown in the Mathew Brady photograph 1861-64, photograph No. 2, in appendix of Historic Structures Report, Part I. See photograph No. 5 for the only evidence of the former floorline which was found.

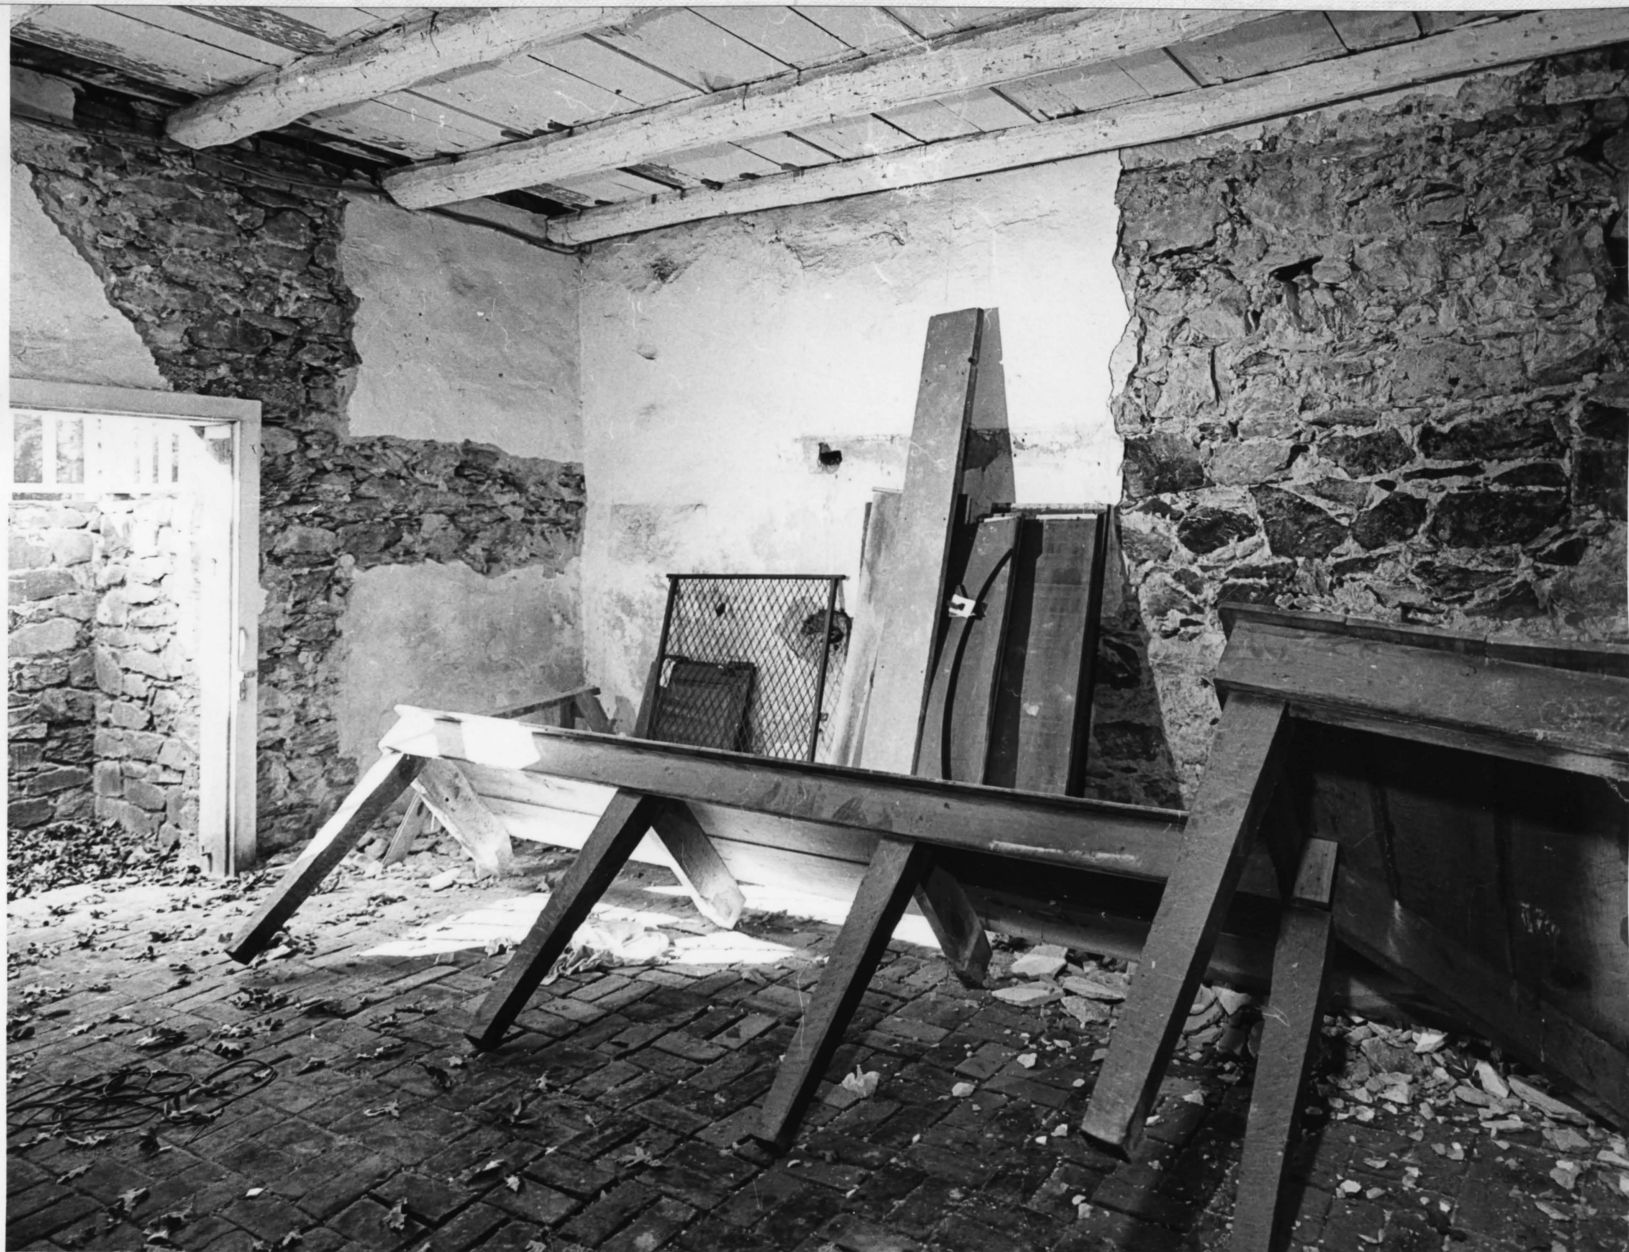
ILLUSTRATION NO. 3

Ground floor, east room, southwest corner.

Showing portions of plaster removed in order to determine the former floorline as it existed at the time that Robert E. Lee resided in the mansion, and as shown in the Mathew Brady photograph 1861-64, photograph No. 2, in appendix of Historic Structures Report, Part I. See photograph No. 5 for the only evidence of the former floorline which was found.

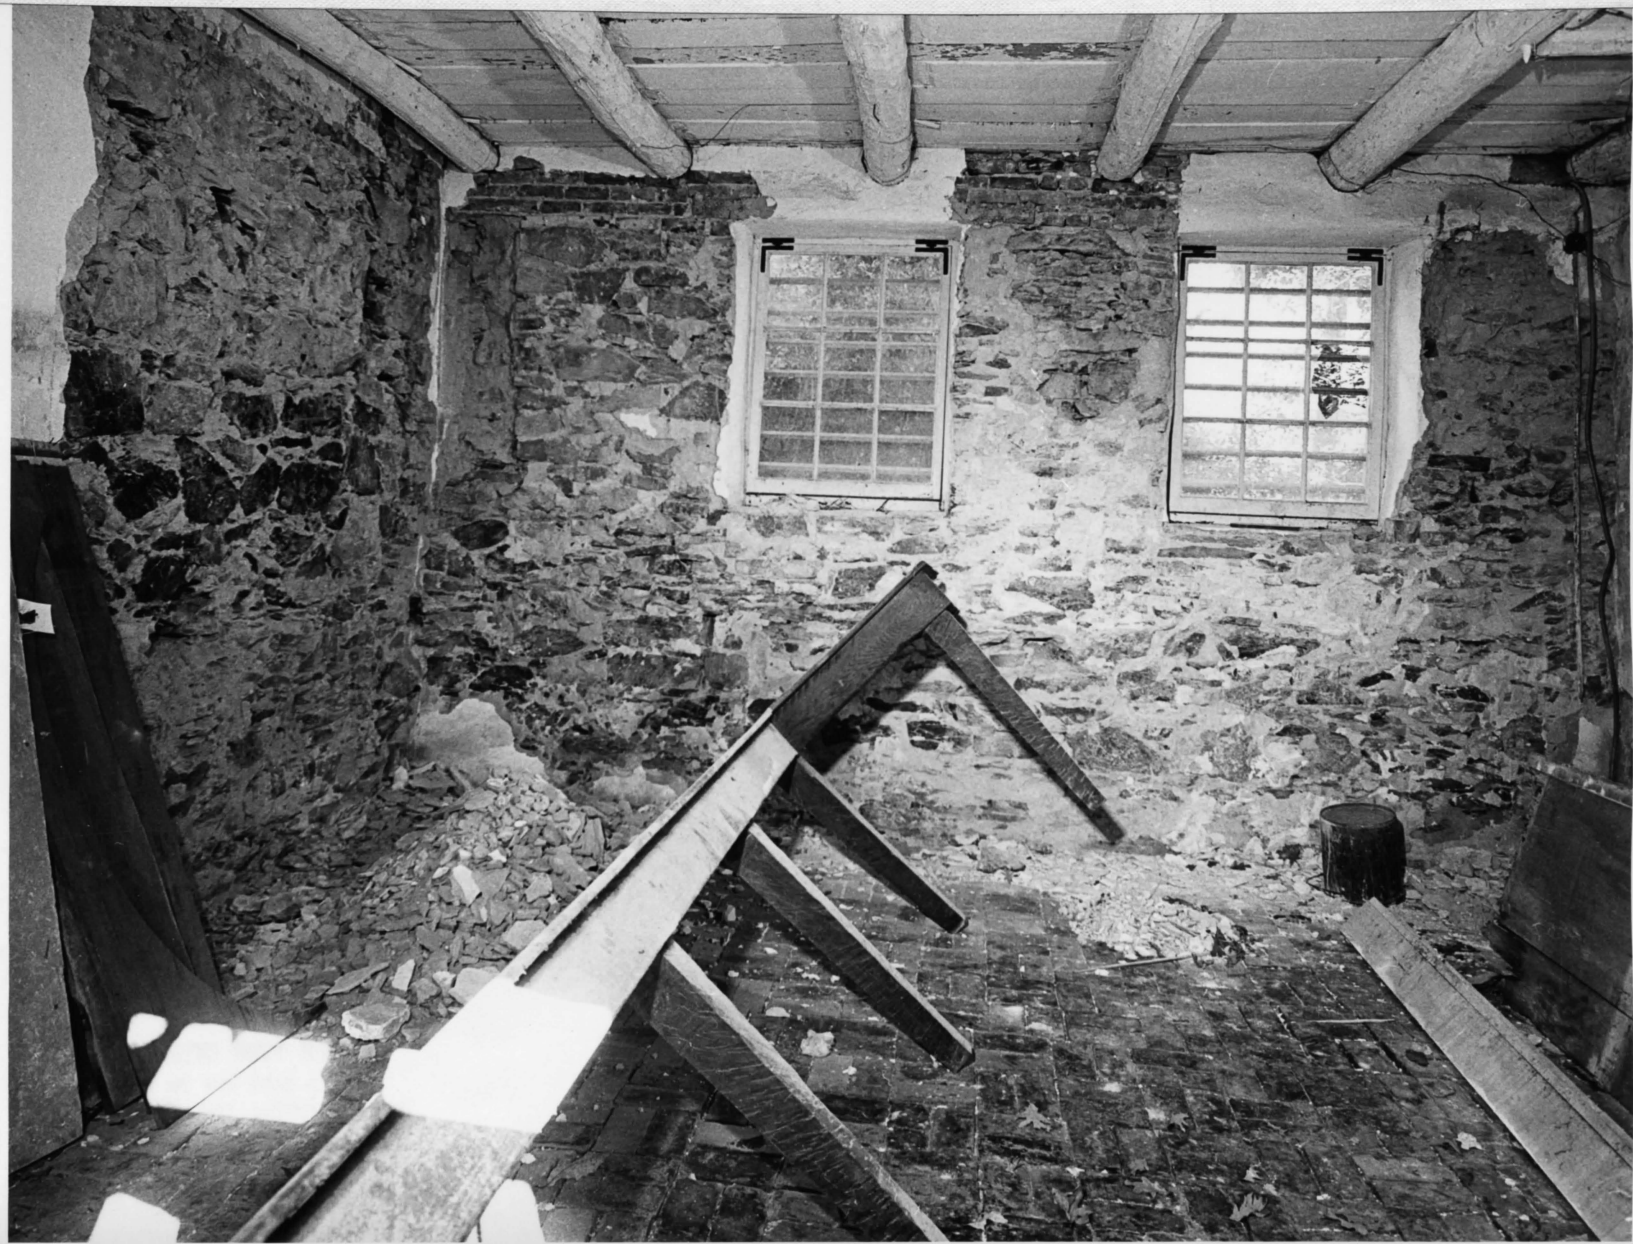
ILLUSTRATION NO. 4

Ground floor, east room, north wall.

Showing portions of plaster removed in order to determine the former floorline as it existed at the time that Robert E. Lee resided in the mansion, and as shown in the Mathew Brady photograph 1861-64, photograph No. 2, in appendix of Historic Structures Report, Part I. See photograph No. 5 for the only evidence of the former floorline which was found.

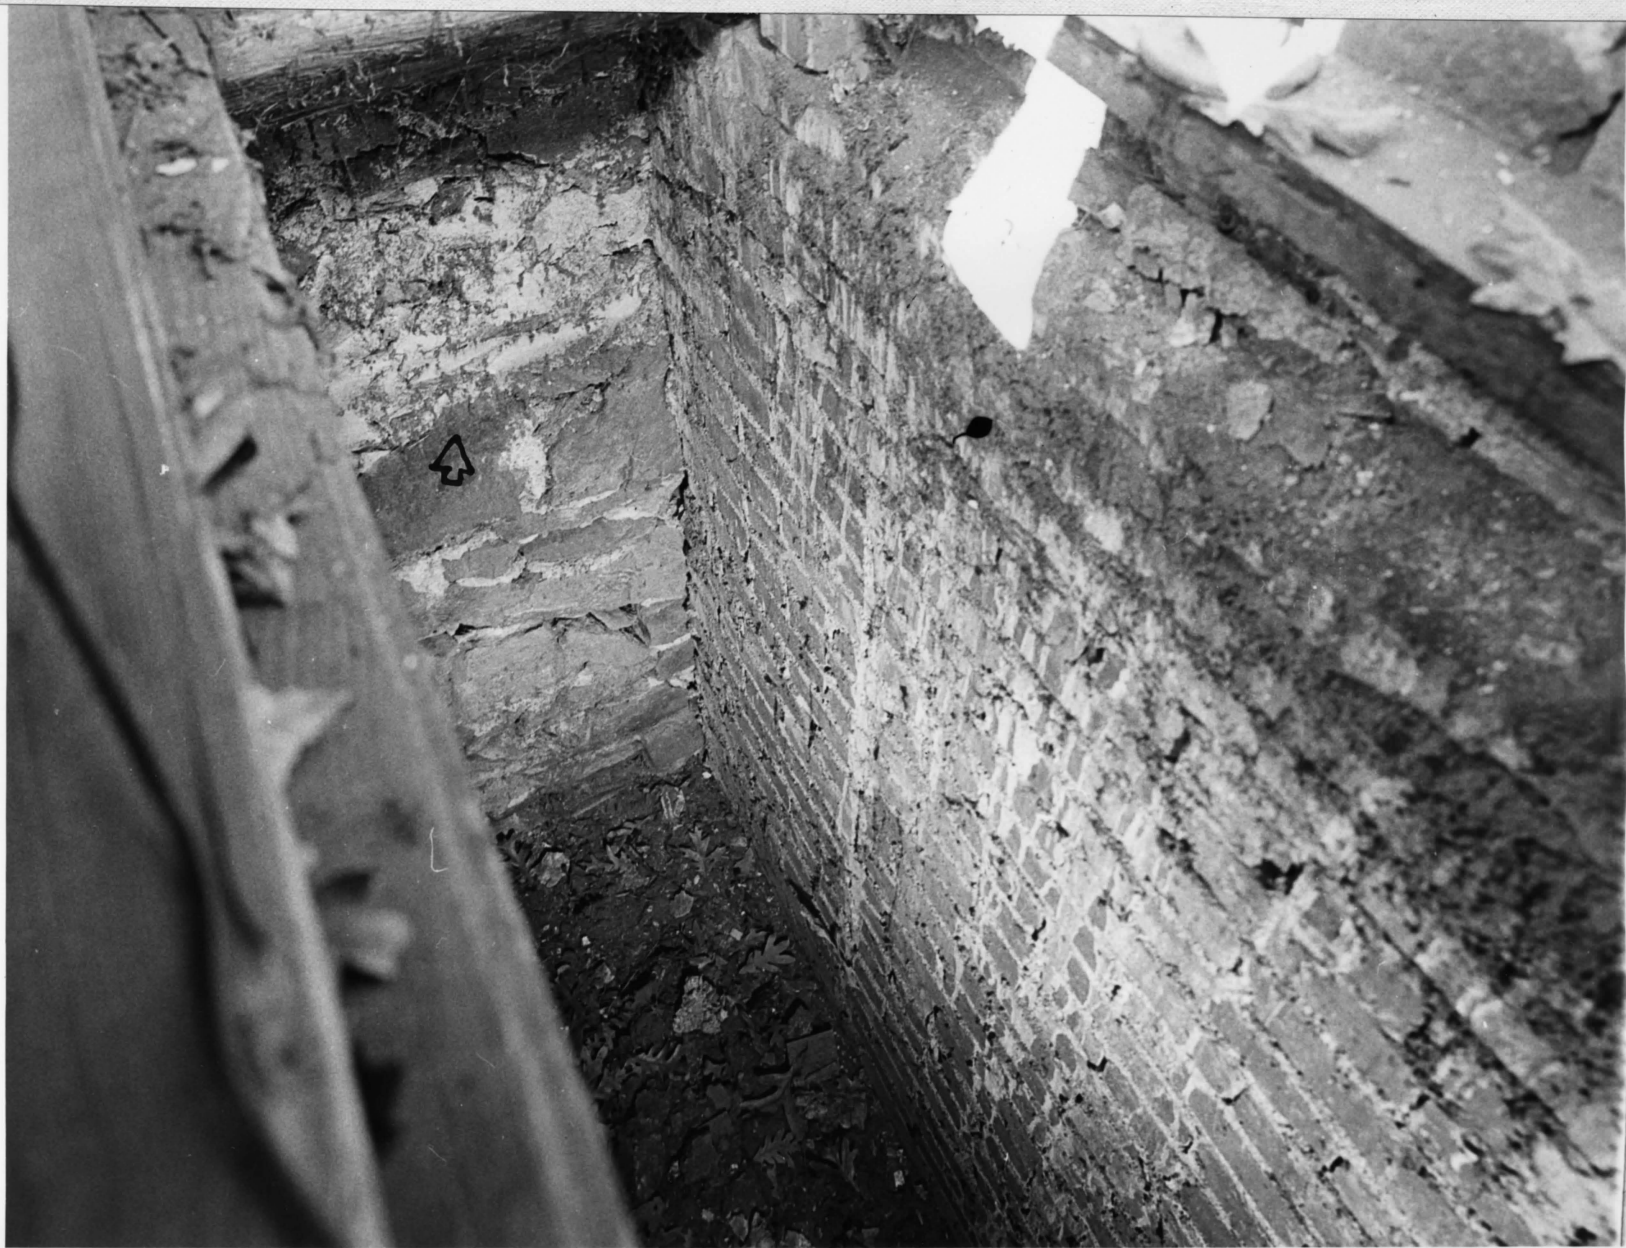
ILLUSTRATION NO. 5

Center room, north wall.

Taken through a trap door in the floor of Room No. 3, showing the only evidence found of the location of the nailers for the baseboard of the room as it existed during the Robert E. Lee period of occupancy.

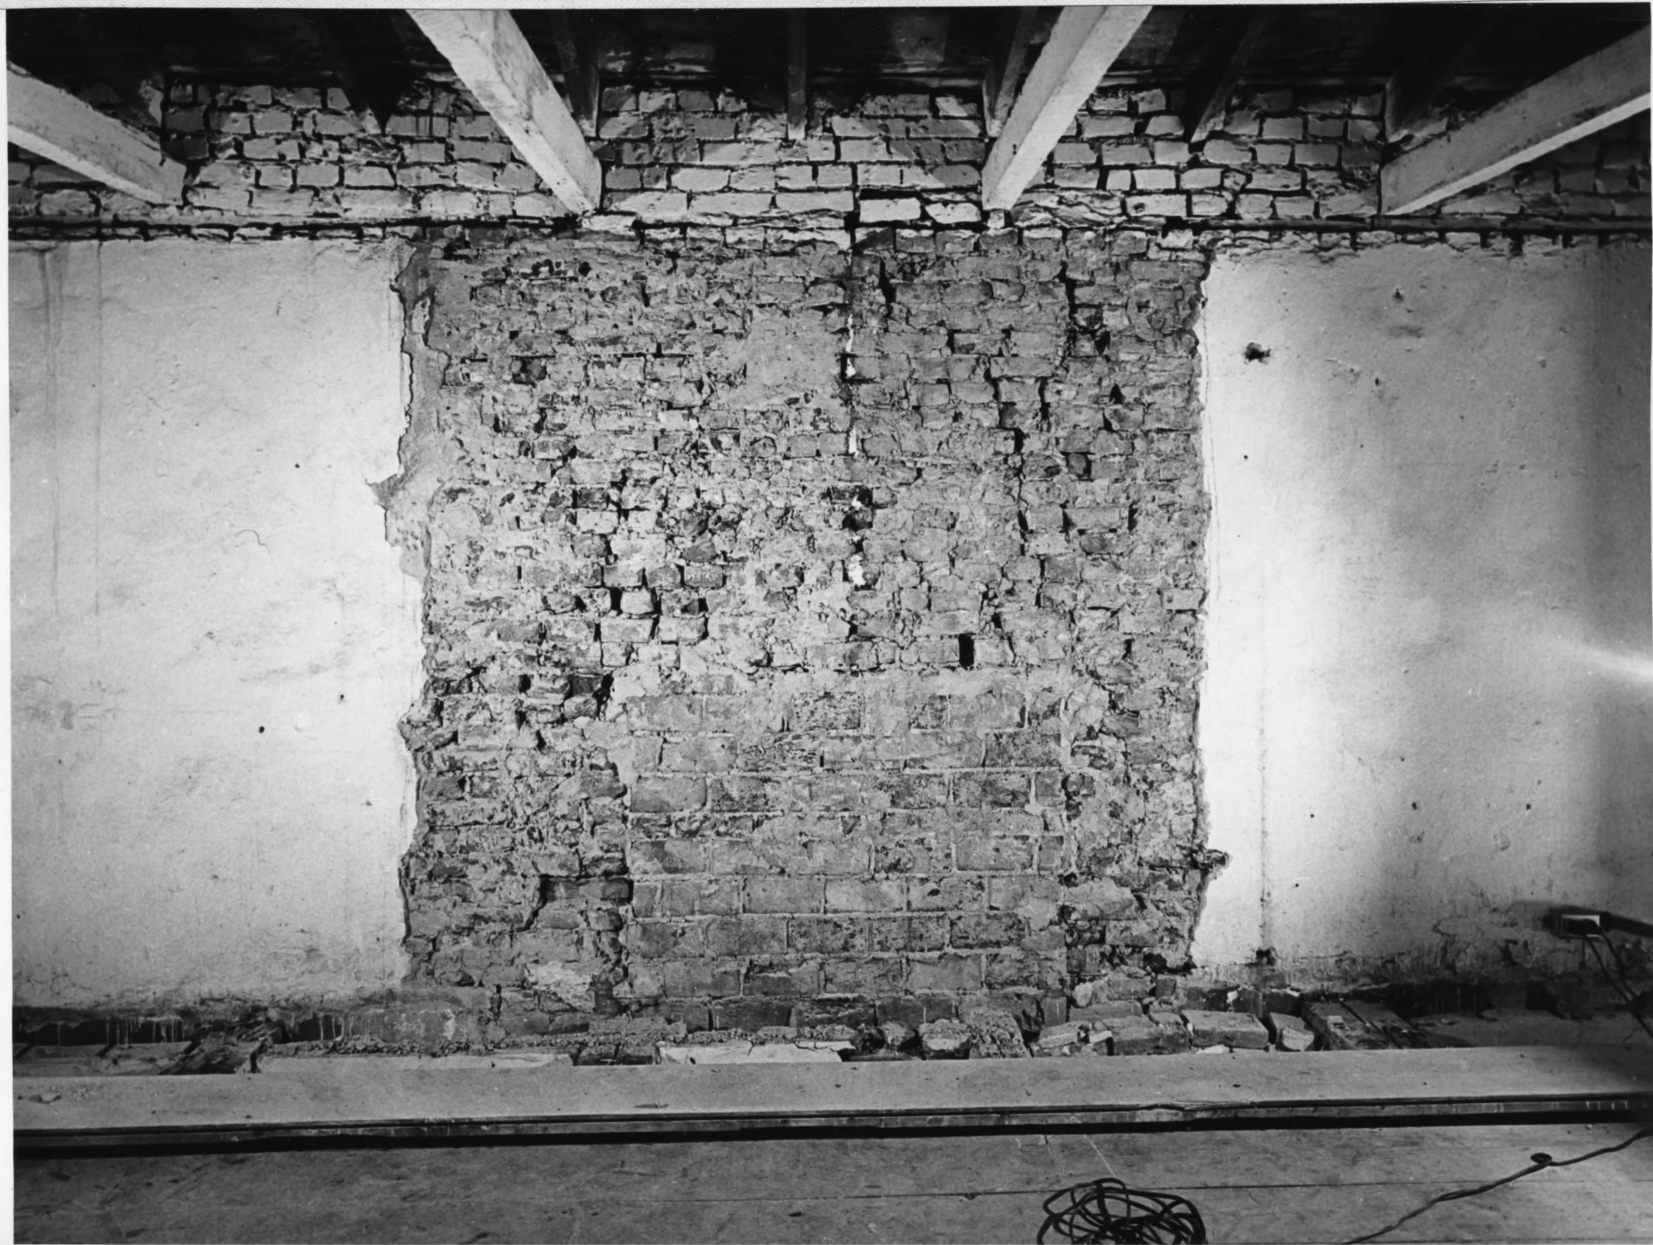
ILLUSTRATION NO. 6

First floor, Room No. 4, south wall.

With a portion of the plaster removed from the south wall showing a former doorway of the Robert E. Lee period bricked up.

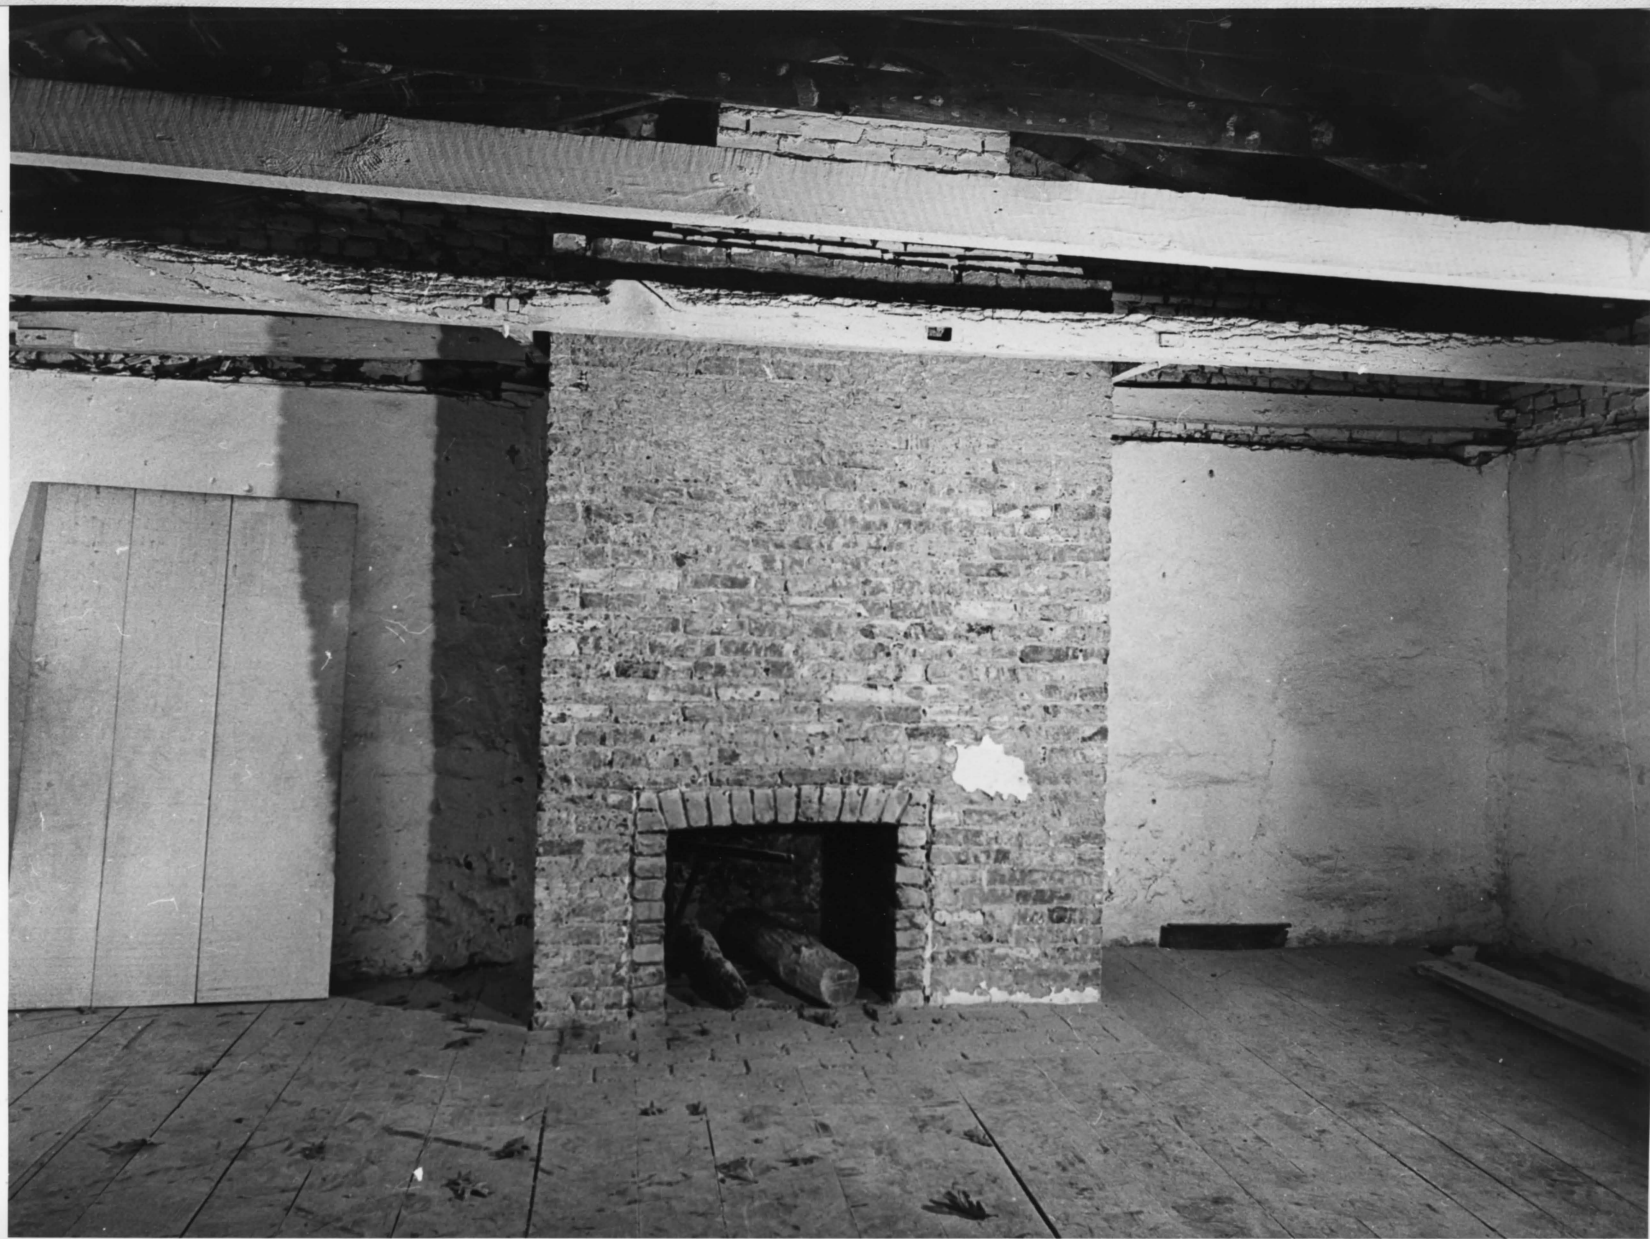
ILLUSTRATION NO. 7

First floor, east room, east wall.

Plaster removed from fireplace breast in search of evidence of a  
fireplace of the Robert E. Lee period.

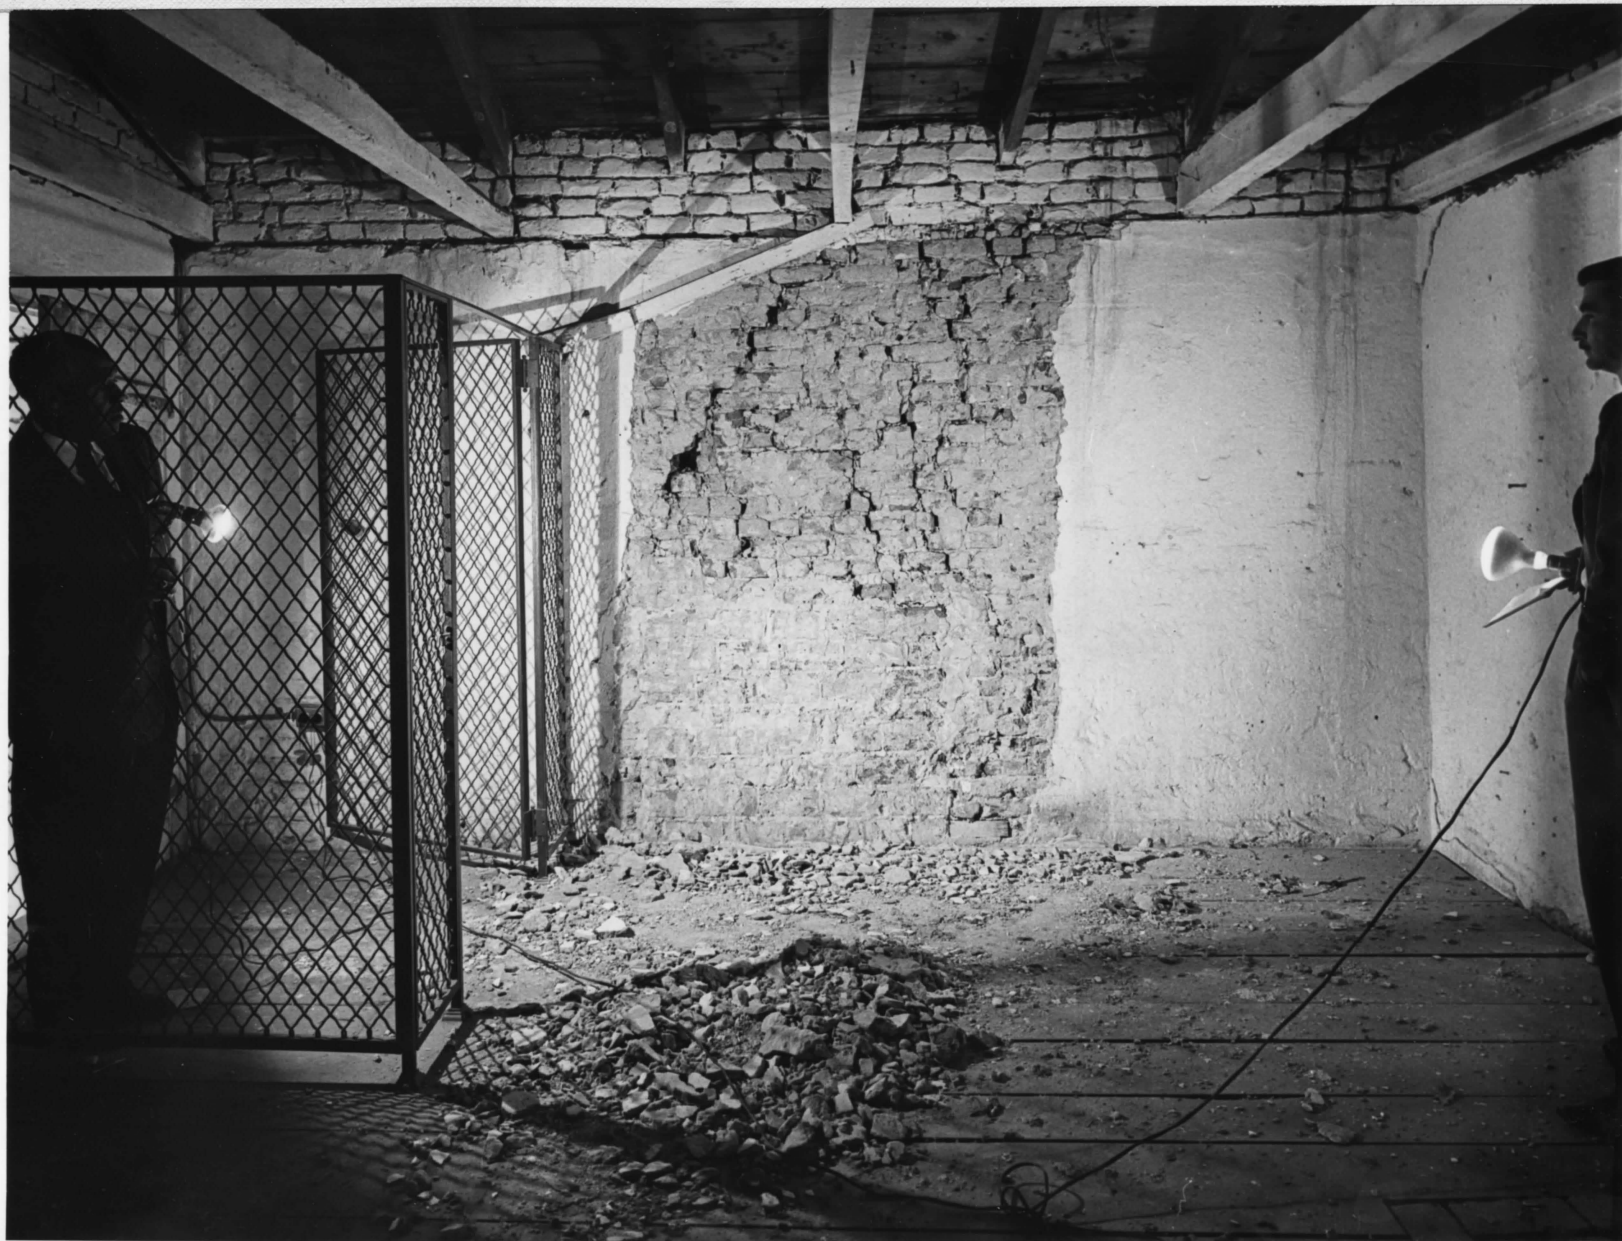
ILLUSTRATION NO. 8

First floor, Room No. 2, south wall.

With a portion of the plaster removed showing the opposite side of  
the bricked up doorway shown in Illustration No. 6.
