# **PRESERVATION OF THE HISTORIC LOCKWOOD HOUSE**

**Phase I, FY2009-2010**

**HARPERS FERRY  
NATIONAL HISTORICAL PARK**

**HISTORIC STRUCTURES TREATMENT RECORD**

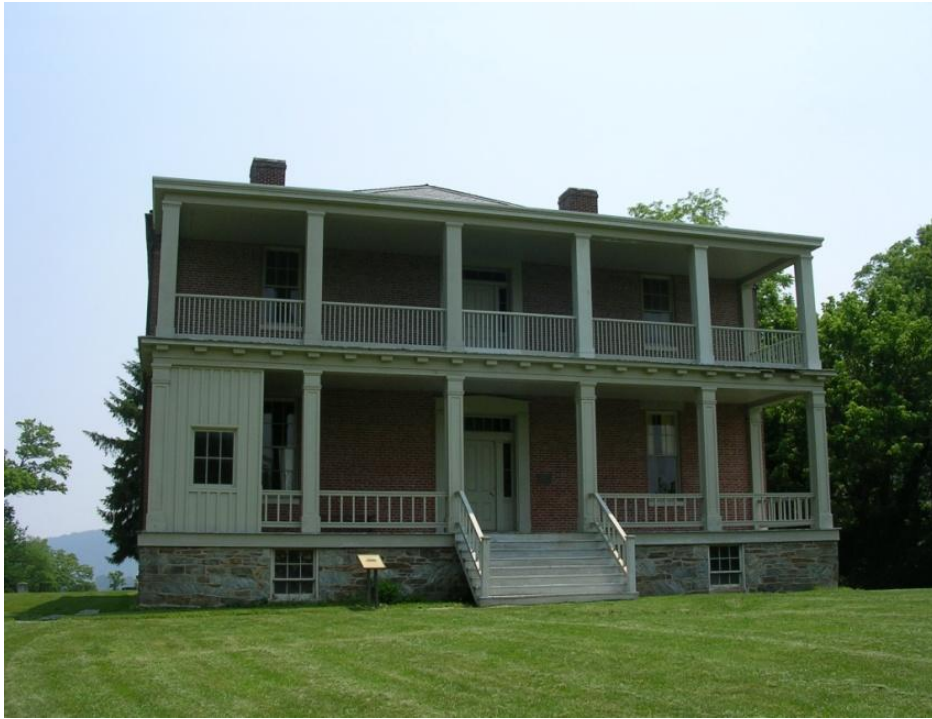
**Photo #1-** Lockwood House before preservation of the second story porch started in August.

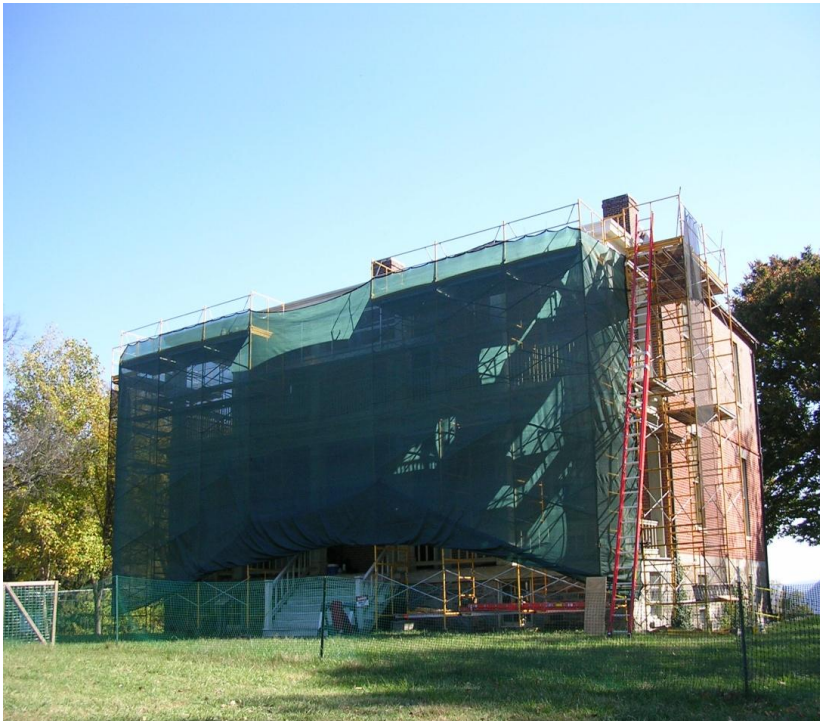
**Photo 2:**  
Scaffolding is erected around the perimeter of the west porch; shade cloth has been draped over the scaffolding.

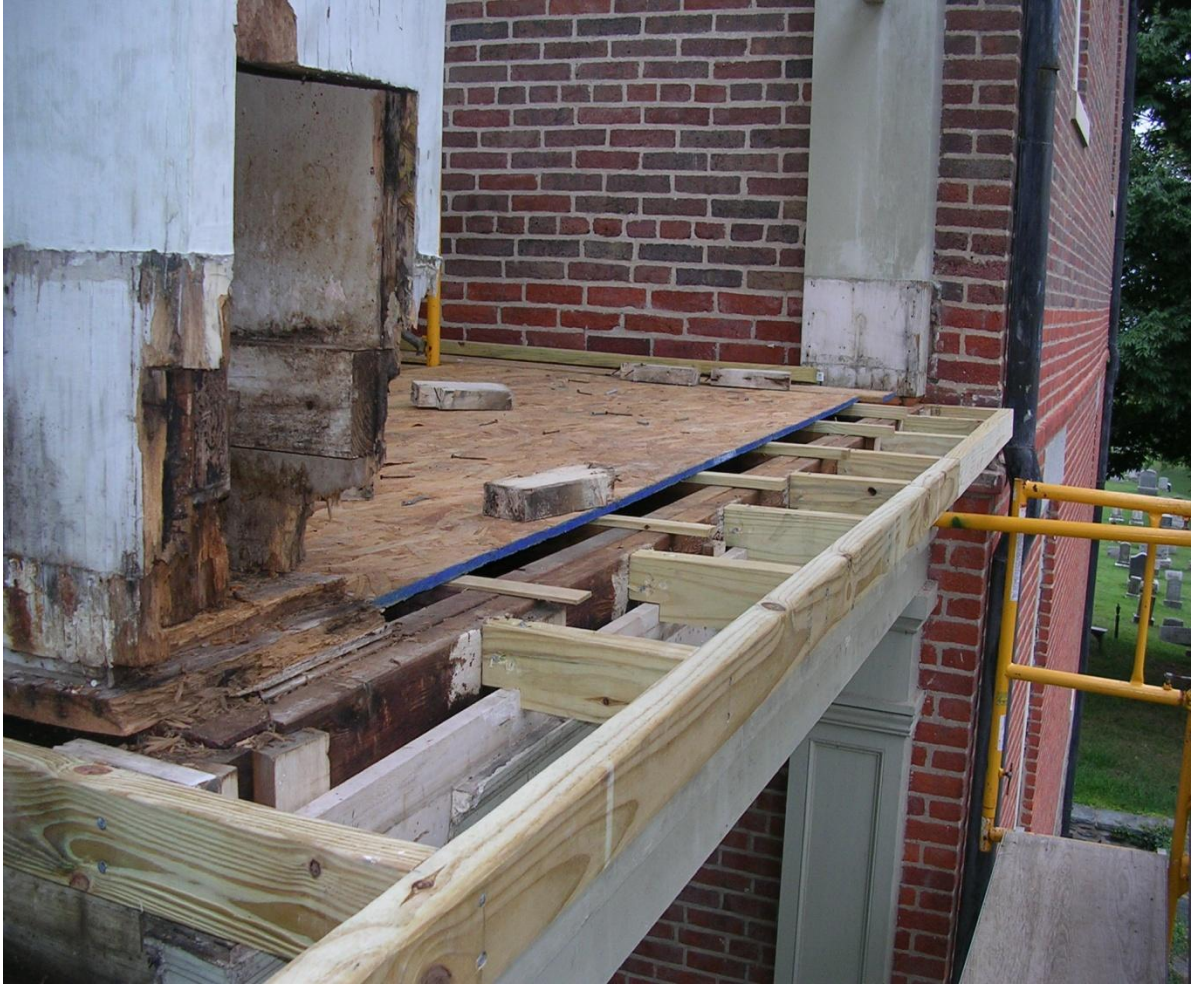
**Photo #3-** The framing for the architrave has been replaced with treated material; the picture also shows a deteriorated column, which was repaired.

- The HPTC crew finished the installation of the new Spanish cedar ceiling boards this week. The ceiling was given its second coat of finish paint.
- The architrave preservation was started with the replacement of the framing members and the removal of the deteriorated soffit and fascia. Vent slots were cut into the soffit for screen placement to allow air movement inside the architrave. All framing material was pressure treated. 36 feet of soffit was replaced with Spanish cedar material and 40 feet of fascia was replaced with Spanish cedar material.

- The base of the northwest corner column was repaired with a half lap replacement of the 4" x 4" post inside the column. The half lap was 1 foot in length and connected with stainless steel screws and structural epoxy. The 4 sides of the column were also repaired with wood Dutchman replacements on all four sides.

- The base of the southwest corner column was also repaired with the interior 4" x 4" post receiving a structural half-lap repair. The 4 sides of the column were also repaired with mahogany Dutchman repairs.

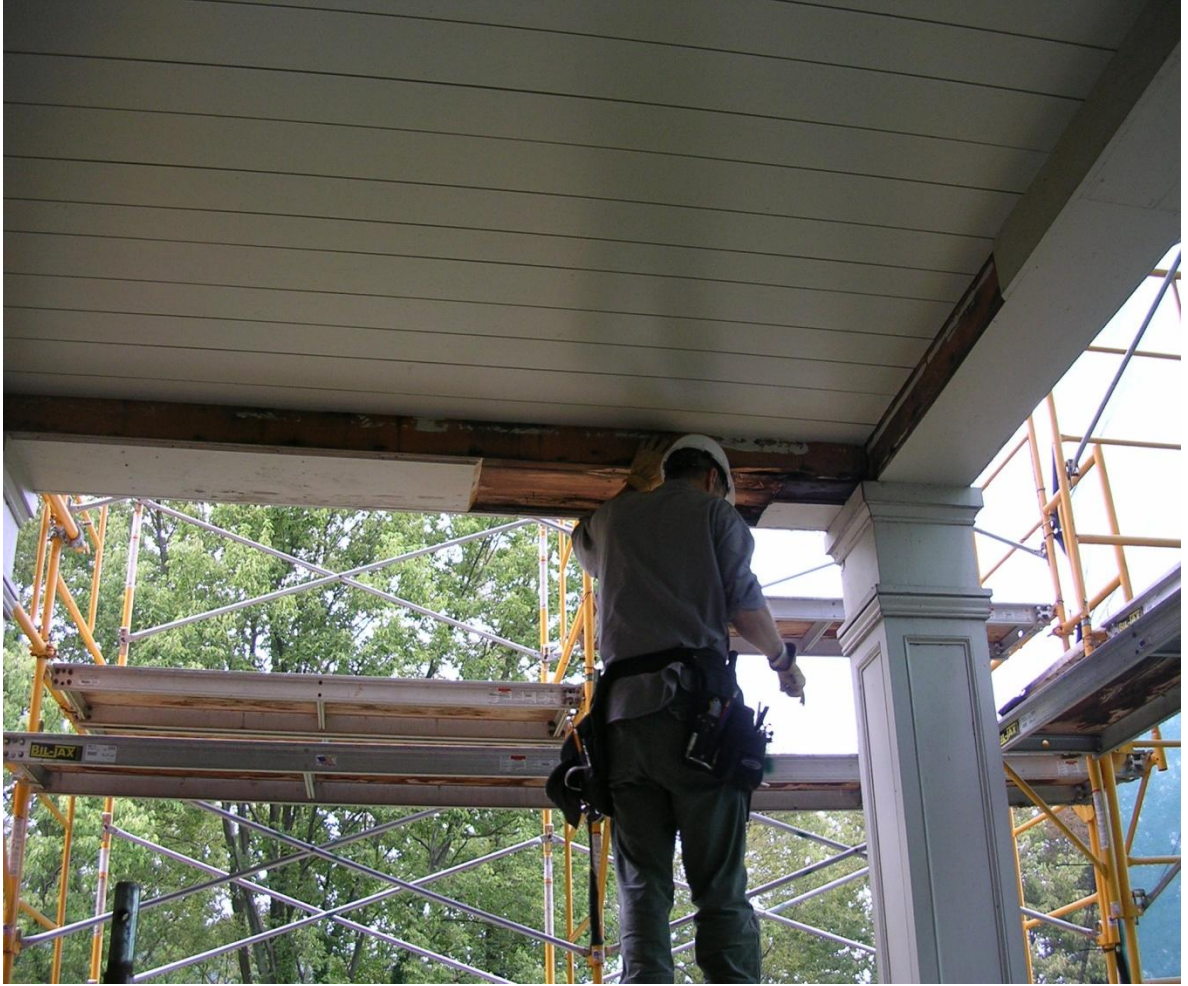
**Photo #5-** The breast beam trim is being replaced with new Spanish cedar trim and the ceiling boards have all been replaced with new Spanish cedar boards.

- The modillion blocks were repaired with wood Dutchman and epoxy repairs.
- The deteriorated framing on the south elevation of the breast beam was repaired with pressure treated wood, most of the deterioration was on the northwest corner. The wood wrap on the interior of the breast beam was replaced with spanish cedar material. 22 inches of framing material was replaced on the framing of the breast beam. 42 inches of trim wrap material was replaced in this area.

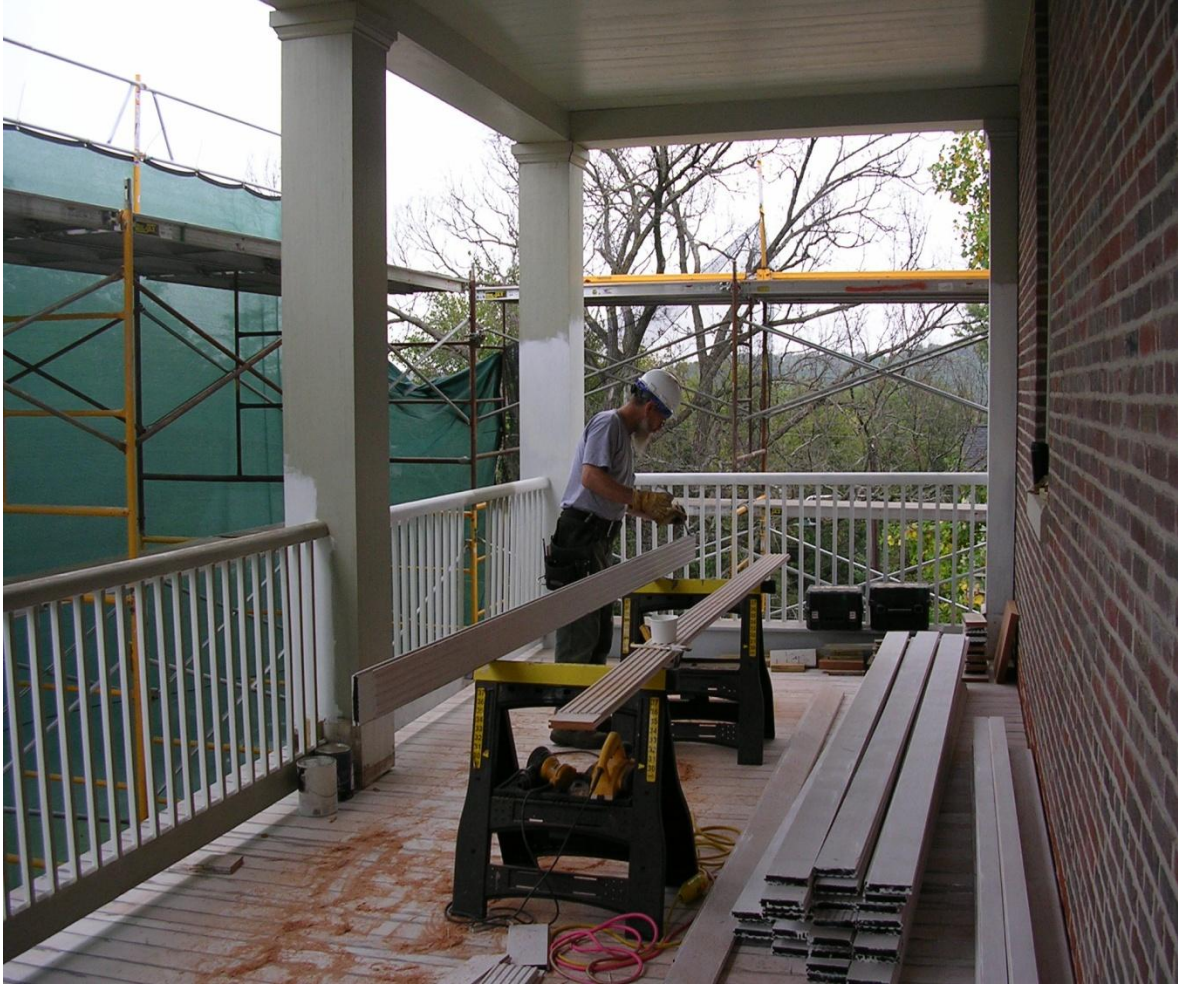
**Photo 6:** Photo shows the replacement flooring is being painted on the tongue and groove for maximum weather protection; it was then installed with historic cut nails.

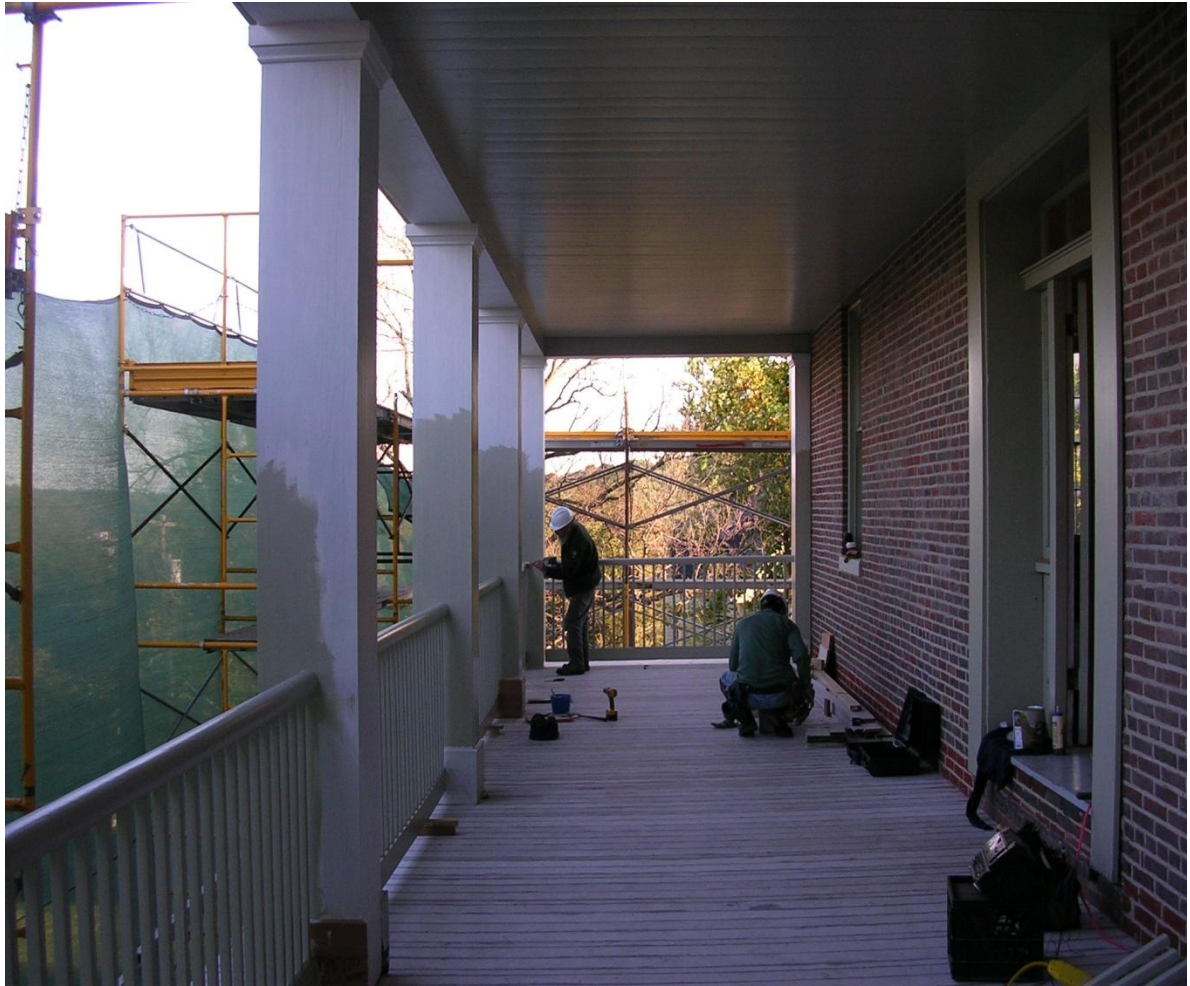
**Photo 7:** Porch flooring is being prepped for painting, columns are also being painted, and the base is being replaced with Spanish cedar material.

- New base trim was milled in the HPTC shop out of mahogany lumber.
- The HPTC crew installed new base trim of mahogany lumber on the columns; only 5 original bases were reused, as the rest were deteriorated. All cuts were back-primed.
- The wood architrave was given two applications of Sherwin Williams Exterior Latex Paint.
- The balustrade was given two applications of Sherwin Williams's exterior paint.
- The job site was cleaned of all debris and secured.

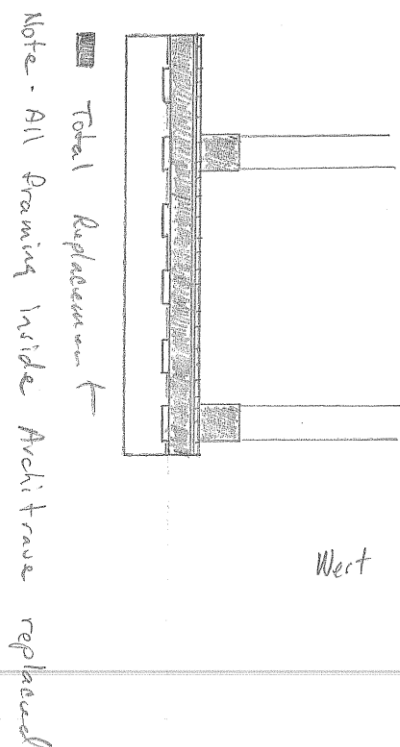
West Elevation

Note - All second floor ceiling boards replaced  
 Note - All second floor flooring replaced.

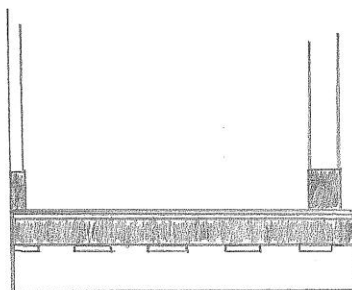
North Elevation of west porch

Note - All framing inside architrave replaced  
 Note - All second floor ceiling boards replaced  
 All second floor flooring replaced
