**REPORT ON THE INVESTIGATION OF THE EXTERIOR  
PAINTS: CONDITIONS AND TREATMENTS.  
ARLINGTON HOUSE, ARLINGTON, VIRGINIA**

**Prepared by Frank G. Matero, Architectural  
Conservator, North Atlantic Historic Preservation  
Center/NARO. July 1979**

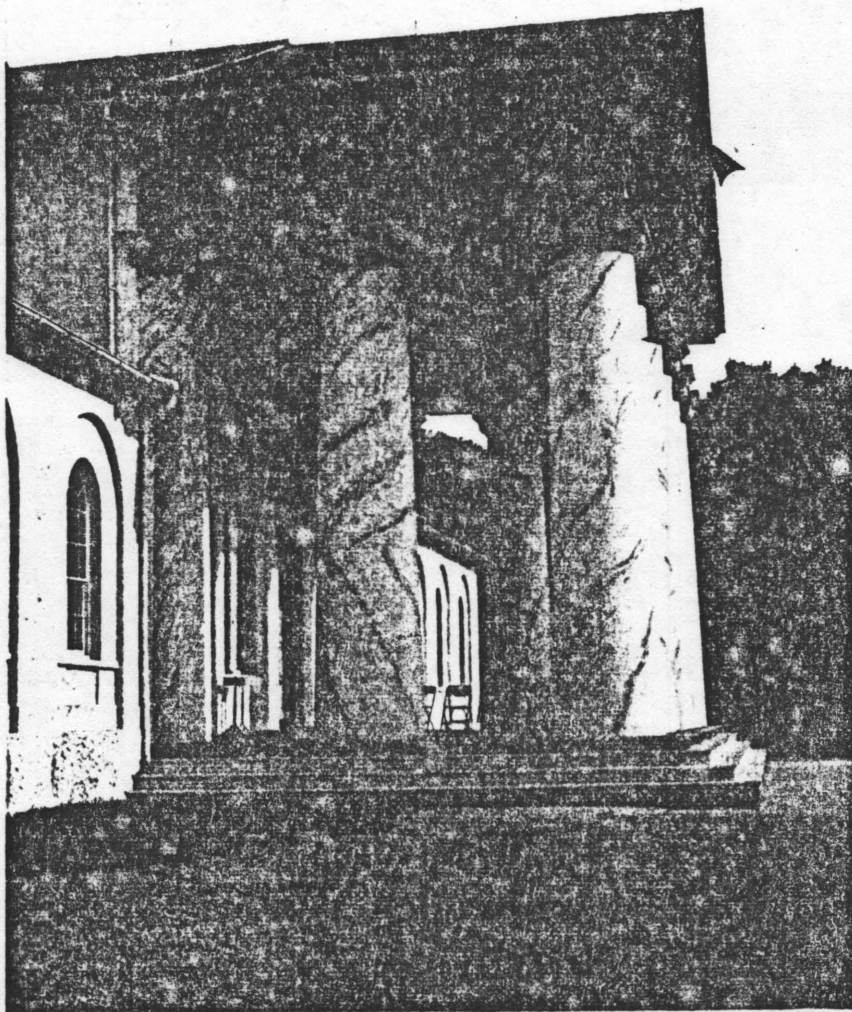
Figure 1

#### Central Block: East facade (figs. 1 & 2)

- a. portico cornice and pediment soffit,
- b. column capitals
- c. column shafts: upper third of eastern exposure,
- d. south portico pilaster (southern exposure),

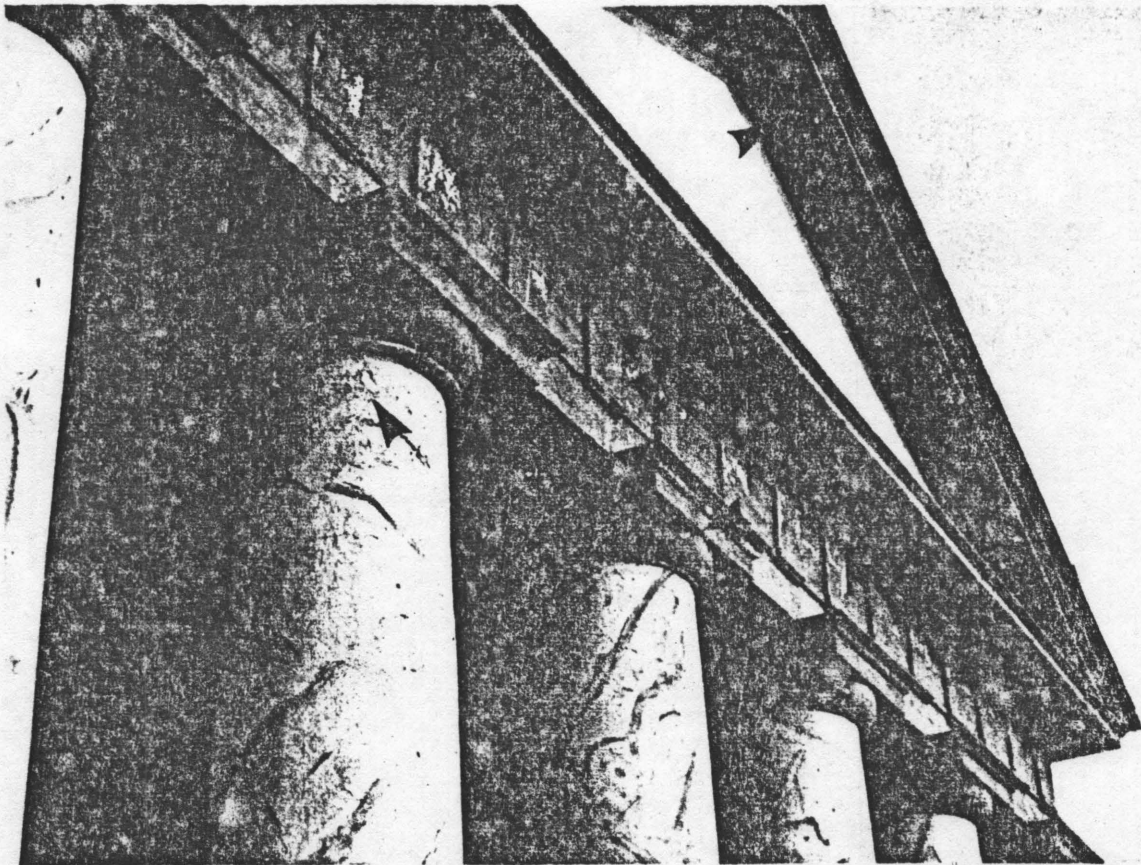
Figure 2

1. An examination of the wooden cornice and entablature of the east and south sides of the portico (south facade) exhibited an excessive build-up of paints characterized by severe peeling, cracking, and cross-grain checking (Figs. 2 & 4).

These conditions can be attributed to the differential expansion and contraction between the many paint layers and the wood substrate. In addition, these openings have allowed water to penetrate and swell the wood fibers thus breaking the bond between the paint and wood and causing further deterioration of the paint film.

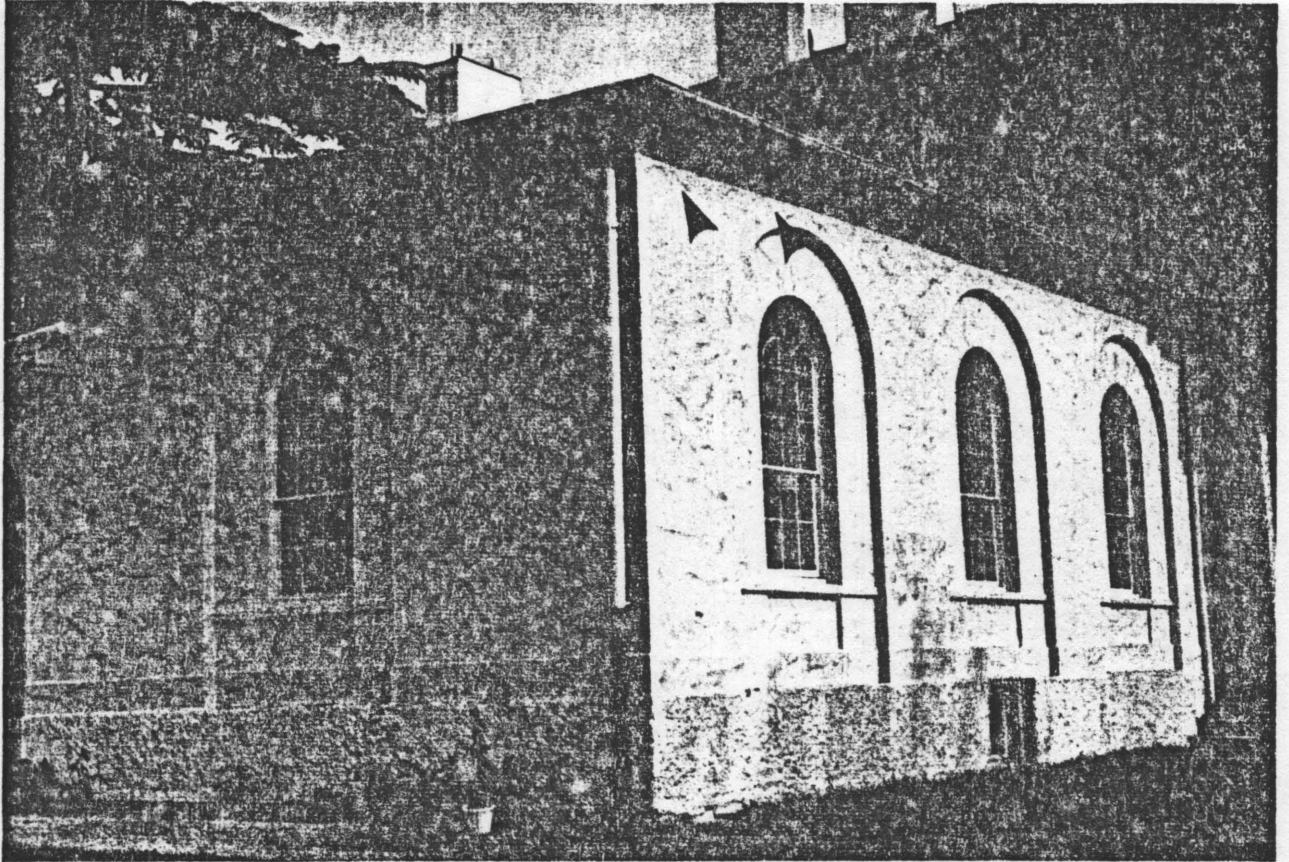
Figure 3

#### South Wing: East facade (fig. 3)

- a. southeast corner (upper wall and soffit).

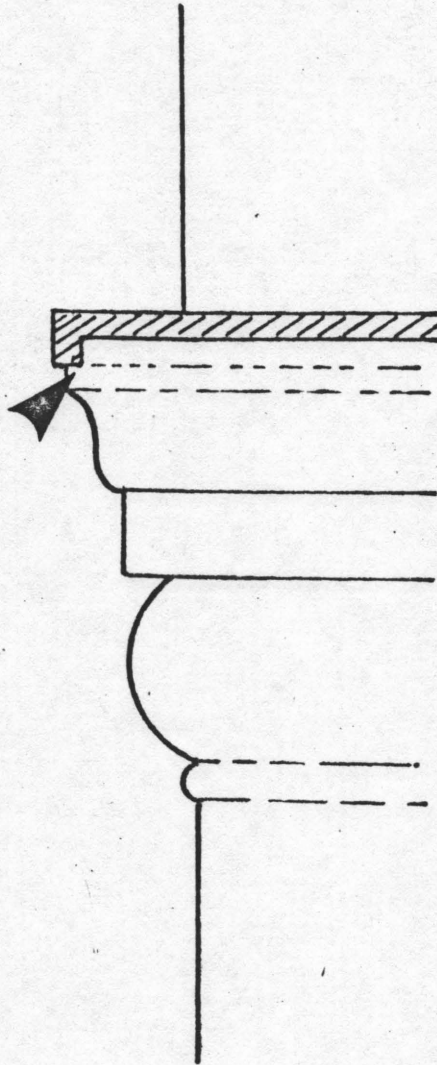
Figure 5

3. Moisture meter readings taken in this area indicated a low though unacceptable (approx. 15%) moisture content in the wood. Higher readings (15-20%) were found in the lower architrave area and the abaci of the capitals. This high moisture condition has caused excessive peeling and general rot in this area and can be attributed to the retention and absorption of water caused by a metal flashing sleeve which was installed over the tops of each capital and around the lower edge of the architrave(Fig.5).

Representative portico capital showing metal flashing sleeve installed over the echinus. Arrow indicates point of greatest water penetration.

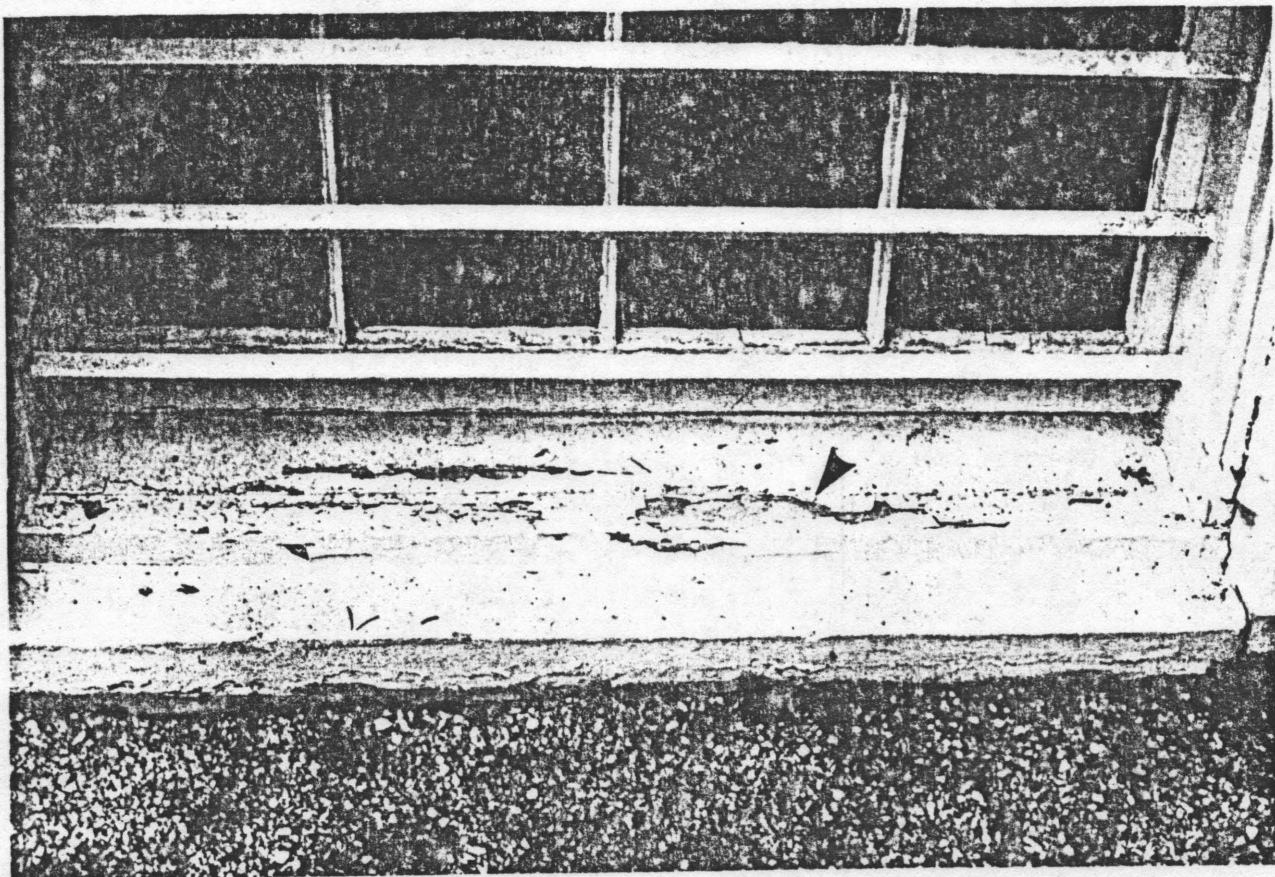
Figure 6

5. An examination of the window sills and upper ledges of the water table indicates severe blistering and paint film deterioration due to water penetration. Poor run-off detailing, minor structural cracking, and inflexible paint build-up are responsible.(Figs.6 & 7).

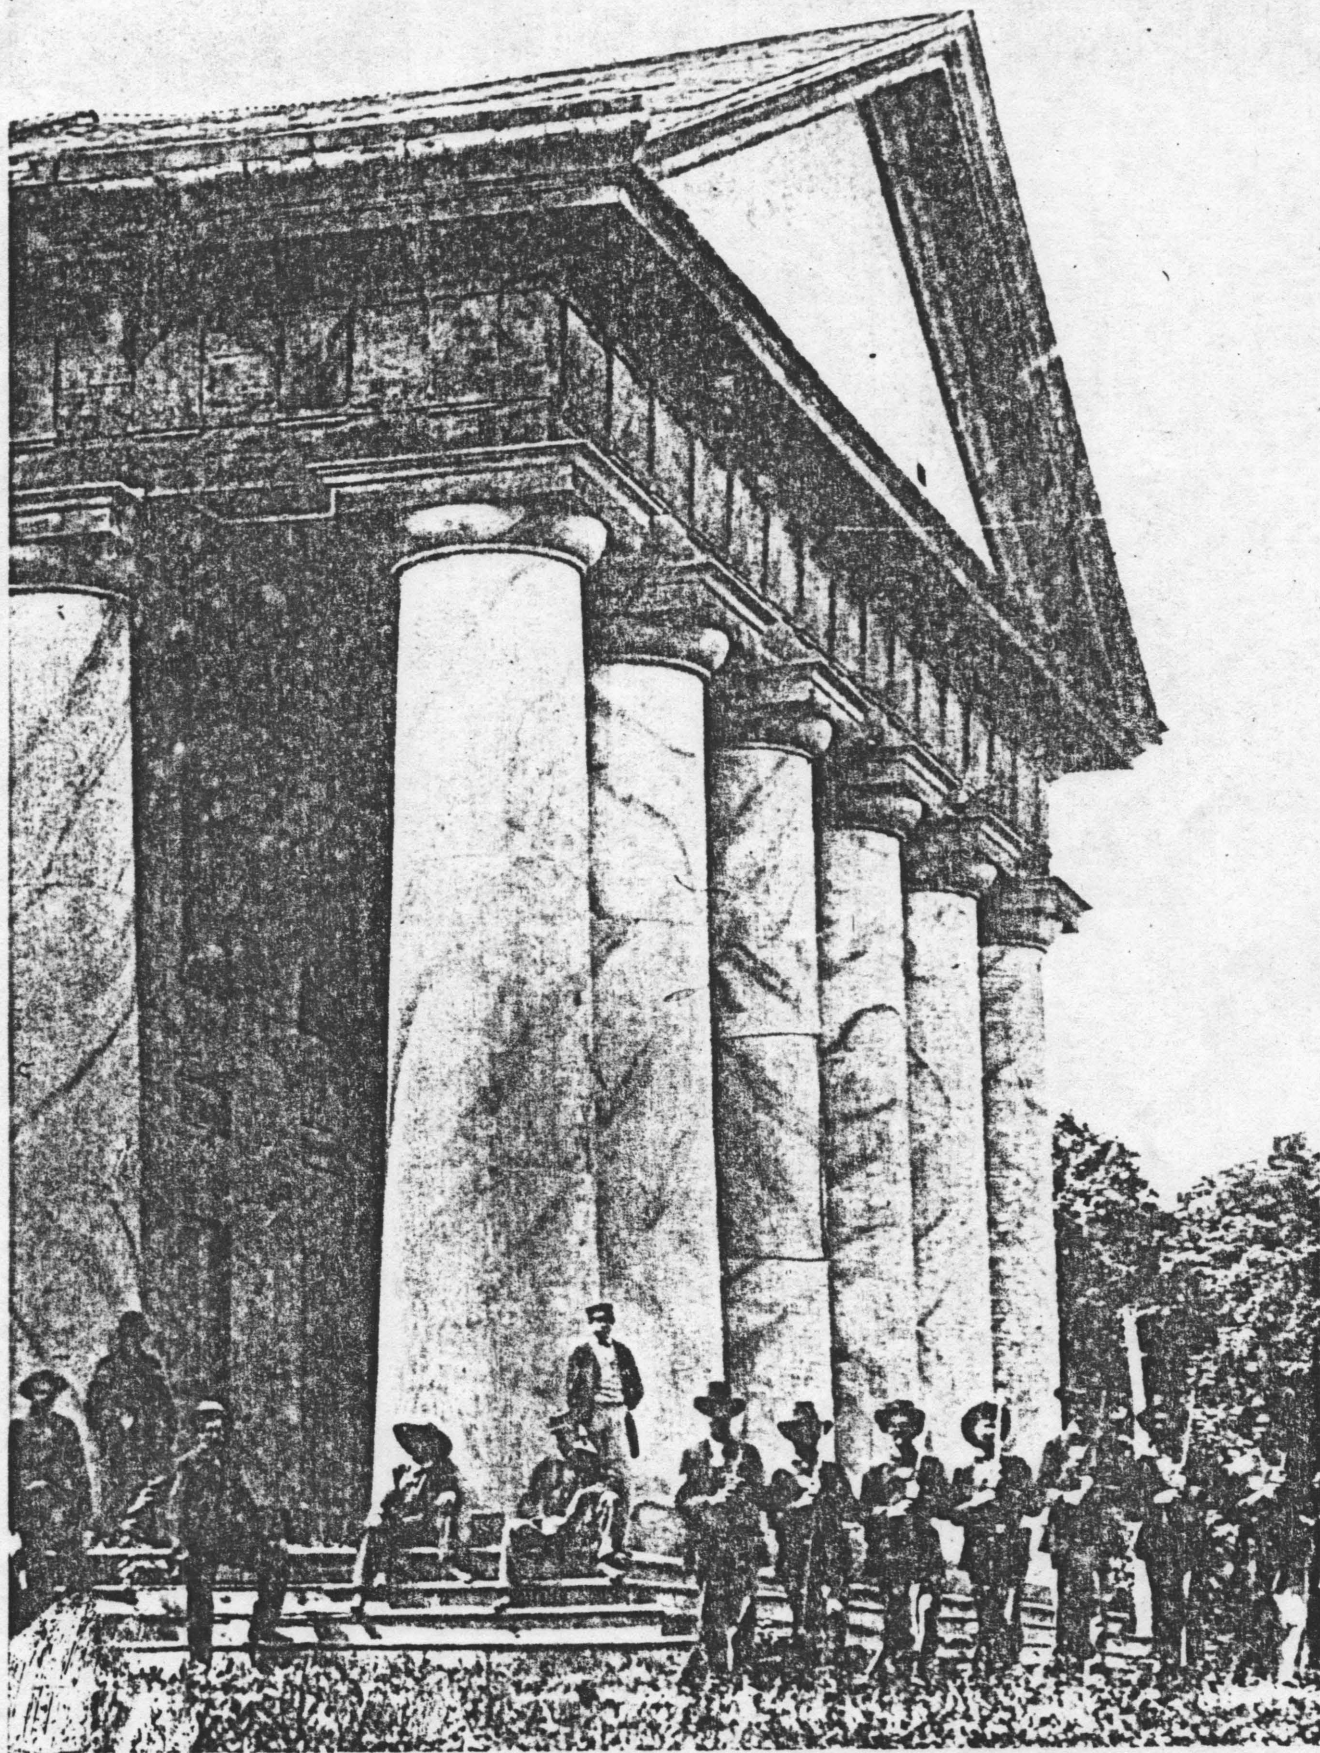
Figure 8

According to early photographs of the house dated c.1867, (Fig. 8) the present marbleizing appears to be fairly accurate in its overall tonality, pattern, pattern location, and style. Lacking in the present restoration, however, are the beautifully marbleized panel insets above the first story openings on the main portico facade. These appear to have been painted out by the turn of the century as indicated in a southeast view of the house taken in 1904. A comparison of values between the stucco walls and coarse aggregate raised basement in the 1867 photograph indicates that the basement story of the wings was painted a darker color than the rest of the masonry. In addition, it is interesting to note that by 1867 the west (rear) facade and chimneys were still exposed brick, not receiving a stucco finish until some time before 1904.
