Subject: Annual Inspection Report of Gloria Dei (Old Swedes')  
Church National Historic Site

REPORT ON ANNUAL INSPECTION AT

GLORIA DEI (OLD SWEDES\*) CHURCH NATIONAL HISTORIC SITE

Park Historian William M. Campbell

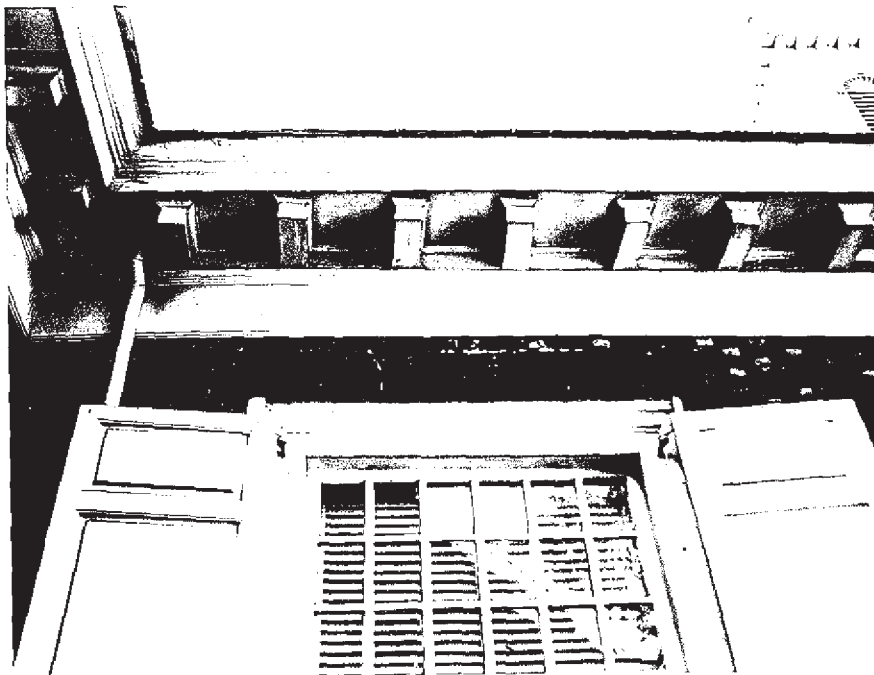
Fig. 2. Cracked lintel in north wall of west end of church.

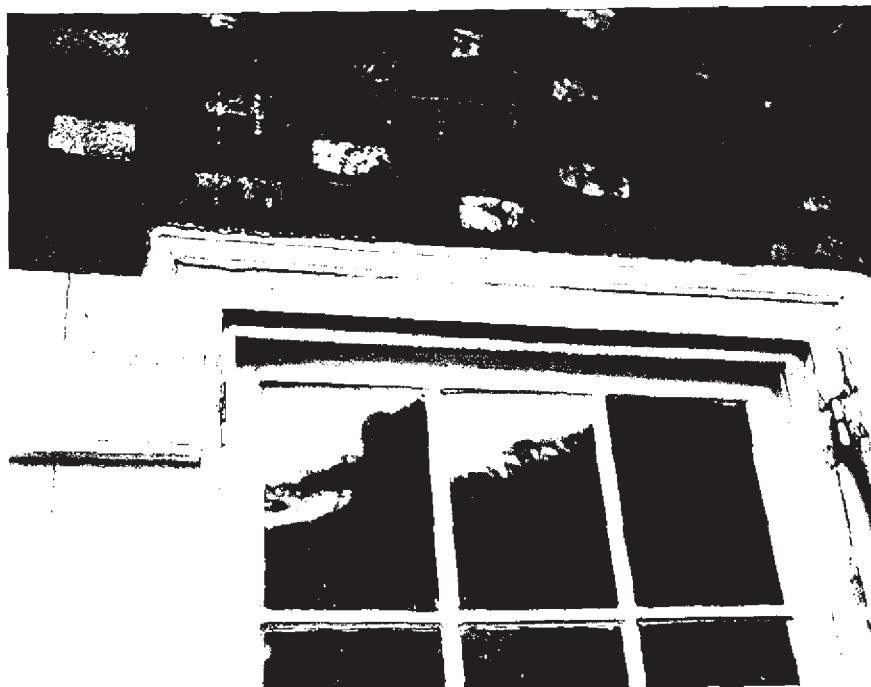
Fig. 3. West wall of north arm. Pointing above window missing, allowing water to enter.

The most urgent need for preservation of the church is, at present, the cleaning of the joints in the brickwork of all loose mortar and refilling and pointing with the proper mixture of mortar.

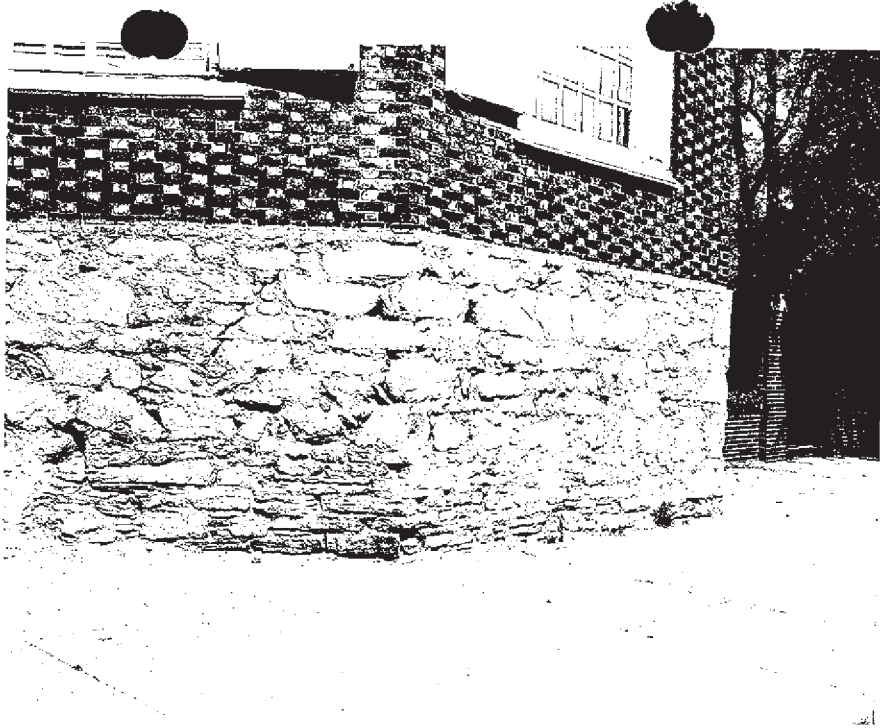
The exterior of the church remains in much the same condition as it was found at last year's inspection. The condition of the mortar and the settlement cracks are, perforce, in worse condition than they were a year ago, and this disintegration of the mortar, mentioned in reports as far back as 1954, is, if not arrested, working slowly through dampness, freezing, and erosion toward the gradual destruction of the building (Illustrations No. 2, 3, 4, 5, and 6). All of the roughcasting on the base of the apse, last year removed in part, has since been removed in toto, and the rough stonework should be made watertight by pointing, with such gallating as is necessary to fill large interstices (Illustration No. 5).

Fig. 5. Apsidal stone foundation looking northwest.

Pointing, rather than roughcasting or stucco, is recommended. A lithograph in the Historical Society of Pennsylvania by William L. Breton, made in 1828, shows the stonework to have been exposed.

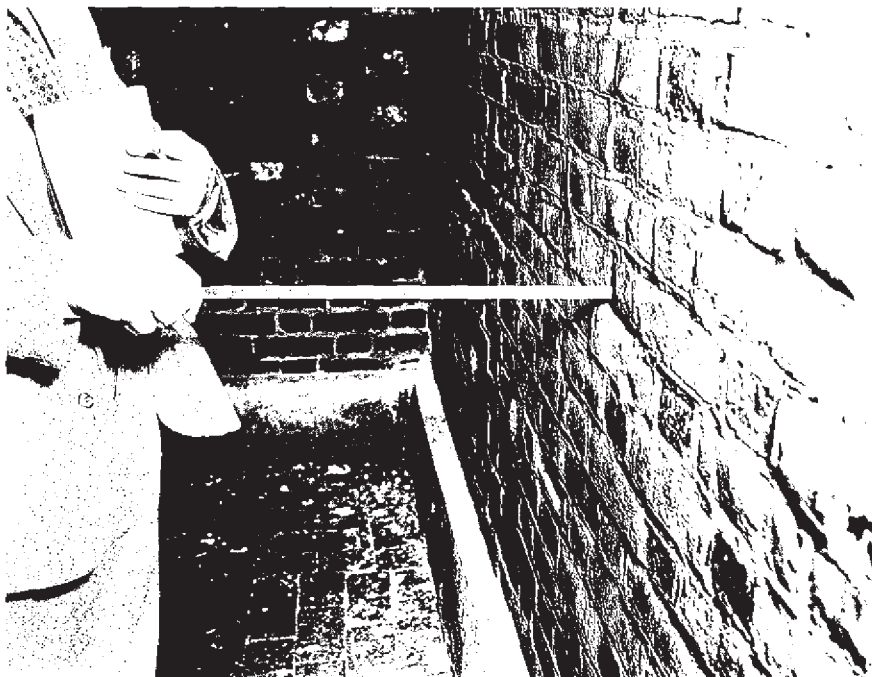
Fig. 6. West wall of south arm, showing interstice  $\pm 9''$  deep. Behind this wall is a vault in which are kept early church records.

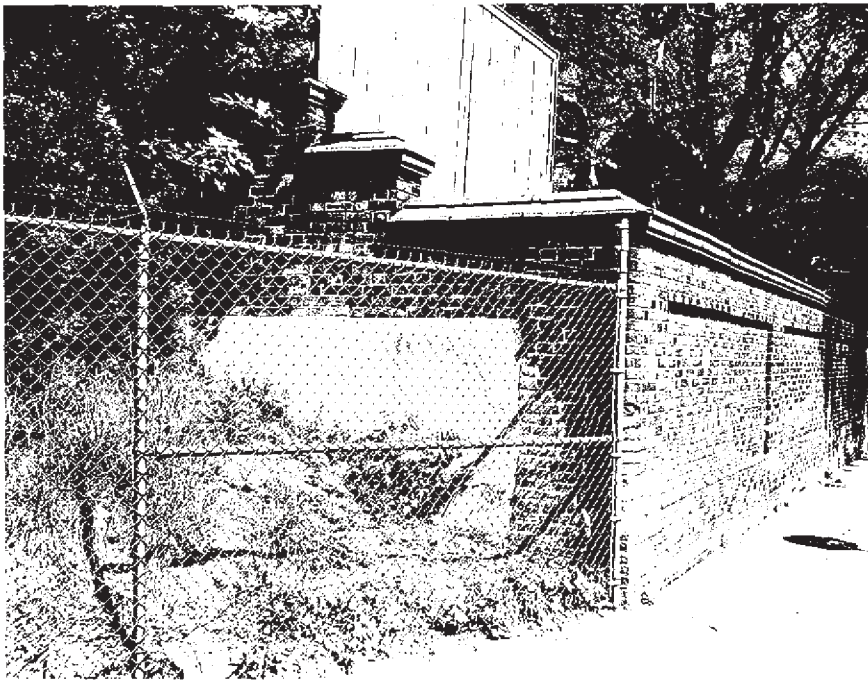
Fig. 7. Return of Swanson Street wall; in good shape.

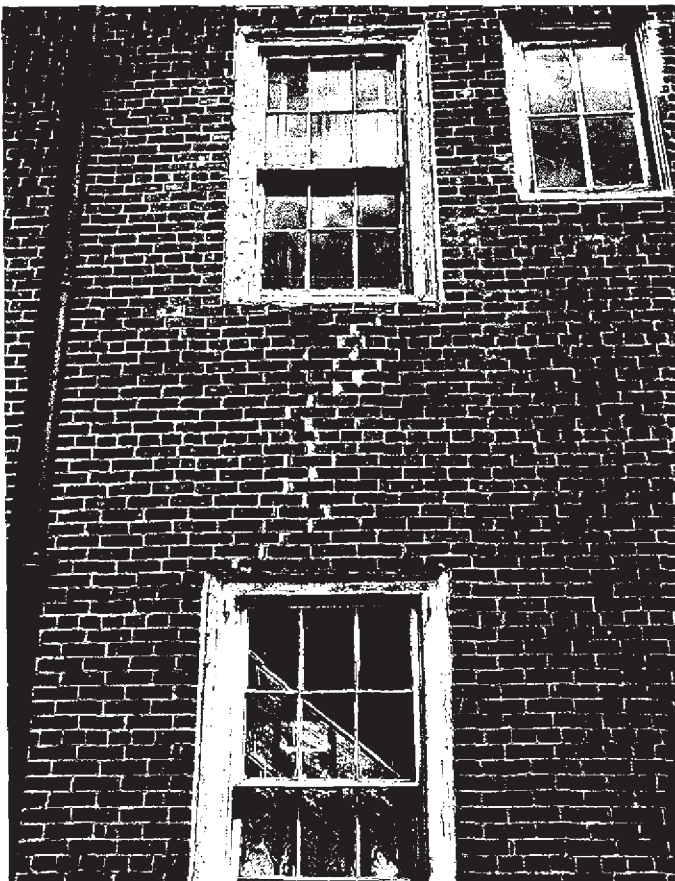
The poor condition of the masonry exterior of the Guild House has not changed except that, like the church, another year's destructive forces have been at work (Illustrations No. 8, 9, and 10).

The movement of the south wall constitutes a real danger of collapse if not shored until permanent measures of stability are taken.

Fig. 8. South wall of Guild House, showing settlement crack between head and sill of lower and upper windows.

A careful investigation of the guild house's south wall by a competent architect should be made to determine its safety and make recommendations for making it stable.

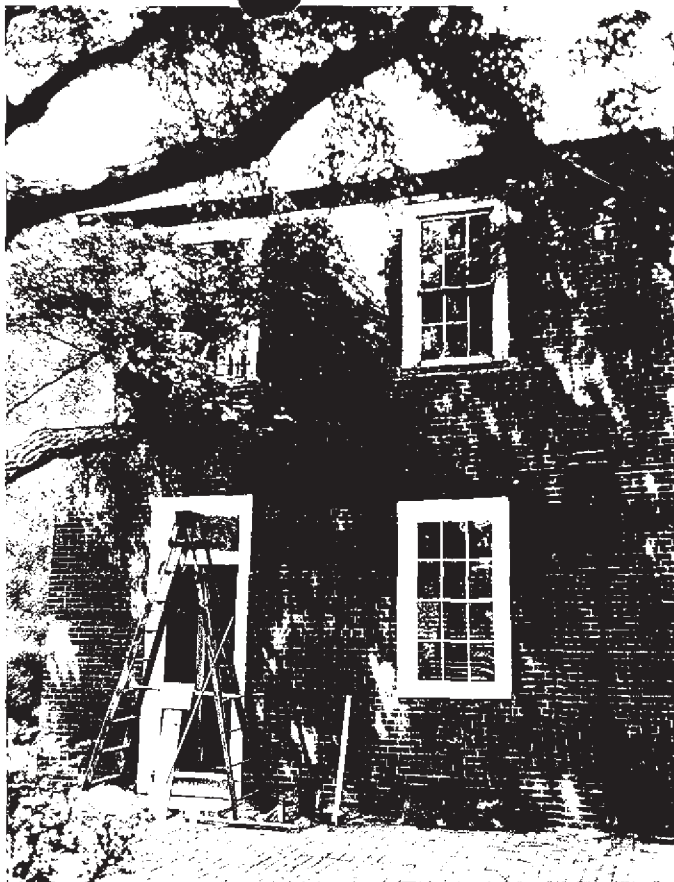
Fig. 9. South end of  
east wall of Guild House.

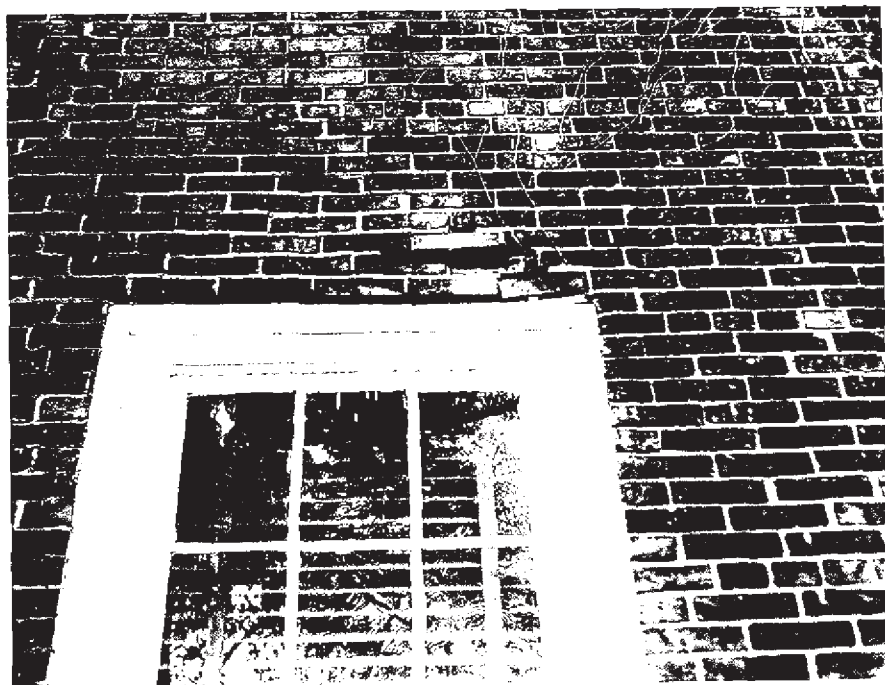
Fig. 10. North end of east wall. Note bricks above window.

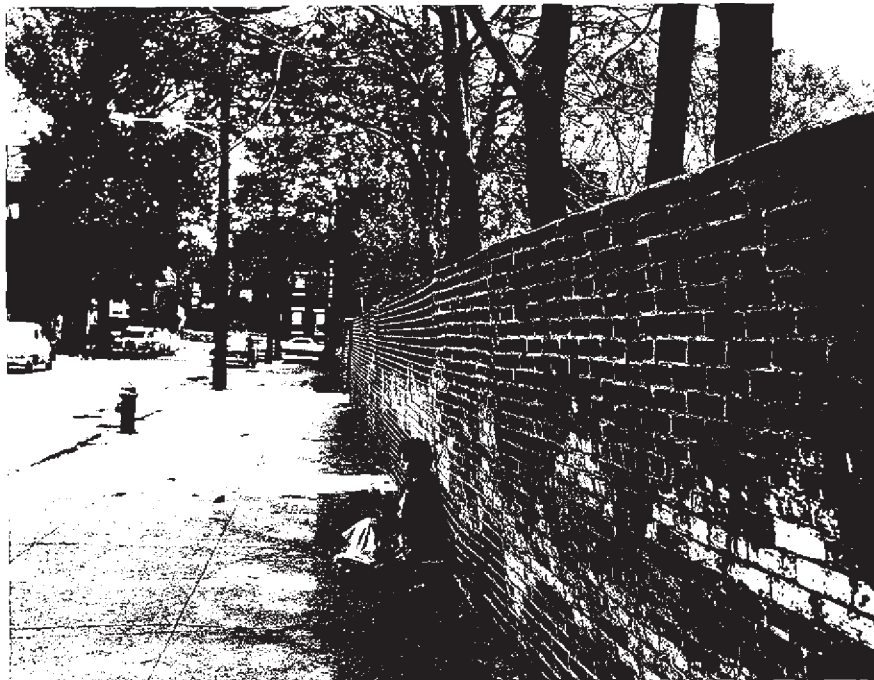
The garden wall along Water Street, north of the guild house, has been pushed out of plumb by the proximity of a row of trees on the grounds' side (Illustration No. 11).

Fig. 11. Water Street wall, pushed out by trees on grounds site.

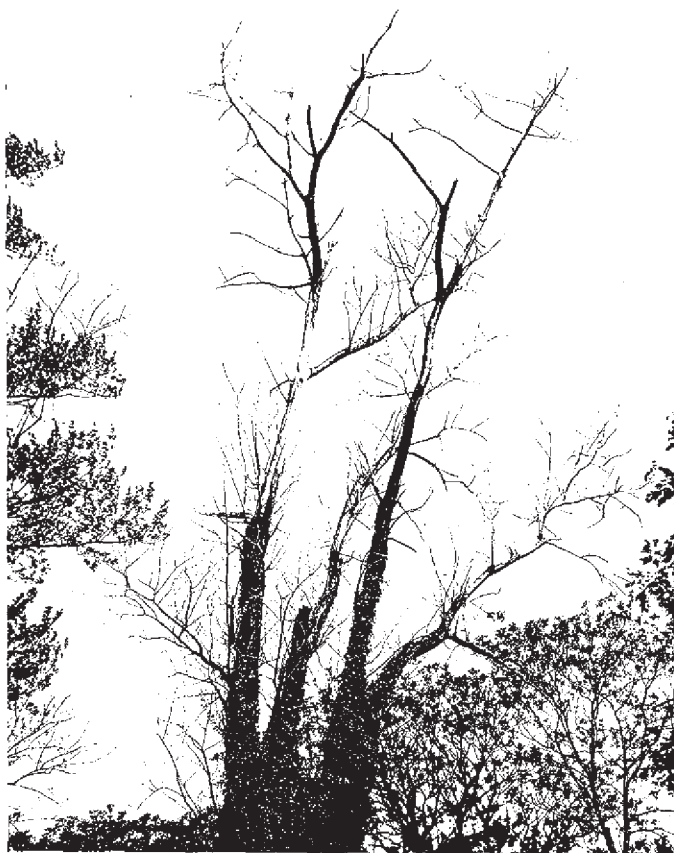
The grounds are, in general, in good shape except for the hazardous condition of the two Carolina poplar trees bordering on the walk from the church to the guild hall (Illustration No. 12). However, Dr. Roak has already let a contract to have the trees cut back, leaving about ten feet of the trunks to be covered by the surrounding ivy.

Fig. 12. Dead Carolina poplar trees to be cut to about 10 feet high and ivy allowed to cover them.

In addition to Dr. Roak's caring for the dead trees (Illustration No. 12), he has transplanted certain trees and shrubs from shaded areas to others more suitable to their proper development. He has also planted pachysandra on the southeast side of the church, which has enhanced the attractiveness of that area.
