REPORT  
of the  
1951 REHABILITATION WORK ON THE BUILDINGS AT  
INDEPENDENCE SQUARE

by John B. Lukens,  
Architect

INDEPENDENCE NATIONAL HISTORICAL PARK PROJECT

July 13, 1951

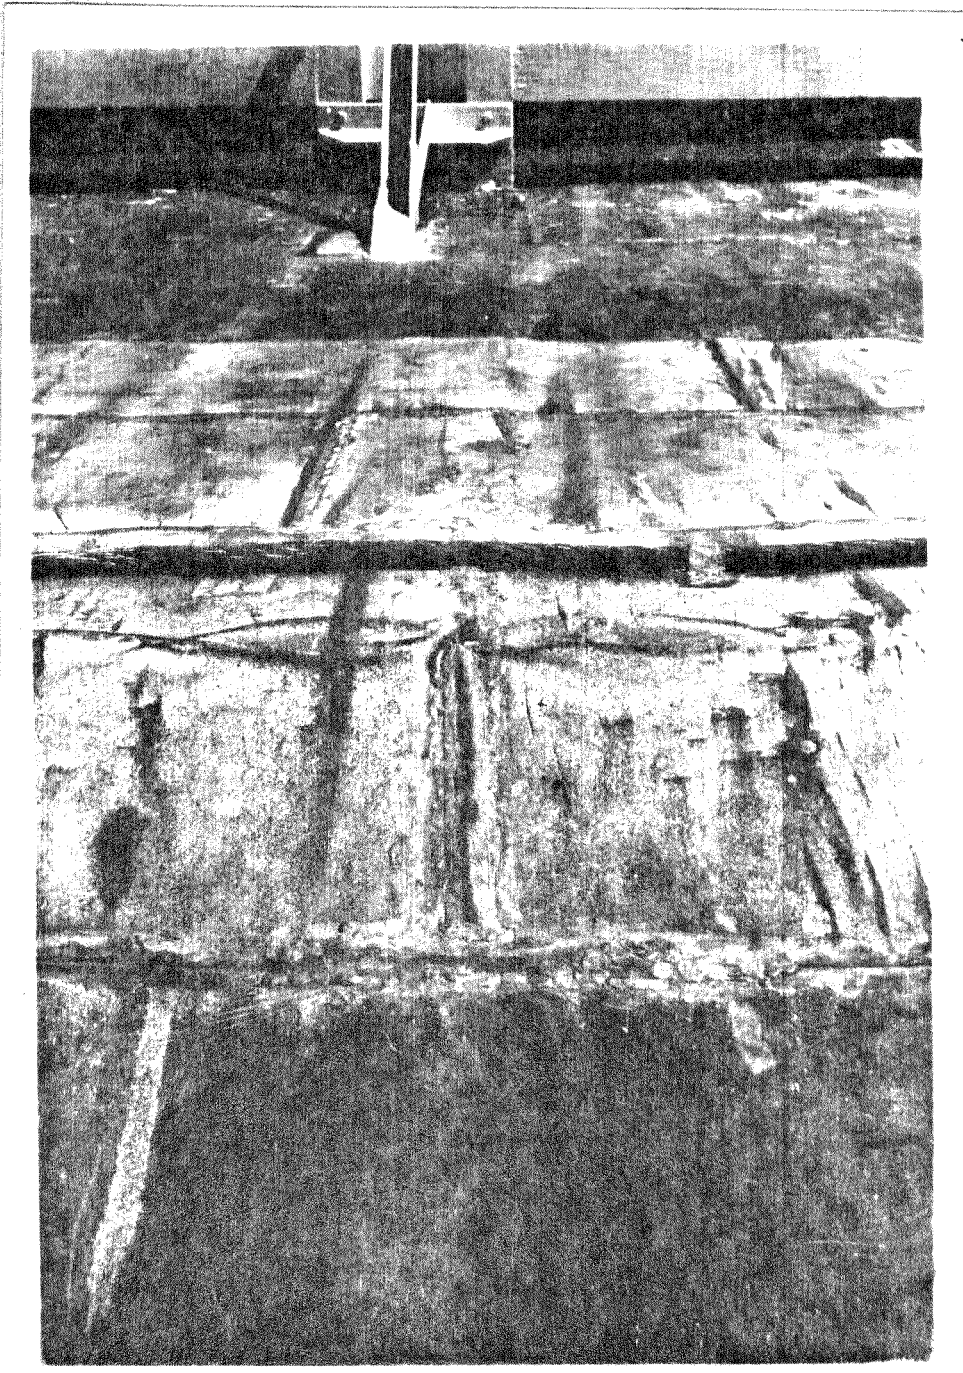
#1 - Repaired Seams in Copper Deck on Top of Main  
Roof of Independence Hall.

(The repaired seams appear as an inverted "T"-  
shape just below center of picture. Repairs  
were made by laying new strips of copper over  
the open seam and soldering around all sides  
of the strips.)

Before beginning the repair work it was very evident that the roofs leaked in several places. The writer recommended that a good roofer be consulted before any of the other repair work should be started. This office contacted the firm of M. G. Kulser & Sons who were currently engaged in re-roofing Carpenters' Hall, and Mr. Harry Kulser of that firm inspected the roofs on Wednesday, March 14, in company with Messrs. McCullough and Lukens of this office. It was found that the tin roof which girdles the tower of Independence Hall at the top of the brick portion of the tower had deteriorated beyond repair and needed to be completely replaced at a cost which would necessitate competitive bidding. (Illustrations #2 and #5). It was Mr. Kulser's opinion, however, that the necessary repairs and maintenance work on all the other roofs could be accomplished for less than \$500. Consequently, Mr. Kulser submitted a proposal under which his firm undertook to furnish 90 man hours of work on all the roofs except the badly deteriorated tin one for \$465. A purchase order was issued on the basis of this proposal. This maintenance work was executed by a highly-skilled veteran roofer between April 12 and April 30, 1951. (See Illustration #1). All former leaks were stopped as a result and no leaks have appeared to date.

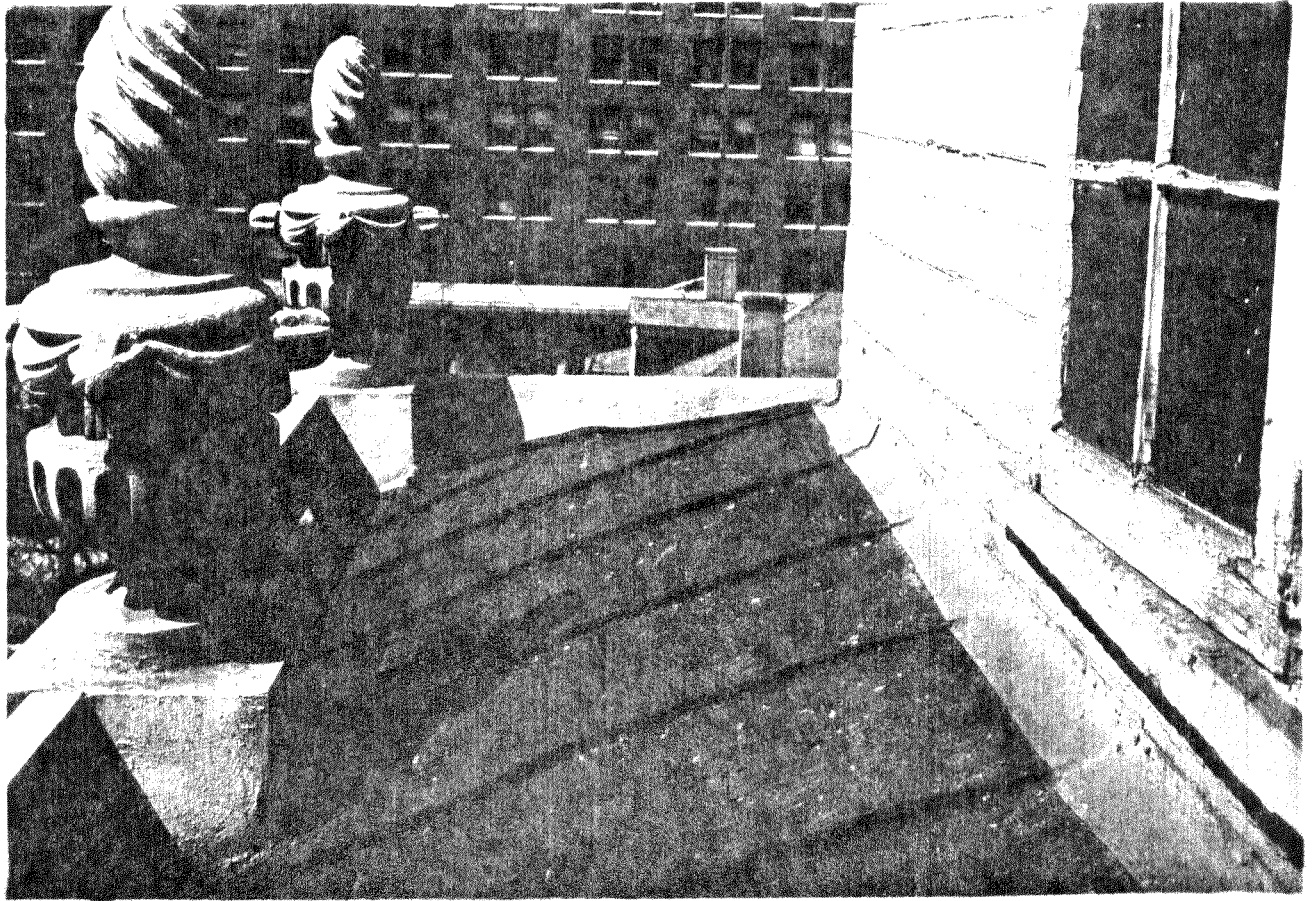
The existing tin roof was a standing seam roof with a flat-seamed portion around the lower (outer) edge. (See Illustration #2). It is more fully described in the specifications for the new roof. The old wood shingles were measured by this office during the time when they were uncovered and observations are recorded on an Historic American Buildings Survey sheet under date of April 10, 1951.

#2 - Old Tin Roof before Repairs, Independence Hall  
Tower.

(Note holes through tin in center foreground.)

The old lead flashing between the top edge of the tin and the sides of the wood steeple (see Illustration #2) was entirely replaced with new sheet lead by the contractor.

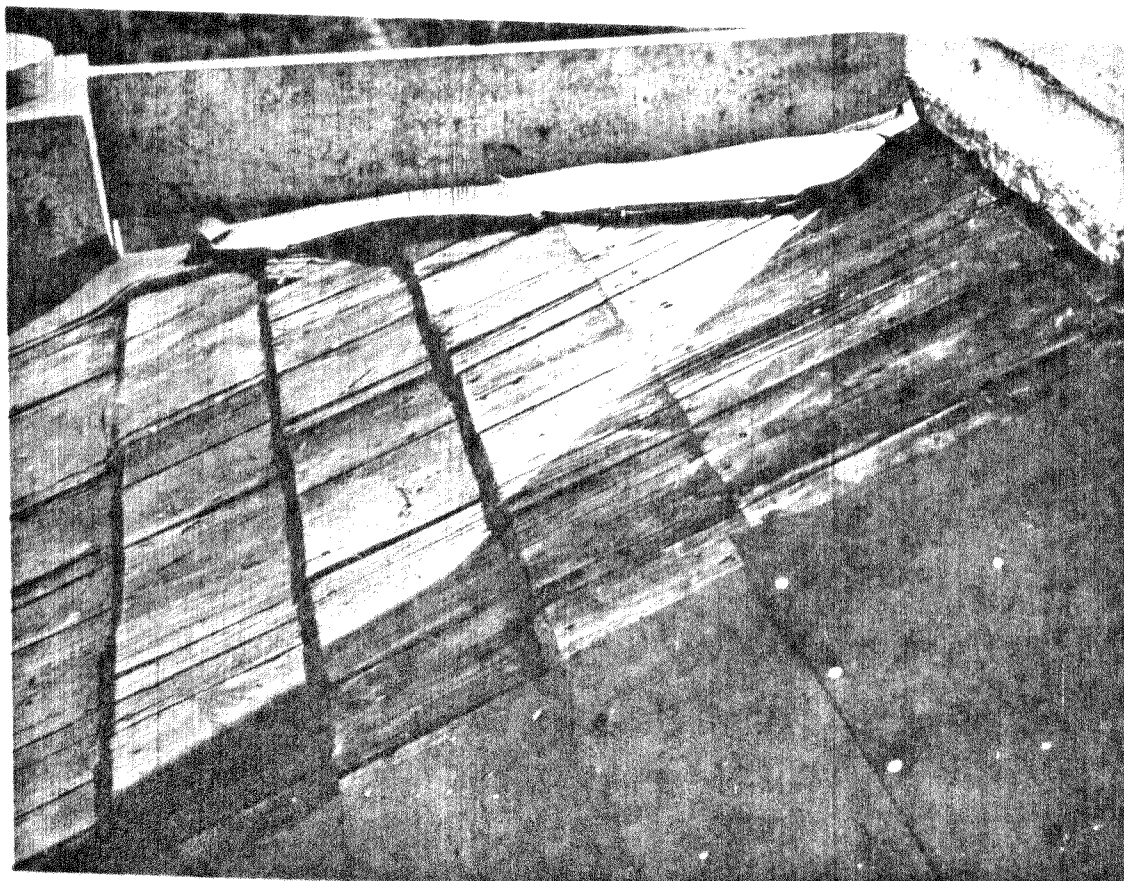
tin was found to be laid over older wood shingles which had bevelled butts (see Illustration #3) and an unusual arrangement at the hips. Some consideration was given to the possibility that this roof might have had a shingled surface after 1828 and that it should be restored as a shingled roof. However, further study convinced all concerned that the shingles were vestigial remains of the old pyramidal roof which covered the brick tower from 1781 to 1828, during which period there was no steeple on the tower. It is believed that the architect of the present steeple in 1828, William Strickland, simply had the central portion of this old pyramidal roof cut out and had his timber steeple built up through the hole, the remaining portion of the shingled roof being then covered over with tin. The policy adopted for the recent repairs was, therefore, to replace the existing tinwork with an exact reproduction in new material.

#3 - Old Shingles Exposed During Replacement of Tin  
Roof on Tower, Independence Hall.

(Note bevelled butts.)

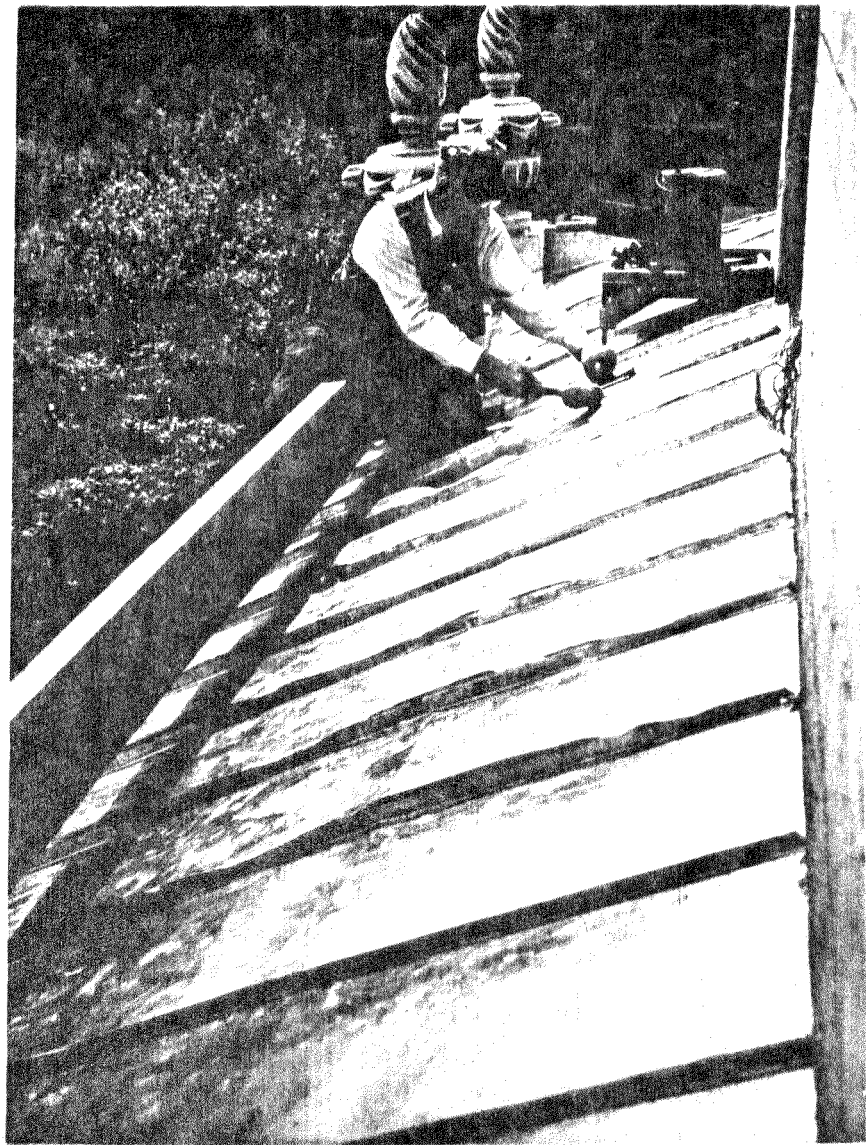
#4 - Installing New Tin Roof, Independence Hall Tower.

Specifications for the new tin roof were sent out to three roofing contractors on March 28, 1951. On April 4, 1951 the contract was awarded to M. G. Kulser & Sons, the same firm which was then engaged in performing general maintenance work on the other roofs. The contract price was \$1790 and no other bids were received. The work on this roof was completed satisfactorily on May 22, 1951. (See Illustrations #4 and #6).

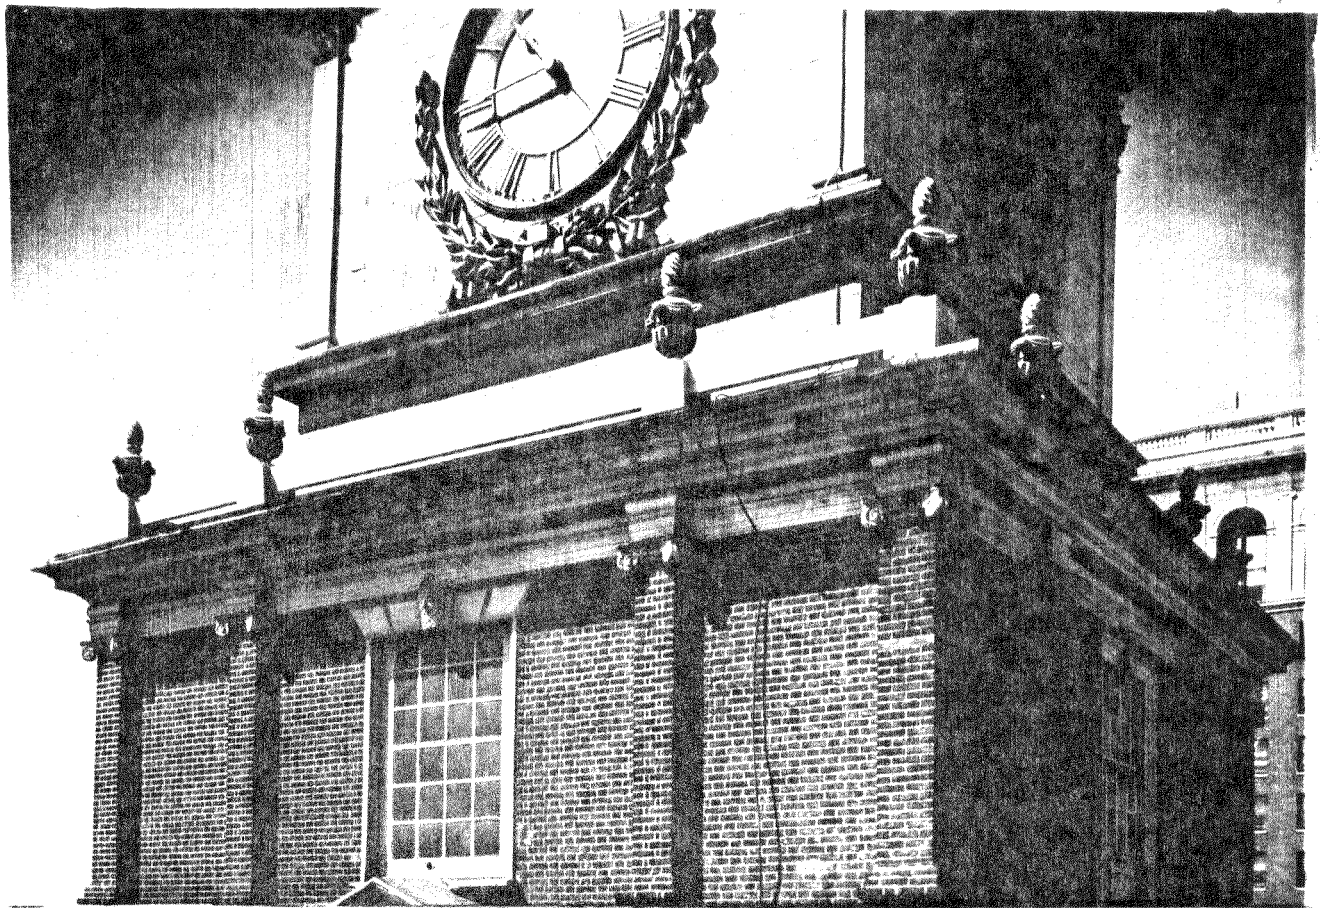
#5 - Tower before Repairs, Independence Hall.

(Note rusted edge of old tin roof and rust-streaks on wood cornice below.)

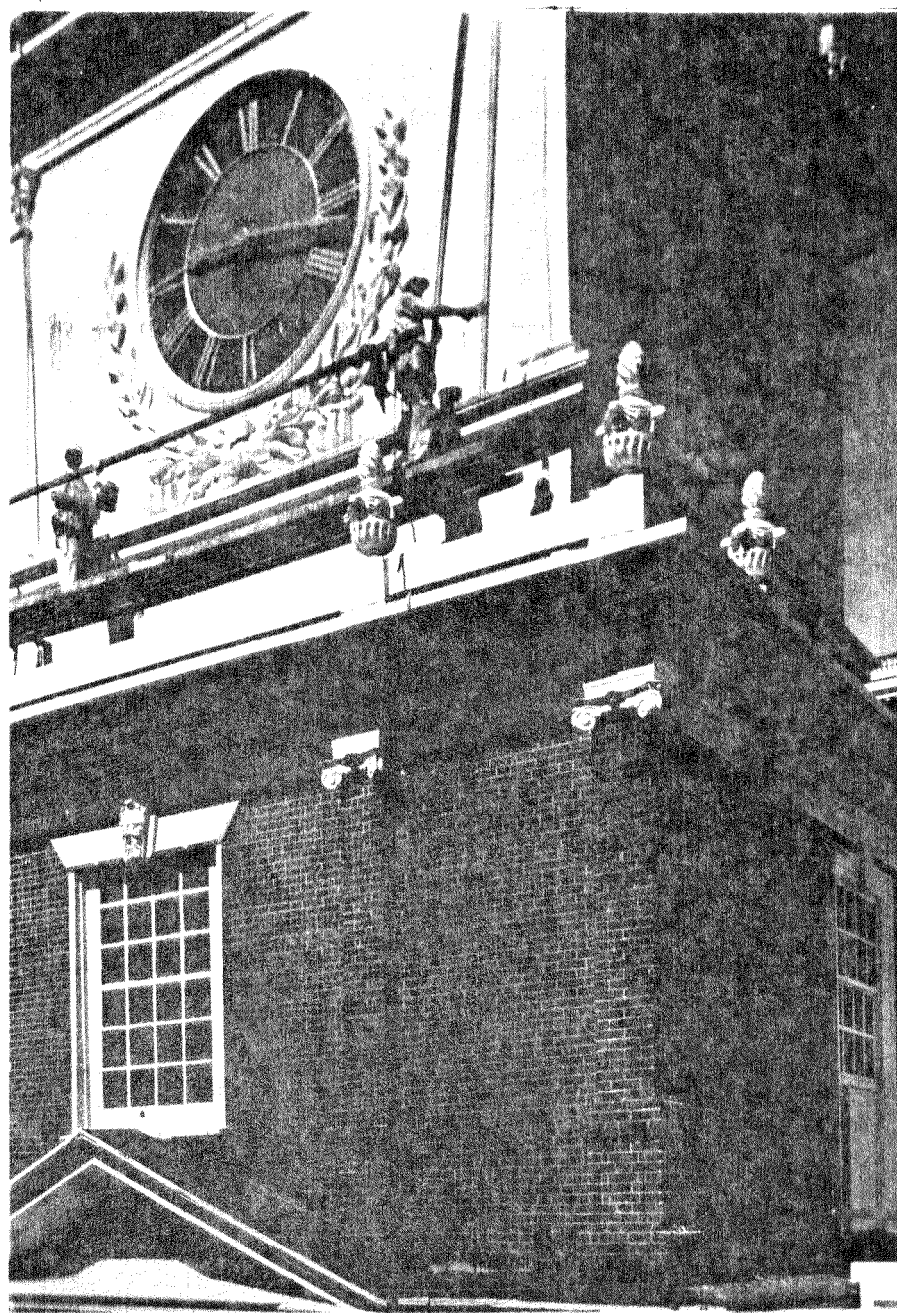
#6 - Tower after Repairs, Independence Hall.

(Painting still in progress, July 6, 1951.)

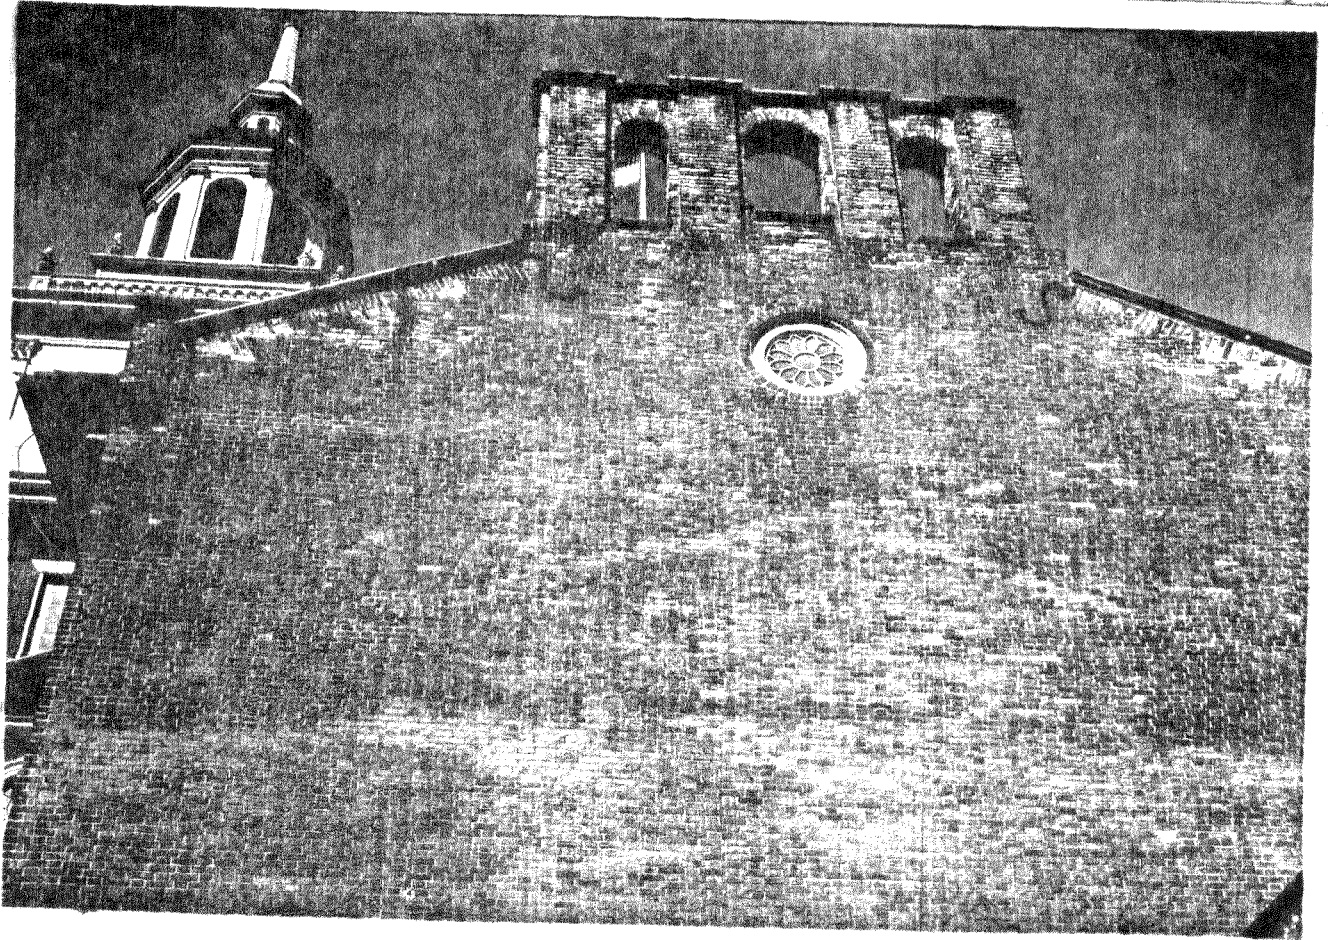
#7 - East End of Independence Hall before Repairs.

(Note bricks out of plumb just below central arched opening in chimney. Also, vestiges of roof-line of Robert Mills' fireproof wing buildings, built circa 1813 and removed in the 1890's.)

During the course of the job all bricks which had moved out of plumb due to frost but were not defective were relaid to the correct face as part of the pointing work and without being considered as "extra" work.

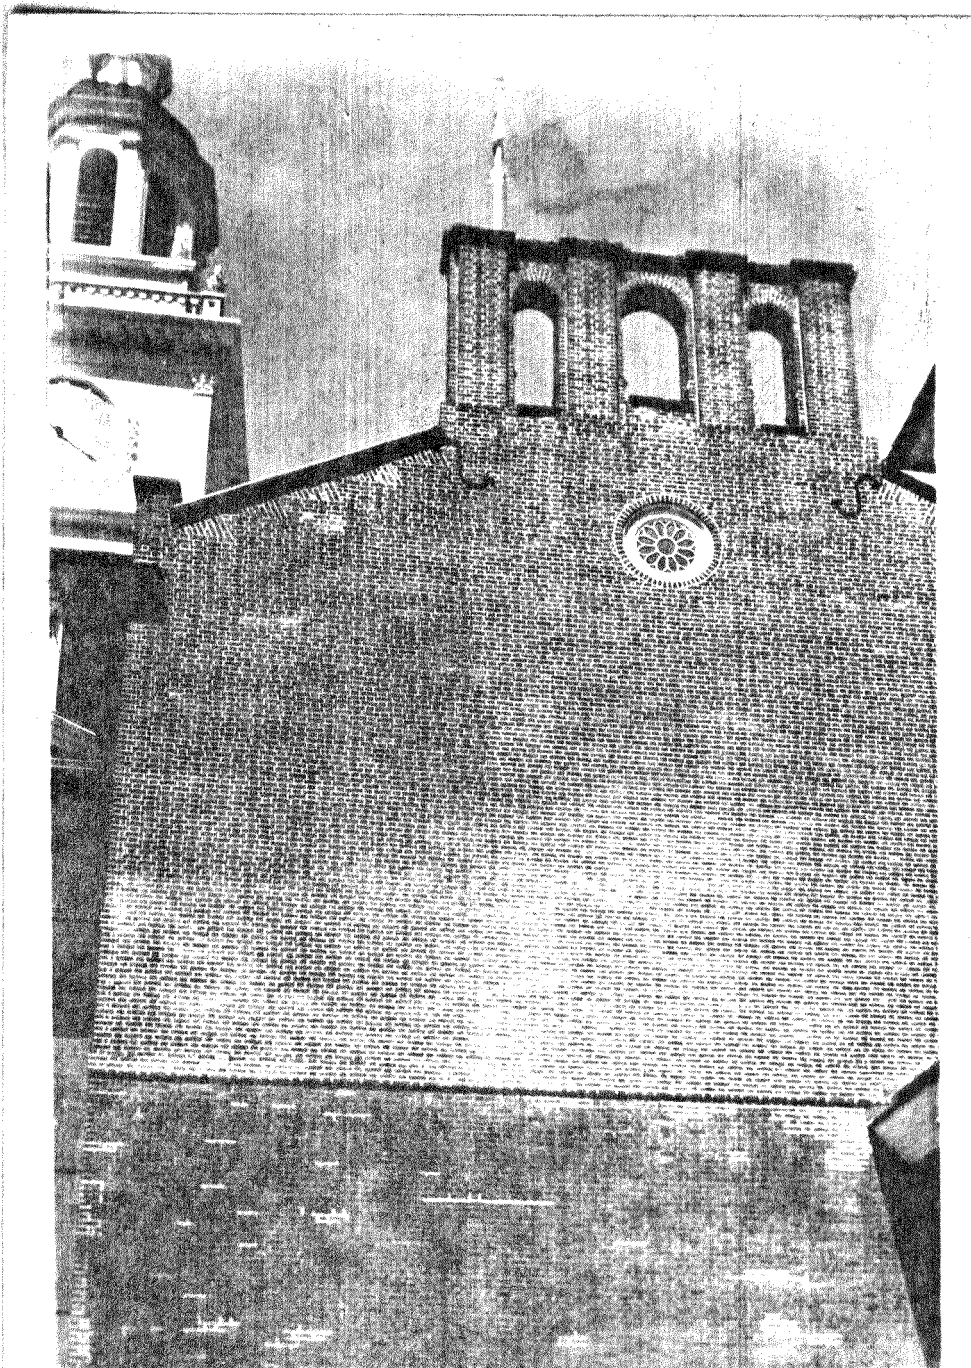
#8 - East End of Independence Hall after Repairs.

The style of mortar-joint selected consisted of a flat surface of mortar sunk  $1/16$ " behind the face of the brick, with a square groove,  $1/8$ " wide and  $1/8$ " deep scored through the center of the mortar surface. Two of the contractor's men were taken by the writer to Carpenters' Hall where joints of this description were shown to them. The proper joint was produced by them on the job, after several attempts, by using a tool called a "slicker". The tongue in the center of the blade of the slicker, which makes the groove in the joint, was ground down somewhat, following the instructions of the writer, in order to make the grooves less deep. (Illustrations #8 and #9).

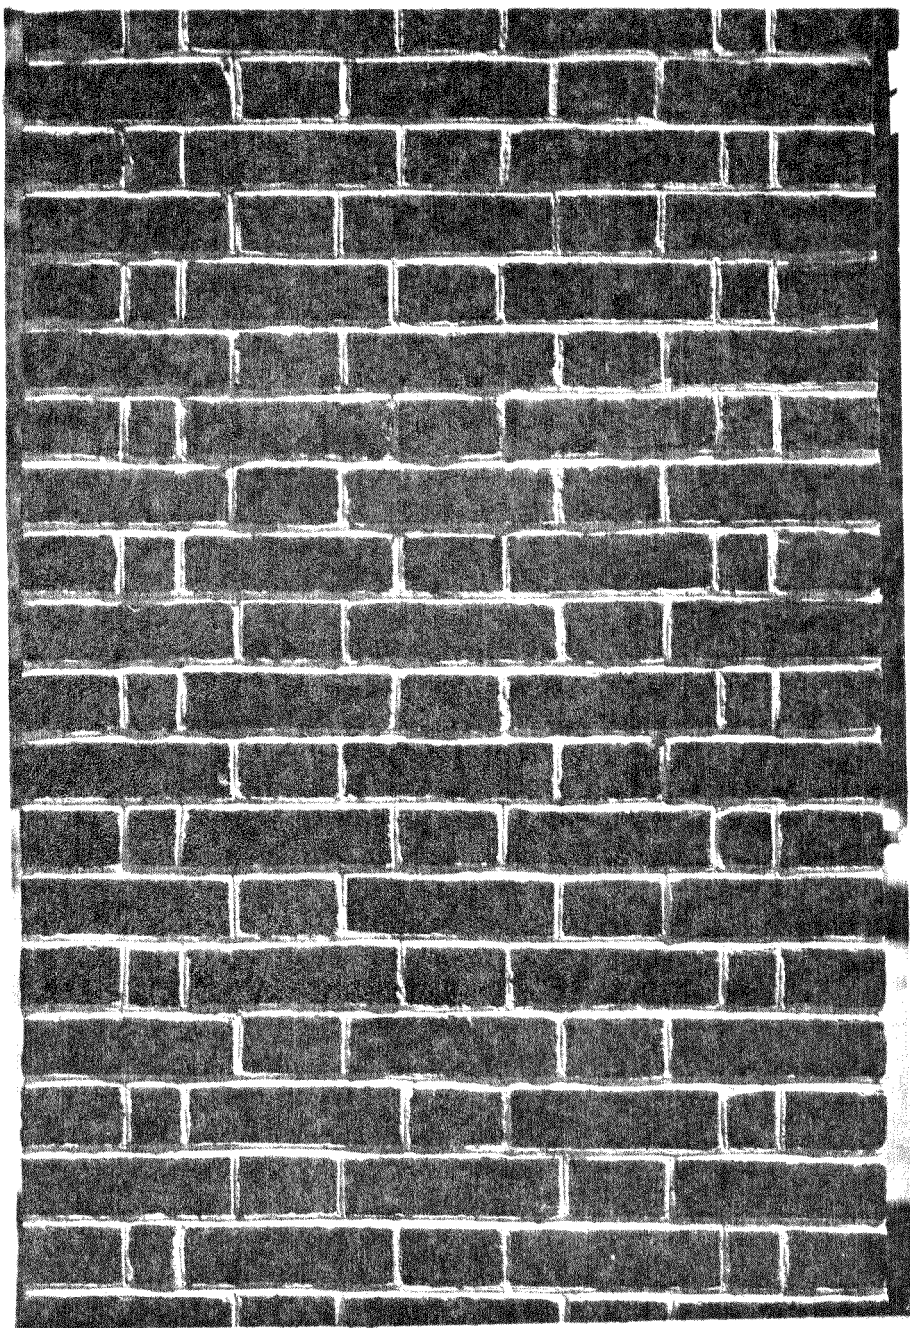
#9 - New Pointing of Mortar Joints in East Arcade,  
Independence Hall.

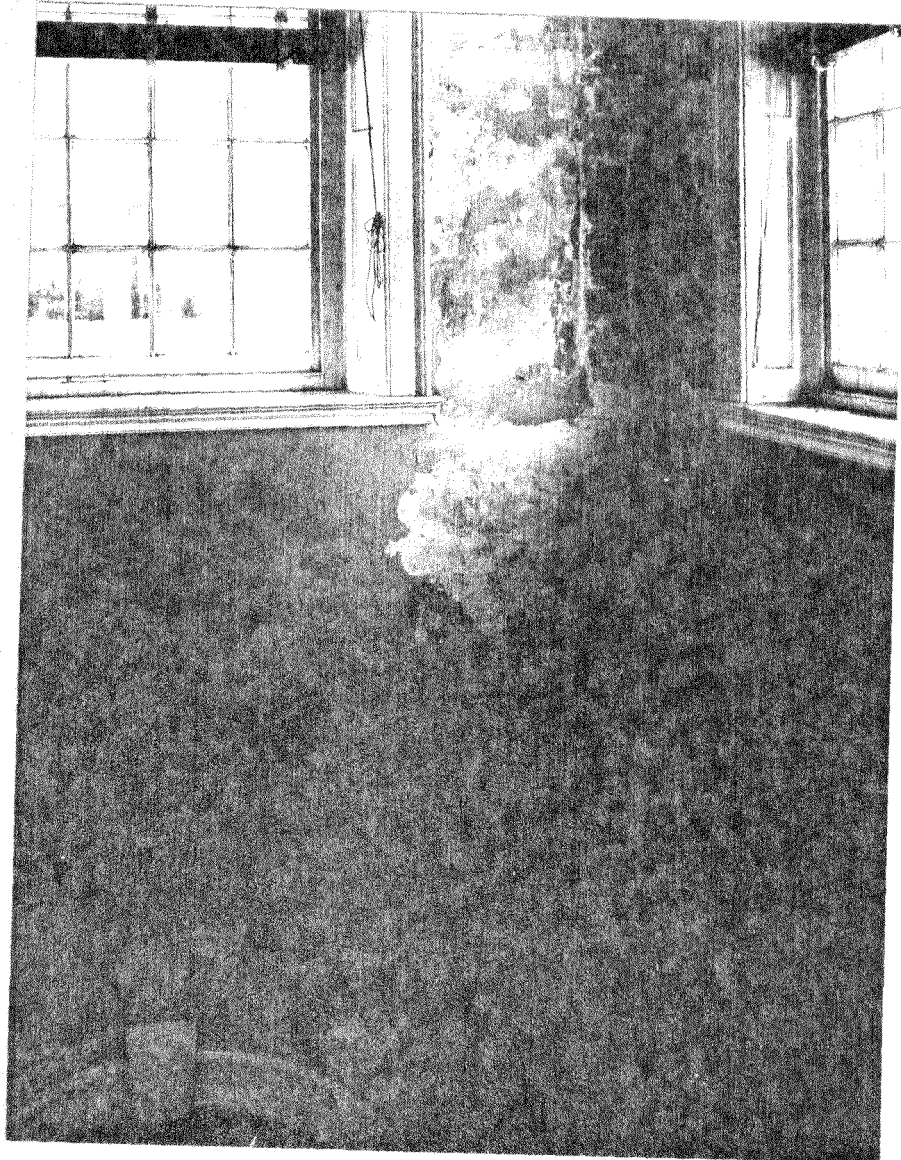
#10 - Plaster Wall in Congress Hall before Repairs.

Repairing of existing plaster work was needed in all five buildings. This work was handled as an incidental to the painting work \* and a large portion of it was actually done by the painters, due primarily to the difficulty of hiring plasterers. There were a few places, such as the first floor of the West Wing, where the painters, under pressure to finish their work at an early date, painted over new plaster patches before they had dried sufficiently. Some discoloration of the paint can be seen as a result. Generally, however, the plaster repairing work of both the plasterers and the painters was accomplished in a commendable manner. (Illustrations #10 and #11).

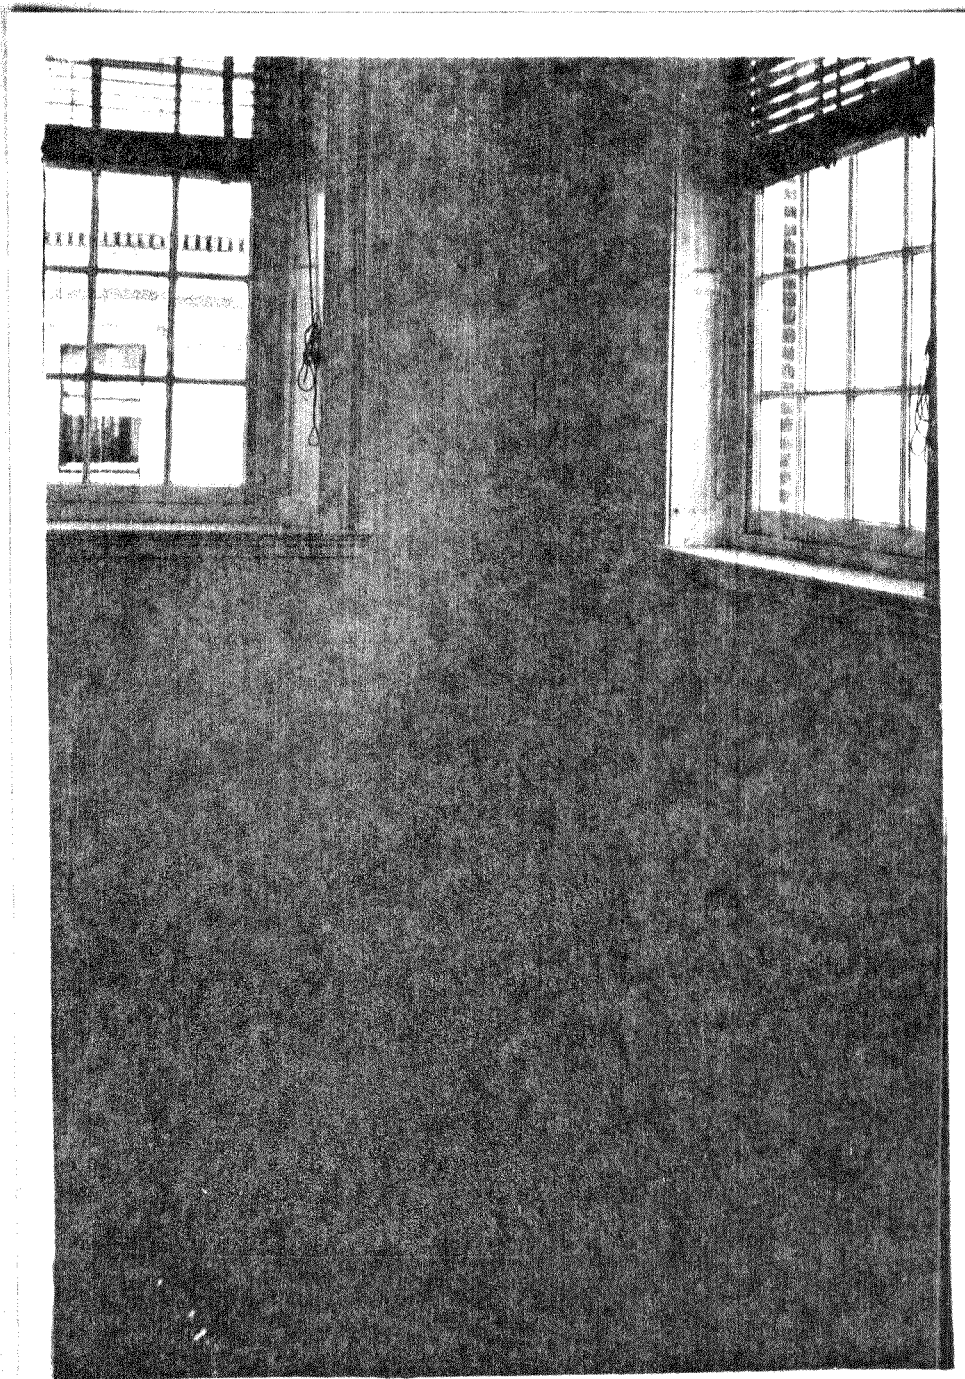
#11 - Plaster Wall in Congress Hall after Repairs.

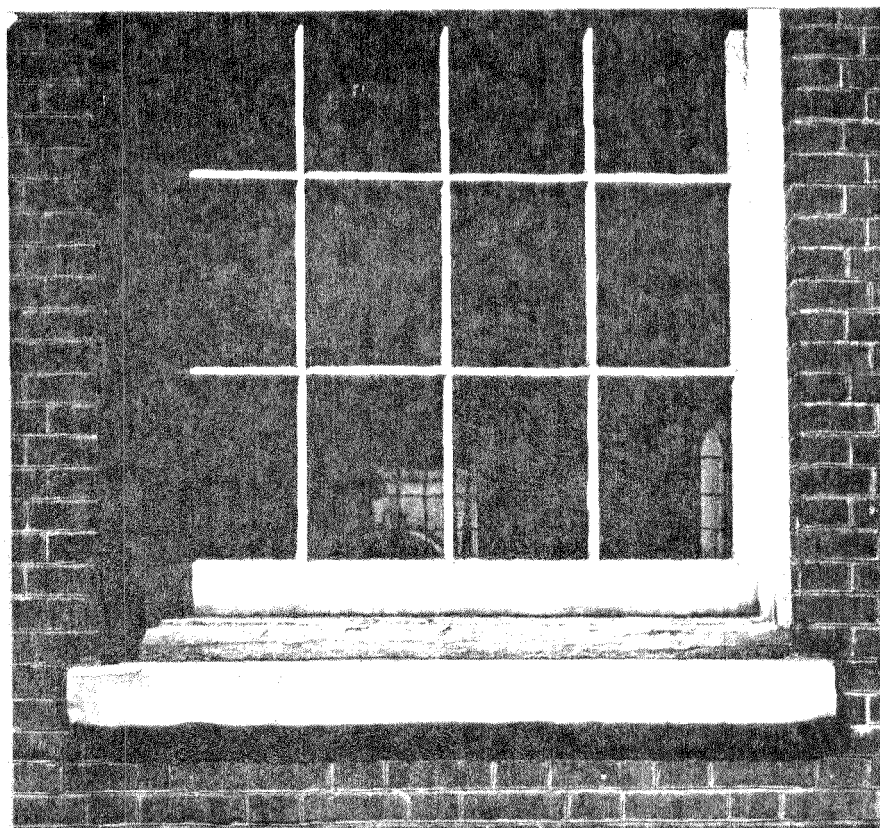
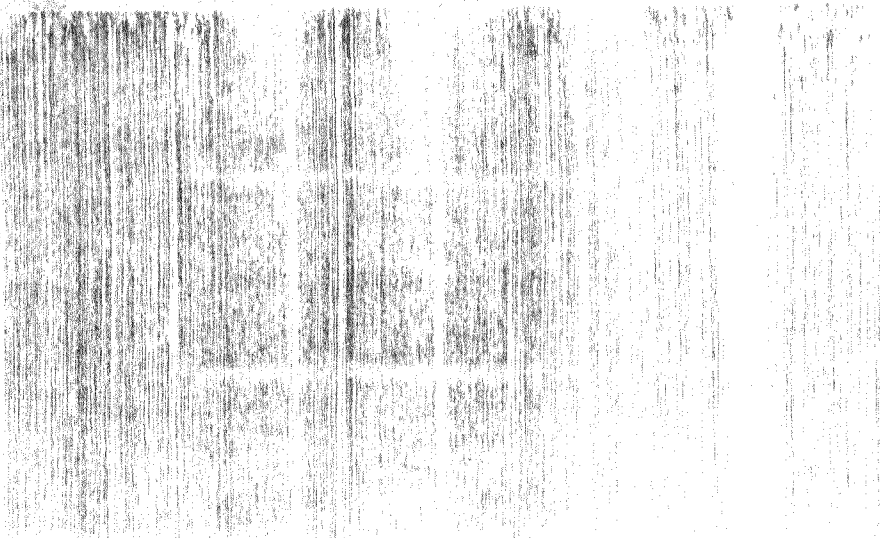
#12 - Exterior Window-Sill, Congress Hall, before  
Painting.

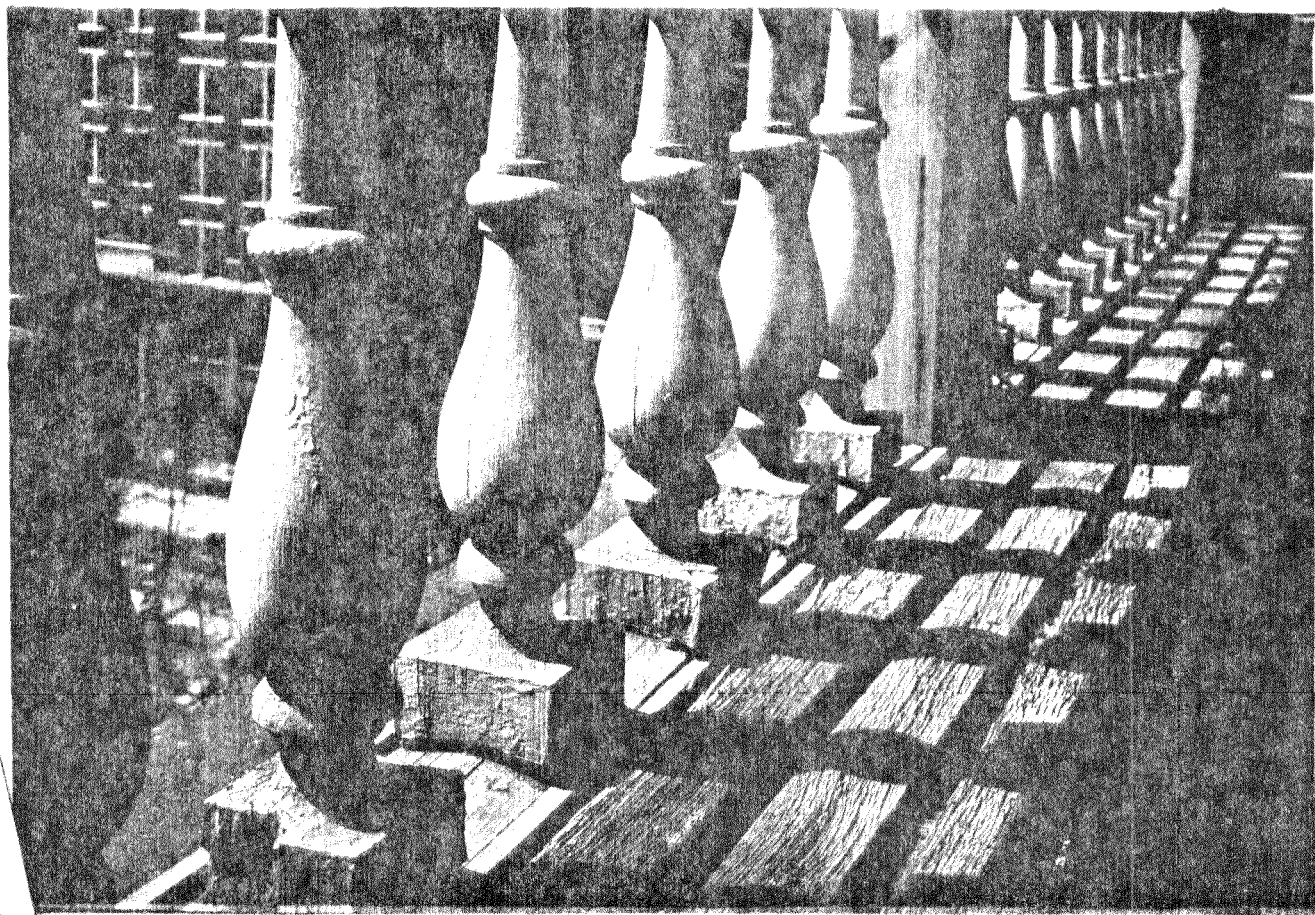
Repair of the ballustrade on the tower, item (b), above and Illustration #13, also entailed use of lumber not locally available. The top rail was apparently in good condition whereas the bottom rail was badly rotted in spots and many of the balusters were partially decayed. The piers at the corners and mid-points of each span appeared to be in good condition. It was decided that the bottom rail should be entirely replaced with new material but that the balusters could be patched or pieced out with material cut from the old bottom rails after they are replaced.

#13 - Ballustrade on Tower of Independence Hall before  
Repairs.

(Note bottom rail temporarily reinforced with  
1" X 6" battens; also, old wood grille or  
"duck-boards".)

For the bottom rail, eight pieces of genuine *pinus strobus* (eastern white pine) were obtained as a donation from the Vestal Lumber and Manufacturing Company of Knoxville, Tennessee through the Southern Pine Association. When the material arrived it had not been adequately

For the replacement of wood grilles or "dusk-boards", Item (c), above, and Illustration #13, this office was able to obtain "Clear Heart or A" grade tidewater red cypress from a local yard. The carpenter work is being done by the carpenter on the staff of this project.

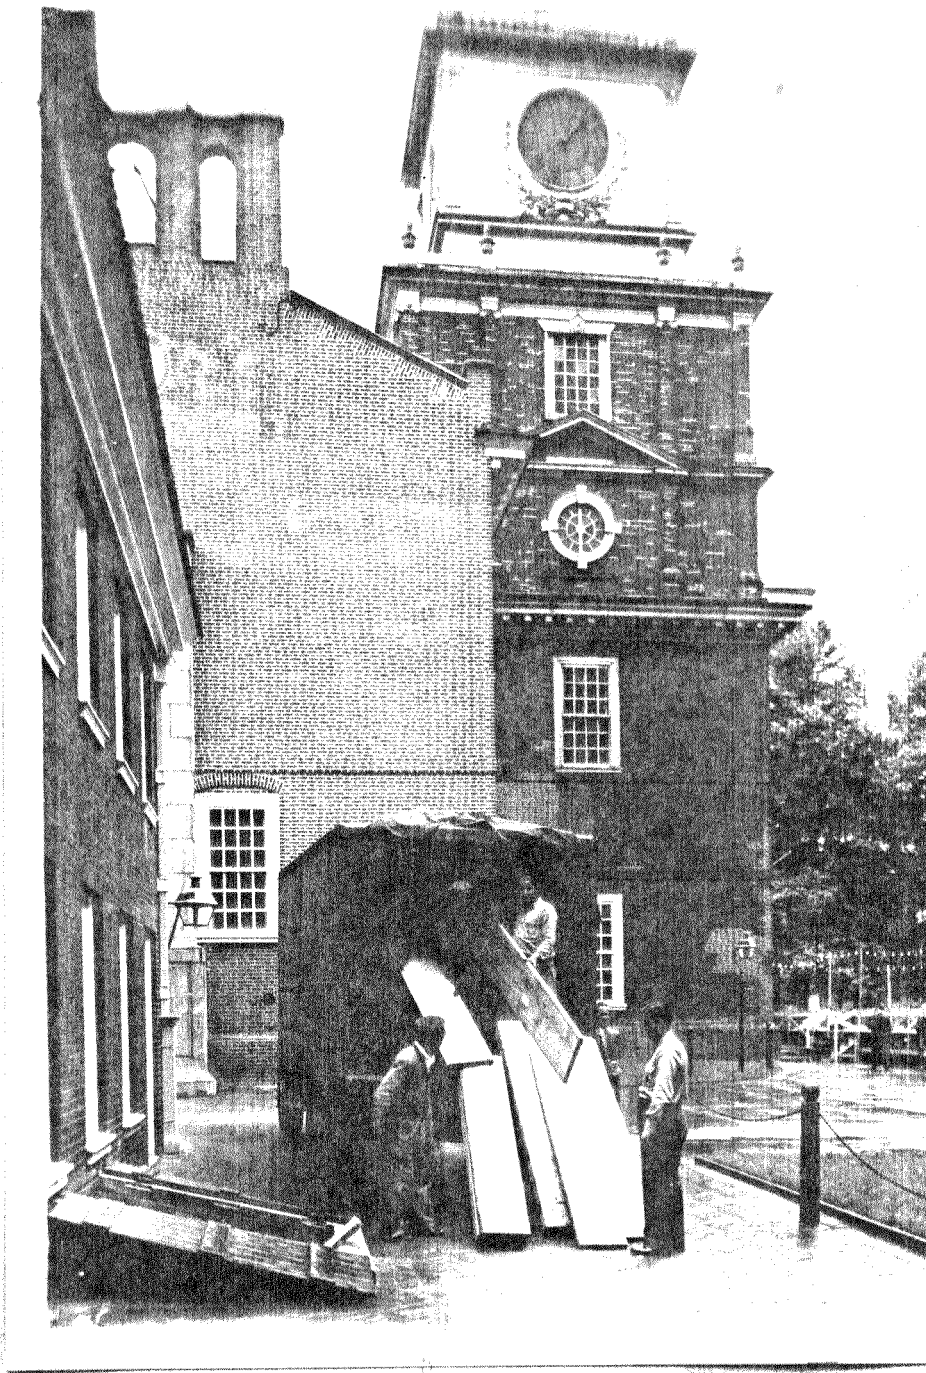
When this lumber reached the Project, it was noted that a good number of the pieces are edge-grained for a part of their width but that most of the material is flat grained. A representative of the

#14 - Lumber for Replacement of Treads in Main Stair  
Being Unloaded after Shipment from Florida.

A canvassing of local lumber dealers and builders soon revealed that no boards of the proper material and dimensions could be obtained in the Philadelphia area. Consequently, an appeal for the proper kind of lumber was given nation-wide publicity by radio and other means. A number of offers of donations of lumber for this purpose resulted, and the offer of the Southern Pine Association was accepted. On behalf of the Southern Pine Association, the lumber was prepared and shipped to the project by the Alger-Sullivan Lumber Company of Century, Florida. This shipment reached Independence Hall on June 13, 1951. (Illustration #14).
