391/132013  
INTERIM HISTORIC STRUCTURES REPORT, PART I

FRANKLIN'S HOUSE

INDEPENDENCE NATIONAL HISTORICAL PARK

NOVEMBER 1960

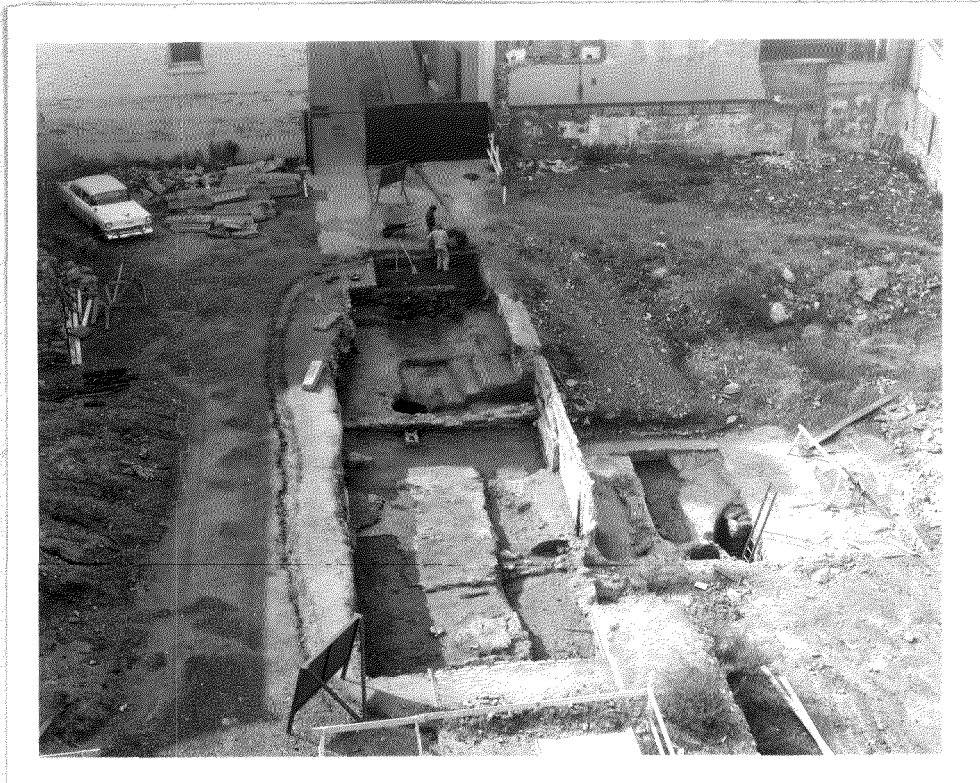
**Chapter III**  
**Illustration No. 1**

**View of the excavations in Franklin  
Court, looking south from the roof  
of 314 Market Street. Photograph  
taken October 5, 1960.**

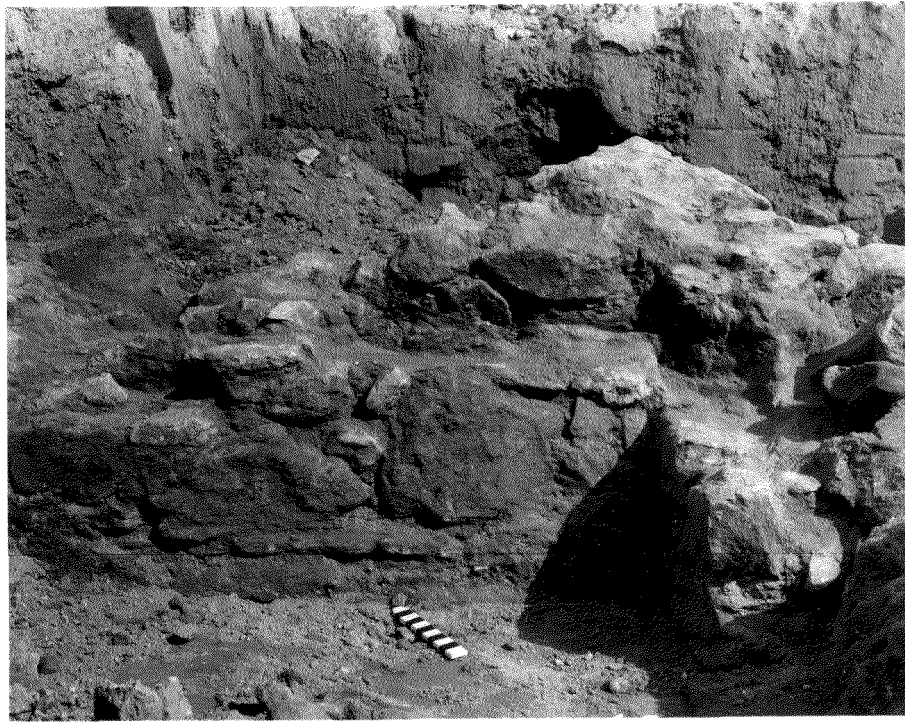
Chapter III  
Illustration No. 2

The north wall foundation (Feature 36) has been exposed as far as the building line on the west side of Orianna Street, where it was destroyed by later construction (Illustrations No. 2 and 3). This wall, of stone, is 1.5 to 3 feet wide, 13.5 feet long and 2 feet deep. Its top lies at a depth of approximately 5 feet below the modern surface. The eastern portion, for a length of 6.5 feet, has been knocked over and now lies partially on its original south face.

Remains of the north foundation wall of the Franklin house (Feature 36), near its remaining western end. The southward projection on the right is believed to be a part of the 1765 east wall of the house. The arrow points north.

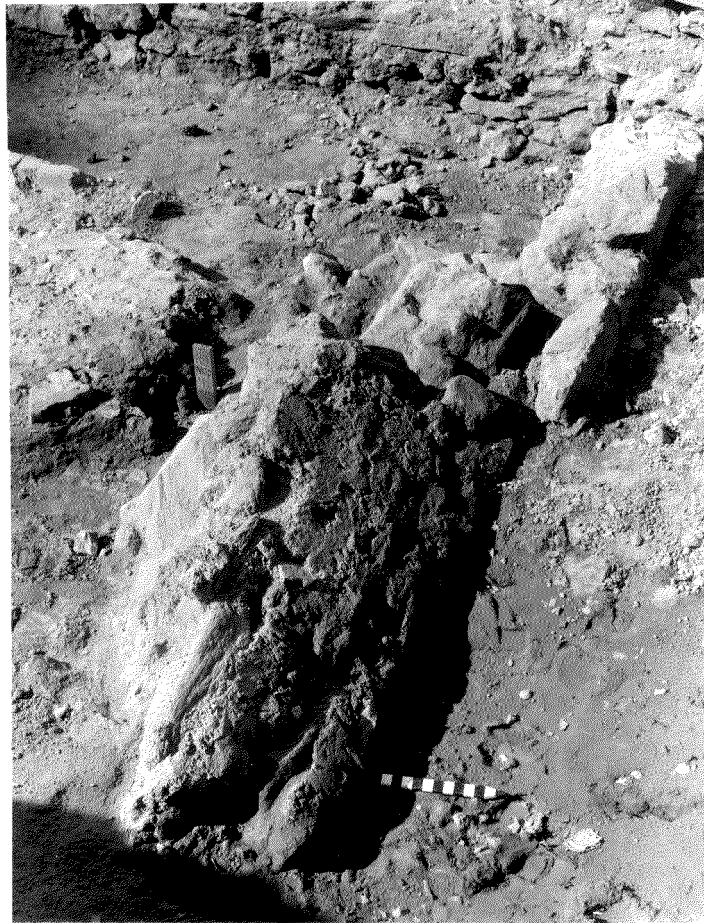
Chapter III  
Illustration No. 3

Looking west along the north wall foundation of the Franklin house (Feature 36). The portion of wall in the foreground has been knocked over and lies partially on its side. Arrow points north.

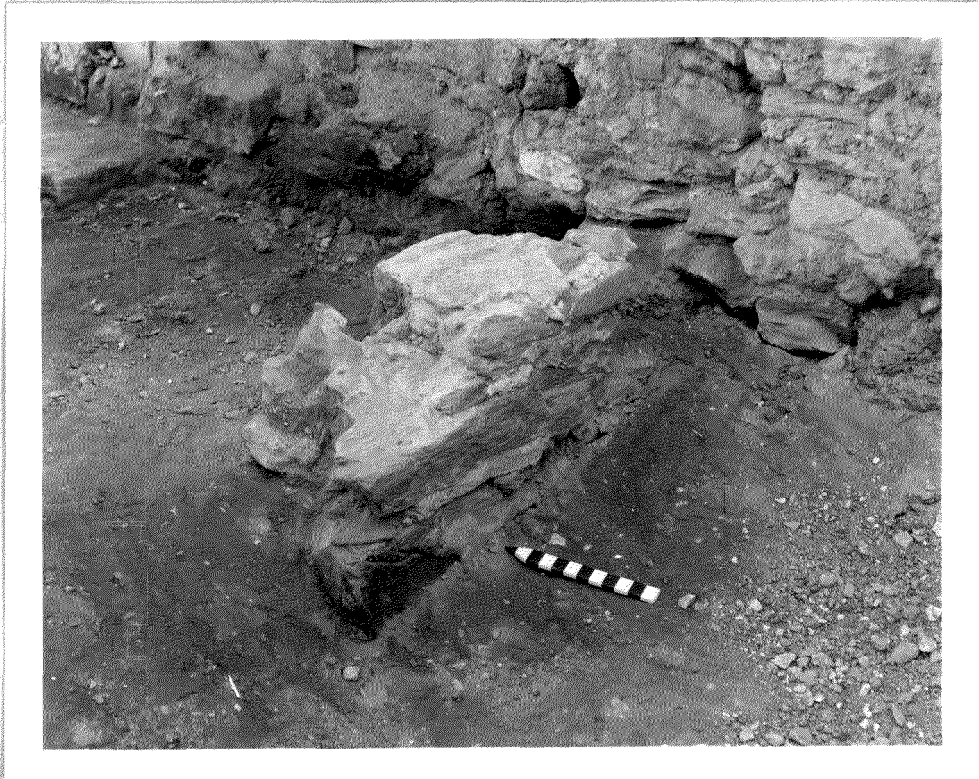
Chapter III  
Illustration No. 4

Only a small portion of the south wall foundation (Feature 37) remains, the major portion having been removed at some previous time (Illustration No. 4). The remaining wall extends 3.5 feet westward from the modern building line on the east side of the street. This feature, too, is stone. It is 1.5 feet wide, 2 feet in depth, and its top is 4.5 feet below present surface. The previous position of this wall westward of the remaining portion was marked by an ill-defined line of rubble extending to the modern walls on the west.

The foundation of the south wall  
of the Franklin house (Feature 37).  
Arrow points north.

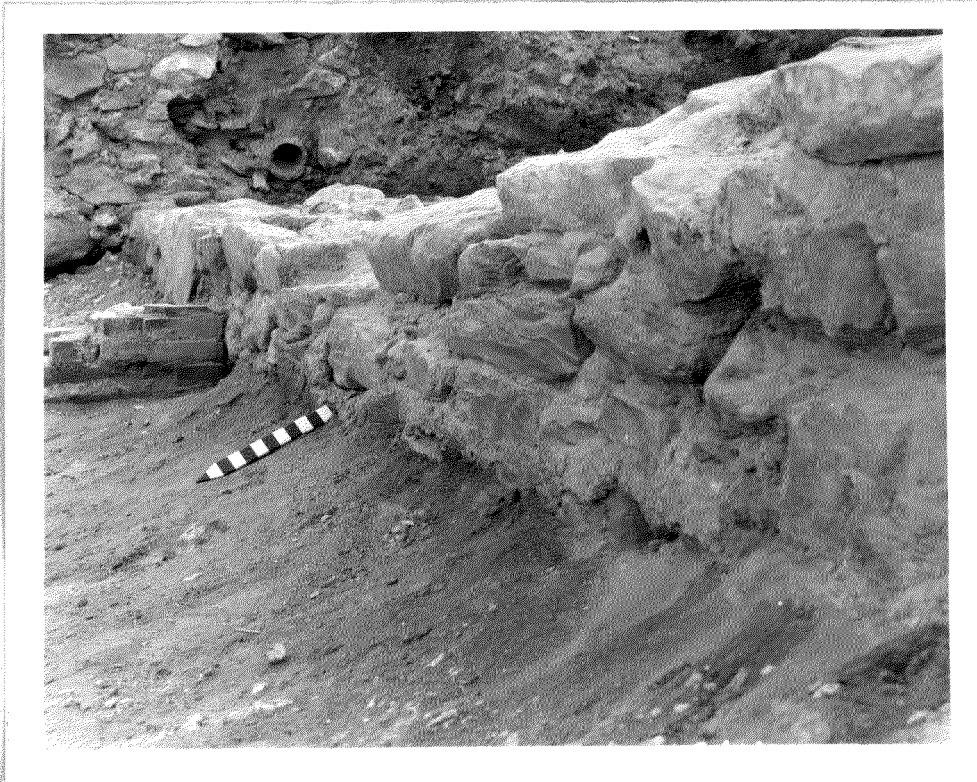
5.2 feet south of the house foundation is another stone wall (Feature 39) which completely spans the space between the modern building lines (Illustration No. 5). This wall is 19.7 feet long, 1.5 feet wide and 2.1 feet deep. Its top lies at a depth of 4.5 feet. I believe this wall to represent the retaining wall of an area-way or light well on the south side of the Franklin house. It probably provided light for Franklin's cellar windows. There was no evidence of a floor between this wall and the foundation wall to the north.

Looking east along the light-well  
retaining wall (Feature 39). The  
brick inlet to the privy (Feature  
45) can be seen in the middleground.  
Arrow points north.

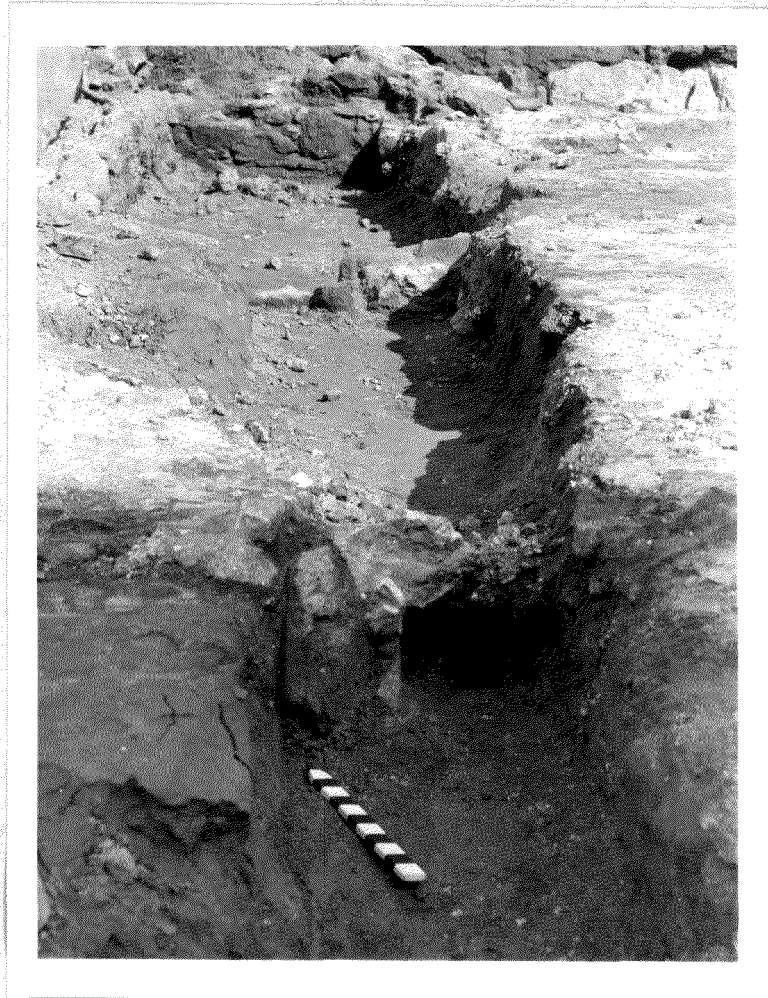
Chapter III  
Illustration No. 6

Other walls or wall traces include portions of the stone foundation and the construction trench of the original (1765) east wall of the Franklin House (Feature 65, Illustration No. 6). This feature lies 5.5 feet east of the modern building line on the west side of Orianna Street. The wall, formerly present but now largely missing, was similar in size and material to foundation walls previously described. Running westward from Feature 65 is another stone

Portions of the original (1765) east wall of the house (Feature 65). The stone in the foreground and part of the stone in the middleground are remnants of that wall. Arrow points north.

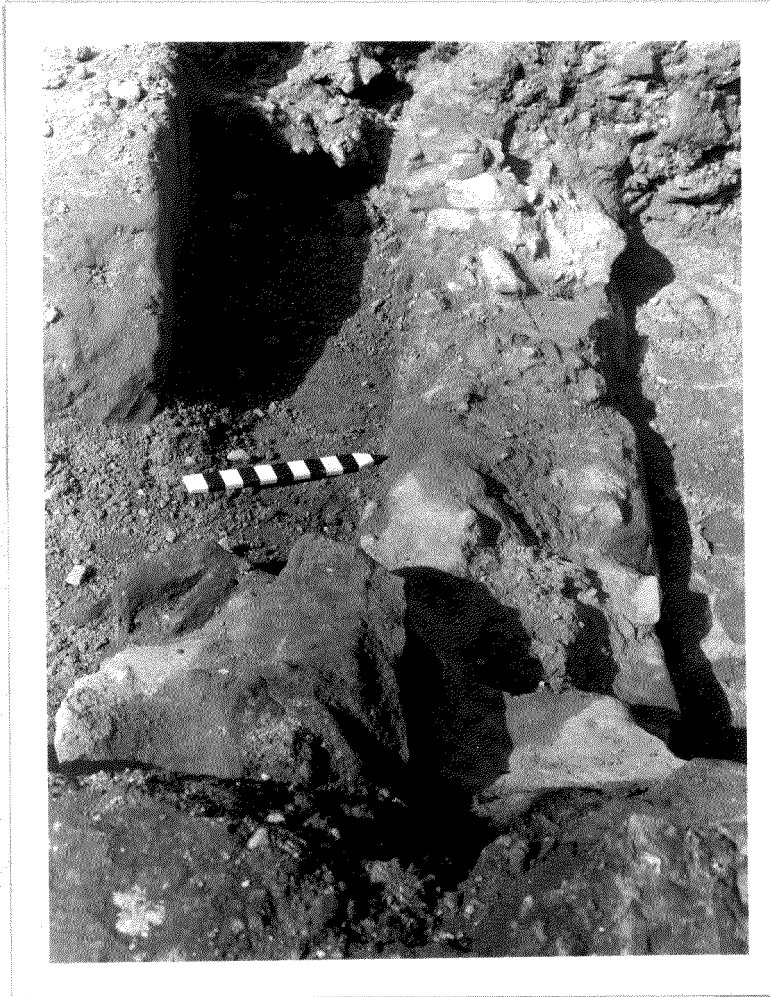
foundation (Feature 66) which extends to the building line on the west (Illustration No. 7). This feature has not been completely excavated but is similar to the other foundations. It lies 15 feet south of the inside of the north house wall. It indicates that the original cellar had at least two rooms.

East-west partition foundation in the  
1765 portion of the Franklin cellar  
(Feature 66). Arrow points north.

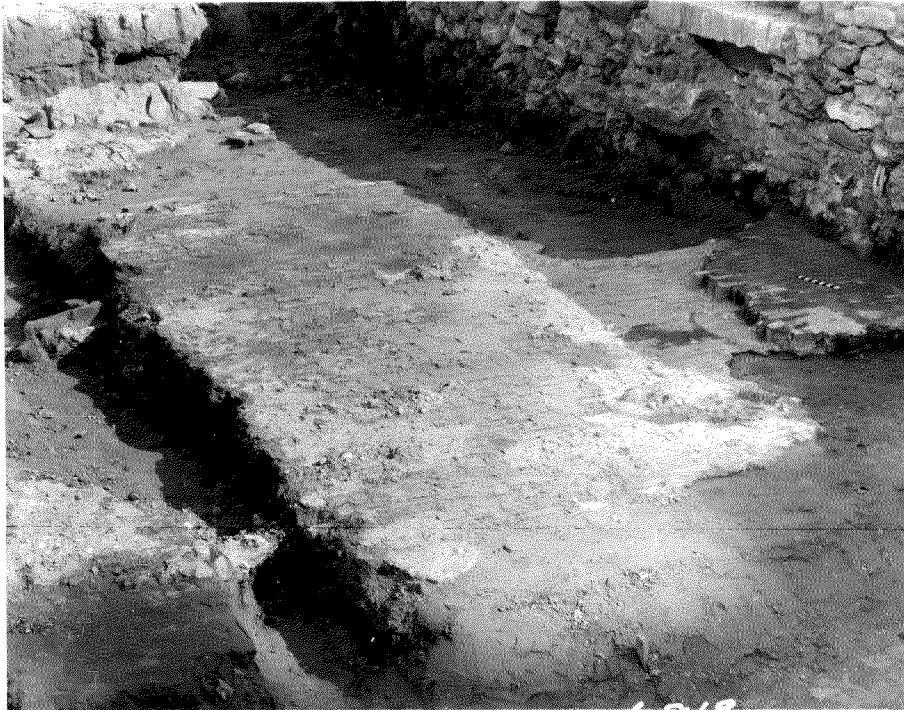
The small portion of the brick floor of Franklin's cellar which Schumacher uncovered in 1953 is the only intact piece of flooring remaining. West of the bricks is a large rectangular area of poor mortar bearing brick impressions. This mortar, Feature 42, covers the southern two-thirds of the 1786 addition to the house (Illustration No. 8). It is rectangular in area, 9.5 feet by 18.5 feet. The brick which formerly rested on this base were laid on edge and were oriented with their long axes east and west. North of Feature 42 lies another, smaller patch of mortar sub-flooring (Feature 43) upon which the brick were set on edge with their long axes running north-south. This undoubtedly indicates two different rooms in the cellar of the addition (Illustration No. 9).

Cellar floor remains. The brick on the right is the only piece of intact flooring remaining. It and the large rectangular area of mortar in the middle ground constitute Feature 42. Feature 43 lies in the upper left of the picture and Feature 67 in the lower left. Arrow points north.

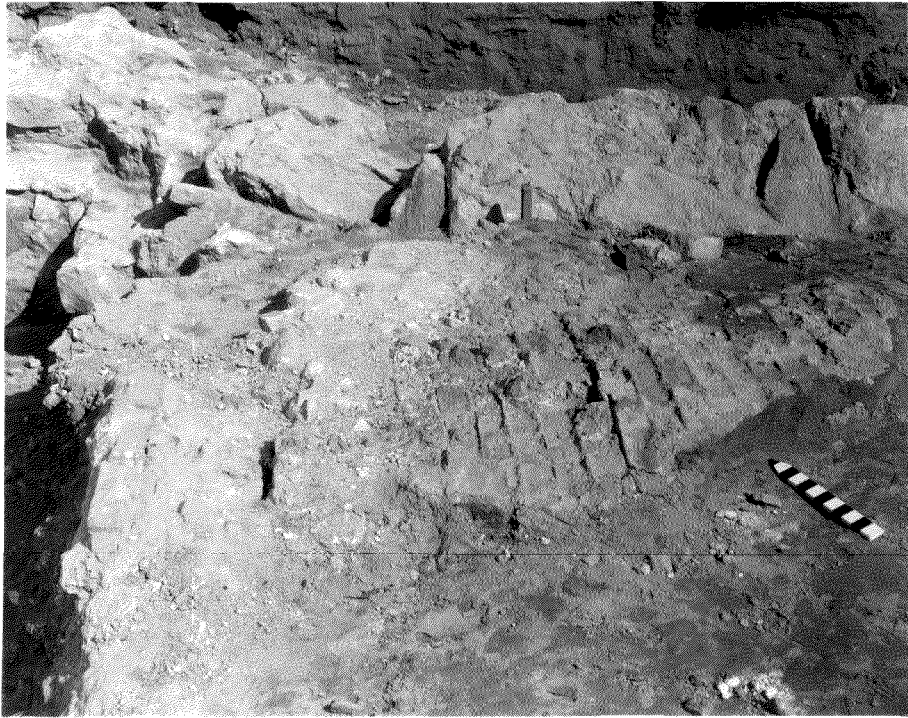
Chapter III  
Illustration No. 9

All of the subfloor mortar is soft and of uneven thickness. It is in serious danger of deteriorating.

Patch of lime mortar subflooring near the  
north wall of the house (Feature 43). Arrow  
points north.

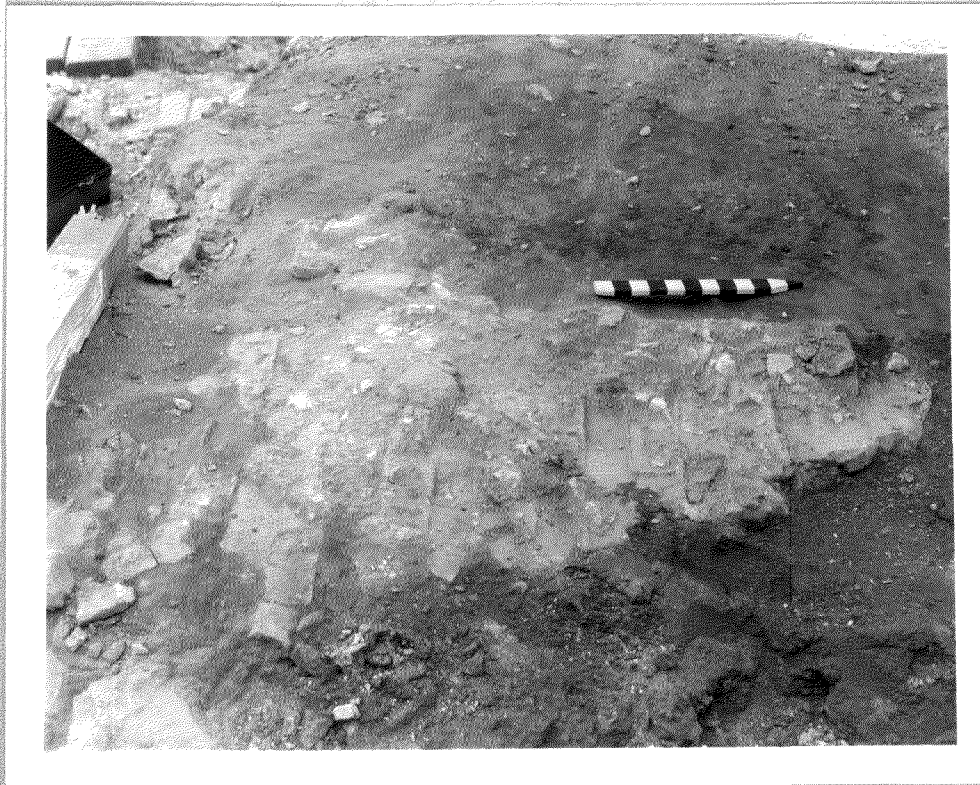
Chapter III  
Illustration No. 10

Just west of the 1765 east wall trench and north of the south wall line there is another small patch of brick and mortar cellar floor (Feature 67). No complete bricks remain, but brick impressions can be seen in the mortar. This feature is approximately

4 feet long (north-south) and 2-1/2 feet wide (Illustration No. 10).

The only floor evidence remaining in the 1765 portion of the house is this small patch of lime mortar (Feature 67). Arrow points north.

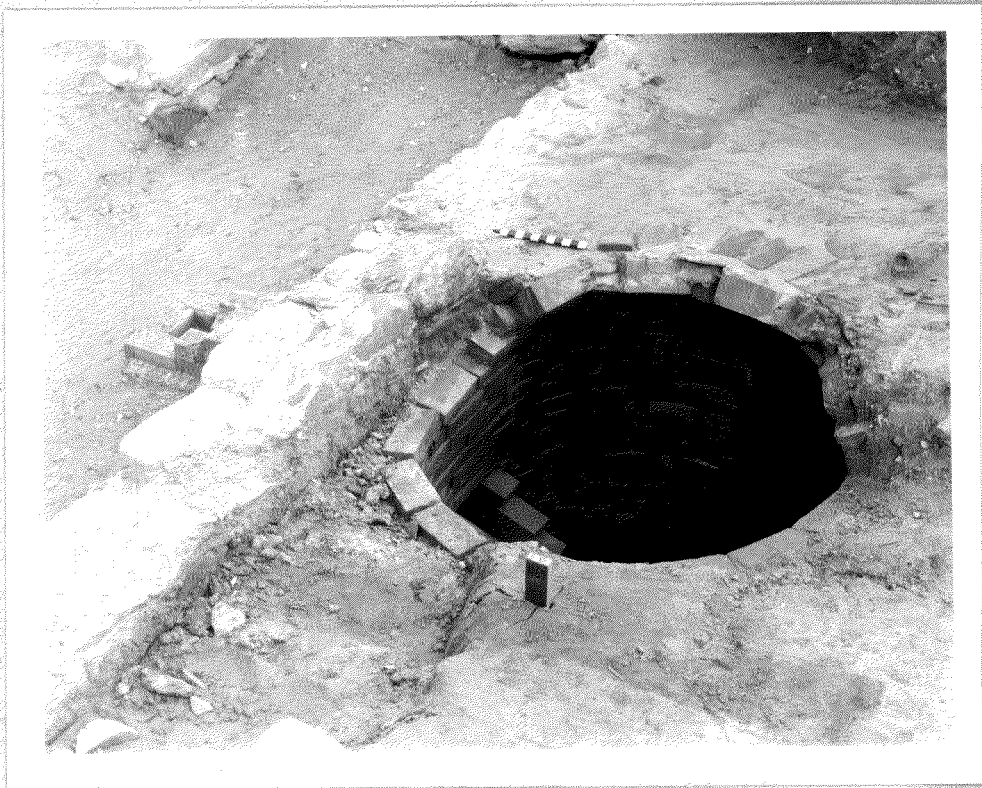
The privy (Feature 38) is represented by a brick-lined pit, 4 feet inside diameter, which abuts the south side of the light well wall (Illustrations No. 11 and 12). The pit, now excavated to its bottom at 13 feet below the top of Feature 39, was formerly domed over with a brick roof. Its top had been broken open during the laying of a sewer line beneath Orianna Street. Immediately north of the pit, and on the north side of Feature 39, is a rectangular brick structure (Feature 45) whose top contains two square holes (Illustration No. 13). The southernmost of the two holes communicates with the privy pit, through the light well wall, by means of a sloping stone slab (Illustration No. 14). The structural evidence indicates to me that Dr. Franklin, unlike most of his contemporaries, built his toilet separate from his privy pit, and that he undoubtedly had some sort of flush arrangement. Feature 45 is 1.5 feet wide east-west, 2.3 feet long north-south, and 2.9 feet deep.

View of the privy pit (Feature 38). The stone wall is Feature 39, the light-well retaining wall. Part of Feature 45, the brick inlet to the privy, can be seen to the left of the stone wall. Arrow points north.

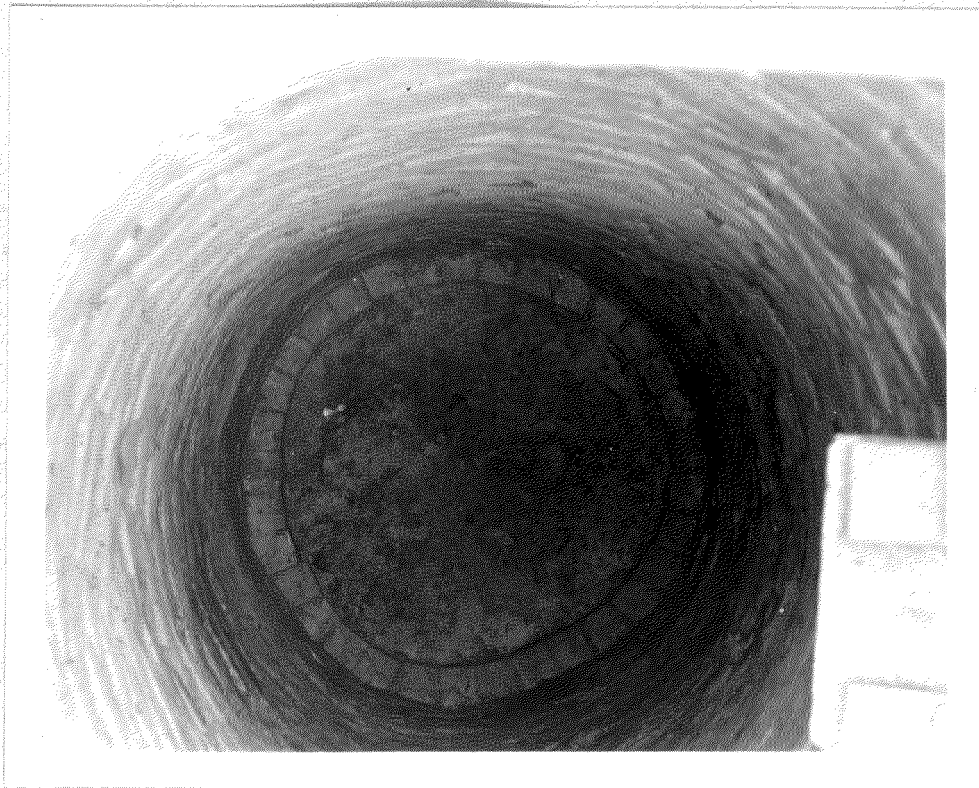
View directly down into the privy pit:  
the top of the photograph is the east  
side. Note the lowest course is com-  
posed of headers projecting inward.  
Part of the stone slab inlet can be  
seen in the upper left.

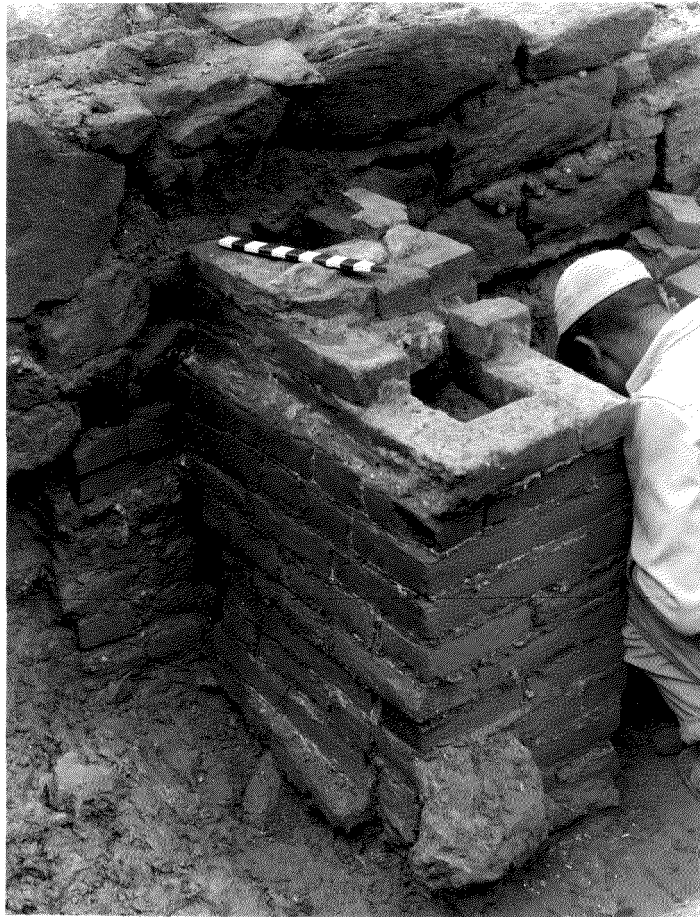
The brick privy inlet (Feature 45). Note that it abuts directly into the light-well wall (Feature 39). The square hole behind the arrow communicates to the privy pit via the stone slab seen in Illustration No. 14. Arrow points north.

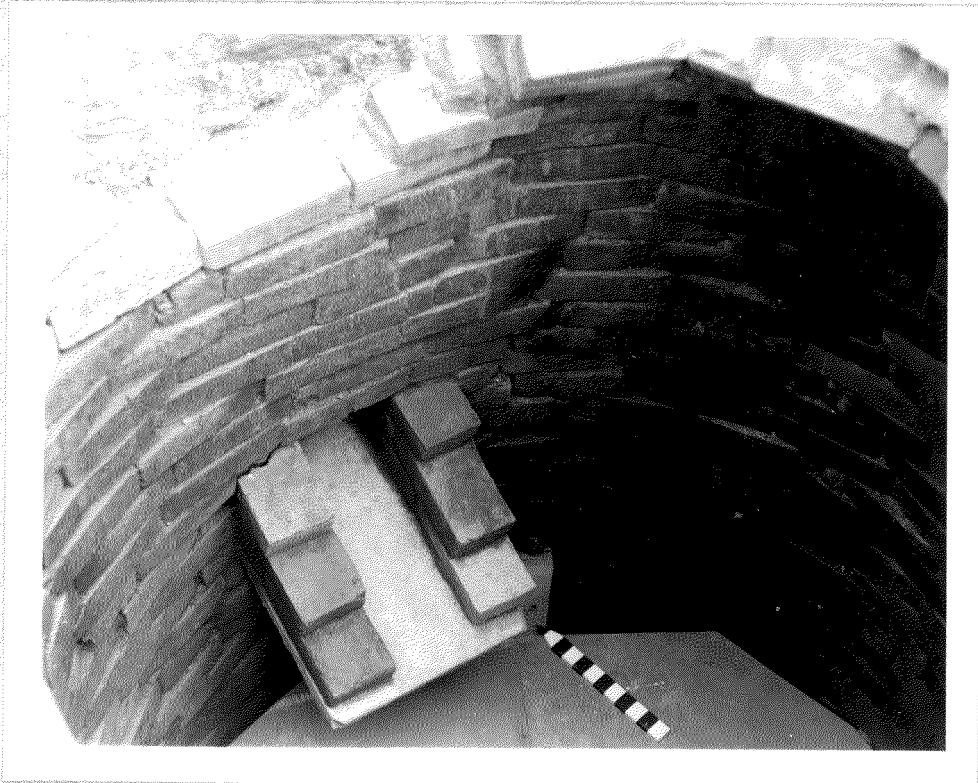
View of the stone slab in the privy pit.  
The arrow, pointing north, lies on a  
temporary wooden platform in the privy.

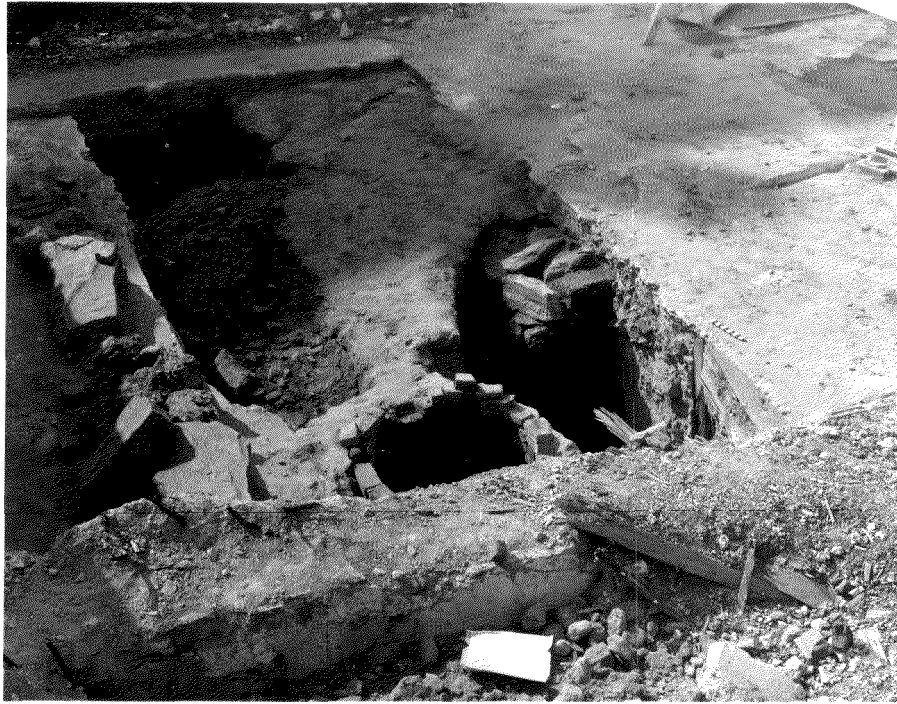
The remaining two features lie in the western part of the house (Illustration No. 15). Feature 63 is the remains of Franklin's ice storage pit (Illustration No. 16). It was originally a stone-lined pit some 10 feet in diameter and 10 feet in depth below the cellar floor. Unfortunately, some two-thirds of the pit has been destroyed by the intrusion of a massive reinforced concrete foundation,

View of the ice storage pit (Feature 63)  
and the small brick-lined pit (Feature 61).  
The arrow lies on a modern concrete foun-  
dation which destroyed over half of the ice  
pit. Arrow points north.

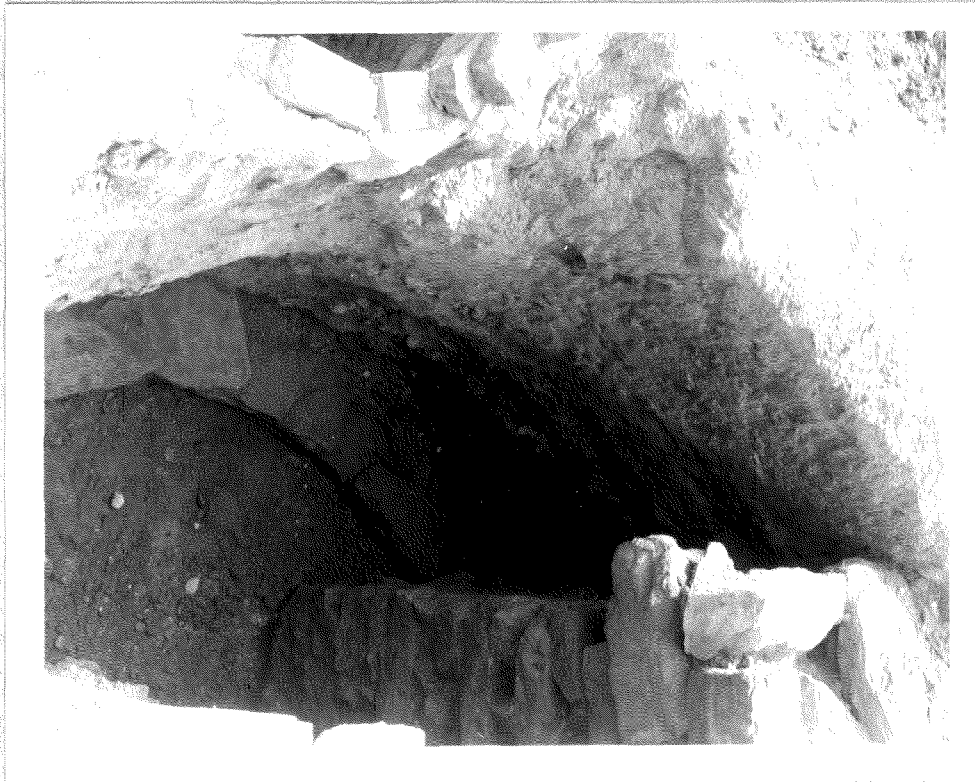
and about 4 feet of the top has been removed by modern construction. The exterior edge of the ice pit apparently almost abutted the west wall of the house and was about 1.5 feet from the south wall. A pile of stones in the southern half of the remaining feature may be original construction.

View southward into the ice pit (Feature 63). Note the stone lining at the bottom. The stone cribbing in the right of the photograph is as yet unexplained.

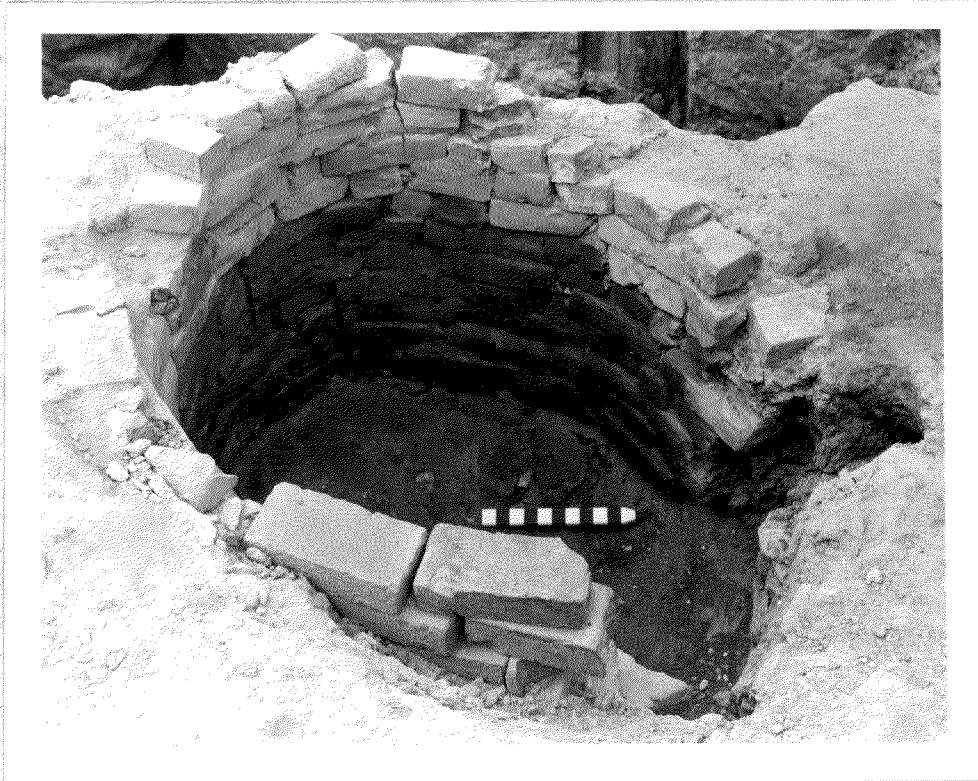
Just east of the ice pit we uncovered Feature 61, a small brick-lined pit (Illustration No. 17). Although the brick wall was probably complete at one time, a part on the north is now missing so that the remainder forms a horseshoe-shaped wall. It is approximately 3 feet in inside diameter, although very irregular, and is only 2.5 feet in depth. It is built of brick bats and fragments and presents the appearance of hasty and careless construction. All the artifacts from this pit are of nineteenth century date and the pit itself may well date from a nineteenth century building on this spot. I doubt if it is associated with Franklin's structure.

The small brick-lined pit (Feature 61).  
Arrow points north.

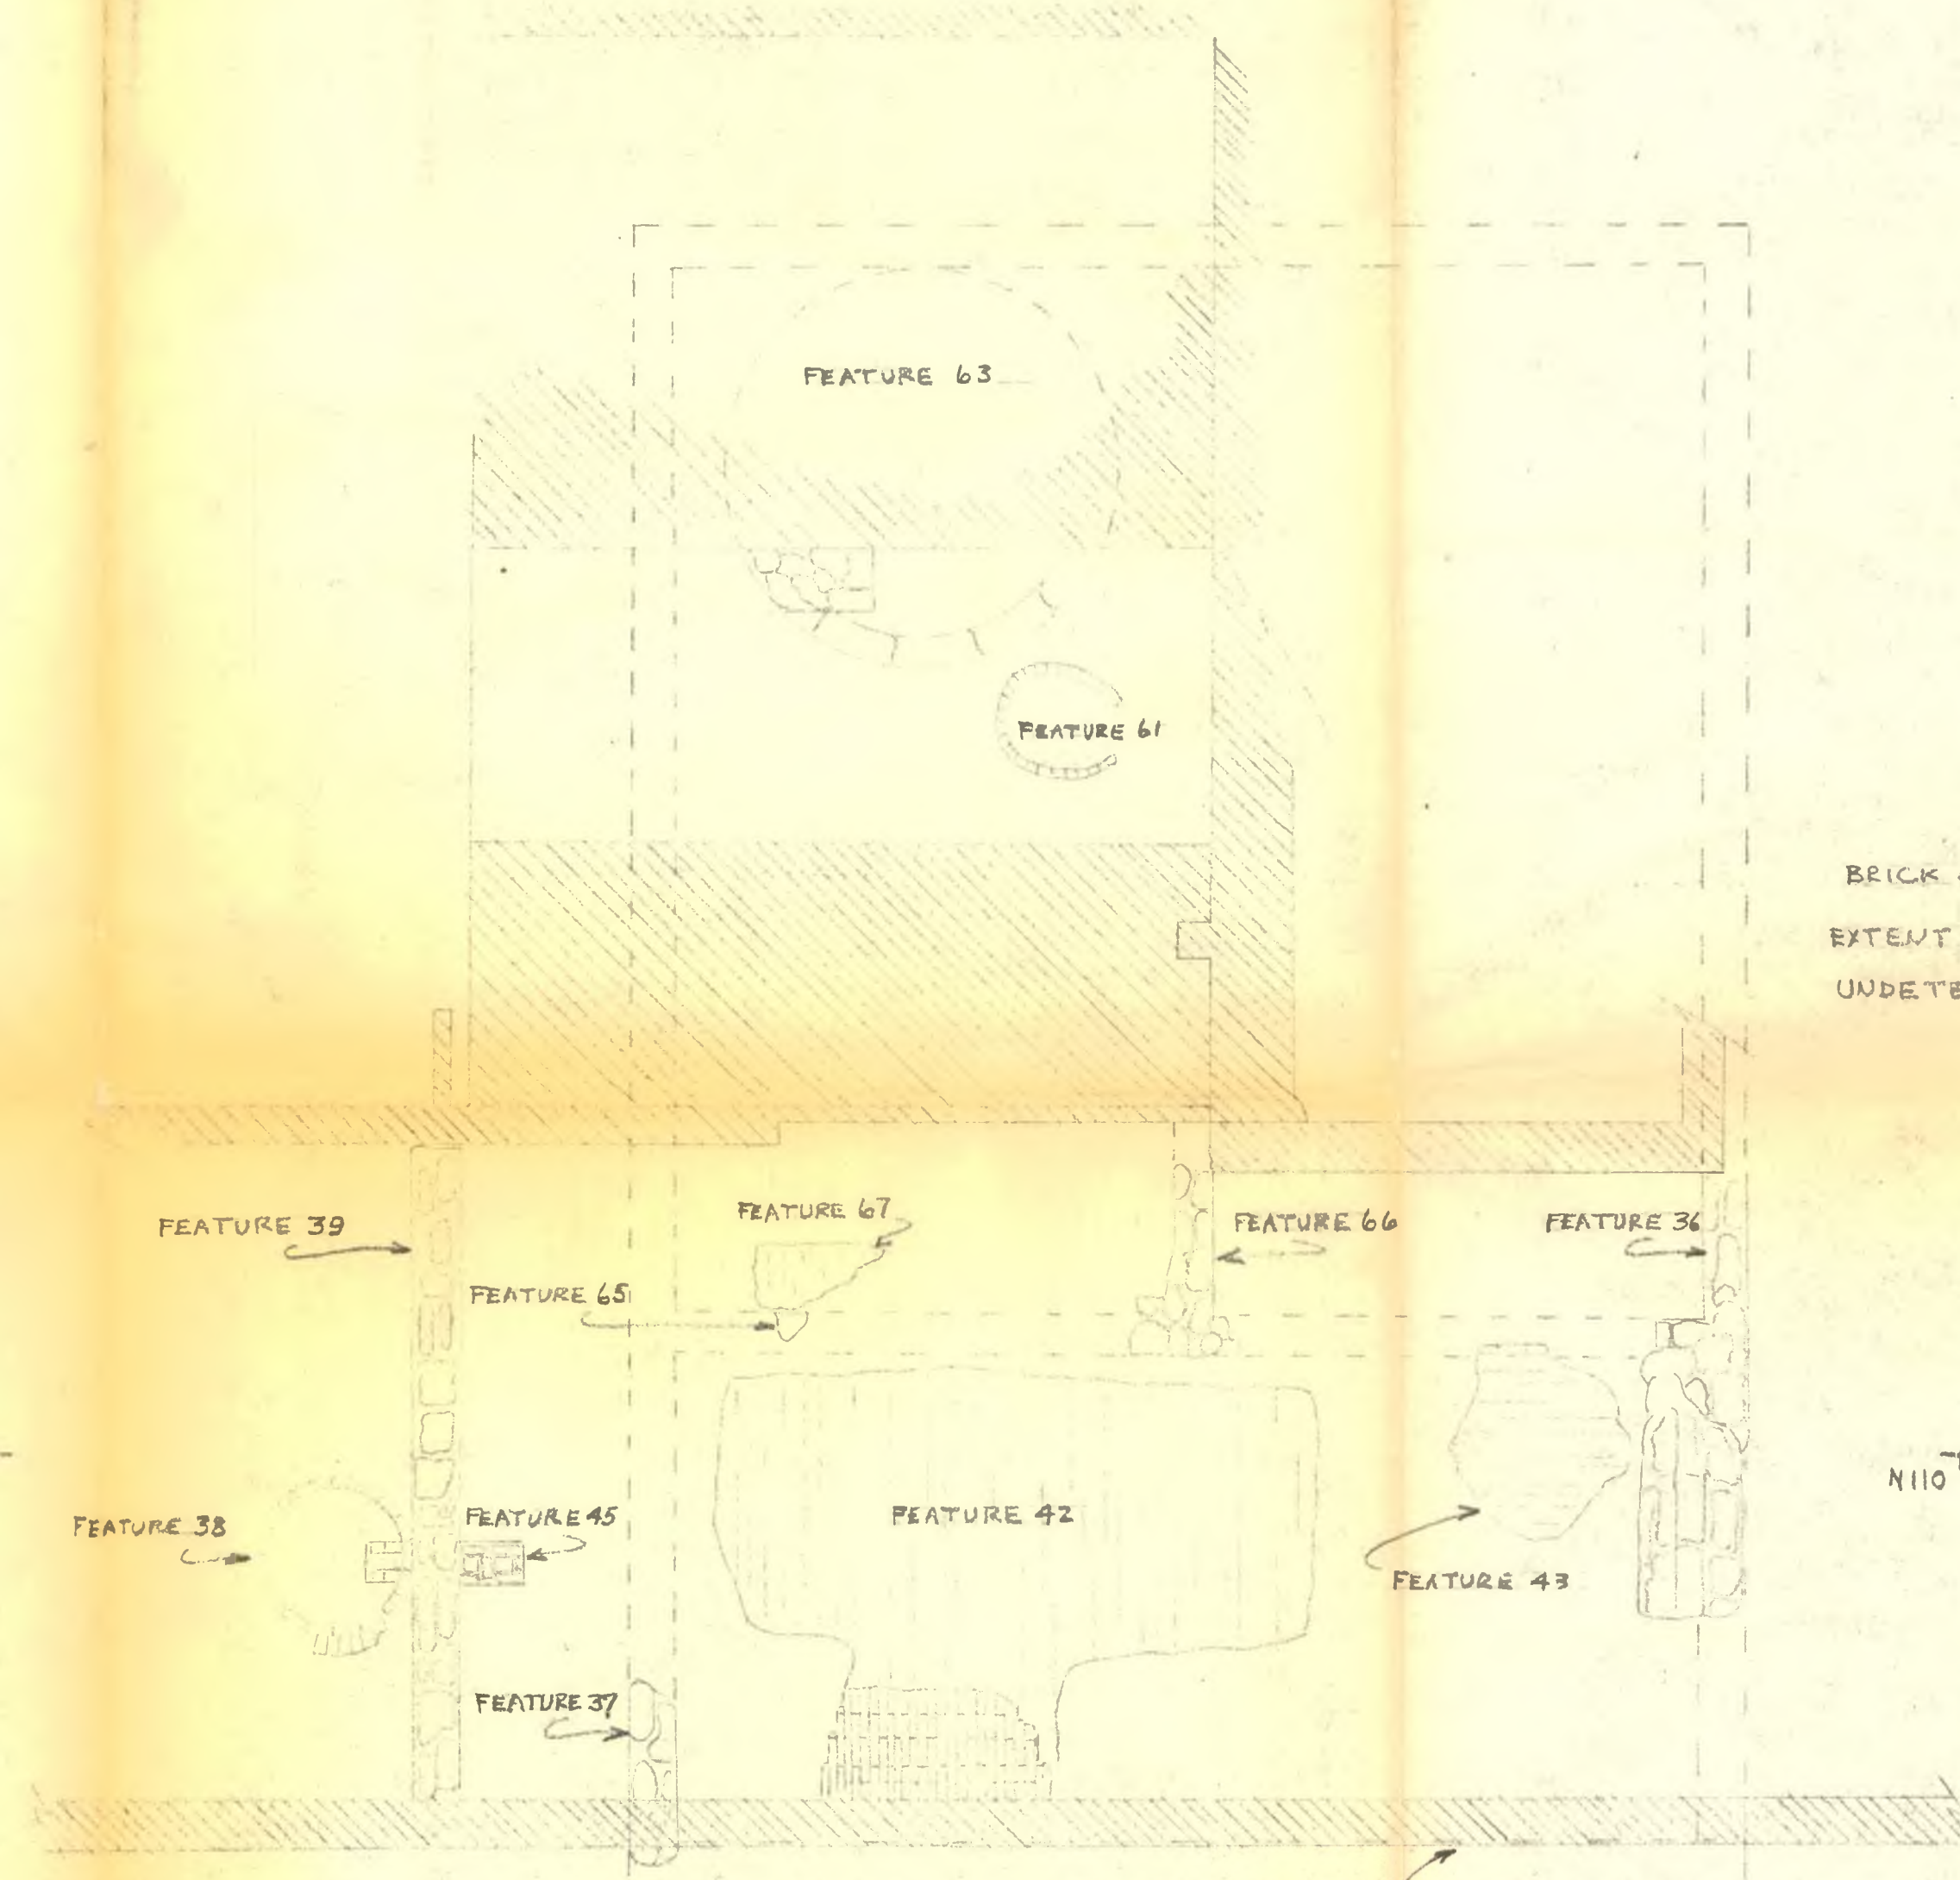
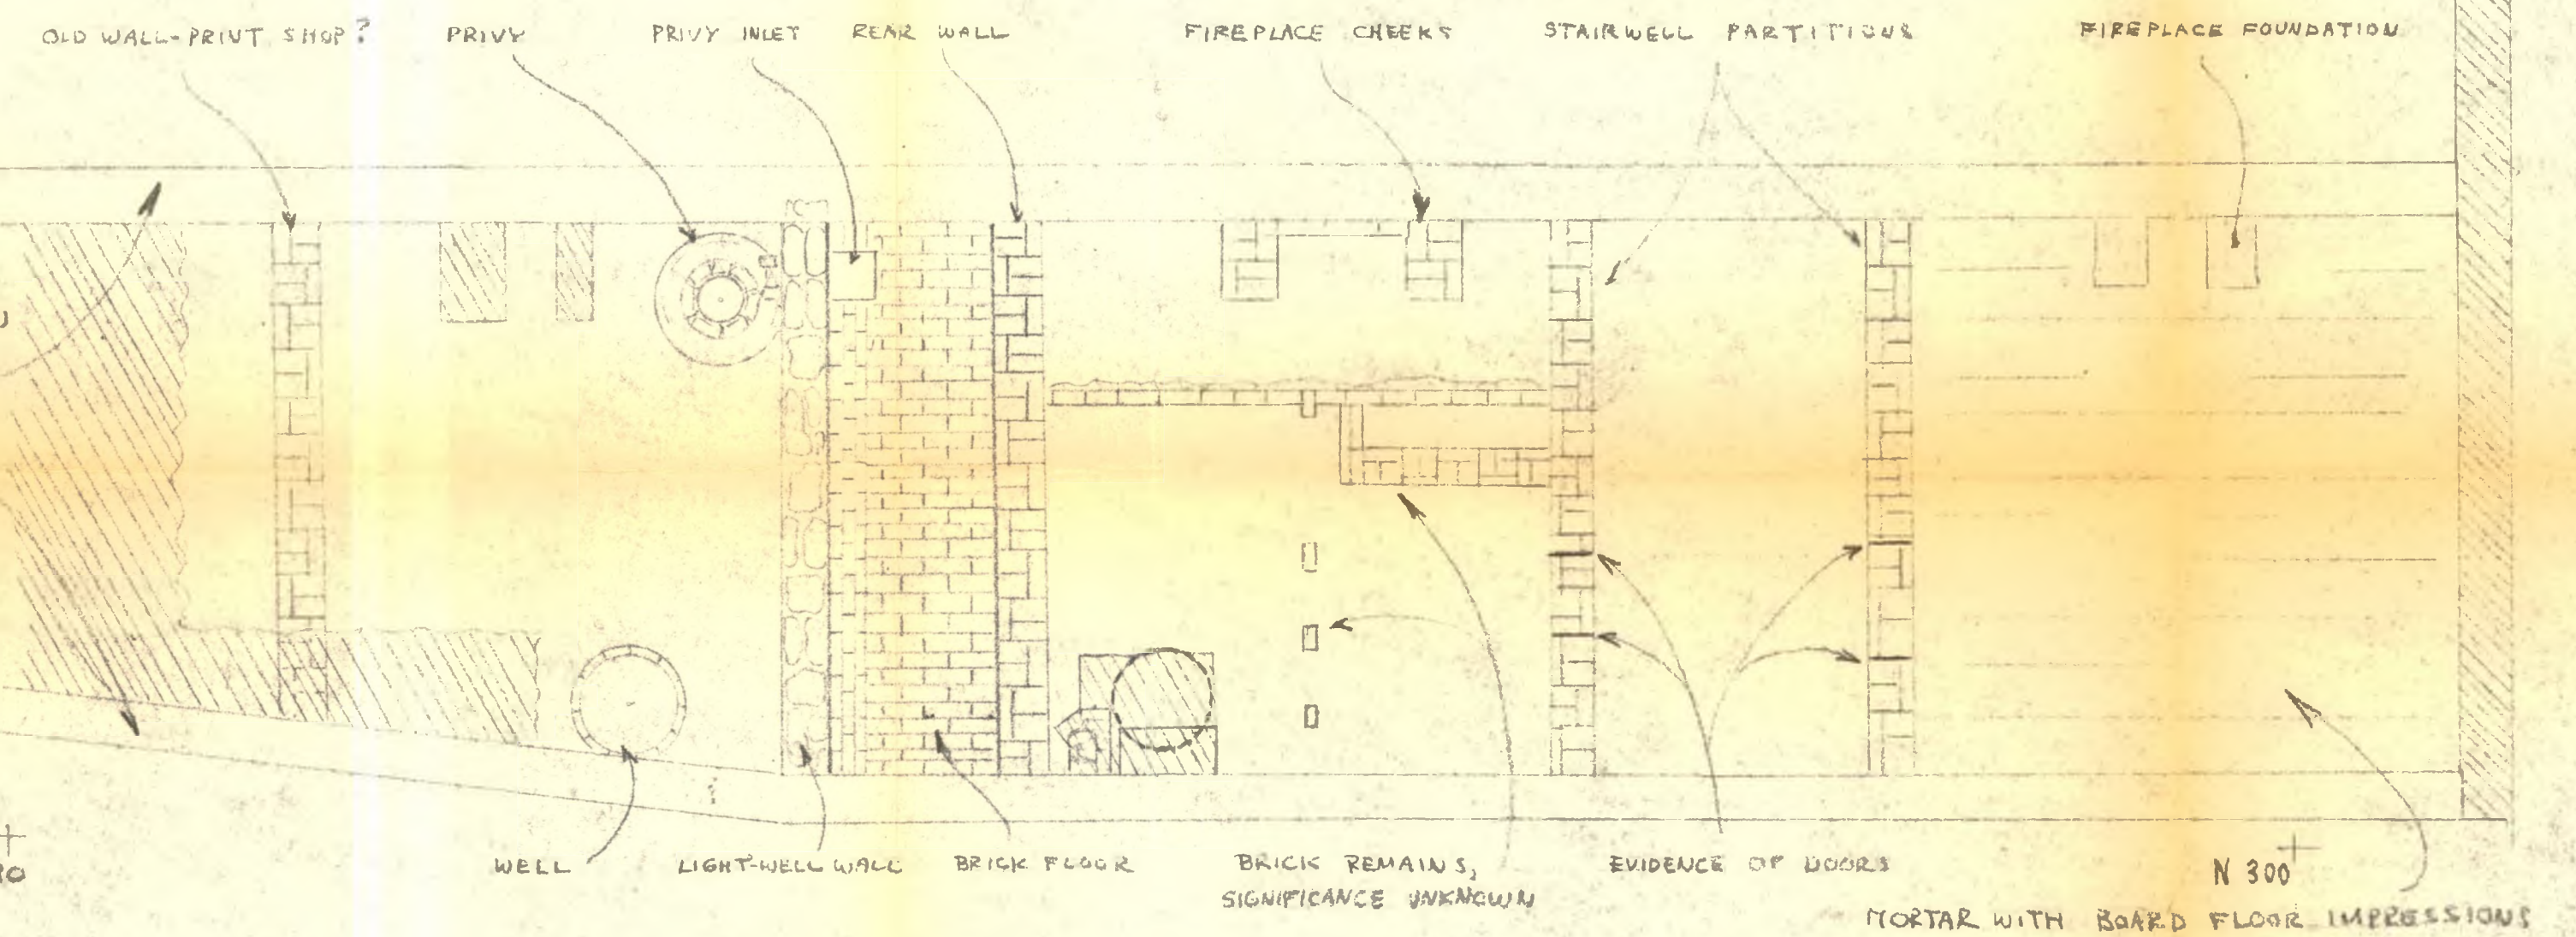
Chapter III  
Illustration No. 18

Since July 11, 1960, work has been progressing in the house area and to the south thereof. Beginning in Schumacher's 1953 trenches, we have expanded the dig to the westward to include the total limits of the house, northward to just beyond the north wall of the house, and southward into the yard or garden area. All of the features found by Schumacher have been relocated and completely exposed. In addition, several new features have been found (Illustrations No. 1 and 18).

Plan of the excavation in Franklin Court.
