PART II, PORTION, ROOF

FIRST BANK OF THE UNITED STATES

INDEPENDENCE NATIONAL HISTORICAL PARK

HISTORIC STRUCTURES REPORT  
PART II (PORTION)  
ARCHITECTURAL DATA SECTION  
ON  
THE FIRST BANK OF THE UNITED STATES  
RESTORATION OF ROOF  
Independence National Historical Park

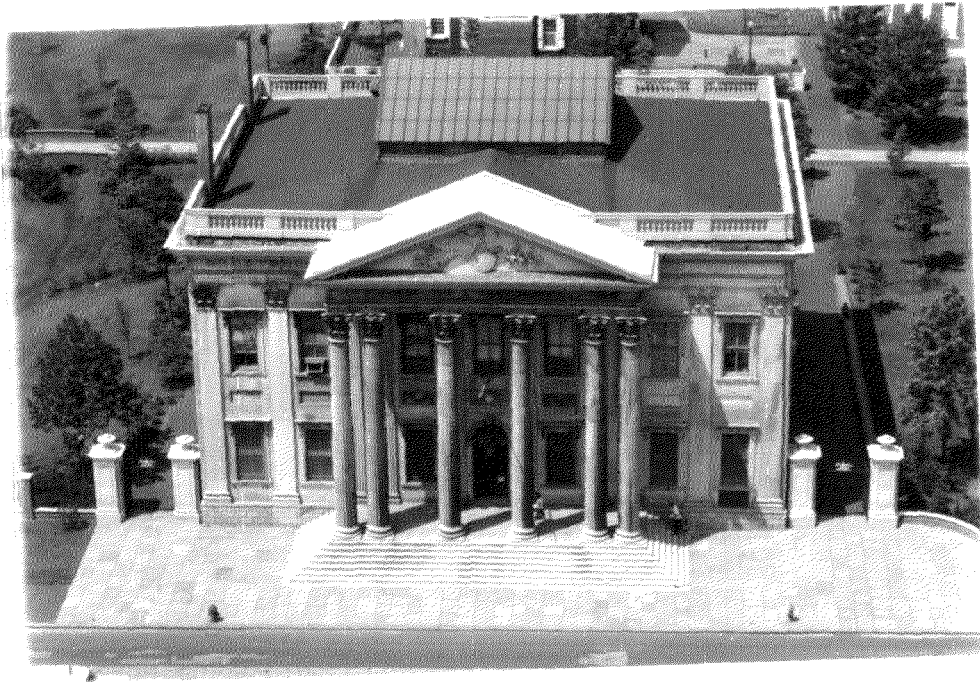
Chapter II  
Illustration No. 3

First Bank of the United States as it appeared after the 1901-1902 remodeling with the asphalt roofing and the skylight. Note unaltered portico roof. Independence National Historical Park photograph (1962).

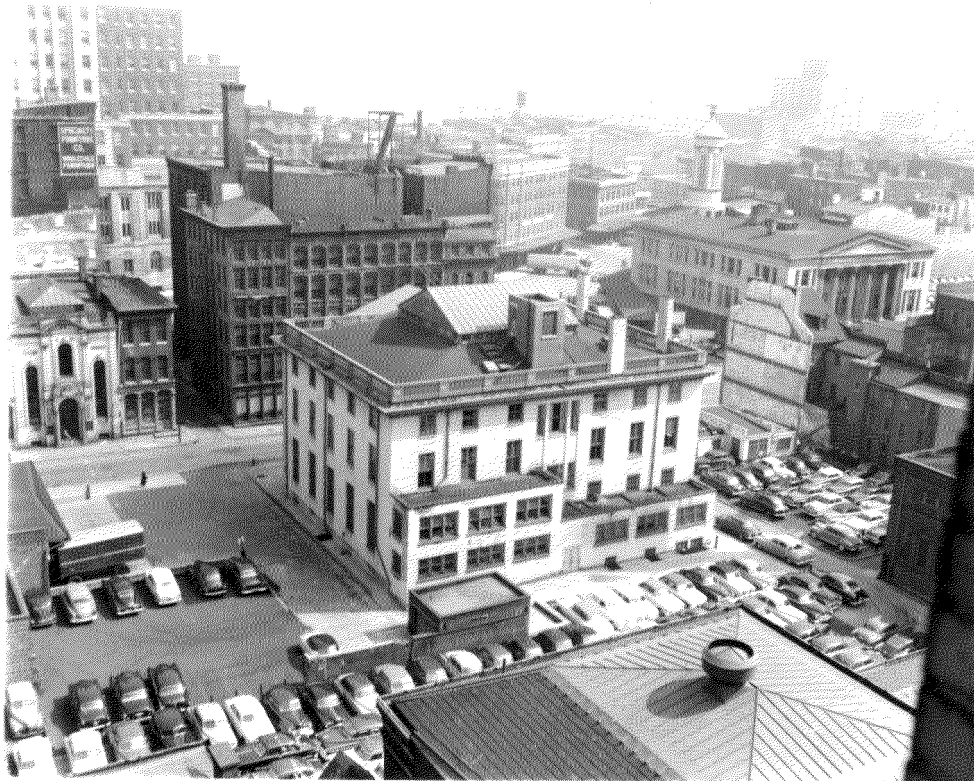
View of the First Bank of the United States looking east. Note the elevator housing, skylight, balustrade, and three chimnies constructed during the major alterations of 1901-1902. Independence National Historical Park photograph (1952).

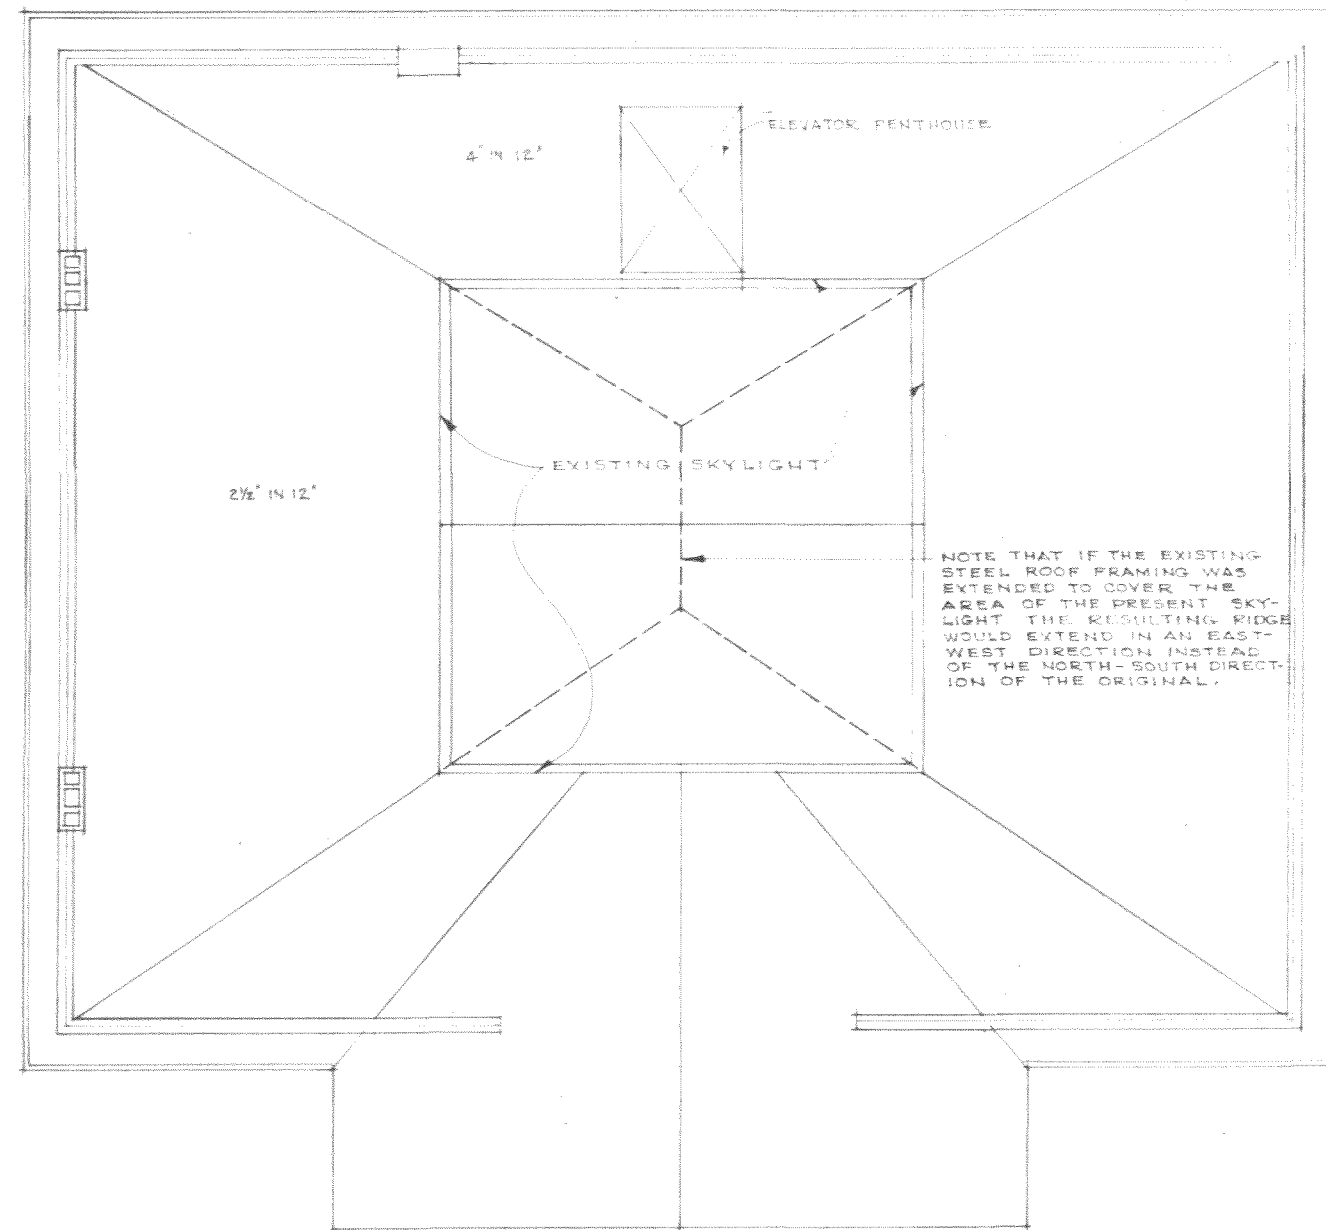
EXISTING ROOF

The forming of the roof hip to adjust from the rectangular shaped building to the square skylight base caused the roof pitches to change from a constant in the original to four (4) inches to the foot on the east and west slopes and approximately two and five-eighths inches on the north and south slopes.

The present condition of the skylight is poor. Much of the metal work is rusted on the exterior and water is admitted around the glass panels.

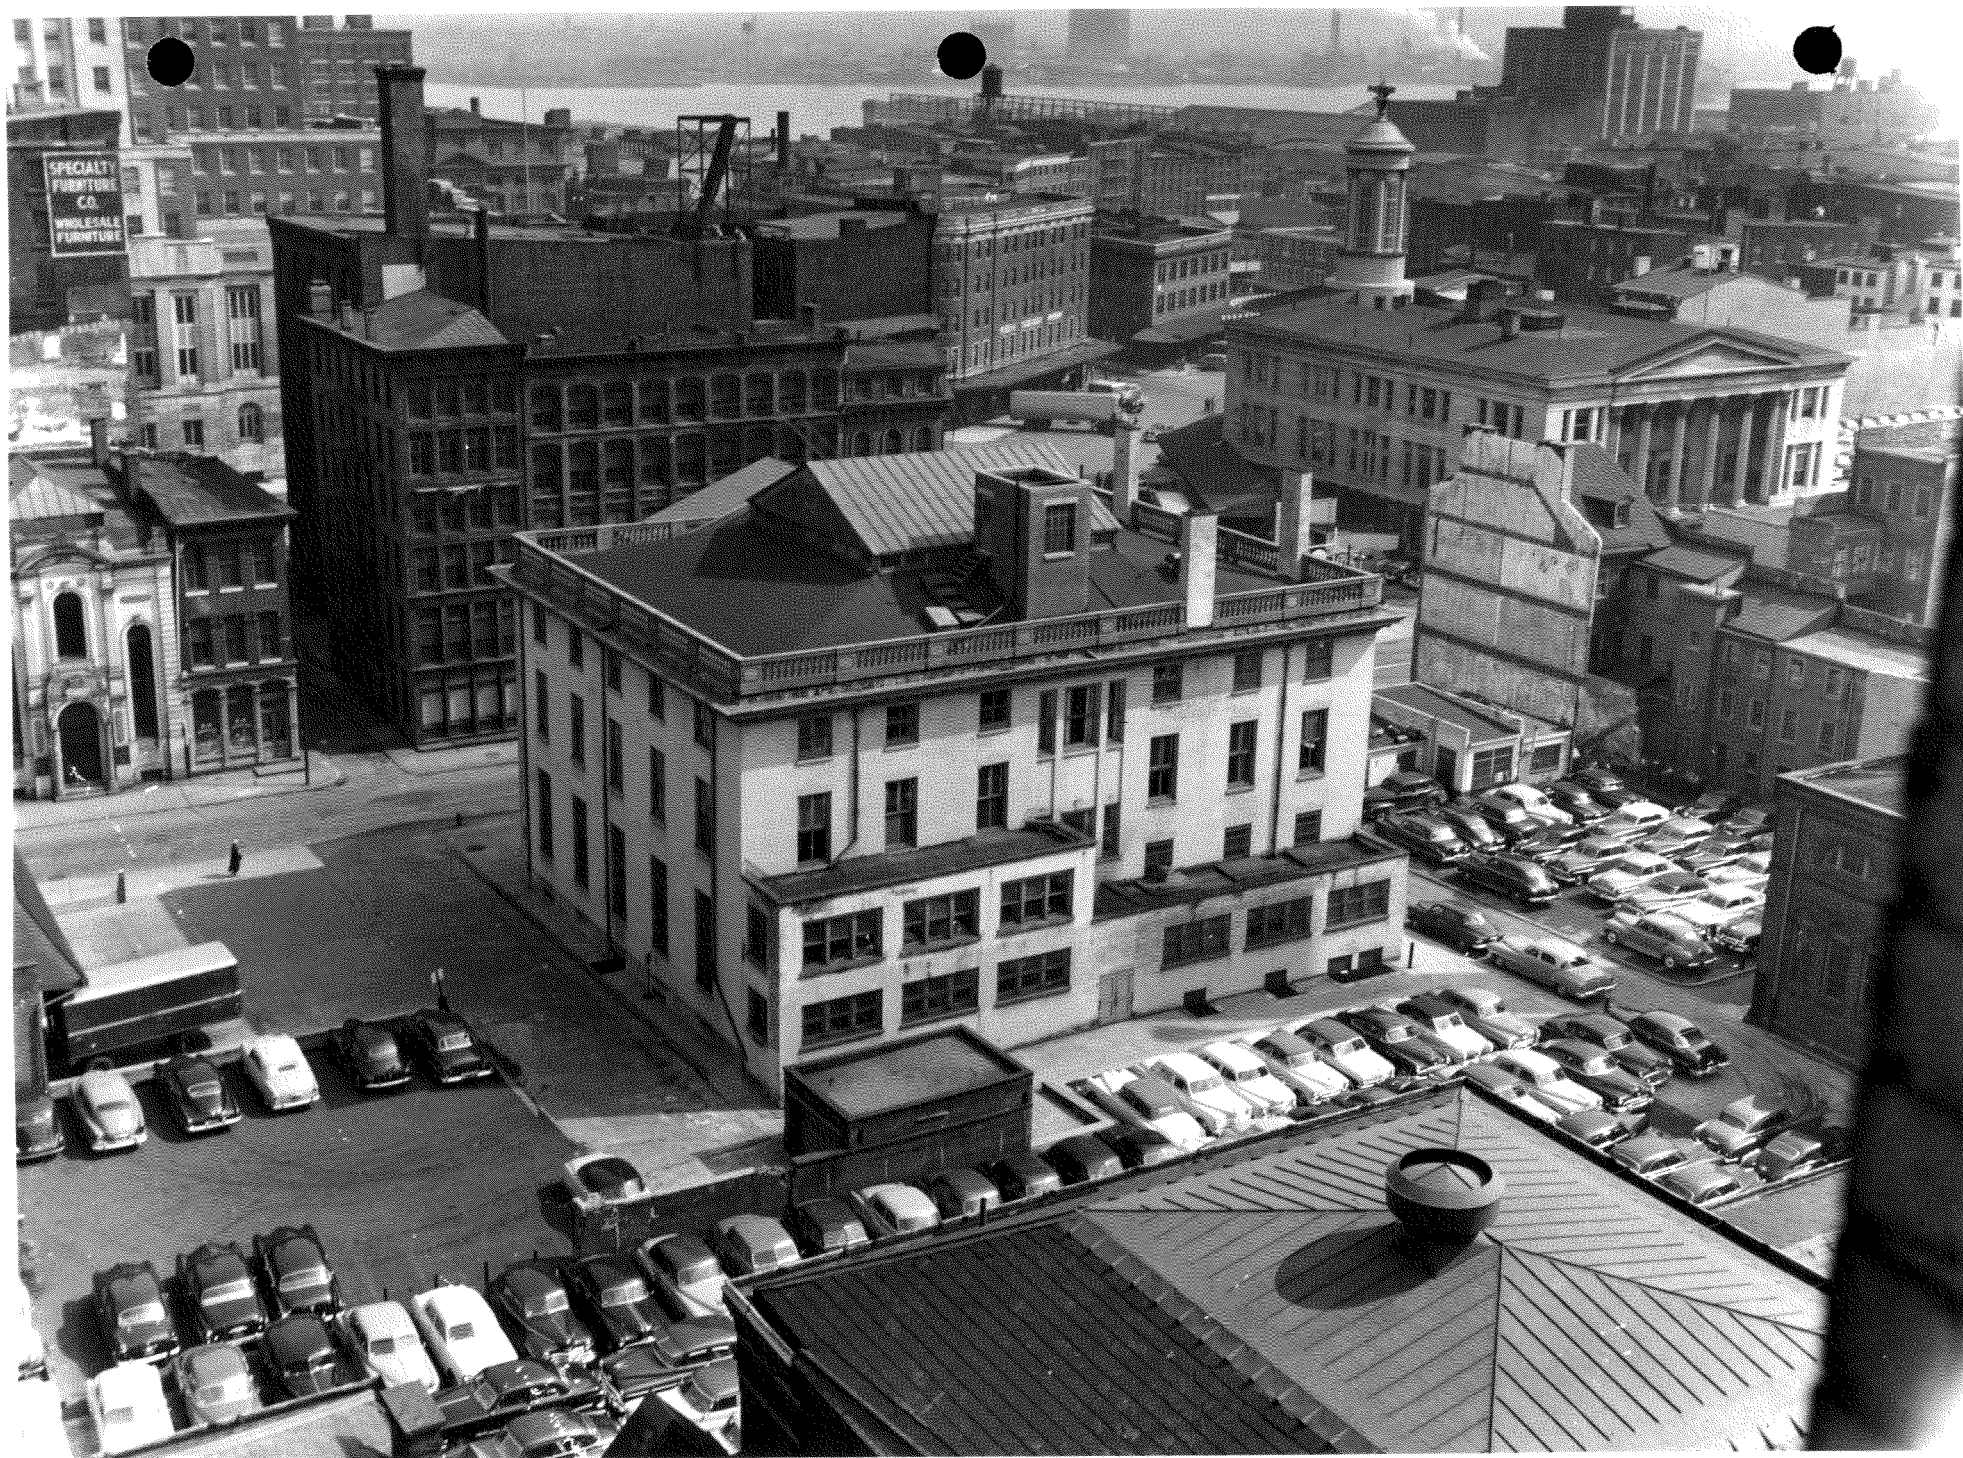
ILLUSTRATION NO. 5

Aerial view of the First Bank taken from the northwest before the surrounding buildings were demolished. This photograph shows clearly the existing roof conditions which have not changed. Note the two roof pitches, the glass skylight and the elevator penthouse. The original roof had no superstructures. Note that only three of the original chimneys have been retained.
