HISTORIC STRUCTURES REPORT  
PART II (Portion)  
ARCHITECTURAL DATA SECTION  
ON  
INDEPENDENCE HALL  
REHABILITATION OF  
TOWER STAIRWAY, TOWER EXTERIOR AND STEEPLE

Prepared by  
Lee H. Nelson  
and  
Joseph Petrak  
Architects

United States Department of the Interior, National Park Service  
Eastern Office, Design and Construction  
Division of Architecture

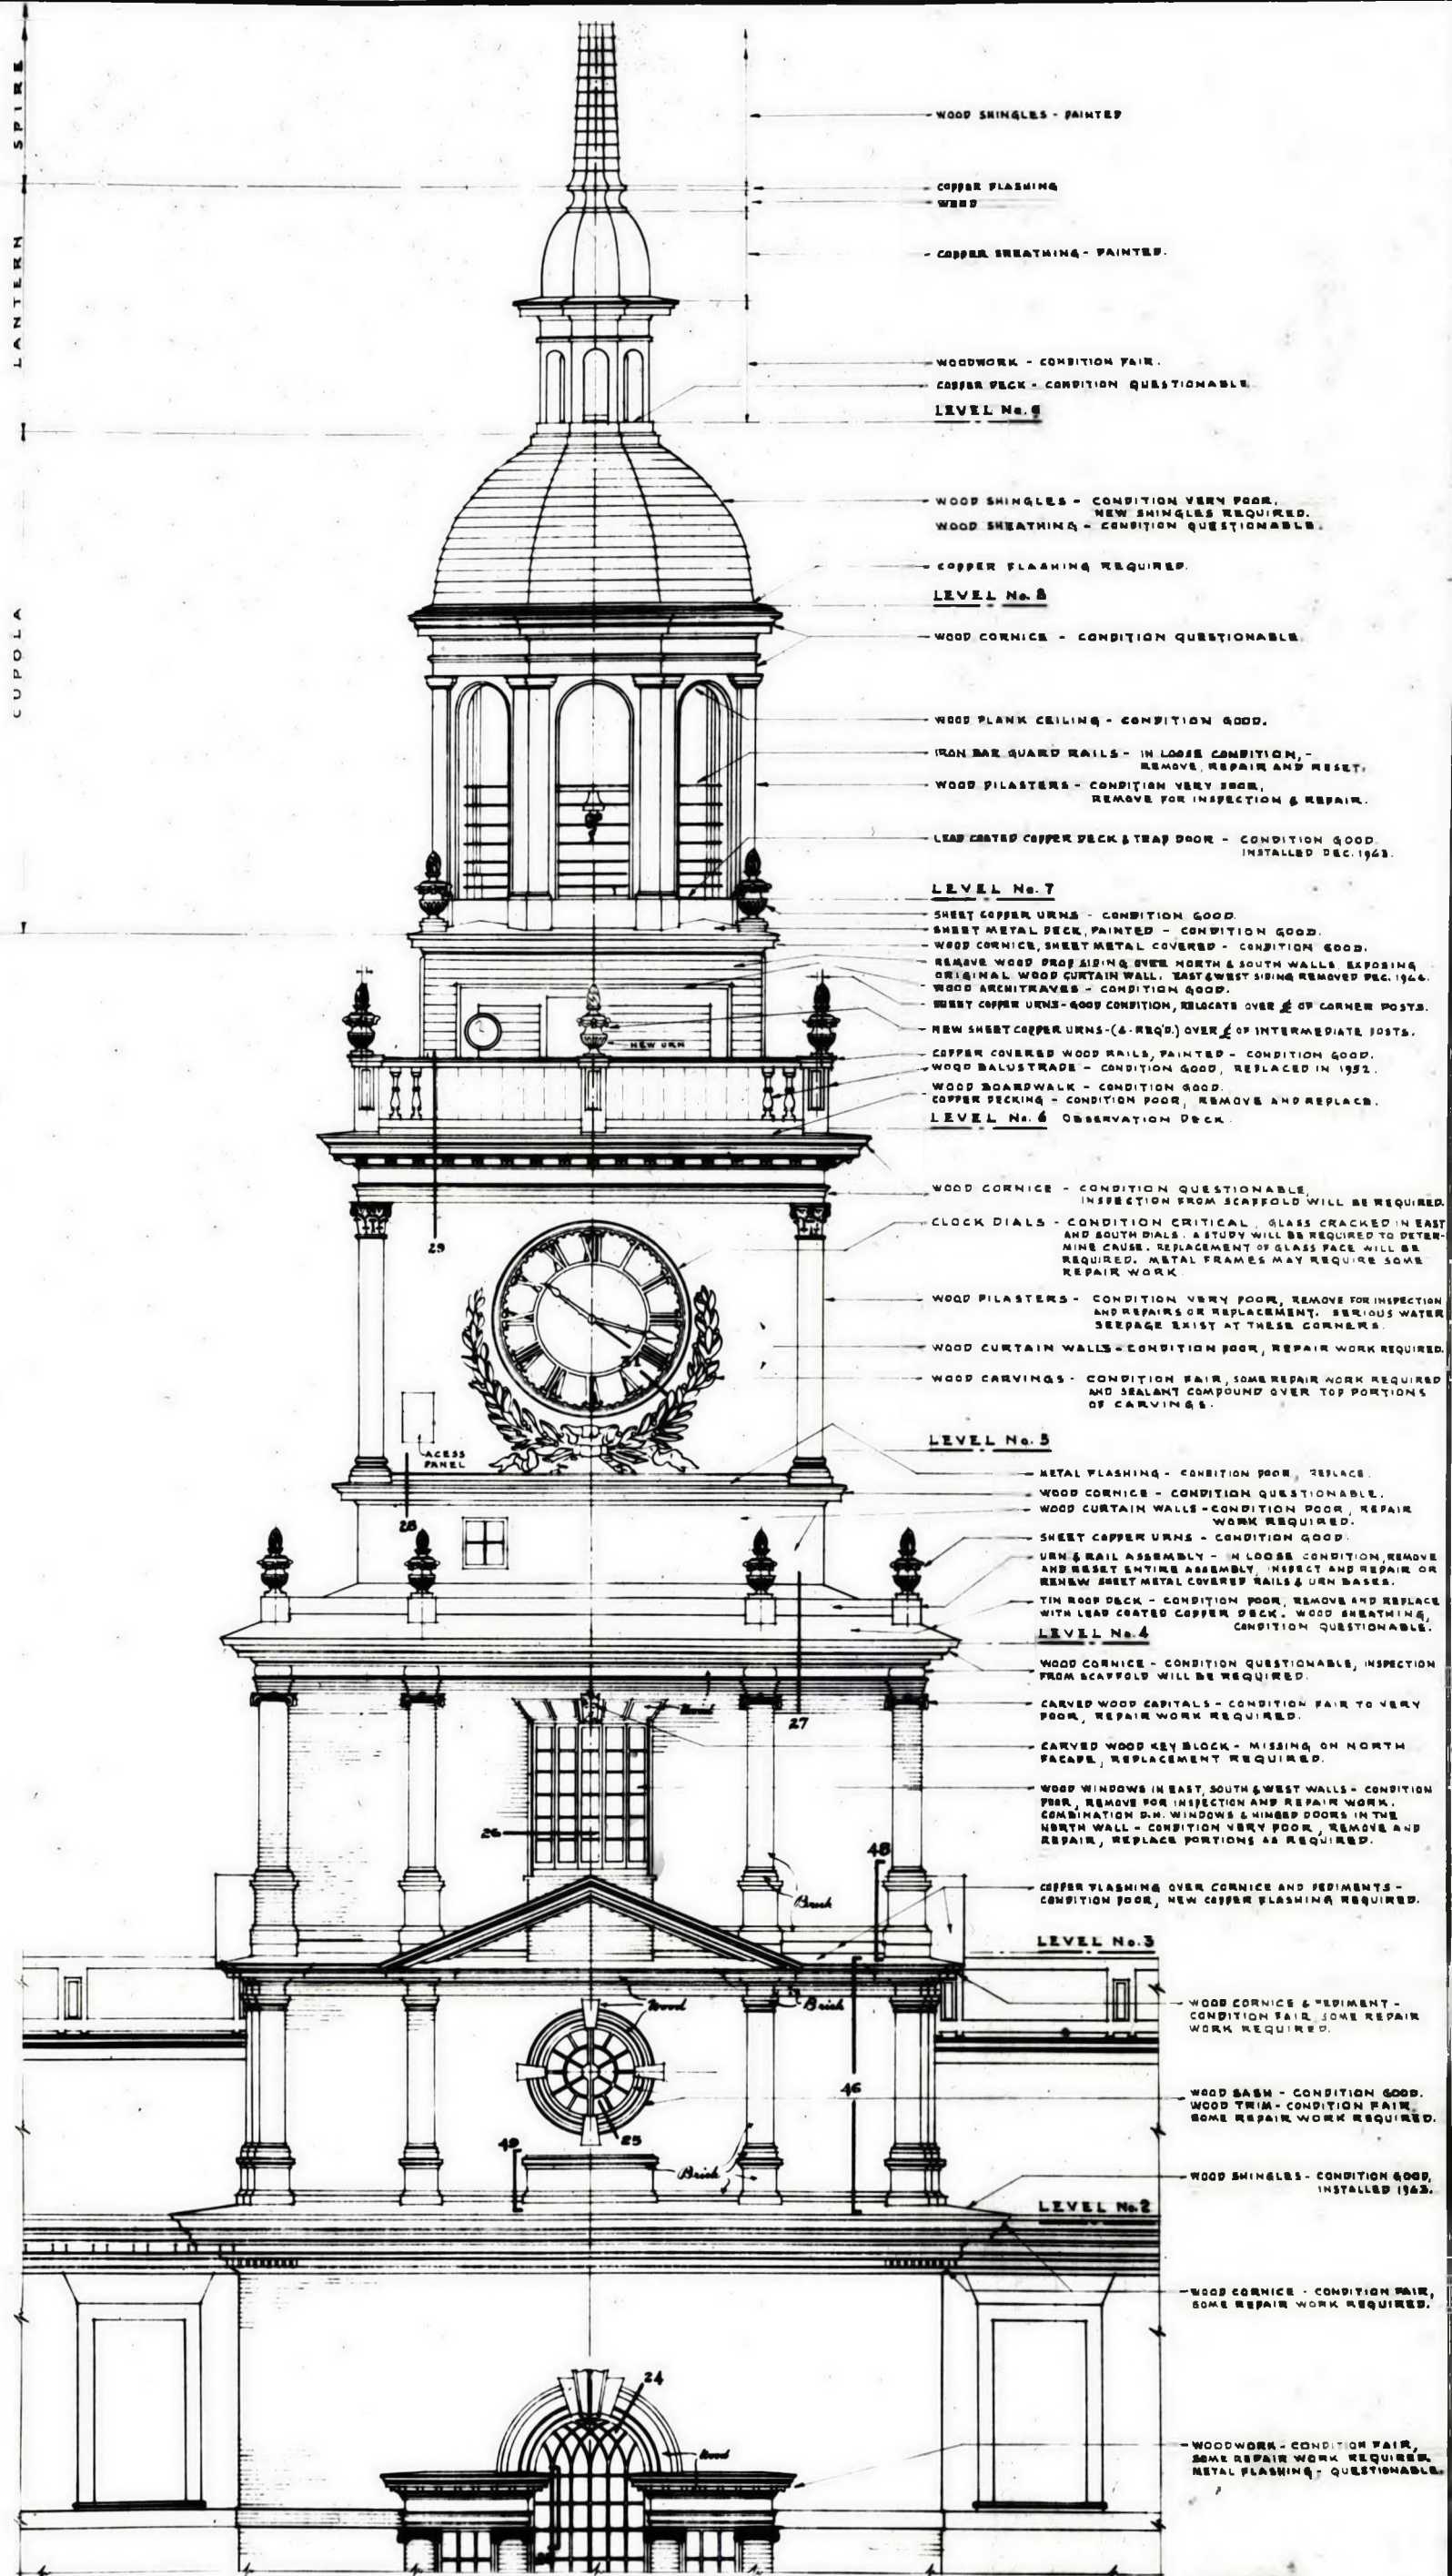
PHYSICAL EVALUATION OF EXISTING EXTERIOR CONDITIONS  
AND  
RECOMMENDATIONS FOR REHABILITATION

NOTE: EVALUATION OF PRESENT CONDITIONS WERE MADE BY VISUAL EXPLORATION IN ACCESSIBLE AREAS. AREAS NOT ACCESSIBLE WERE VIEWED WITH BINOCULARS. A COMPLETE EVALUATION OF THE EXISTING CONDITIONS OF THE WOODWORK AND METAL WORK BENEATH THE NUMEROUS LAYERS OF PAINT CAN BE MADE ONLY BY A COMPLETE REMOVAL OF THE EXISTING PAINT. A THROUGH EXPLORATION OF ALL MEMBERS FROM A SCAFFOLD IS RECOMMENDED.

Illustration No. 1 graphically illustrates the general work required on the Tower and the Steeple. These recommendations are summarized below:

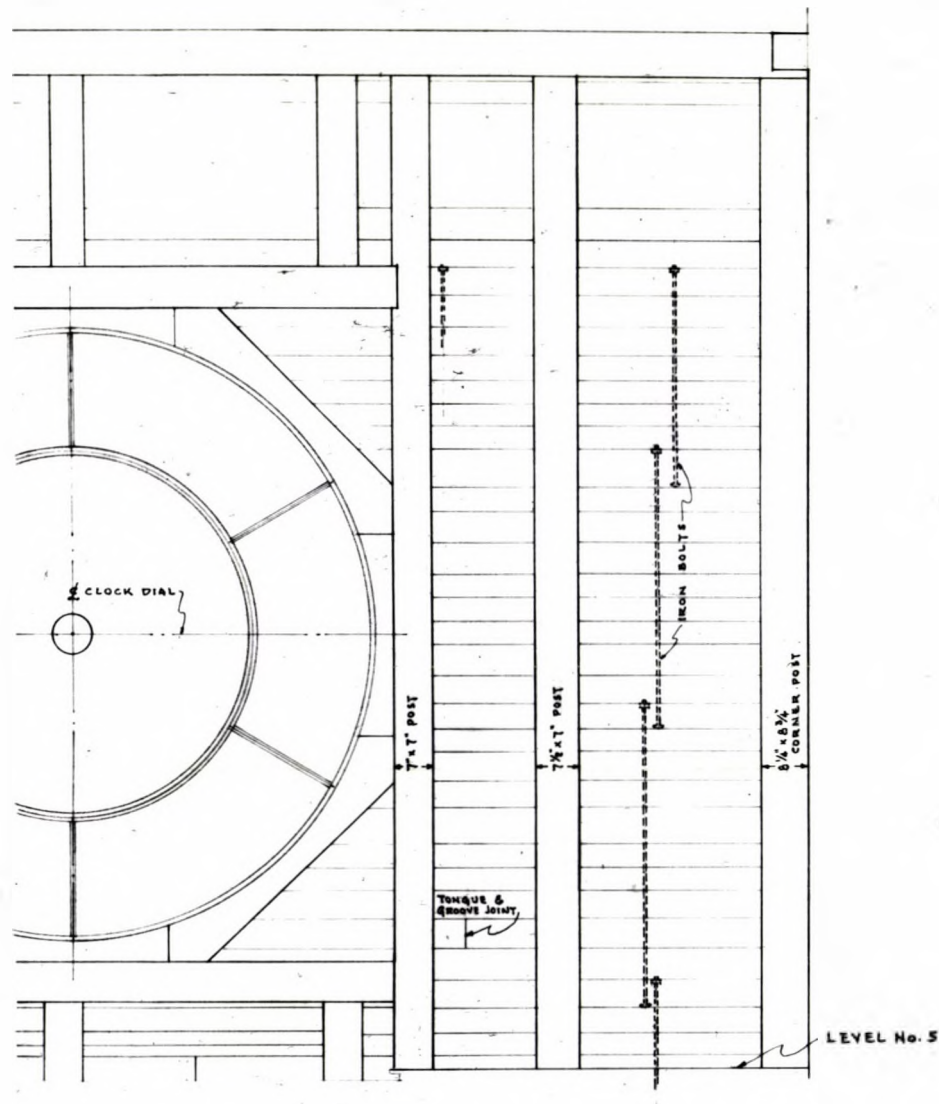
PORTION OF EAST ELEVATION OF INTERIOR OF DIAL ROOM  
(LEVEL No. 5) SHOWING EXISTING WOOD CURTAIN WALL.  
NORTH, SOUTH AND WEST WALLS SIMILAR.

3. Wood Curtain Wall - The wood curtain walls are in a deteriorated condition but can probably be retained after a general rehabilitation. These curtain walls were drastically altered by the installation of new clock faces in 1876. Before that time the openings to receive the clock dials were 7 feet in diameter. In 1876 they were increased to 9 feet to receive the present dials. The assembly of the curtain wall is similar to that described for level No. 4 and the method of rehabilitation would be the same.
