HISTORIC STRUCTURES REPORT

OLD CITY HALL

Independence National Historical Park

Structural Rehabilitation

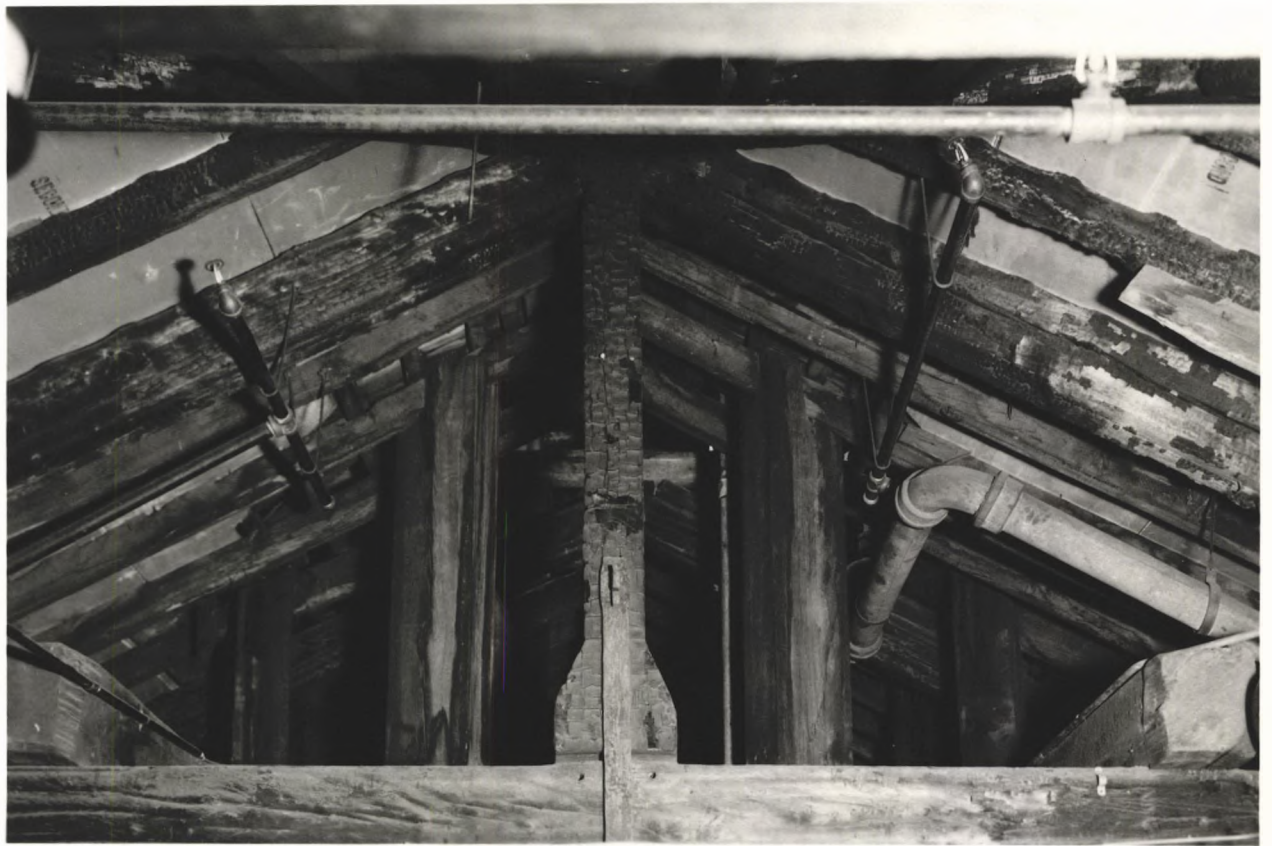
ILLUSTRATION NO. 4

The southernmost attic truss for example has not only deflected excessively but is severely twisted (see Illustration No. 4). On this account temporary wooden posts have been installed underneath this truss at the panel points to prevent further deflection and possible failure.

At present, there are five trusses supporting the roof, cupola, and ceiling of the subject building. Truss No. 5 is in very bad condition, has about 5" of sag and is badly twisted. At Truss No. 4, on each side, is an existing 24" or 26" beam supporting the second floor construction by means of rods hanging from 8" channels framing on top of the girders. These beams do not, at present, support the roof. Truss No. 3 supports the cupola, and the top chord has been badly damaged by fire. This truss has no carrying partition below running directly to the basement, and carries the roof and ceiling on the full span across the building. Truss No. 2, adjacent to the stairway, is out of plumb; as is, also, Truss No. 1. Trusses No. 1 and 2 rest on a partition below,

General view of Attic Truss No. 5 (rebuilt after 1823 fire).

Note excessive twisting in truss. Lower chord of truss has about a 5" sag; upper chord of truss has about a 4" twist and the one queen post of the truss is about 8" out of plumb. Unfortunately, remedial measures (note long diagonal) have damaged truss rather than helped it, because the diagonal load is carried into the lower chord about 3 feet from the wall.

1. In reference to the support of Truss No. 5, a 24 WF beam to be placed north of the truss and 16 WF beams from the new girder to the rear wall. This will provide adequate support for the truss, roof rafters, and dormer window. This is shown on the plan showing repairs to roof, marked Drawing No. 1. I also suggest supporting the ceiling rafters at the dormer window by a transverse 16 WF beam, with posts and hangers as shown on this drawing.

It is planned to retain all the old trusses in the structural rehabilitation by supplementing them with steel girders spanning the masonry walls and hanging and/or posting the floor and ceiling loads where required.

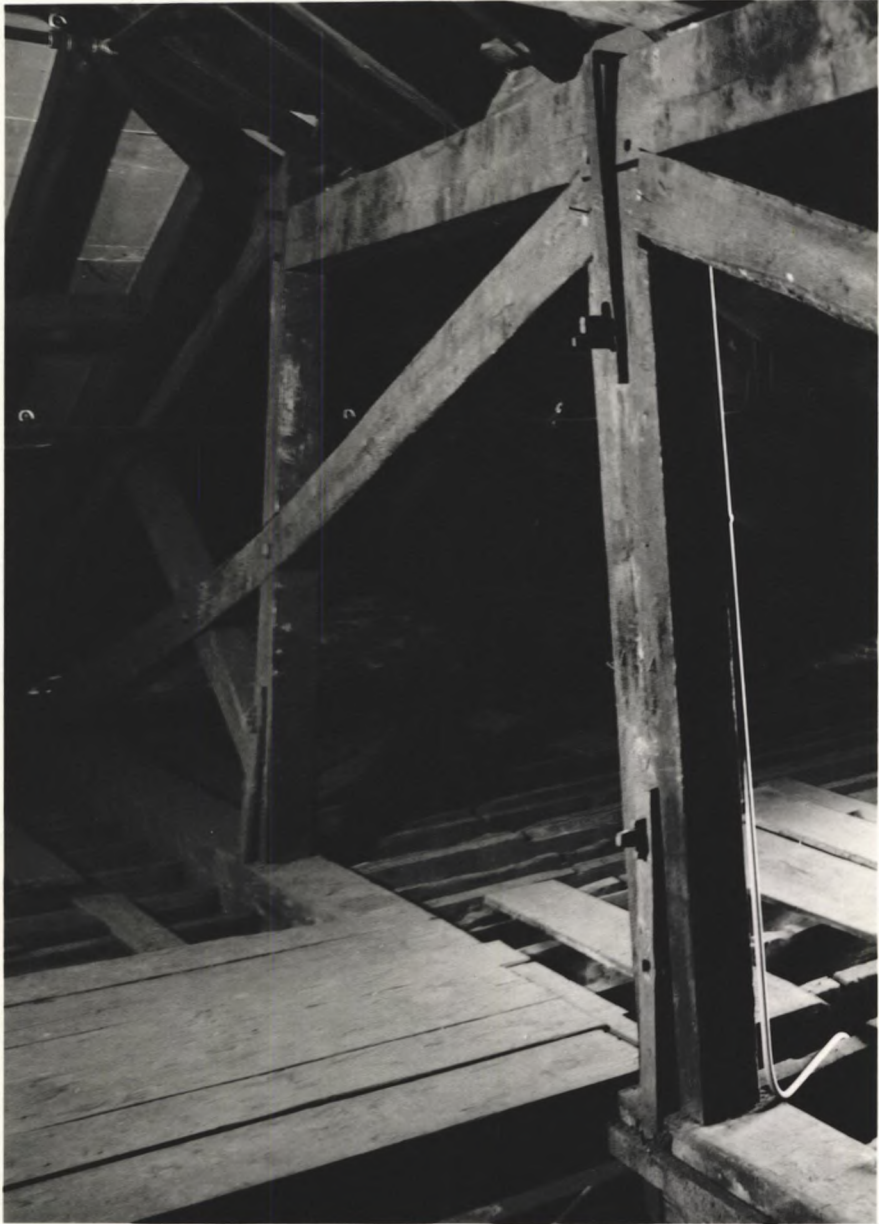
ILLUSTRATION NO. 5

Joint detail Attic Truss No. 2.

Note extensive charring from 1823 fire. Also note severe checking in all members probably as a result of water damage during the fire. This unusual connection shows the queen post, top chord, and diagonal chord supporting a major roof rafter. There is no connection between the queen post and the major rafter but the queen post does relieve the rafter of deflection owing to its long span.

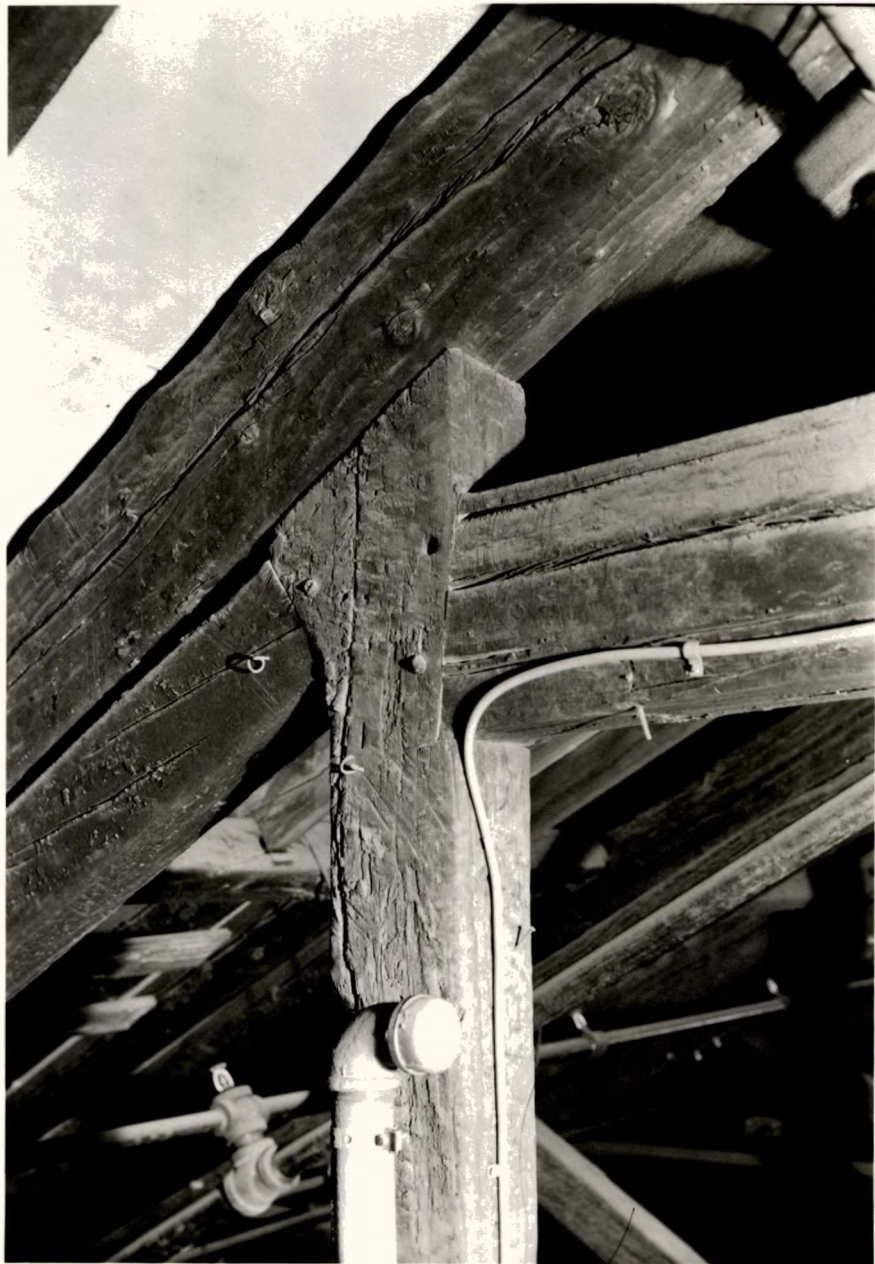
ILLUSTRATION NO. 6

Joint detail, Attic Truss No. 1.

Note connection between queen post and lower chord. This is basically a mortise and tenon joint but supplemented with iron U-straps and a system of iron wedges. Note shallow attic floor joists, many of which have shrunk away and have technically failed in shear or bending. The attic floor system is supplemented with diagonal floor beams visible at left which frame into lower chords of truss (never at panel points). Note excessive checking in diagonal floor beam and lower chord of truss. All such attic floor joists and floor beams connections should be supplemented with steel hangers.

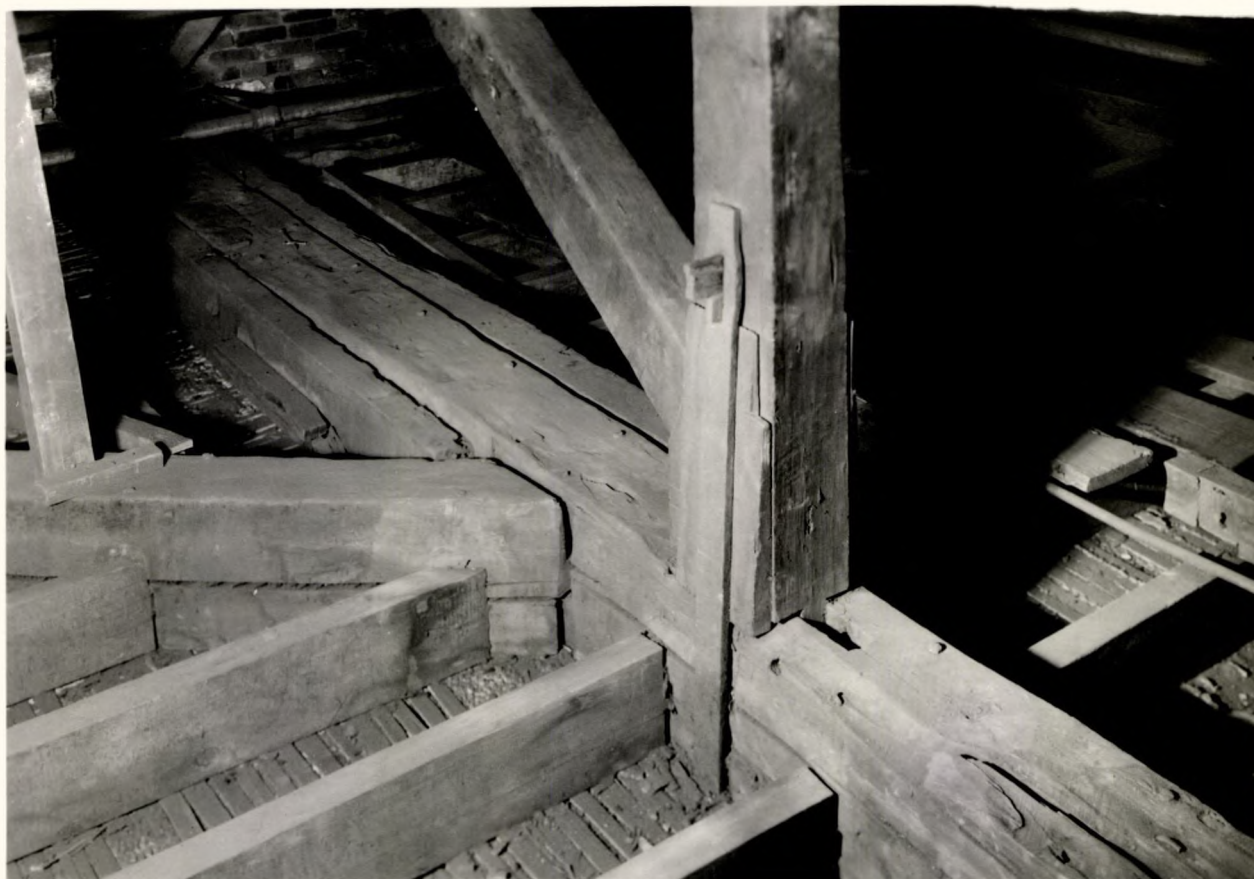
ILLUSTRATION NO. 7

View looking into northeast corner of attic showing hip-roof framing and attic floor framing. Note particularly the extensive fire charring on the hip rafter and secondary rafters. The rafters are structurally inadequate due to their small cross-section and long spans. Some of the rafters have actually failed and have been temporarily propped up.

Fortunately most of the attic floor joists were not heavily fire charred because of the floor boards which existed at the time of the fire. However, most of the attic floor joists are inadequately secured to the major framing members.

A new network of steel girders and steel secondary members will permit posting or hanging of all the critical points in the attic and will provide the necessary framework for future repair work as it becomes necessary.
