HISTORIC STRUCTURES REPORT  
PART II (PORTION)  
ON  
SECOND BANK OF THE UNITED STATES  
Restoration of Roof and Iron Work  
Independence National Historical Park

Prepared by  
Joseph Petrak  
Architect  
May 1964

Restoration of Roof and Iron Work

Independence National Historical Park

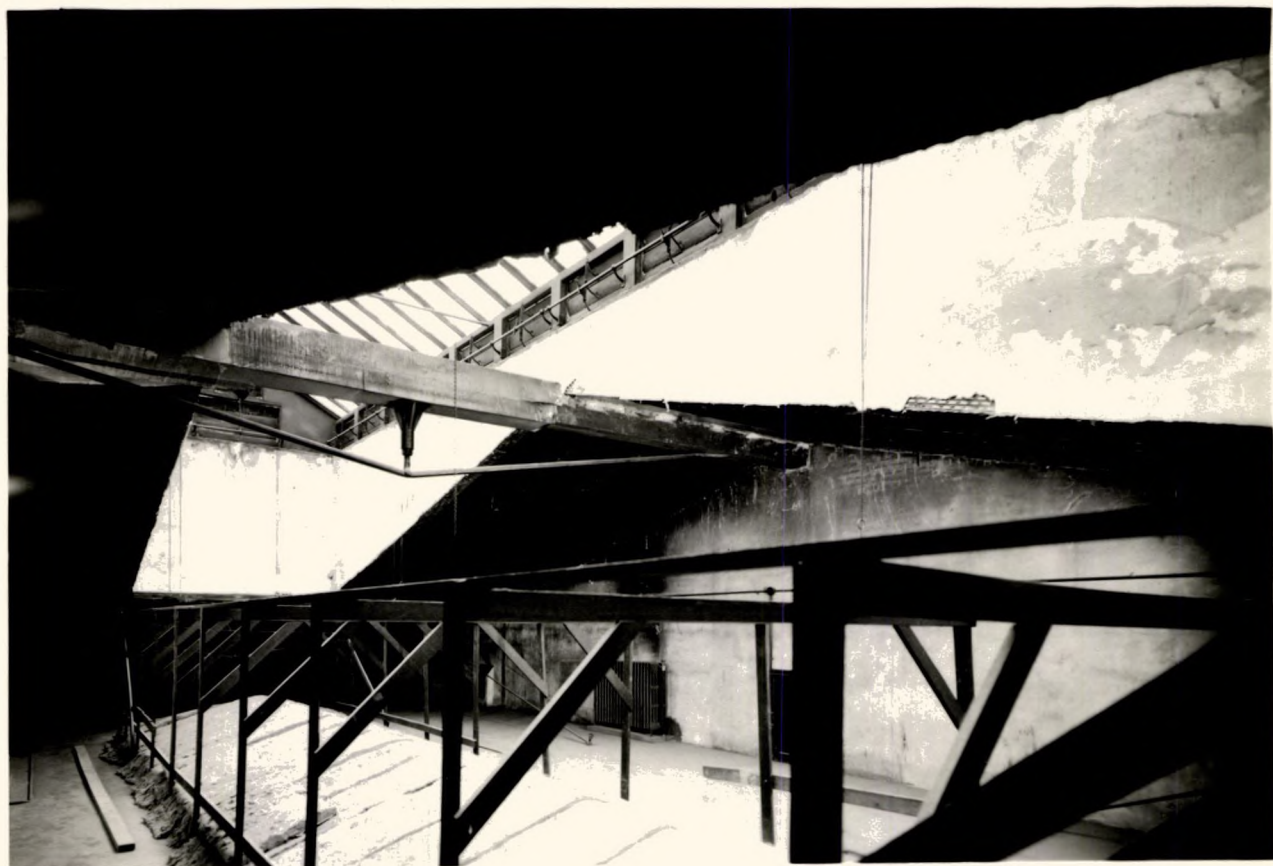
ILLUSTRATION NO. 12

View showing present rafters and iron trussed wood girders spanning over the original brick barrel vault of the Banking Room.

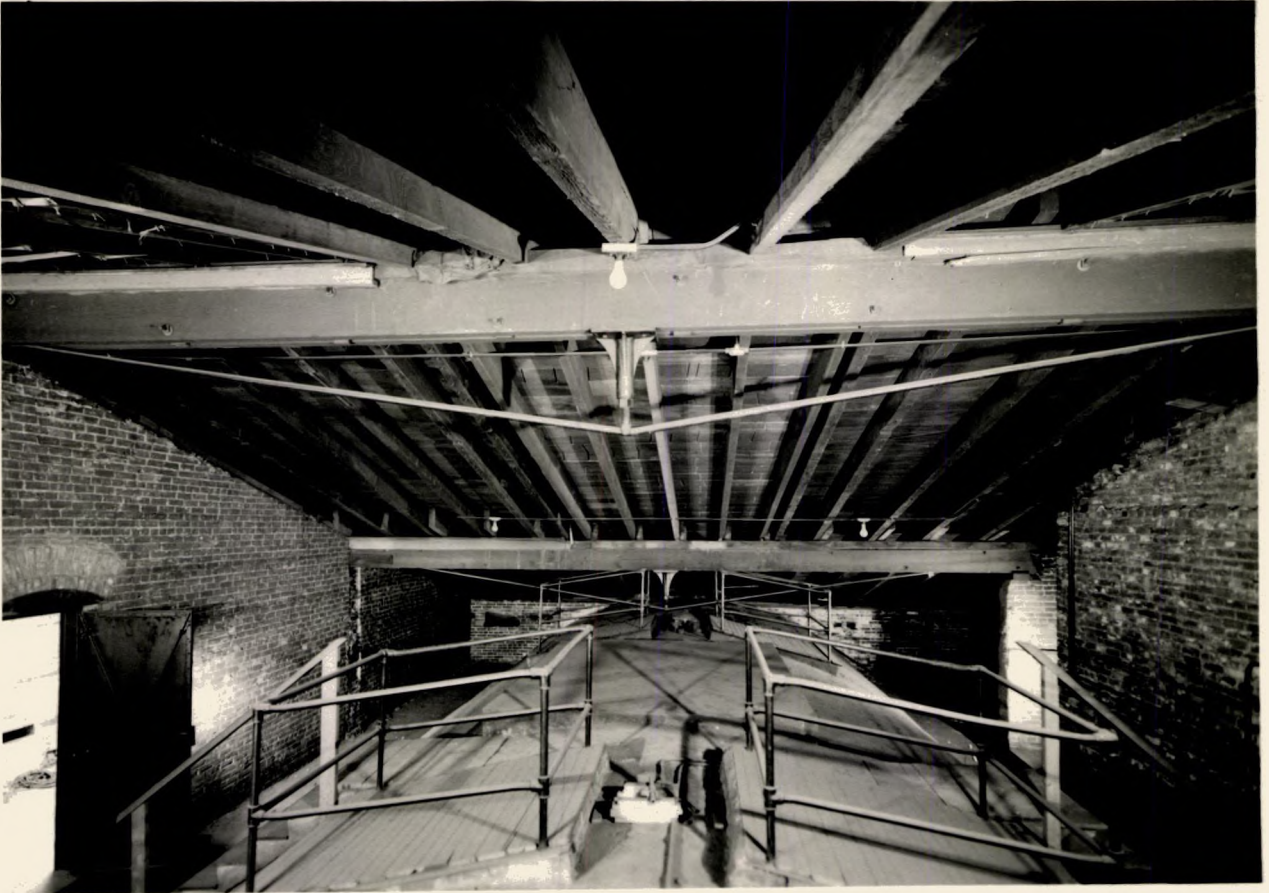
ILLUSTRATION NO. 13

Interior view (looking east) of present non-historic skylight, located at the north end of roof. The west end of this skylight is adjacent to the location of the original Skylight No. 2. See present roof framing plan, Illustration No. 18.

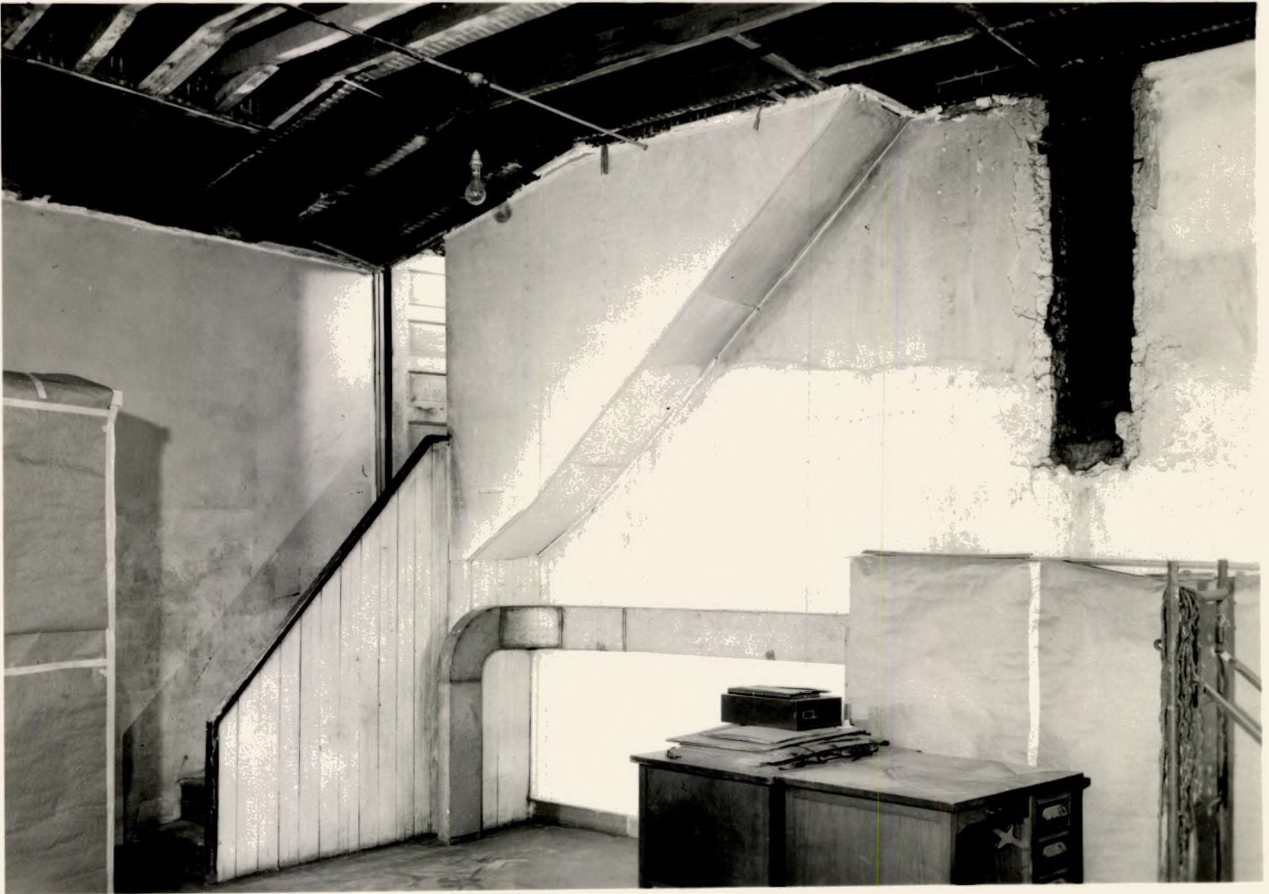
ILLUSTRATION NO. 16

View showing the original stair-well between attic and second floor. Skylight No. 2 positions directly over this stair-well. The balusters and steps are not original.
