Historic Structures Report Part I  
on  
Congress Hall  
Independence National Historical Park

Prepared by  
Staff  
Independence National Historical Park  
Philadelphia, Pennsylvania

May, 1959

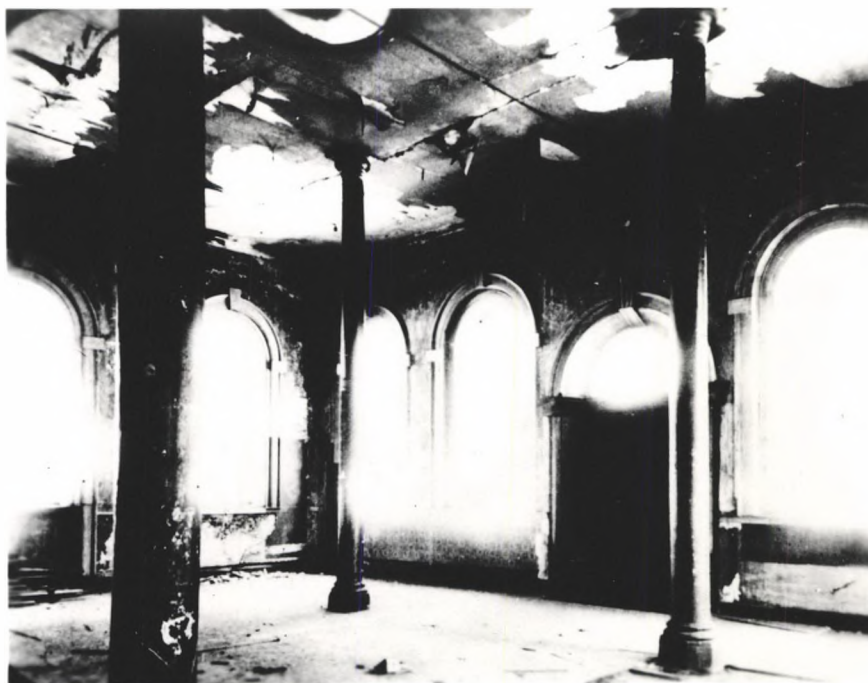
Photo taken in 1900, showing north and west walls of north room, first floor. Note plaster patch half way up west wall in corner which indicates landing of original west staircase. Note also that the frame of the original Chestnut Street door is still in place, although the doorway has been blocked up.

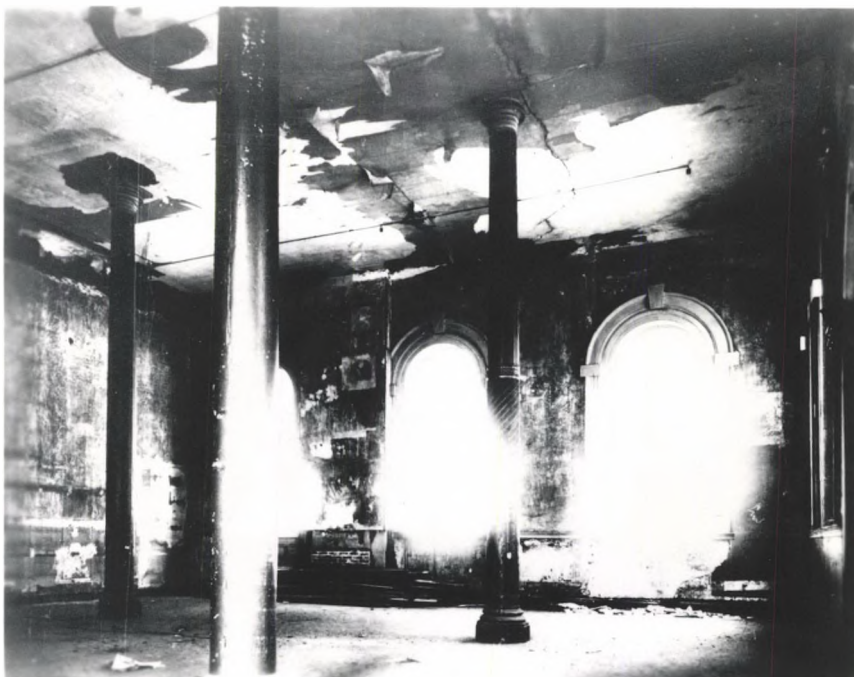
Photo taken in 1900, showing west and south walls of the then north room, first floor. Note the "long step-like marks...about half way up the chimney breasts" which mark the location of the House gallery, and are referred to in Appendix O, page 9.

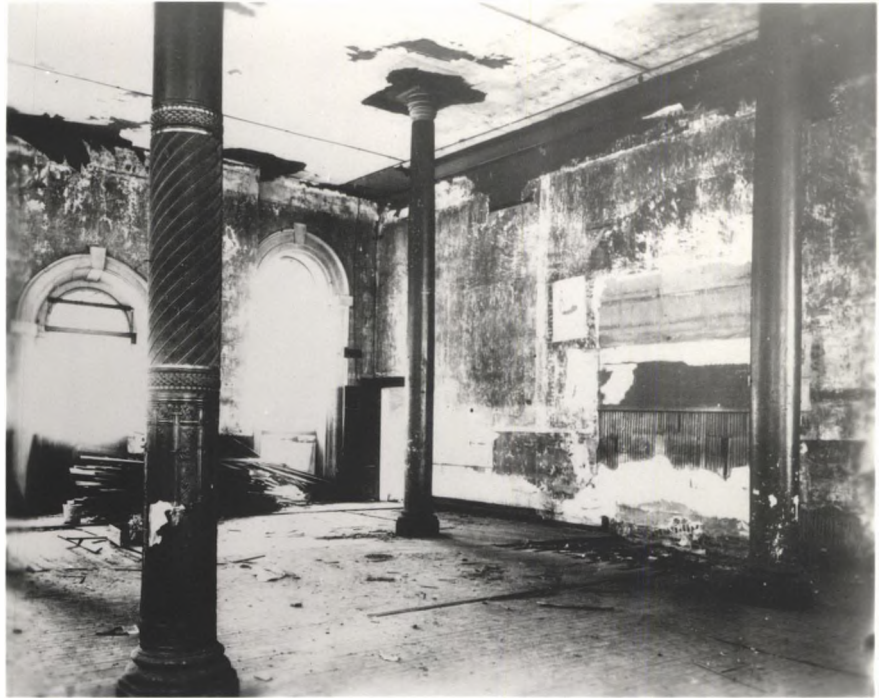
Photo taken in August, 1910, showing east and south walls of north room, first floor. Note the original doorway to the left, and the position of a former doorway in the south wall marked by sawn lath.

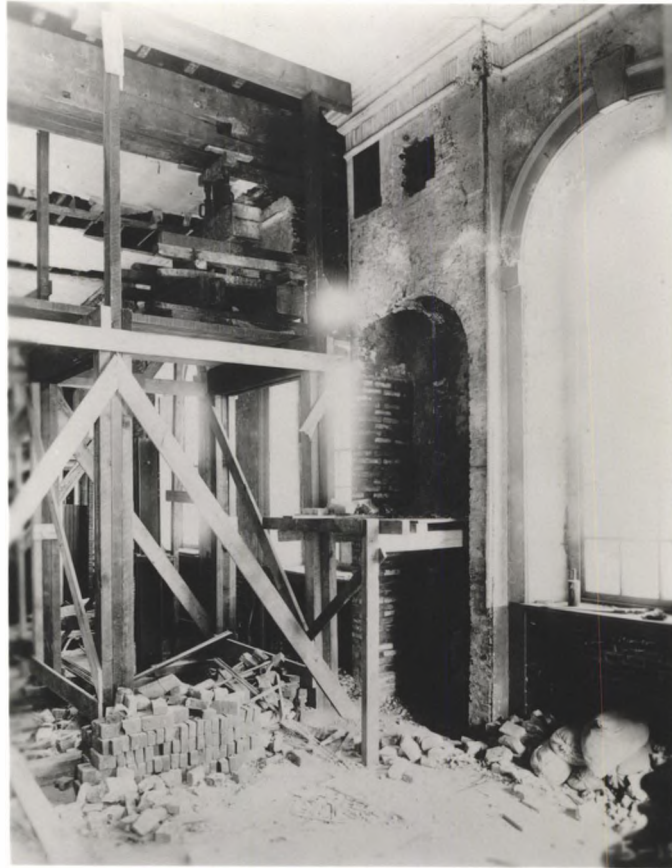
When the work was finally done in 1912, the entire girder system was stronger in one way or another. The girder under the Senate Chamber floor (girder "A") was bolted to a steel "I-beam" and returned to its position (Illustration No. 38; Appendix P, Illustration No. 2). The same method was applied to the girder over the House of Representatives gallery (girder "D"), and the two wooden columns which had been there were left in place under it (Appendix Q, p. 19; Illustration No. 40). Only the beam under the Senate Chamber bay was entirely replaced.<sup>18</sup> The joists of the second floor also were found to be unreliable by the A. I. A. The ceiling joists under the Senate Chamber were replaced with new pieces (Appendix Q, p. 15). Two new joists were placed between each pair of old joists of the Senate Chamber floor. Elsewhere under the second floor a single new joist was added between each pair of old joists (Appendix Q, p. 15).

Scaffolding, jacks, and blocks support Girder "A" which is being raised into place following installation of steel beam. "Grillage" piece can be seen amidst scaffolding. Note also the evidences of the original appearance of the niche at the south end of the east wall.

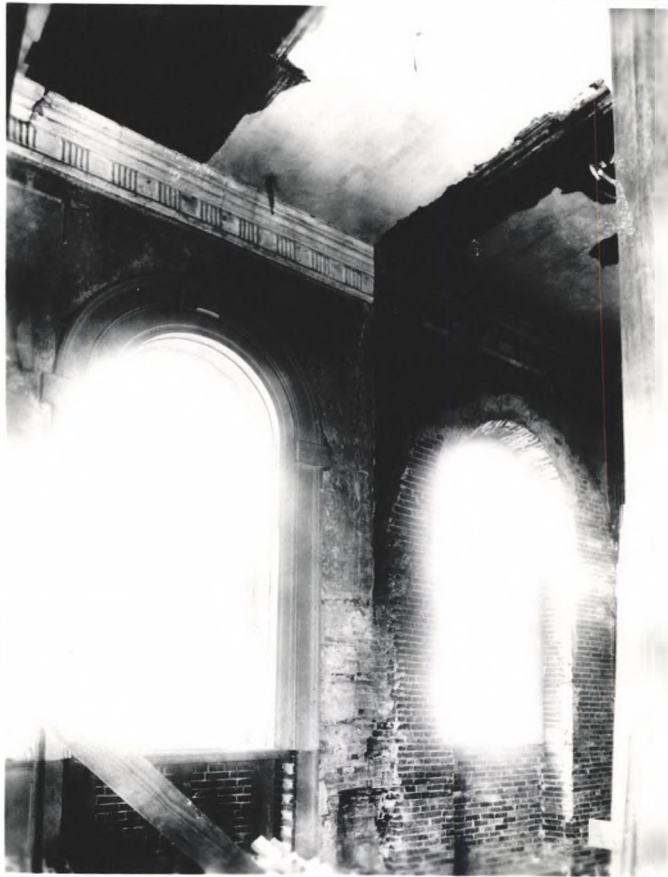
First floor west wall, showing intersection of southern (brick) partition of 1818-1820 cross wall. Photo taken March 15, 1912, shortly after demolition of the cross hall. Note remains of original cornice above the window on the right, and the plaster, which may have been original, on the ceiling above the same window. Note also that the partition destroyed half of the center fireplace on the west wall and a portion of the chimney breast above it.

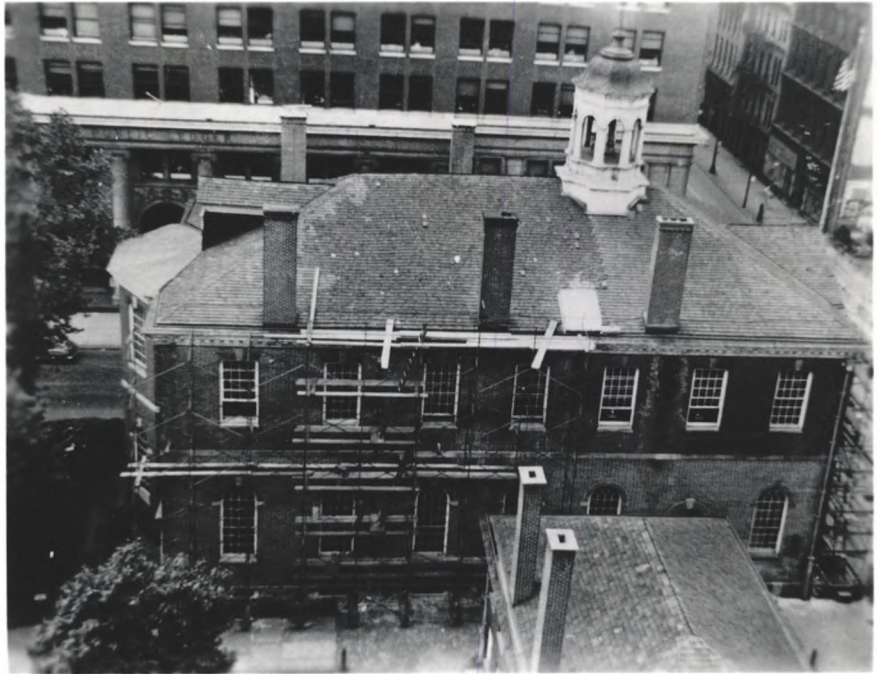
View of Congress Hall in 1942 shows, by line of shingles above side scaffolding, sag in roof where failure of truss has since been discovered. Note roof structure over many-sided bay.

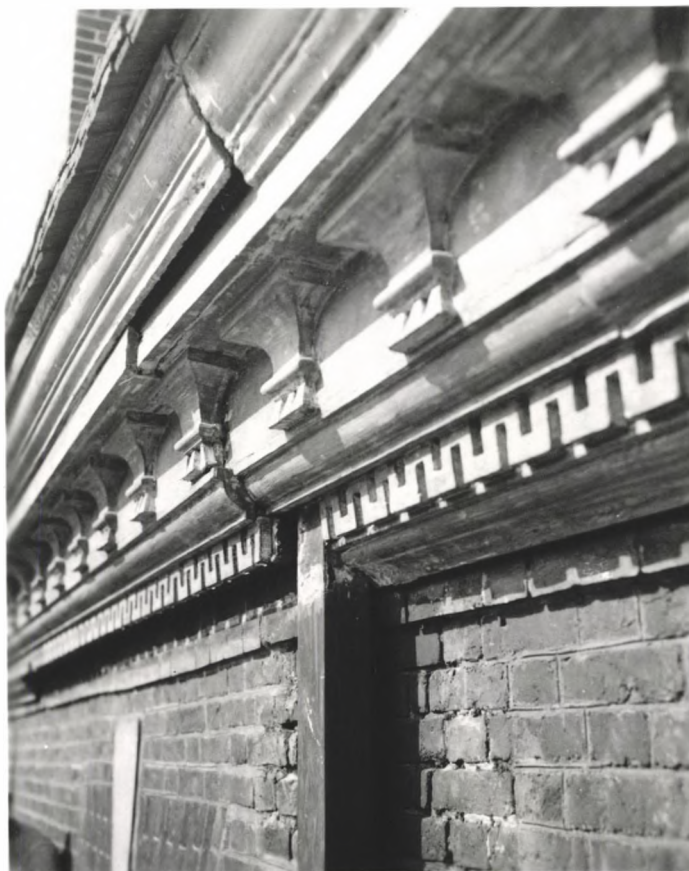
September, 1958. View of cornice at seam between early section of Congress Hall on right and 1793 extension on left beyond drainpipe shows how brick wall has been pushed out by failure of truss above. The displacement then was five inches.

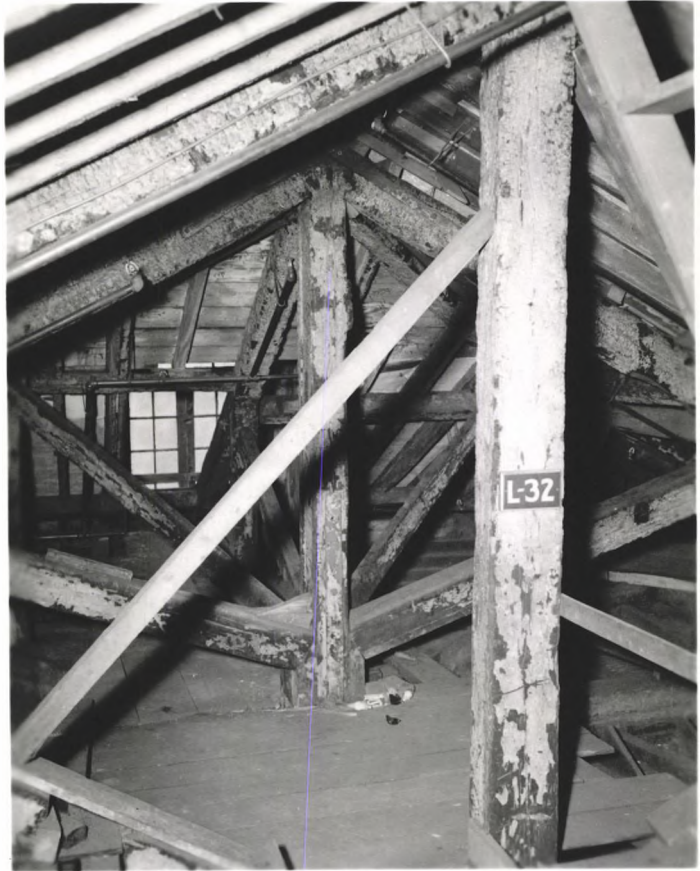
P, Illustration No. 1). The four further north except for the bottom chord were destroyed in the fire of 1821 or that of 1850 and replaced.<sup>19</sup> The remaining trusses are badly charred. The king-pin construction over the bay is still in place too (see Illustration No. 51). The rafters and other original wood structural elements of the Senate Chamber's coved ceiling are also intact (see Illustration No. 52).

September 1958 view of Congress Hall attic over 1793 extension shows original roof truss members still in place. In center is king pin with supports radiating out to perimeter of many-sided bay. Note charred surfaces of structural members.

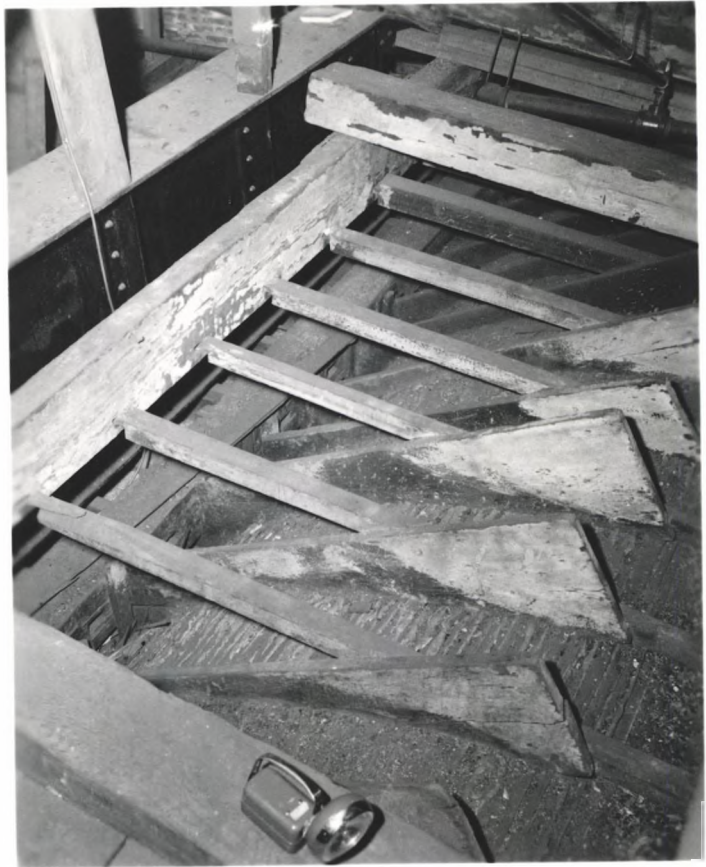
Chapter II  
Illustration No. 53

September 1958 view of attic side of cove ceiling. Note how rafters have pulled out of their mortises because of truss' failure. Steel beam identified as "girder B" is on left. Cut laths of original plaster ceiling can be seen below rafters.
