Historic Structures Report Part I  
on  
First Bank of the United States  
Independence National Historical Park

Prepared by  
Staff  
Independence National Historical Park  
Philadelphia, Pennsylvania

November 1959

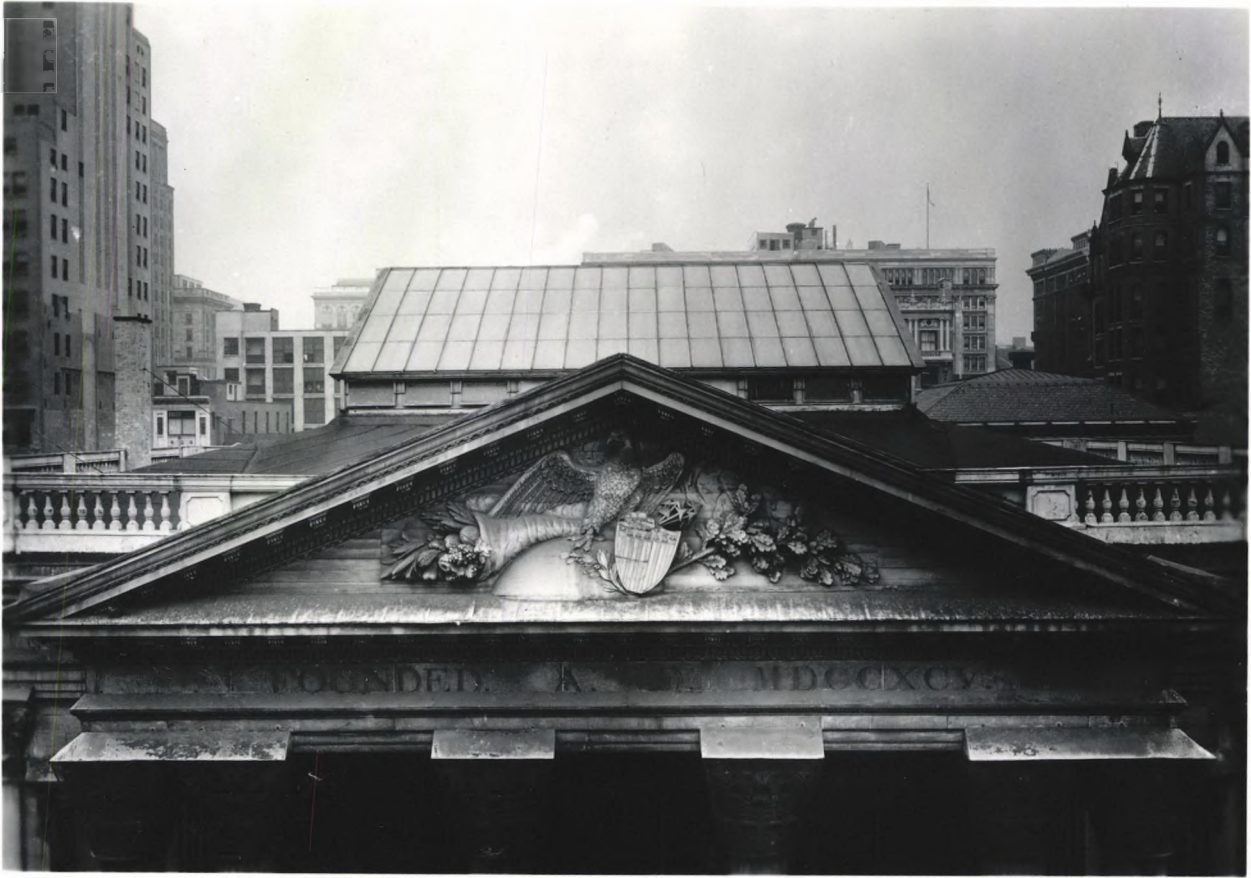
Chapter II  
Illustration No. 6

The elaborately carved wooden tympanum  
of the Bank of the United States.

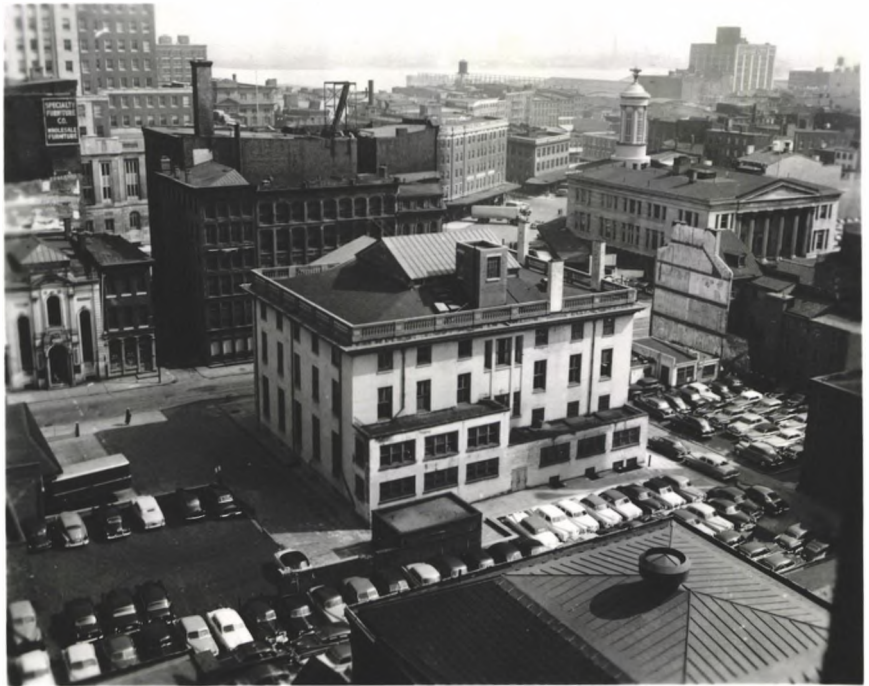
Chapter II  
Illustration No. 7

The bank looking southeast. Note the 1901-02 roof, the 1912 rear additions, and the tripartite windows of the second and third floors.

The present asphalt covered hipped roof with its skylight and elevator housing replaced the original copper covered hipped roof in 1901-1902. It is recommended that the present roof be removed and replaced with a restoration of the original. The elevator and elevator housing on the roof should be removed.

In 1912 a stepped addition was erected at the rear of the bank. It is recommended that this addition be removed, the garden wall that was there be rebuilt on its foundations, and the west wall of the bank be restored to its original condition.

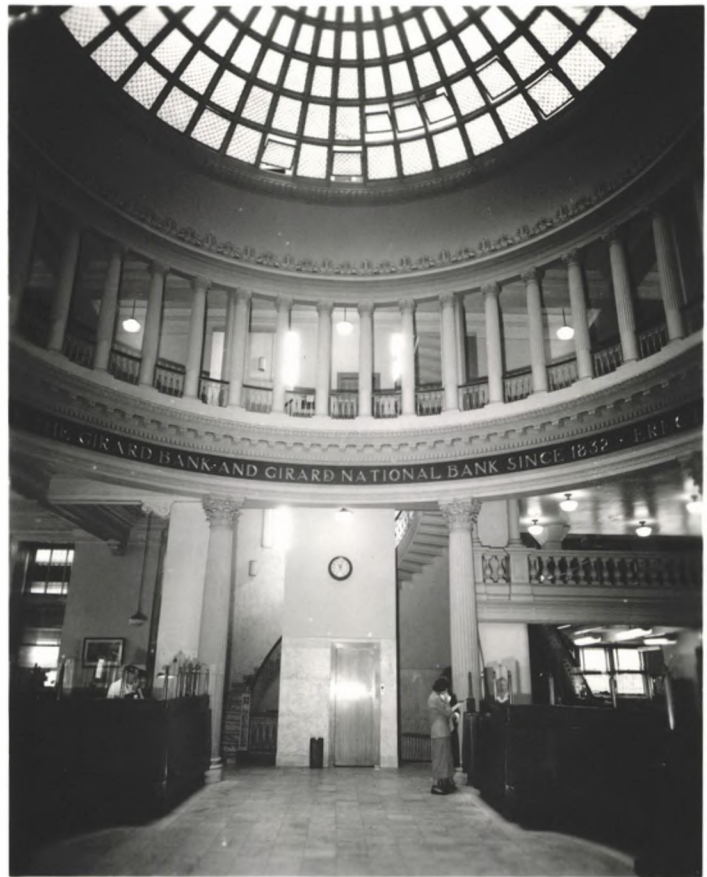
Chapter II  
Illustration No. 13

The present rotunda of the bank,  
looking west toward the rear of  
the building.
