HISTORIC STRUCTURES REPORT

INDEPENDENCE HALL

Restoration of Roof

Gary Dysert  
Architect  
March 1963

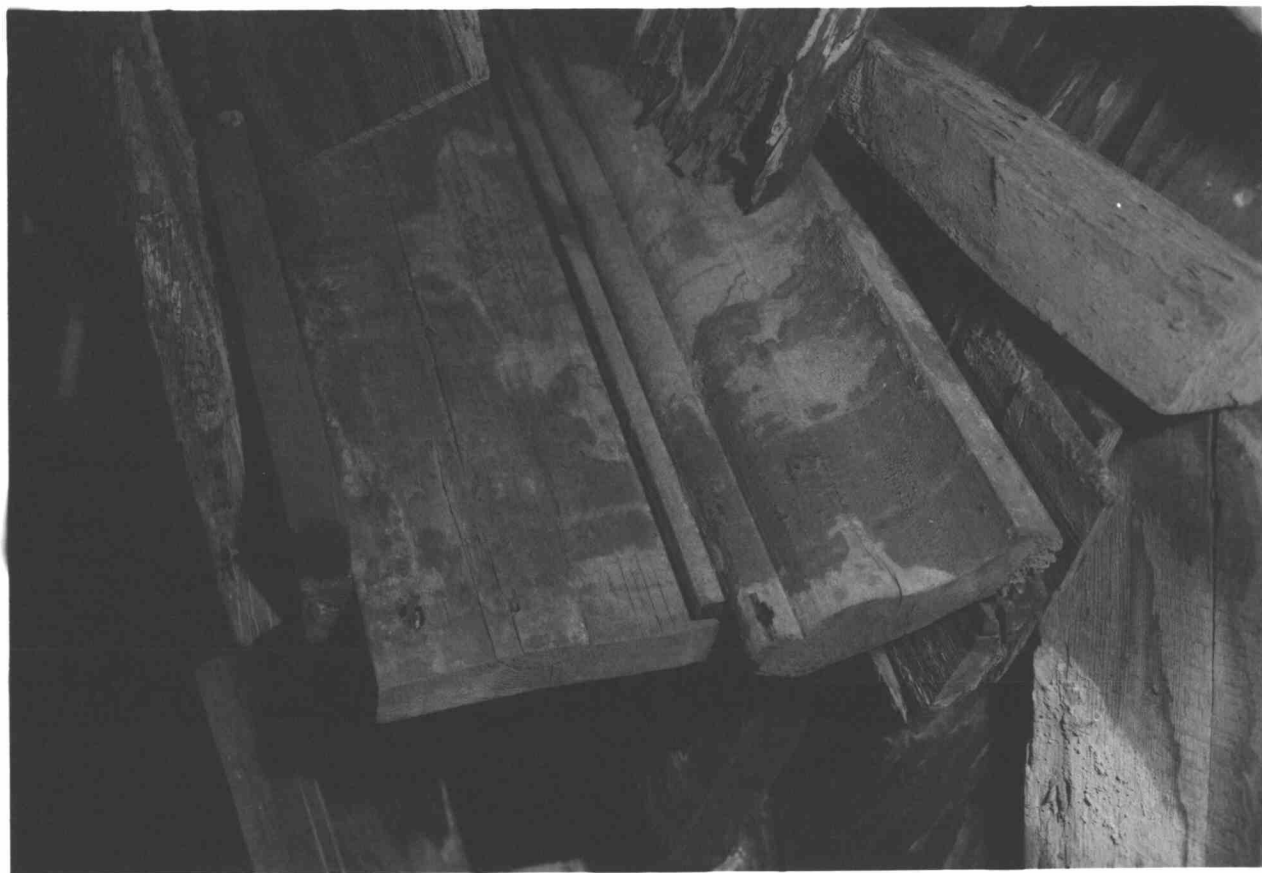
ILLUSTRATION NO. 2

The roof is formed over nine gambrel-like trusses that support it from below (see Illustration No. 1). The roof slopes are symmetrical about the ridge line. The lower slope rises from the main cornice to a balustrade that connects the chimney masses at each end of the building. Directly below the balustrade the pitch of the roof changes so that it is almost flat from that point to the ridge. The change in pitch was articulated with a cornice consisting of a bed moulding, fascia, and crown moulding (see Illustration No. 2).

Fragment of original (1730's) cornice at the juncture of the lower slope and upper slope of the roof. The fragment of upper slope shingles (note paint on under side of ends of the shingles), crown moulding and fascia (still in place in the attic of Independence Hall) were covered over when the dormer and tower were added in the 1750's. A 1-3/8 inch unpainted strip along the lower portion of the fascia shows the location of a bed moulding. The bed moulding evidently closed the gap between the fascia and shingles of the lower slope of the roof.

The cornice at the change in roof slopes should be copied from the fragment of the original, with a new crown moulding, fascia, and bed moulding.

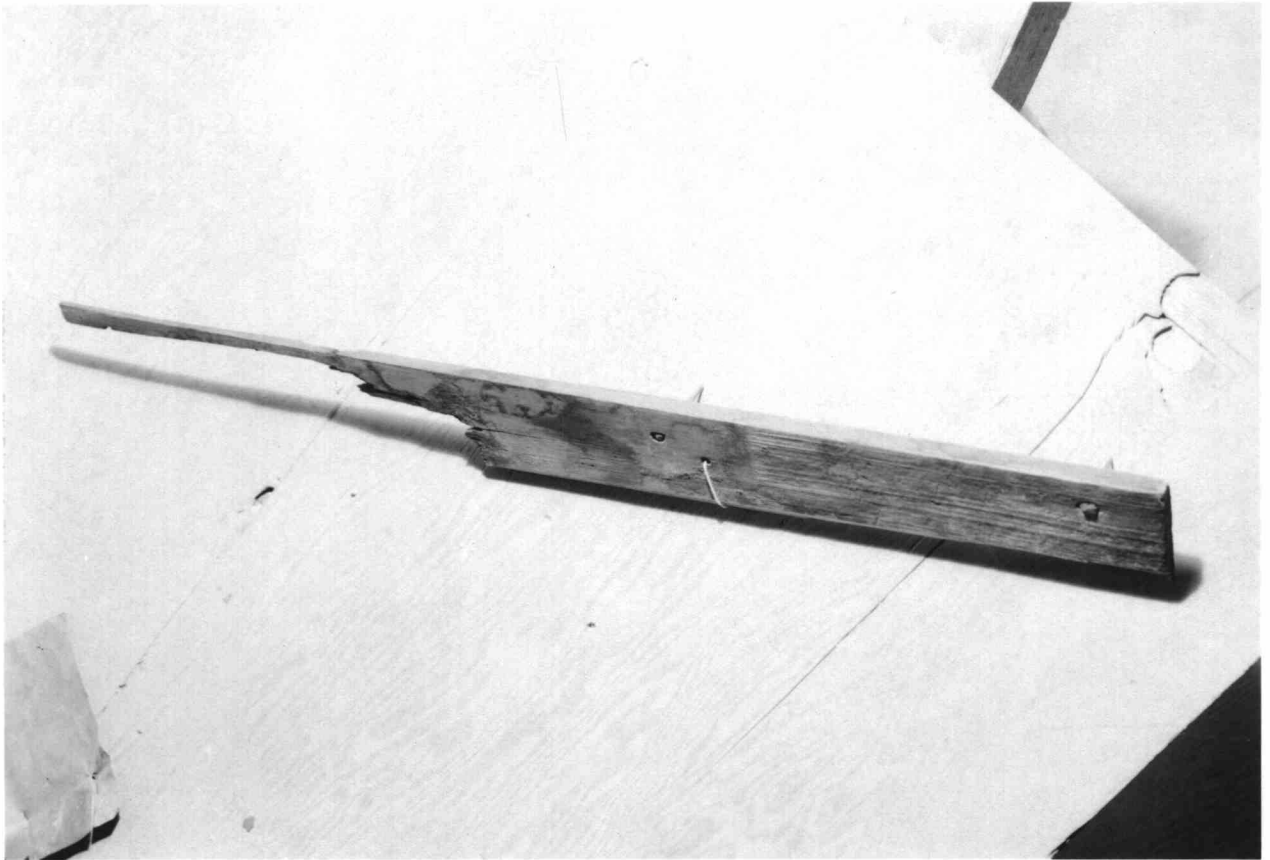
ILLUSTRATION NO. 3

When the roof was completed in the 1730's it was apparently covered in its entirety with wood shingles; the lower slopes being laid on lath and the upper pitches on solid sheathing. The shingles were 36" long, face nailed and exposed 11" to the weather (see Illustration No. 3). Due to the flatness of the upper pitches, the shingles were laid continuously over the ridge instead of the usual roof comb,

Original (1730's) shingle removed from upper slope of roof. The 36 inch shingle was hand planed on both sides and laid 11 inches to the weather (note weathered surface or "face" at right end of shingle). Shingles were nailed to 5/4 sheathing with three rows of hand-wrought nails, including one row of face-nails (note hand wrought nail at right end or face of shingle). There is no apparent evidence of paint or other applied surface treatment on the shingle.

The lower slopes should be stripped of their 1918 work and replaced with 5/4 fireproof sheathing laid on the existing original rafters and trusses. This sheathing will closely approximate the thickness provided by the lath that was used originally as well as providing fire protection. New taper-split shingles (36" long) should be laid directly on the sheathing with 11" to the weather to match the original shinglework.

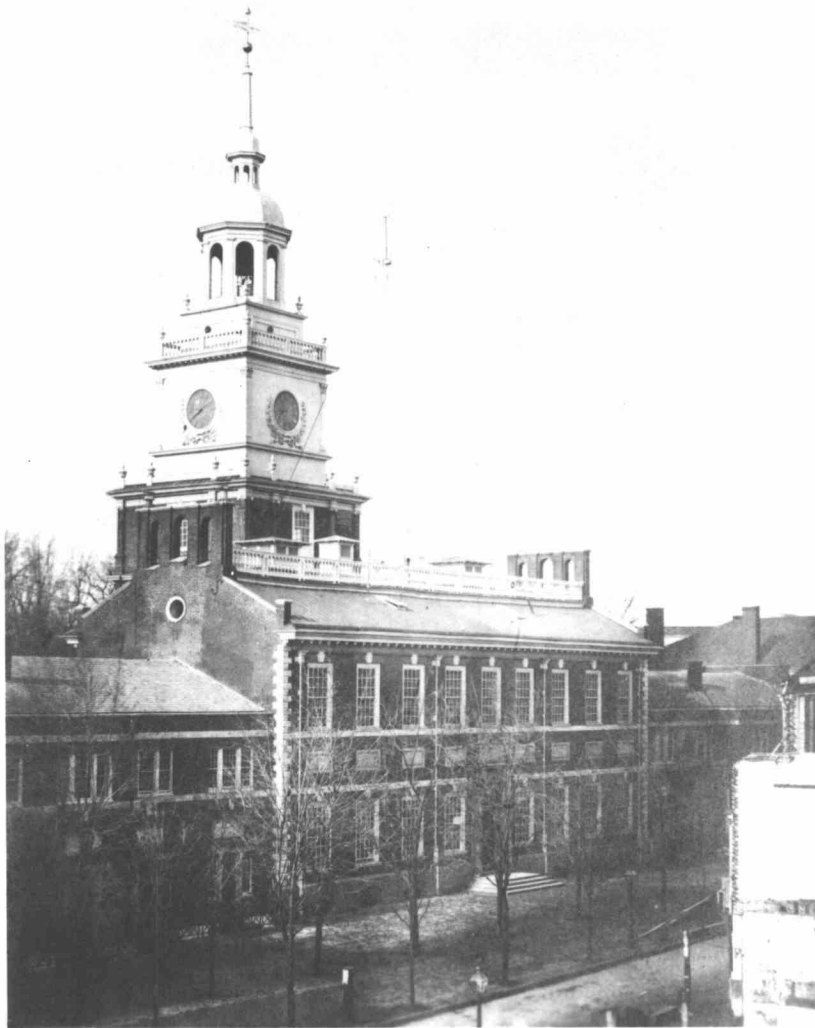
ILLUSTRATION NO. 4

In 1854 the roof was pierced by ventilators for the city council chambers on the second floor.<sup>7</sup> The ventilators were large wooden cupola-like structures but were replaced with smaller sheet-iron units in 1874<sup>8</sup> (see Illustration No. 4).

One of the earliest photographs (ca. 1856) of Independence Hall showing its 1847 tin roof with standing seams, and c. 1854 wood cupola-like ventilators. Over the years the roof of Independence Hall has been cluttered with a variety of cupolas, turrets, balustrades, flag poles, ventilators, skylights, mechanical and electrical devices. This vast array of decorative and functional features are not relevant to the restoration of the roof, except that the existing utilities (floodlights and fire hydrants) will be accommodated.

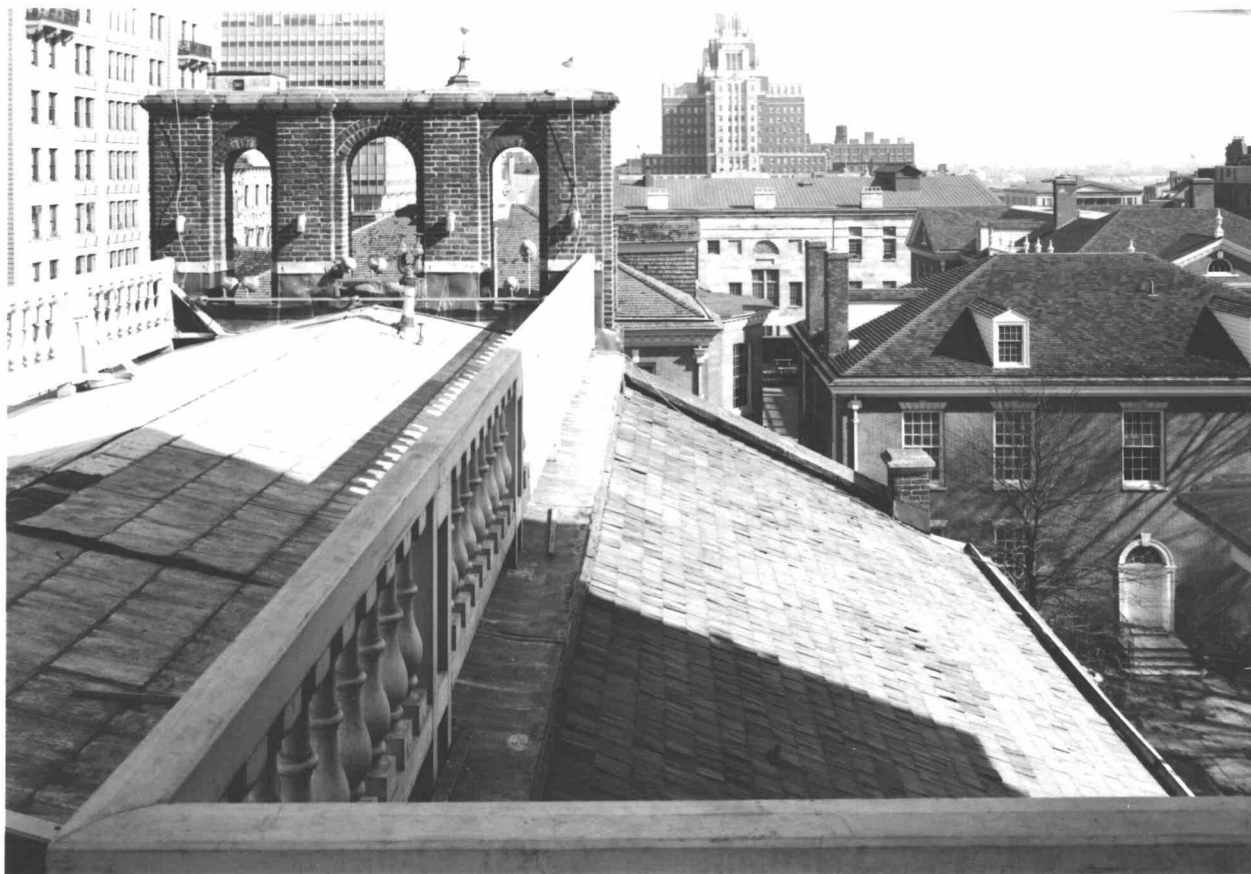
ILLUSTRATION NO. 5

The balustrades, the crown moulding and facia below the balustrades were replaced in 1945 with unfortunate results. The wooden facia was replaced with sheet metal over gypsum board and the bed moulding was not replaced at all. The new crown moulding only vaguely resembles the original (see Illustration No. 5).

The existing roof is forty five years old and badly deteriorated. It is recommended that a complete rehabilitation of the roof be undertaken as soon as possible. Further it is recommended that the roof be restored as accurately as possible to its character and appearance during the historic period.

Existing conditions showing c. 1918 roof.

Upper slopes are covered with lead-coated copper and the lower slopes with 24" cypress shingles laid 7" to the weather. The pole gutters are fabricated from lead-coated copper.

The 1918 lead-coated copper on the upper slopes should be removed and replaced with copper laid directly on the existing 1789 sheathing, thus restoring the 1789 roof form and covering materials.

New copper pole gutters and flashing will complete the rehabilitation of the roof.
