June 2, 2000

**Subject:           Report of Lead Paint Survey Services  
                      Marmion Row Building 1A East Porch  
                      Harpers Ferry National Historic Park  
                      Harpers Ferry, West Virginia  
                      LAW Project 20340-0-2592**

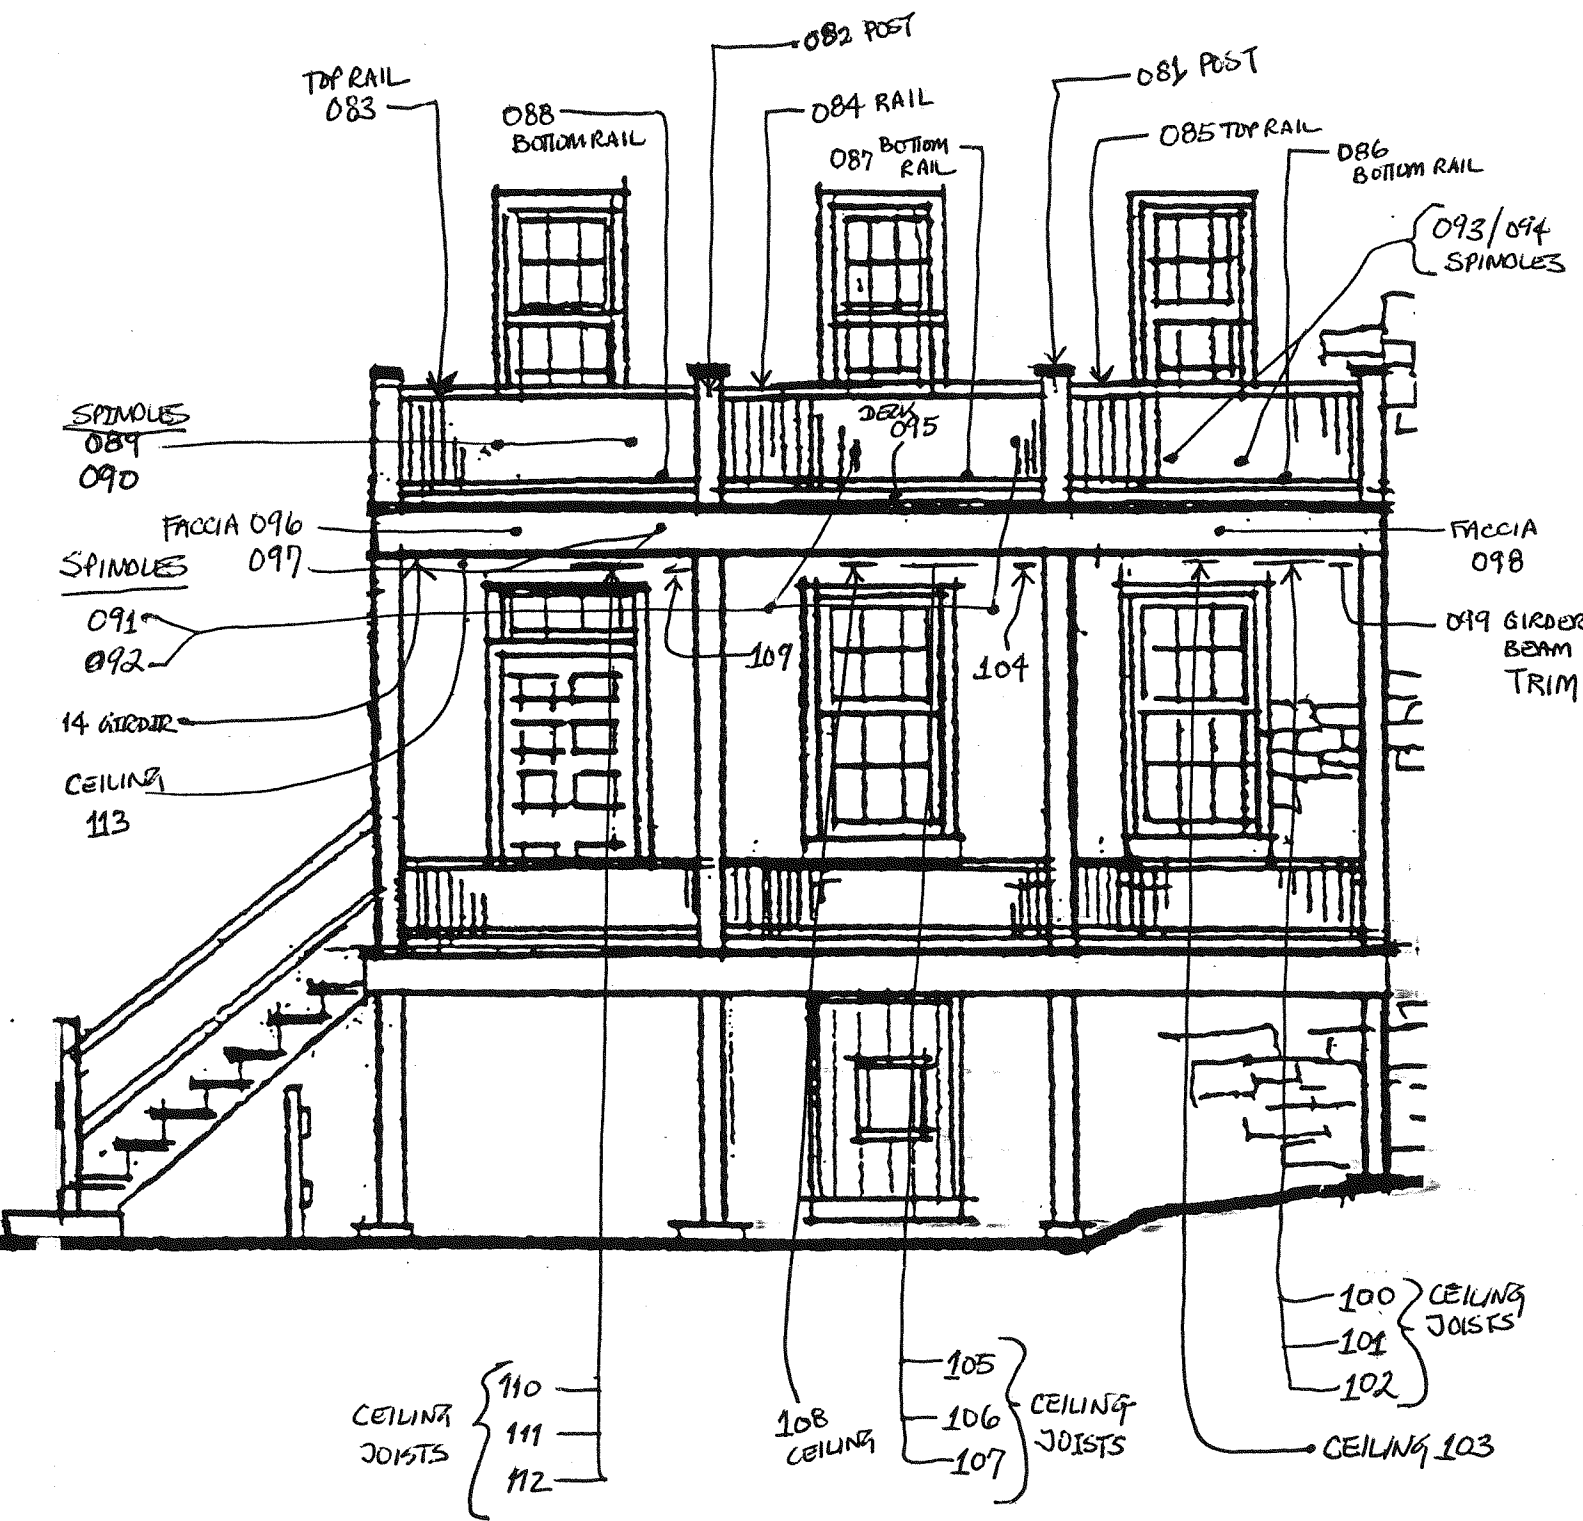
EAST ELEVATION - 1A EAST PORCH,  
NOT TO SCALE. HAF/NDP/NPS.  
HISTORIC HARPER HOUSE

Of the 114 surfaces tested, 18 surfaces had readings equal to or greater than 1.0 mg/cm<sup>2</sup>. These surfaces included framing, pilasters, spindles, bottom rails, joists, and girders. The 18 surfaces that tested positive for lead-based paint are shown as highlighted entries in the attached XRF field readings. The painted surfaces were observed to be in poor to good condition. The results of the XRF field readings are included in Appendix A – Summary of XRF Field Readings.
