Reference: Asbestos Containing Materials and Lead Based Paint Survey, Civil War Story  
Building 3, 31 High Street, Harper's Ferry, WV

**REPORT OF ASBESTOS CONTAINING MATERIALS AND  
LEAD BASED PAINT SURVEY**

**CIVIL WAR STORY BUILDING 3  
HARPER'S FERRY, WEST VIRGINIA**

**ECS PROJECT NO. 01:24343**

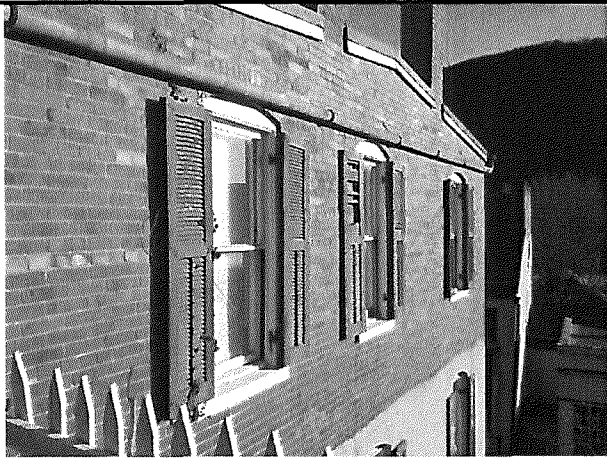
1. View of the windows along the side of the building.

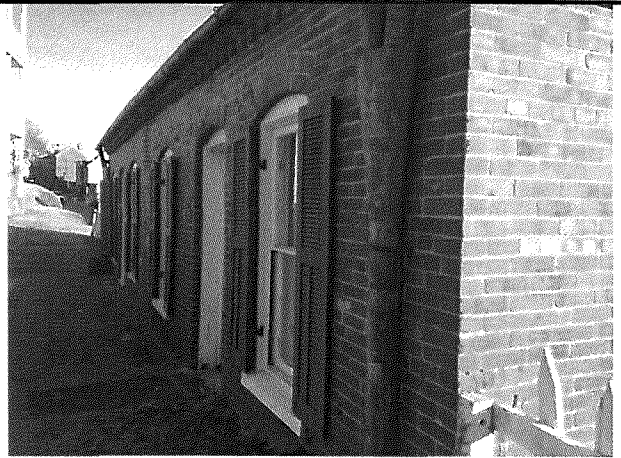
2. View of the rear windows.

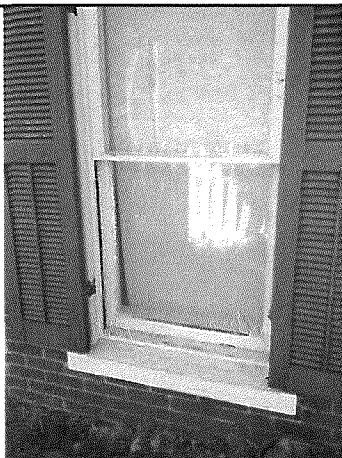
3. Typical view of the window.

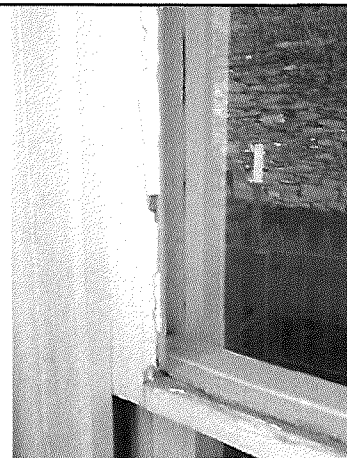
| <b><u>Sample #</u></b> | <b><u>Sampling Location</u></b> | <b><u>Material/Description</u></b> | <b><u>Analytical Results</u></b> |
|---|---|---|---|
| 1 | Exterior Windows | Exterior White Window Glaze | NAD |
| 2 | Exterior Windows | Exterior White Window Glaze | NAD |

4. View of the glazing.

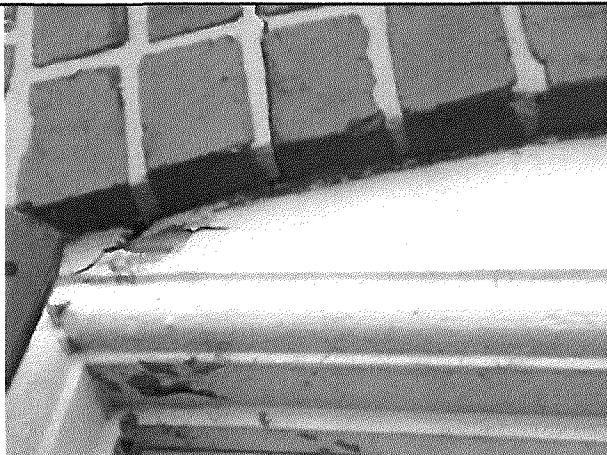
The exterior window caulk was observed to be missing in most locations. Samples were collected from residual caulk identified near the top of the window casings. Similar materials referenced above as asbestos containing may be present in other areas of the building.

| <b><u>Sample #</u></b> | <b><u>Sampling Location</u></b> | <b><u>Material/Description</u></b> | <b><u>Analytical Results</u></b> |
|---|---|---|---|
| 3 | Exterior Windows | Exterior White Window Caulk | NAD |

5. View of the window caulk (ACM), Sample No. 3.

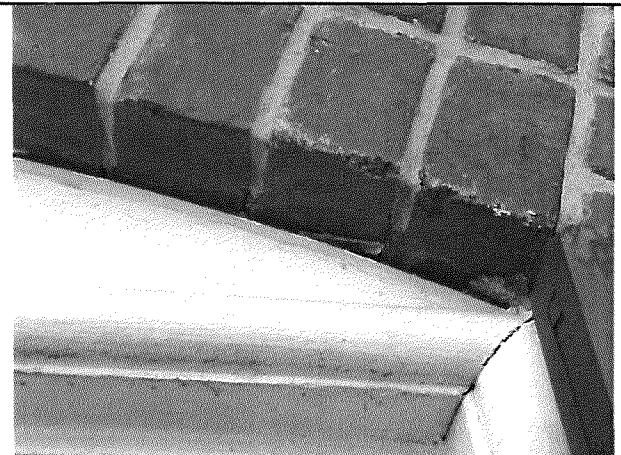
The materials listed in Table 1 consist of non-friable materials which contain greater than one percent ( $> 1\%$ ) asbestos. By definition, these materials are considered ACMs. Friable materials will easily produce airborne asbestos fibers if disturbed. Non-friable materials may also produce airborne asbestos fibers if disturbed.

| <b><u>Sample #</u></b> | <b><u>Sampling Location</u></b> | <b><u>Material/Description</u></b> | <b><u>Analytical Results</u></b> |
|---|---|---|---|
| 4 | Exterior Windows | Exterior White Window Caulk | Asbestos: 2% Chrysotile |

6. View of the window caulk (ACM), Sample No. 4.

Federal and state regulations require asbestos-containing materials be removed prior to disturbance by renovation/demolition operations by a qualified contractor.

If the ACM materials will remain in place, ECS recommends that they be placed within an Operations and Maintenance Plan for continued monitoring.
