Reference: Asbestos Containing Materials and Lead Based Paint Survey, Murphy Farm House, 123 Murphy Road, Harper's Ferry, WV

**REPORT OF ASBESTOS CONTAINING MATERIALS AND  
LEAD BASED PAINT SURVEY**

**MURPHY FARM HOUSE  
HARPER'S FERRY, WEST VIRGINIA**

**ECS PROJECT NO. 01:24343**

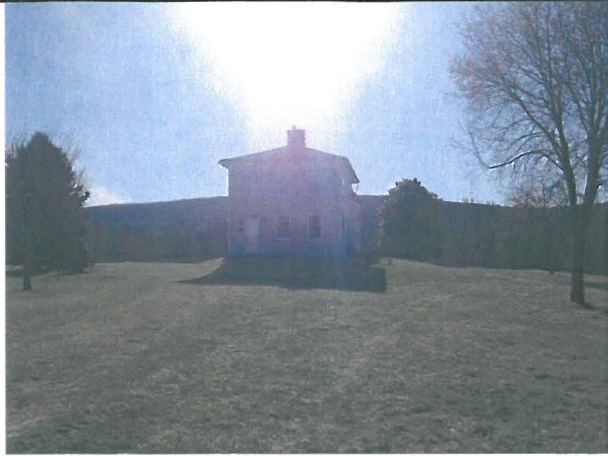
1. View of the Murphy Farm House, and front upper roof.

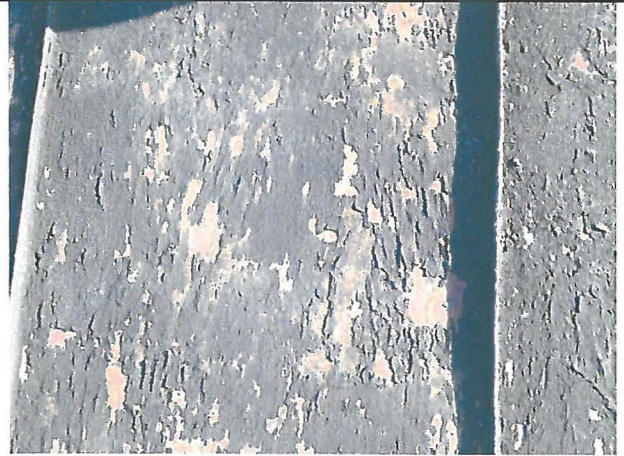
| <u>General Location</u> | <u>Material</u> | <u>Friability</u> |
|---|---|---|
| Lower Metal Roof | Black Roof Membrane on Metal Roof | Category I<br>Non-Friable |

The roofing materials were observed to be in fair condition. Similar materials referenced above as asbestos containing may be present in other areas of the building

| <u>Sample #</u> | <u>Sampling Location</u> | <u>Material/Description</u> | <u>Analytical Results</u> |
|---|---|---|---|
| 1 | Rear Lower Roof | Black Membrane on Metal Roof | Asbestos: 4% Chrysotile |
| 2 | Rear Lower Roof | Black Membrane on Metal Roof | Asbestos: 4% Chrysotile |

2. View of the lower metal roof with black membrane (ACM), Samples 1-2.

Federal and state regulations require asbestos-containing materials be removed prior to disturbance by renovation/demolition operations by a qualified contractor.

If the ACM materials will remain in place, ECS recommends that they be placed within an Operations and Maintenance Plan for continued monitoring.

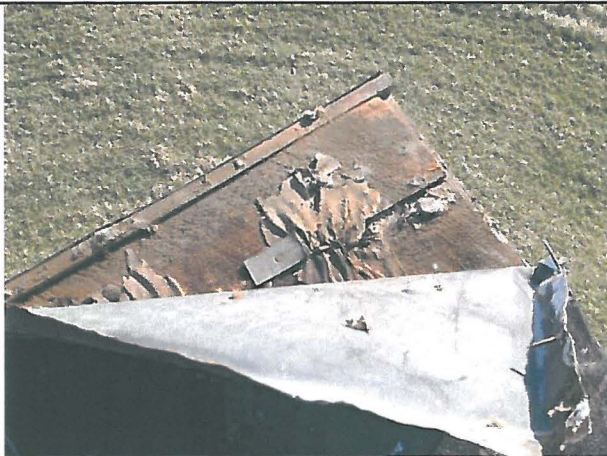
| <u>Sample #</u> | <u>Sampling Location</u> | <u>Material/Description</u> | <u>Analytical Results</u> |
|---|---|---|---|
| 3 | Rear Lower Roof | Tan Felt Paper under Metal Roof | NAD |
| 4 | Rear Lower Roof | Tan Felt Paper under Metal Roof | NAD |

3. View of the paper membrane beneath the metal roof.

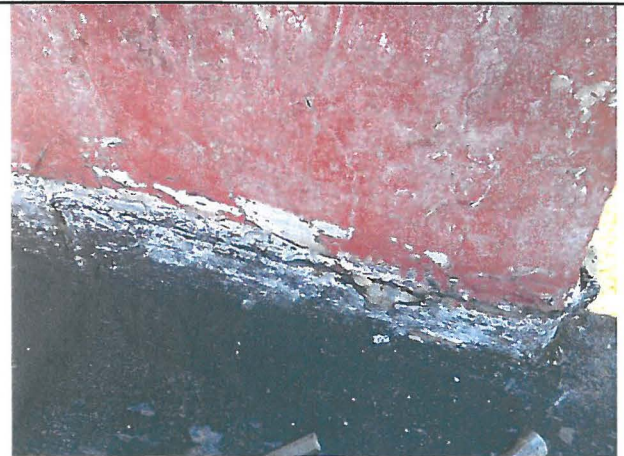
| <u>General Location</u> | <u>Material</u> | <u>Friability</u> |
|---|---|---|
| Lower Metal Roof at Chimney | Black Chimney Flashing with Tar | Category I<br>Non-Friable |

| <u>Sample #</u> | <u>Sampling Location</u> | <u>Material/Description</u> | <u>Analytical Results</u> |
|---|---|---|---|
| 7 | Rear Lower Roof | Black Chimney Flashing | Asbestos: 7% Chrysotile |
| 8 | Rear Lower Roof | Black Chimney Flashing | Asbestos: 7% Chrysotile |

4. View of the chimney flashing (ACM), Samples 7-8.

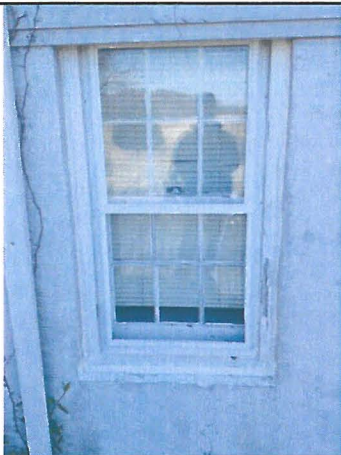
detected in several components or tested areas to range from 0.05 to 0.27 mg.cm<sup>2</sup>. Based on this information, all of the window components should be considered as lead containing. It is recommended that where LBP is to be disturbed that work be performed in accordance with the US EPA Renovation Repair, and Painting Rule using a certified contractor under 40 CFR 745.

5. Typical view of the window.

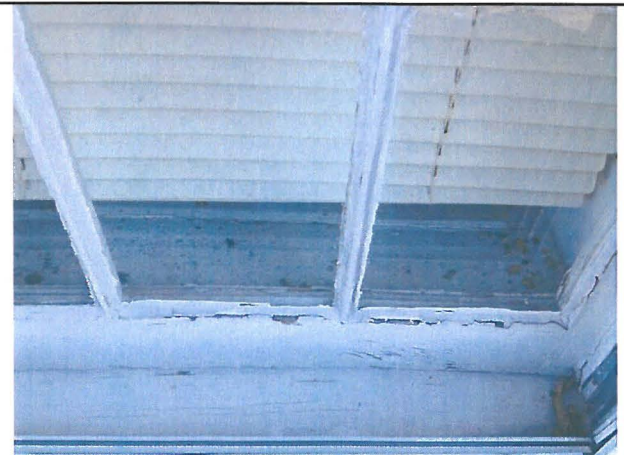
| <u>Sample #</u> | <u>Sampling Location</u> | <u>Material/Description</u> | <u>Analytical Results</u> |
|---|---|---|---|
| 9 | Exterior Windows | Exterior White Window Glazing | NAD |
| 10 | Exterior Windows | Exterior White Window Glazing | NAD |

6. Typical view of the window glazing.
