# United States Department of the Interior

## Memorandum

Subject: In-stream wood assessment for Dingmans Creek and other drainages, DEWA

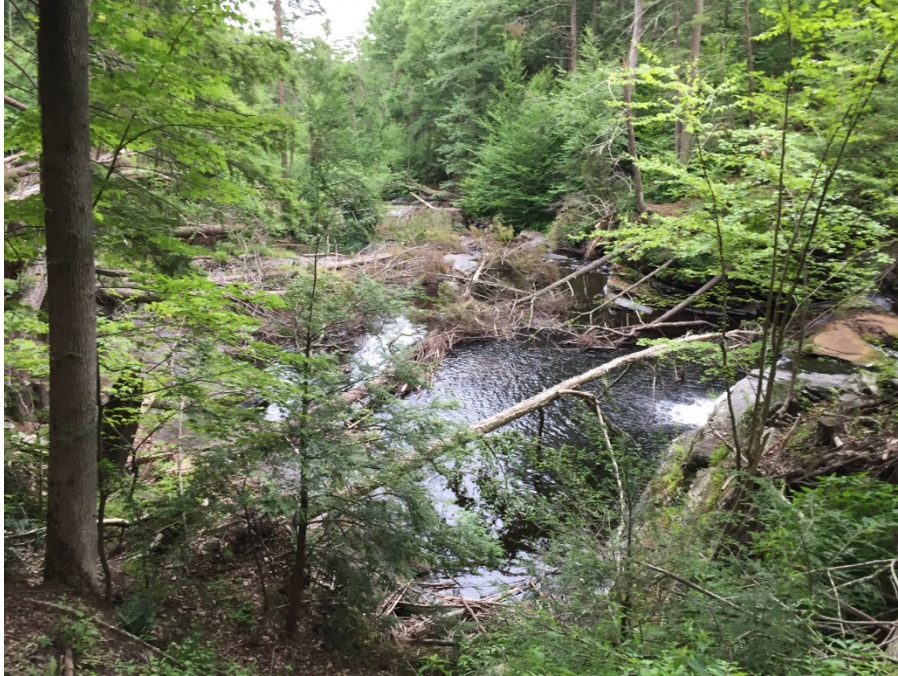
**Figure 4.** Looking downstream at Factory Falls in the Childs Park area. Note the large collection of instream wood, including channel spanning trees. NPS – 2018.

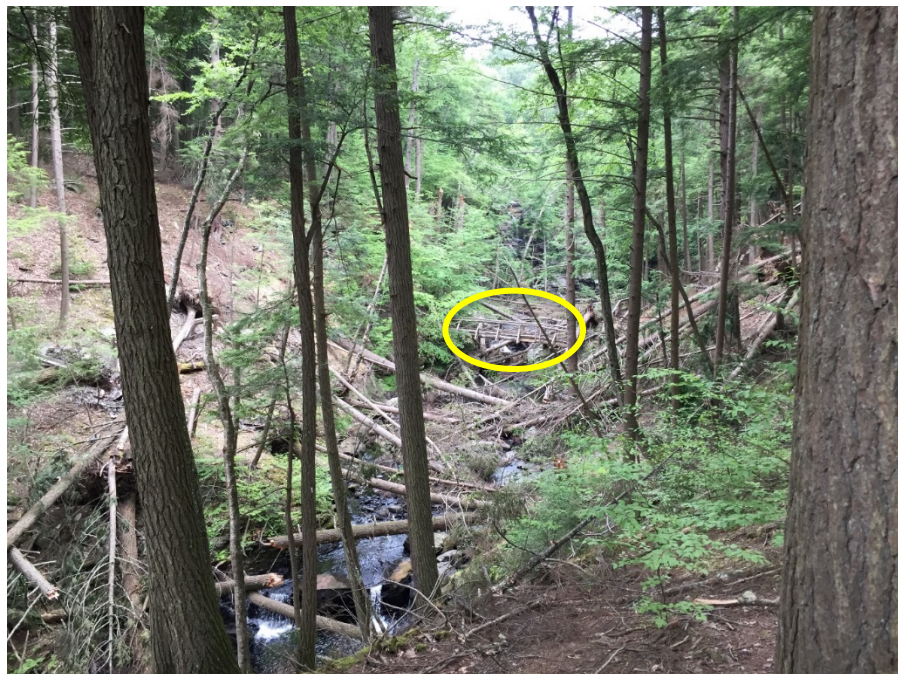
**Figure 5.** Looking upstream at Dingmans Creek in the Childs Park area. Note the large collection of instream wood in the area of the footbridge (circled in yellow). NPS – 2018.

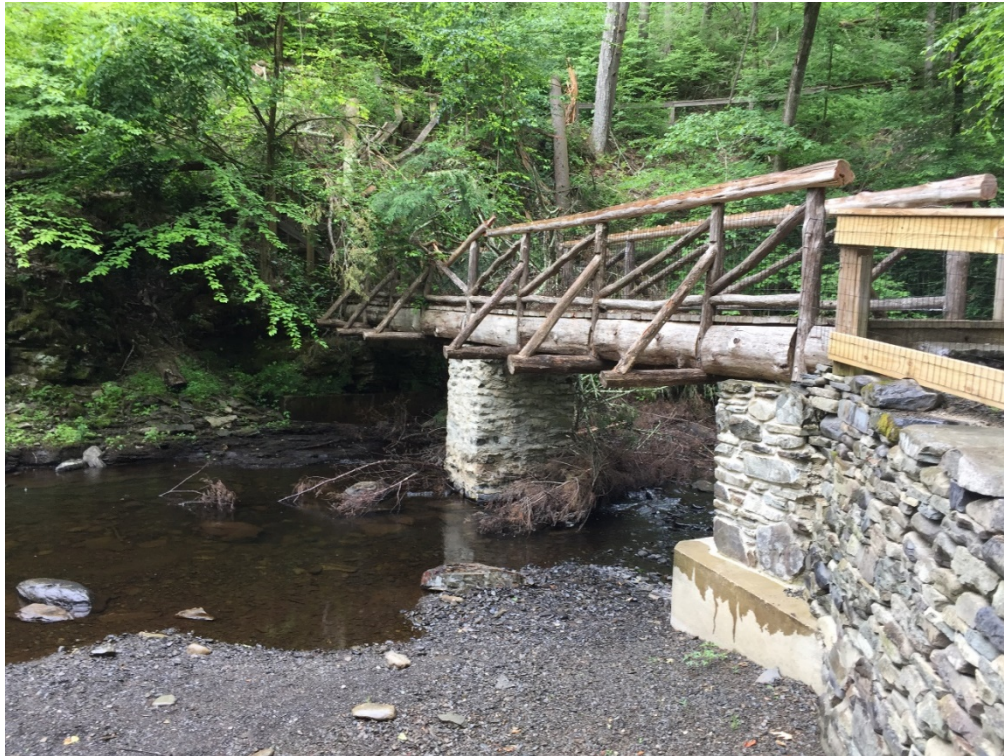
**Figure 6.** Looking upstream at Dingmans Creek in the Childs Park area. Note the collection of instream wood in the area of the footbridge. NPS – 2018.

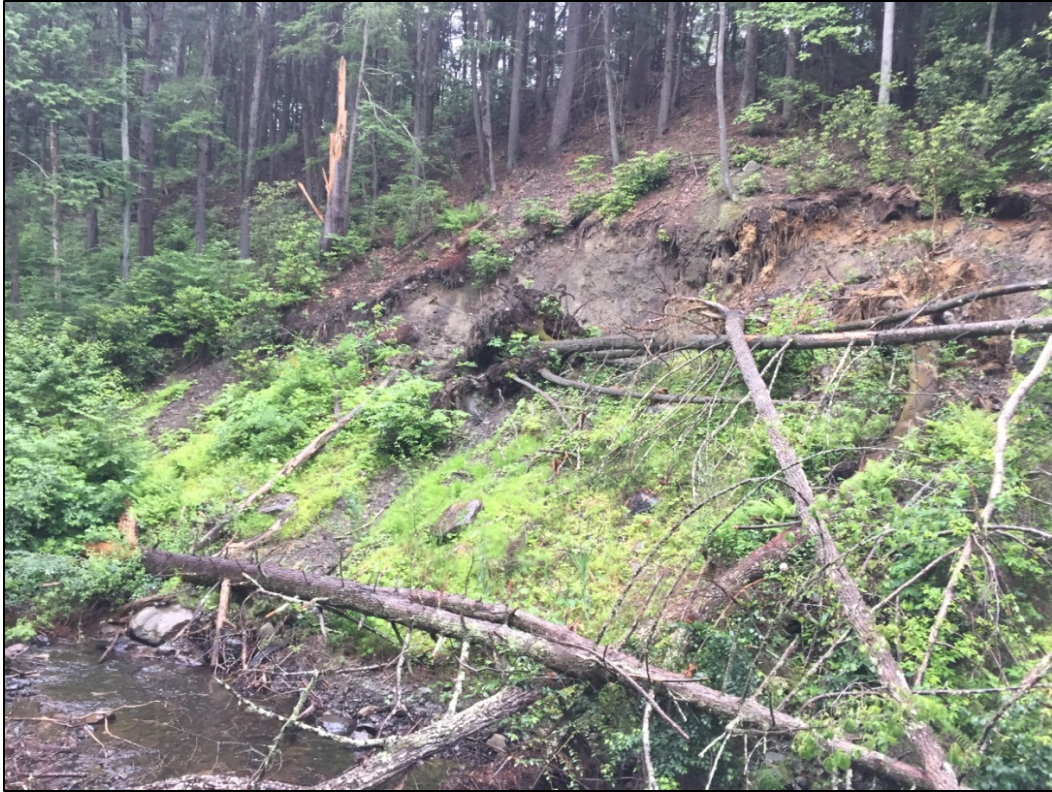
Along Dingmans Falls Visitor Center (DFVC) road and trail, we evaluated two road crossings as well as the stream reach between the DFVC and Dingmans Falls (Figure 3). Immediately upstream of the upper road crossing, a number of large logs had been mobilized by a slope failure, and were poised to move into the creek, possibly blocking flow under the bridge (Figure 7). This site serves as an example of a potential threat that could be considered for treatment. Besides the upper crossing shown in Figure 7, we saw no other conditions that appeared to pose a threat in this area. Most of the stream reach between the DFVC and Dingmans Falls had very little instream wood, even in the low gradient, collection areas.

**Figure 7.** Slope failure immediately upstream of the upper bridge crossing on DFVC road. View is looking upstream. Several large logs that have been mobilized will wind up in the channel, and could block flow under the bridge.

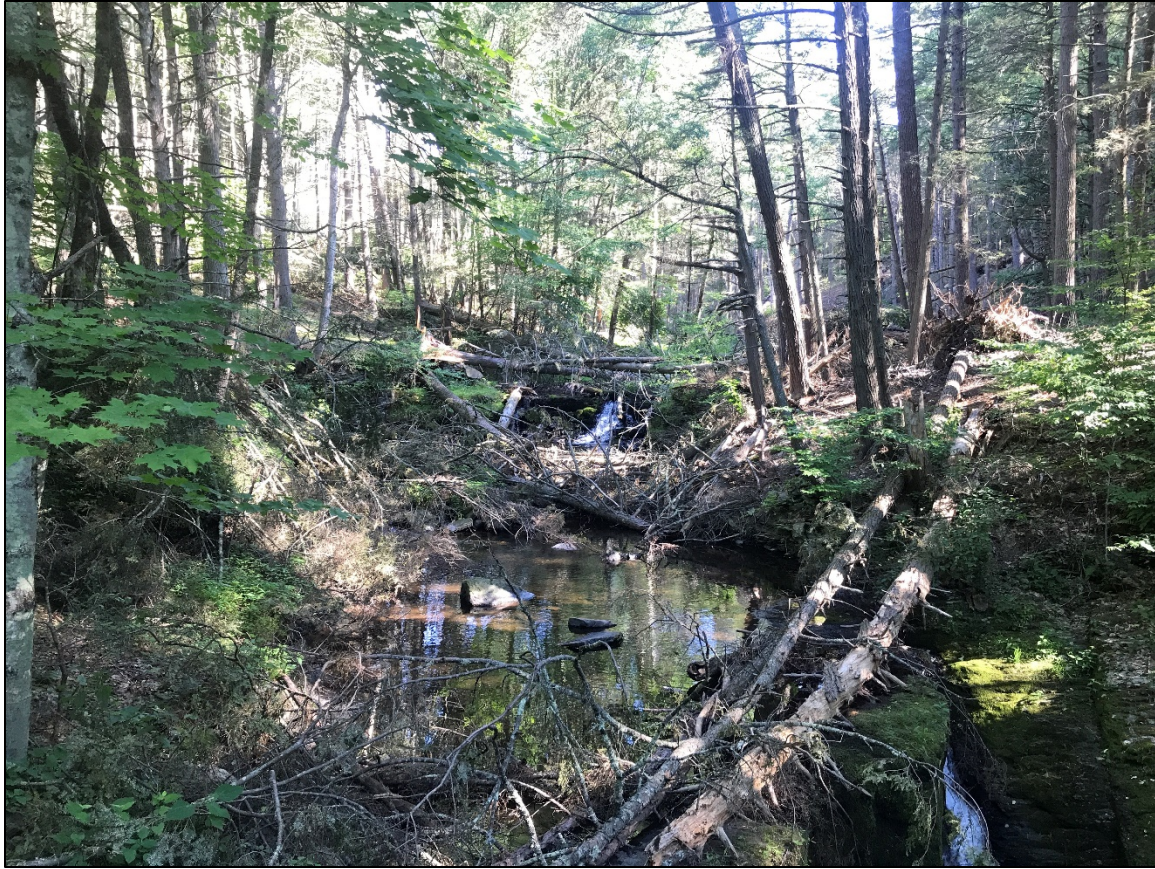
Photograph A1. Adams Creek looking upstream 339<sup>0</sup>N from the location of the historic water wheel (41.252117, -74.882109). Much of the instream and floodplain wood shown in the photograph was recently deposited as a result of the winter Nor-Easters that came through the park in [March](#), 2018. This site is indicative of similar blow down areas within the survey watersheds and our recommendation is to leave the instream and floodplain wood in place and allow it to move and collect naturally. Some of the ecosystem services that are exemplified in this image are: providing energy dissipation, adding structure and diversity to the channel morphology, providing instream nutrient source and refugia, etc.

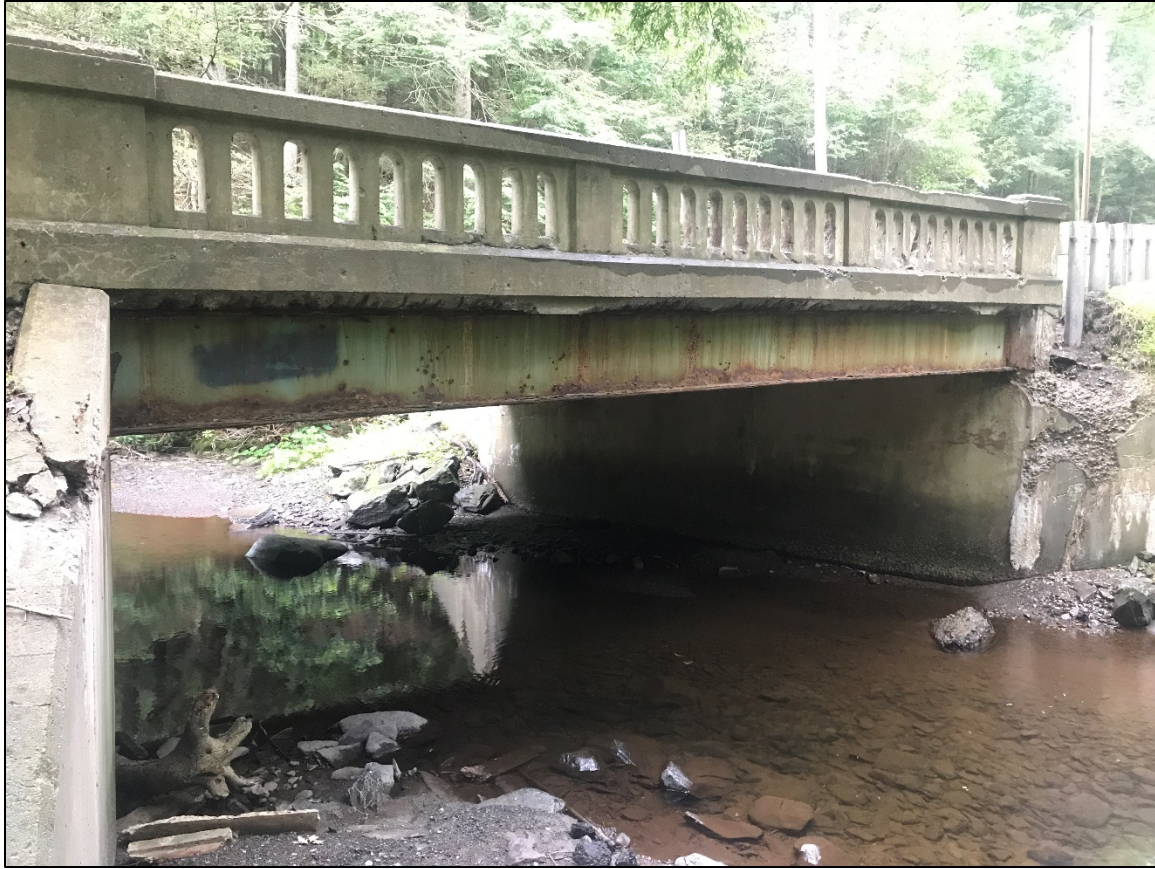
Photograph A2. Dingmans Creek looking downstream 185°S looking at the stream as it flows underneath the SR 2001 Bridge (41.232312, -74.910356). This bridge is indicative of the type of structures that would be vulnerable to instream wood movement within our assessment watersheds. As can be seen here, the bridge is single-span with no piers, which minimizes the chance of instream wood captures. This is the type of structure present at every major bridge crossing we examined as part of this study. Nevertheless, under certain conditions, a logjam could form at this type of bridge crossing leading to redirected flows and possibly damaging resources and infrastructure. A reconnaissance level survey of all bridge crossing after any large flow should be considered.

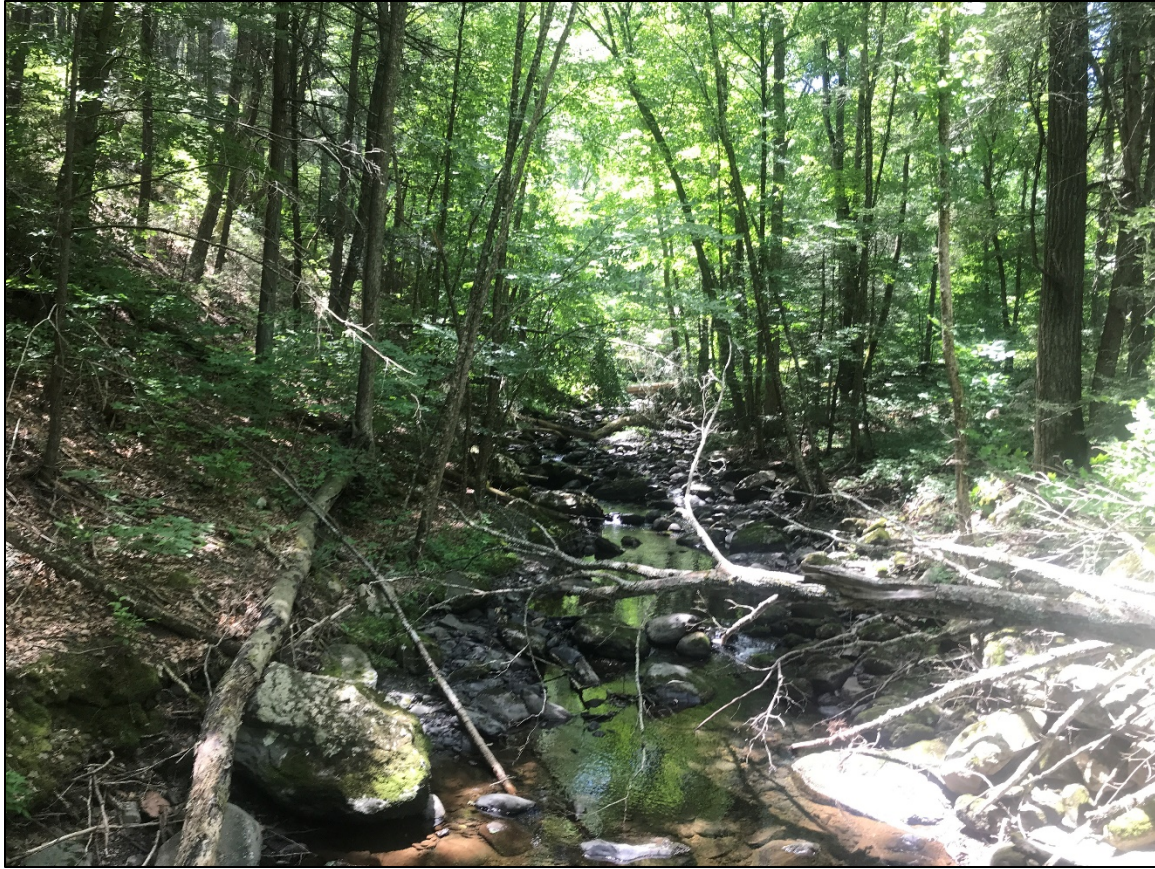
Photograph A3. Hornbecks Creek looking upstream 243°SW as it flows underneath a trail bridge (41.190812, -74.891804). The instream and floodplain wood shown here is not currently threatening any park infrastructure and resources and is unlikely to readily move under normal flow conditions. Many of the trees span the entire width of the channel with some still partially rooted or anchored into the bank. Much of the wood exhibits high degrees of branching that tends to inhibit mobility. Some redistribution during floodflows should be expected, but it is unlikely that the trail bridge or any other park infrastructure or resources will be impacted by the resulting conditions.

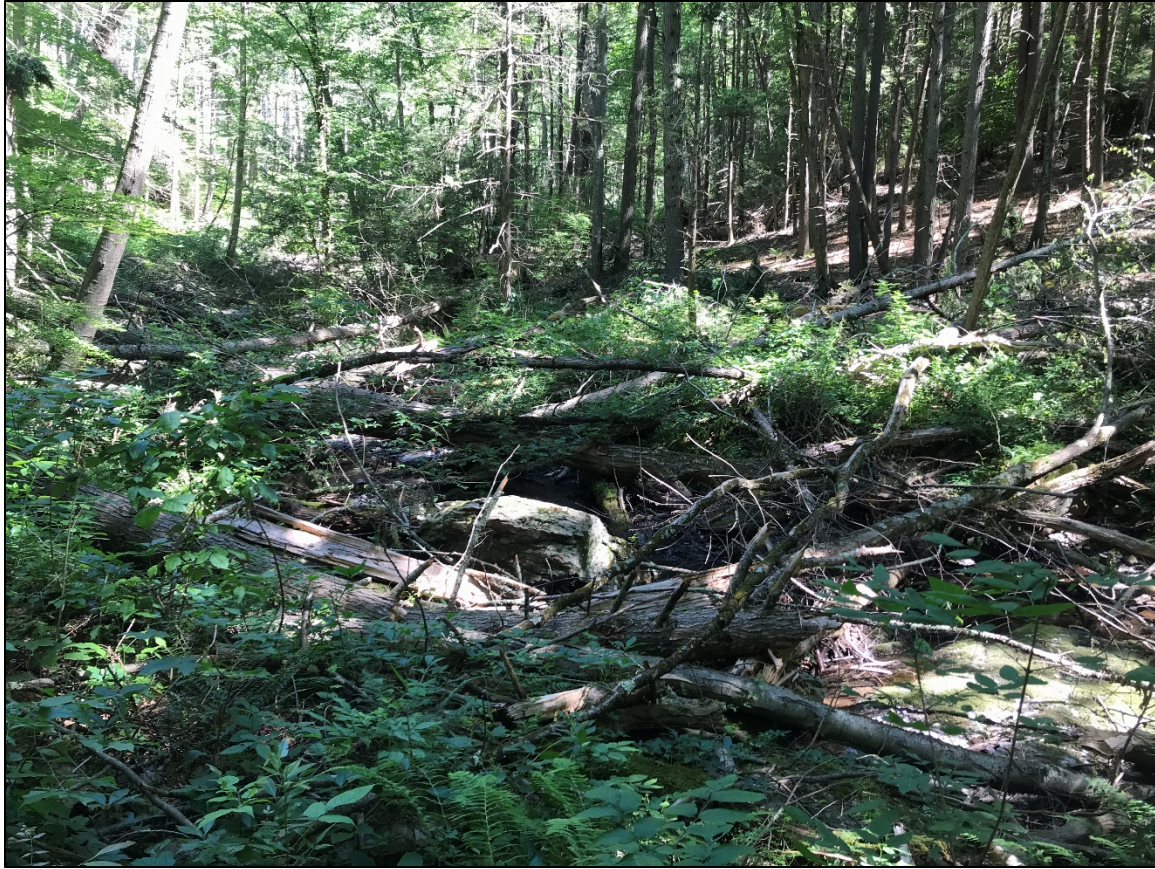
Photograph A4. Mill Creek looking upstream 2°N at a large deposit of instream wood (41.154668, -74.917715). This reach of the stream appears to be heavily impacted by downed timber, yet ecosystem services identified in Figure A1 are provided here by the instream and floodplain wood. The wood shown here is unlikely to move downstream during normal flow conditions, but some redistribution during flood flows should be expected. Given the setting, it is unlikely that this instream and floodplain wood could impact either park infrastructure or resources.

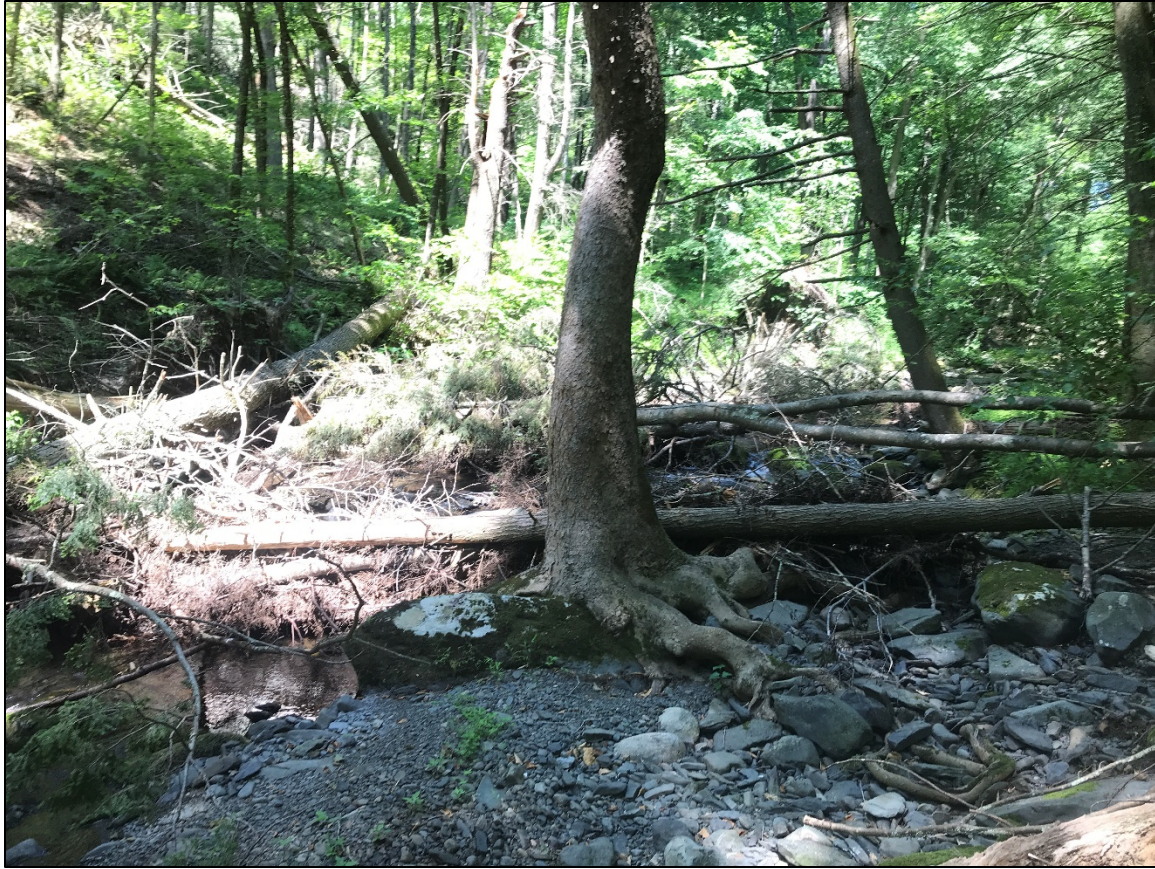
Photograph A5. Toms Creek looking upstream 297°NW at a large collection of instream wood (41.129811, -74.960302). Note the length and diameter of the downed timber. Deposits of instream wood like this tend to be relatively stable, even during high flows due to the difficulty of moving large trees through a fluvial system. These types of large (long) pieces of wood often times serve as structural elements in logjams and form bed steps by trapping sediment.
