# Quarters 1 Superintendent's Residence, Garage, and Permanent Masonry Landscape Features Historic Structure Report

## Quarters 1

# Historic Structure Report

June 2013

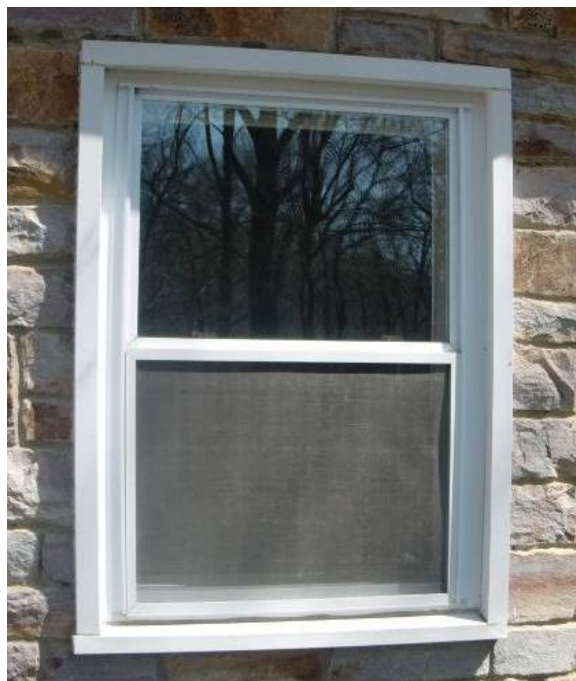
*Figure 113.* The dining room windows have been replaced with vinyl-clad units. Note lite patterns do not match. Photo: HPTC (04/21/12).

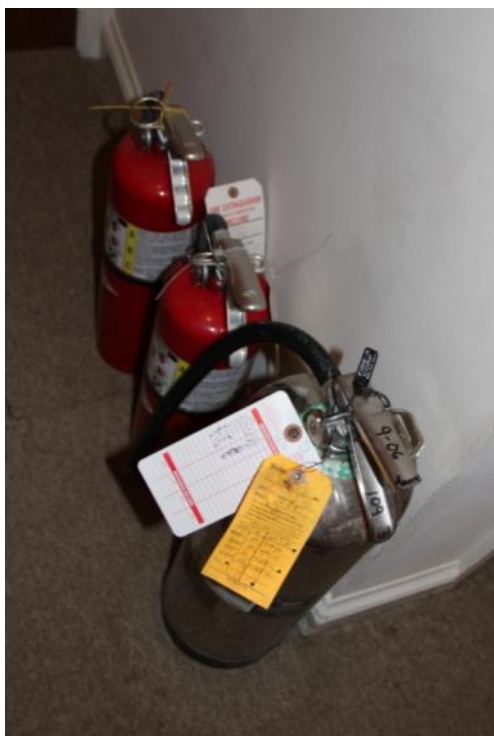
Figure 182. The three fire extinguishers for Quarters 1 need to be redistributed throughout the building. Photo: HPTC (06/12/12).

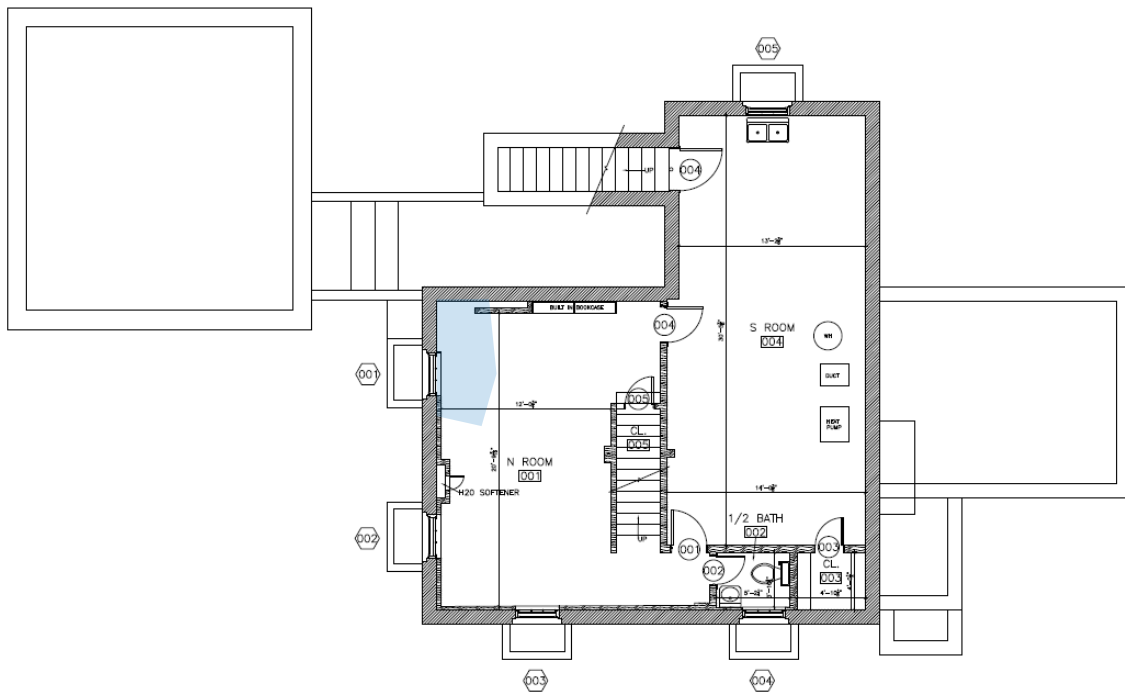
Figure 206. Basement floor plan. Blue overlay depicts area of moisture infiltration from exterior grade above. Drawing: HPTC (2012).

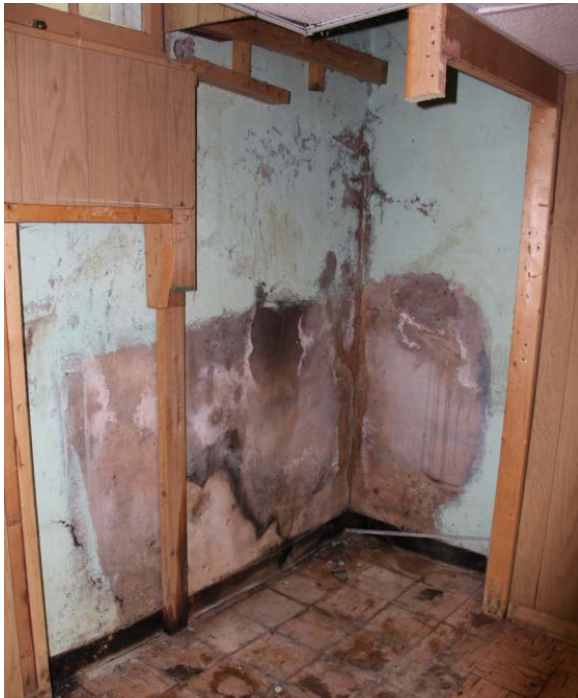
| <div><div><p><i>Figure 344.</i> Evidence of rising damp, through flaking paint, and mold can be seen at the northeast corner of Room 004. Photo: HPTC (06/20/12).</p></div><div><p><i>Figure 345, right.</i> The area of immediate concern at the northeast corner of Room 001. Note the adjacent window opening (W001). Photo: HPTC (06/20/12).</p></div></div> | | | |

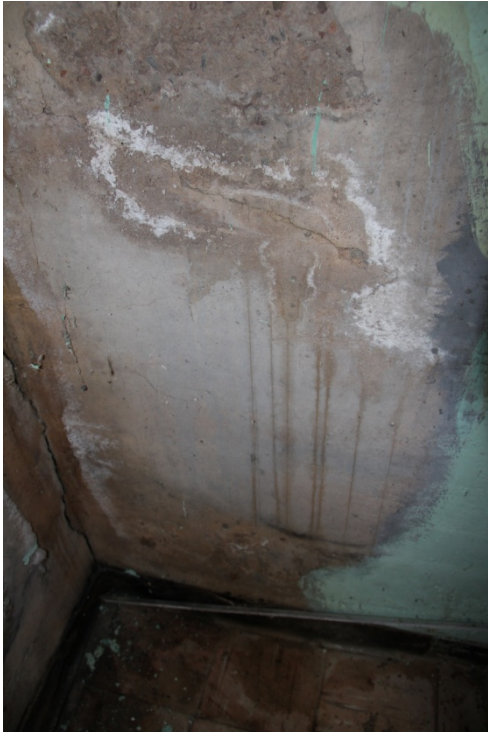
Figure 346. Cracks have formed in the concrete walls and evidence of seeping water can be seen. Photo: HPTC (06/20/12).

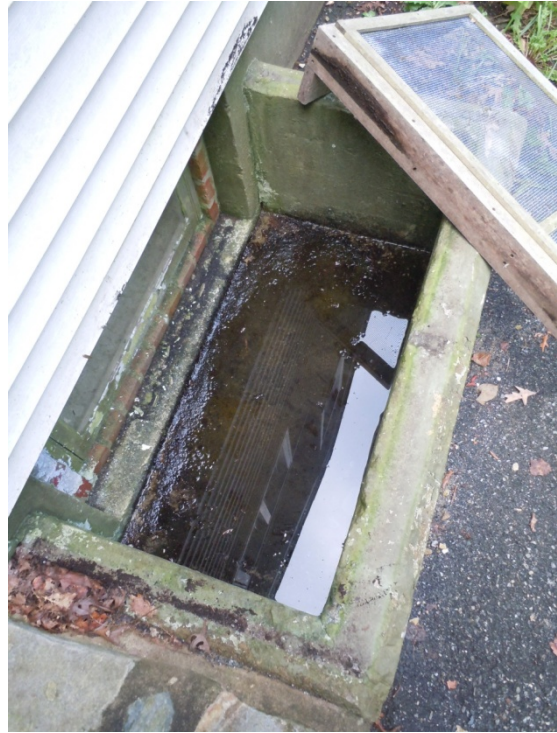
Figure 347. Water is being retained in the well of W001 adjacent to the northwest corner of Room 001. Photo: HPTC (08/29/12).

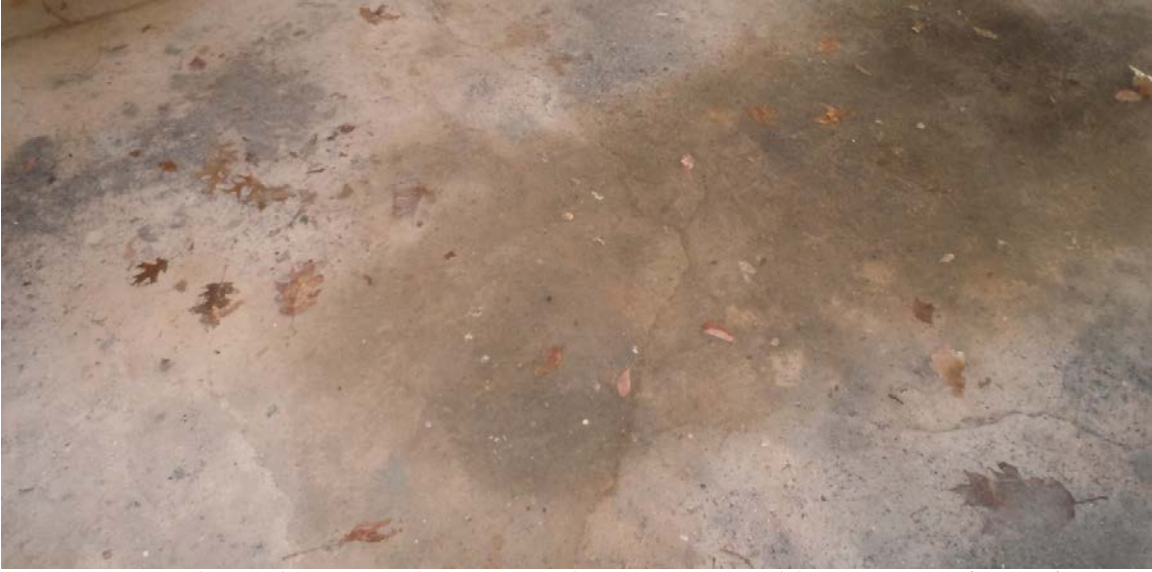
| <b>A103001-4 Garage Slab On Grade</b> | |
|---|--|
| <p>Figure 354. Minor cracking and staining can be seen across the garage concrete slab. Figure: HPTC (07/17/12).</p> | |

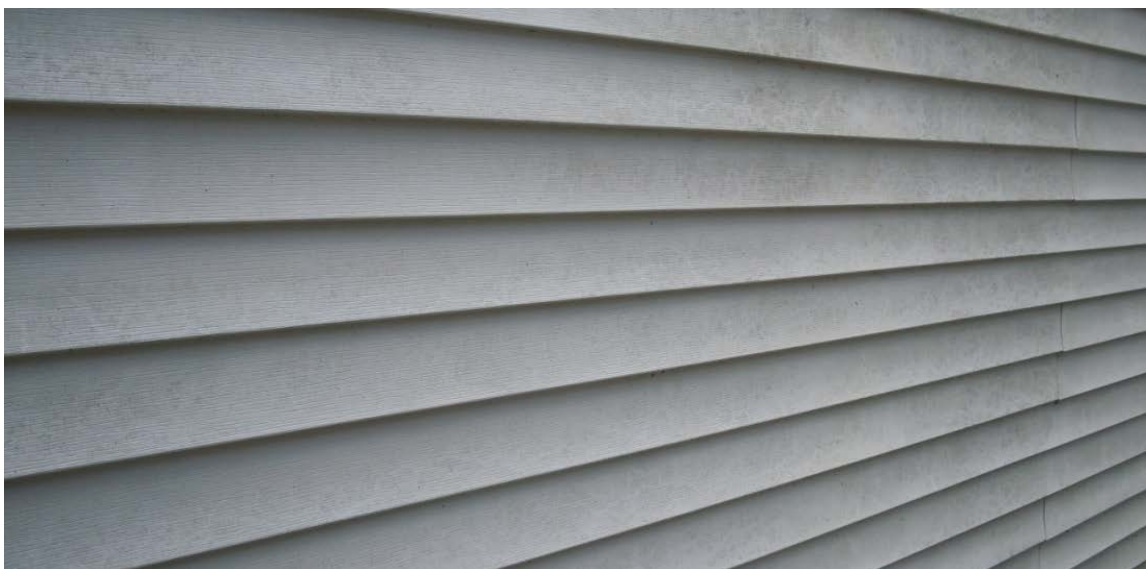
Figure 355. Modern vinyl siding covers the north elevation brick wall of the main block. Photo: HPTC (08/29/12).

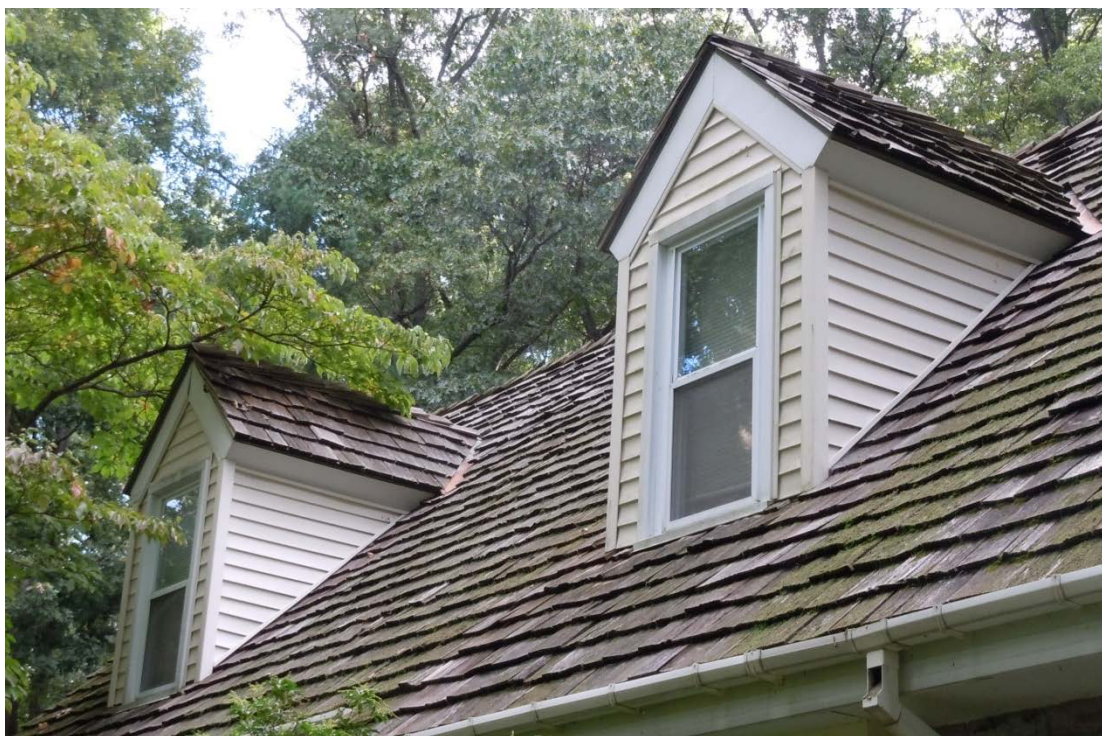
*Figure 358.* The cedar shakes of the main block hipped and gable roofs have neared the end of their useful lifespan. Note the overhanging vegetation that should be cut away from the building. Photo: HPTC (08/29/12).

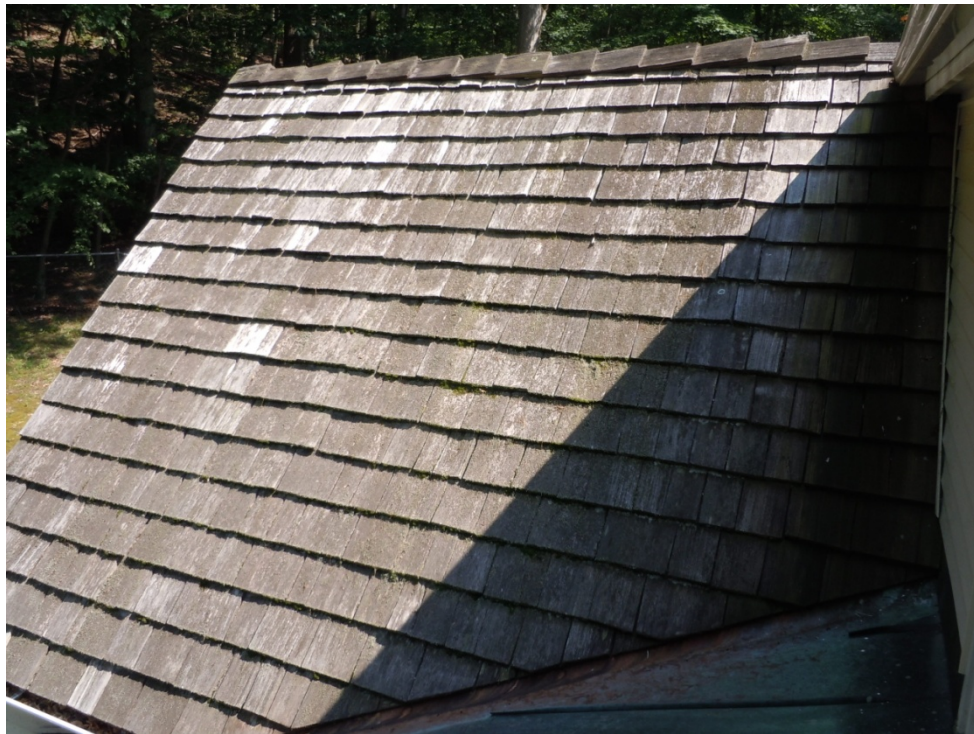
*Figure 359.* The northern slope of the eastern ell cedar roof exhibits warped and weathered shakes nearing the end of their lifespan. Photo: HPTC (07/17/12).

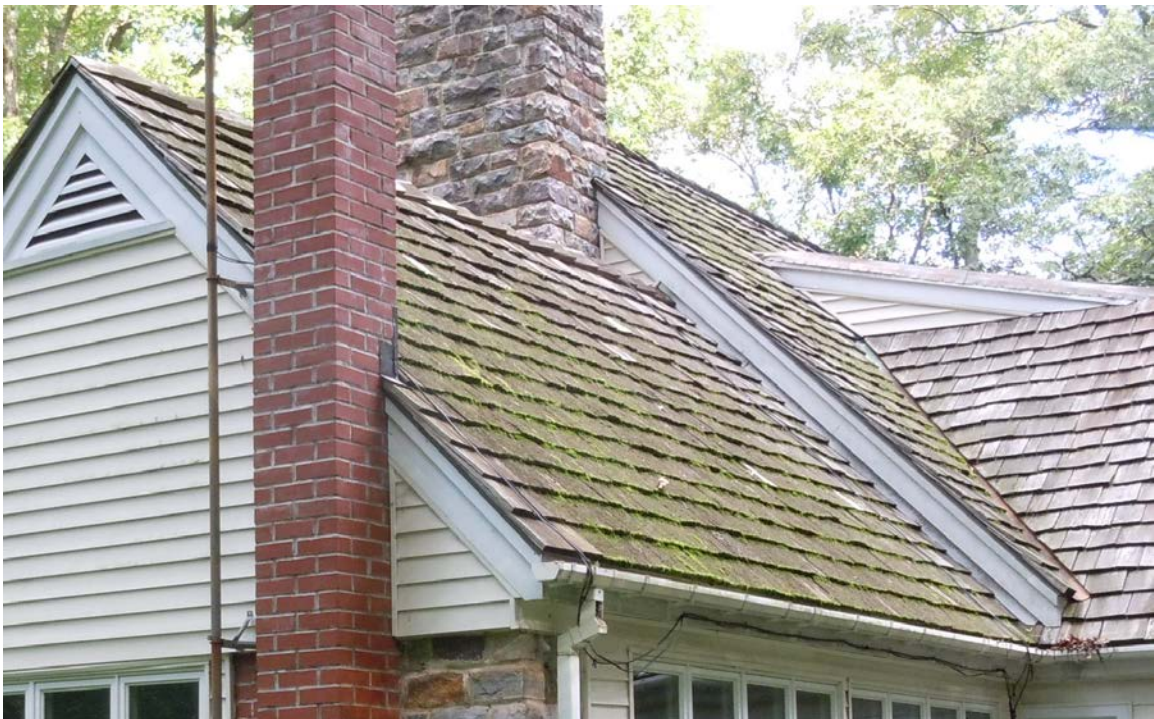
Figure 360. The eastern slope of the sun porch cedar roof exhibits biological growth. Photo: HPTC (08/29/12).

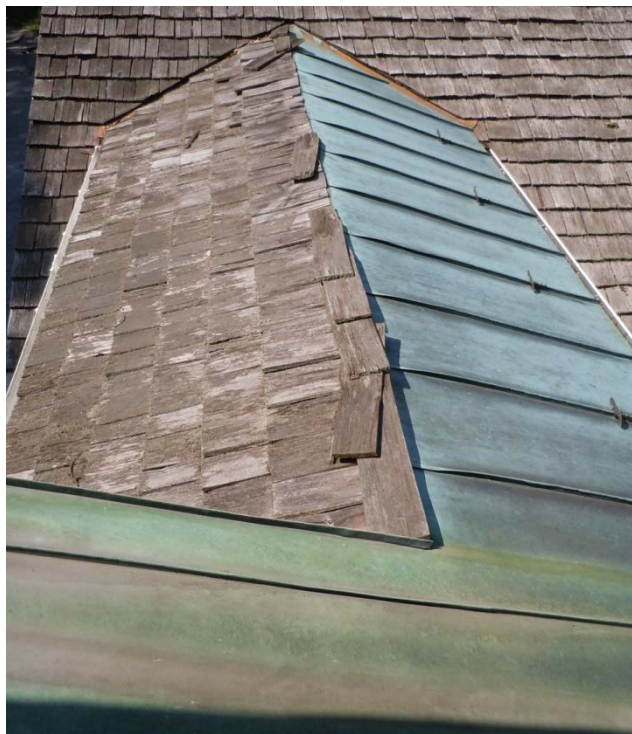
*Figure 361.* The cedar shakes composing the ridge cap have become detached in many places. The copper standing-seam roof is not historically accurate for these roofs. Photo: HPTC (07/17/12).

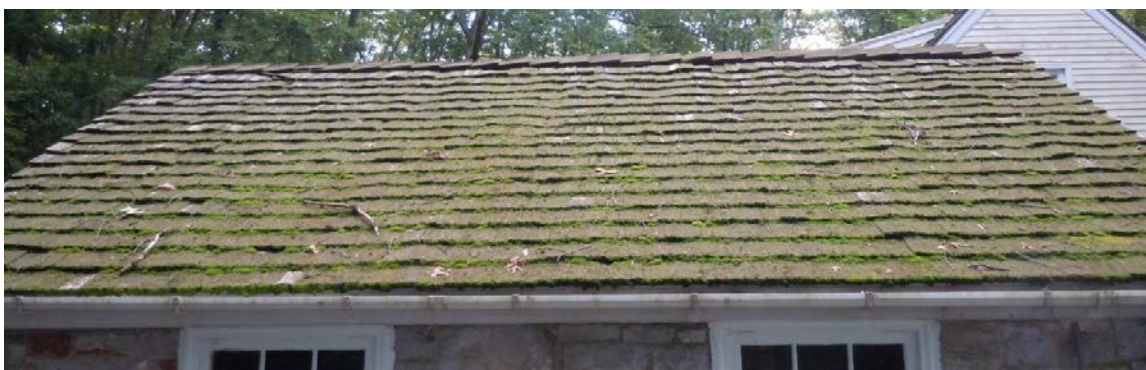
Figure 362. The cedar shakes on the garage gable roof exhibit a large amount of biological growth. Photo: HPTC (08/29/12).

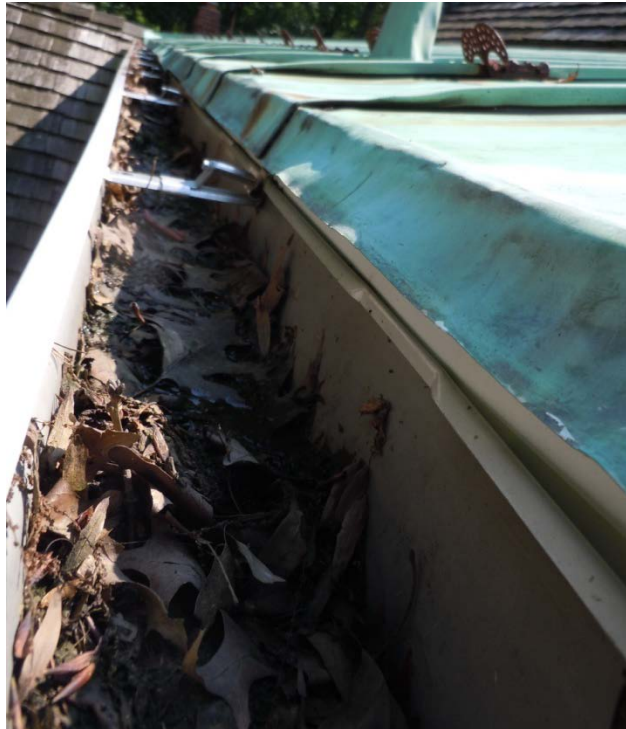
*Figure 364.* Vegetative debris has collected in the rear dormer gutter clogging both the gutter and the downspout. Photo: HPTC (08/29/12).

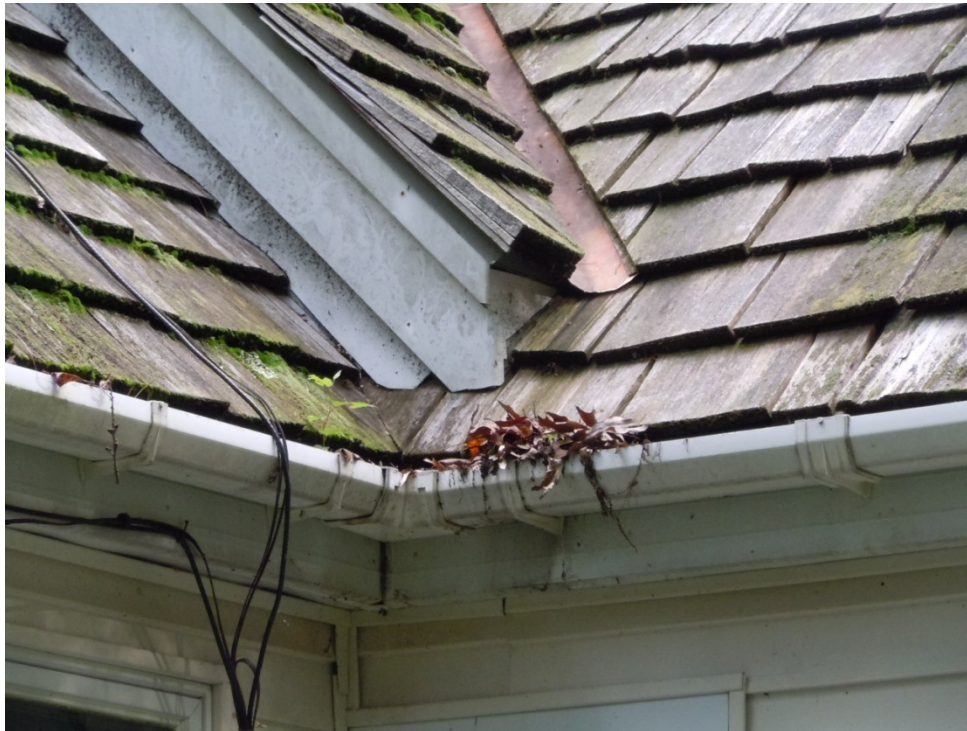
*Figure 365.* Vegetative debris has accumulated in the gutters of the eastern ell. The U-shaped gutters are not considered to be character-defining features. The size of the gutter is also significantly smaller and cannot carry the rain runoff from this roof. Note communications cables hung from the building – it should be determined if these are active; if not they should be removed, if they are they should be rerouted through the building in an unobtrusive manner. Photo: HPTC (08/29/12).

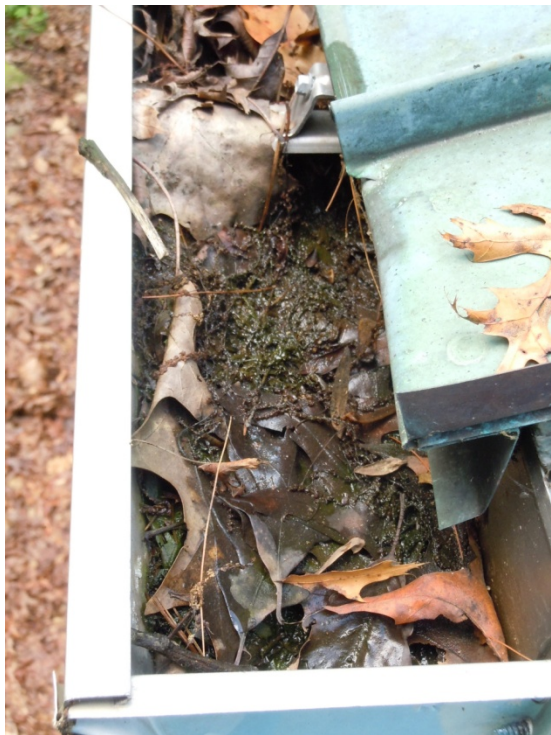
Figure 366. The accumulation of vegetative debris in a gutter at the breezeway roof has caused the retention of water in the system. Photo: HPTC (08/29/12).

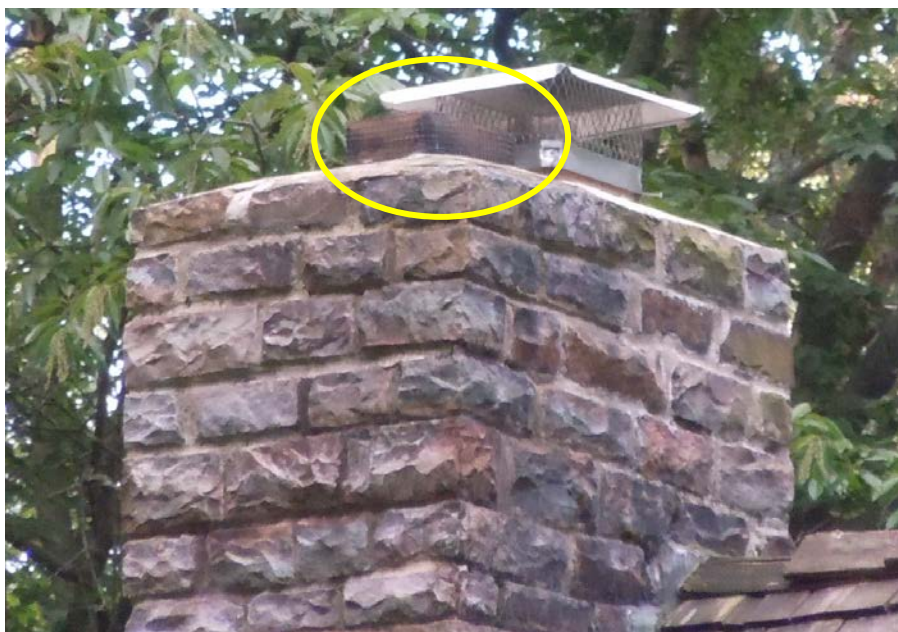
Figure 369. The eastern flue of the stone chimney lacks a chimney cap. Photo: HPTC (08/29/12).

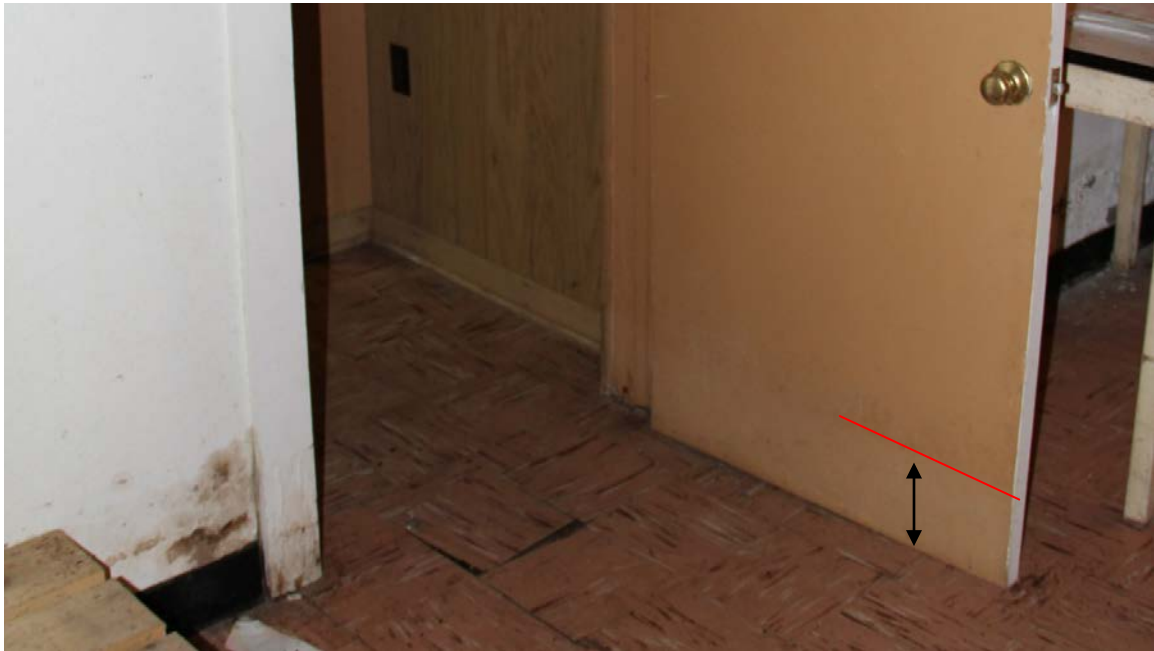
Figure 370. Water staining on the lower portion of a basement door. Arrow indicates level of rising damp on virtual surfaces. Photo: HPTC (06/20/12).

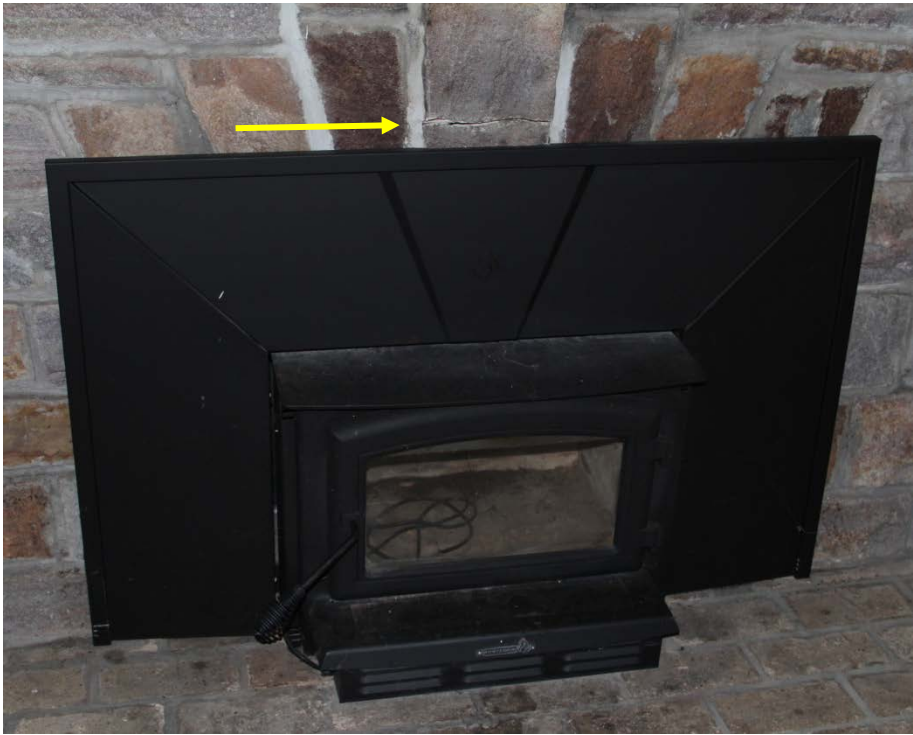
| C103098 Other Casework - Fireplaces | |
|---|--|
| <p>Figure 371. The stone keystone was damaged when the modern woodstove was added to the main block fireplace. Photo: HPTC (06/12/12).</p> | |

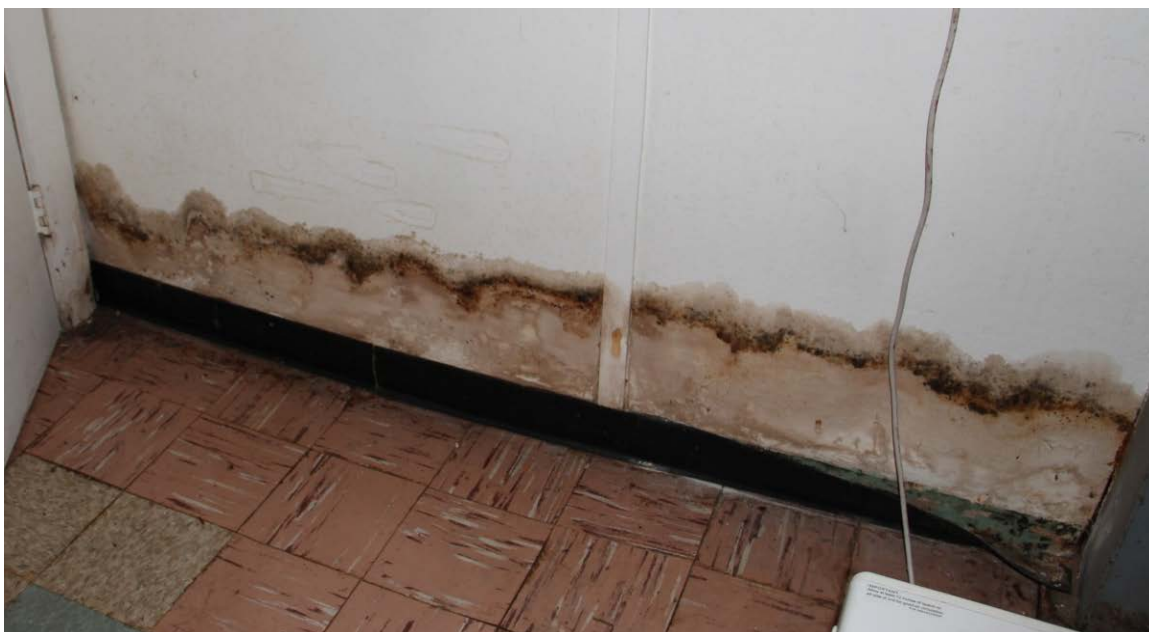
Figure 372. Water staining and bio-growth on the lower foot of the basement wallboard. Photo: HPTC (06/20/12).

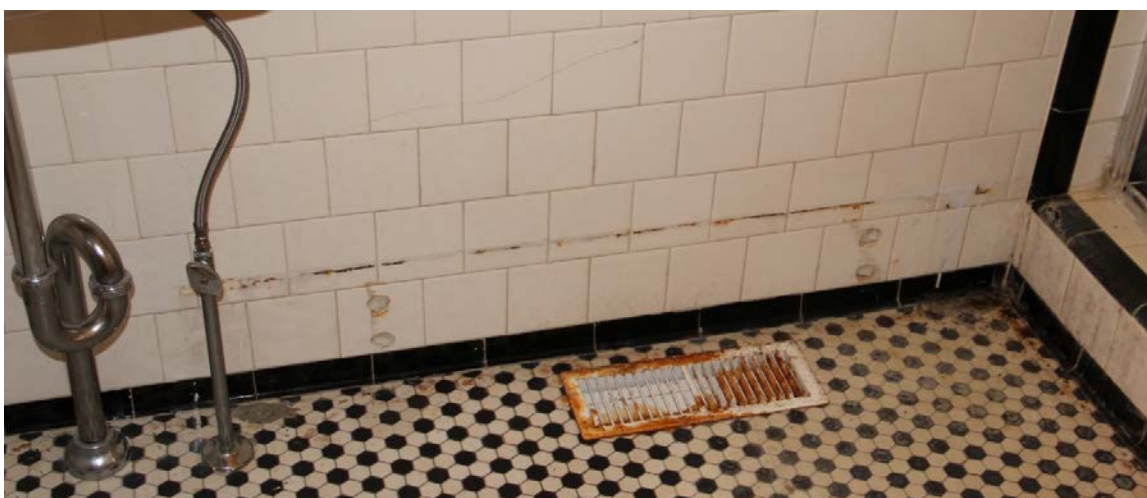
Figure 373. Rudimentary repairs were made to the ceramic wall tile in the first-floor bathroom. Note the rusty floor register due to high humidity in this area. Photo: HPTC (06/12/12).

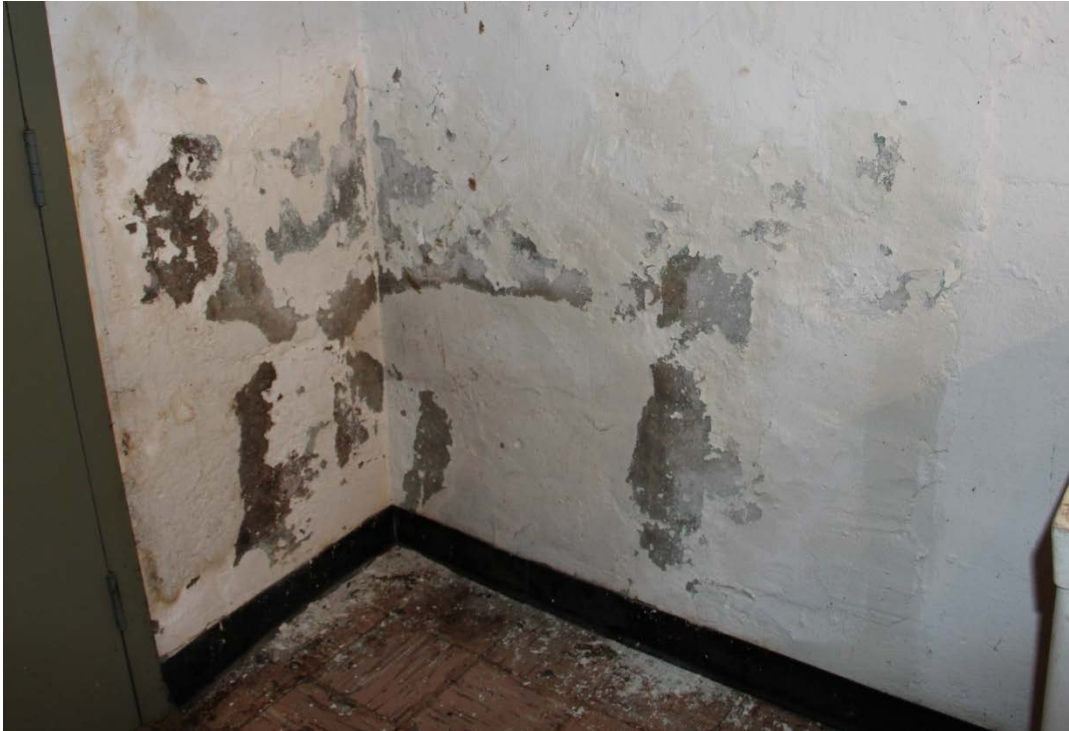
| <b>C301005   Painted Wall Finishes</b> | |
|---|--|
| <p><i>Figure 374. Blistering and flaking paint on the basement concrete foundation wall surfaces indicates that rising damp has occurred. Photo: HPTC (06/20/12).</i></p> | |

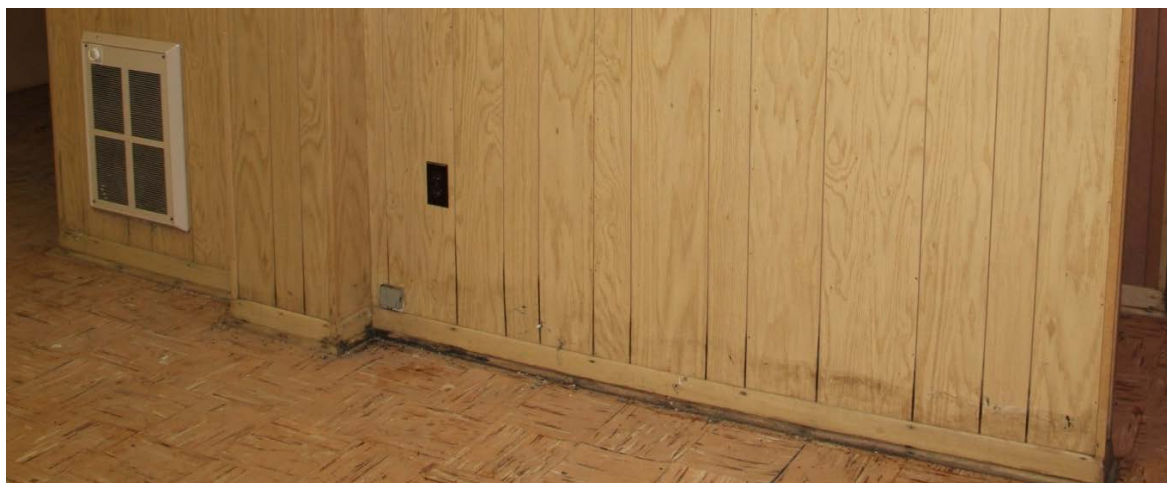
Figure 375. Water staining and bio-growth on the lower foot of the basement paneling. Photo: HPTC (06/20/12).

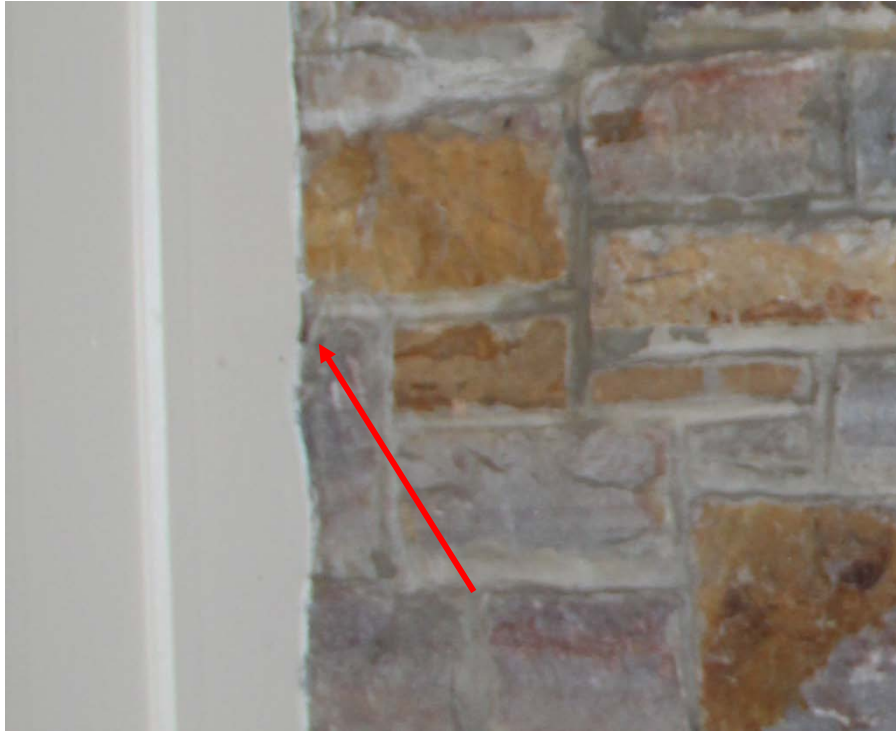
Figure 376. The "masonry seam sealant" between the stone wall and the wood wall is known to contain asbestos and is in poor condition. Photo: HPTC (06/12/12).

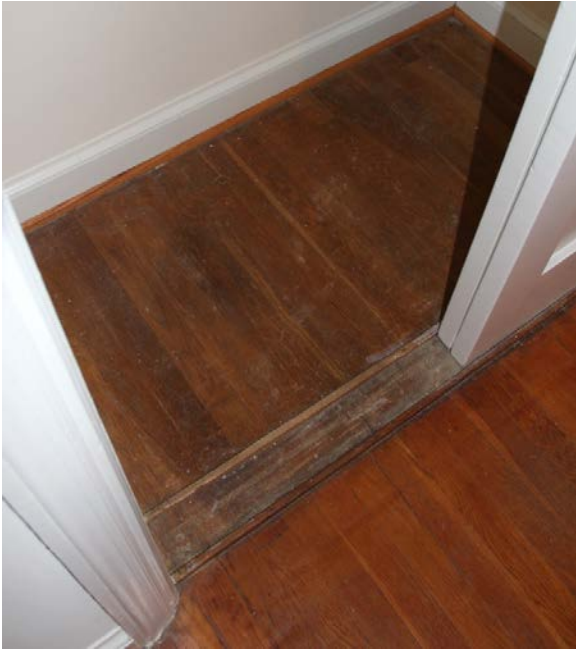
| C302003 Wood Flooring | |
|---|---|
| <p><i>Figure 377 and Figure 378, right.</i> The exposed oak-strip floors on the first and second floors are in a dull, but fair condition. Scratches indicate a lack of maintenance. Photo: 06/12/12.</p> | |

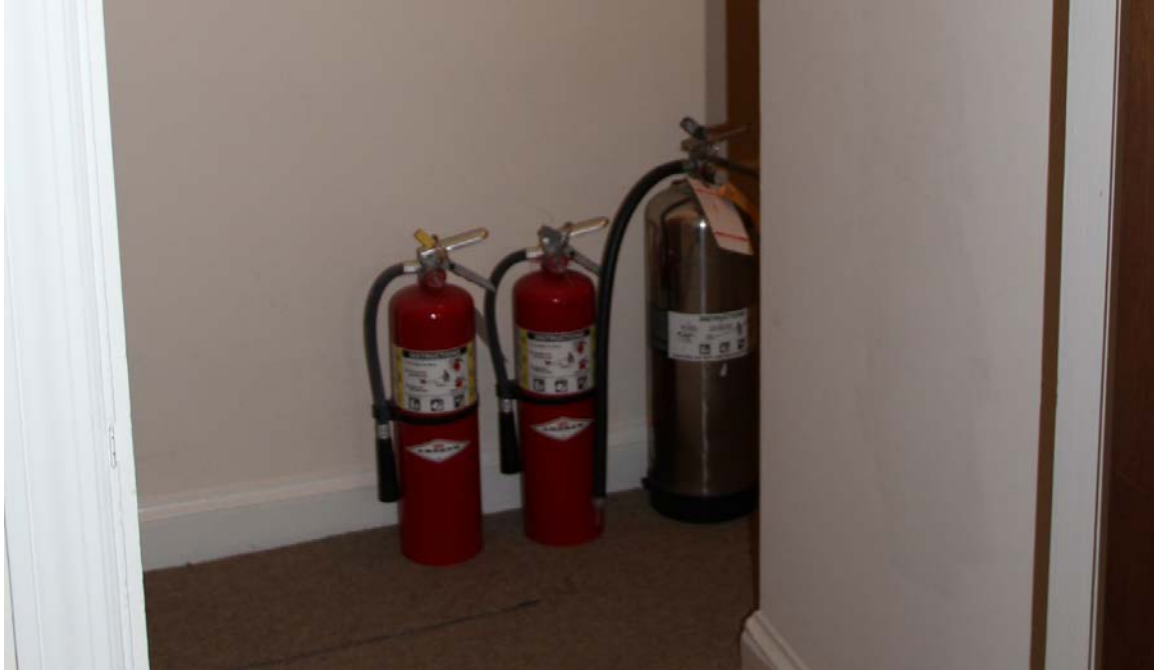
Figure 383. The fire extinguishers were not redistributed throughout Quarters 1 after they were last serviced. Photo: HPTC (06/12/12).

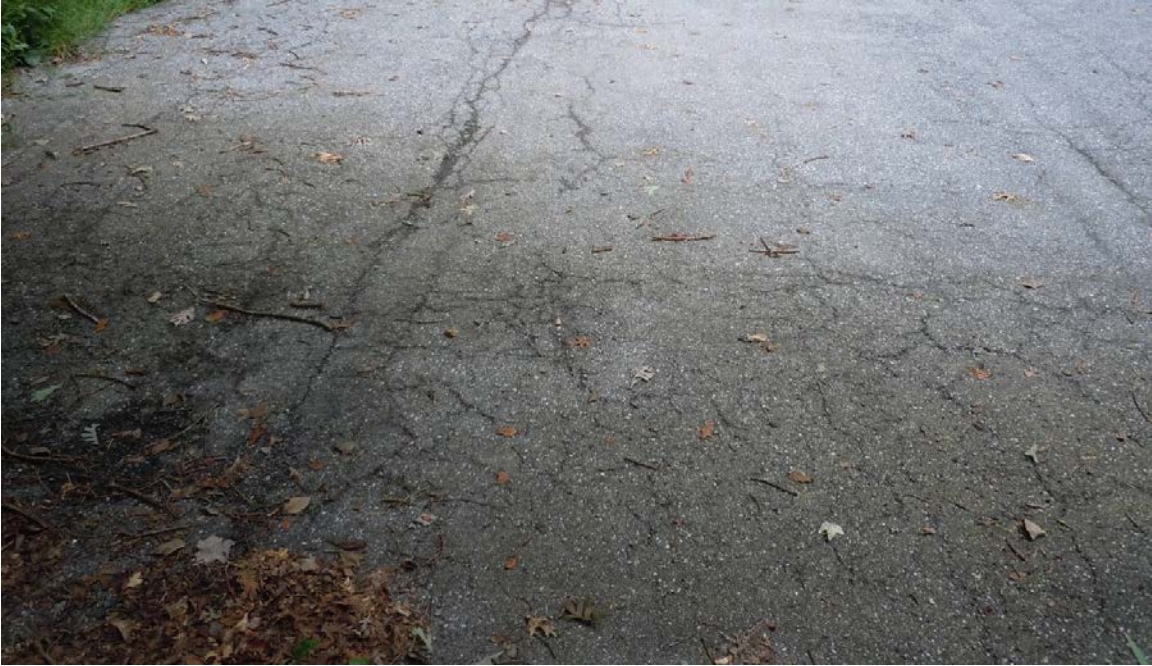
| <p><i>Figure 384. Minor cracking can be seen across the asphalt parking area. Photo: HPTC (08/29/12).</i></p> | |
