# Old Stone House

## Historic Structure Report FINAL DRAFT

Rock Creek Park  
Washington, DC

April 2013

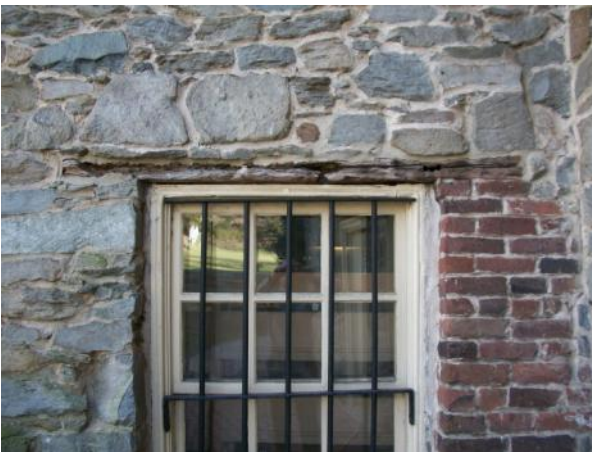
**Figure 84, above.** W103 degraded lintel and mortar above prior to rehab work. (NPS, 2012)

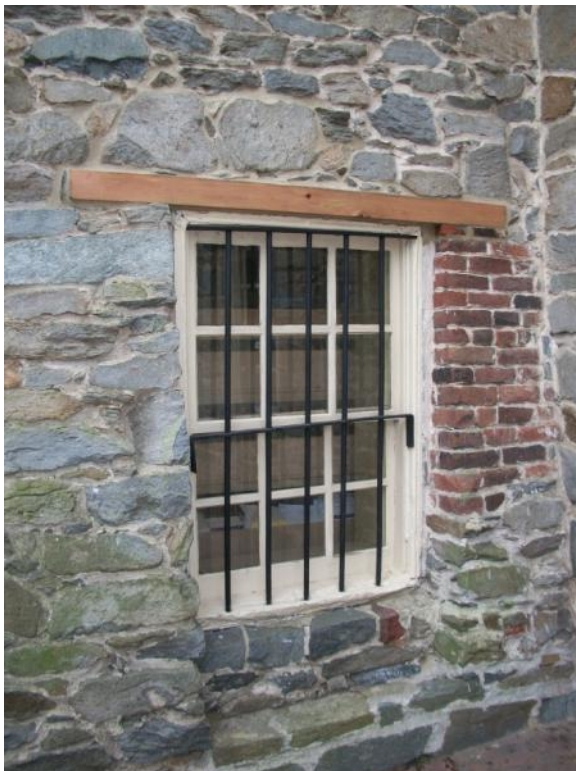
**Figure 85, right.** The same window with new lintel and repointed mortar above. (NPS, 2012)

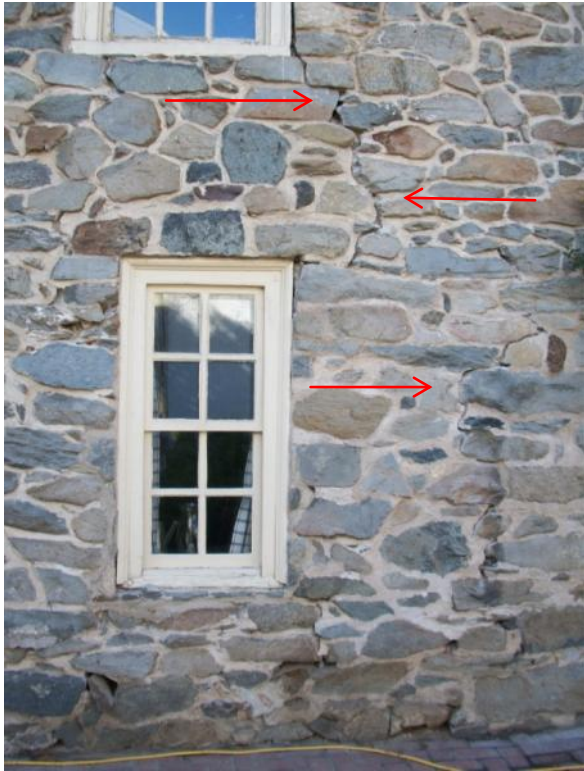
**Figure 86.** The east elevation of the north addition exhibiting a long crack, starting at the lower corner of W207 and running to the foundation, prior to repointing. (NPS, 2012)

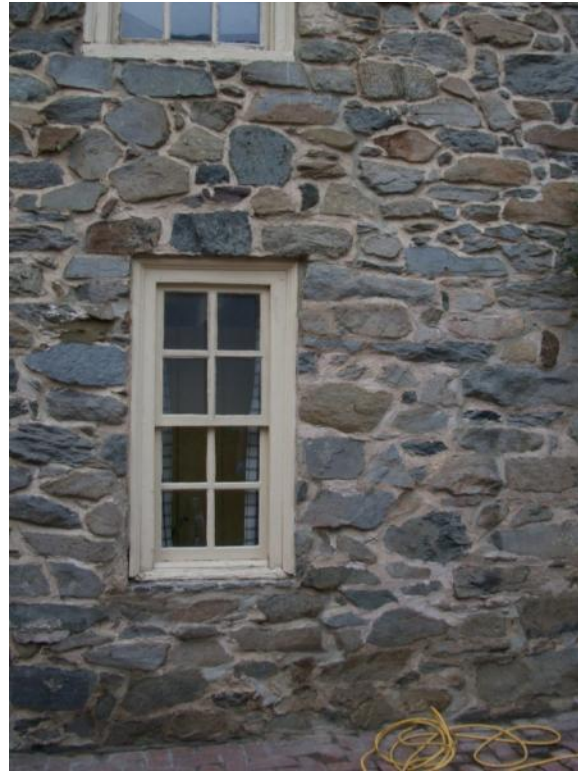
**Figure 87.** The same area after repointing work was completed. (NPS, 2012)

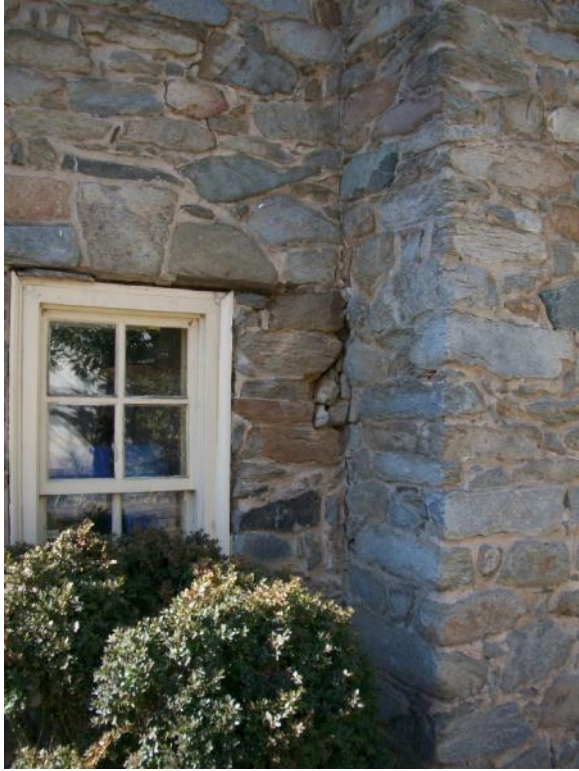
**Figure 90.** A crack runs along the junction of the chimney and the exterior wall. (NPS, 2012)

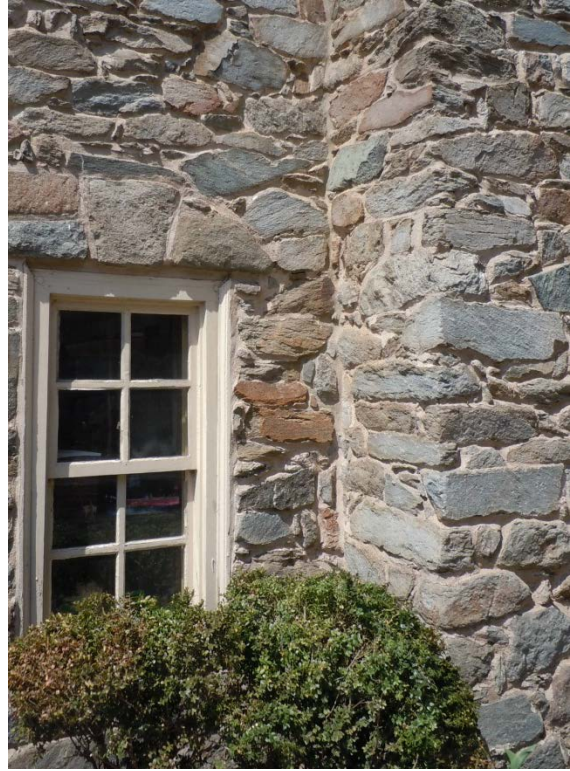
**Figure 91.** The same junction after repointing was completed. (NPS, 2013)

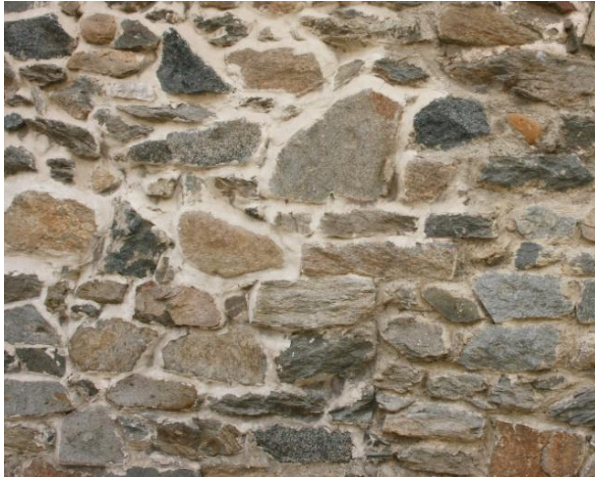
**Figure 114.** Bluestone masonry wall, west elevation. Some repointing is visible (upper left corner). (NPS)

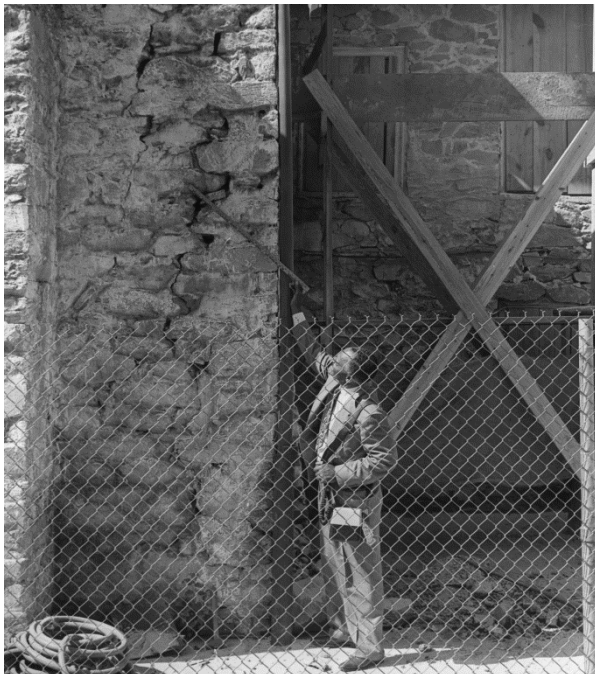
**Figure 116, left.** Detail of the east elevation of the main block in 1955. Note large crack adjacent to corner. (NPS, 1955)

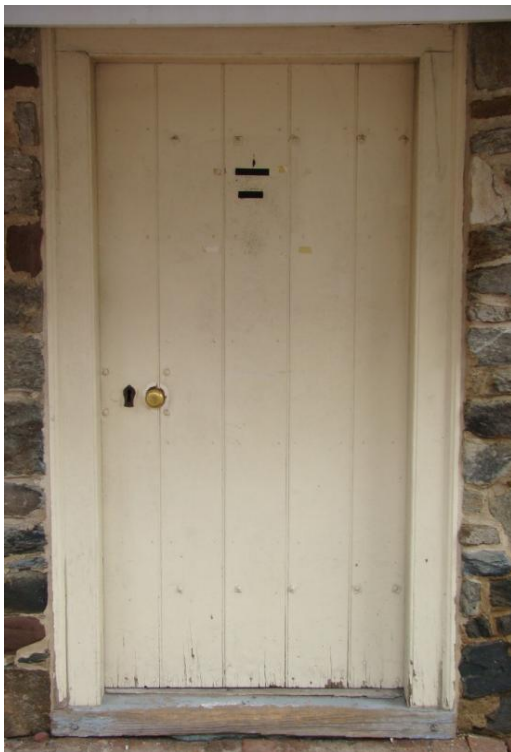
**Figure 139.** D101E. (NPS, 2011)

The doors and frames are in good condition, with no visible damage. Sills are worn down from visitor traffic; they are not original.

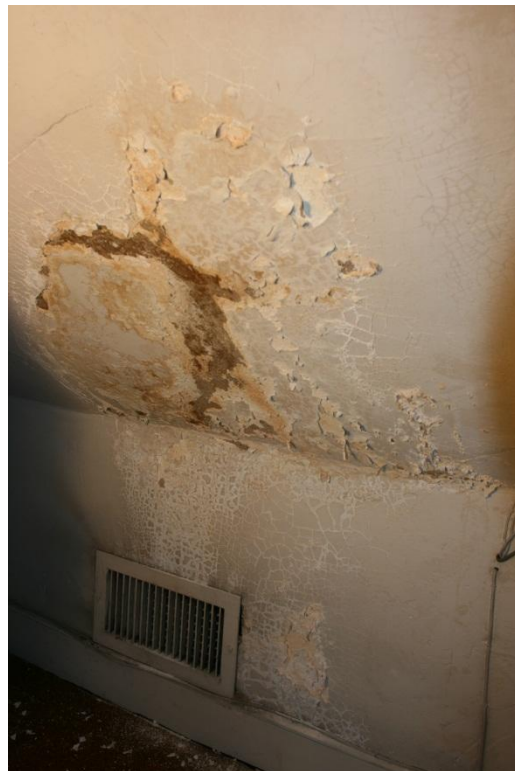
**Figure 200, right.** Plaster exhibiting previous water damage in Room 302; the cause has been remedied. (NPS)

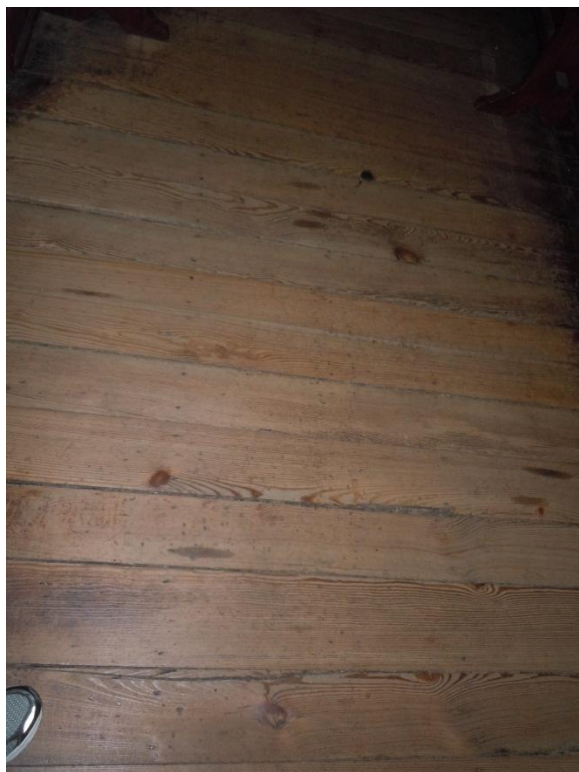
**Figure 204.** Random-width wood floor in Room 201A; note worn surfaces. (NPS, 2013)

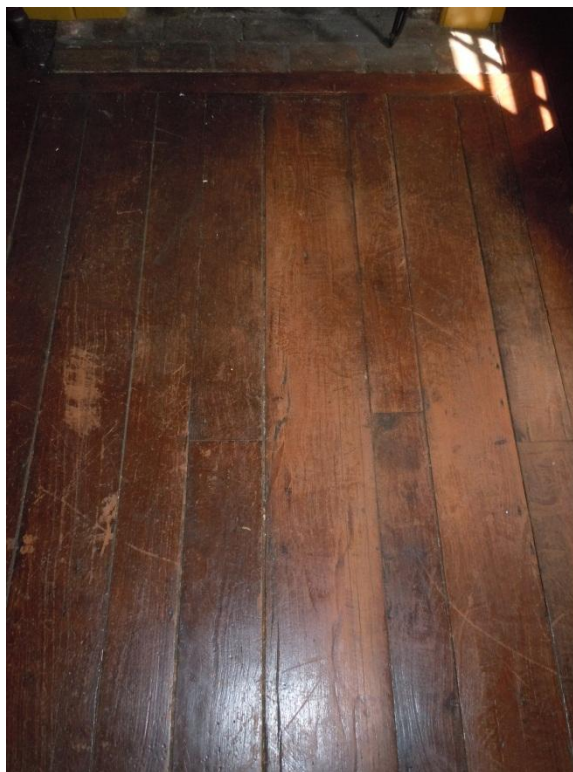
**Figure 205.** Random-width wood floor in Room 304; scratches can be seen across the surface. (NPS, 2013)
